LLNL-TR-648143

A Visual Description of the Concrete Exterior of the Cactus Crater Containment Structure

Terry Hamilton

October 2013

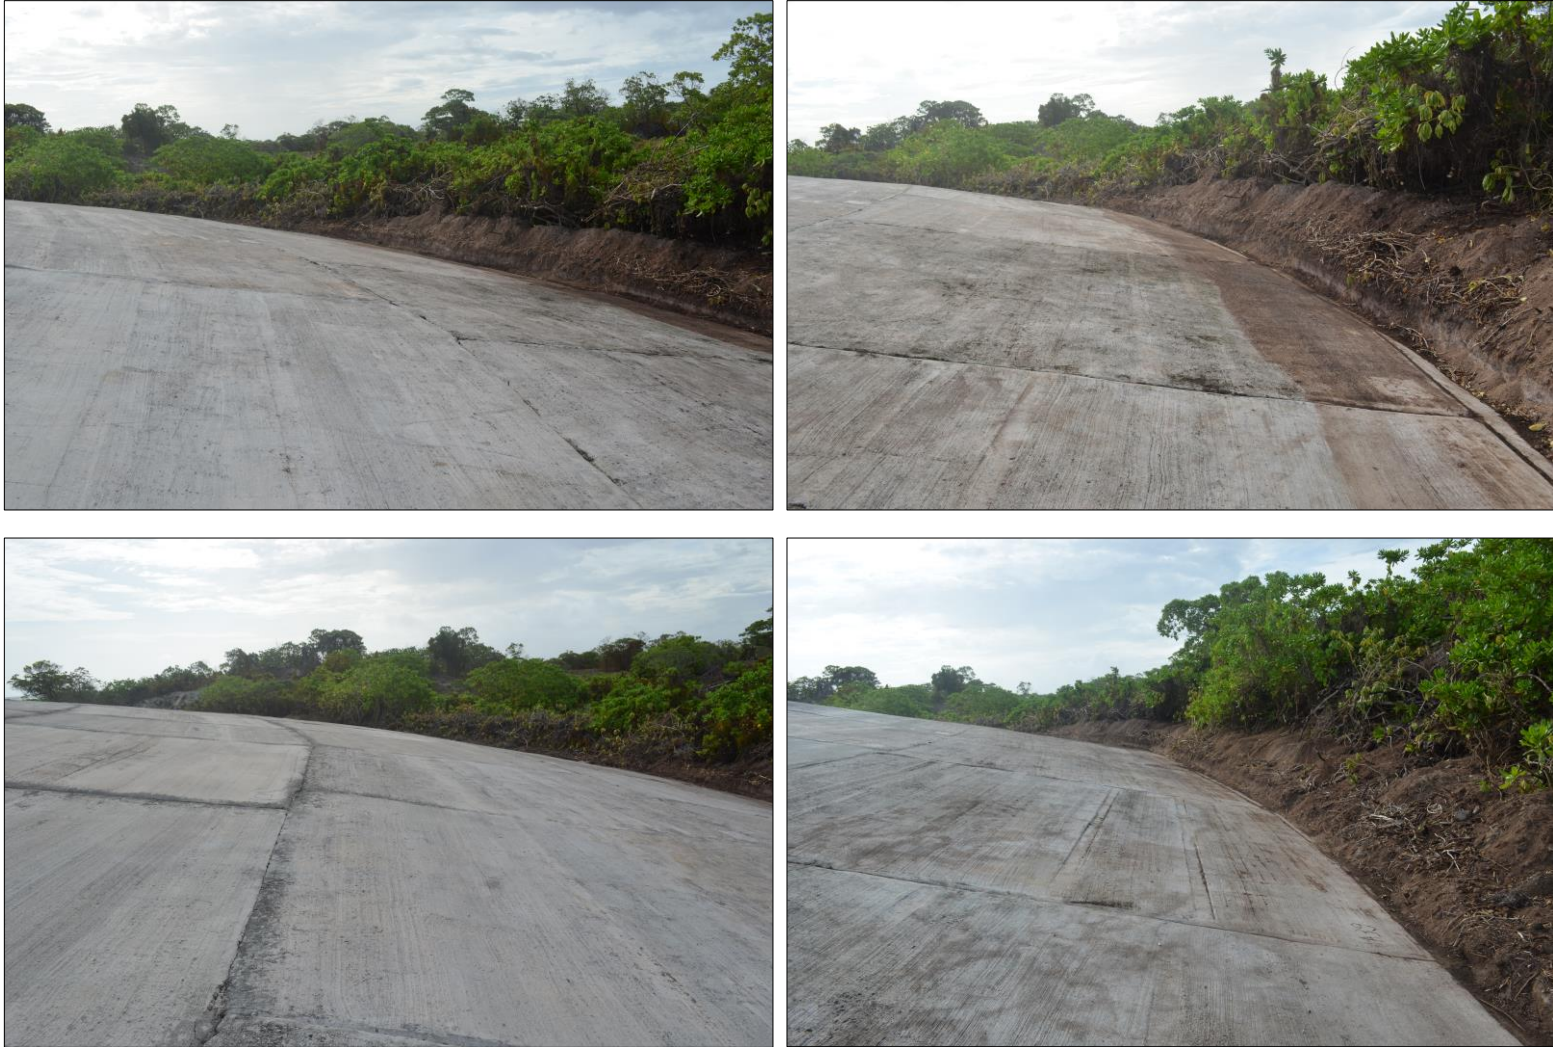
Fig 12. Vegetation growth over the face of *Runit Dome* (Initial conditions, Visual Survey, May 2013).

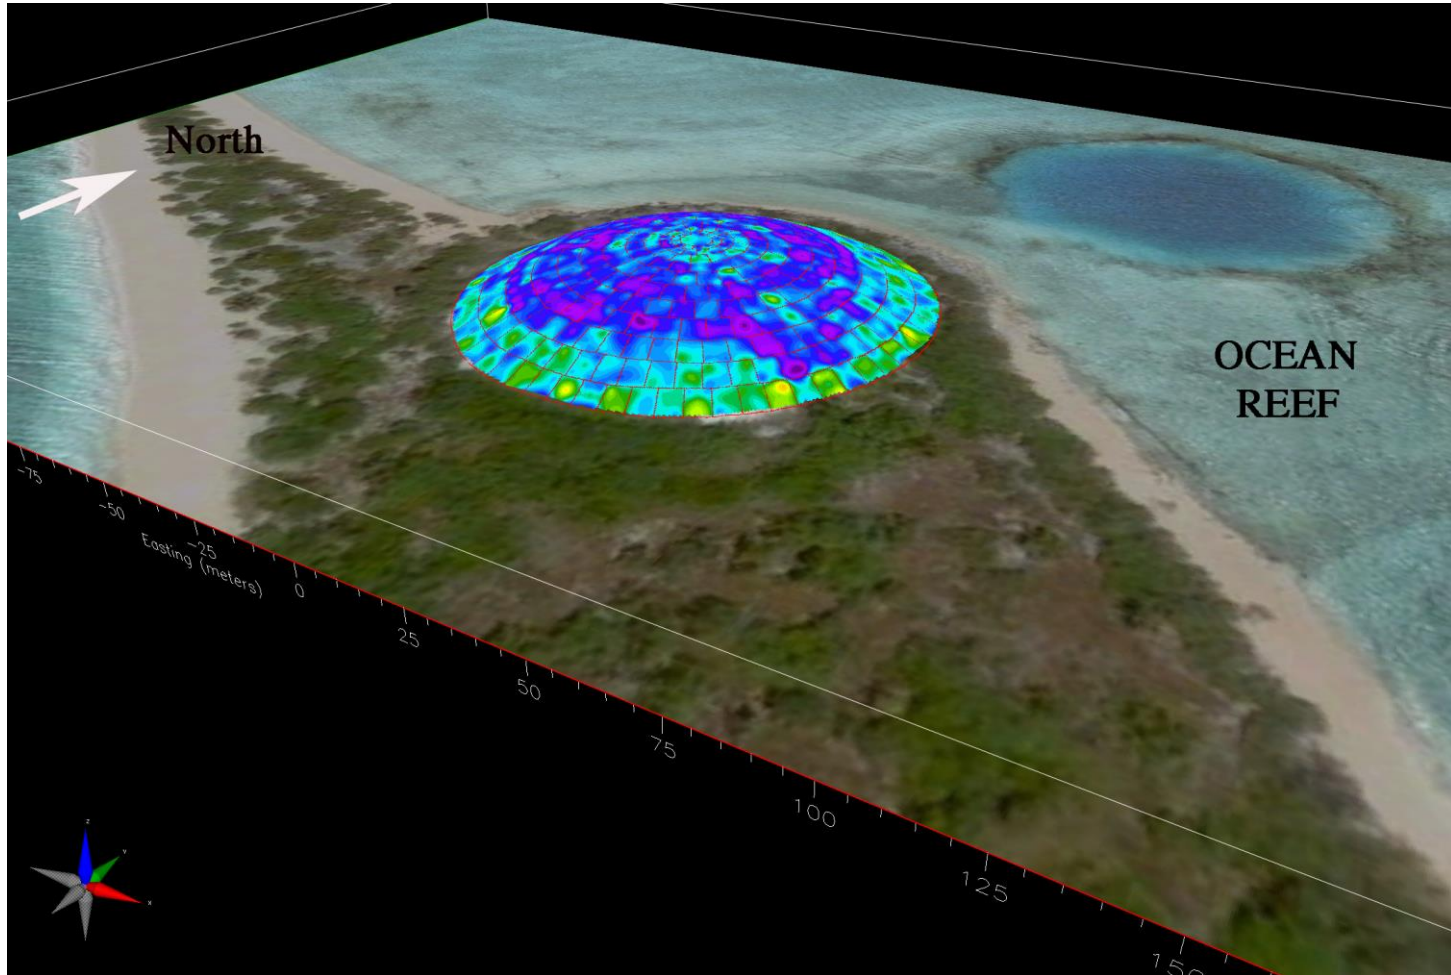
The design thickness of the concrete cap was 45 centimeters (DNA, 1981). The IE and SASW tests indicate that the majority of the concrete is in a structurally “sound” condition but the thickness of the cap is highly variable. The average thickness of the concrete cap was measured at 43 centimeters

Fig. 42. A Google map image showing a contour-plot overlay of the relative thickness of the concrete cap covering *Runit Dome (Impact Echo (IE) measurements with the thinnest areas around the middle of the dome represented in a darker bluish, purple shade)* [compiled from data collected by Olsen Engineering, Inc., Visual Survey, May 2013].

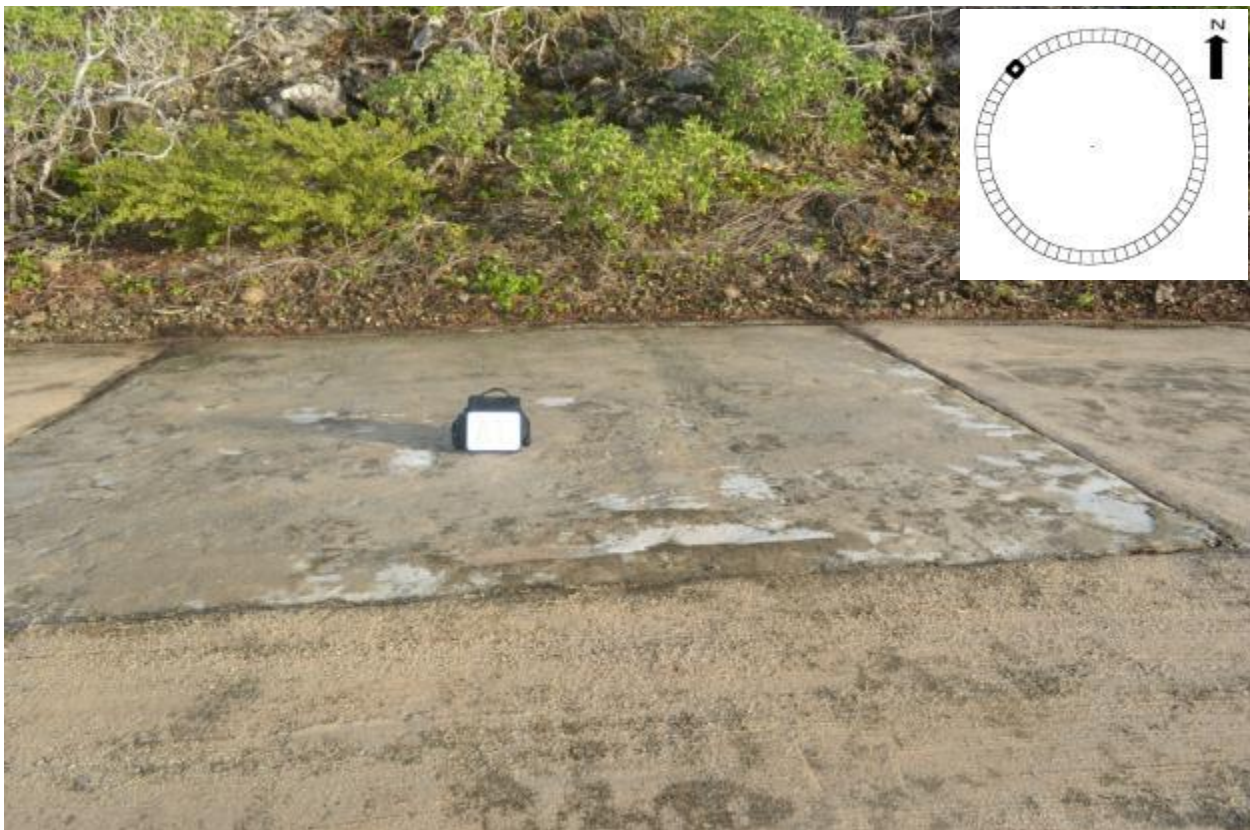
CAP SECTION LOCATION: Panel A2

Some rooting vegetation removed from along the panel seams. There is significant spall of concrete (about 2-3 meters wide, and up to 5-10 centimeters deep) running along the bottom seam adjacent to the keywall.

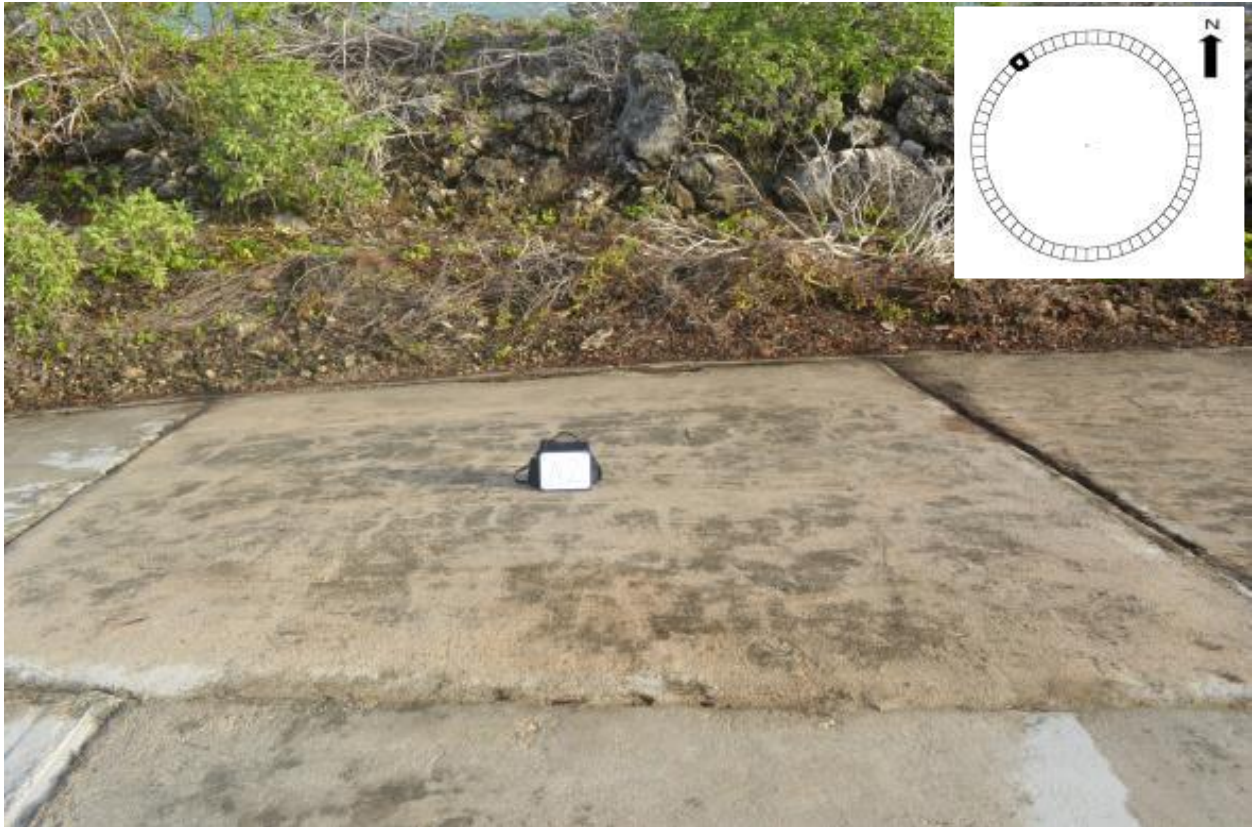
CAP SECTION LOCATION: Panel A3

No significant or obvious interior cracks extending across the top of the panel. The panel has a rough and weathered appearance. Some rooting vegetation removed from along the seams. Some minor spalling/chipping of concrete in the upper left-hand corner of the panel.

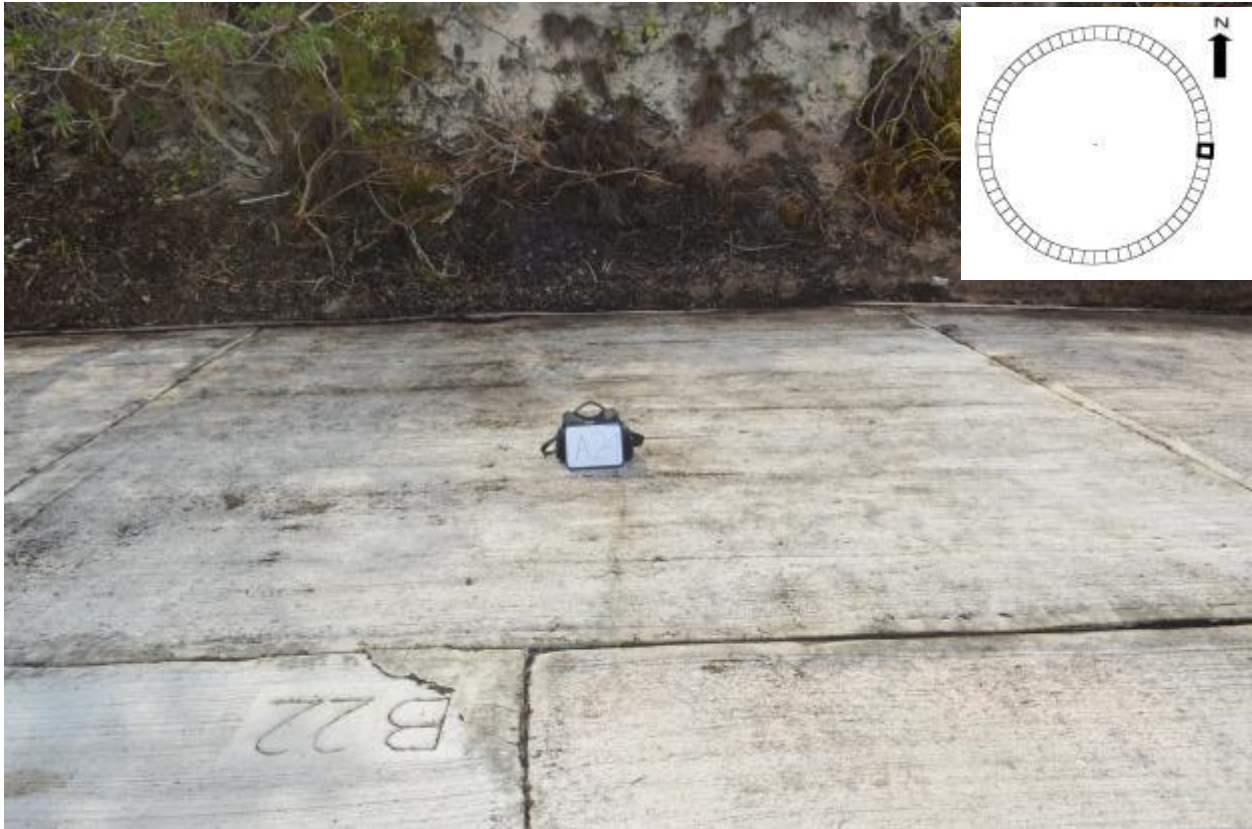
CAP SECTION LOCATION: Panel A25

The panel has a rough and weathered appearance. A significant spall of concrete is visible along the seam adjacent to the keywall (several centimeters deep, and about 80 x 30 centimeters in area).
