# Debris Flow from 2012 Failure of Moraine-Dammed Lake, Three Fingered Jack Volcano, Mount Jefferson Wilderness, Oregon

Scientific Investigations Report 2014–5208

By David R. Sherrod and Barton B. Wills

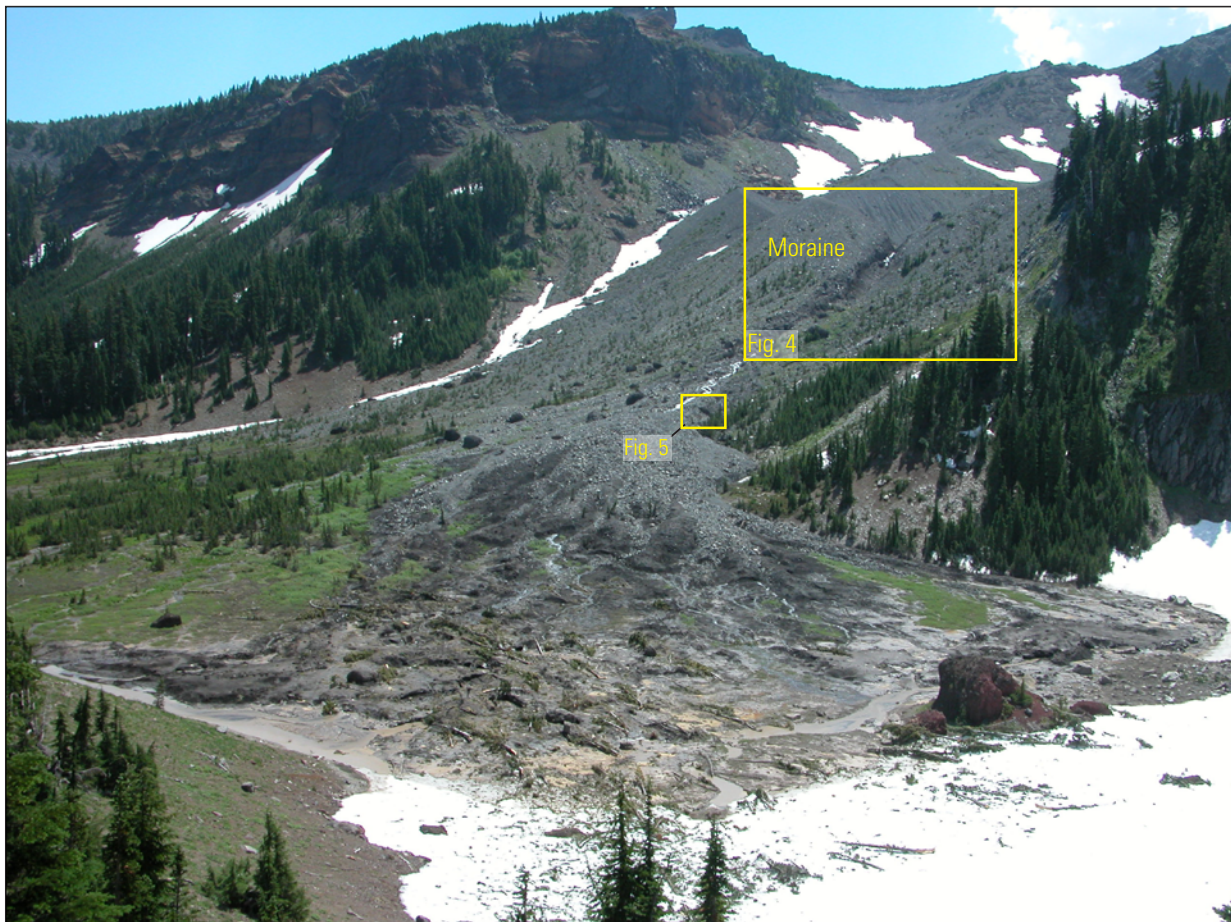
In the late spring or early summer of 2012, a flood emanated from a small moraine-dammed lake on the northeast flank of Three Fingered Jack in the Mount Jefferson Wilderness. Channel erosion or slope collapse breached the natural dam of the lake, leading to a sudden lowering of lake level by 2.8 m and discharge of 12,700 cubic meters (m<sup>3</sup>) of water. The resulting debris flow formed a bouldery deposit extending about 0.35 km downslope (fig. 1).

**Figure 1.** View south-southeast across debris-flow deposits to neoglacial moraine, 500 m distant. Prominent bedded vent deposits on central skyline form the east flank of Three Fingered Jack volcano, summit of which is out of view to right (west). Yellow boxes outline areas of figures 4 and 5. Author photo DSCN0097, Aug. 6, 2012.

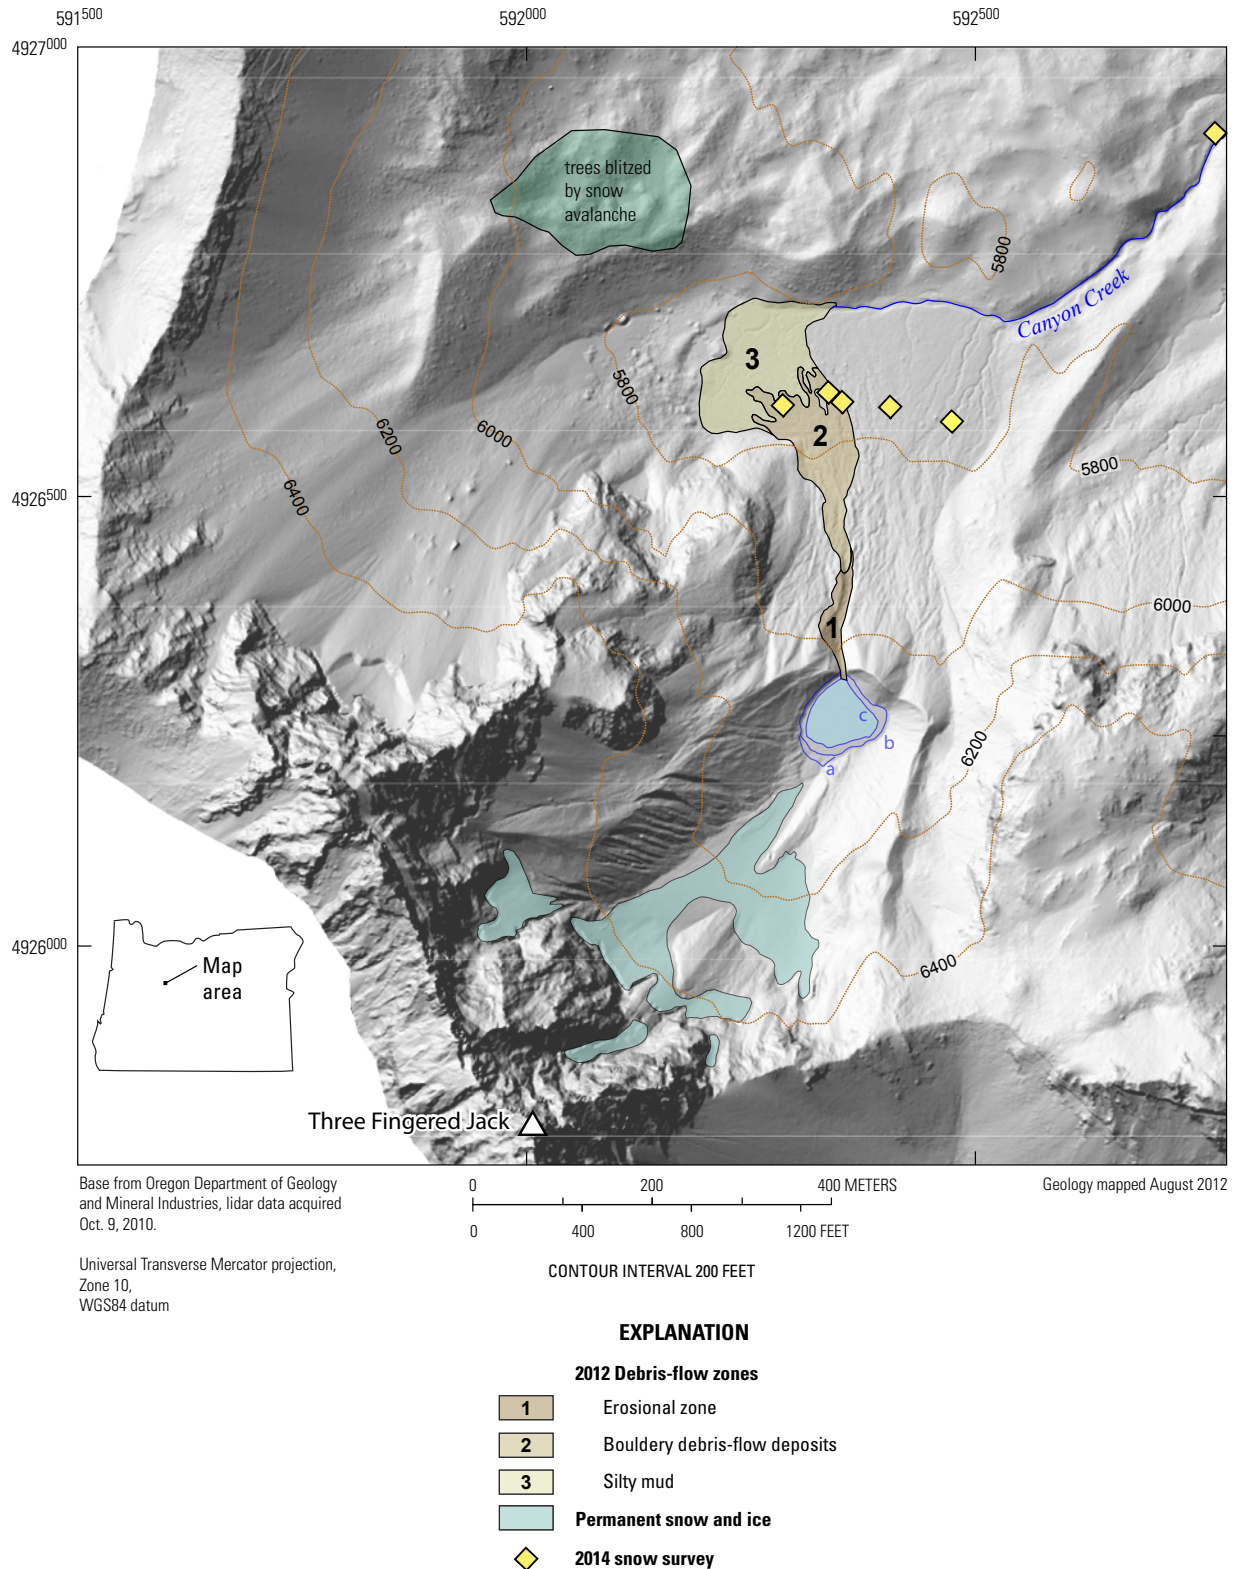
The 2012 debris flow swept northward about 350 m from the lake to its distal margin (fig. 2); related silty mud extends another 80 m. The area affected, about 2.63 ha (6.50 acre), is divided into three zones on the basis of deposit characteristics. Zone 1 is an upper erosional zone inset into the narrow lake-outlet canyon. No deposition occurred in zone 1 during the 2012 event; instead, near-vertical and freshly eroded canyon walls, which are formed of nonindurated till, suggest the debris flow entrained most of its sediment here as the canyon walls collapsed (fig. 4).

**Figure 2.** Map showing distribution of 2012 debris-flow deposit from moraine-dammed lake failure on northeast flank of Three Fingered Jack, Cascade Range, central Oregon. Lake extent is that of 2012 (shoreline c); shoreline 'b' is traced from lidar (2010); and shoreline of 1993 (labeled 'a') (O'Connor and others, 2001) coincides with 2010 shoreline except in southern part. Shift from shoreline 'a' to shoreline 'b' is driven mainly by prograding alluvial fan. Hillshade map provided courtesy of Ian Madin, Oregon Department of Geology and Mineral Industries; lidar acquisition date October 9, 2010. Topographic contours shown for altitudes from 5,800 to 6,400 ft, at 200-ft interval, from Three Fingered Jack quadrangle (U.S. Geological Survey, 1988).

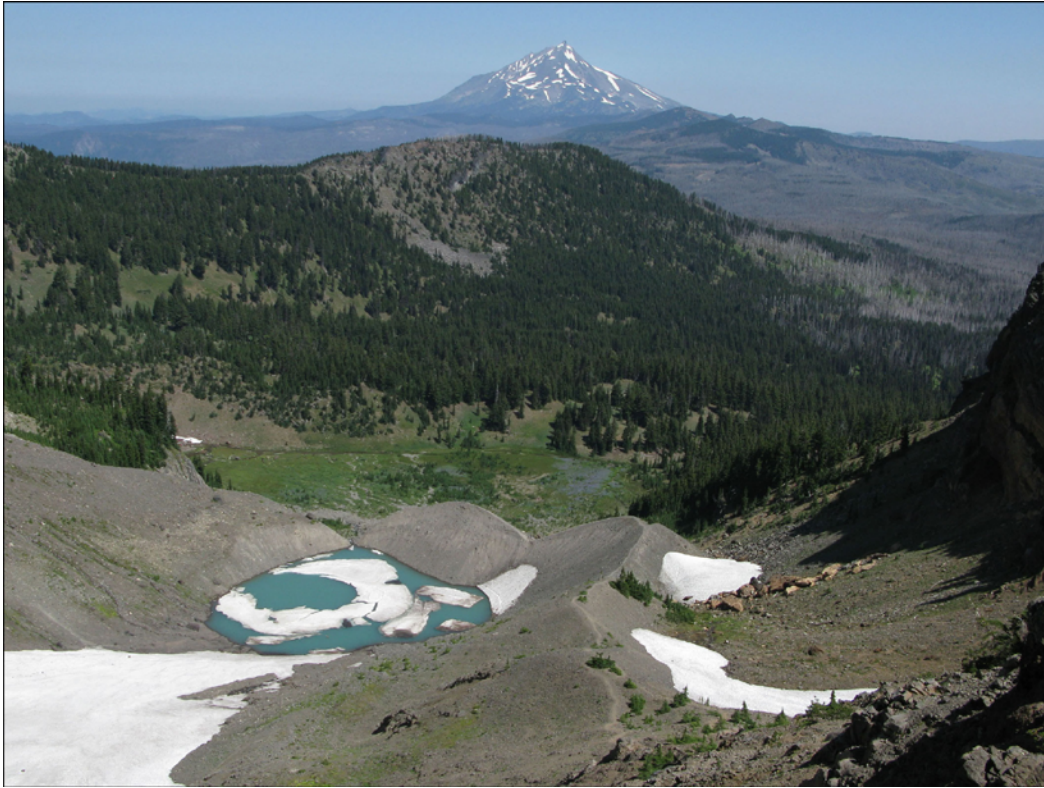
**Figure 3.** Cirque lake and lateral and terminal moraines on northeast flank of Three Fingred Jack. In distance 22 km north-northeast is Mount Jefferson (3,200 m; 10,497 ft). Altitude difference between lake and meadow is 85 m (280 ft). Stream from lake flows along left edge of meadow (track of 2012 debris flow), then right along north edge of meadow, to where it enters the canyon of Canyon Creek. Photo IMG\_0847 taken Aug. 3, 2009, by Ken Bevis, used with permission.

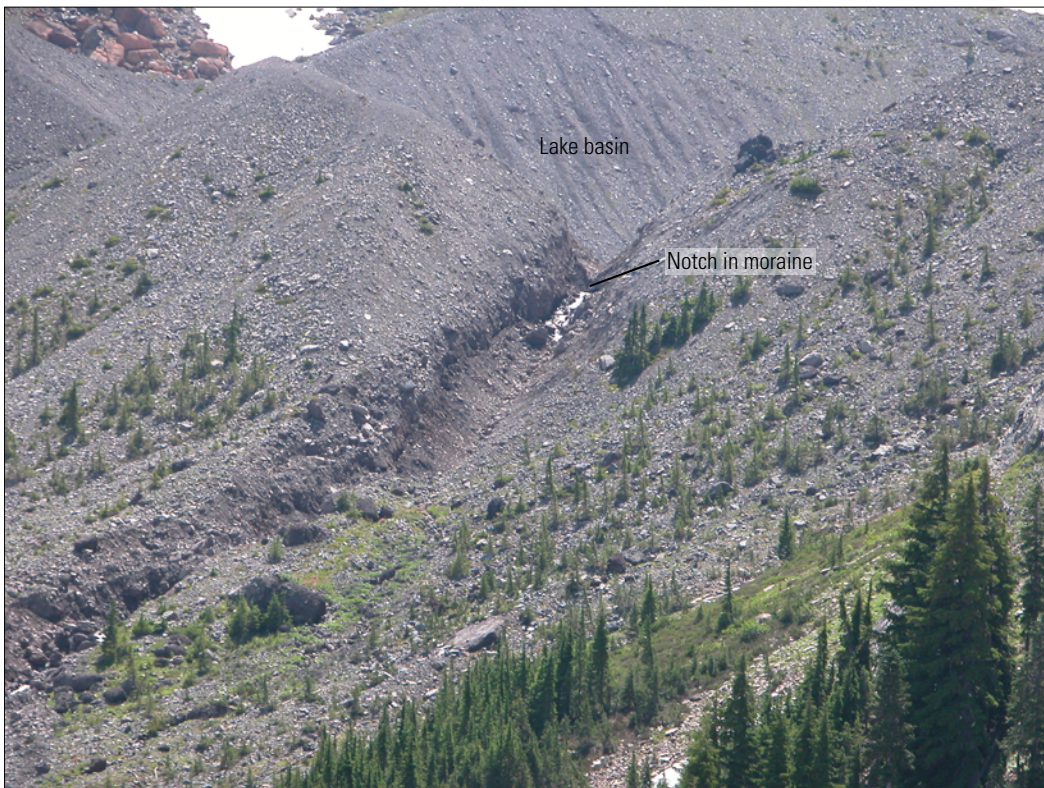
**Figure 4.** View south-southeast into canyon that heads at moraine-dammed lake. Oversteepened canyon walls are consequence of 2012 lake breakout. Author photo DSCN0098, Aug. 6, 2012.

A triggering event may have been as simple as the undermining and erosion of one or two large boulders that armored the stream channel; or perhaps a landslip from the moraine face at or just below the lake outlet. The channel walls of the canyon leading downslope from the lake are susceptible to rapid erosion, so even a shallow nick into the natural dam could quickly lead to deluge. The debris-flow deposit shows no evidence for lengthy interlude during its emplacement.

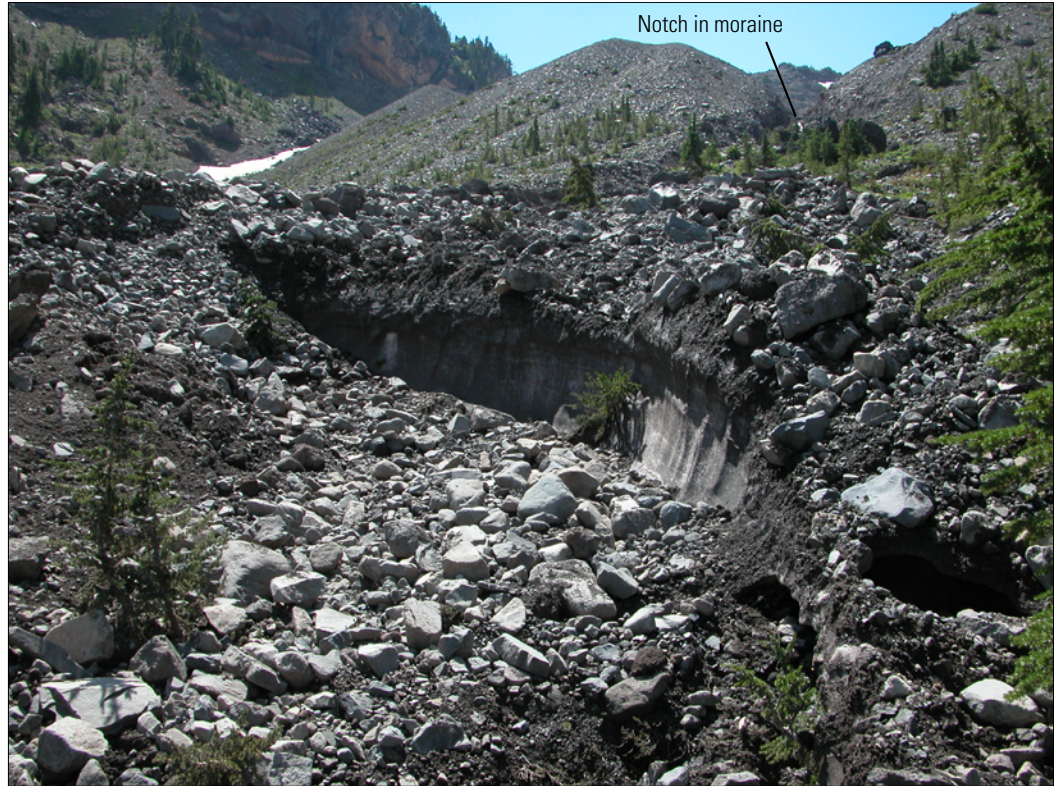
**Figure 5.** Bouldery debris-flow deposit atop 1.5 m of snow, winter 2011–12 snowpack. Author photo DSCN0091, Aug. 6, 2012.

Snow and ice about 1.5 m thick underlay the debris-flow deposit on the alluvial fan of zone 2 in late July 2012. This relation, exposed by thaw and stream erosion, indicates the debris flow was a late spring or summer event, occurring after the winter snowpack was well developed and already wasting. Mud coatings, some of them delicate, are preserved on shrubs in zone 3 of the deposit, and the mud trimline that rings the hillslope adjacent to zone-3 deposits suggests no substantial new snowfall occurred subsequently, the melting of which would have rinsed away some of the mud.

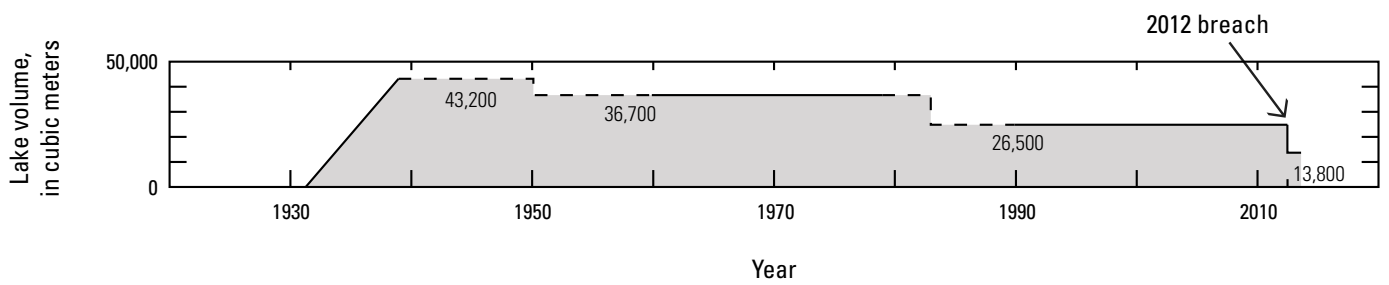
The moraine-dammed lake in the northeast cirque of Three Fingered Jack was never large. Lake volume soon after ice retreat was an estimated  $43,000 \text{ m}^3$ . The volume then decreased stepwise following dam failures, the first before 1960 (to  $37,000 \text{ m}^3$ ) and another between 1977 and 1983 (to  $26,500 \text{ m}^3$ ; fig. 6; O'Connor and others, 2001). The 2012 breach cut the lake volume to  $13,800 \text{ m}^3$ , or about one-half the volume of the lake that had existed since the early 1990s (table 1). Today the lake holds only about one-third of its historically largest volume.

**Figure 6.** Time-volume graph for moraine-dammed lake on northeast flank of Three Fingered Jack. From O'Connor and others (2001), modified to show loss from 2012 breach.

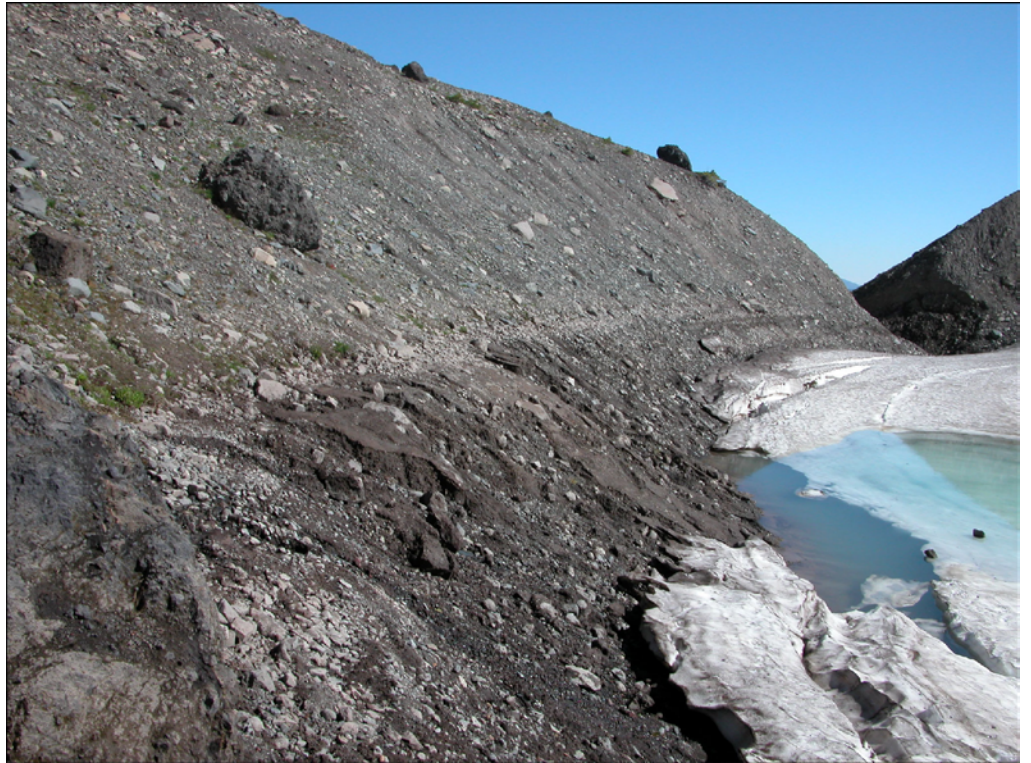
When seen in August 2012, the lake's water level stood 2.8 m lower than an older prominent shoreline, and the slope between the shorelines was barren of vegetation and coated by mud (fig. 7). Higher up, the slopes host scattered alpine herbs and sparse prostrate shrubs. This older shoreline corresponds to the lake level that existed in the years following the 1993 O'Connor-Hardison survey (O'Connor and others, 2001). Its persistence through nearly two decades is shown by the near coincidence of the 1993 surveyed shoreline and a shoreline mapped from 2010 lidar data (shorelines a and b, respectively, on fig. 2). The 1993 shoreline is well developed on the western and eastern sides of the basin. It is poorly preserved along the south side where an alluvial fan extends into the lake, fed by sediment deposited from seasonal melting of the perennial snowfield. Shoreline preservation is nil on the north or northeastern side where the terminal moraine slopes steeply into the lake. For reference purposes, this older shoreline is taken as a datum ("0-m shoreline"), since it was the lake level of the only previous survey. The August 2012 lake surface becomes the -2.8-m shoreline.

**Figure 7.** View north along west side of lake. August 2012 lake level fell 2.8 m from prominent 1993 shoreline, which persisted at least through 2010 lidar acquisition date. Alpine vegetation dots the slope above the 1993 shoreline, whereas slope is devoid of vegetation and coated by mud below. Author photo DSCN0028, Aug. 6, 2012.

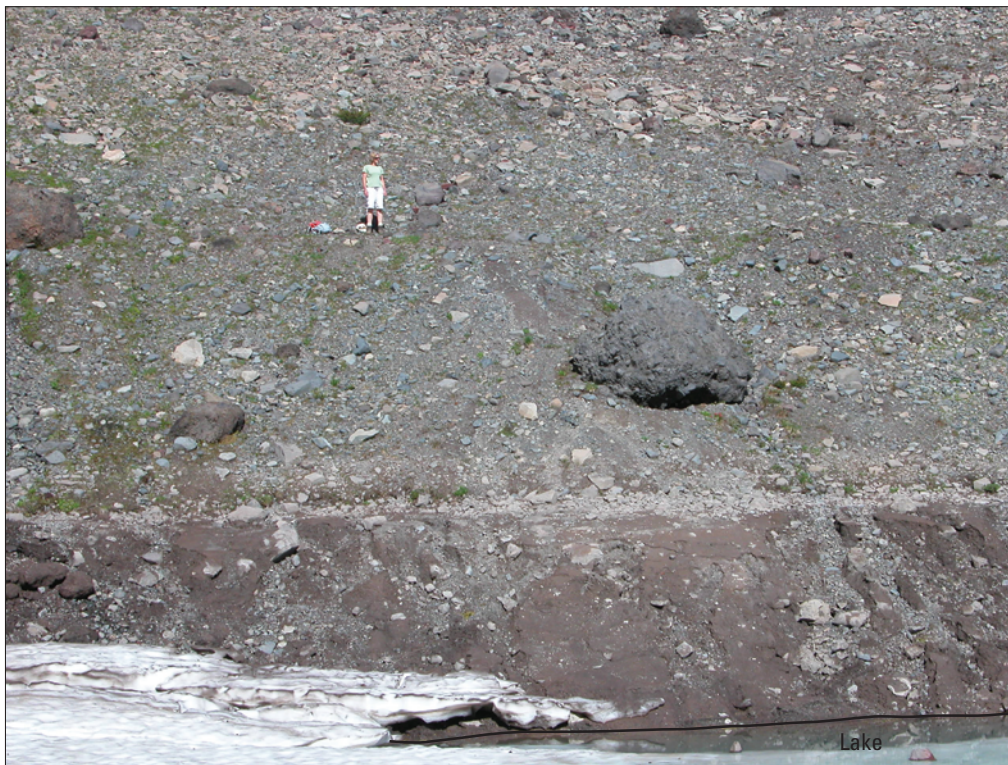
Pre-1993 lake shorelines are also evident on the west side of the lake. They are characterized by exceedingly narrow benches (beach-backslope morphology). Two of these shorelines were mentioned by O'Connor and others (2001): 1.8 m and 2.6 m above the early 1990s shoreline; positional error reported as  $\pm 0.1$  m. The most prominent paleoshoreline stands 6 m above the early 1990s shoreline (fig. 8).

**Figure 8.** Highest(?) shoreline on west side of lake, 6 m above 1993 shoreline and 8.8 m above August 2012 lake. Woman for scale is 1.8 m tall. Author photo DSCN0034, Aug. 6, 2012.

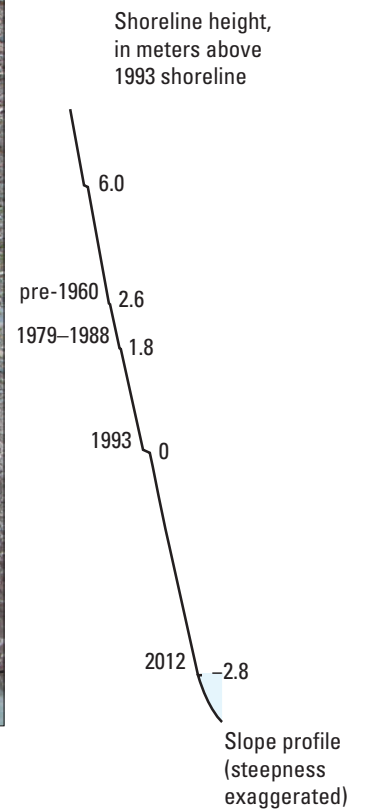
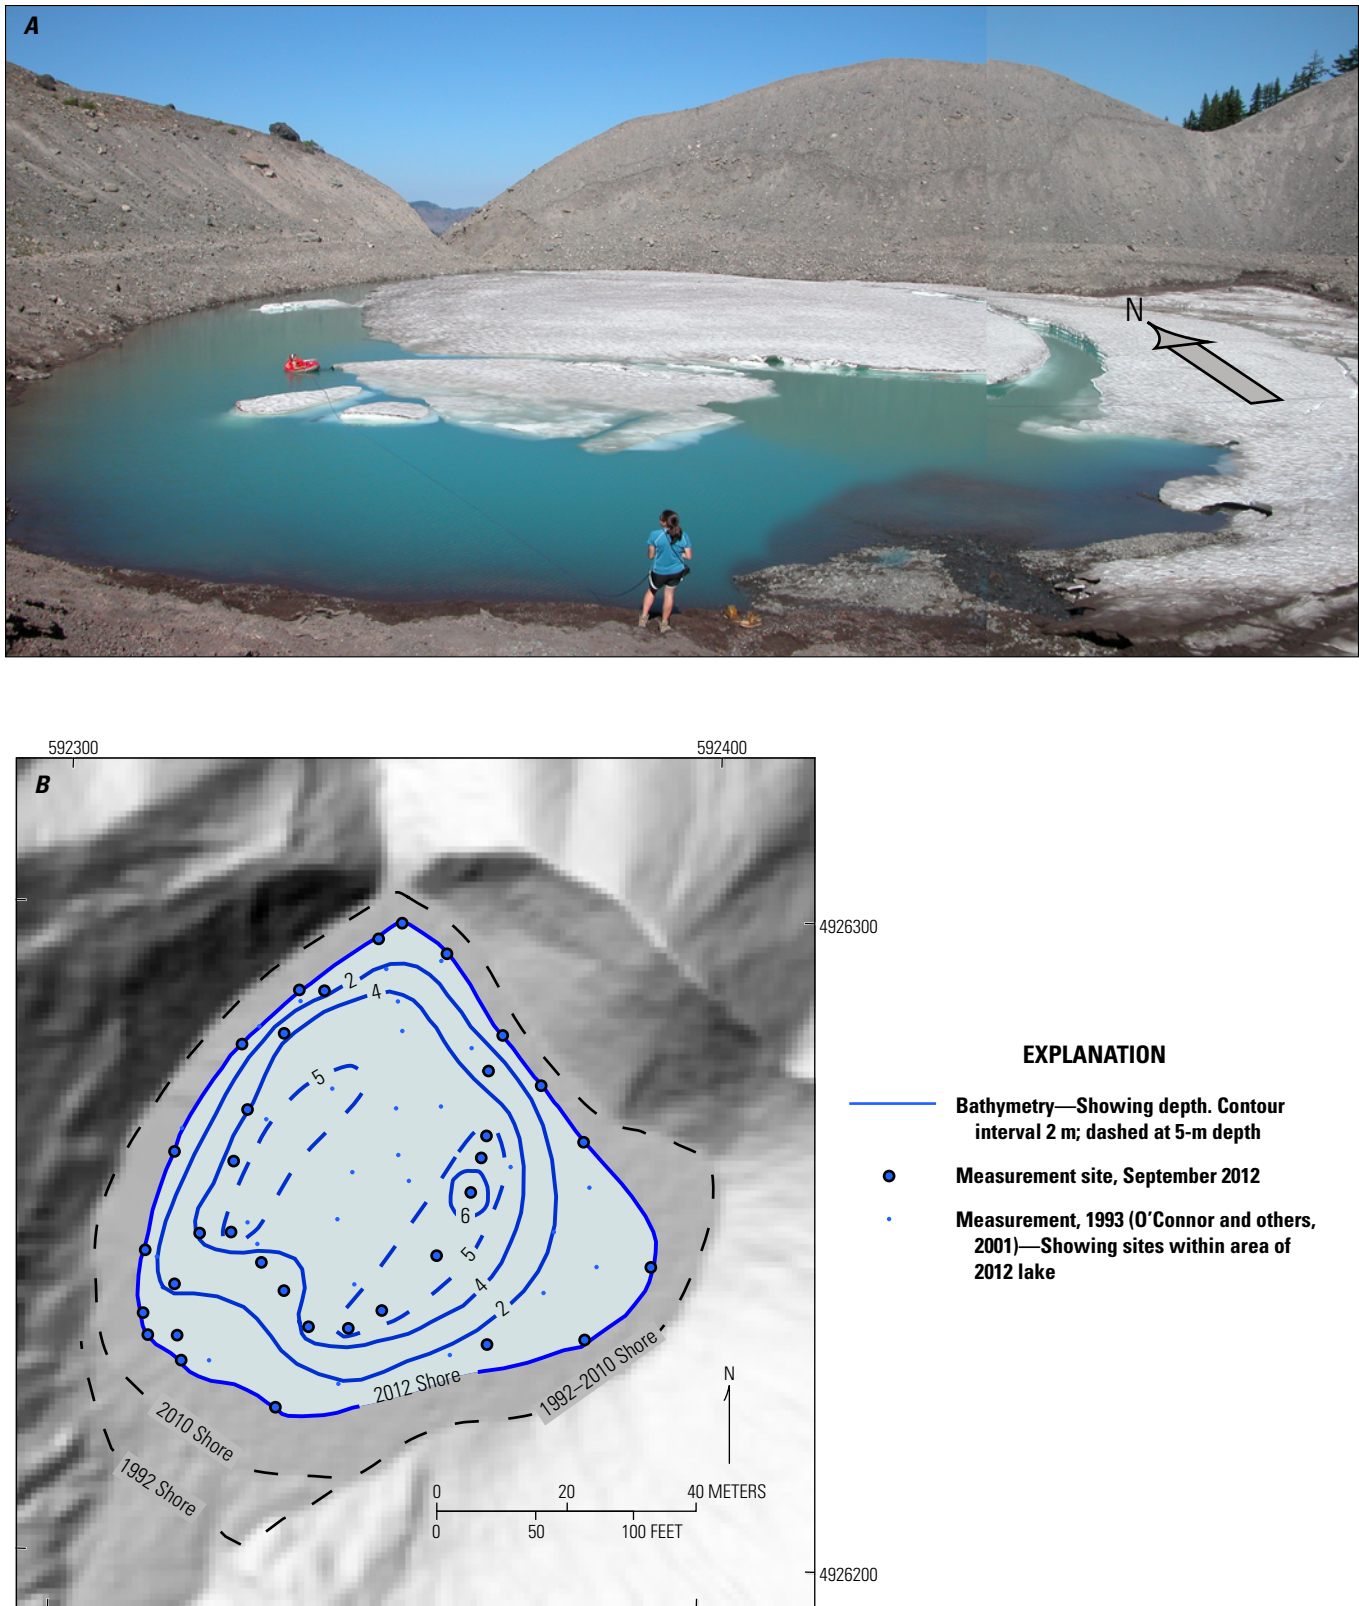
A lake-depth survey in September 2012 was limited by thick ice pack that remained on the lake throughout the summer (fig. 9A). The resulting bathymetric map (fig. 9B) relies in part on measurements from the 1993 survey (O'Connor and others, 2001) adjusted by subtracting the 2.8 m of depth drained by the 2012 moraine failure. This method does not account for 1993–2012 sedimentation. Depths plumbed during the 2012 survey were as great as 6 m.

**Figure 9.** Lake depth survey of September 7, 2012. *A*, Data were gathered by floating with leadline (for depth) and reflector prism; positional control by total-station measurements to the prism. Survey was hindered by unusually persistent late-summer lake ice. Author photo is mosaic of two frames from different vantages. *B*, Bathymetric map, drawn by combining 1993 and 2012 measurements. Base from 2010 lidar survey; Universal Transverse Mercator projection, zone 10N, datum WGS 1984.

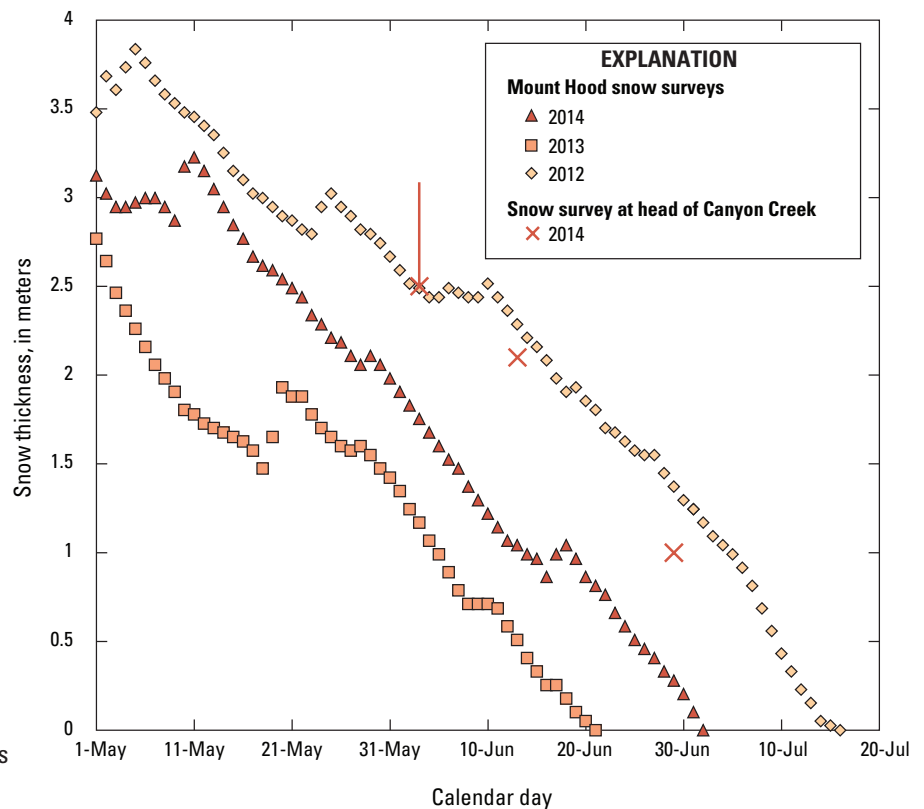
A notable trend on the snow thickness plot shows nearly linear wasting of snowpack—thinning at rates of 6–9 cm per day, and pausing only during inclement weather. Limited data from the 2014 snow survey at the head of Canyon Creek (X symbols on fig. 10) suggest a similar thinning rate. Also, the Canyon Creek 2014 snowpack was as much as 0.5 m thicker than that at Mount Hood site 651. As a field observation, when the snow at Three Fingered Jack was 1 m thick during our 2014 survey (June 30), snowpack still fully blanketed the lake, the meadows downslope of the lake, and the narrow canyon of Canyon Creek, down to an altitude of 1,710 m (5,600 ft) (see 2014 snow survey point in far-right corner of fig. 2). We surmise a similar setting characterized the area at the time of the moraine dam failure in 2012.

**Figure 10.** Snow thickness plot. Mount Hood data are from SNOTEL Site 651 for May, June, and July of years 2012–14, courtesy of Natural Resources Conservation Service ([www.wcc.nrcs.usda.gov/snotel/Oregon/oregon.html](http://www.wcc.nrcs.usda.gov/snotel/Oregon/oregon.html)). Data for head of Canyon Creek show measurements augered by us on June 3, 13, and 29 of 2014. The June 3 measurement failed to penetrate snowpack entirely; line upward from its value emphasizes range of likely thickness. Lengthy spans with near-constant slope correspond to snowpack thinning at rates of 6–9 cm per day.

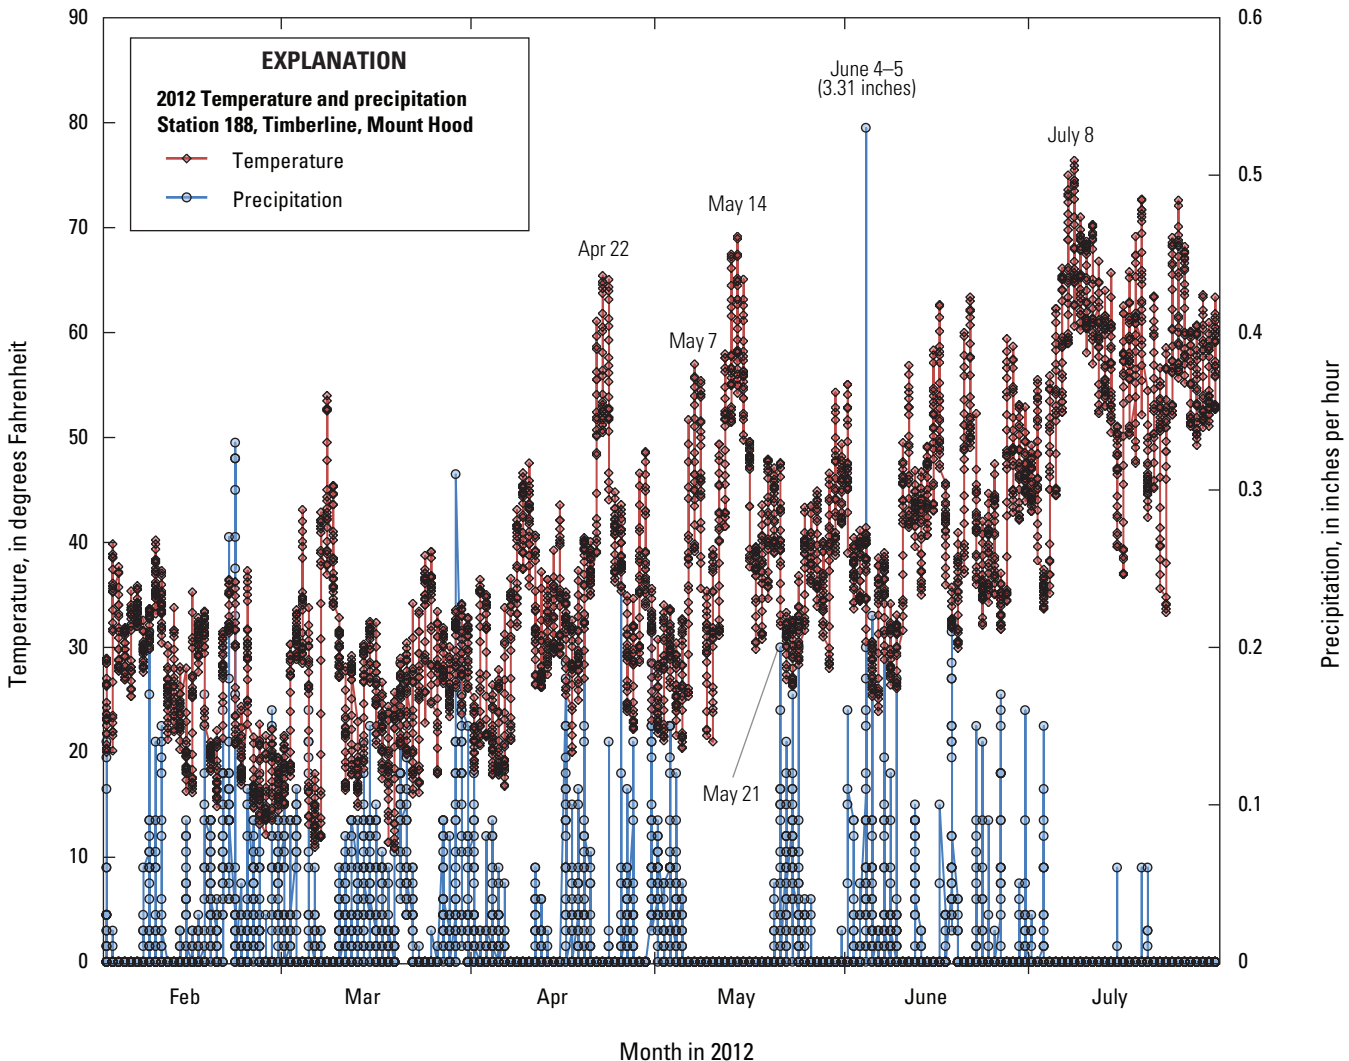
Since high-altitude weather stations are lacking in the Mount Jefferson Wilderness, the records shown here are for a station at 1,830 m (6,000 ft) on Mount Hood (Timberline), 95 km to the north, courtesy of the Northwest Weather and Avalanche Center. The Timberline data (fig. A1) show a spate of warm temperature readings (daytime highs of 75°) beginning on July 7. Previous temperature spikes lasting for a day or two occurred on May 14, May 7, and April 22. For precipitation, a notable storm hit the Mount Hood area on June 4–5, when 3.31 inches of rain fell in a 48-hour period.

**Figure A1.** Graph showing Timberline (Mount Hood) precipitation and temperature data, courtesy of U.S. Forest Service Northwest Weather and Avalanche Center.
