Seawater intrusion beneath the quayfront buildings of Bryggen, Bergen:

Resultats from new dipwells MB 28 and MB 29, and from repeated measurements of chloride and sulphate in quayfront dipwells during 2009

Case: 1829-17

Date: 5th February 2010

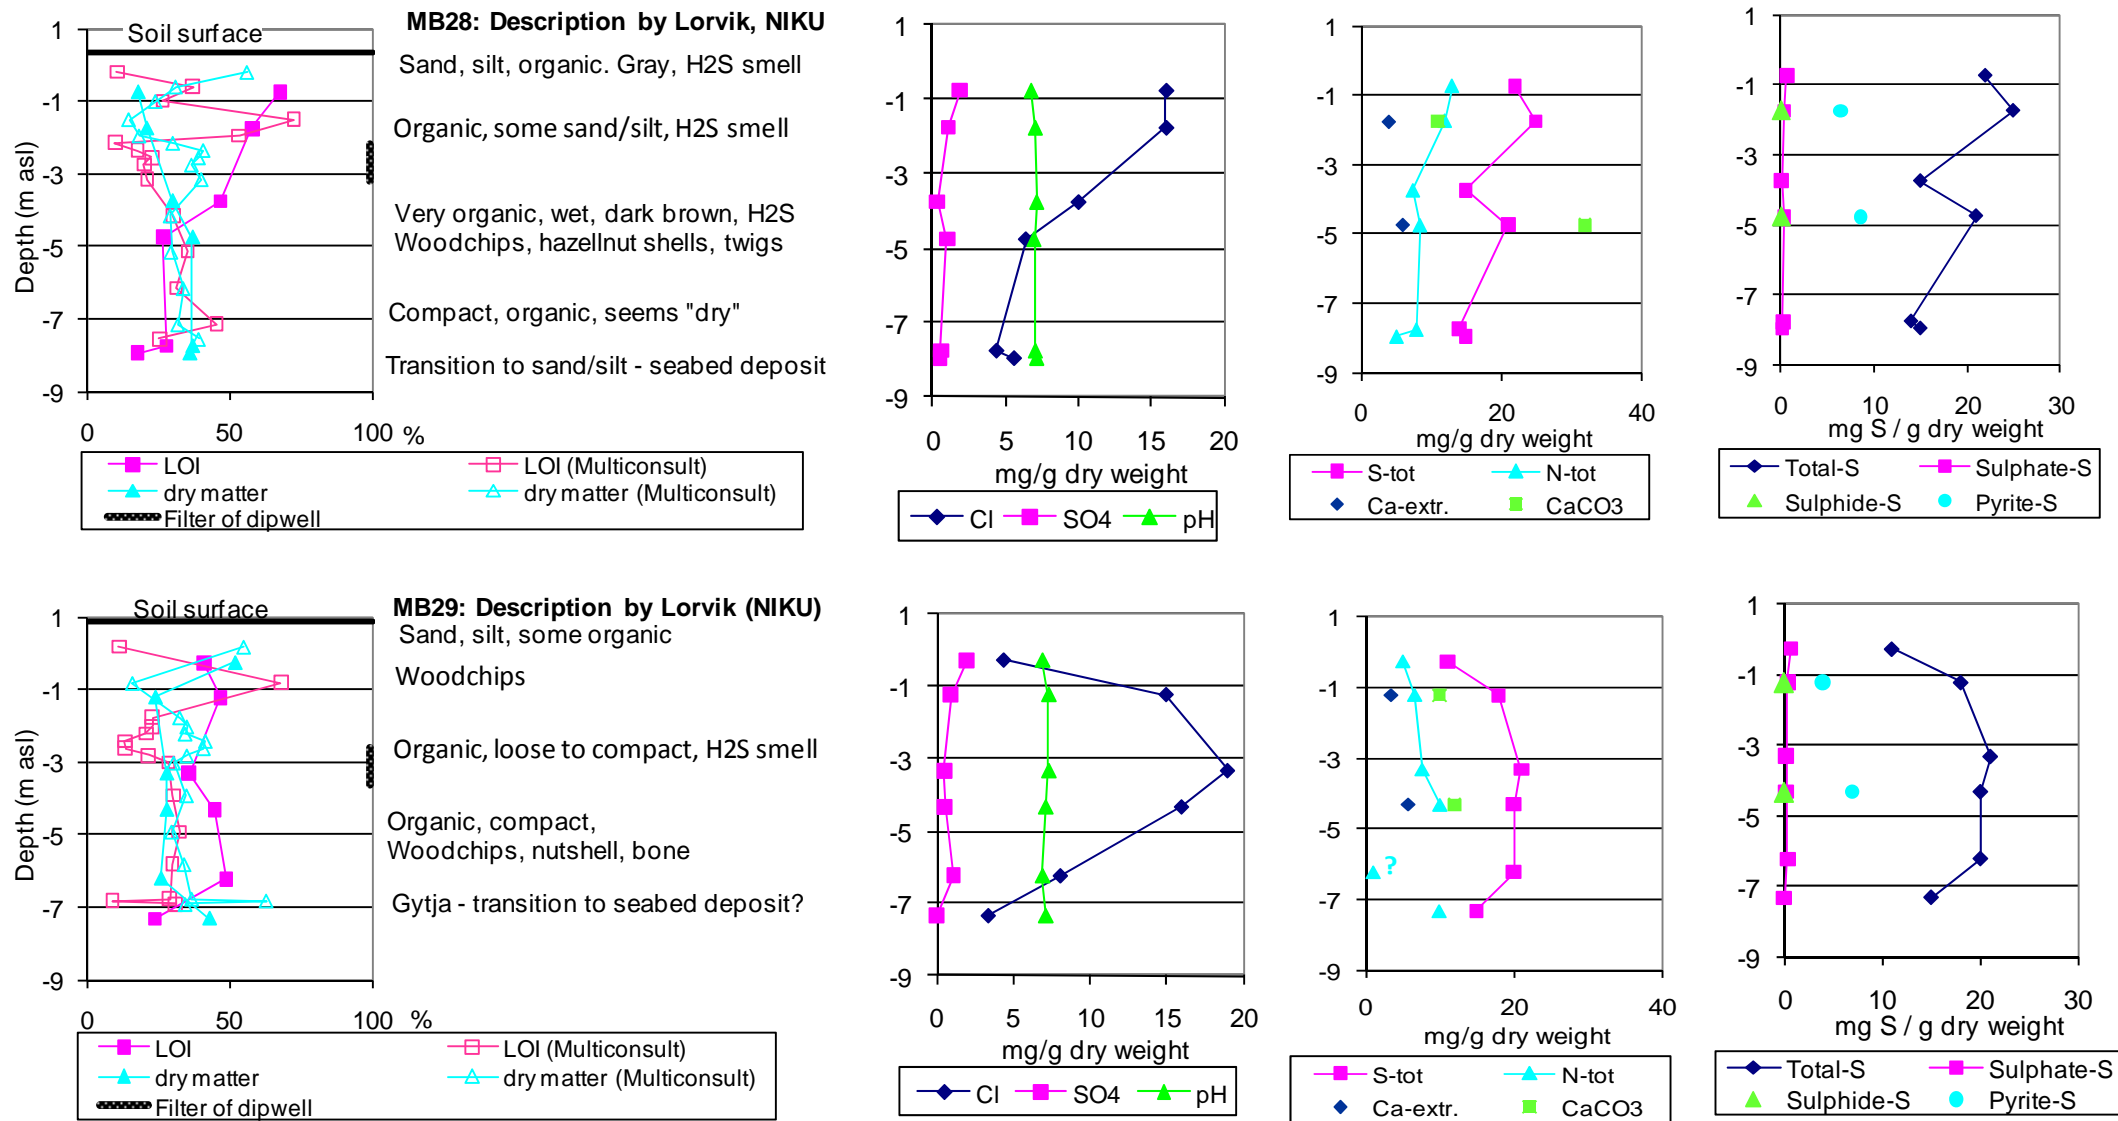
Figure 2: Description and soil analyses of drillings MB28 and MB29. Ca-extr. is Ca extractable by ammonium chloride, CaCO₃ is measured by adding HCl to the sample and measuring the CO₂ developed, sulphide-S is Acid volatile sulphide, sulphate-S is water extractable sulphate, and pyrite-S is calculated from pyrite-Fe, which is measured as iron extracted in boiling HNO₃ (after removal of non-pyritic iron). It took more than a month between sampling of the soil (25th – 27th February) to analysis in the laboratory (3rd – 21st April) and it cannot be excluded that some oxidation of pyrite or sulphide-S has taken place during storage, giving a production of sulphate-S.

Figure 2 (left) shows the organic content and water content of soil samples from dipwell MB28 and MB29, along with a brief description of the different soil strata (taken from Lorvik & Dunlop, 2009). Open symbols are data from Multiconsult, whereas closed symbols are data from Eurofins. There is some variation between the two set of data, which could be due to a large heterogeneity of the soil making it difficult to take a representative sample.

MB28 has a sandy/silty deposit in the uppermost meter down to approximately -0.5 m asl. Beneath this the deposits are described by Lorvik as organic to very organic with a medium to good state of preservation (C3-C4) and locally with H₂S smell. At -6 to -7.7 m asl the deposits are so compact that they feel dry. The loss on ignition data are quite variable and with large differences between Multiconsult and Eurofins, especially in the top. In the deeper deposits they are more constant at 30-40%.

MB29 has layers of sand/silt and charcoal in the uppermost meter, down to approximately -0.2 m asl. Beneath this the deposits are described by Lorvik as organic to very organic with a medium to good state of preservation (C3-C4) and locally with H₂S smell. The loss-on-ignition data are typically between 30 to 50% for most of the analysed samples.

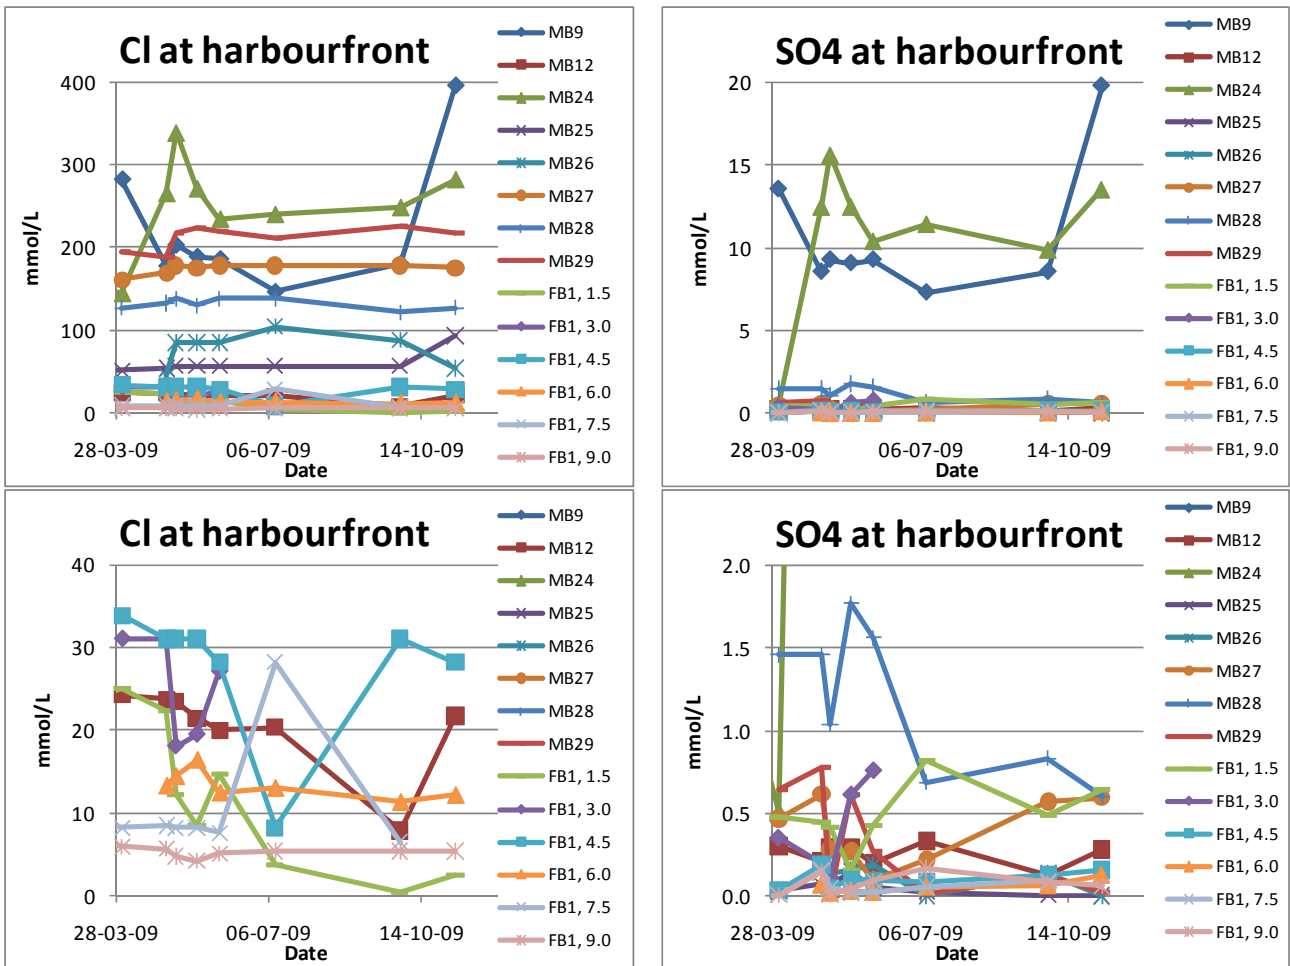
Figure 4: Time series for chloride and sulphate in dipwells from the quayfront area. Dipwells with low concentrations are also shown in the lower two figures (note different level on y-axis). The curves indicate that samples from FB1, 4.5m and 7.5 m on the 10/7 may have been interchanged by mistake, but this has not been possible to verify or falsify. The same applies for the samples from MB25 and MB26 on the 5/11.

But one thing is the penetration – another is the dynamics. Is there an active exchange today, or is it old stagnant seawater that is observed in these dipwells? This should be possible to evaluate from the time series for chloride (Figure 4) and conductivity (Figure 5) – if there is a flooding or a sudden intrusion of seawater, the chloride content and conductivity should increase. Figure 4 show a significant variation in the chloride

concentration in MB9, MB24, FB1 1.5 and FB1 3.0, an intermediate variation in MB12, MB26 and MB29, and only a modest variation in the rest of the dipwells (the sudden variation in FB1 4.5 and FB1 7.5 on the 10th of July is possibly due to an exchange of samples). MB24, MB9 and FB1 1.5 are the most variable, which is not surprising as they are also the uppermost dipwells. MB28 is placed next to MB9, but deeper in the deposits, and only shows a modest variation. MB26 and MB29 are at the same depth as MB28 and show an intermediate variation. The multilevel sampler FB1 shows surprisingly low concentrations at all depths.

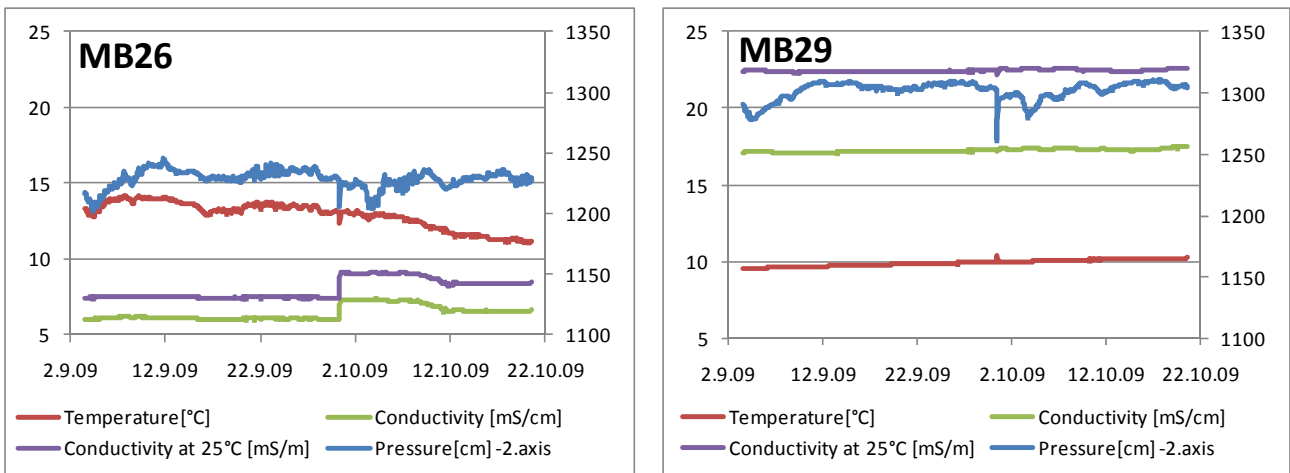
Figure 5: Results from groundwater loggers measuring the pressure, temperature and conductivity every hour. The measured conductivity has been recalculated to the conductivity at 25°C, assuming that the conductivity increases with 2% for each °C. The pressure is not compensated for variations in air-pressure. A groundwater sample is taken from both dipwells on the 30th of September, giving a sudden decrease in the pressure and (for MB26) a change in the conductivity.

Further insight into the dynamics is given by the conductivity loggers (Figure 5). In seawater there is a close correspondence between the chloride content, salinity and conductivity, where seawater at a salinity of 35‰ contains 19.4 g Cl/kg (corresponding to 546 mmol/L) and has a conductivity of 53 mS/cm at 25°C, so the chloride content in mmol/L may be estimated from the conductivity as [Cl] (mmol/L) = 10.3*conductivity (mS/cm). The same relation may to some extent be used for mixtures of seawater and freshwater, and during the water sampling on the 30.9.2009 the following results are found:

The good correspondence indicates that in these two dipwells the conductivity is a good measure of the seawater and chloride content. The conductivity has been monitored in dipwells MB26 and MB29 for a period of two months. Figure 5 shows that there is very little variation in the conductivity, indicating stagnant conditions. The main change is observed in MB26, where the conductivity increases abruptly on the 30th of September and then slowly decreases. This is due to sampling of water for Cl and SO₄ analysis, where the dipwell is emptied a few times in order to sample fresh water from the surroundings. Ideally a dipwell should always reflect the conditions in the surroundings, but the data here shows that this is not always the case.

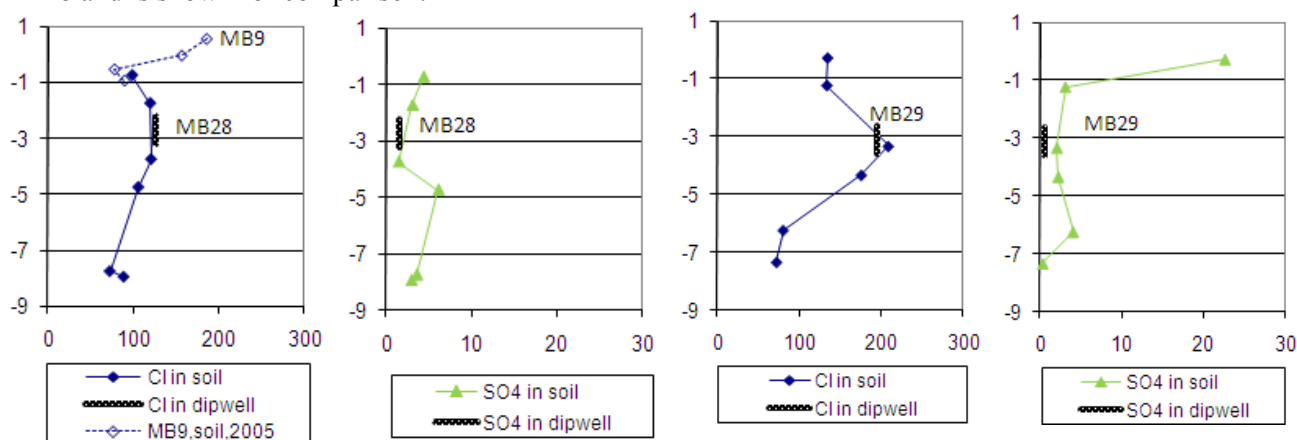
Figure 7: Measurements of water soluble chloride and sulphate in soil samples from MB28 and MB29 (MB9 is placed right next to MB28 and is shown for comparison). Recalculated to mmol/L using the water content of the soil. For comparison is also shown the concentrations measured in water from the dipwells, sampled 1st of April 2009.

Figure 7 shows in more detail how water-soluble chloride (and sulphate) was distributed in the soil samples from MB28 and MB29, where the results have been recalculated to mmol/L and compared to the content measured in the dipwells in April 2009. MB9, which was installed in November 2004, is placed right next to MB28 and is shown for comparison.

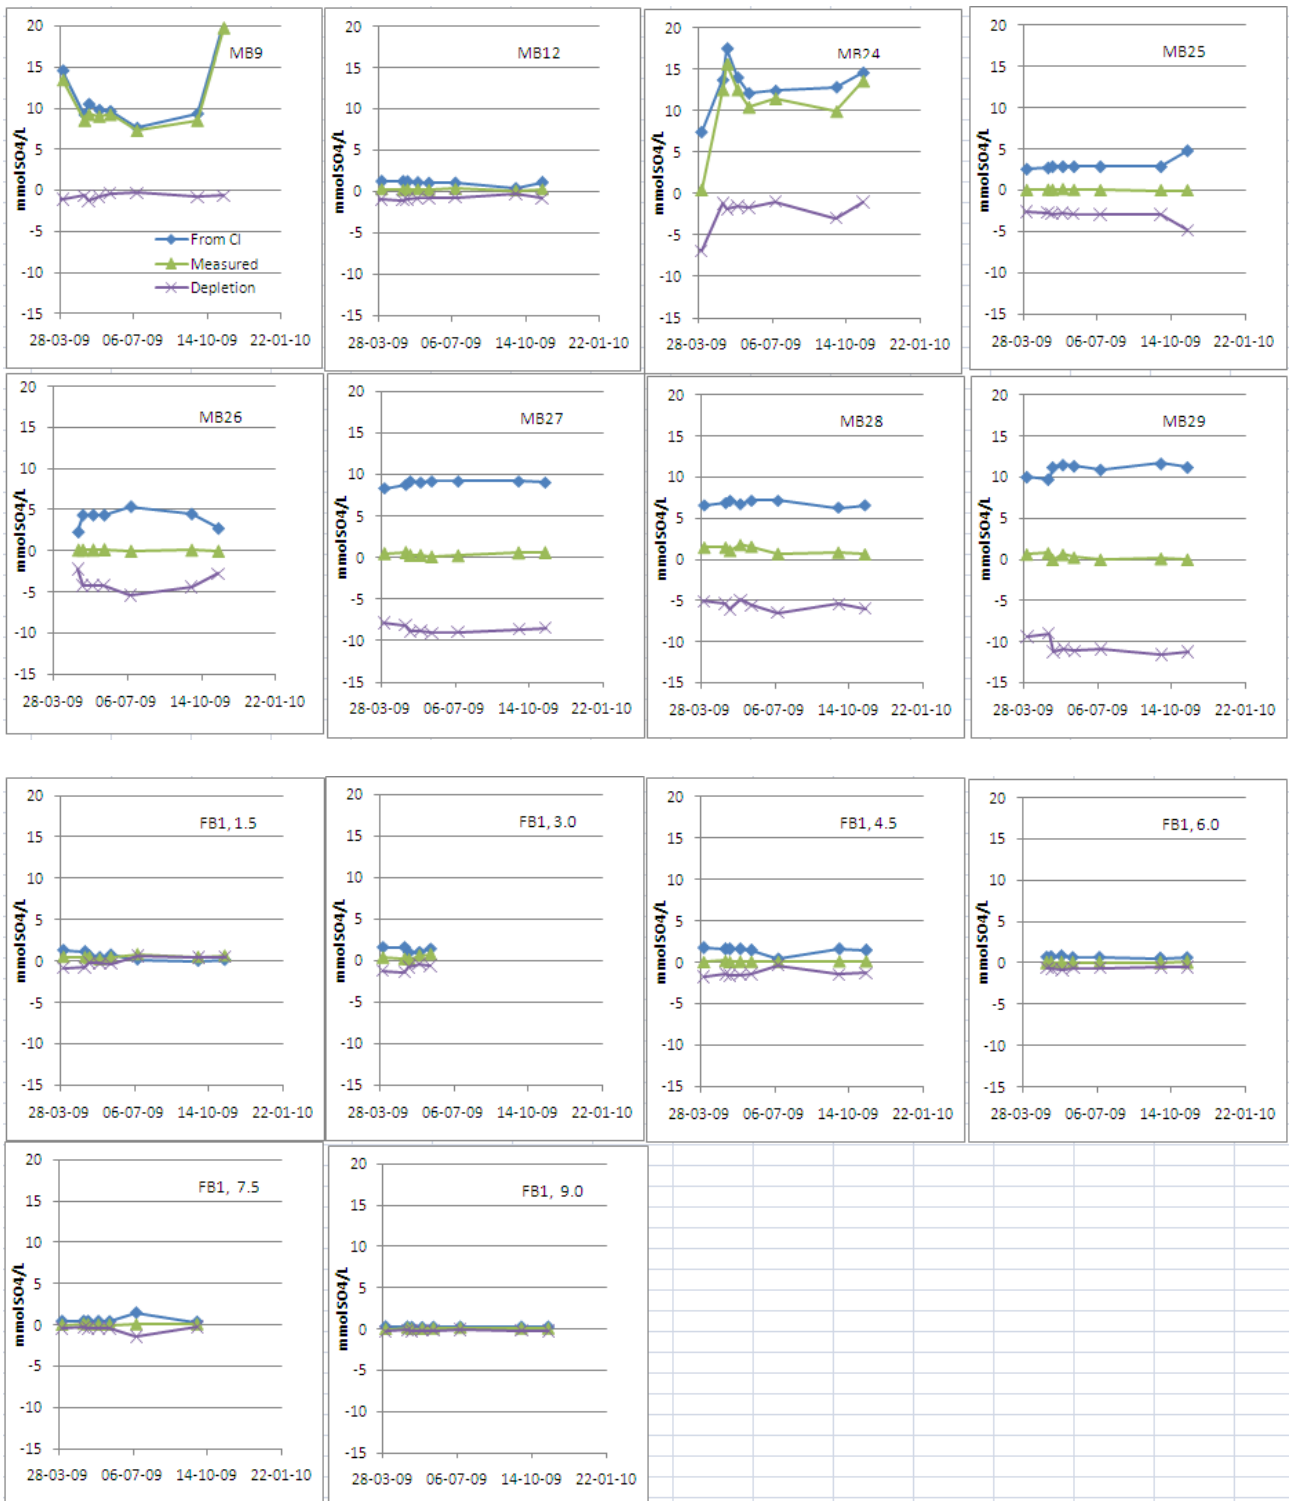
Figure 8: Temporal variation in 14 dipwells/piezometers in the sulphate concentration measured $[SO_4^{2-}]$, along with the theoretical concentration ($0.052 * [Cl]$) and the sulphate depletion ($[SO_4^{2-}] - 0.052 * [Cl]$), where 0.052 is the $SO_4:Cl$ ratio normally found in seawater.

In order to study sulphate reduction the ideal situation would be to begin when the area is flooded with seawater supplying both chloride and sulphate to the deposits, and then measure over time whether the sulphate disappears faster than the chloride. This should in principle give an increasing “sulphate depletion” over time. However, no flooding occurred during the monitoring period and for most of the dipwells hardly any sulphate is found in the water – for instance the FB1 multilevel sampler is almost sulphate free at all levels, and the same is the case for MB12, MB25, MB26, MB27 and MB29. Obviously if no sulphate is available no sulphate reduction can take place.

On the other hand MB9 and MB24 have high concentrations of sulphate, but here the water exchange seems to be so fast that it is difficult to observe any sign of sulphate reduction before the water is exchanged again –

obviously the sulphate reduction is not limited by the supply of sulphate in these two dipwells. There is a single period (from the 10/7 to the 30/9) where the sulphate concentration in MB24 decreases while the chloride content increases, which changes the sulphate depletion from -1 to -3 mM in 80 days. A consumption of 2 mM in 80 days corresponds to 9.1 mM SO₄/year, which may oxidise 18 mM organic carbon/year if used by sulphate reducing bacteria (the real rate is probably even higher as there may well have been a fresh supply of seawater during these 80 days).

MB 28 contains a small amount of sulphate during the first sampling in April 2009 and also here the sulphate concentration decreases while the chloride concentration remains constant. The rate may be estimated from the slope of the curve to approximately to 5 mM SO₄/year which may oxidise 10 mM organic carbon/year. However, the sulphate is used up during the monitoring period, and the average rate for the whole year may be limited by the supply of sulphate.
