**THE SARMISHSAI PETROGLYPH SITE**  
**NOWBAHOR DISTRICT**  
**NAVOI REGION**  
**THE REPUBLIC OF**  
**UZBEKISTAN**

**REPORT:**  
**Eighth mission to Sarmishsai**  
**May 2010**

**PROJECT:** Conservation and Management of Sarmishsai Cultural and  
Natural Heritage Site, Navoi oblast, the Republic of  
Uzbekistan

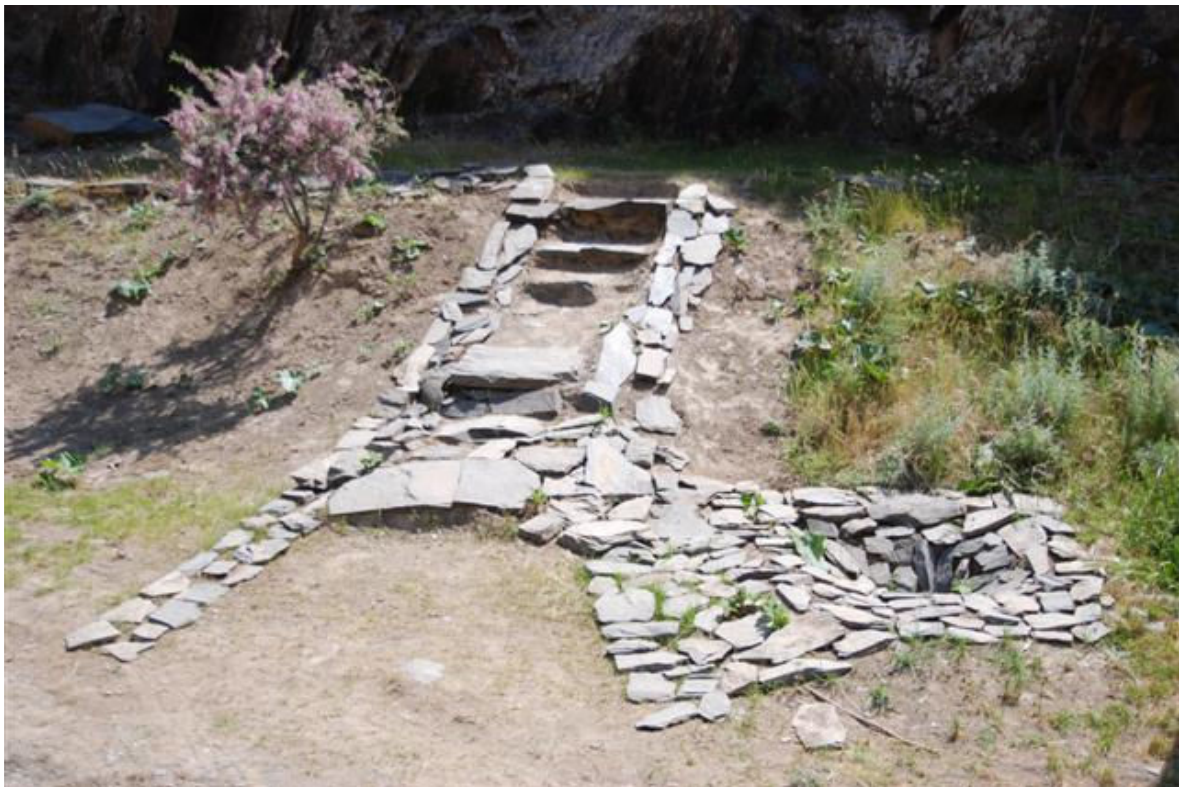
*The steps from the road up to the walkway passing petroglyph group IX. Stone paved garbage disposal to the right. Photo: A-S Hygen*

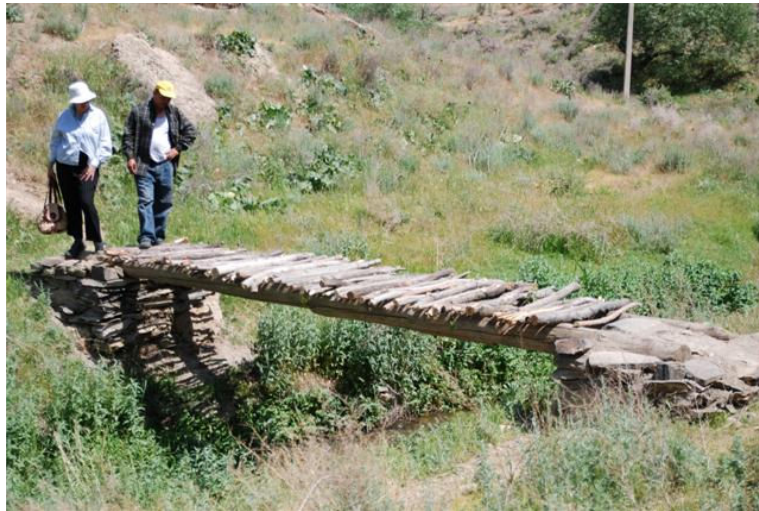
*The bridge by group VIII needs some remodelling.  
Photo: A-S. Hygen*

- The decent to this bridge on the west bank of the river is very steep and uncomfortable, and further erosion is on-going. The path should be inclined from the north until it meets the road; the existing path should be re-planted (this is according to previous plans).

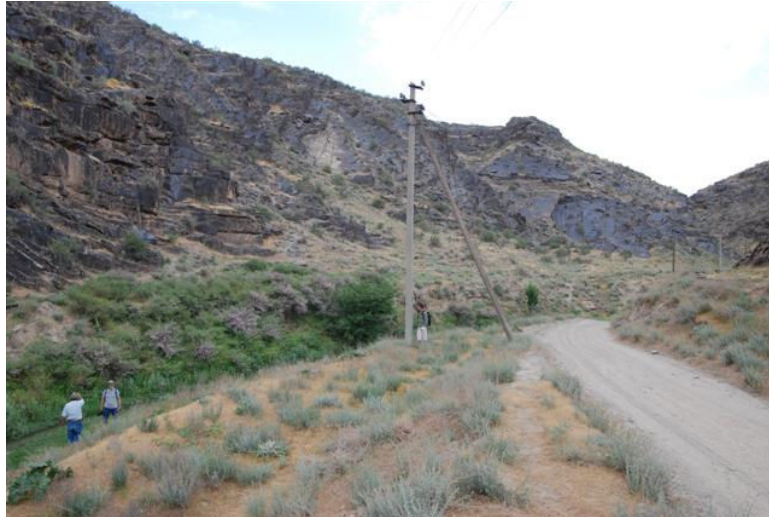
- The bridge over the river between group VII and group IX has been discussed a number of times. On the west bank of the river it should not start further north than minimum 14 m south of the electricity pole (south-east of group VII and north-west of group IX) in order not to over-shadow the landscape overview towards the north-west and the important panels of group VII. The bridge will be about 20 m long and should be built of wood.

*The new bridge between group VII and group IX should not start further north than minimum 14 m south of the electricity pole in the middle of the picture. Photo: A-S. Hygen*

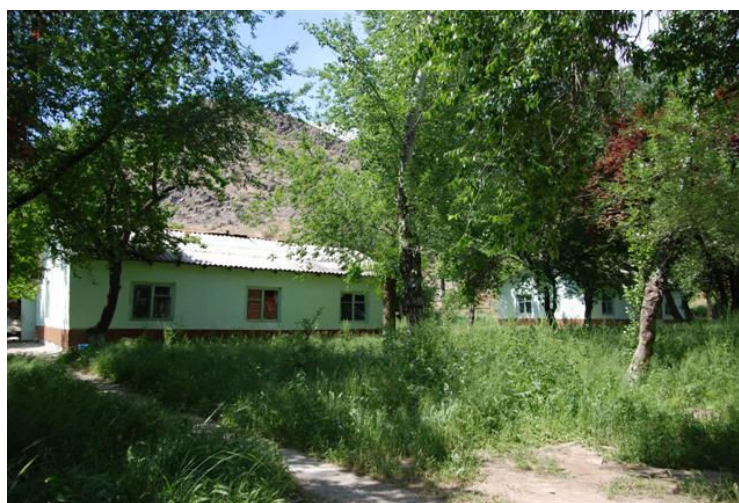
The collection of houses by the north entrance to Sarmishsai Gorge was built in 1964 for researchers and workers connected to the geological company searching for gold in the area. In 1967 the area was passed on to Bukhara Geological-Technical Collegen then renamed and passed on to the Economic-Financial College in Bukhara. In 2002 the geological project in Sarmishsai was closed when NMMC decided to do no more research or exploitation of minerals in the area. Today, even though the area belongs to Sarmishsai Reserve-Museum according to the Kadaster, it now partly functions as a temporary summer field station for college students and partly as camp ground for paying visitors. These uses cause major problems in Sarmishsai.

*Buildings at the north camp. Photo: A-S. Hygen*

The site is very well suited for a reception area / visitors' / field centre for Sarmishsai, housing a number of functions: Reception, tickets and sales, café, office, storage, field station, house for guards and guides, etc. Some upgrading of the houses and the garden will be necessary. Admission area in the north will permanently solve the problem with visitors passing through 'Gornyi' Camp.

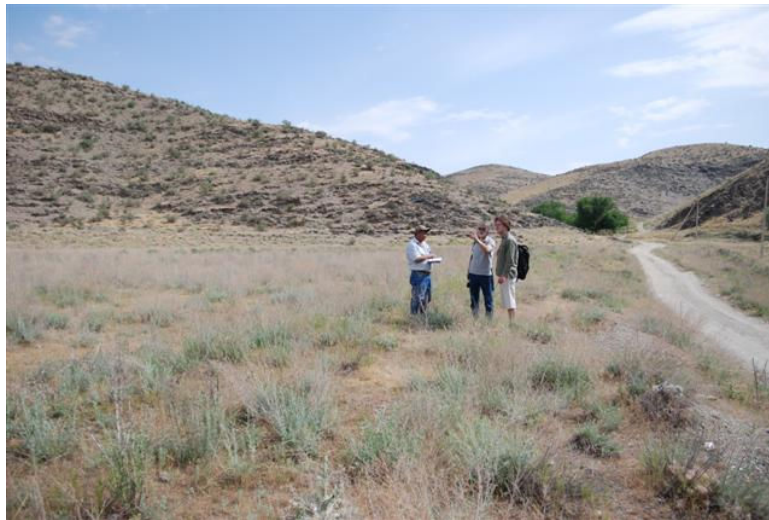
*Timirov, Helskog and Jørgensen showing the suggested position of the main parking lot south of the north entrance and west of the road. Photo: A-S Hygen.*

If the plans for reception area / visitors' centre in the north are carried out – which is strongly to be hoped for – it follows that a new parking lot must be established. A possible area could be north of group I and west of the road, c. 300 m south of the new possible entrance. An alternative is to have the main parking lot west of the road and to have the possibility of an additional few private cars east of and close to the road. However, it is important not to destroy traces of old cultivation terraces west of the road, and that the east parking is close to the road in order to avoid erosion and landslide towards the river. A simple resting place with benches is possible south of the east side parking.

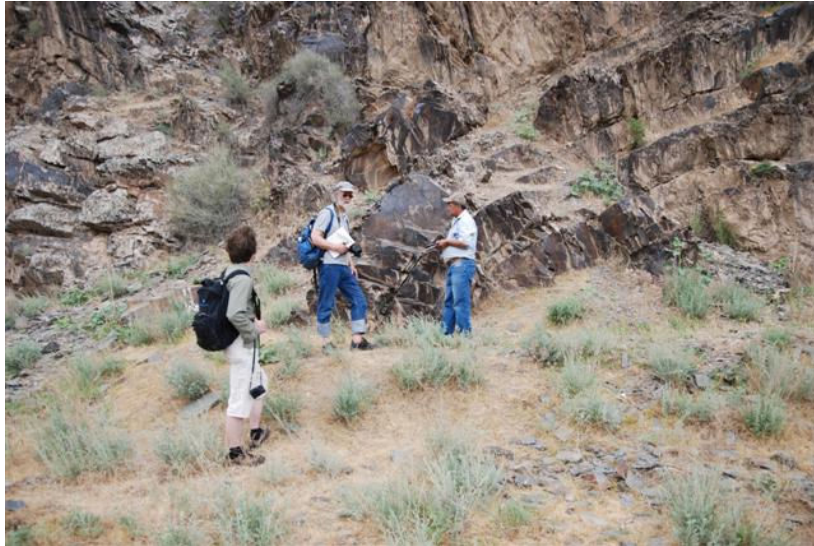
*From the left, Jørgensen, Helskog and Temirov show the extent of the recommended platform in front of the group II boulder.*

With the solutions described above, the access to the north part of the walkway system will be via the road and to a path first leading to station 1, then towards group II. An arrow sign by the road should point the way. In order to protect the very vulnerable group II petroglyphs, a stone and clay platform with a 30-40 cm stone barrier of should be made in distance from the boulder (see photo below). Stones with stop signs will admonish visitors not to climb rocks. The functionality of this barrier should be monitored; if necessary, the barrier and the platform must be extended.

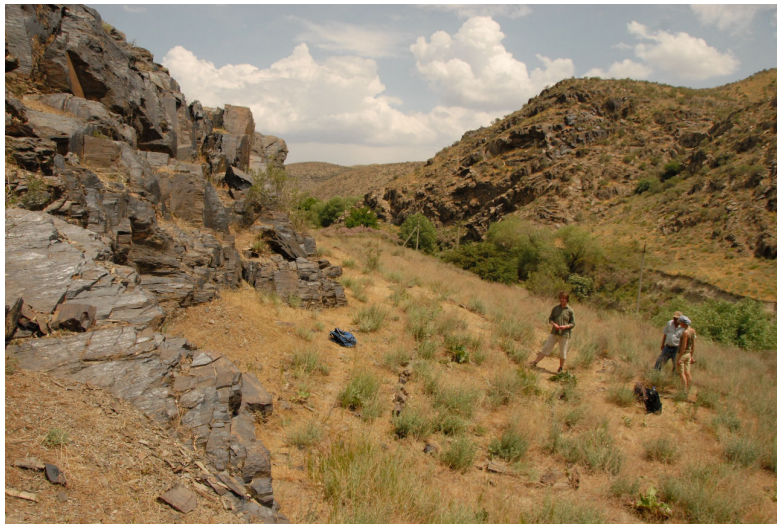
*The position of the recommended platform in front of group V.  
Photo: K. Helskog.*

- Group III should be viewed from the walkway. This is not an established viewing station.
- A stone barrier / low fence should be made c. 2 m from the face of group IV. A c. 2x6 m stone and clay platform should be made behind the barrier. Visitors' behaviour should be monitored and if necessary, modifications should be made. Access and decent from the platform is along the same walkway.
- The stone and clay platform which should be made in front of group V, and the walkways connecting to it, were marked with stones in the landscape.
