Geomorphology of the Elwha River and its Delta

By Jonathan A. Warrick, Amy E. Draut, Michael L. McHenry, Ian M. Miller, Christopher S. Magirl, Matthew M. Beirne, Andrew W. Stevens, and Joshua B. Logan

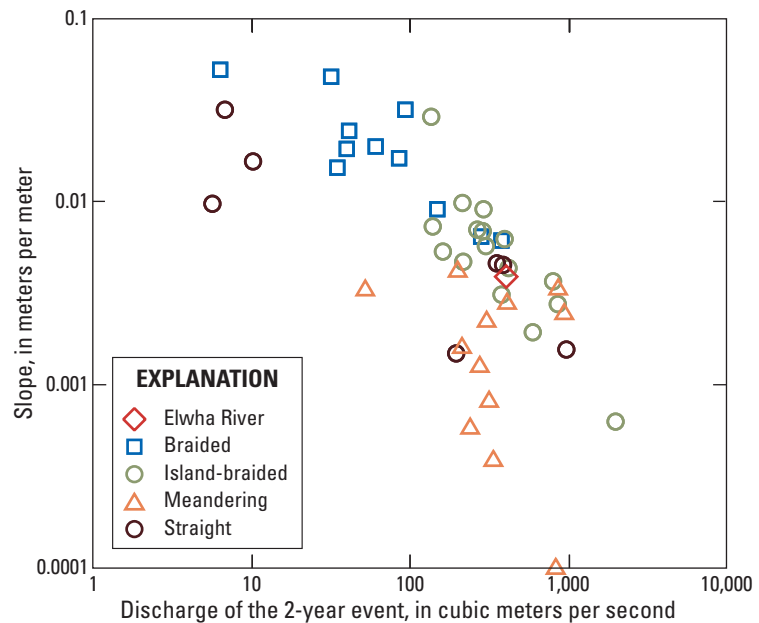
Figure 3.6. Comparison of the channel form of the lower Elwha River to 42 river reaches from other rivers in western Washington. Slope in the average slope of the river section and discharge is calculated as the 2-year peak discharge which represents an approximation of bankfull flow. Adapted from Beechie and others (2006).

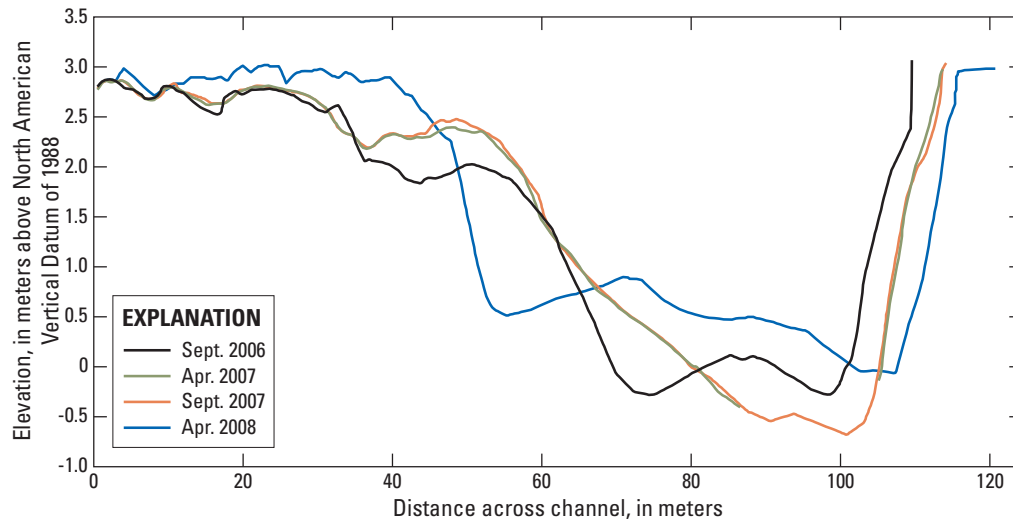
Figure 3.9. Measured channel change on the final meander showing several meters of lateral migration per year of the lower Elwha River, Washington. (After Draut and others, 2010.)

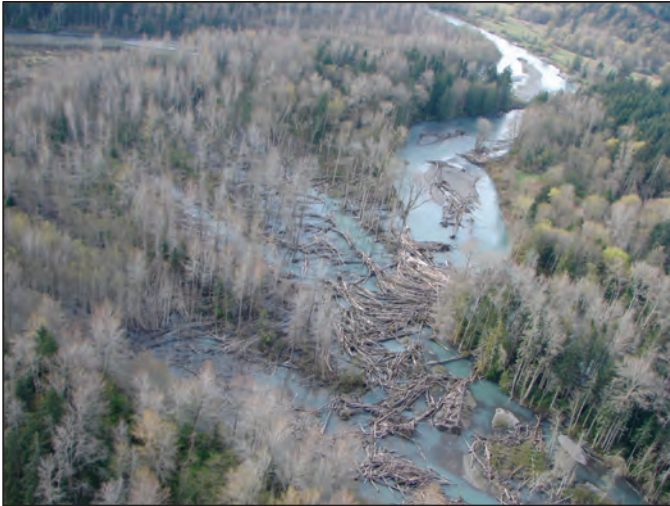
Figure 3.11. Woody debris resulting from channel avulsion in the lower Elwha River, Washington. Flow direction is from the top to the bottom of the photograph. The avulsion point is shown at the top of the photograph. (Photograph taken by Tom Roorda, Northwestern Territories, Inc., April 4, 2007.)

During the winter high flows between 1994 and 2000, an avulsion formed a new westernmost channel in the Elwha River; this new channel has been referred to as the Hunt Road Channel (“D” in fig. 3.7). A large flood in December 2007 broadened this new channel, after which most of river discharge flowed down the Hunt Road Channel (fig. 3.10). This 2007 flood also downed hundreds trees that accumulated in woody debris piles throughout this reach (fig. 3.11).

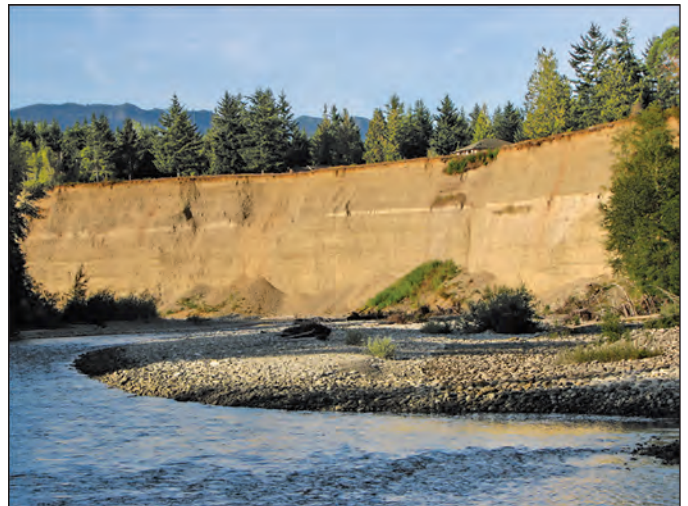
Figure 3.12. Large bluff immediately upstream of the mouth of the Elwha River, Washington. This bluff has eroded substantially during the past several decades, and it may be a primary source of sediment to the lower river and littoral cell. (Photograph taken by Amy E. Draut, U.S. Geological Survey, September 8, 2008.)

Lateral erosion of the river into a 38-m-high bluff of glacial till immediately upstream of the river mouth may contribute an important input of bed material (fig. 3.12). Using repeat aerial photography (fig. 3.8), Draut and others (2008) showed that this bluff retreated about 70 m between 1965 and 2006. Extrapolated to the full 310 m bluff length, this retreat would have contributed about 820,000 m³ during these 41 years, which is equivalent to an annual rate of about 21,000 m³/yr.

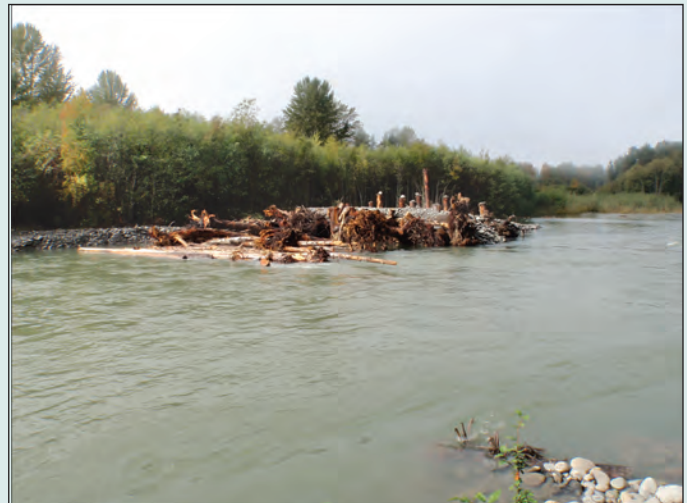
Figure S3.1.1. Newly constructed engineered log jam on the Elwha River, Washington during winter flooding 2009. This structure is one of 50 that the Lower Elwha Klallam Tribe has installed in the lower Elwha River prior to dam removal.

Engineered log jams (ELJs) are designed to mimic the natural architecture of large, stable logjams that are critical to anastomosing of forested island channel morphology commonly found in large western Washington rivers. ELJs at the river reach level may be used to promote island formation, to activate side channels (in conjunction with dike removals), and reduce flow velocities. ELJs also promote habitats that are used heavily by adult and juvenile salmonids of all species. ELJs typically develop large, complex scour pools that interact with groundwater to provide the cool temperature refugia preferred by salmon. Monitoring has shown that these habitats contain 2–6 times as many juvenile salmon as similar habitats without complex wood structures.

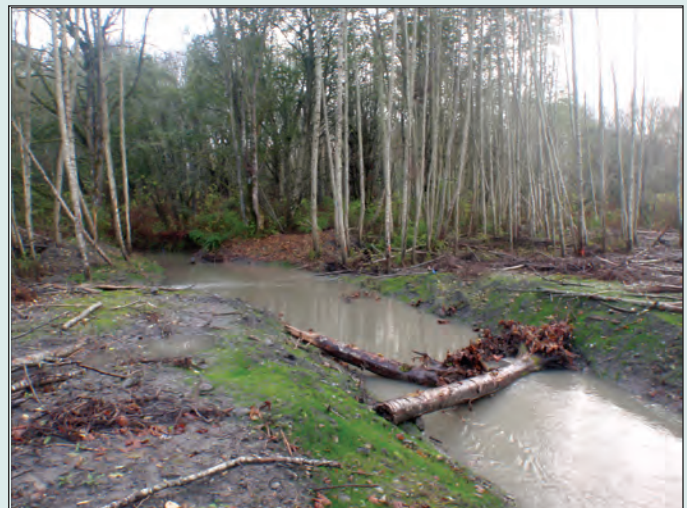
Figure S3.1.2. Newly activated flood plain overflow channel during the first winter following removal of a 1,500 foot flood plain dike on the Elwha River, Washington, 2009.

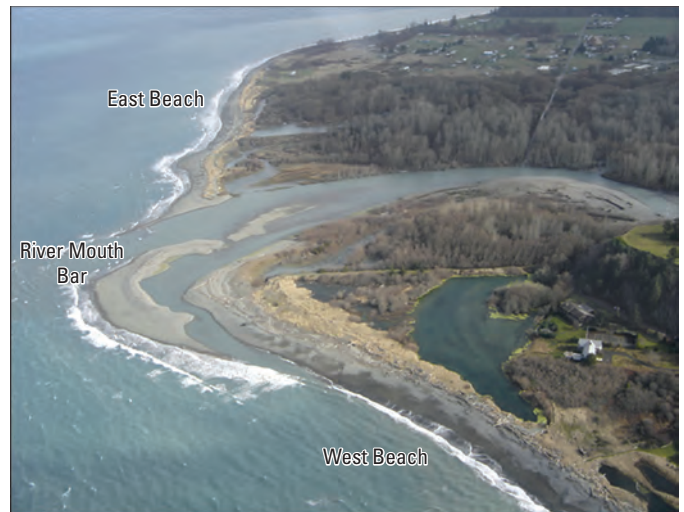
Figure 3.13. The mouth and delta shoreline of the Elwha River, Washington. (Photograph taken by Ian M. Miller, University of California, Santa Cruz, February 12, 2005, at 11:24 Pacific standard time)

The Elwha River delta (fig. 3.13) is a wave-dominated deltas within the broader Puget Sound region (Shipman, 2008; Warrick and others, 2009a). The morphology of wave-dominated deltas are controlled largely by littoral redistribution of river sediment. Waves at the Elwha River delta arrive from the west, and these waves induce littoral currents and sediment transport toward the east (toward Ediz Hook), as described in Warrick and others (2011, chapter 5, this report).

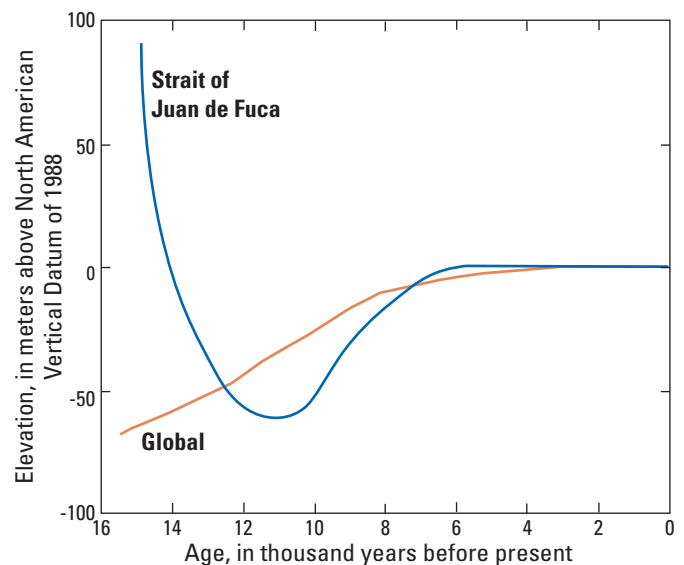
Figure 3.14. History of relative sea level for the Strait of Juan de Fuca off the coast of Washington (after Mosher and Hewitt, 2004). The global eustatic sea level curve (Global) is based on Peltier (2002).

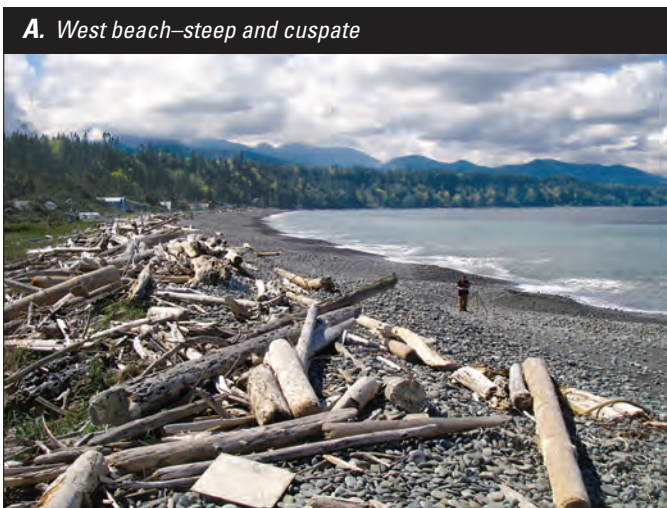
Figure 3.17. Differences between the beach on the west and east sides of the current river mouth of the Elwha River delta, Washington.

The 20th century oral histories from Lower Klallam Elwha Tribal members describe hundreds of meters of land lost from coastal erosion of the beach east of the river mouth (“east beach”) and a fundamental shift of the low-tide area of the beach from being favorable shellfish habitat to a cobble substrate poorly suited for shellfish habitat (Reavey, 2007; Warrick and others, 2009a). The changes described by the Lower Elwha Klallam Tribe are consistent with aerial-photograph-derived erosion rates (fig. 3.16), which have accelerated significantly from 0.8 to 1.4 m/yr during 1939–90 and 1990–2006, respectively (Warrick and others, 2009a). Further, this oral history is consistent with the current differences between the west beach, which has not changed significantly in position and is mostly sand and gravel, and the east beach, which is eroding and has a cobble low-tide terrace (fig. 3.17).

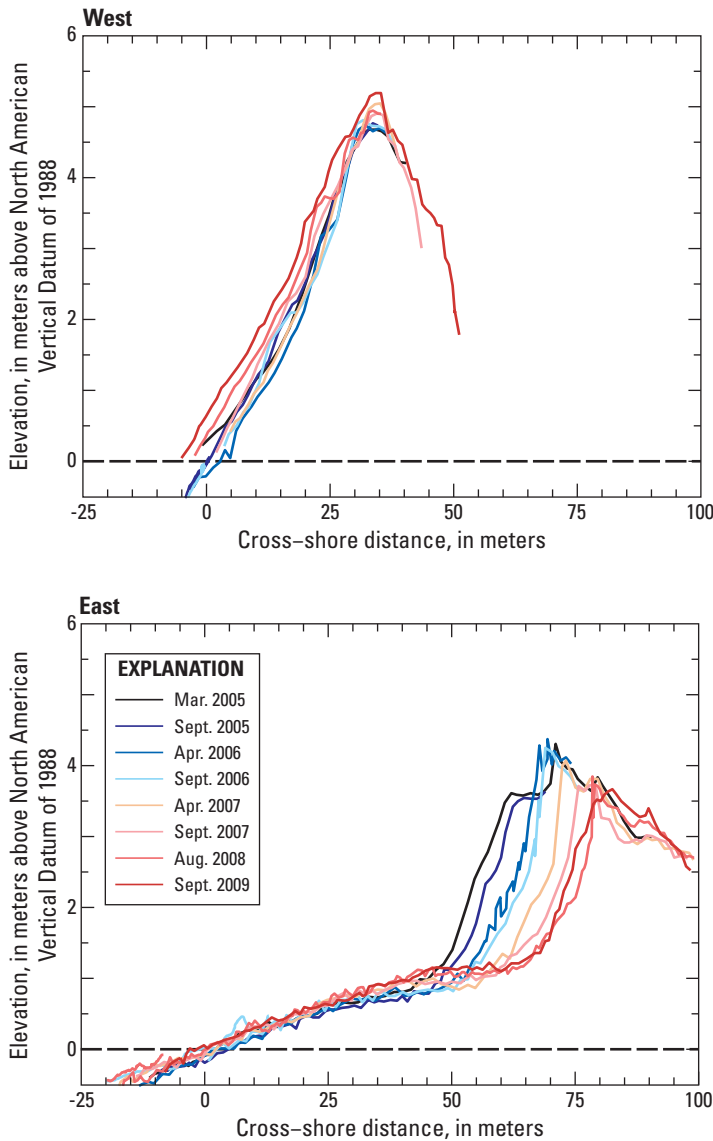
Figure 3.21. Example beach topographic profiles for the west and east beaches of the Elwha River delta, Washington, from surveys by the U.S. Geological Survey. The west beach has been relatively stable over time, whereas the east beach has eroded substantially.

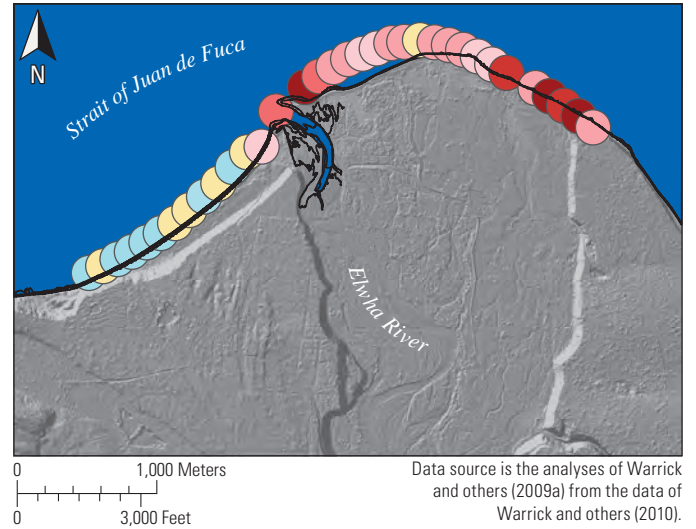
Figure 3.22. Shoreline change along the beaches of the Elwha River delta, Washington, during 2004–06 from real time kinematic global positioning system (RTK-GPS) surveys. (After Warrick and others, 2009a.)

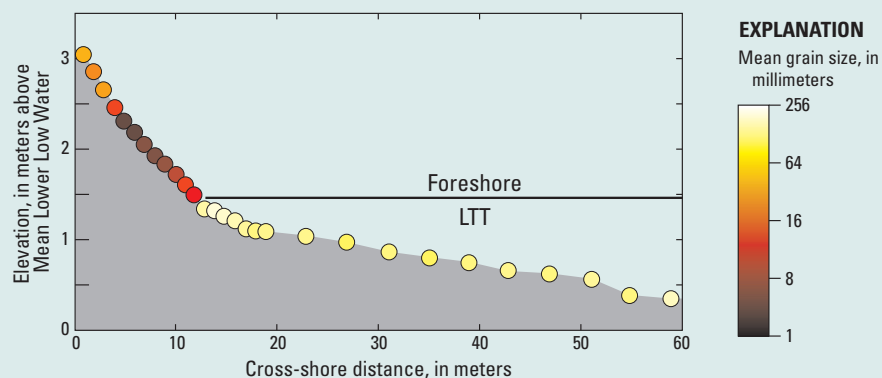
Figure S3.2.2 Example results of the mean sediment grain size from Cobble Cam photographic analyses across the east beach of the Elwha River delta (after Warrick and others, 2009b). A distinct grain size change is apparent between the foreshore and the low-tide terrace (LTT).

To sample grain size on the beach or a river bar, photographs were taken at regular intervals across these landforms. Photographs must be taken orthogonally to the ground surface to limit distortion of surface features. Traditionally, the calculation of grain size parameters for each photograph was obtained from manual sizing and counts from each photograph, which required 1–2 hours of analysis time for each photograph. New methods suggested by Rubin (2004) have significantly shortened analysis time owing to an automated calculation of grain size based on spatial patterns in each photograph. These “cobble cam” techniques were applied to the Elwha River flood plain and coastal landforms by Warrick and others (2009b) with excellent results. Photographic sampling from Elwha River landforms show a broad diversity in grain size and sorting (fig. S3.2.1). Comparisons of the automated analyses with physical samples of the substrate show that errors in the analyses are only 14 percent, which are more than adequate to characterize the differences prevalent in these landforms. There are significant differences in the grain sizes across river bars, beach cusps, and the low-tide terrace to foreshore transition (see fig. S3.2.2). The successful development and implementation of these methods should allow for the quantification of changes throughout the Elwha River landforms as they occur in the future.
