Fluvial Geomorphology and Suspended-Sediment Transport During Construction of the Roanoke River Flood Reduction Project in Roanoke, Virginia, 2005–2012

Scientific Investigations Report 2015–5111

By John D. Jastram, Jennifer L. Krstolic, Douglas L. Moyer, and Kenneth E. Hyer

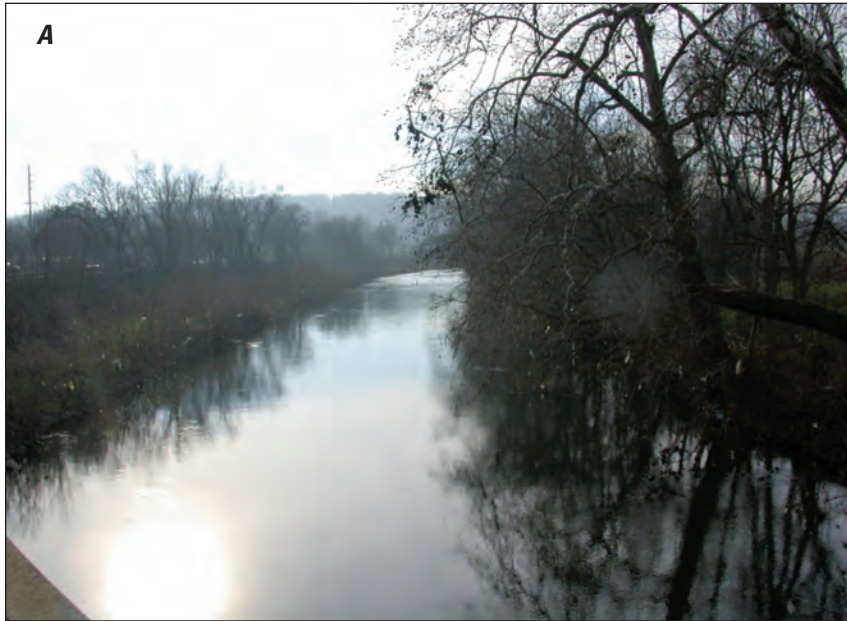
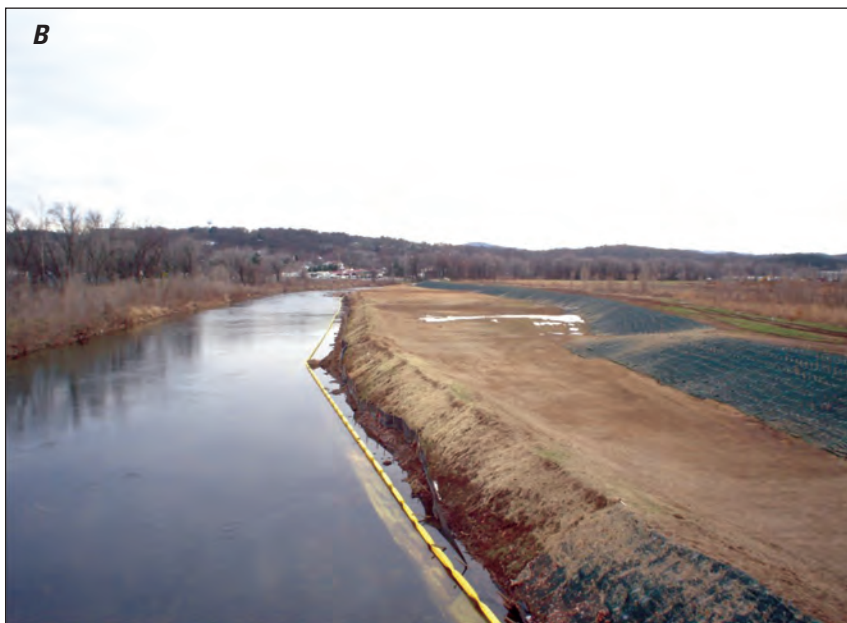
Figure 2. Photos of *A*, pre- and *B*, post-construction channel upstream of 13th Street, Roanoke, Virginia, 2005 and 2006, respectively.

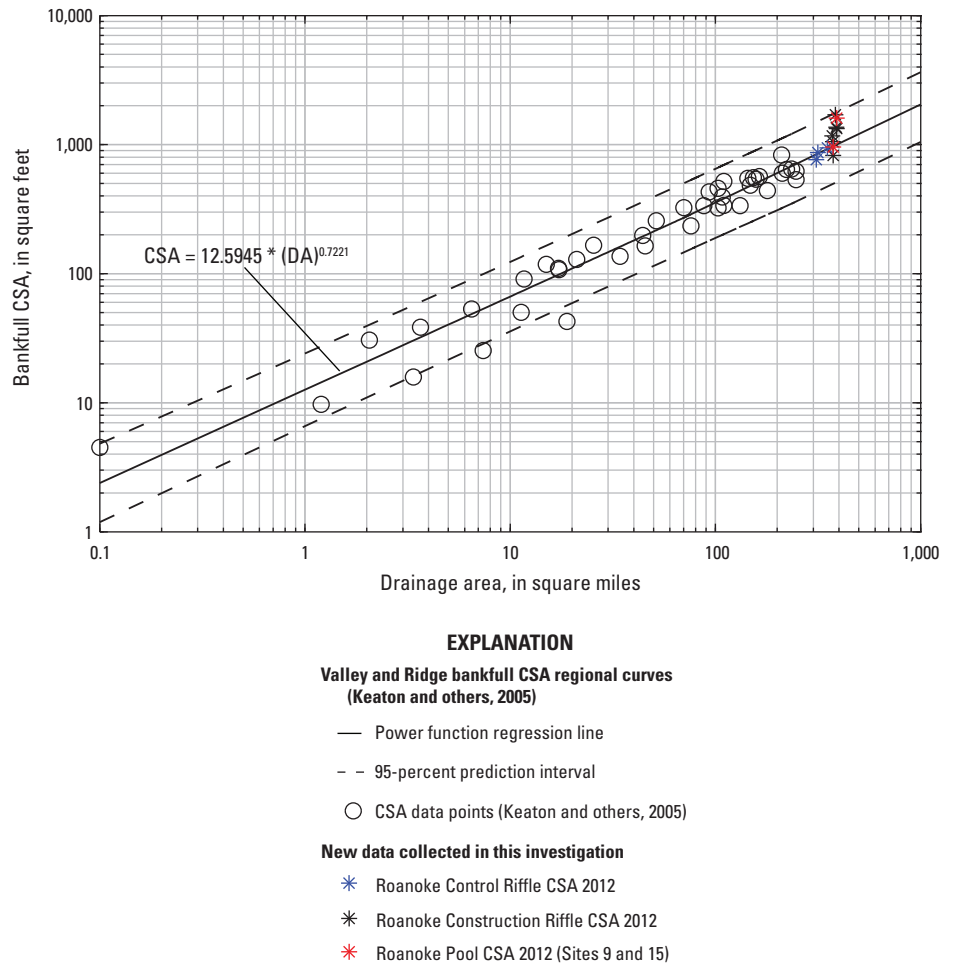
Figure 15. Bankfull cross-sectional area (CSA) in 2012 for Roanoke River riffles and pools at sites 9 and 15 including Valley and Ridge regional curve data and power curve developed in Keaton and others (2005).

At monitoring sites with riffles or pools where the RRRFP created bench cuts, the 2012 bankfull CSAs were plotted along with the previously published values for the bankfull regional curves developed by Keaton and others (2005; fig. 15). For Roanoke River drainage areas ranging from 310 mi² to 390 mi², bankfull CSAs predicted for riffles by using the regional curve regression equation range from 791.9 to 935.0 square feet (ft²). At the end of the study in 2012, measured bankfull CSAs for all sites, regardless of riffle or pool habitat type, ranged from 759.9 to 1,702.9 ft² (table 6). The drainage areas of monitoring sites are slightly larger than the sites included in Keaton and others (2005), but the Roanoke data are within the 95-percent prediction interval of the regional curves (fig. 15).

to 1,330.4 ft², the new bankfull CSA for site 15 is reasonable. Overall, for sites 9, 12, and 15, the range of bankfull CSA values is wide, but within the 95-percent prediction intervals for the Valley and Ridge regional curves (fig. 15; Keaton and others, 2005), and is therefore a reasonable design to maximize flood conveyance within the bounds of observed conditions in natural channels in the region.

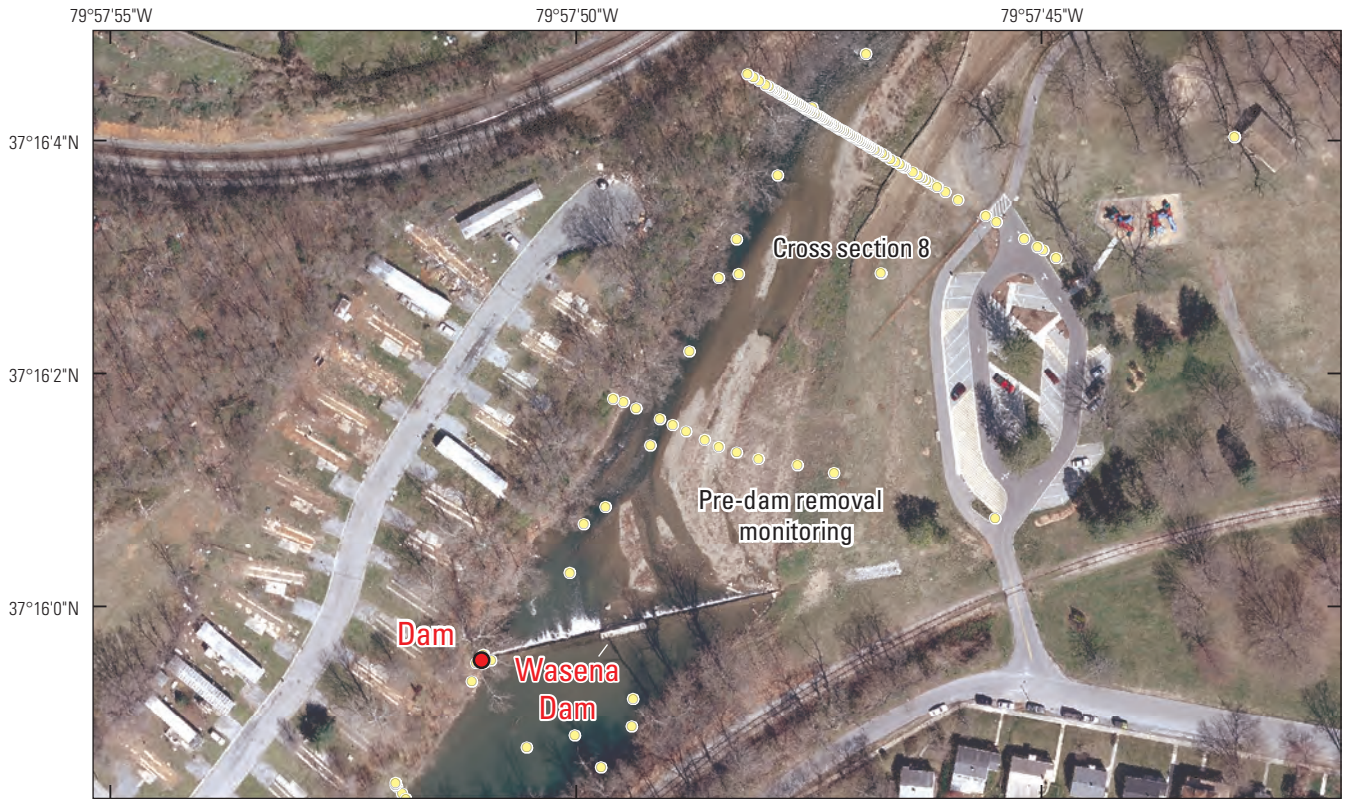
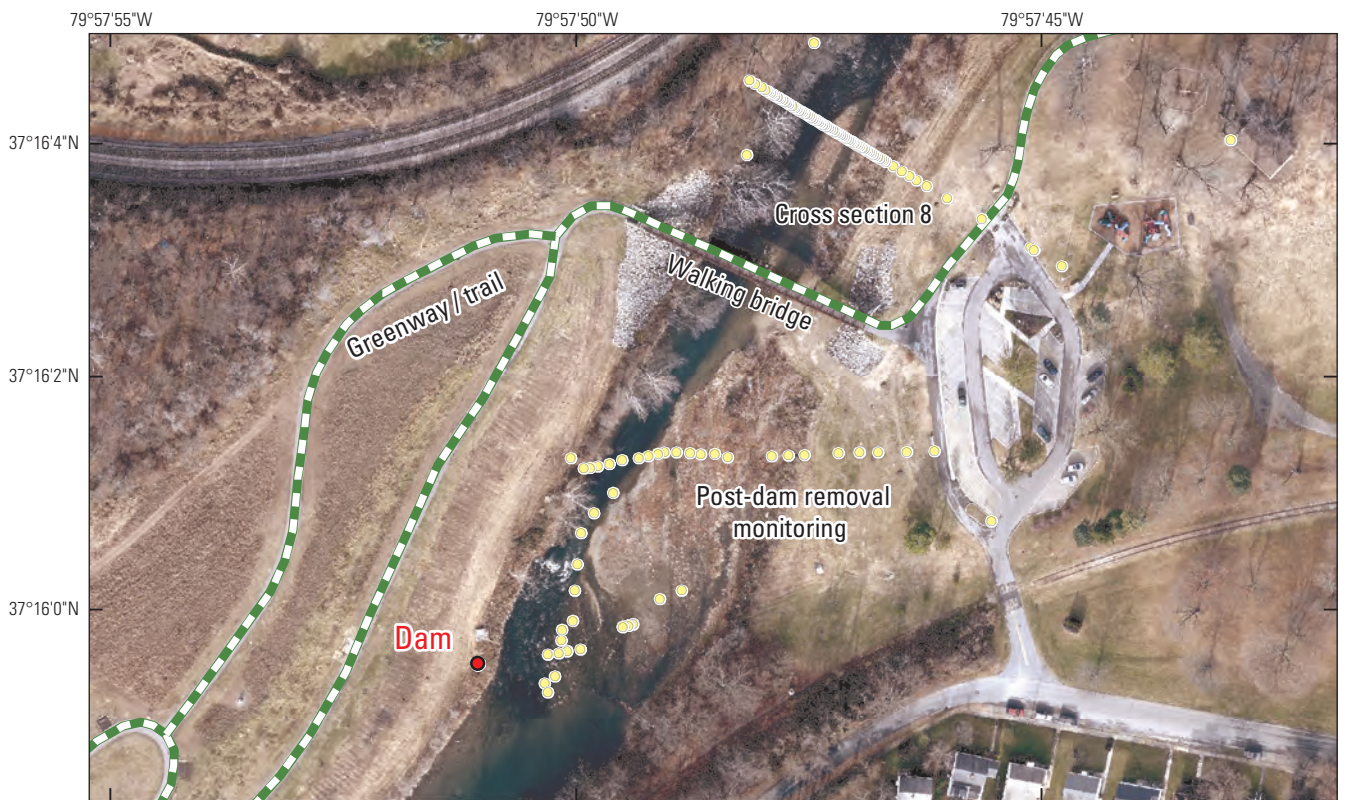
Figure 16. Wasena Dam and downstream river channel before removal in 2008 and after removal of the dam in 2013, Roanoke, Virginia.
