# Streambed Scour Evaluations and Conditions at Selected Bridge Sites in Alaska, 2012

By Robin A. Beebee and Paul V. Schauer

Scientific Investigations Report 2015–5154

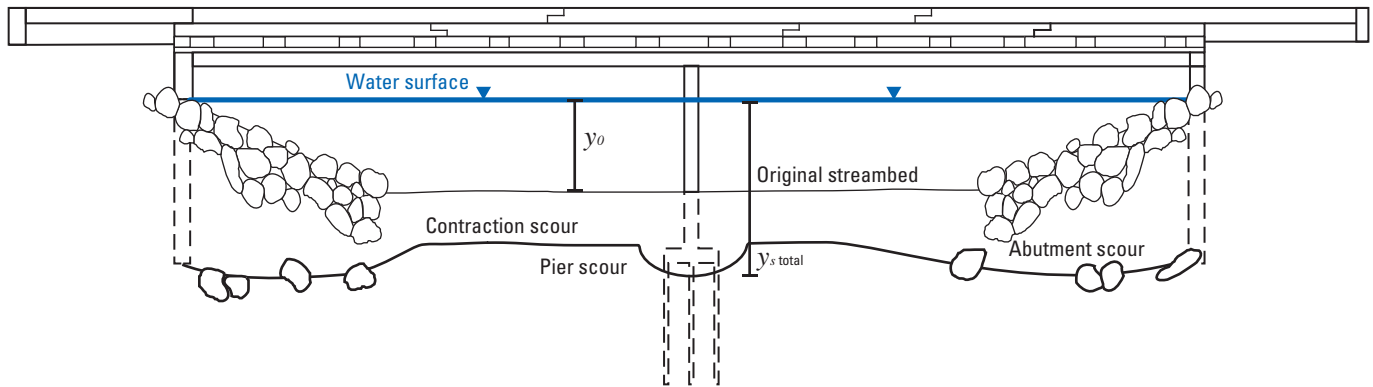
**Figure 1.** Example of streambed scour around a bridge foundation.

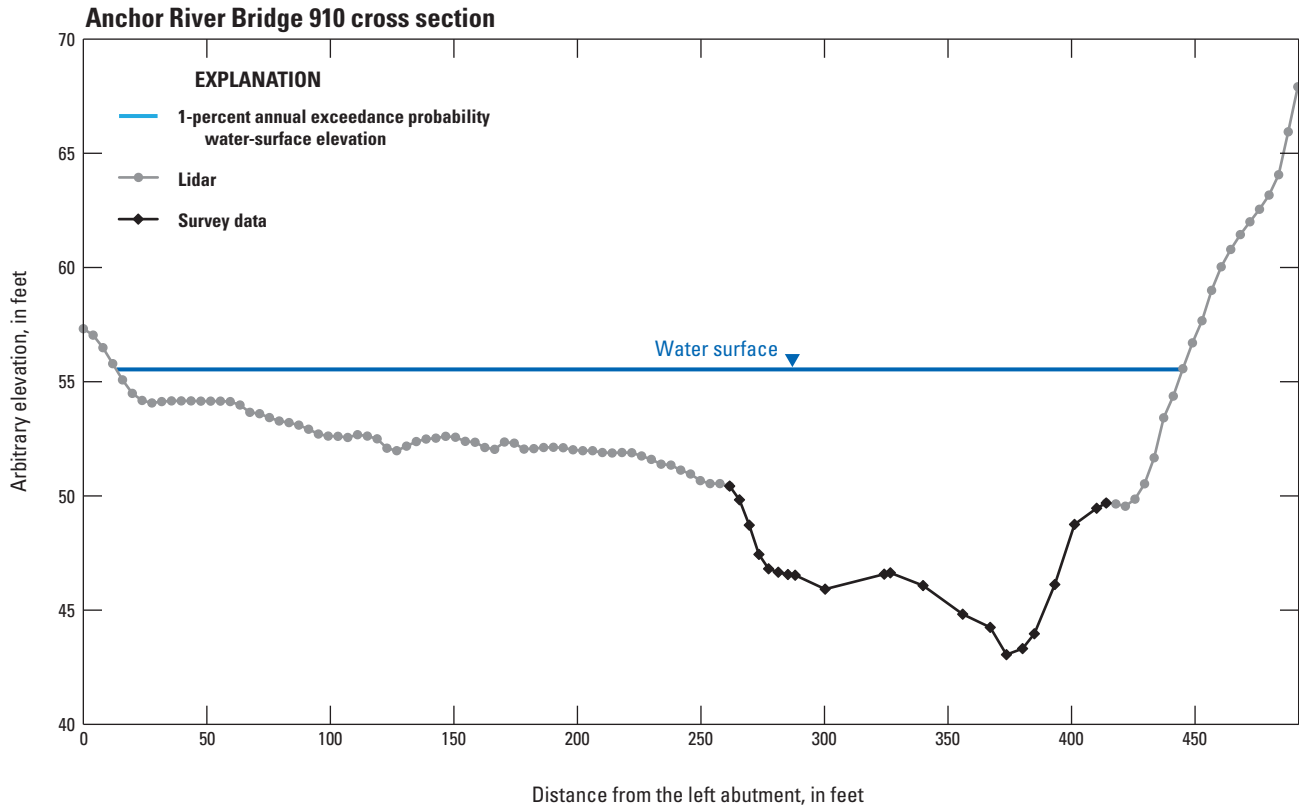
**Figure 3.** Cross section of surveyed channel with lidar-derived overbank elevations at Anchor River Bridge 910, Alaska.

In most cases, geometry was compiled from survey data and entered manually into HEC-RAS. However, where overbank flow was significant, and water-surface profiles depended on topographic detail in the flood plains, the geometry was supplemented with overbank elevations from lidar data. In these instances, HEC GeoRAS (Ackerman, 2009) was used to extract cross-sectional information from lidar datasets (fig. 3). Incorporating overbank data from lidar is primarily helpful in identifying preferential flow paths in complex flood plains and determining where overflow of the bridge approaches might occur.

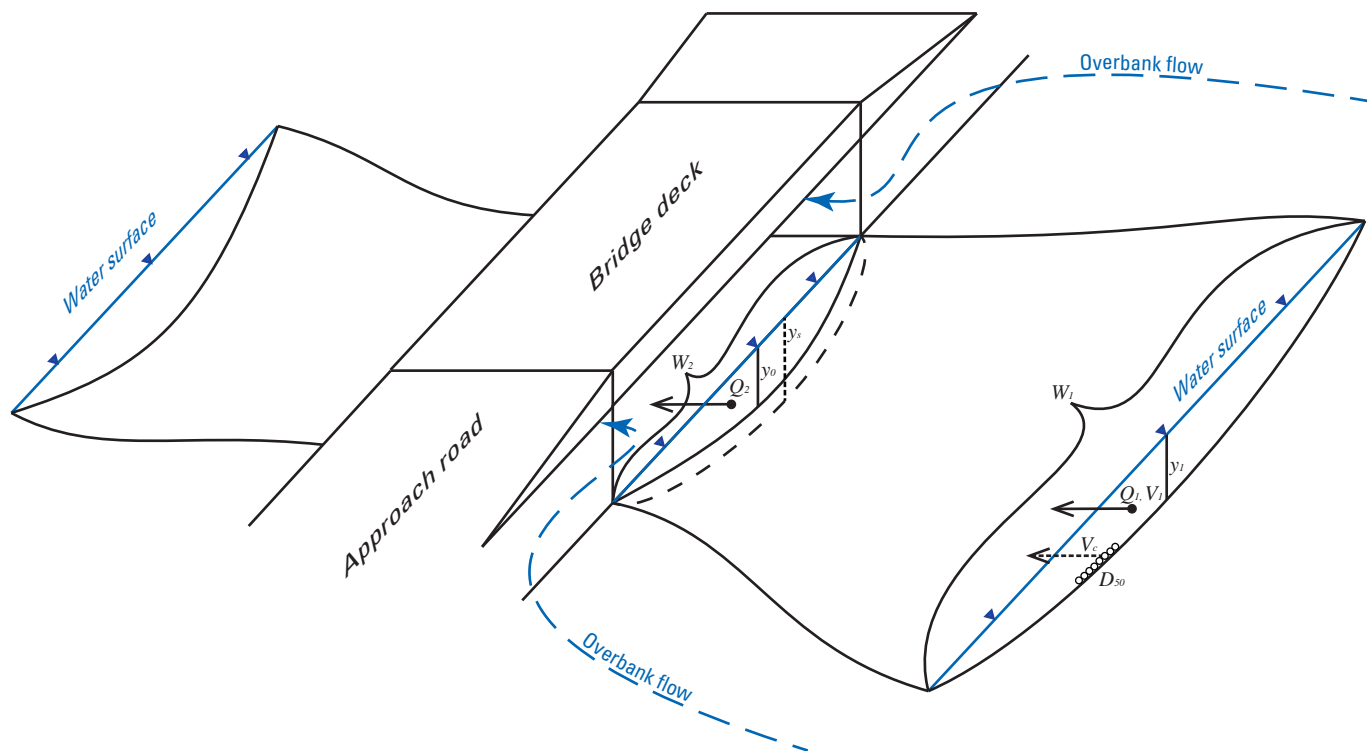
**Figure 4.** Basic contraction scour conditions and variables defined in equations 1–3.

Contraction scour occurs where bridges force flow through a smaller cross-sectional area than the approach channel. Horizontal contraction scour is caused by road approach embankments and abutments in the flood plain or main channel that intercept flow and direct it through the bridge opening. Vertical contraction scour occurs when the

superstructure of the bridge (girders, deck, curb, and railing) intercepts the water surface, creating pressure flow conditions. In both cases, contraction scour occurs because, as flow accelerates through a smaller cross section, velocity and shear stress increase and transport streambed material downstream. As scour deepens a channel, cross-sectional area increases and shear stress and velocity decrease until scour reaches equilibrium depth (also referred to as the depth of maximum scour). Contraction scour is calculated and presented as a uniform lowering of the streambed across the channel cross section (fig. 4), but it rarely actually works that way because some areas of the streambed are more erodible than other areas, and flow is not evenly distributed across the channel. Contraction scour is calculated differently depending on the sediment transport properties of the approach channel, whether overtopping (pressure flow) exists, and whether streambed material is cohesive or non-cohesive. All methods assume that the simulated flood lasts long enough to cause maximum scour, and that the width of the contracted section remains constant and only depth increases until equilibrium depth is reached. In practice, erosion of embankments under a bridge often causes the channel to widen and deepen during a flood.

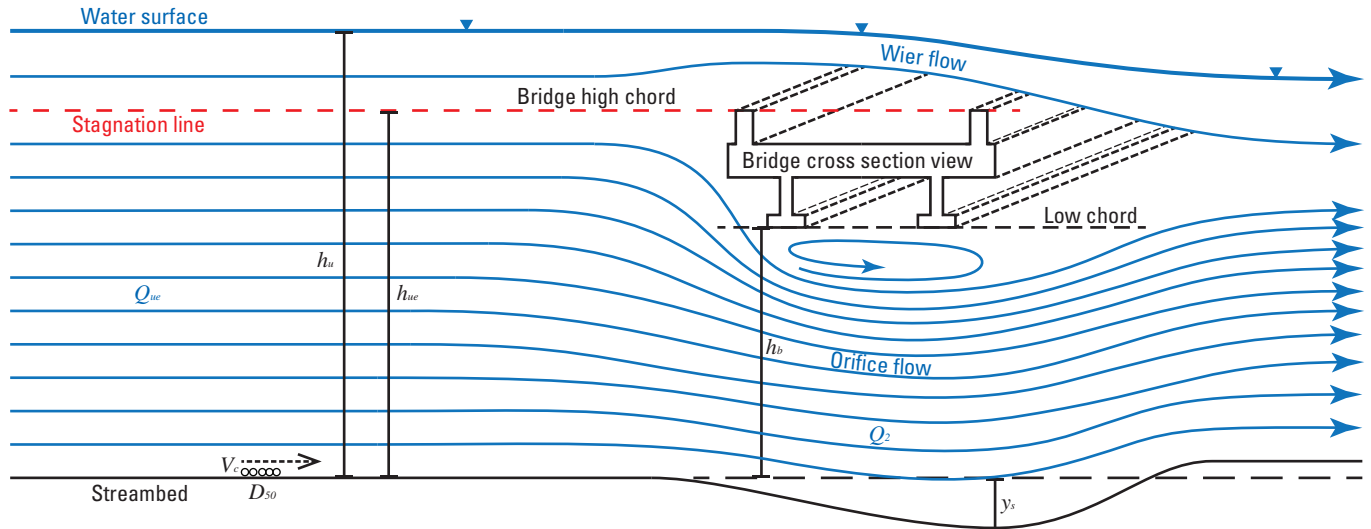
**Figure 5.** Example of vertical contraction scour and variables used to calculate scour.

When flow is intercepted by the superstructure of a bridge and no longer has a free surface, it undergoes vertical and horizontal contraction. These conditions produce additional forces on the streambed and greater stress on the bridge (fig. 5). New bridges are designed with freeboard above the design scour floods to avoid vertical contraction, but some existing bridges are undersized. The 1- and 0.2-percent AEP (or smaller) flows produce vertical contraction conditions at eight of the study sites. Vertical contraction scour is calculated for live-bed and clear-water conditions using equations 4 and 5, respectively. The equations are similar to those for horizontal contraction scour, but include a term comparing the depth of flow upstream of the bridge with the vertical opening of the bridge.

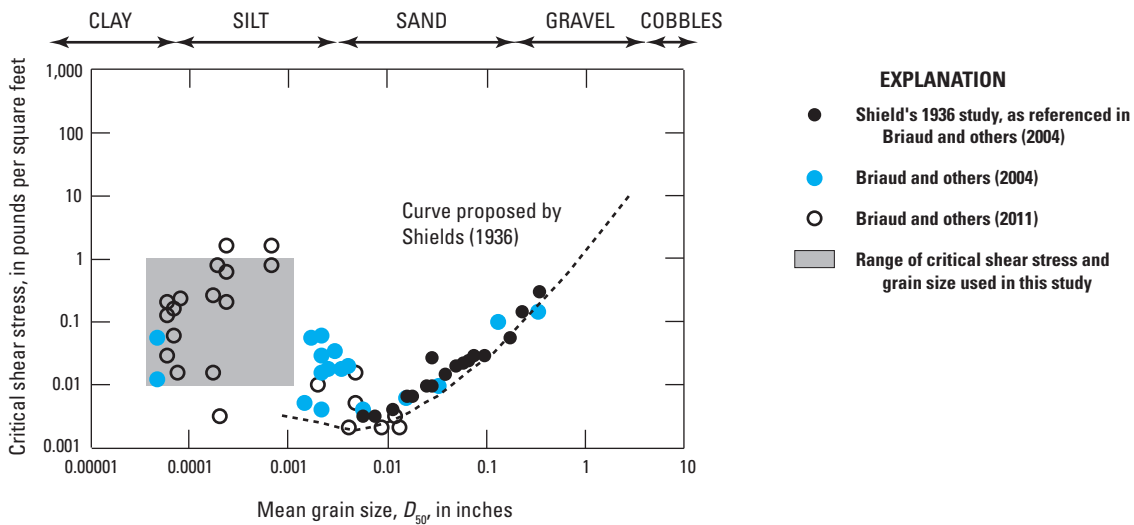
**Figure 6.** Relation between mean grain size and critical shear stress for initiation of particle movement. Values converted from Briaud and others (2011) to inch/pound units.

Lacking resources to measure  $\tau_c$  or  $Q_u$ , the range of  $\tau_c$  in similar soils based on Straub and others (2013), and figures 6 and 7 from Briaud and others (2011) were used.

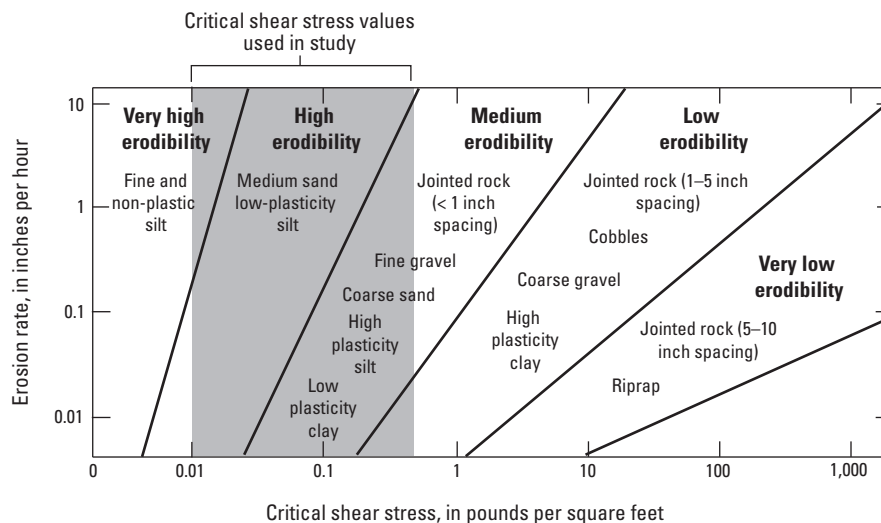
**Figure 7.** Erosion rate compared with grain size and range of shear stress used for selected bridge sites in Alaska, 2012. Modified from Briaud and others (2011).

Briaud and others (2004) suggested that shear stress in cohesive soils ranged from 0.01 to 0.1 lb/ft<sup>2</sup>. Straub and Over (2010) determined that critical shear stress varied from 0.02 to 0.4 lb/ft<sup>2</sup> in their analyses of soils from bridge in Illinois. An apparatus to measure unconfined compressive strength or critical shear stress was not available and each calculation was computed with shear stresses of 0.01–0.4 lb/ft<sup>2</sup>, or until estimated scour was 0.

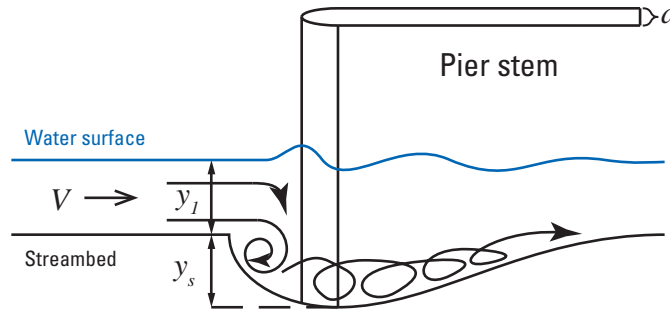
Figure 8. Example of pier scour with variables used to calculate scour.

The undermining of bridge piers from scour is a major cause of bridge failure. During floods, piers obstruct flow and cause water to pile up at the upstream end of the pier (fig. 8). This creates horseshoe shaped vortices that plunge downward around the nose of the pier, scouring bed material from around the base. Scour continues until it reaches an equilibrium depth where the vortices are no longer strong enough to move bed material, similar to contraction scour. Arneson and others (2012) recommended use of equation 7 for most non-cohesive conditions. A factor ( $K_3$ ) is used to correct for live-bed or

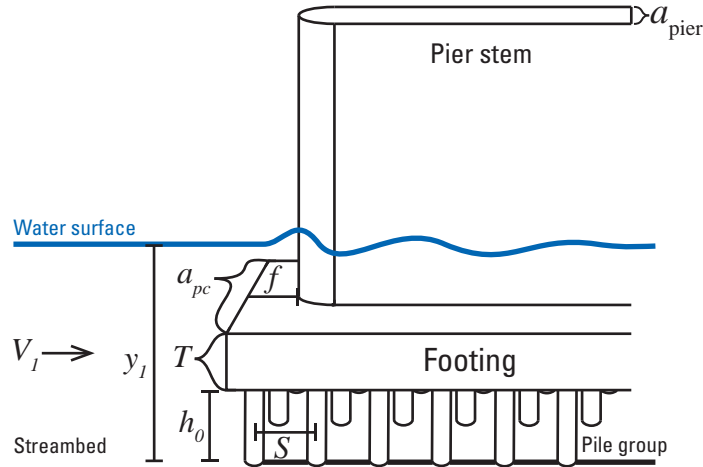
**Figure 9.** Example of complex pier-scour components and variables used to calculate scour using equations 9–11.

Piers with footings that are exposed to streamflow undergo greater scour owing to complex hydraulics around the footing and pile group (fig. 9). Footings are wider and longer than the area of the pier designed to be in the flow, and when they are exposed to streamflow they have greater hydraulic resistance to flow and amplify local scour. Bridge 1744 over Mineral Creek has a shallow footing, and the complex pier scour equation was used to evaluate total pier scour (eq. 9). Complex piers are broken down into a pier stem component, a footing component, and a pile group component, which are added together to get total pier scour. In the case of Mineral Creek, the footing is not completely undermined by scour after the pier stem component is subtracted from the low streambed, so only the pier stem (eq. 10) and footing (eq. 11) components were needed (Arneson and others, 2012).

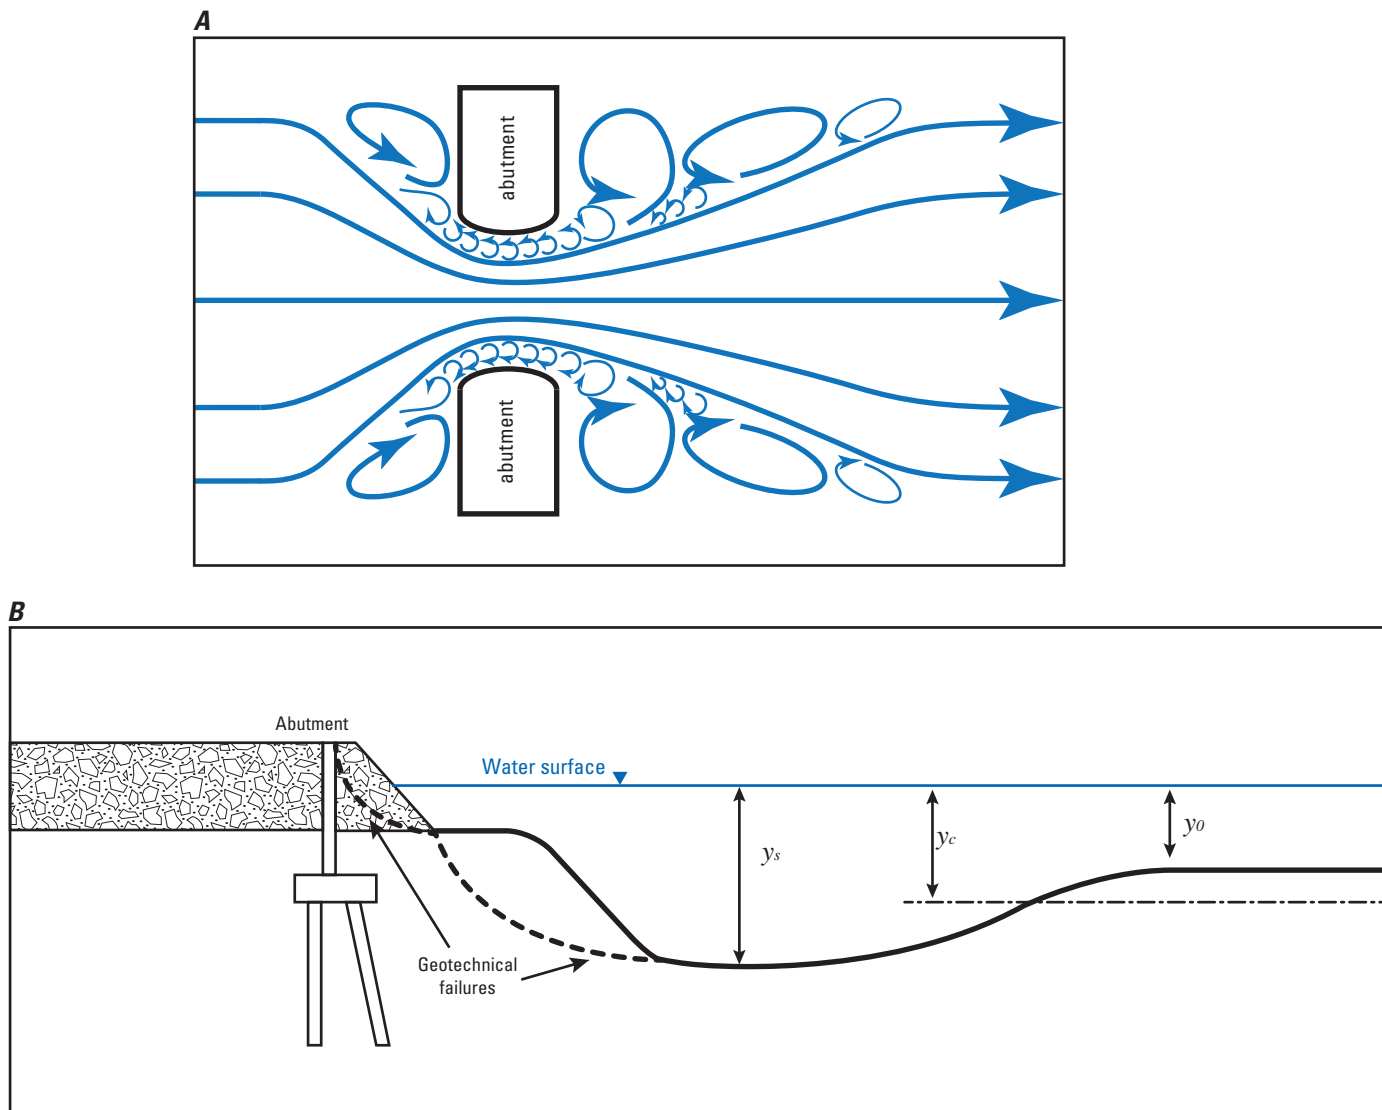
**Figure 10.** Examples of abutment (A) scour plan view and (B) cross-section view. Modified from Ettema and others (2010).

area (fig. 10; Ettema and others, 2010). The NCHRP 24-20 study also concluded that abutment scour is limited by the geotechnical stability of the embankments, which fail and fill in scour holes when they are undercut. Minor embankment failures are common features of the bridge sites in this study, especially at the nine sites where the embankments were not adequately protected by riprap according to the most recent ADOT&PF inspection report.

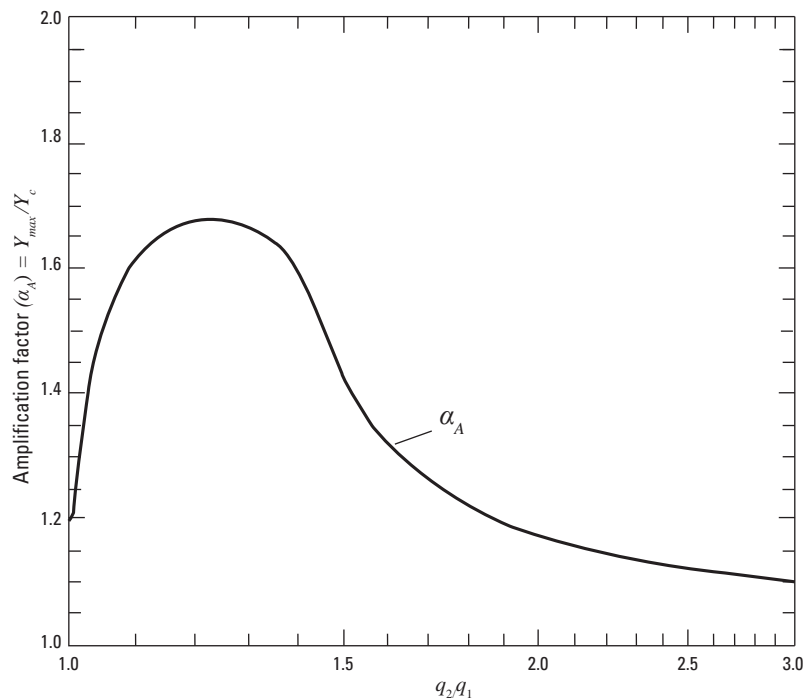
**Figure 11.** Amplification factor for abutment scour. ( $q_2/q_1$ , relative contraction.)

calculated separately, whether live-bed, clear-water, cohesive soils, or vertical contraction equations were used. The amplification factor is determined using figure 11, which is an empirically derived curve relating relative contraction ( $q_2/q_1$ ) as calculated in equation 13 to  $\alpha_A$

- $y_s$  is the abutment scour depth, in feet;
- $\alpha_A$  is the amplification factor for live-bed conditions (fig. 11);
- $y_c$  is the average flow depth at the bridge including live-bed or clear-water contraction scour, in feet; and
- $y_0$  is the flow depth at the bridge prior to scour, in feet.

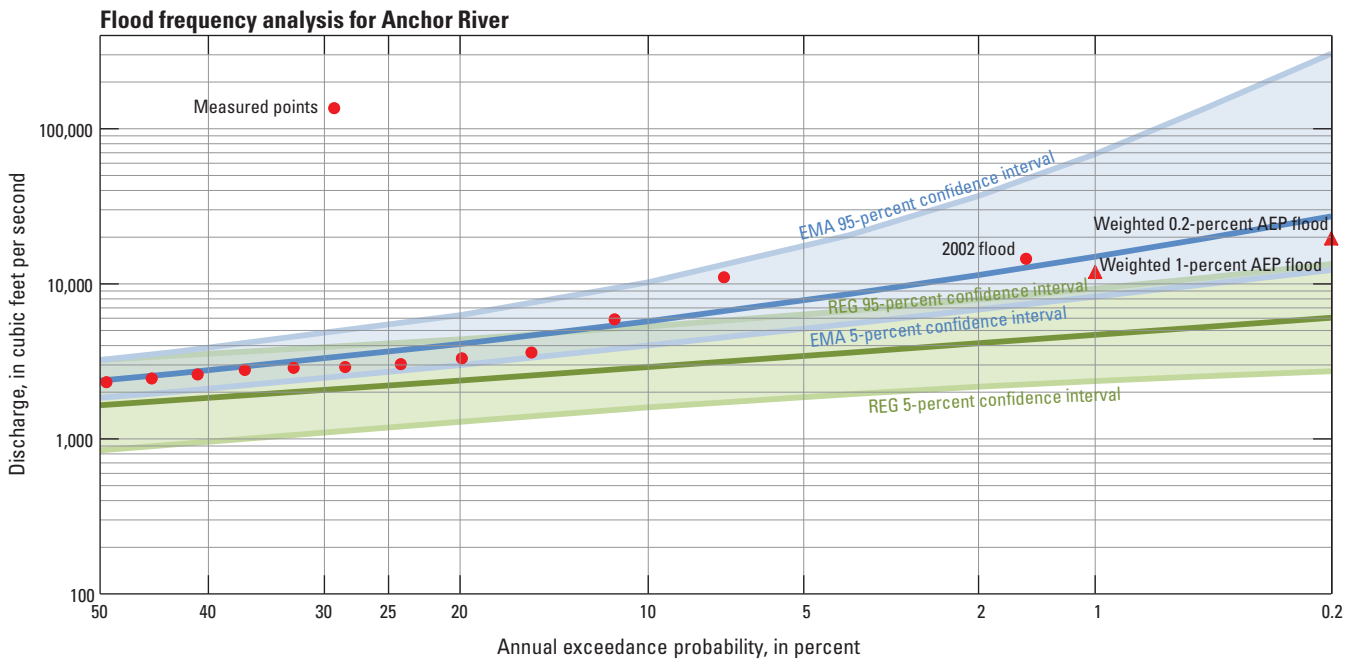
**Figure 12.** Flood frequency curves used to calculate the weighted 1- and 0.2-percent annual exceedance probability floods, with 5- and 95-percent confidence intervals for each analysis and measured peak flows at Anchor River, Alaska.

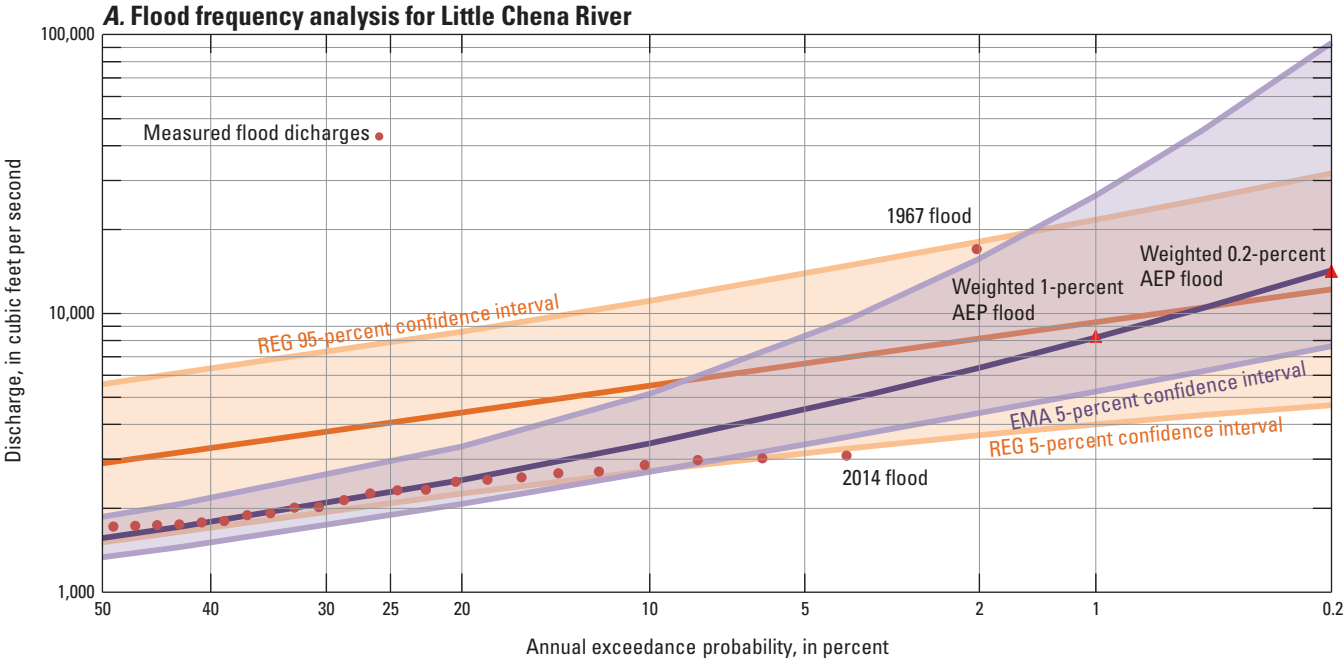
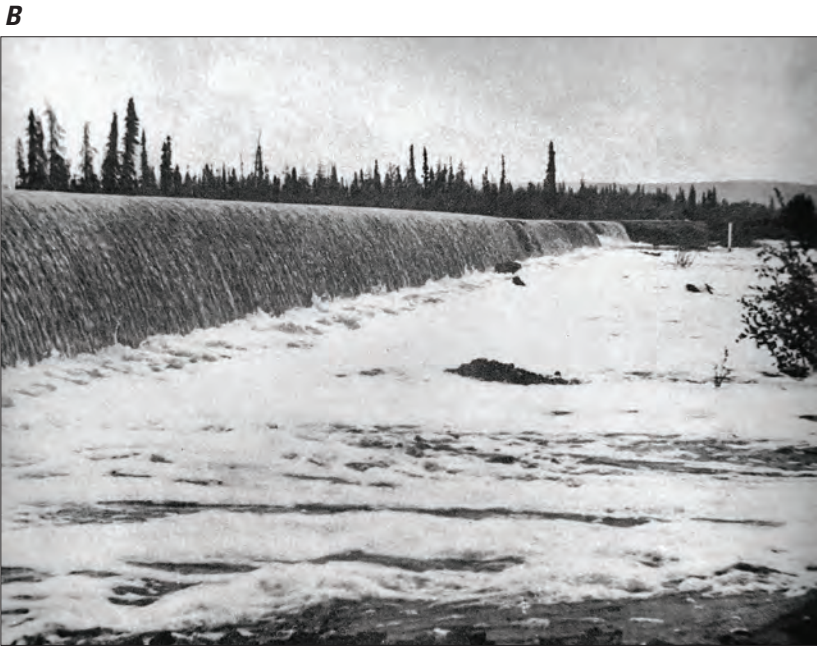
**Figure 13.** (A) Flood frequency curves and (B) Little Chena River overtopping Bridge 270 at Chena Hot Springs Road, Alaska, during the 1967 flood. Photograph by Fairbanks News-Miner (Childers, 1972).

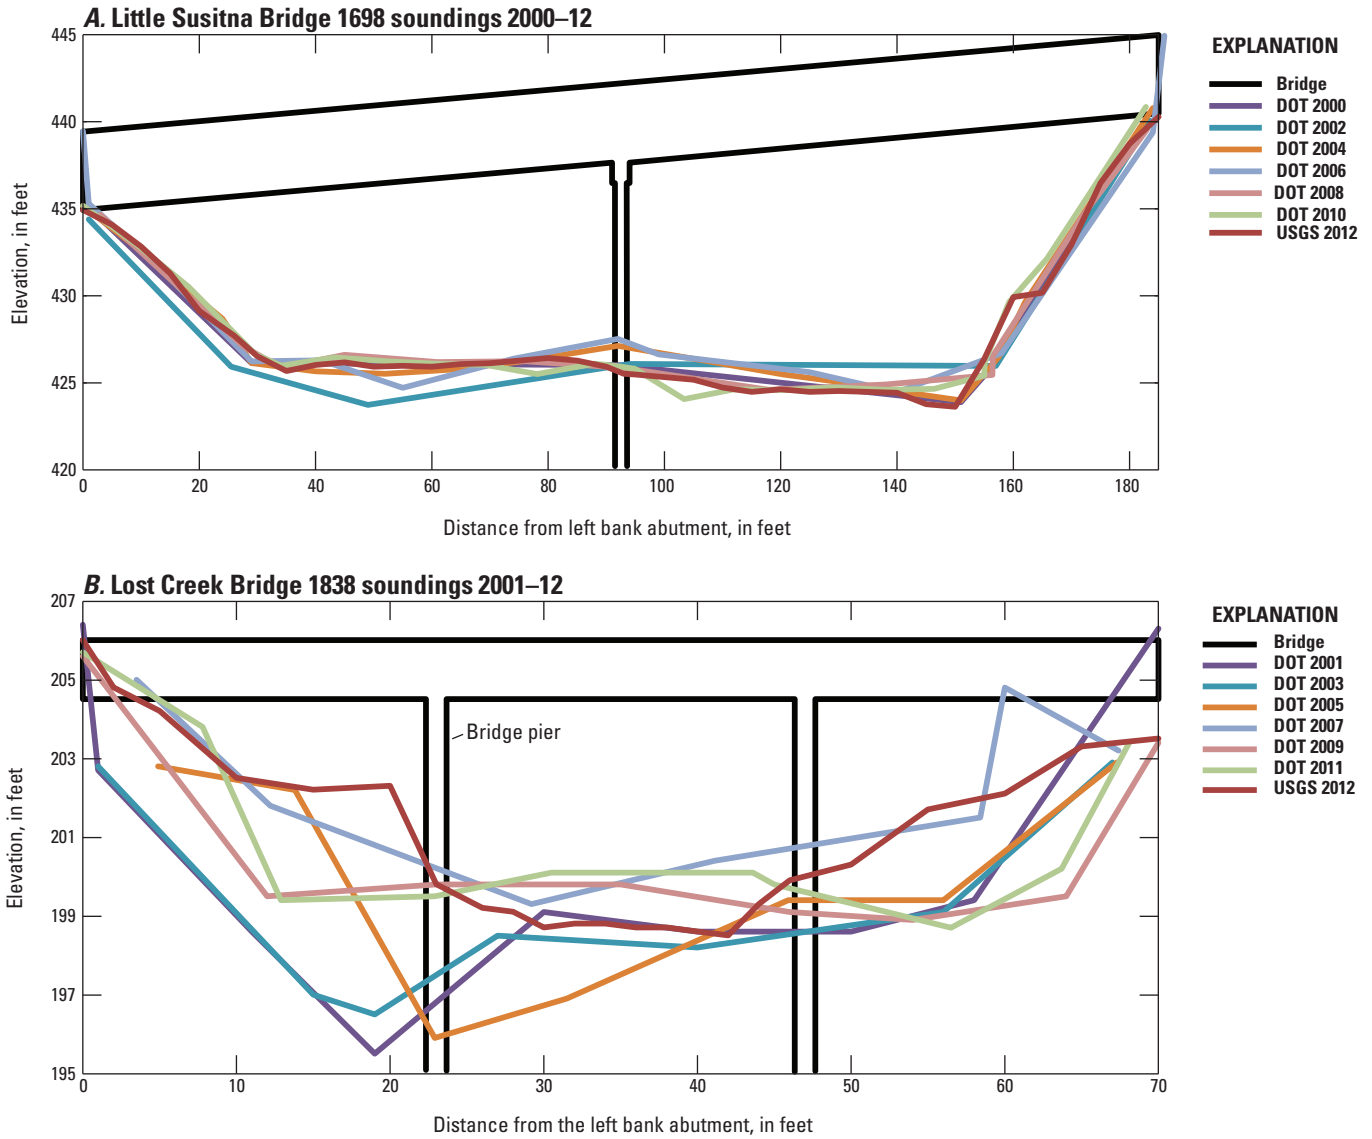
**Figure 14.** Examples of sounding records for (A) a stable site and (B) an unstable site, Alaska.

Stream stability at the reach scale was assessed using geomorphic observations and sounding records (table 5, fig. 14). All sites are alluvial with streambeds and banks composed of sediment, and thus have the potential to shift, erode, or aggrade if disturbed. However, most of the sites are classified as stable or moderately stable with little evidence of reach-scale channel change, significant sediment sources, or human disturbance beyond road embankments or bank stabilization. Moderately unstable sites exhibited evidence of active sediment sources and natural channel change. These include Jack Creek and Little Susitna River. Unstable sites, which have active sediment source areas, evidence of channel change, and human disturbance, include Crooked (Bridge 431), Lost (Bridge 1838), Lowell (Bridge 1136), Mineral (Bridge 1744), and Salmon (Bridge 1820), Creeks (table 5).

Geomorphically unstable sites tend to correspond with variation in streambed elevation in the repeat cross sections (table 5), except that Fish Creek Bridge 1209 and Funny River Bridge 978 both showed streambed changes of greater than 2 ft in repeat cross-section surveys (putting them in the “less stable” category), but these sites did not show evidence of geomorphic instability. In both cases, the bed elevation changes seen in the soundings are consistent with scour owing to the bridge contraction at the abutments rather than reach-scale instability. Little Susitna River Bridge 1698 is located in a braided reach that is geomorphically moderately unstable, but channel soundings at the bridge show little channel change. Soundings did not show definitive signs of either aggradation or degradation at any study sites. The average change in minimum bed elevation between successive soundings was 0.5 ft or less for all sites. Repeat cross-section soundings are useful in identifying instabilities but cannot be used to rule out vulnerability to scour or other response to flooding. Scour and fill often are short-lived and are evident during and shortly after a flood (Conaway, 2007). Soundings taken at 2-year intervals, even if a flood occurs between soundings, may not reflect transient effects of the flood on the channel cross section. All measured cross sections for study sites are in appendix A.

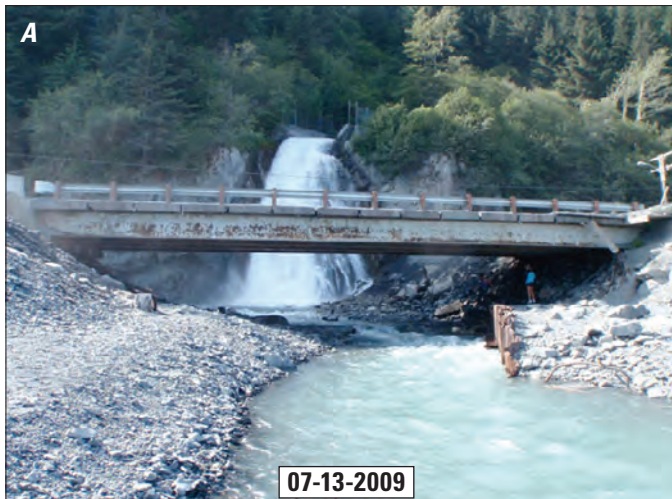
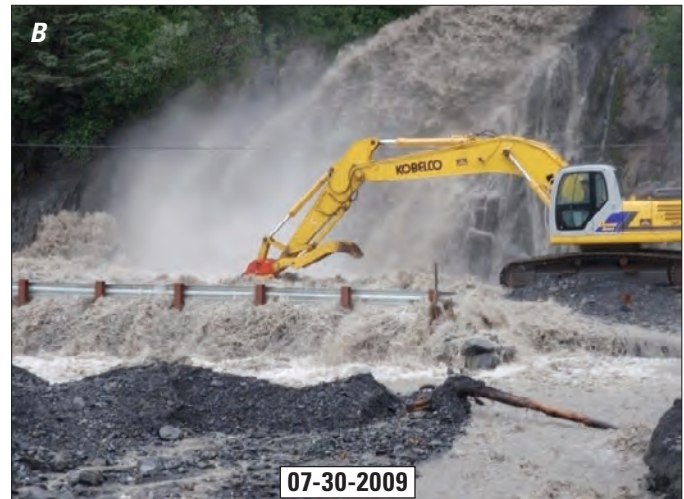
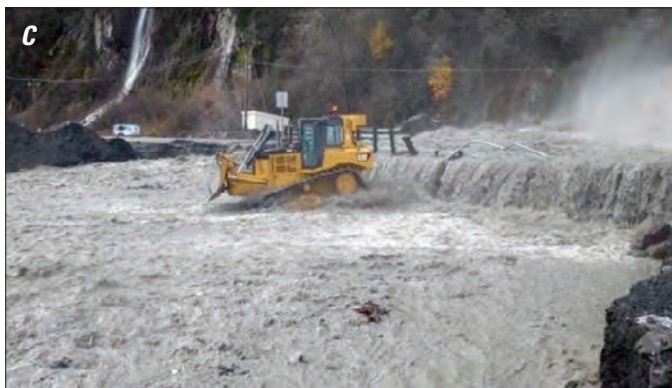
**Figure 15.** Lowell Creek waterfall during (A) low flow and (B) flooding in 2009, (C) flooding in 2013 near Seward, Alaska. Photographs (A) and (B) by Alaska Department of Transportation and Public Facilities, photograph (C) by Carol Griswold (Seward City News).

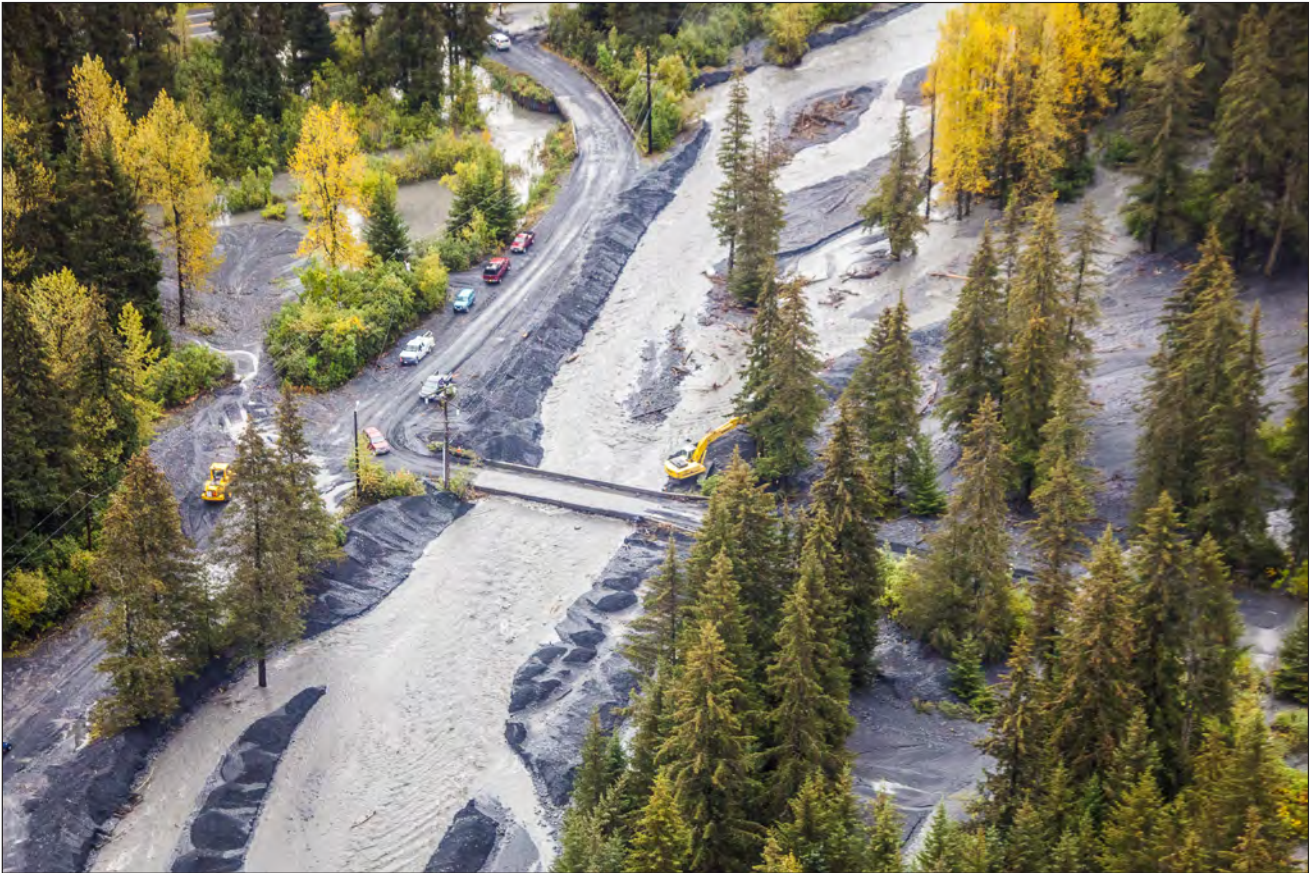
**Figure 17.** Pressure-flow conditions, dredged channel, and gravel berms at Lost Creek Bridge 1838, near Seward, Alaska, September 21, 2012. Photograph by City of Seward.

Both channels are currently contained between berms composed of bulldozed stream channel gravel and are regularly dredged to maintain channel and bridge capacity. Both bridges are projected to be submerged during design flows, and observations at Lost Creek Bridge 1838 in 2012 support this projection (fig. 17). Contraction, pier, and

abutment scour were calculated at these bridges, but similar to Lowell Creek, the dominant hydraulic processes unaccounted for in the scour estimation methods are aggradation and dredging by heavy equipment. Streambed scour is not likely to occur at these sites owing to the aggradational processes.
