Geomorphic Responses of Duluth-Area Streams to the June 2012 Flood, Minnesota

Scientific Investigations Report 2016–5104

By Faith A. Fitzpatrick, Christopher A. Ellison, Christiana R. Czuba, Benjamin M. Young, Molly M. McCool, and Joel T. Groten

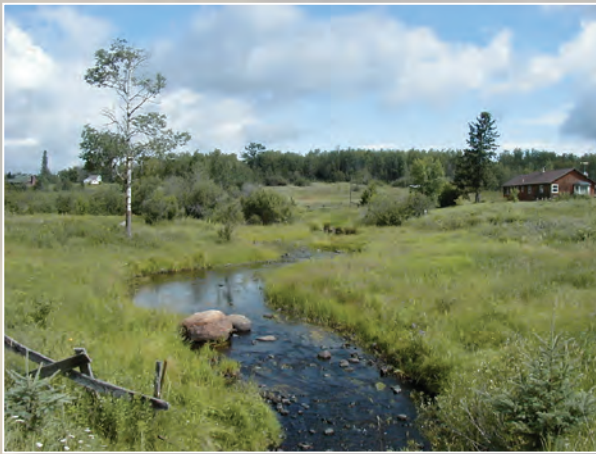
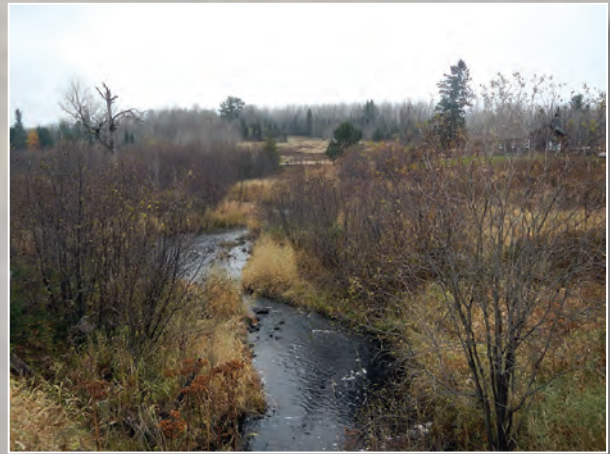
Cover. Top photographs: Upper main stem, Lester River, slope 0.3–1.0 percent, no valley.
Left: Photograph by Kathy Lee, U.S. Geological Survey, July 31, 2003.
Right: Photograph by Christiana Czuba, U.S. Geological Survey, October 30, 2013.

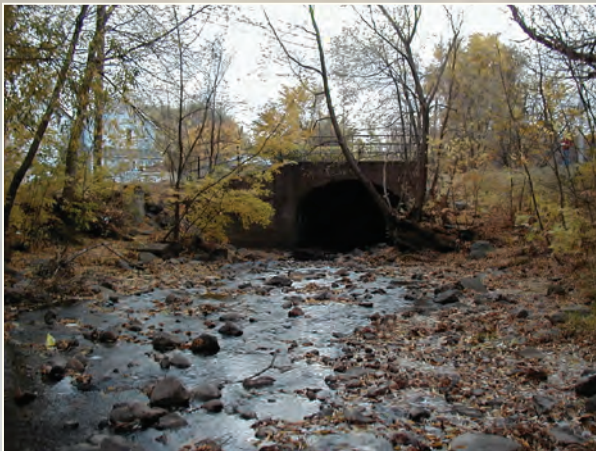
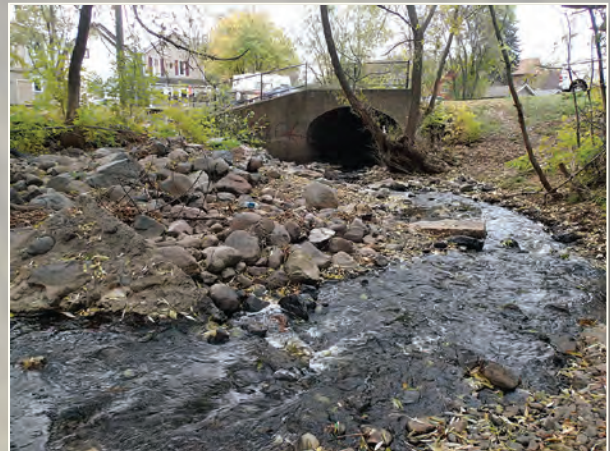
Bottom photographs: Lower main stem, Miller Creek, slope 0.3–1.0 percent, entrenched valley.
Left: Photograph by Kathy Lee, U.S. Geological Survey, October 22, 2003.
Right: Photograph by Christiana Czuba, U.S. Geological Survey, October 29, 2013.

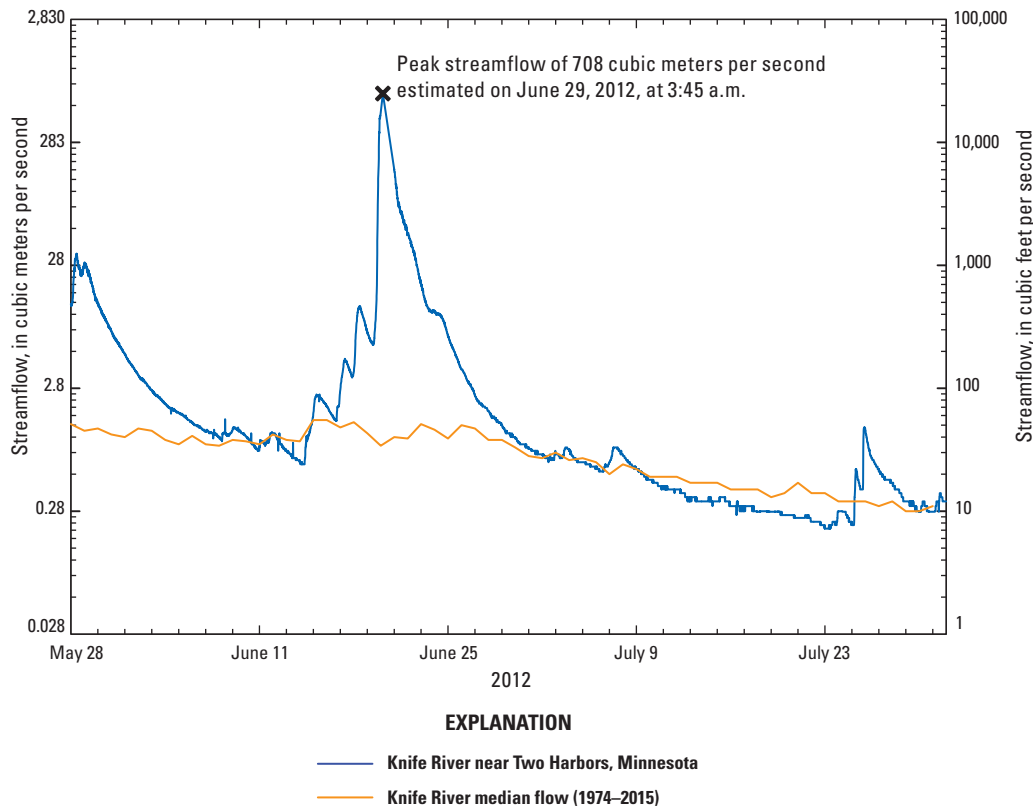
Figure 3. Streamflow hydrograph for Knife River near Two Harbors, Minnesota (U.S. Geological Survey streamgage 04015330) for May 28 through July 27, 2012. (Data from U.S. Geological Survey, 2013.)

Rainfall totals in the Duluth area for the June 19–21, 2012, flood event ranged from 15 centimeters (cm) to greater than 20 cm (fig. 2; Czuba and others, 2012). This resulted in flood peaks with annual exceedance probabilities of less than 0.002 (flood recurrence interval of greater than 500 years) on large and small streams in and surrounding the Duluth area, including the Knife River. The flood hydrograph for the Knife River near Two Harbors, Minn. (USGS streamgage 04015330) illustrates the building effects of runoff related to smaller precipitation events in the days before the flood and the quick rise in flows for the main flood event (fig. 3).

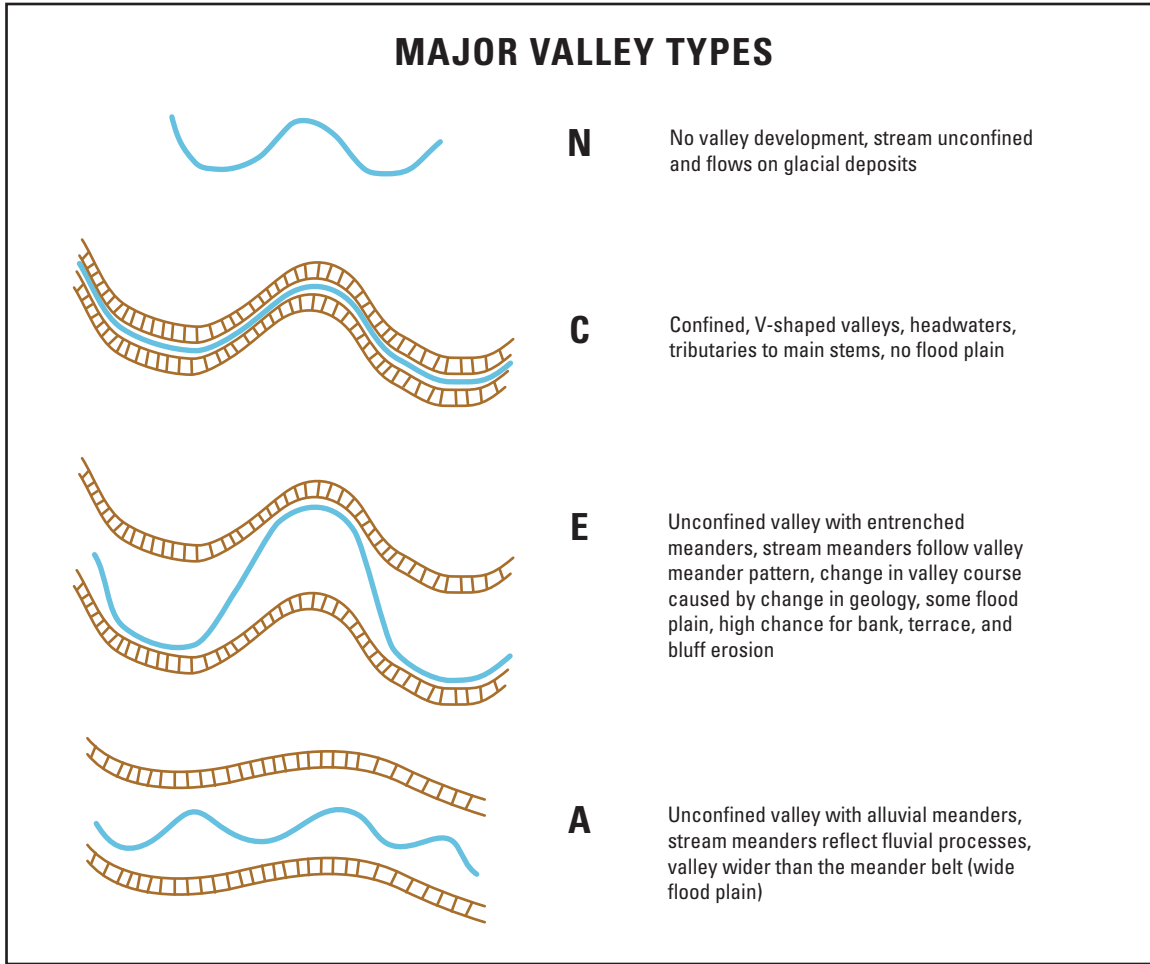
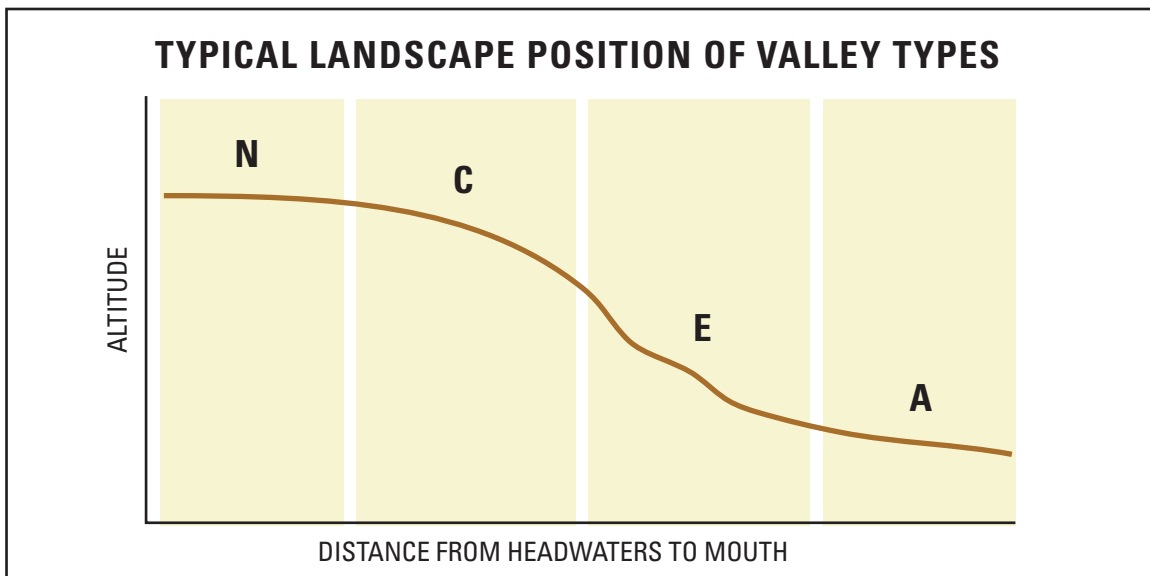
Figure 6. Valley development and valley types along a longitudinal continuum (from Fitzpatrick and others, 2006).

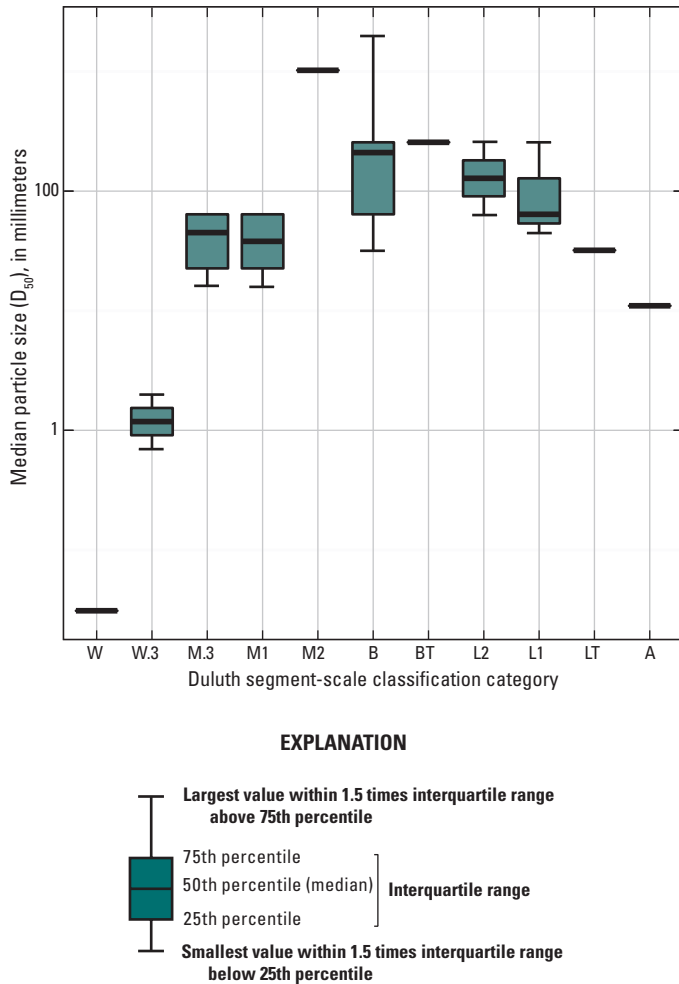
Figure 13. Median particle size by Duluth segment-scale classification category for intensive and rapid-full sites, 2013.

In general, the longitudinal continuum of Duluth-area segment-scale classification categories follow a pattern of channel bed substrate sizes, starting with fine-grained sediment (silt and sand) at wetland sites (segment categories W and W.3) as expected because of gentle reach slopes (fig. 13;

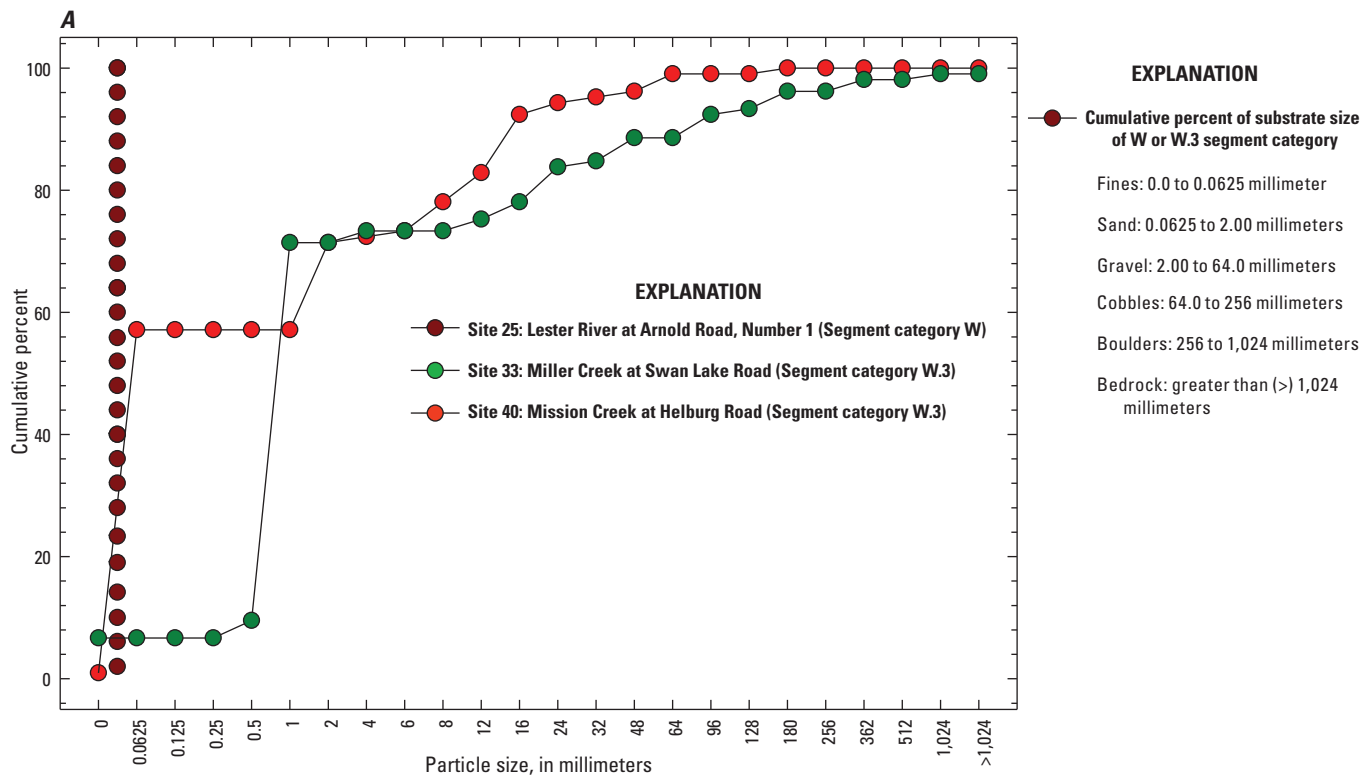
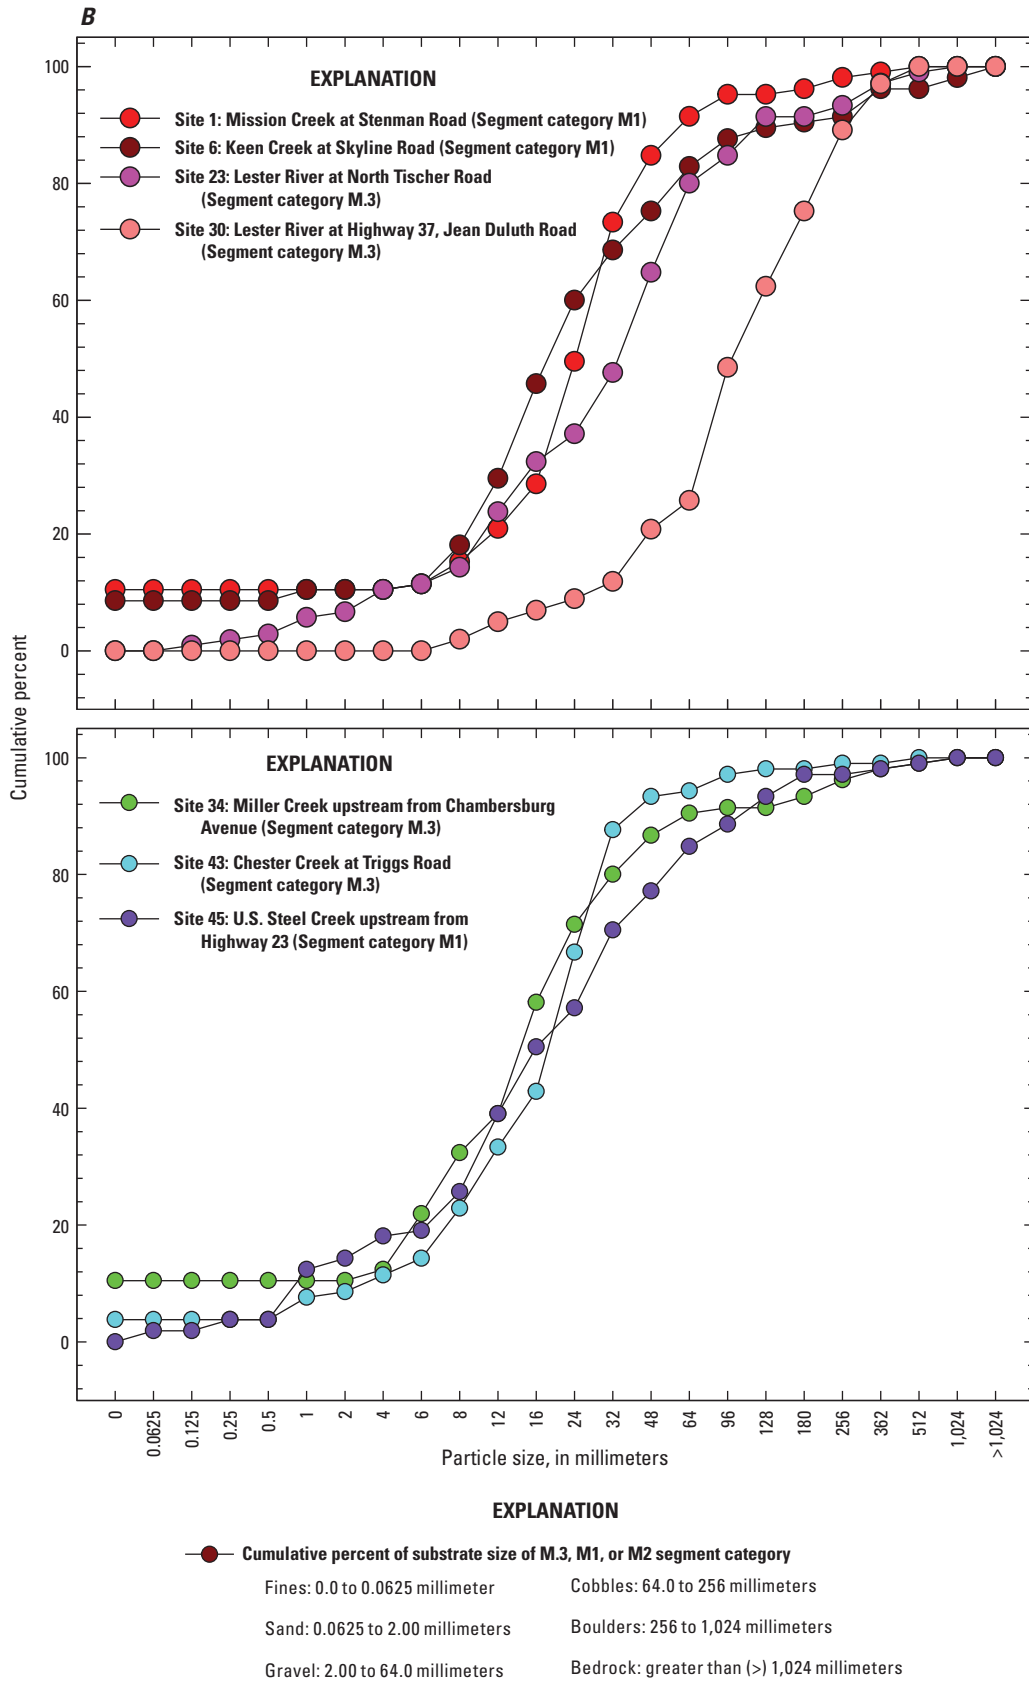
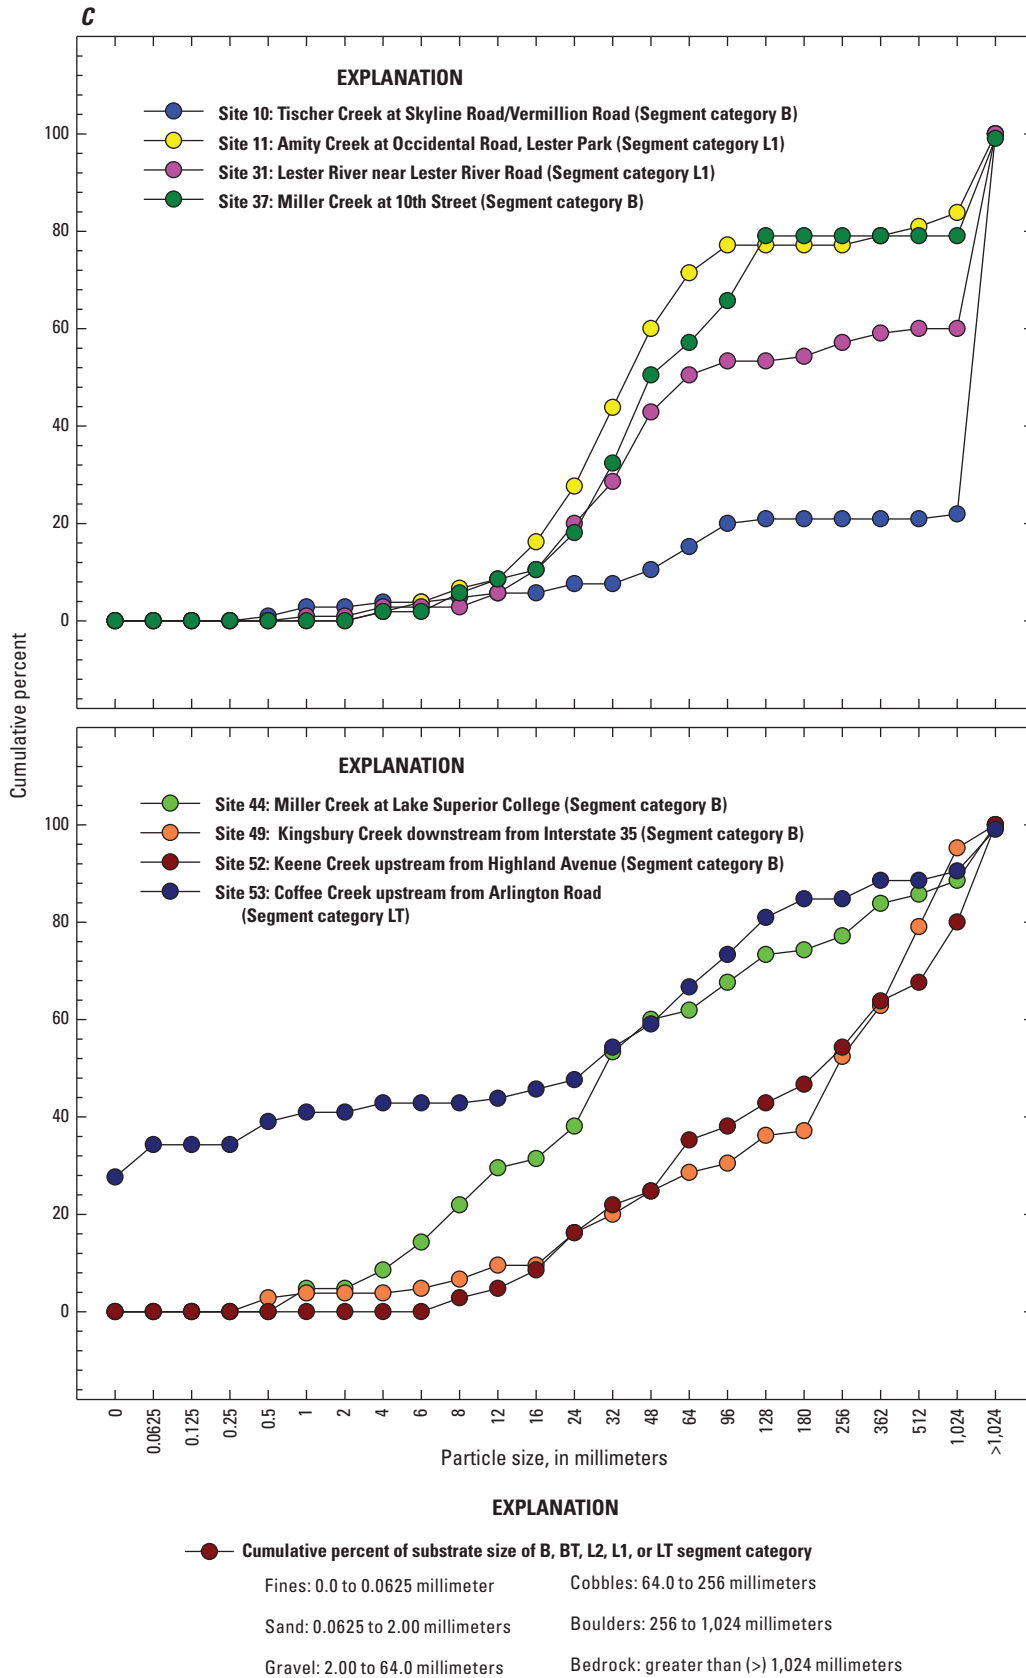
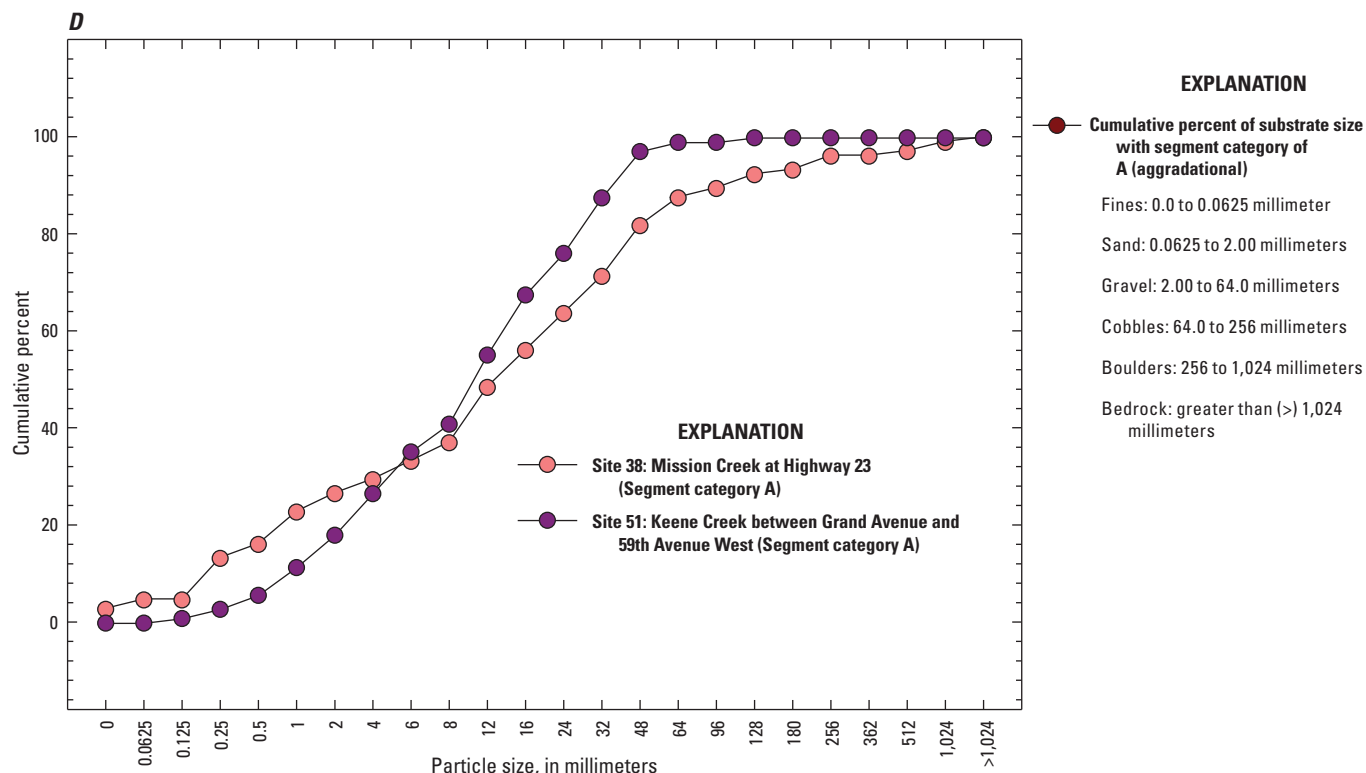
Figure 14. Cumulative frequency plots of substrate particle size (pebble counts) at 2013 intensive sites in the Duluth, Minnesota, area grouped by Duluth segment-scale classification category. A, W or W.3. B, M.3, M1, or M2. C, B, BT, L2, L1, or LT. D, A.

table 4). Middle main stems with moderate slopes have mostly gravel-sized substrate, whereas steep middle main-stem bedrock sites have cobble and larger median particle sizes. Lower main stems, with similar slopes as middle main stems, have coarser sizes because of their downstream proximity to steep sites and possibility of discontinuous bedrock near the surface. Aggradational sites have small gravel substrates. The full cumulative frequency plots are shown for intensive sites organized by segment category (figs. 14A–14D).

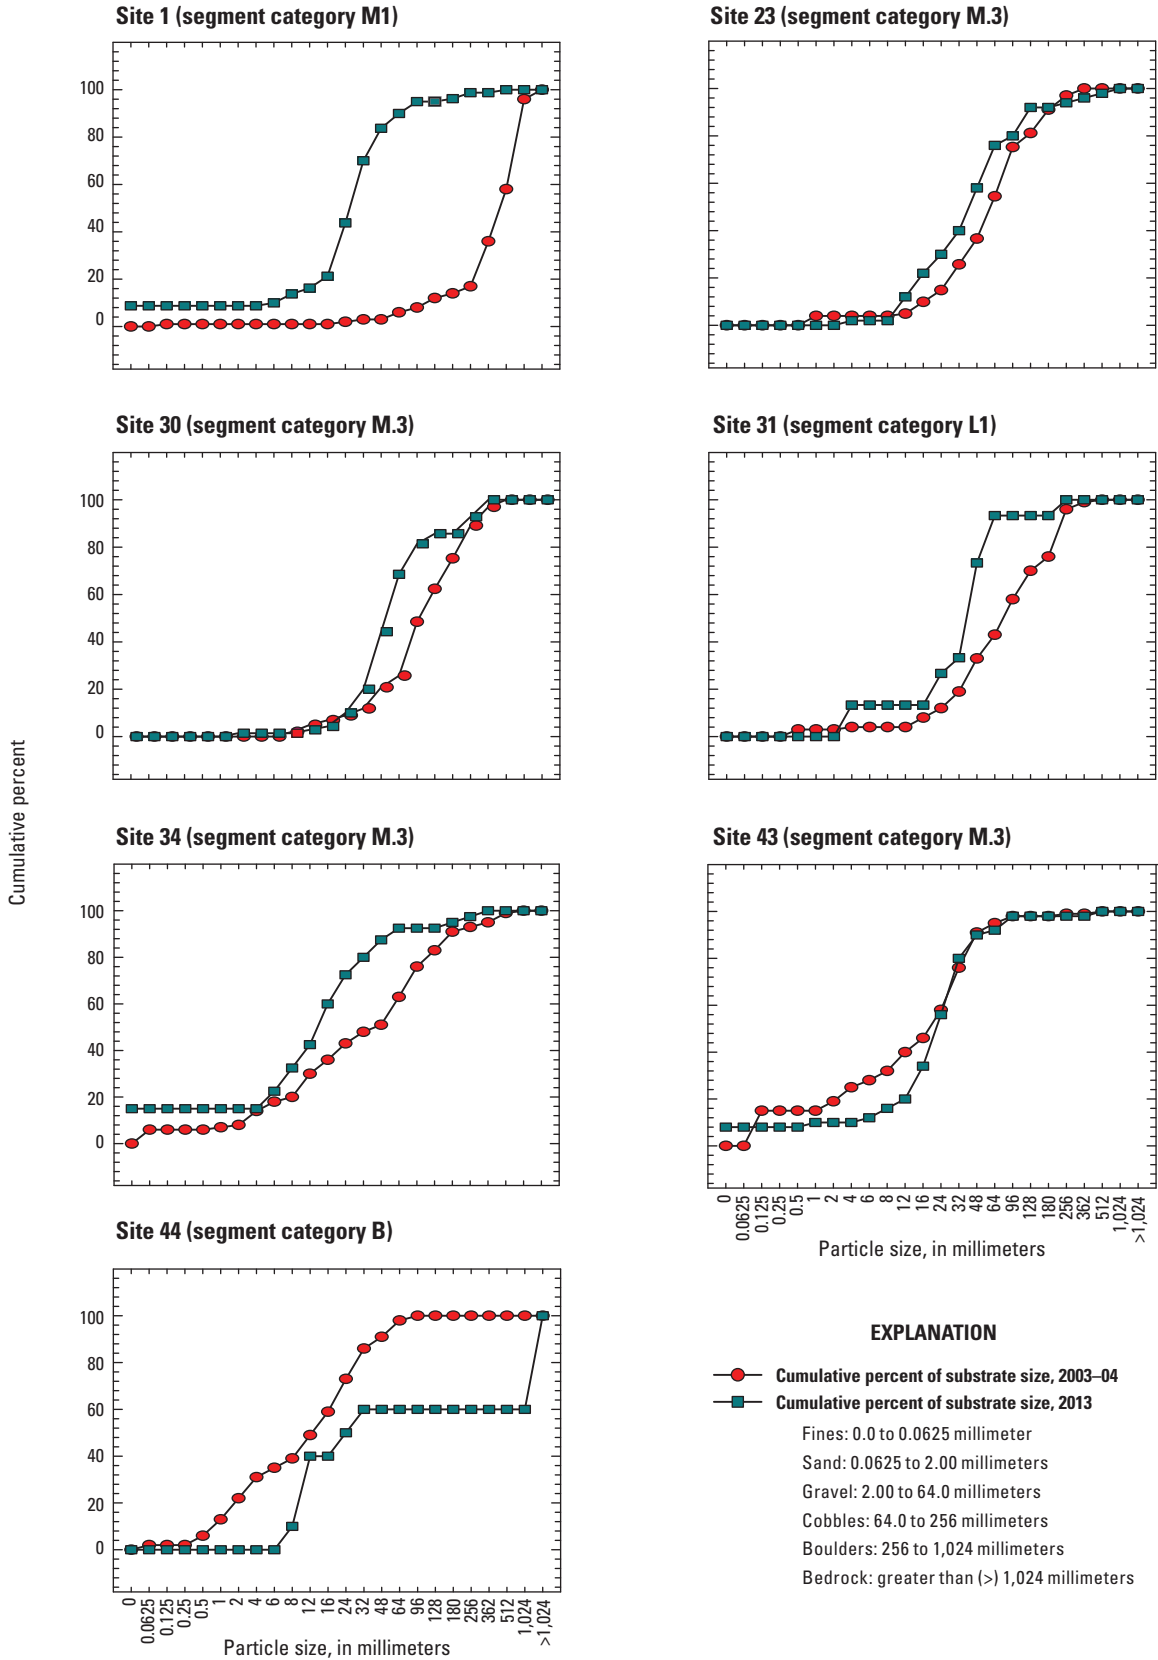
Figure 15. Comparison of pebble count data in overlapping riffles, 2003–4 to 2013.

Seven intensive sites had overlapping pebble count data for riffles from 2003–4 and 2013. The seven sites were from four segment categories—M.3, M1, B, and L1. Riffle particle sizes at four of the seven sites were smaller in 2013 compared to 2003–4 (sites 1, 30, 31, and 34; fig. 15). These included segment categories M.3, M1, and L1. The largest size change was observed at Mission Creek site 1 (segment category M1) where the predominantly cobble and boulder-sized bed material observed in 2003–4 had transitioned to nearly all gravel-sized material. In contrast, at site 44 (Miller Creek, segment category B) the distribution transitioned from about 80 percent of a range of gravel sizes to 60 percent medium to coarse

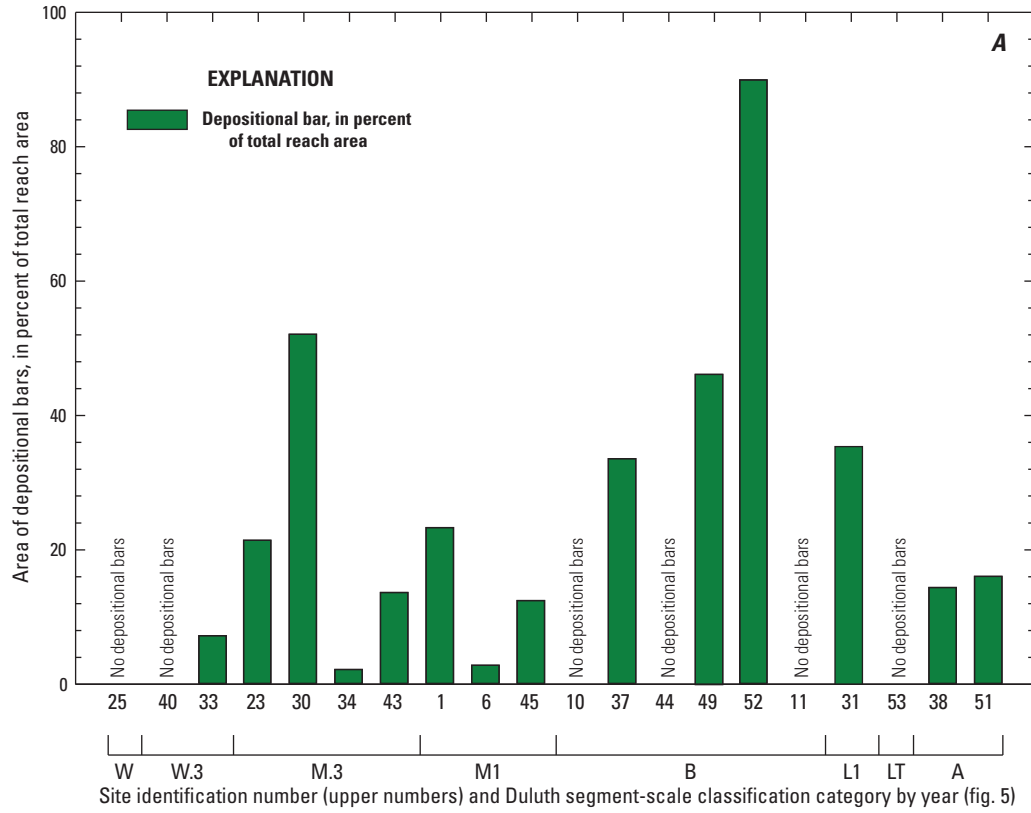
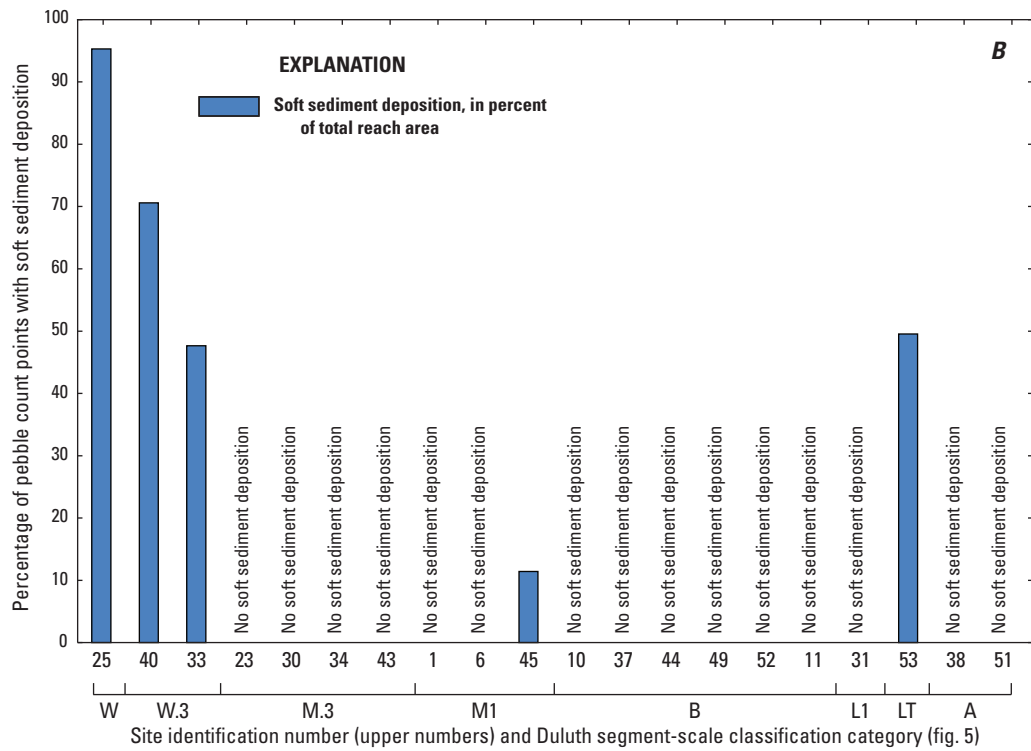
Figure 16. Percentage of reach area for 2013 intensive sites in the Duluth, Minnesota, area. *A*, area of depositional bars. *B*, percentage of pebble count points with soft sediment deposition.

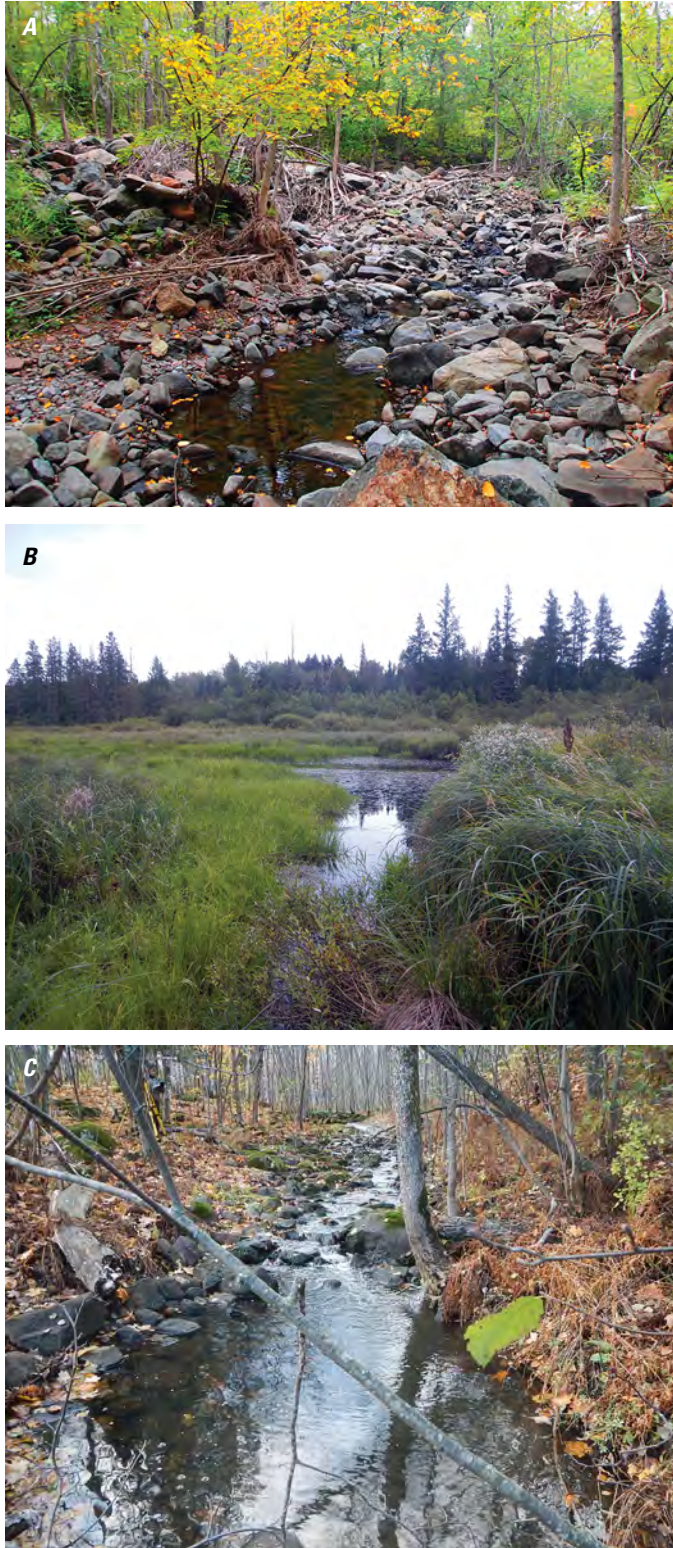
Figure 17. Sites 52 (Keene Creek upstream from Highland Avenue), 25 (Lester River at Arnold Road, Number 1), and 53 (Coffee Creek upstream from Arlington Road). *A*, bar deposition and coarse bed material deposited during the 2012 flood at site 52. *B*, wetland setting at site 25. *C*, pools with soft sediment deposition at site 53.

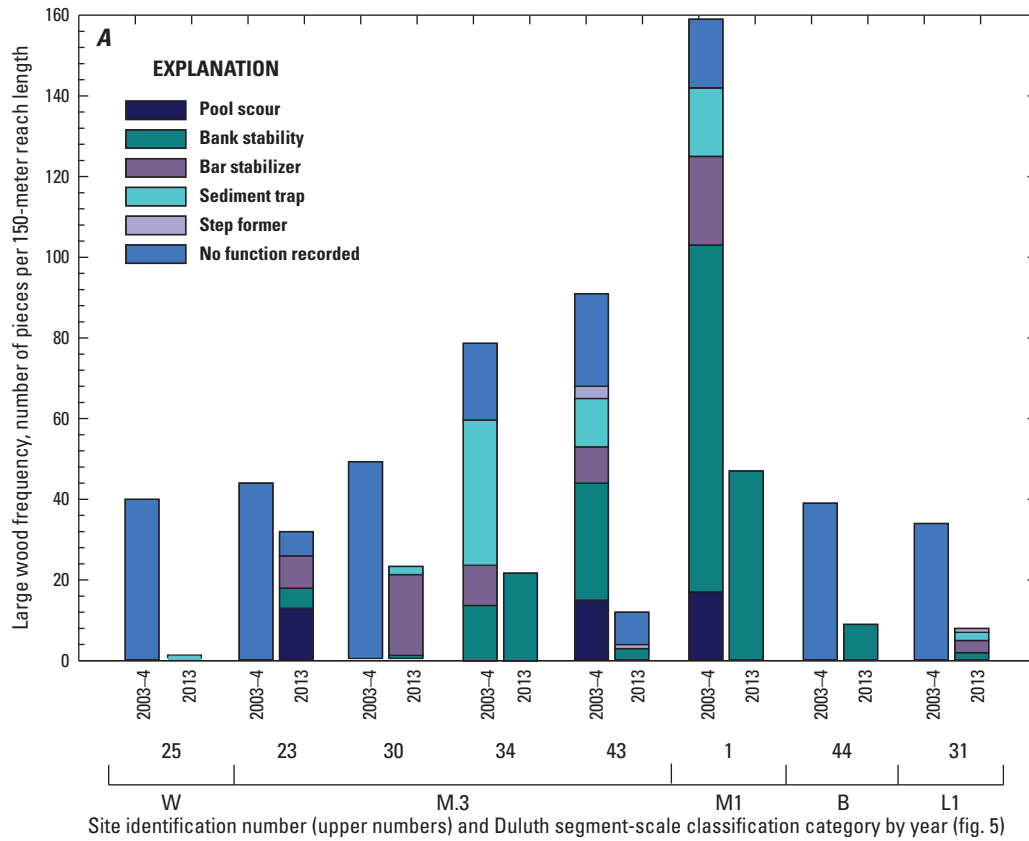
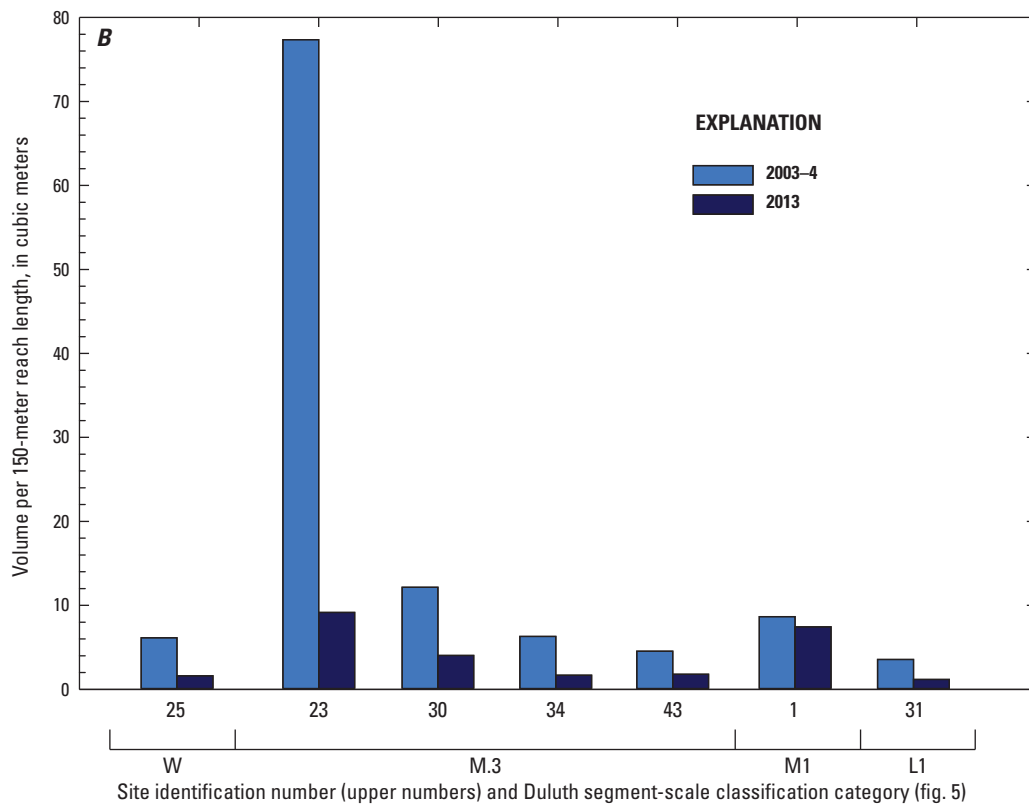
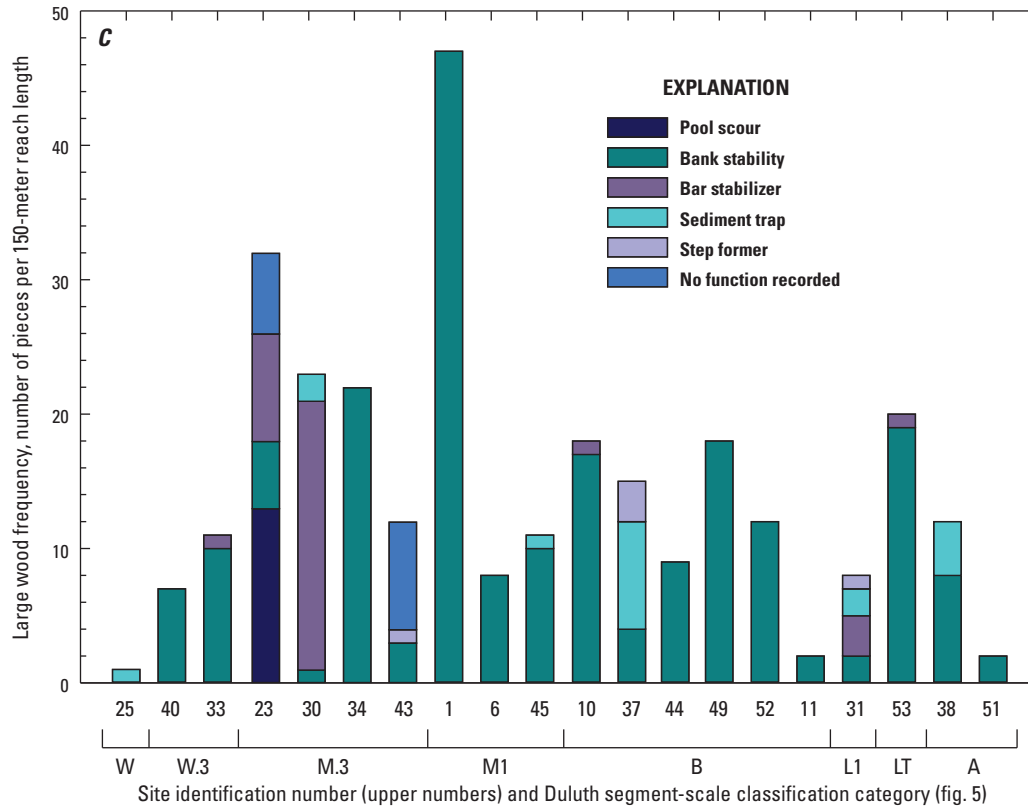
Figure 18. Large wood per 150-meter reach length at intensive sites. *A*, comparison of frequency and function at 2003–4 and 2013 intensive sites. *B*, comparison of volume of wood at 2003–4 and 2013 intensive sites. *C*, frequency and function at all 2013 intensive sites.

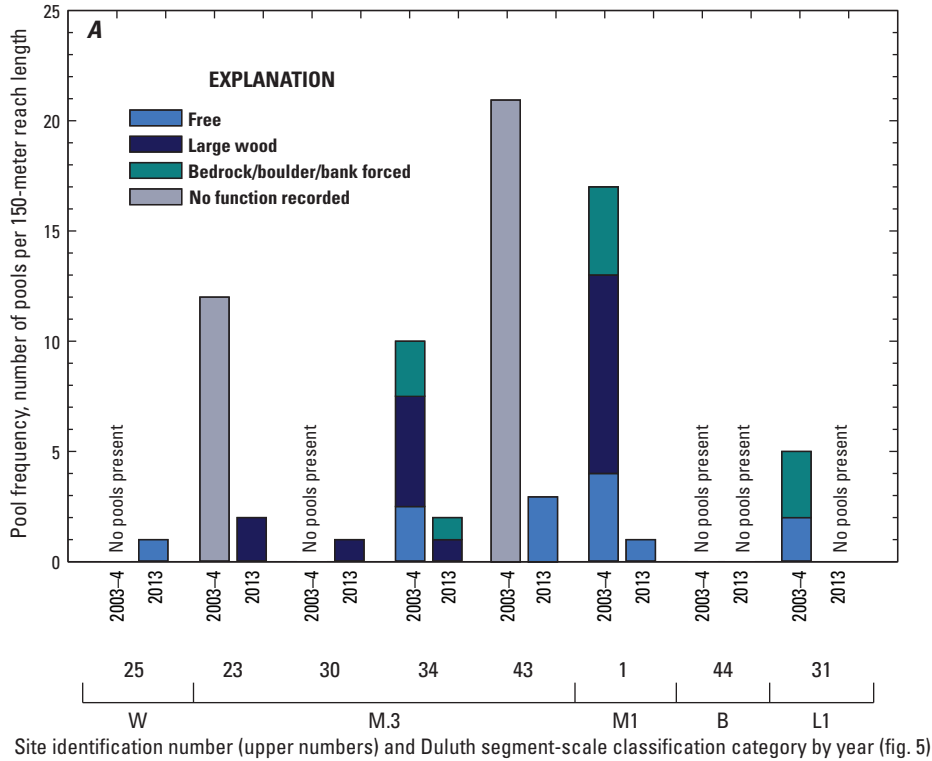
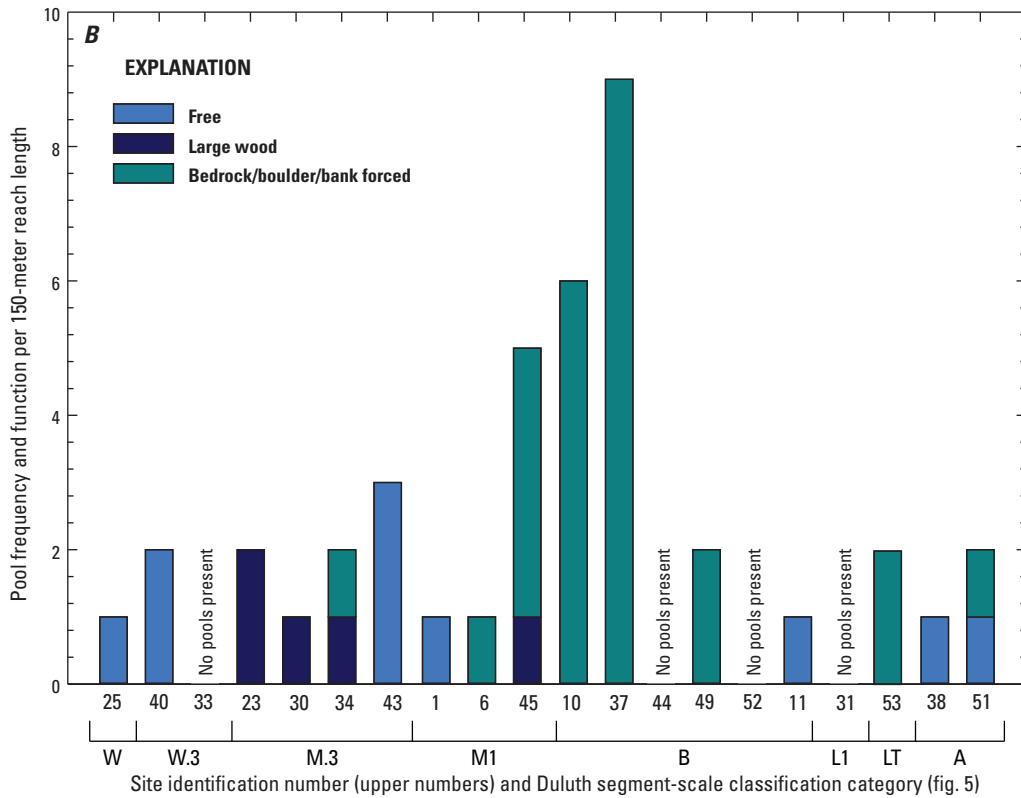
Figure 19. Comparison of pool frequency and function per 150-meter reach length at intensive sites in the Duluth, Minnesota, area. *A*, 2003–4 and 2013 intensive sites. *B*, all 2013 intensive sites.

In 2013, pools were still most frequent in middle main stems (segment categories M.3 and M1) and bedrock (segment category B) sites compared to headwater wetlands (segment categories W and W.3) and especially lower main stems (segment category L1) (fig. 19B). The relatively large number of pools in middle main stems is likely attributable to slope, related channel bedforms (pool-riffle and step-pool), and large wood. For bedrock sites, pools likely are caused by scour

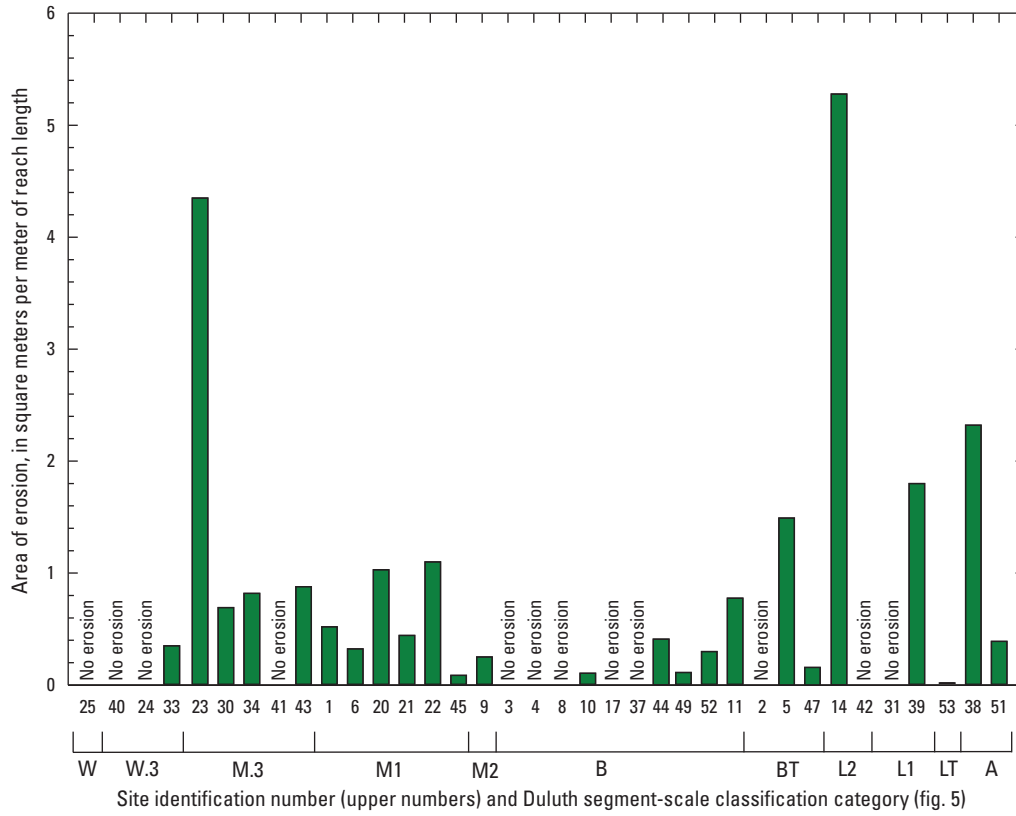
Figure 20. Area of eroding banks, terraces, and bluffs for 2013 intensive sites in the Duluth, Minnesota, area.

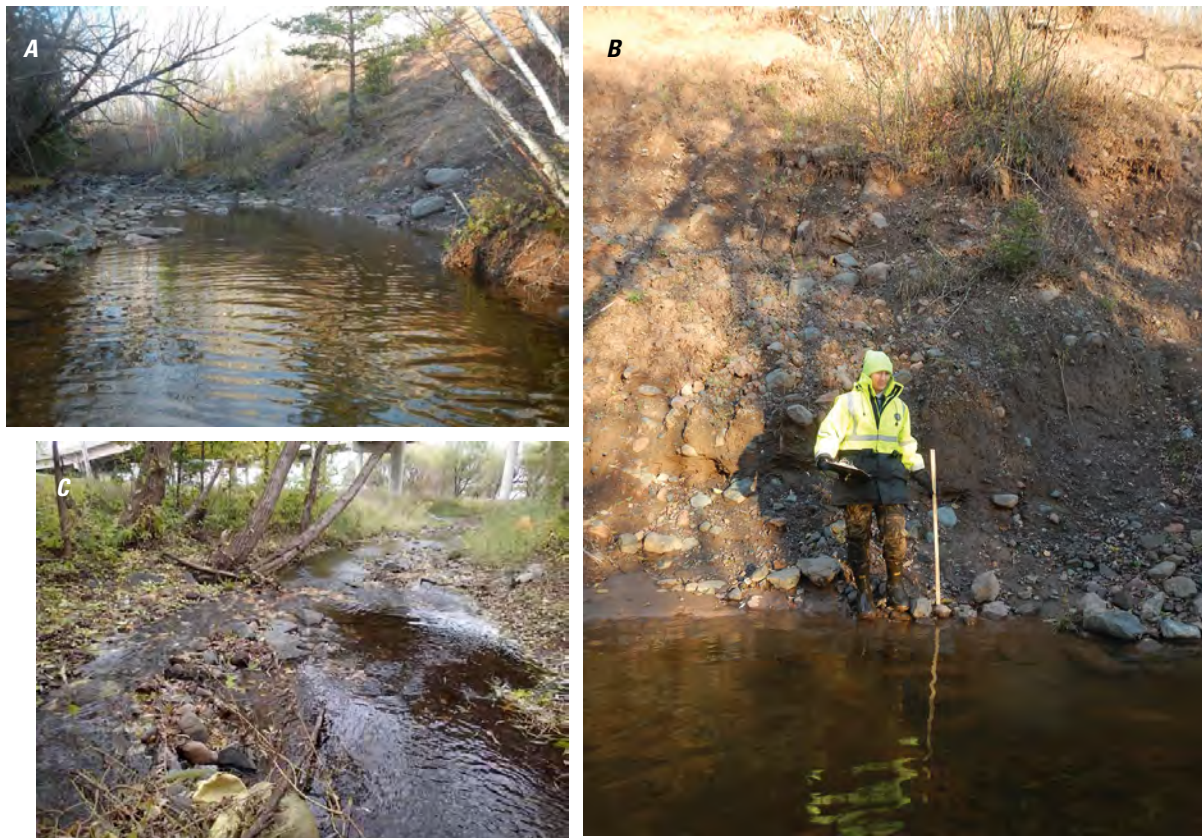
Figure 21. Comparison of erosion at selected sites in the Duluth, Minnesota, area. *A* and *B*, site 14 (Amity Creek at Occidental Road, Amity Creek Park, Number 3) that had excessive bank erosion associated with the 2012 flood. *C*, site 42 (Keene Creek at Bristol Street) that did not have bank erosion.
