Geomorphic Responses of Duluth-Area Streams to the June 2012 Flood, Minnesota

Scientific Investigations Report 2016–5104

By Faith A. Fitzpatrick, Christopher A. Ellison, Christiana R. Czuba, Benjamin M. Young, Molly M. McCool, and Joel T. Groten

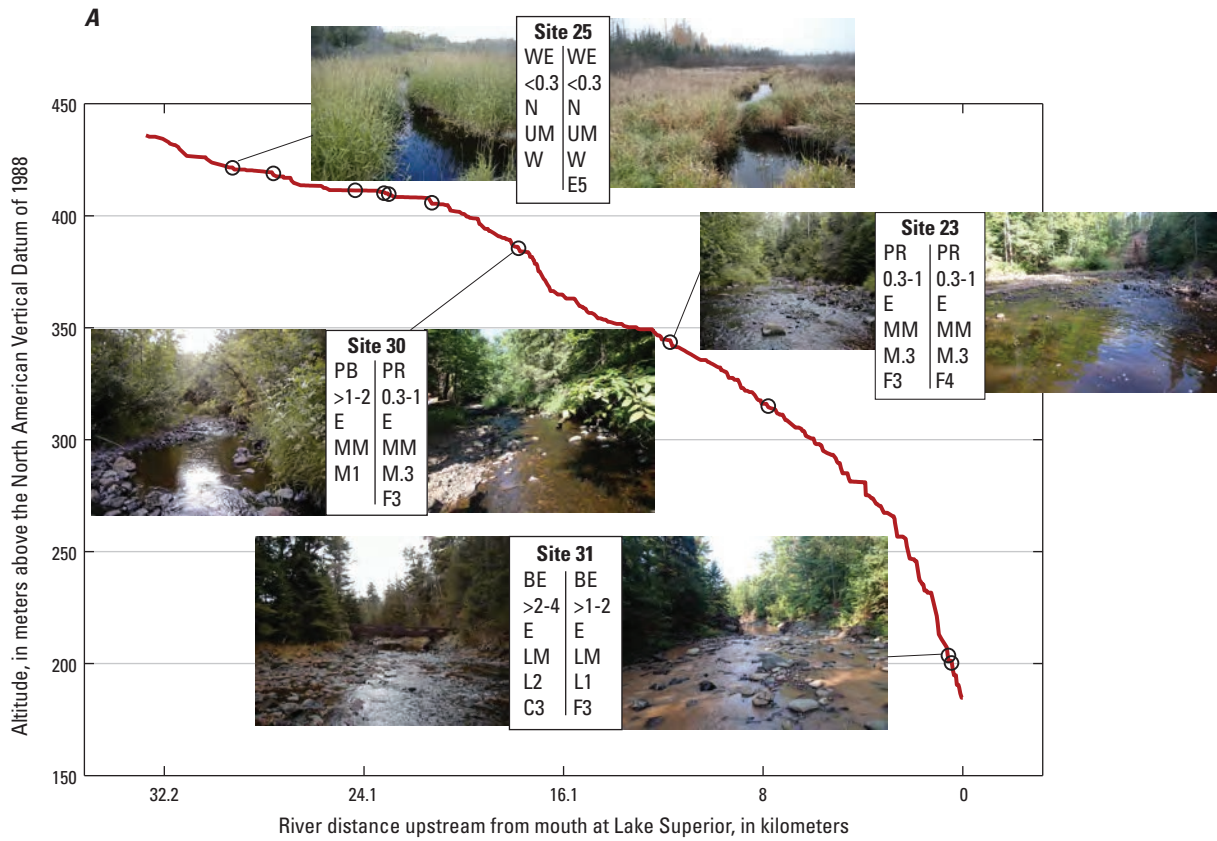
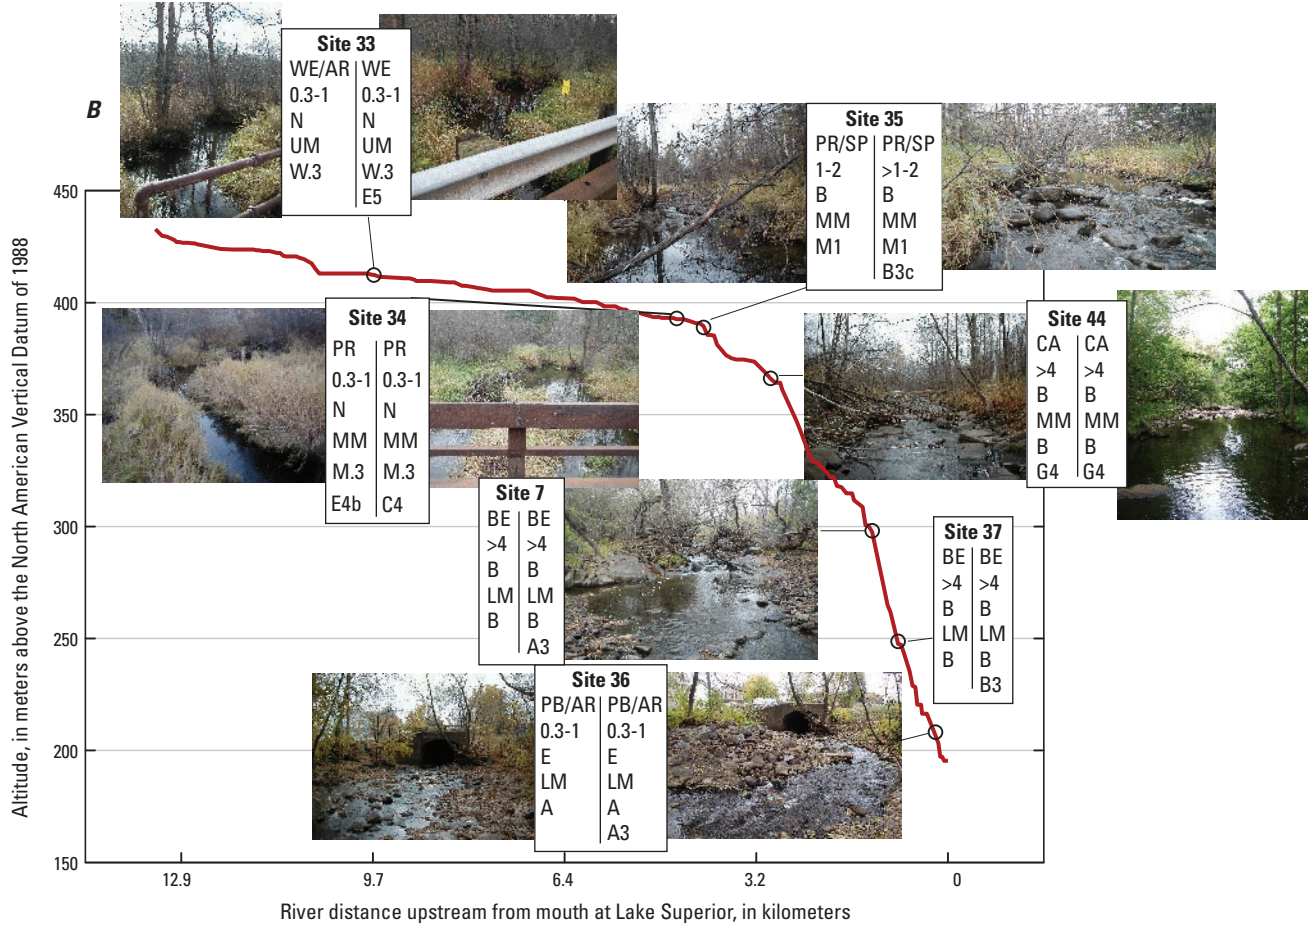
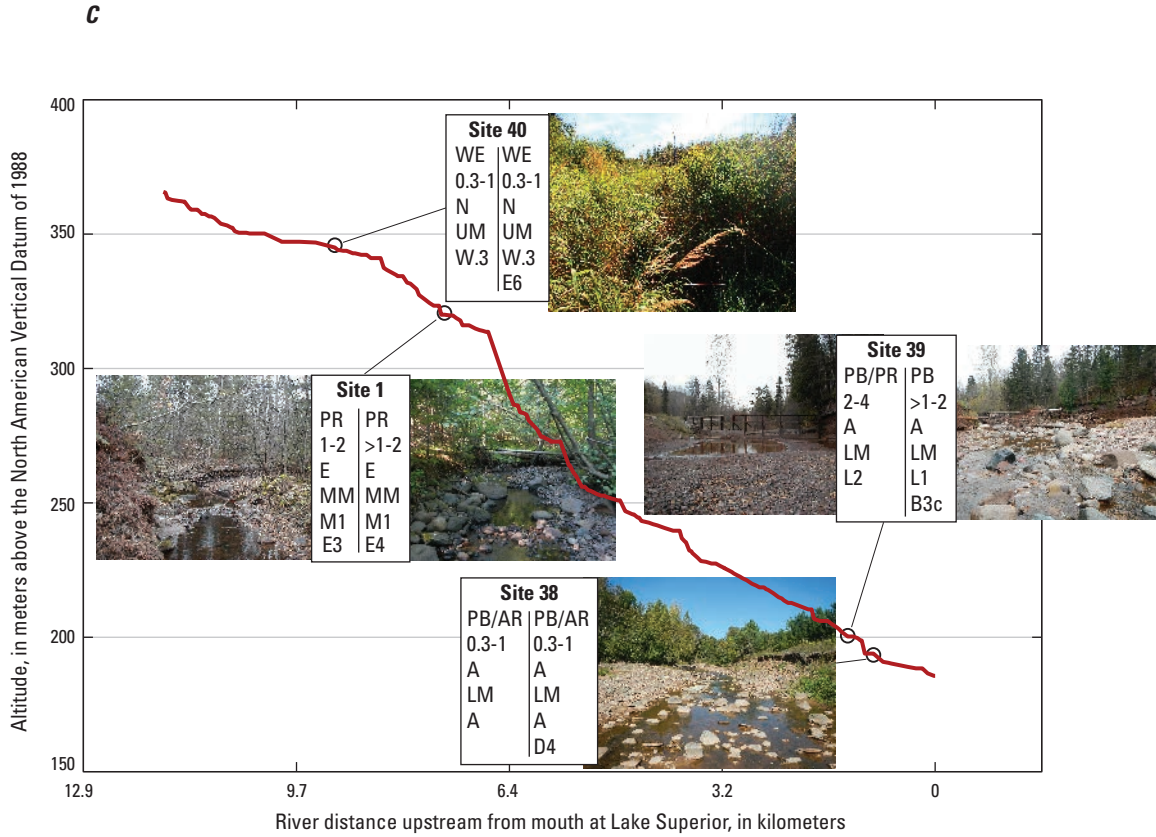
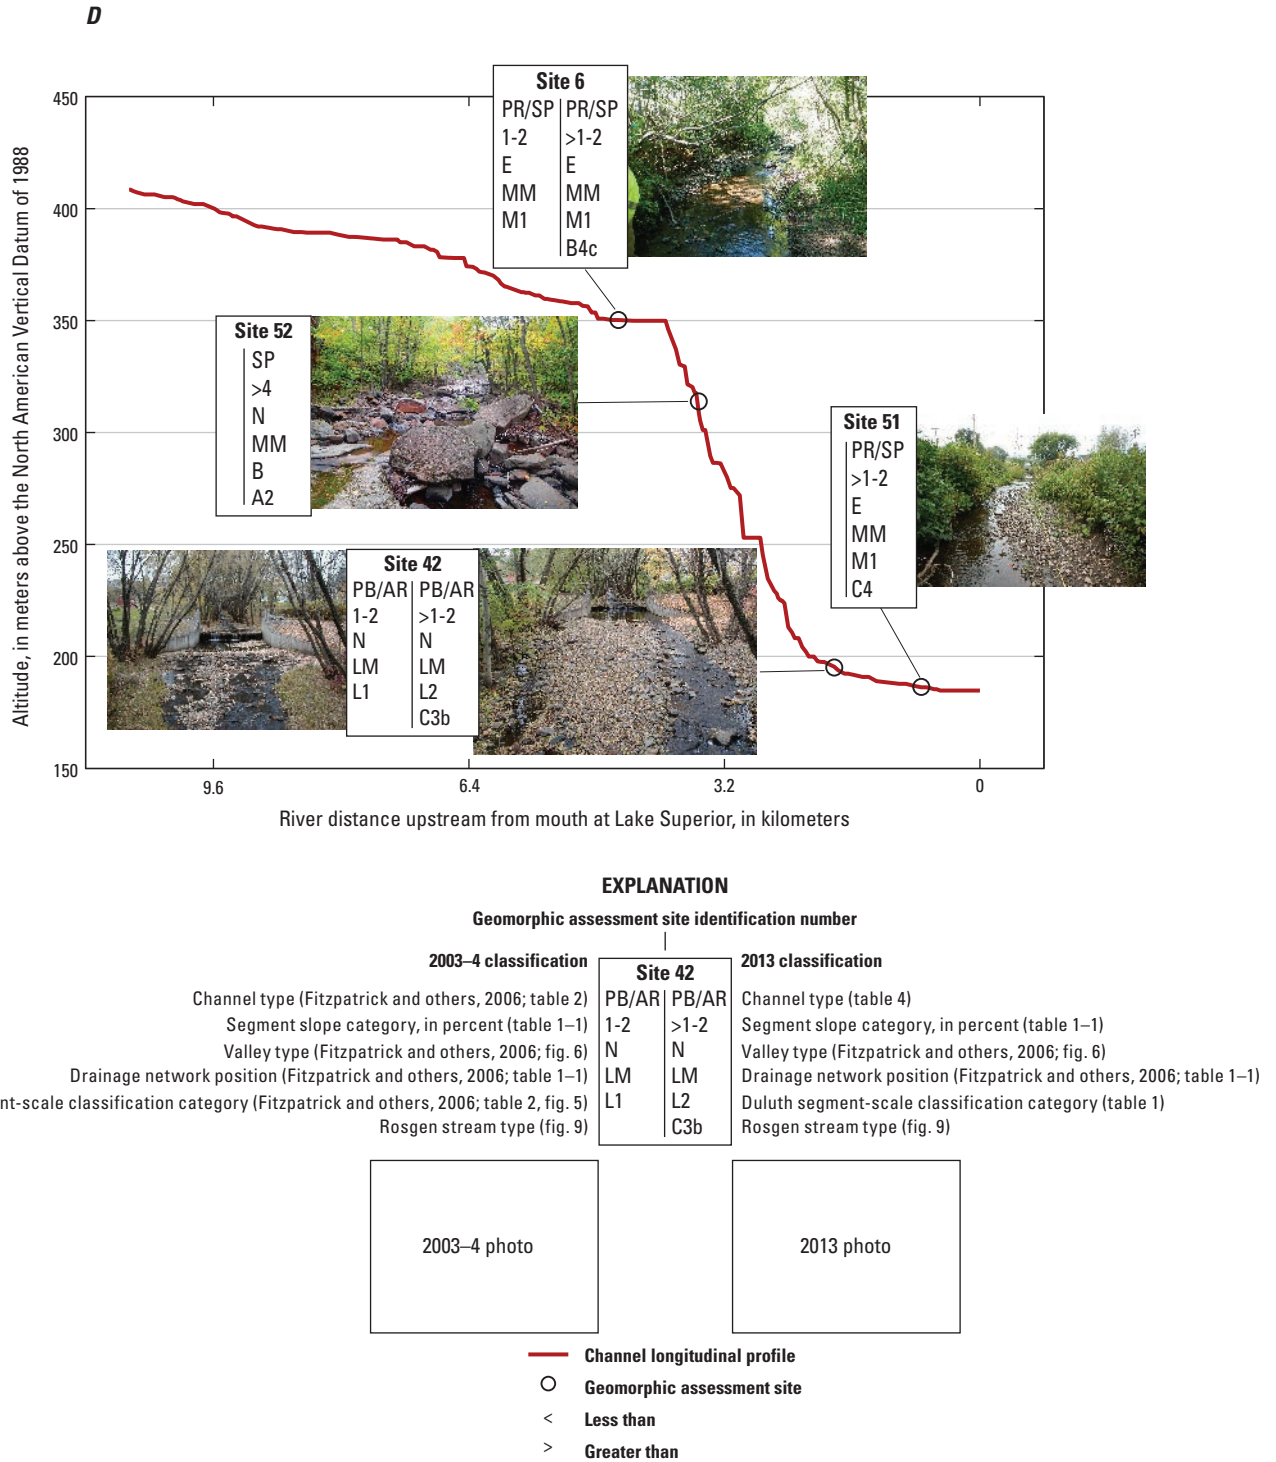
Figure 22. Longitudinal profiles with comparison photographs showing effects from the 2012 flood. *A*, Lester River. *B*, Miller Creek. *C*, Mission Creek. *D*, Keene Creek.

Plotting a comparison of 2003–4 and 2013 photographs of representative sites along the longitudinal profiles of Lester River, Miller Creek, Mission Creek, and Keene Creek illustrate how geomorphic responses to the 2012 flood reflected segment categories in an upstream to downstream progression (fig. 22). Along Lester River (fig. 22A), the upper main stem flows through wetlands, with gentle slopes and ditches (site 25), which had little change after the 2012 flood. Farther downstream, the entrenched valley is cut into glacial outwash and ice-contact deposits, and the slope increases (sites 30 and 23). Evidence of valley side failures and landslides were present, and bank erosion and widening were common outcomes

The Keene Creek longitudinal profile is representative of a smaller tributary with some wetland and low slope sites that quickly transition to a very steep middle main stem flowing on gabbro intrusive bedrock (fig. 22D). Lower main-stem sites had substantial gravel accumulation and aggradation after the 2012 flood such as shown in the comparison photographs of site 42 (fig. 22D).

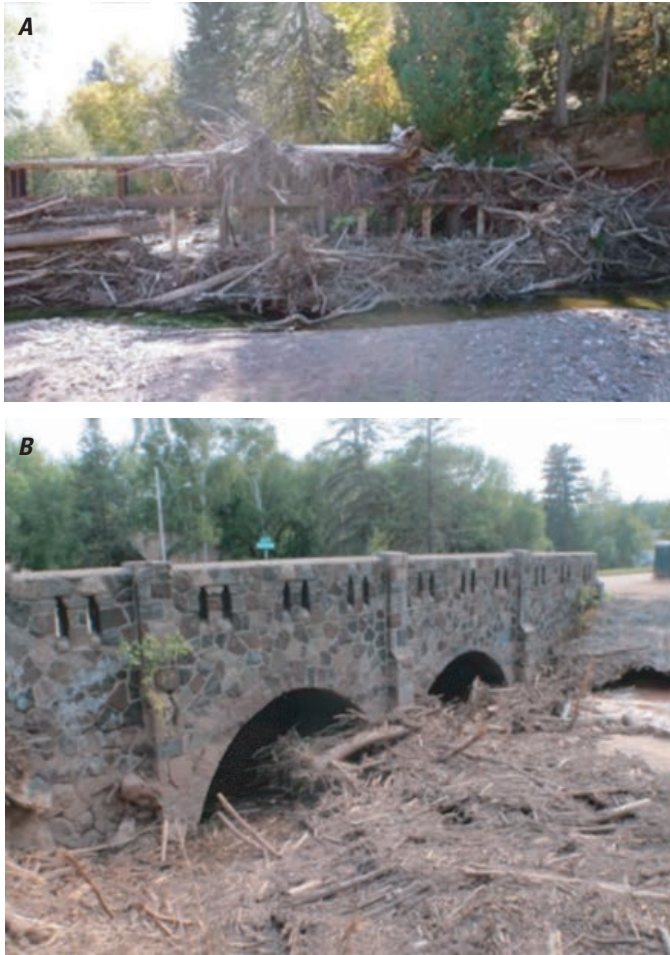
Figure 23. Large wood accumulation along Mission Creek after the 2012 flood. *A*, at the brush catcher. *B*, upstream side of bridge at State Highway 23 (Photographs by Molly Wick, Wisconsin Department of Natural Resources.)

Large wood decreased in study sites after the 2012 flood throughout the Duluth area. There was already a lack of large wood noted in the 2003–4 assessments (Fitzpatrick and others, 2006). The changes in frequency, volume, and function of wood indicate a potentially wide-ranging negative effect on channel bedform diversity and the aquatic ecosystem (Beschta and Platts, 1983). Because much of the streams are still lined with mature trees, some wood will likely be replaced with time; thus, with time, some of the function of the wood should return. The immediate lack of wood available to trap sediment, however, also indicates a possible reduction in the stream's ability to mitigate sediment loads and a decrease in flow resistance (Cummins and Lauff, 1969; Beschta and Platts, 1986; Minshall, 1984; Montgomery and others, 1995). The loss of wood working to stabilize gravel bars will likely cause increases in coarse sediment transport rates during future floods and reduce stable substrate for benthic organisms. The postflood loss of pool volume also indicates a loss of associated aquatic habitat. Step-pool bedforms also dissipate erosive energy to downstream sites. In urban areas, large wood in streams is usually viewed as negative because it can block and damage culverts, bridges, and road crossings (fig. 23).
