LLNL-TR-648143

A Visual Description of the Concrete Exterior of the Cactus Crater Containment Structure

Terry Hamilton

October 2013

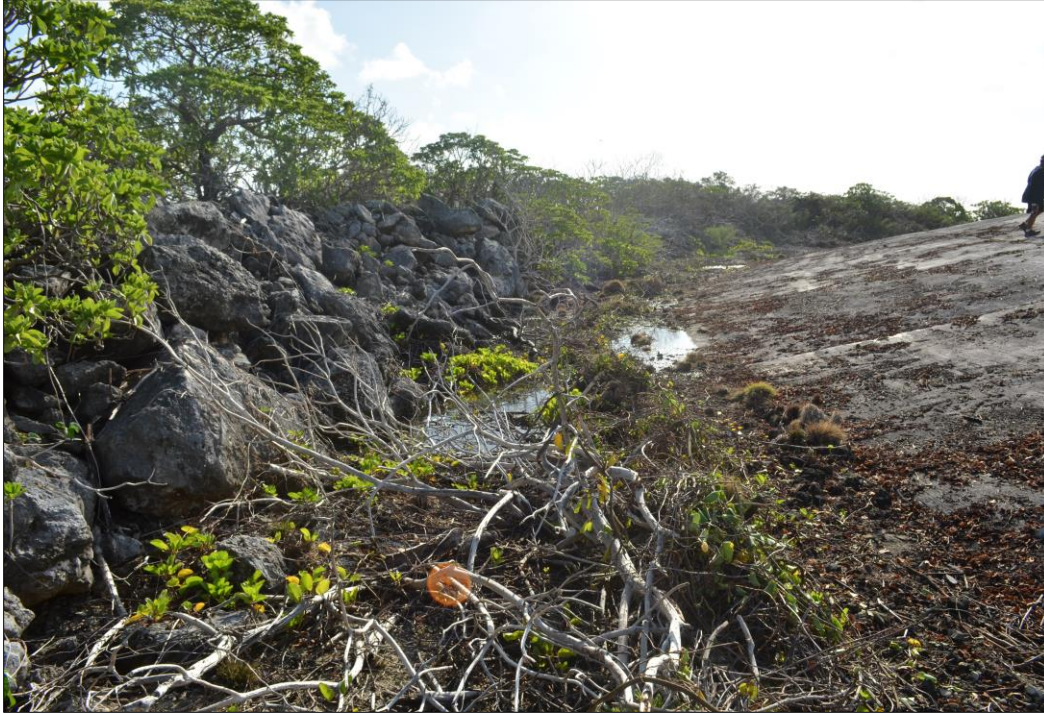
Fig. 4a. Vegetation growing on the inside of the riprap 'mole wall' surrounding the Cactus crater containment structure on Runit Island (Visual Survey, May 2013).

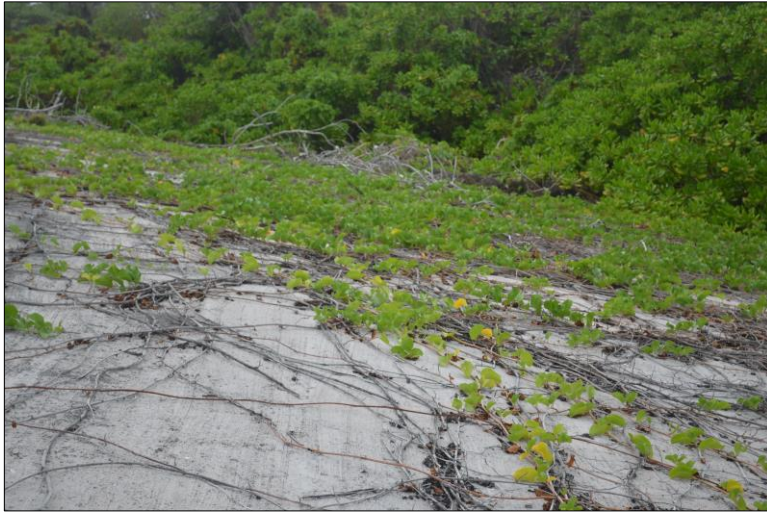
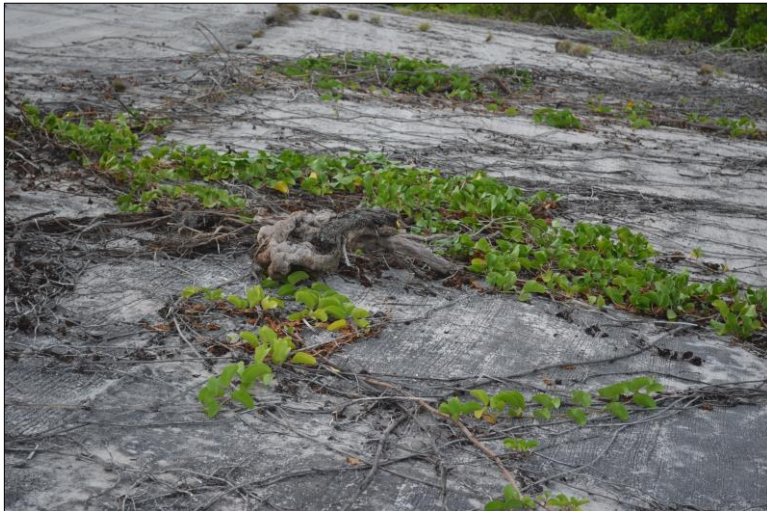
The results of the cleanup actions to remove soil and debris, rooting vines and other vegetative growth covering the lower sections of the dome can clearly be seen in the comparative photos shown below (Fig. 12-13). Future visits to the site should evaluate the rate of encroachment of rooting vines over the dome, and determine the need to introduce a more rigorous vegetation eradication program. This action may be necessary to eliminate the role that rooting vegetation may play in causing the concrete to crack and spall along the seams and in panel corners (Fig. 14-15).

Fig 12. Vegetation growth over the face of *Runit Dome* (Initial conditions, Visual Survey, May 2013).

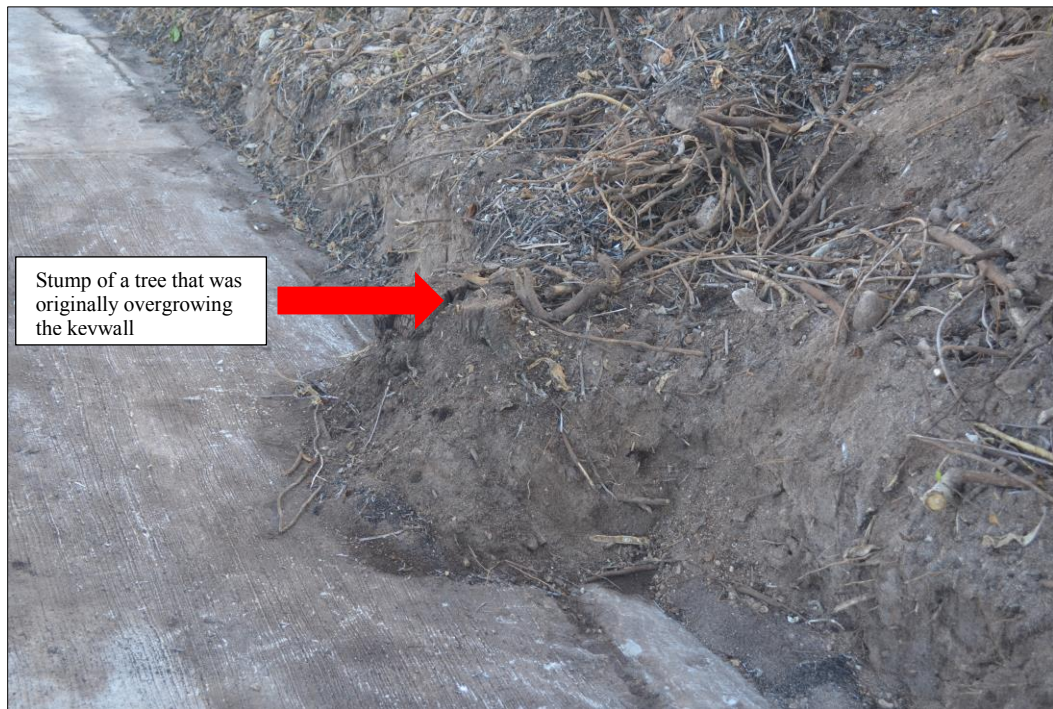
Fig 14. A photo of a tree stump located over the keywall (the stump was later removed) (Visual Survey, May 2013).

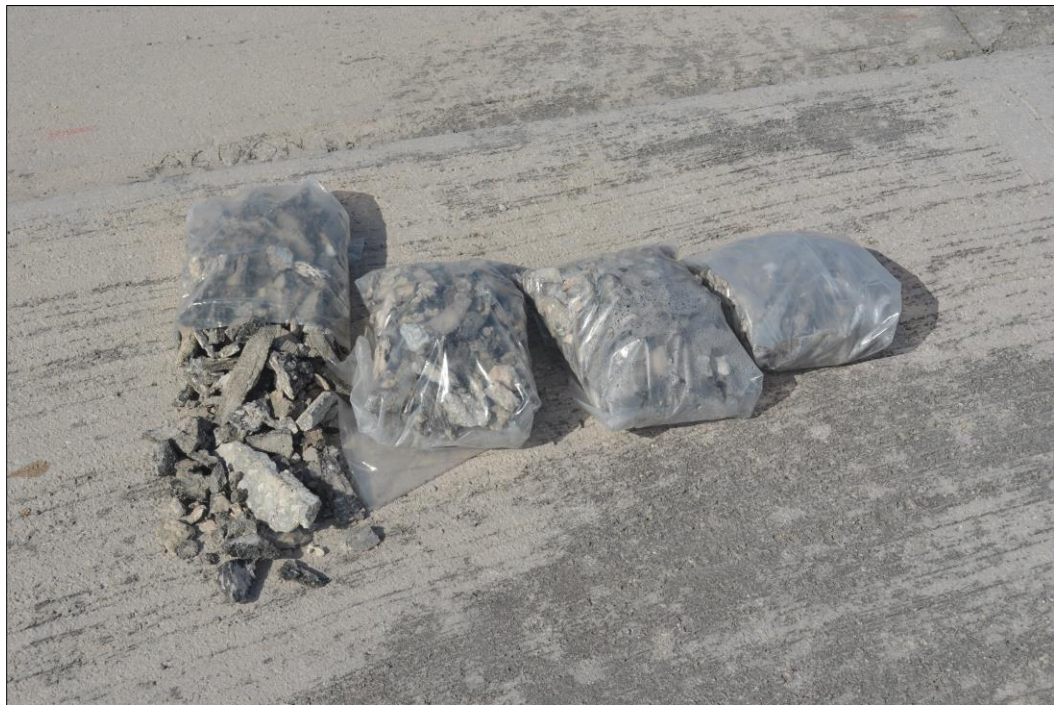
Fig 15. Plastic bags of concrete rubble and other loose debris collected from around *Runit Dome* (Visual Survey, May 2013) [The volume of debris collected could potentially be used to assess the extent of spalling of concrete between surveys].

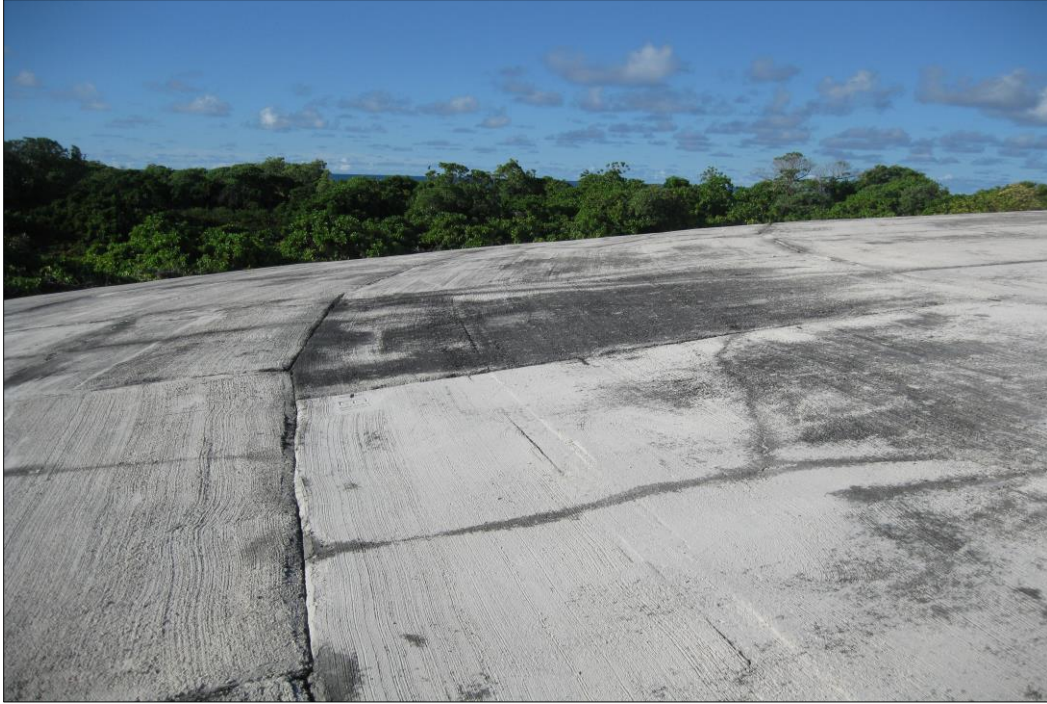
There also appears to be some degree of weathering of the surface of concrete panels as identified in this report by contrasting variations in roughness and discoloration of the original broom finished concrete (Fig. 16). Also, cracks appearing across the top of the concrete panels can easily be identified in photographs by streaks of discoloration (darkened appearance) extending along the crack lines (Fig. 17). Variations in color between and across different concrete panels can also be observed in historical photos of the dome (see NSTec, 2008).

As previously stated, the concrete cap covering *Runit Dome* was constructed from imported cement, mixed local aggregate and seawater. It is therefore feasible that some panels were made up of a slurry mixture containing more seawater than others. As a result, variations in color and the weathered appearance of some concrete panels may be caused by preferential aging of concrete containing a higher average concentration of salt from the added seawater.

Fig 16. A concrete panel (center) showing signs of weathering and discoloration.

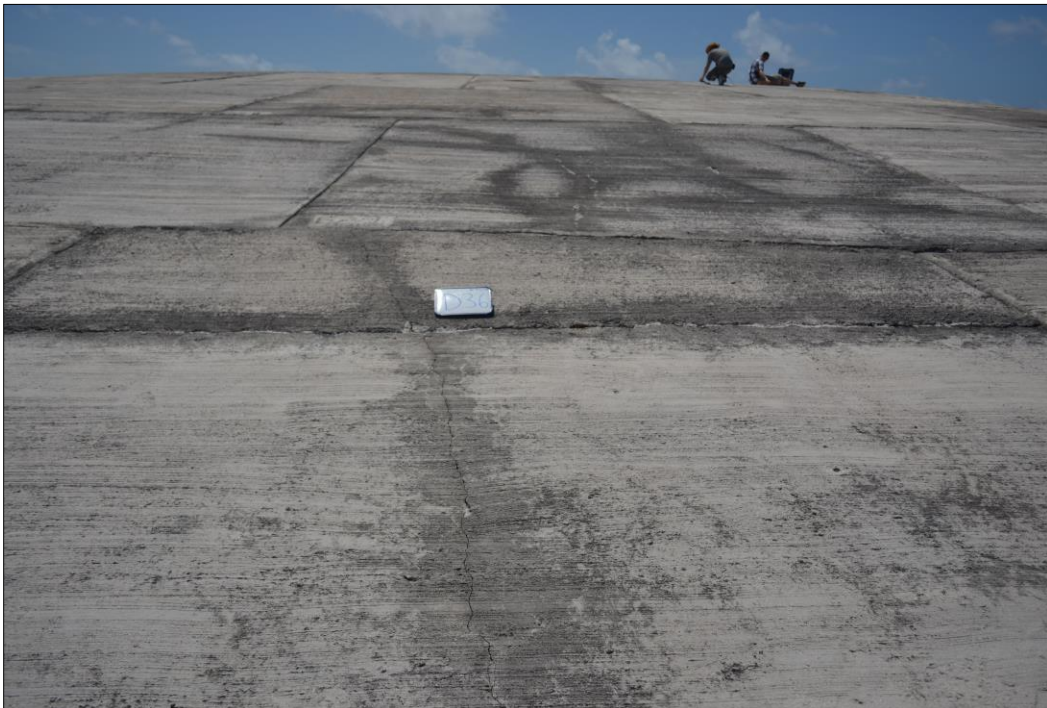
Similarly, streaks of discoloration along crack lines and seam edges may be caused by the action of rainwater penetrating down into the cracks and leaching out sea salts from below the surface of concrete. The salt then re-deposits by drying on the surface of the concrete to give each crack line a distinctive appearance. In order to determine the exact cause for the weathered appearance and discoloration of the concrete panels, petrographic and chemical analyses need to be performed on concrete cores collected from a series of light and dark colored patches of concrete from different panels around the dome (Concrete Science, Inc., 2013).

Fig. 17. Concrete panels showing streaks of discoloration running along crack lines.

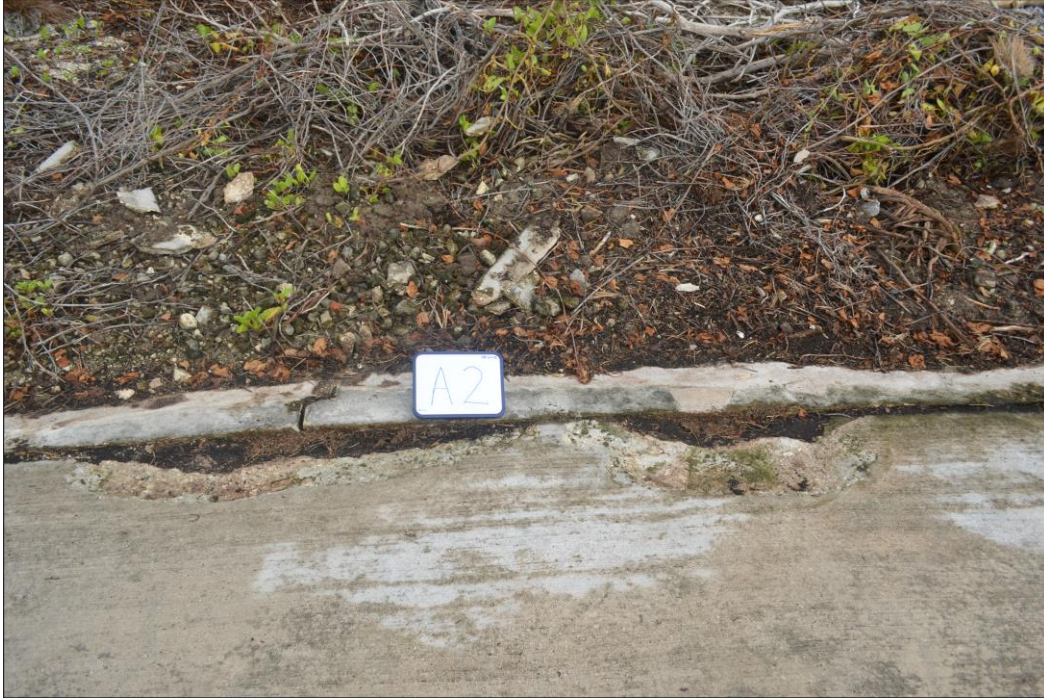
There were at least nineteen (19) concrete panels meeting the definition of containing significant spall or crack elements (Fig. 18-36). Cracks in the corner of panel C-22 and C-43 extend down through the entire concrete cap where it was possible to lift out the concrete segment to reveal the surface of the concrete-contaminated soil-grout mixture below. The presence of these two more severely-cracked panels was also called out in the 2008 Runit Survey report prepared by NSTec (NSTec, 2008) but no action was taken to initiate any repairs. Other photos (Fig. 37-40) highlight more typical observation of cracks in the concrete running either horizontally or vertically across the face of the panels. As previously indicated, many of these cracks contain chipped “spalled’ edges.

Fig. 18. Spalling of concrete along the bottom seam adjoining the keywall on panel A2.

In general, the Cactus crater containment structure appears to be structurally sound. However, it is the opinion of this author that any obvious, visually-defective concrete panels covering the dome represent a potentially serious public perception-management problem. This would especially be true of making definitive statements or drawing publically acceptable conclusions about the overall integrity and radiological safety of *Runit Dome*. For example, the existence of the vegetation growing in the cracks or between panel segments may be considered illustrative of the potential for meaningful infiltration of rainwater down through the top of dome, and also convey a general sense of dilapidation of its function. Moreover, rainwater penetrating down through cracks or between the seams of concrete panels could also affect the potential to dissolve and transport radionuclides down through the debris pile, and into the underlying groundwater. If this is true, then some consideration may need to be given to repairing the cracks, and possibly sealing up the seams between individually formed panels, before developing a long-term groundwater monitoring program to assess changes in water quality beneath and surrounding the containment structure. This work should be performed under the supervision and with on-site training from a licensed Materials and Structural Engineer.

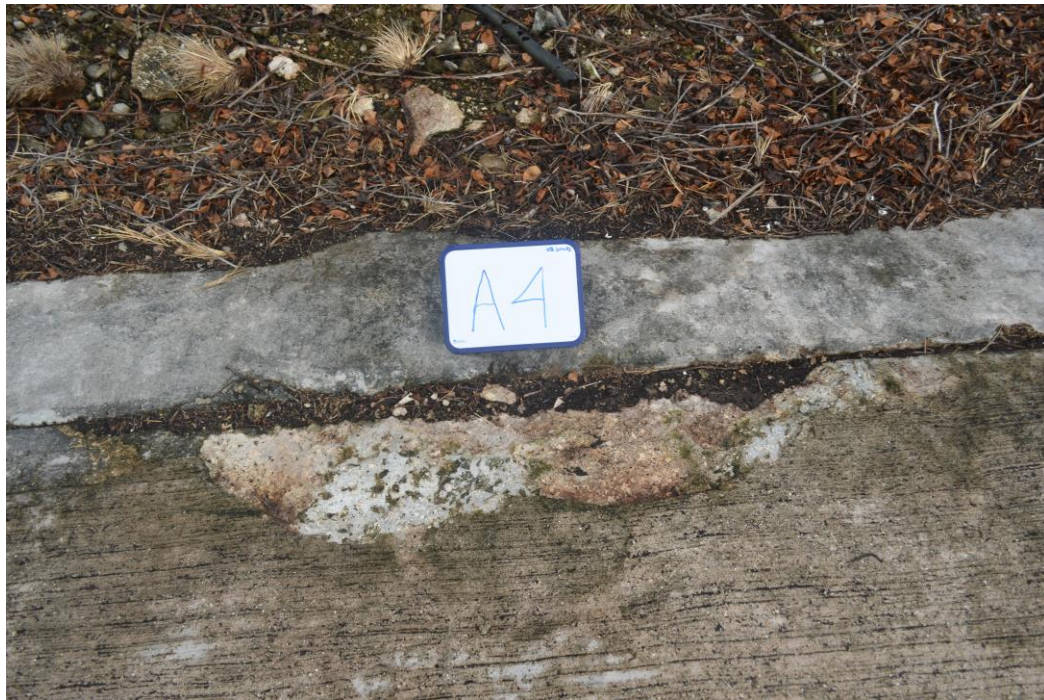
Fig. 19. Spalling of concrete along the bottom seam adjoining the keywall on panel A4.

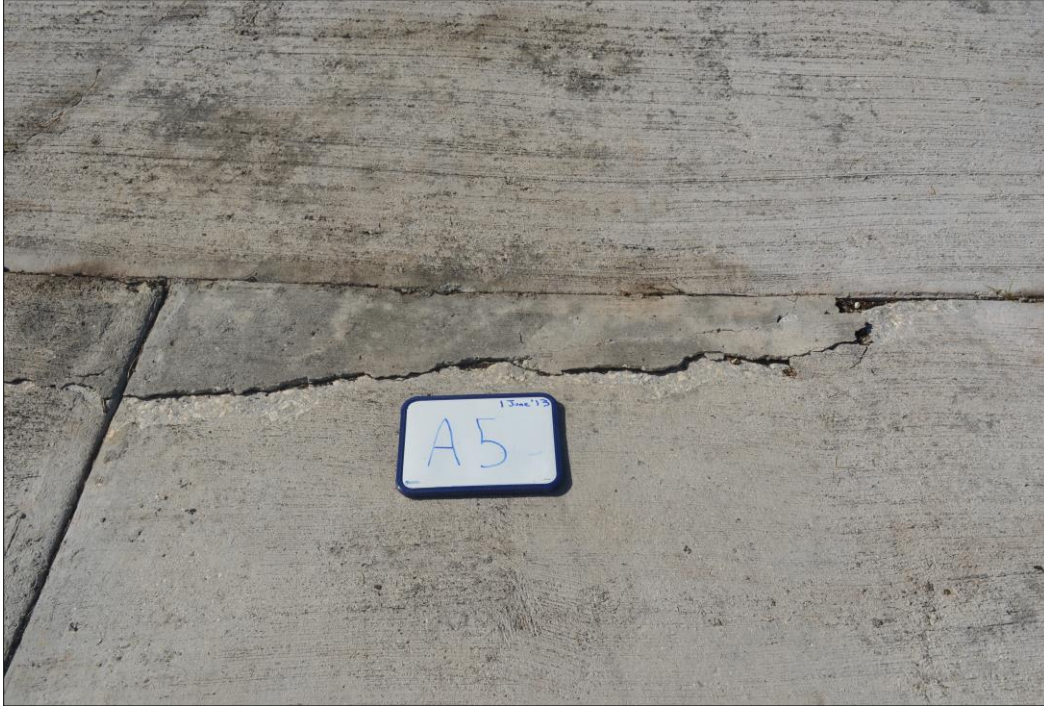
Fig. 20. Cracked concrete with spalled edges on the upper, left-hand corner of panel A5.

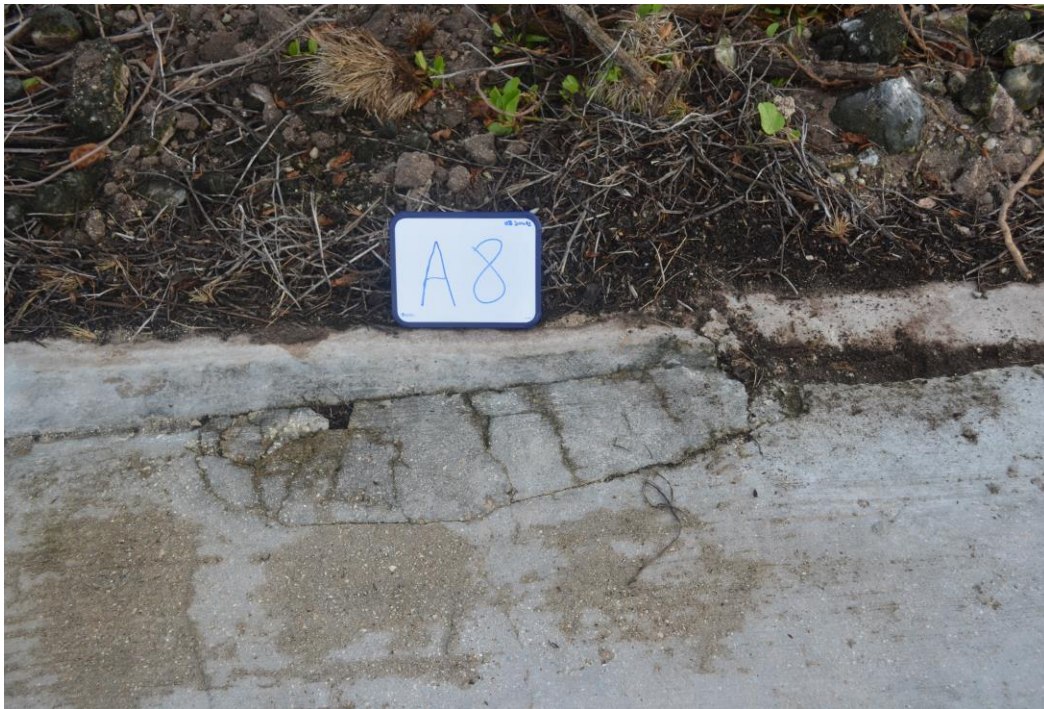
Fig. 21. Cracked concrete with minor spalling along the seam adjoining the keywall on panel A8.

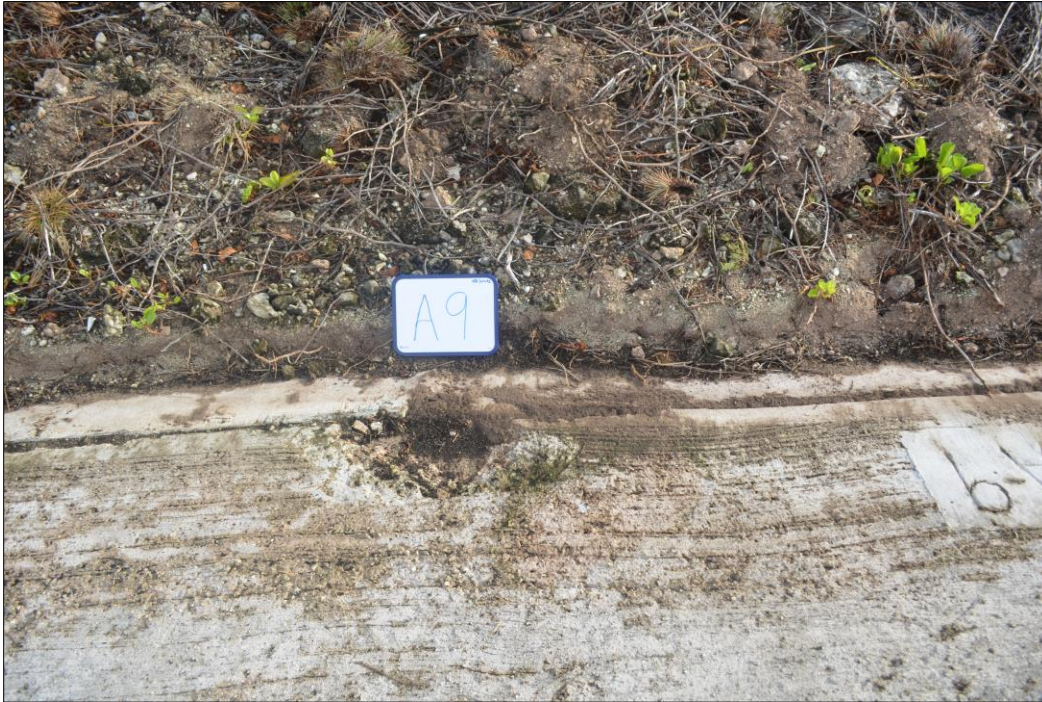
Fig. 22. Spalling of concrete along the seam adjoining the keywall on panel A9.

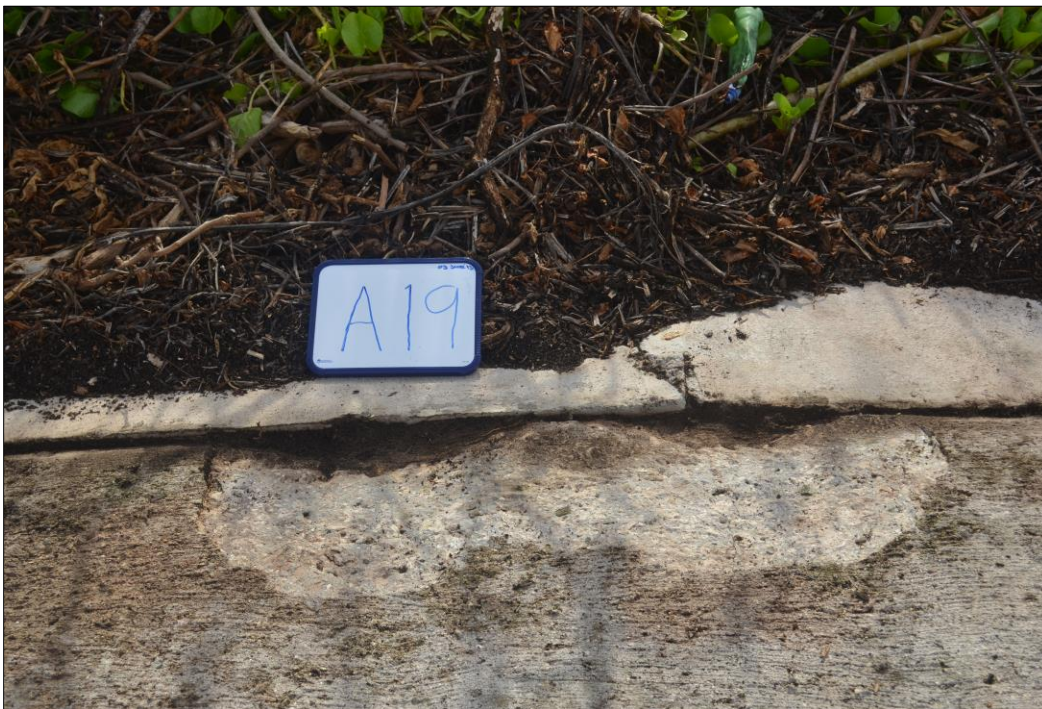
Fig. 23. Spalling of concrete along the seam adjoining the keywall on panel A19.

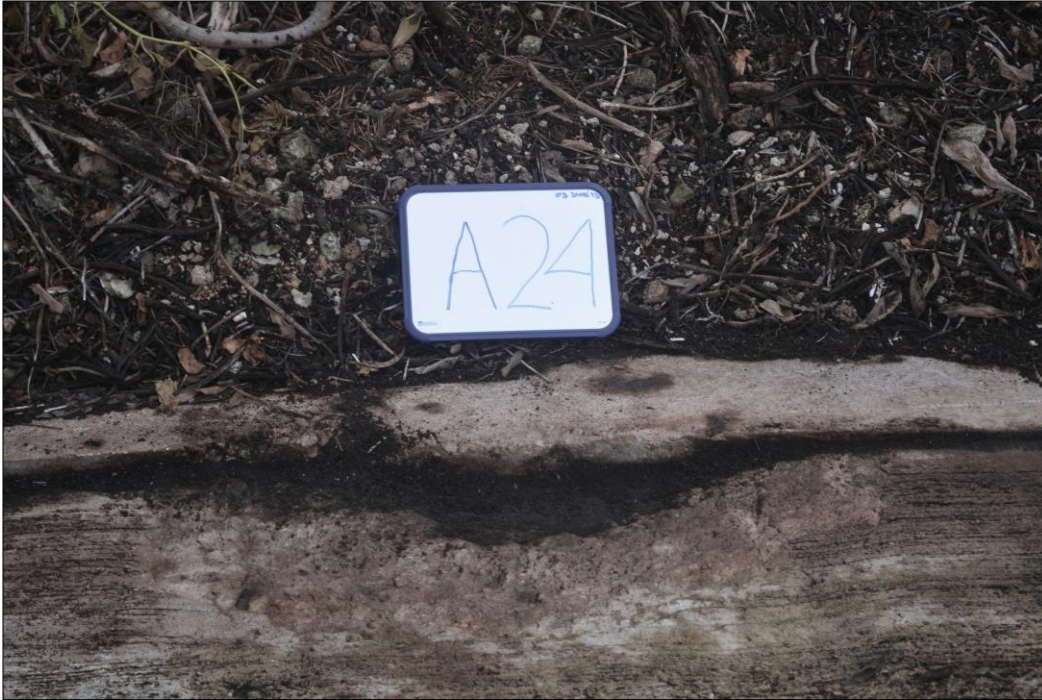
Fig. 24. Spalling of concrete along the seam adjoining the keywall on panel A24.

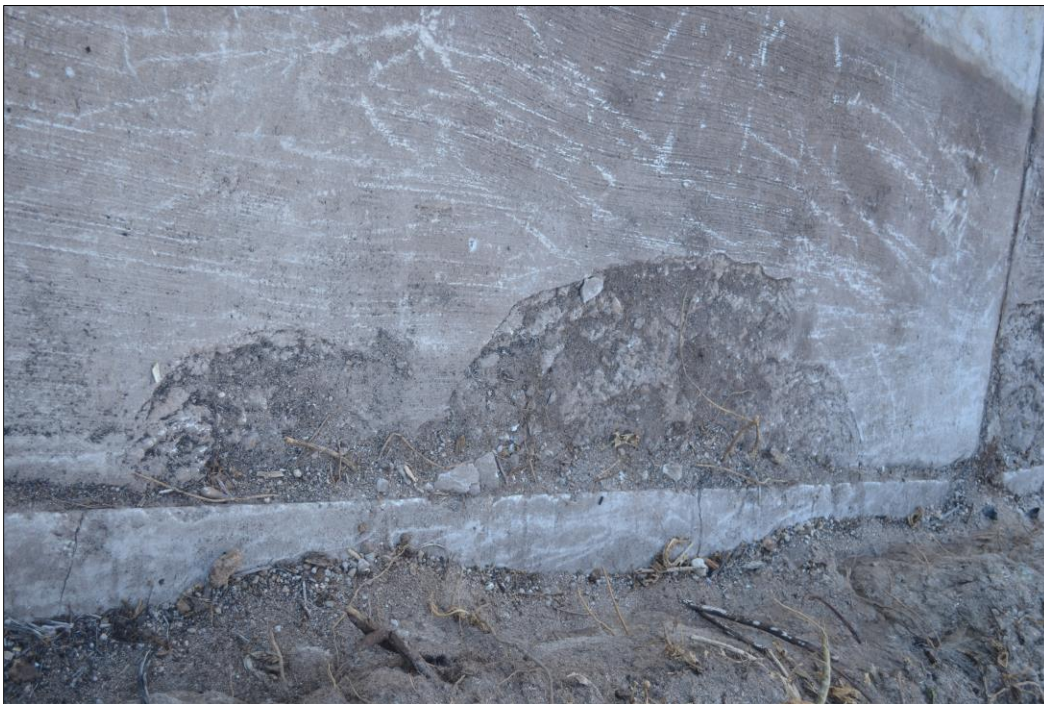
Fig. 25. Spalling of concrete in the bottom right-hand corner along the seam adjoining the keywall on panel A28.

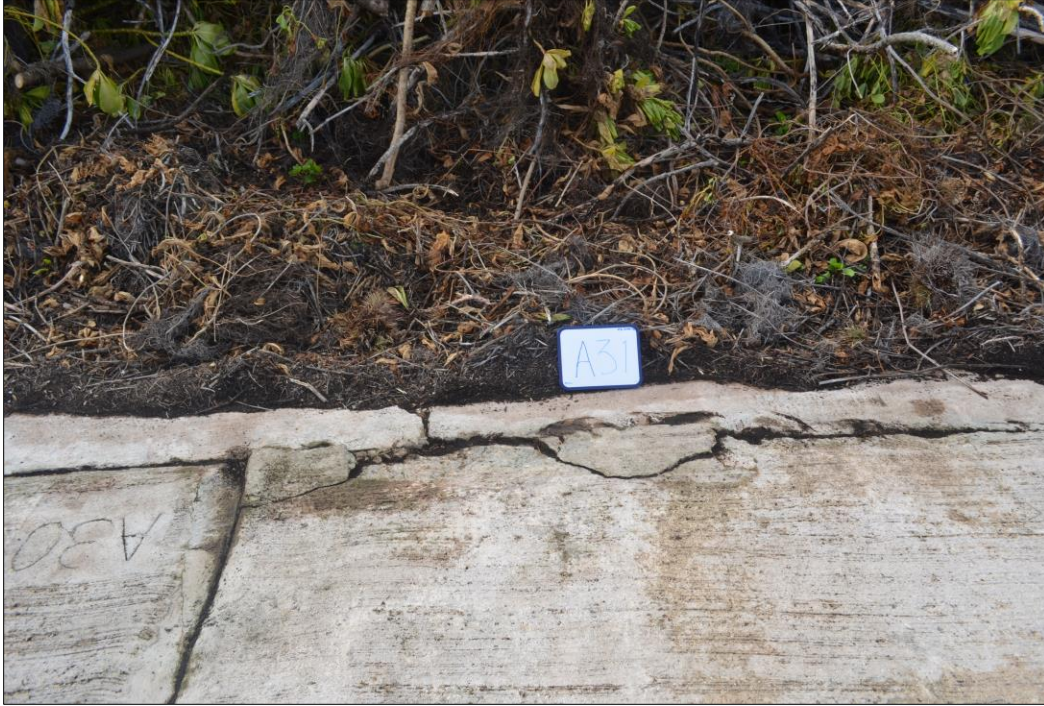
Fig. 26. Spalling and cracked concrete in the bottom right-hand corner and along the seam adjoining the keywall of panel A31.

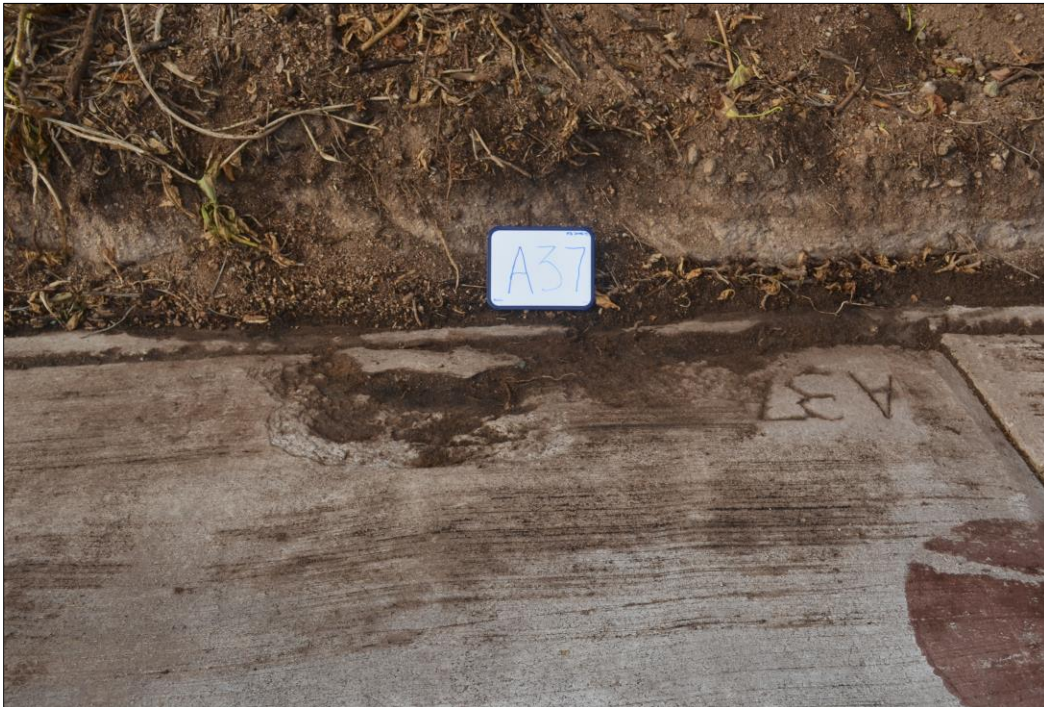
Fig. 27. Spalling of concrete along the seam adjacent to the keywall in the bottom right-hand corner of panel A37.

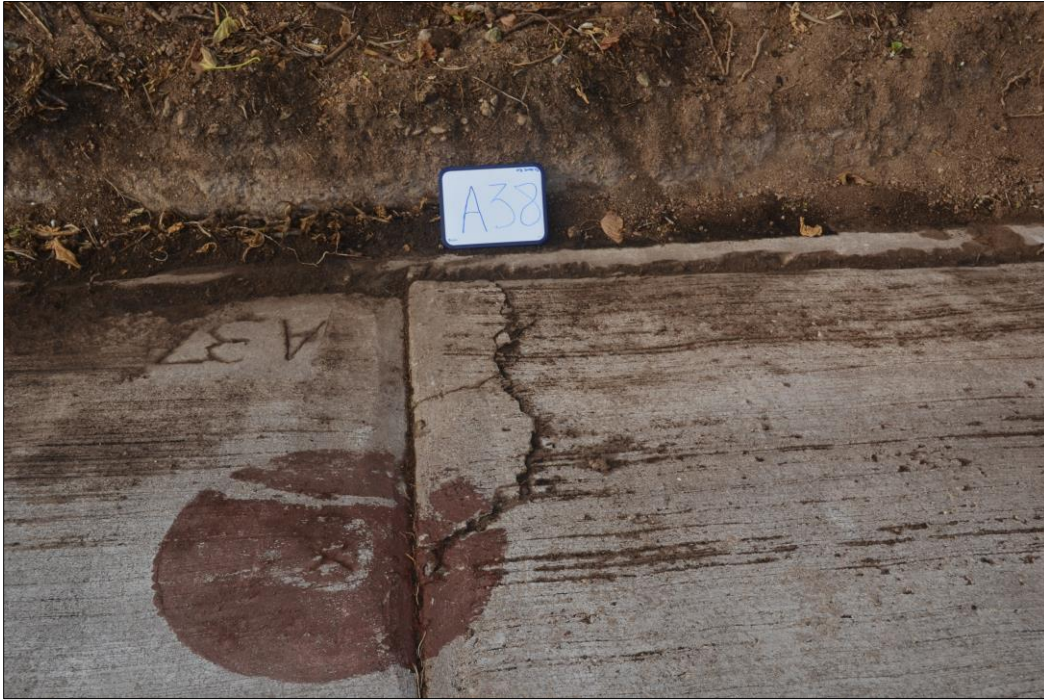
Fig. 28. Cracked concrete with spalled edges on the lower, right-hand corner of panel A38.

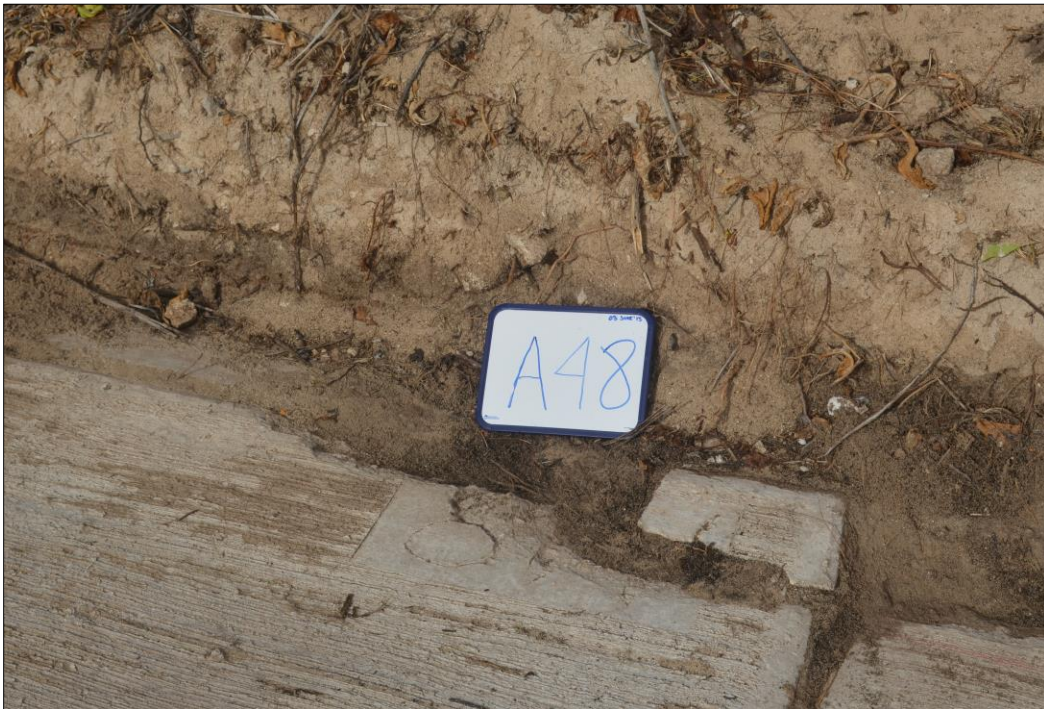
Fig. 29. Spalling and cracked concrete along the seam adjacent to the keywall in the left-hand corner of panel A48.

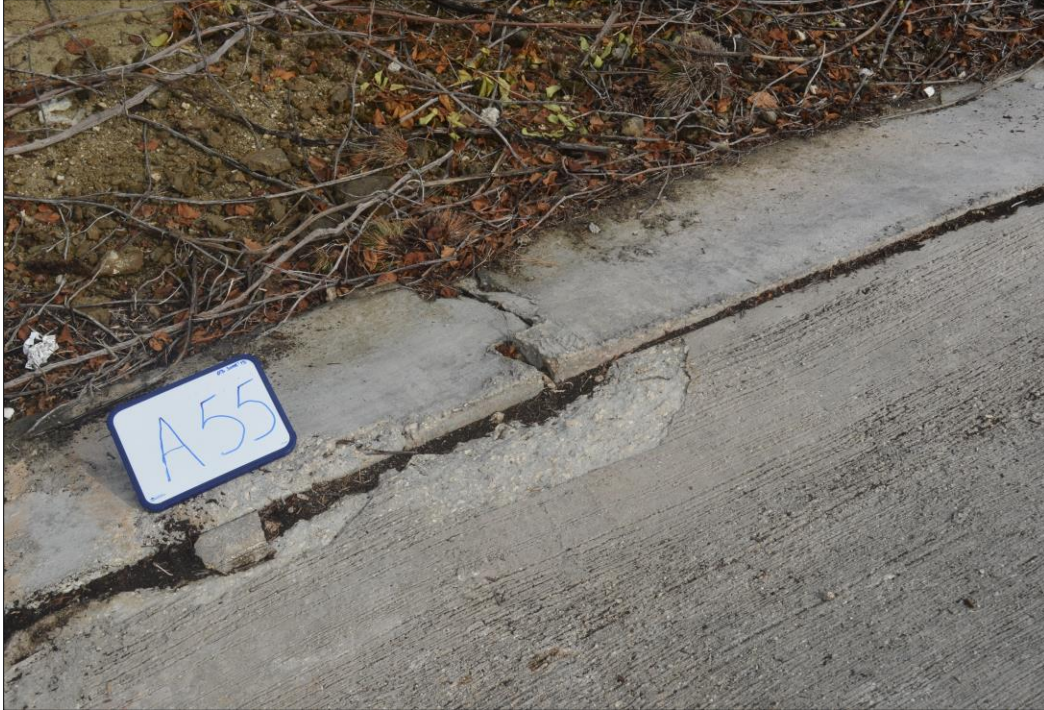
Fig. 30. Spalling of concrete along the seam adjacent to the keywall on panel A55.

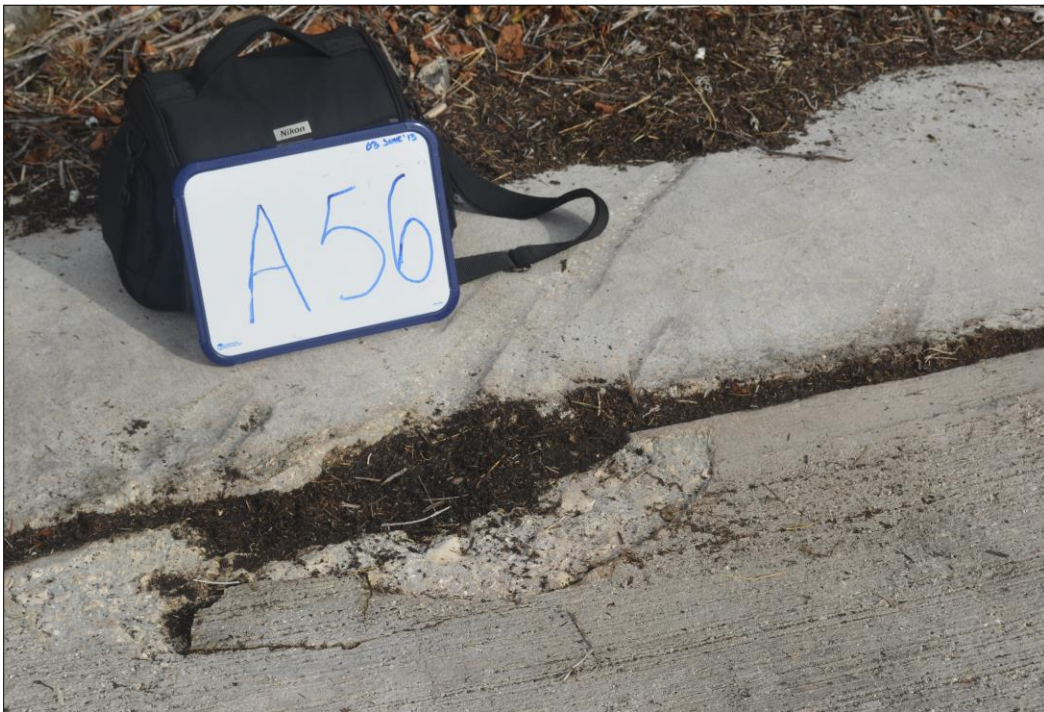
Fig. 31. Spalling of concrete along the seam adjacent to the keywall on panel A56.

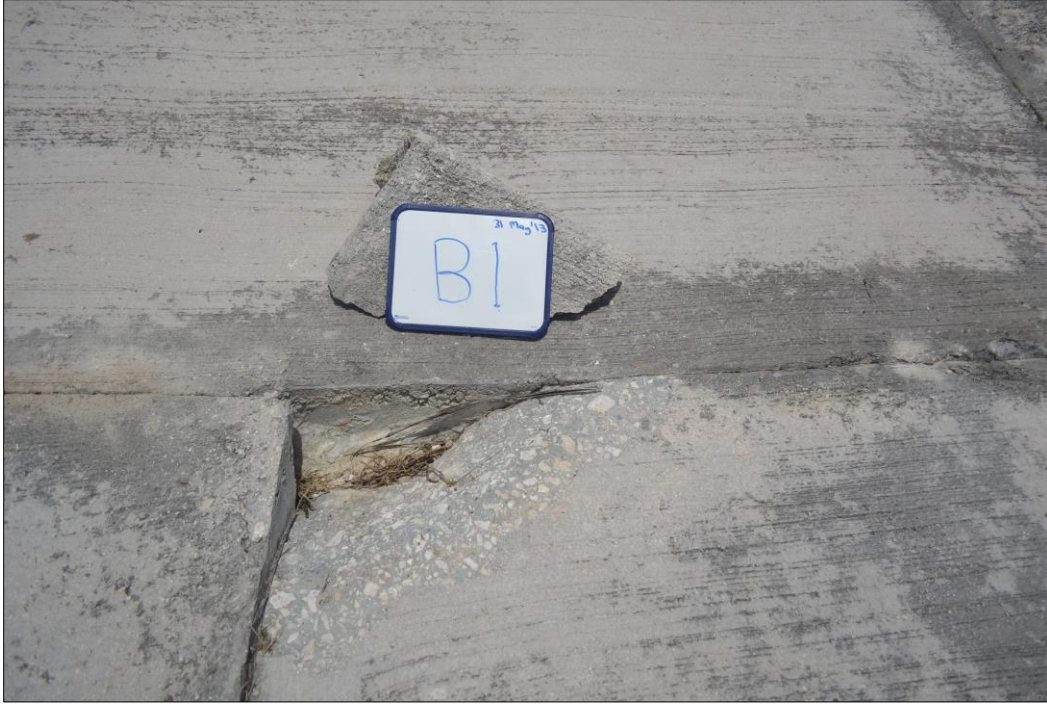
Fig. 32. Major spalling of concrete on the lower, right-hand corner of panel B1.

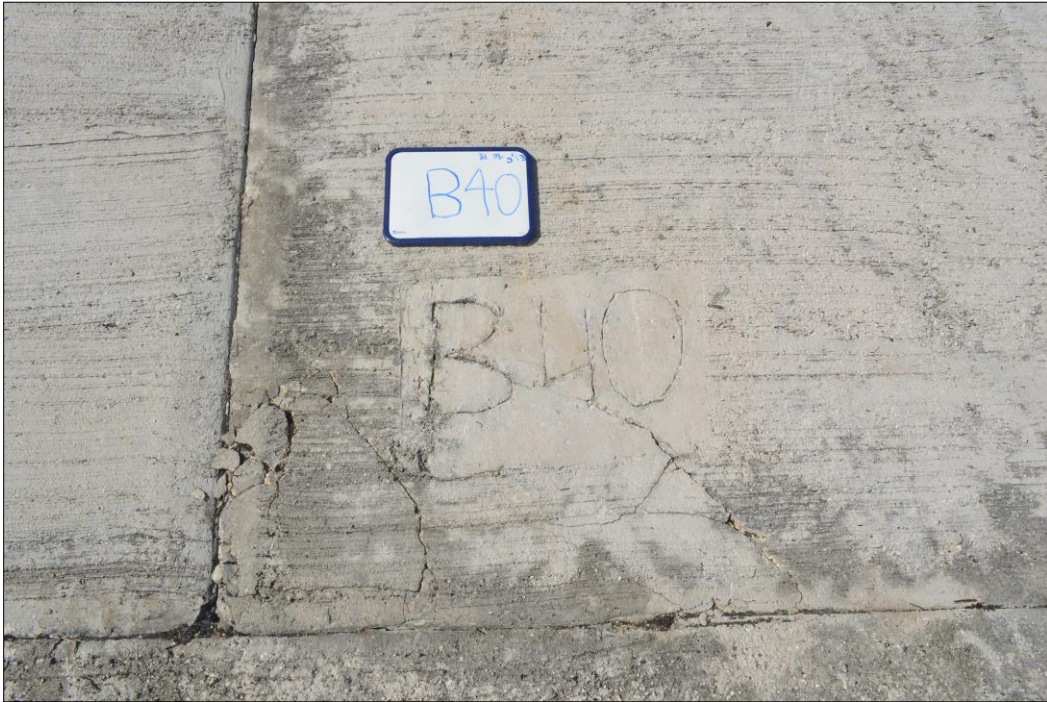
Fig. 33. Cracked concrete with spalled edges on the lower, left-hand corner of panel B40.

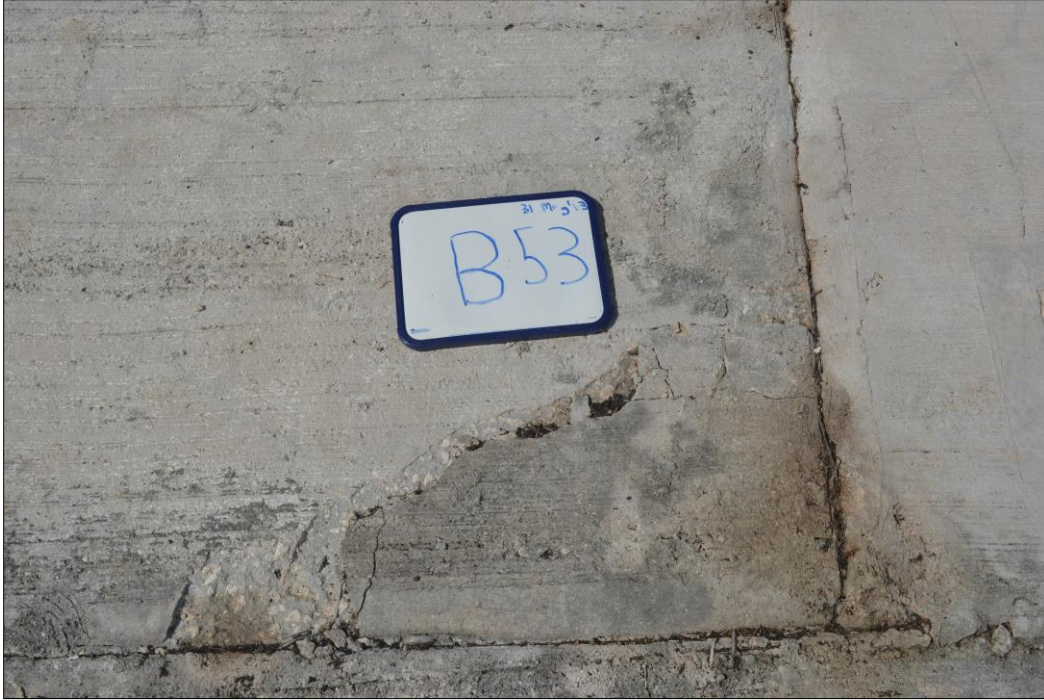
Fig. 34. Cracked concrete with spalled edges on the lower, right-hand corner of panel B53.

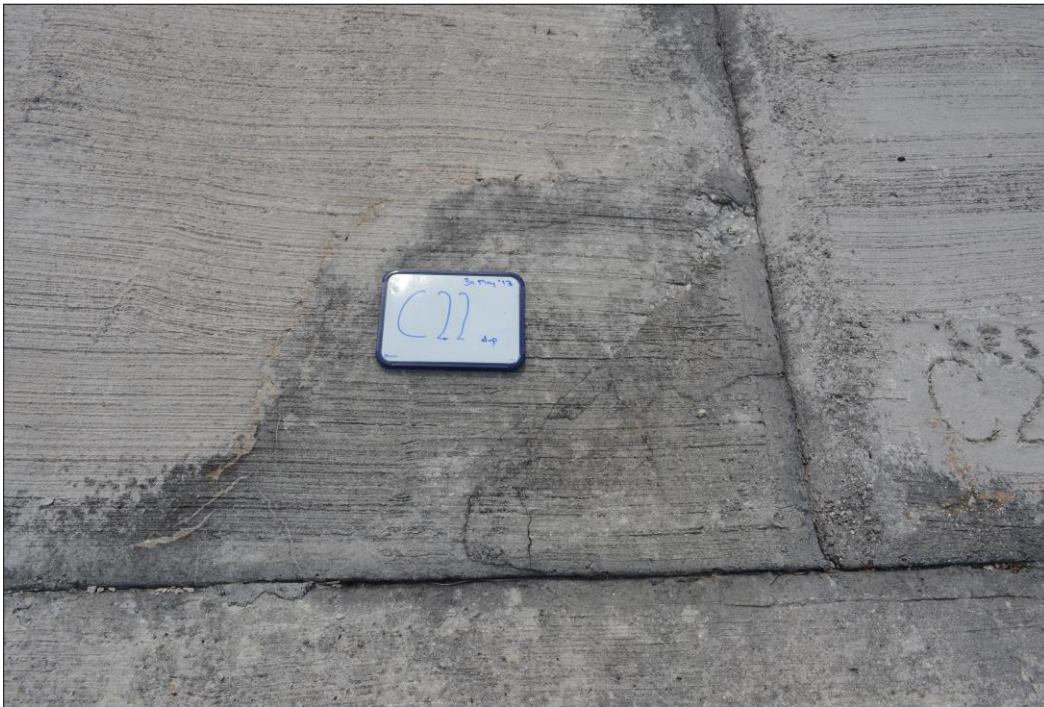
Fig. 35. Cracked concrete with spalled edges on the bottom, right-hand corner of panel C22_duplicate (position C24) [Refer Appendix I for extra panel positioning].

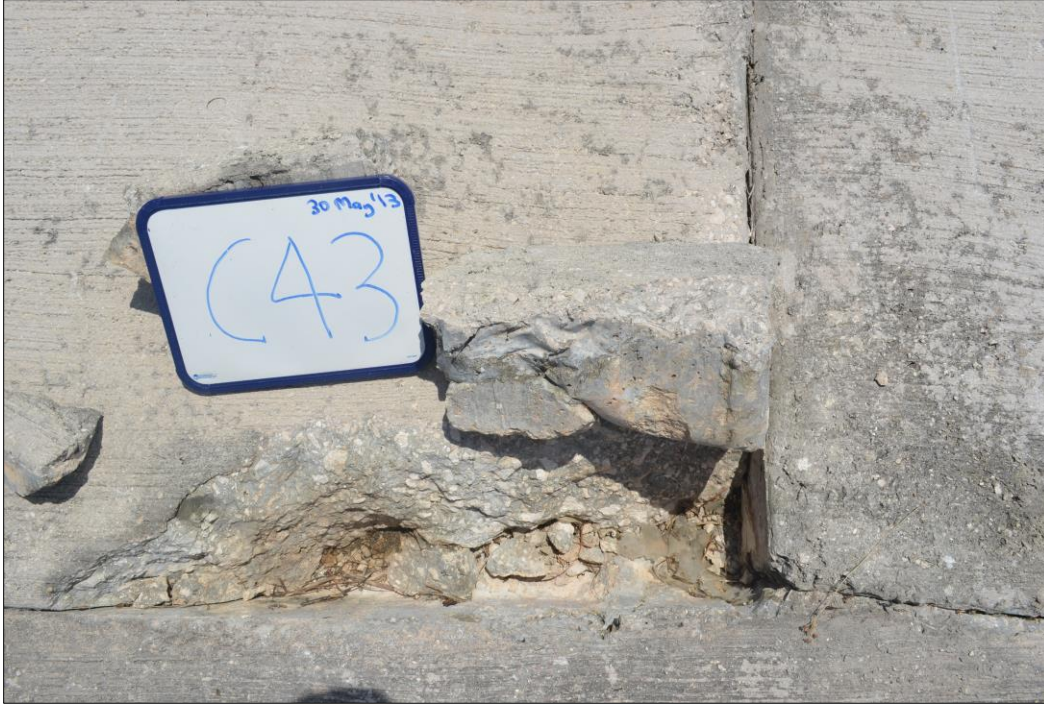
Fig. 36. Major spalling of concrete on the lower, right-hand corner of panel C43.

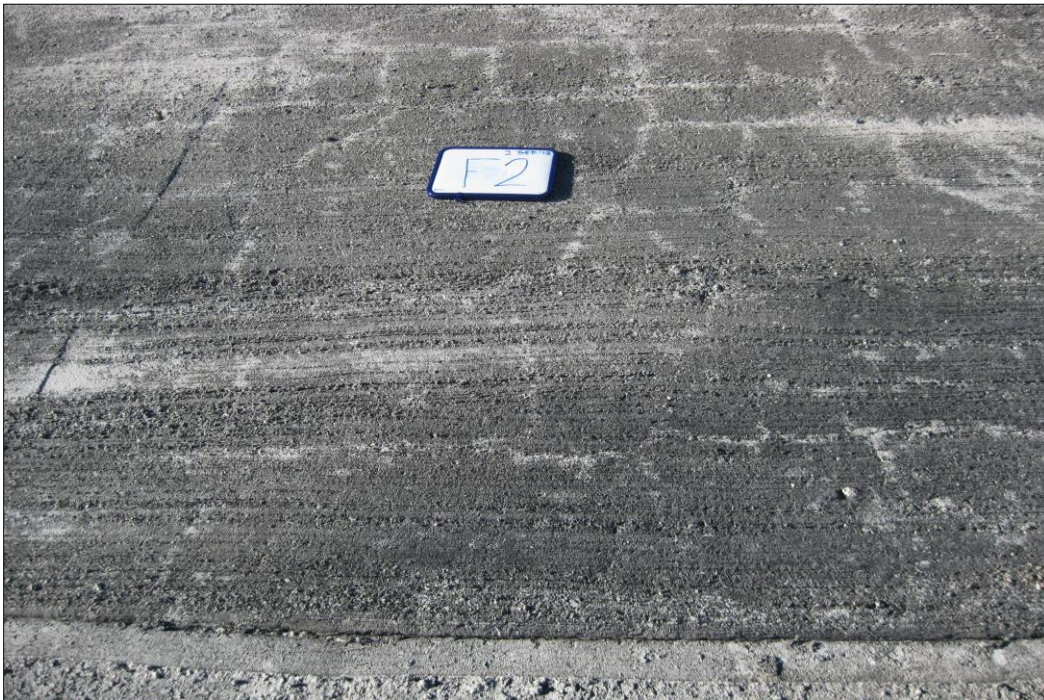
Fig. 37. A visually-defective concrete panel (F2) showing numerous minor surface cracks.

2. Develop and implement a program to repair visually-defective concrete panels in conjunction with a licensed Materials and Structural Engineer. These actions are considered necessary in order to;

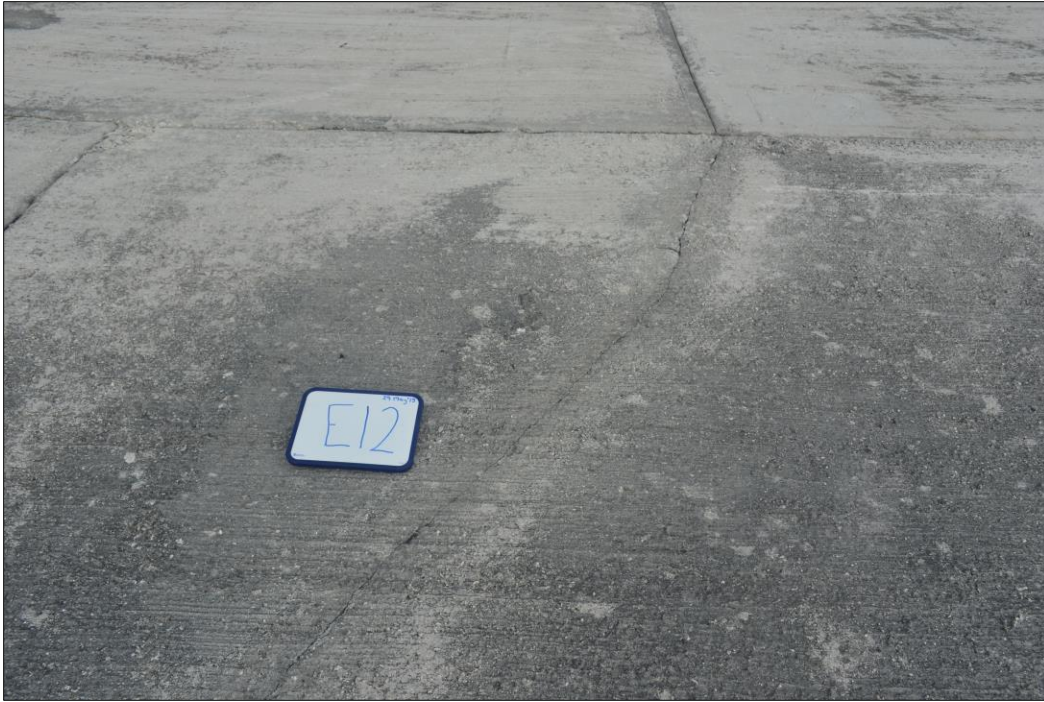
Fig. 39. A visually defective concrete panel (E12) showing a minor to moderate size crack extending upwards across the entire face of the panel segment.

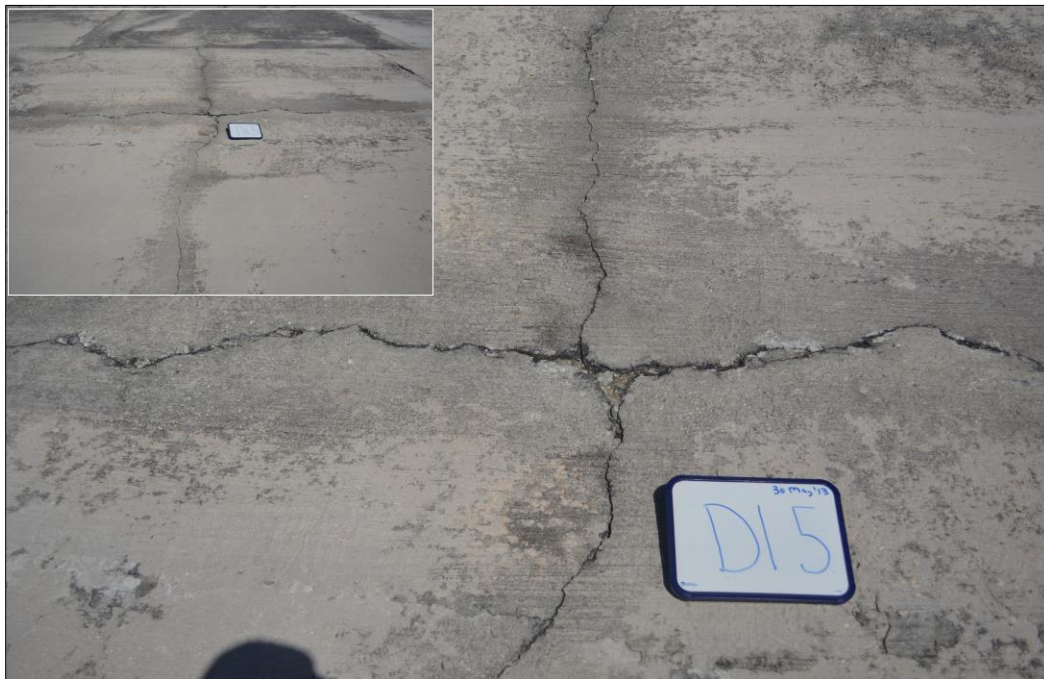
Fig. 40. A more severely cracked concrete panel (D15) with chipped “spalled” edges along the cracks.
