LLNL-TR-648143

A Visual Description of the Concrete Exterior of the Cactus Crater Containment Structure

Terry Hamilton

October 2013

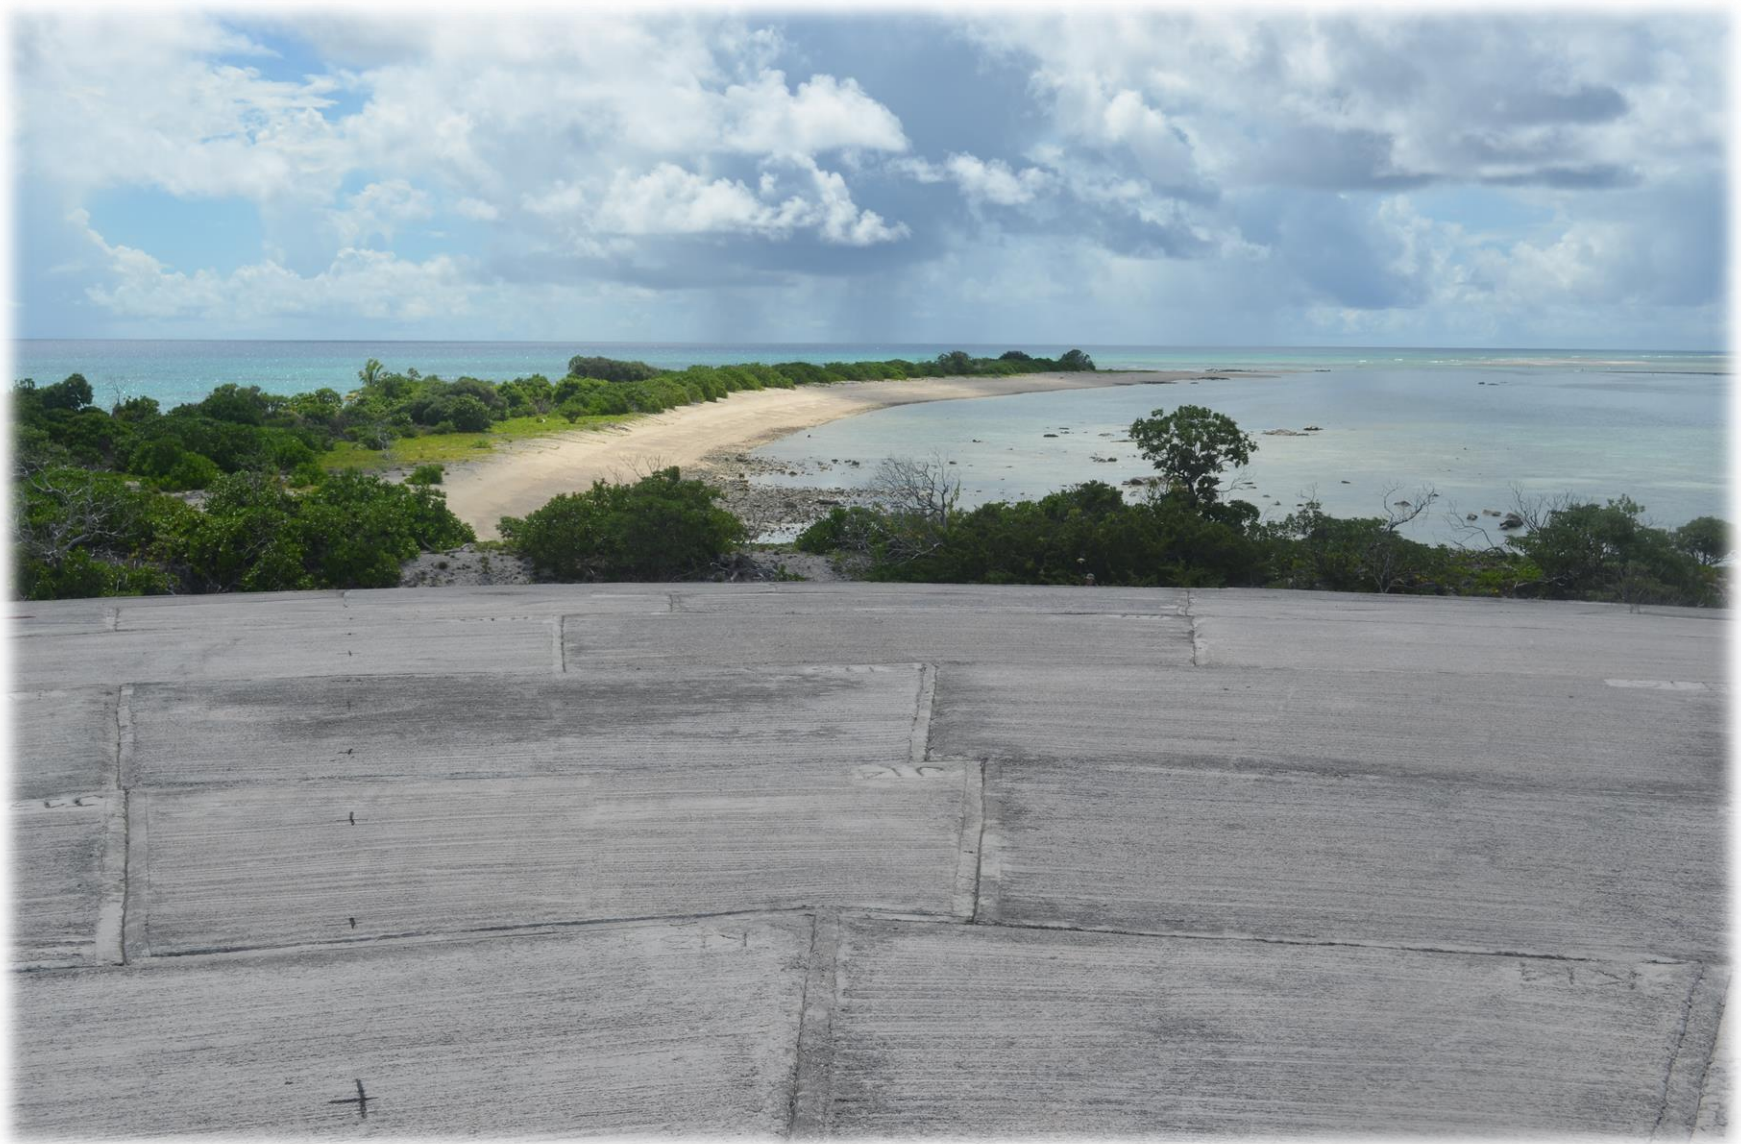
In order to gauge potential impacts of the major storm events and sea-level rise on the shoreline surrounding *Runit Dome*, a decision was made to include a reference photo in this, and in all subsequent, visual survey reports. A reference photo (Fig. 43) of the current island beach configuration was taken from the apex of *Runit Dome* looking towards the north-east end of the island.

Fig 43. View from atop of *Runit Dome* showing the beach configuration on the north end of Runit Island at low tide (Reference Photo, May 2013).

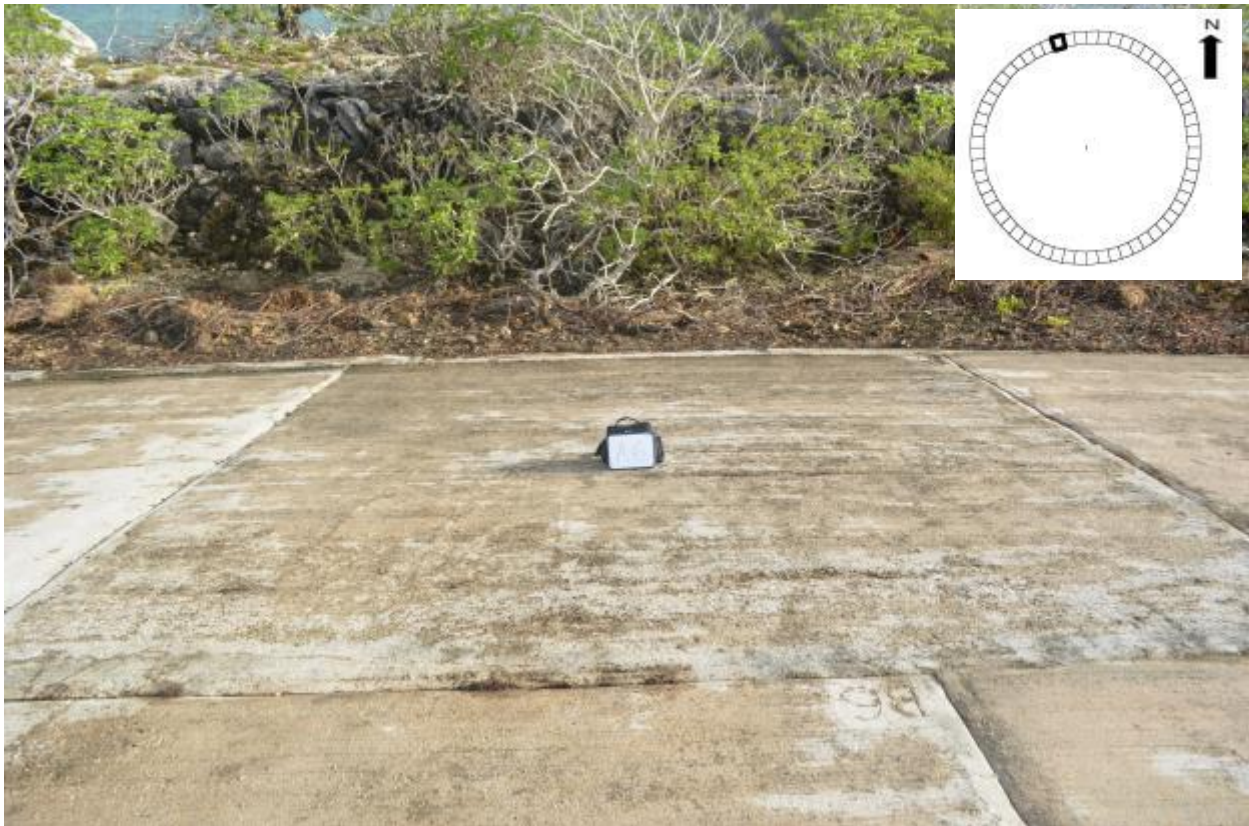
CAP SECTION LOCATION: Panel A7

The panel has a relatively rough appearance. Some rooting vegetation removed from along the seams. Minor spalling of concrete observed along the seam adjoining the keywall. Panel contains a vertical elevation benchmark.

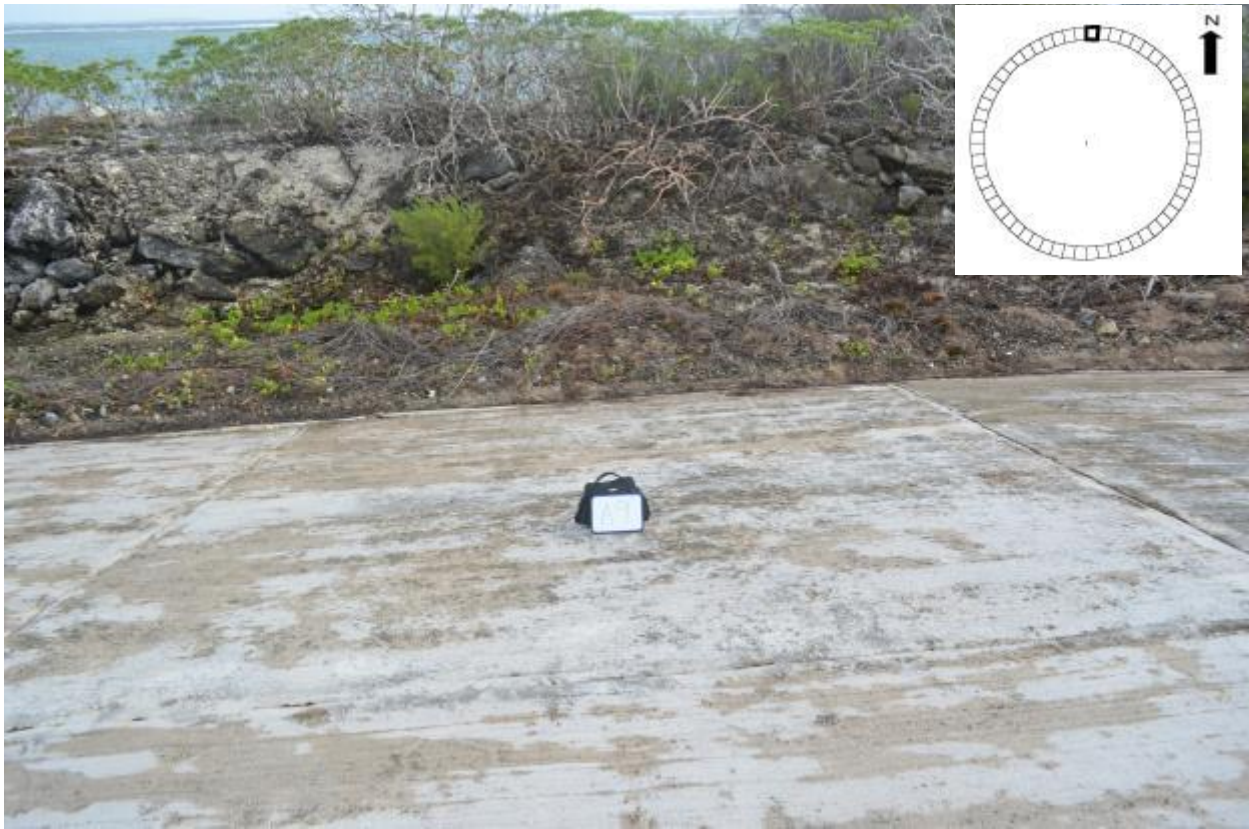
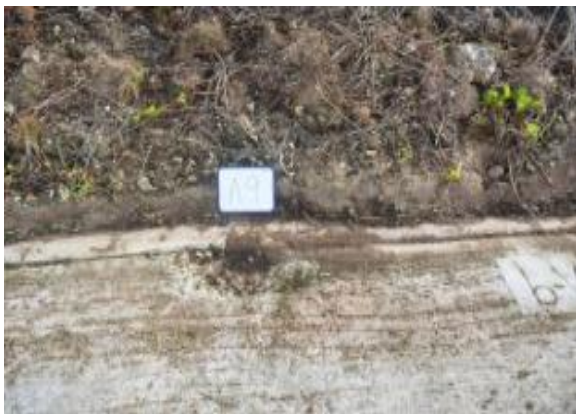
CAP SECTION LOCATION: Panel A10

No significant or obvious interior cracks extending across the top of the panel. The panel has a relatively rough appearance. Some rooting vegetation removed from along the seams.

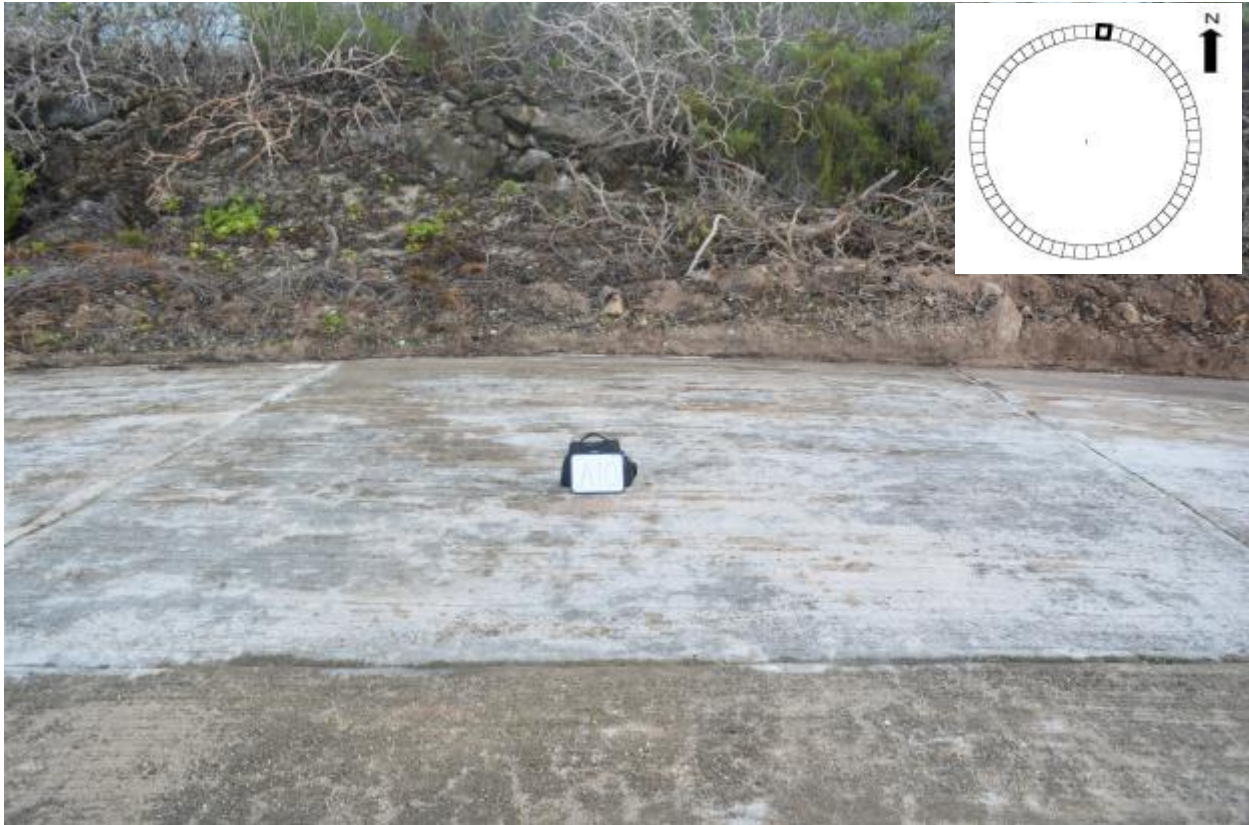
CAP SECTION LOCATION: Panel A11

No significant or obvious interior cracks extending across the top of the panel. The panel has a weathered appearance. Some minor spalling of concrete observed in the upper right-hand corner of the panel. A scrub tree found growing over the keywall and base of the panel was cut down, and the stump removed.

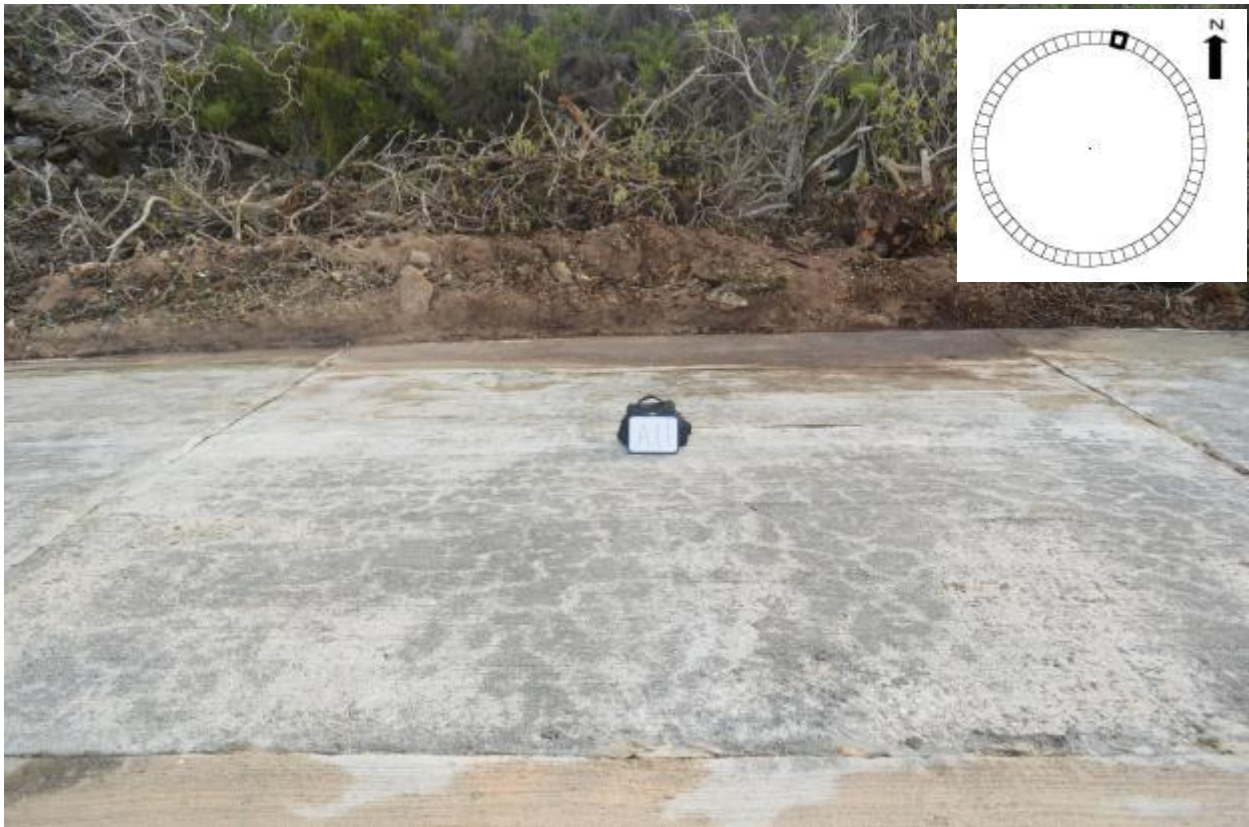
CAP SECTION LOCATION: Panel A12

No significant or obvious interior cracks extending across the top of the panel. The panel appears rough and weathered. Some rooting vegetation removed from along the seams.

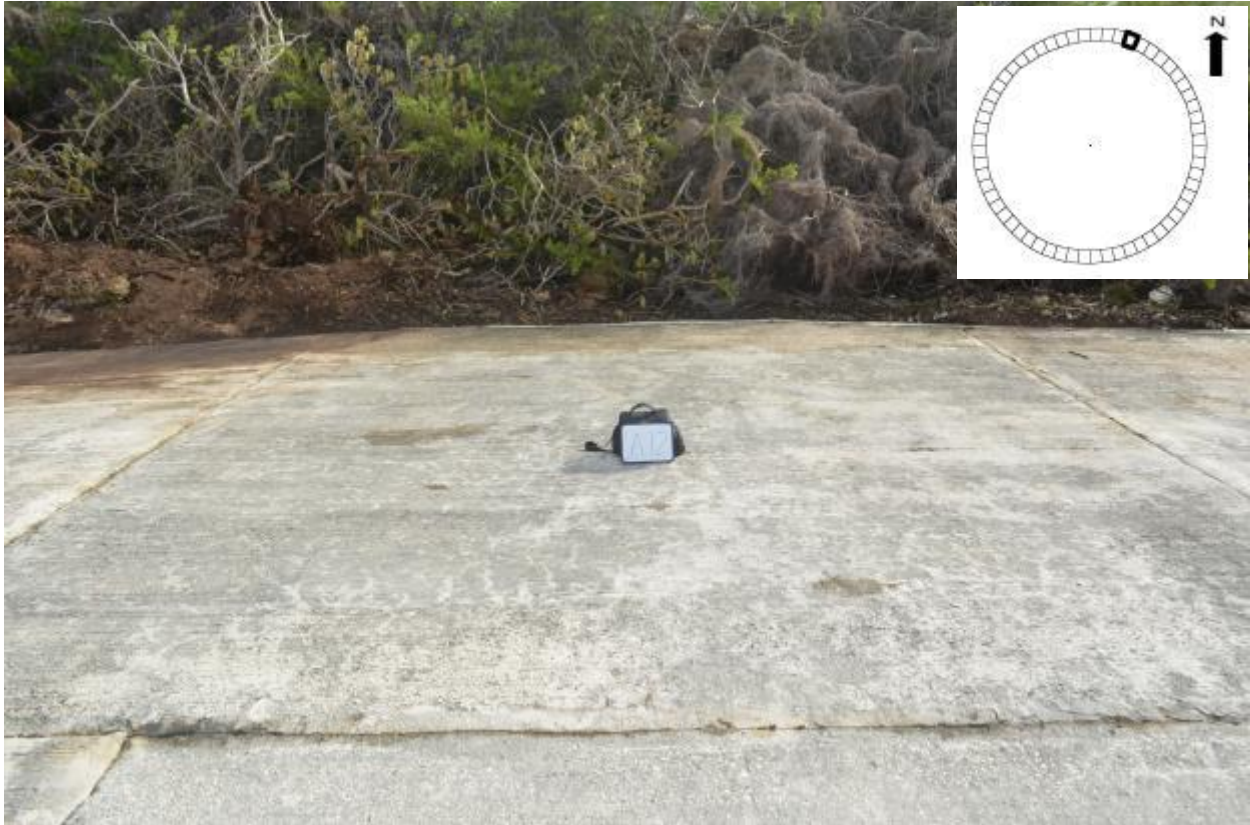
CAP SECTION LOCATION: Panel A13

No significant or obvious interior cracks extending across the top of the panel. The panel has a relatively rough weathered appearance. Some rooting vegetation removed from along the seams. Some minor spalling of concrete observed in the upper left-hand corner of the panel.

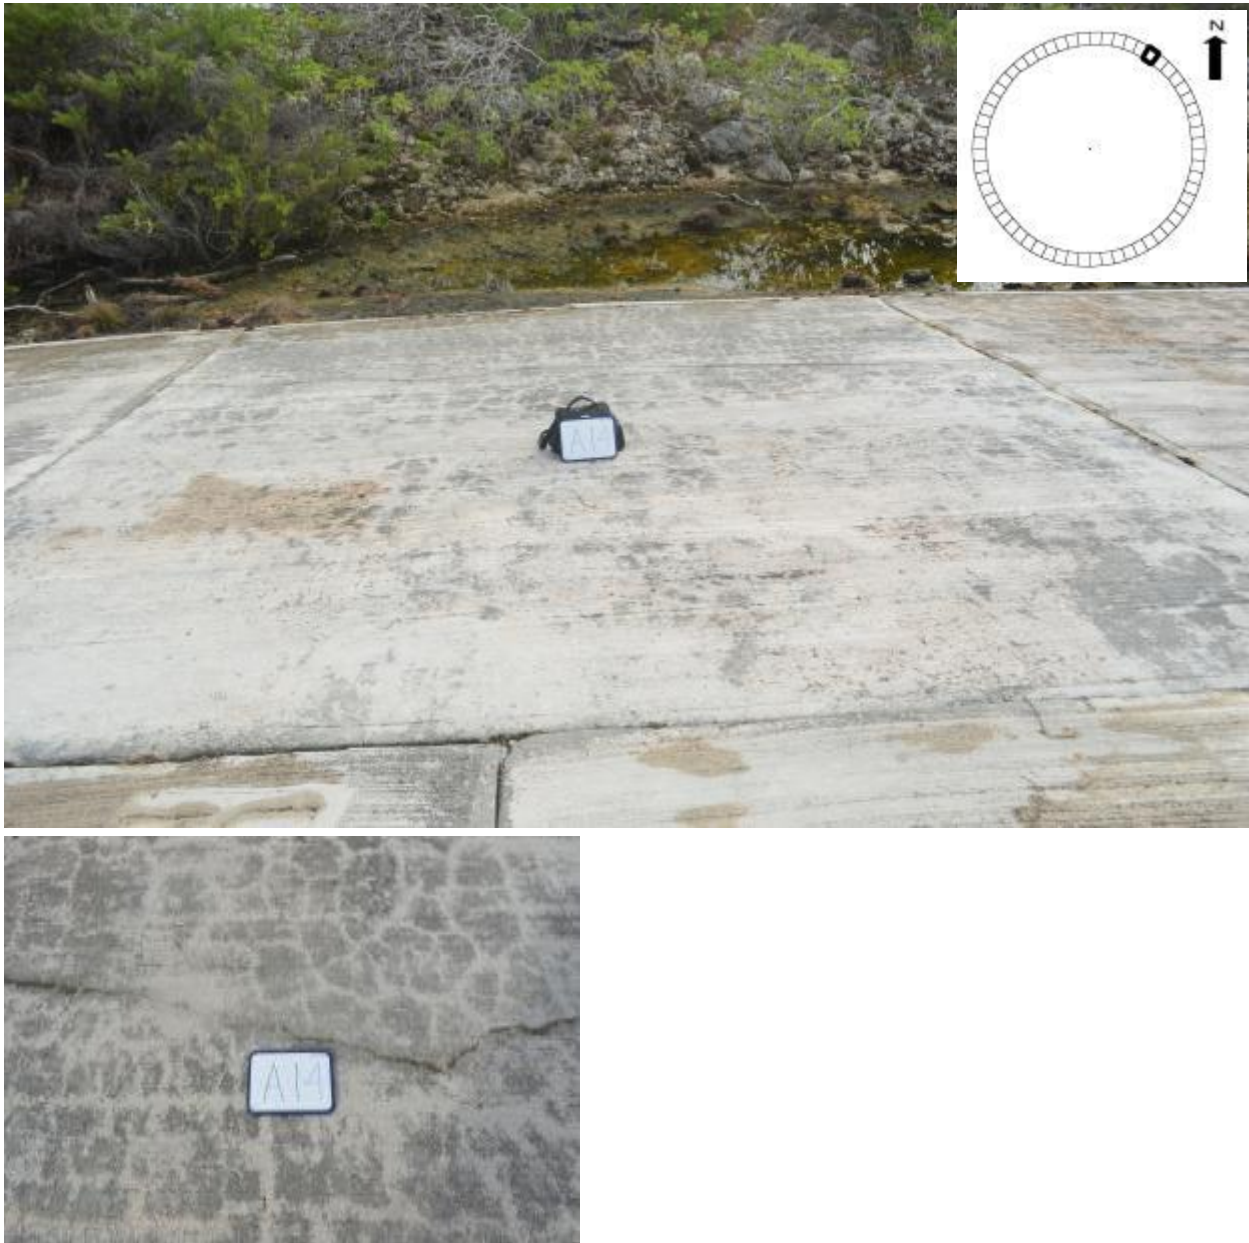
CAP SECTION LOCATION: Panel A15

The panel has a rough appearance. Some rooting vegetation removed from along the seams. A minor surface crack observed traversing about 1 meter down from the top seam about 1.3 meters from the right-hand corner of the panel.

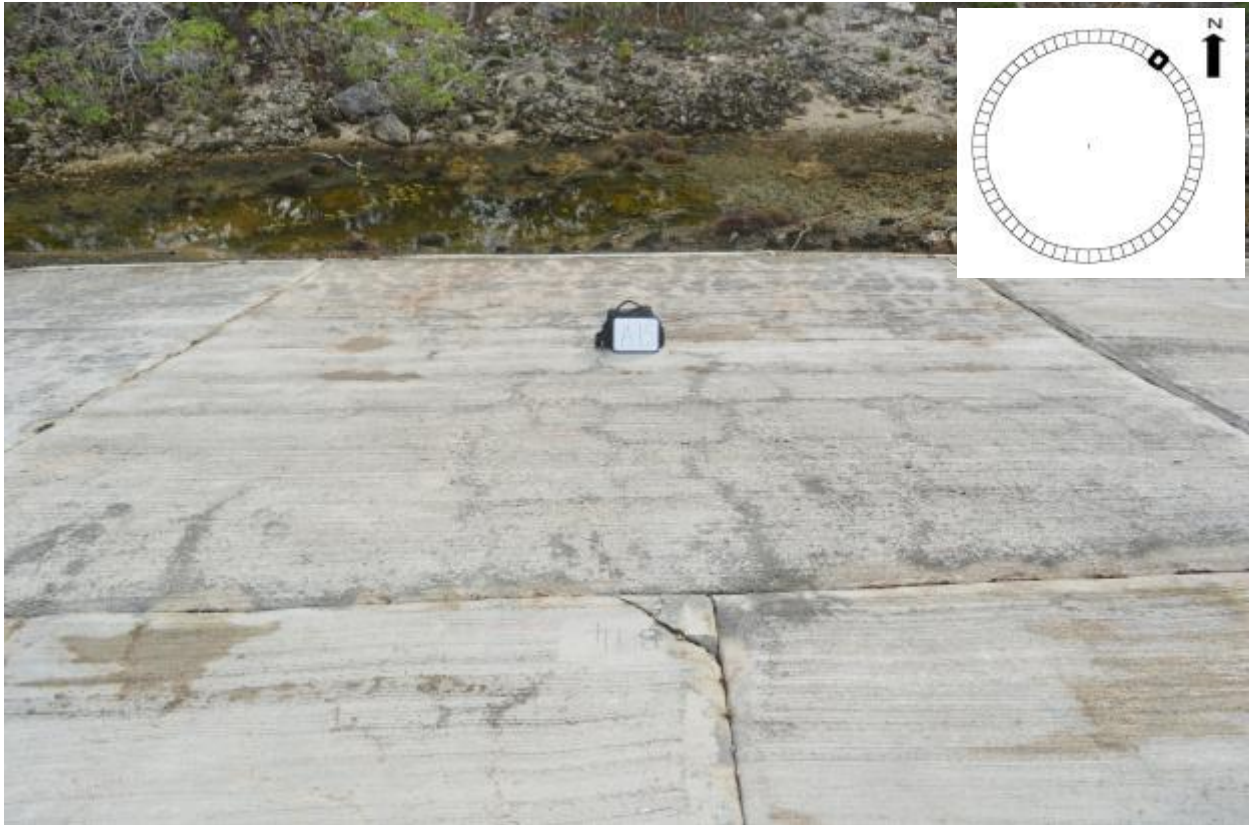
CAP SECTION LOCATION: Panel A16

Some rooting vegetation removed from along the seams. A visible crack observed traversing across the segment at a mid-point up the panel.

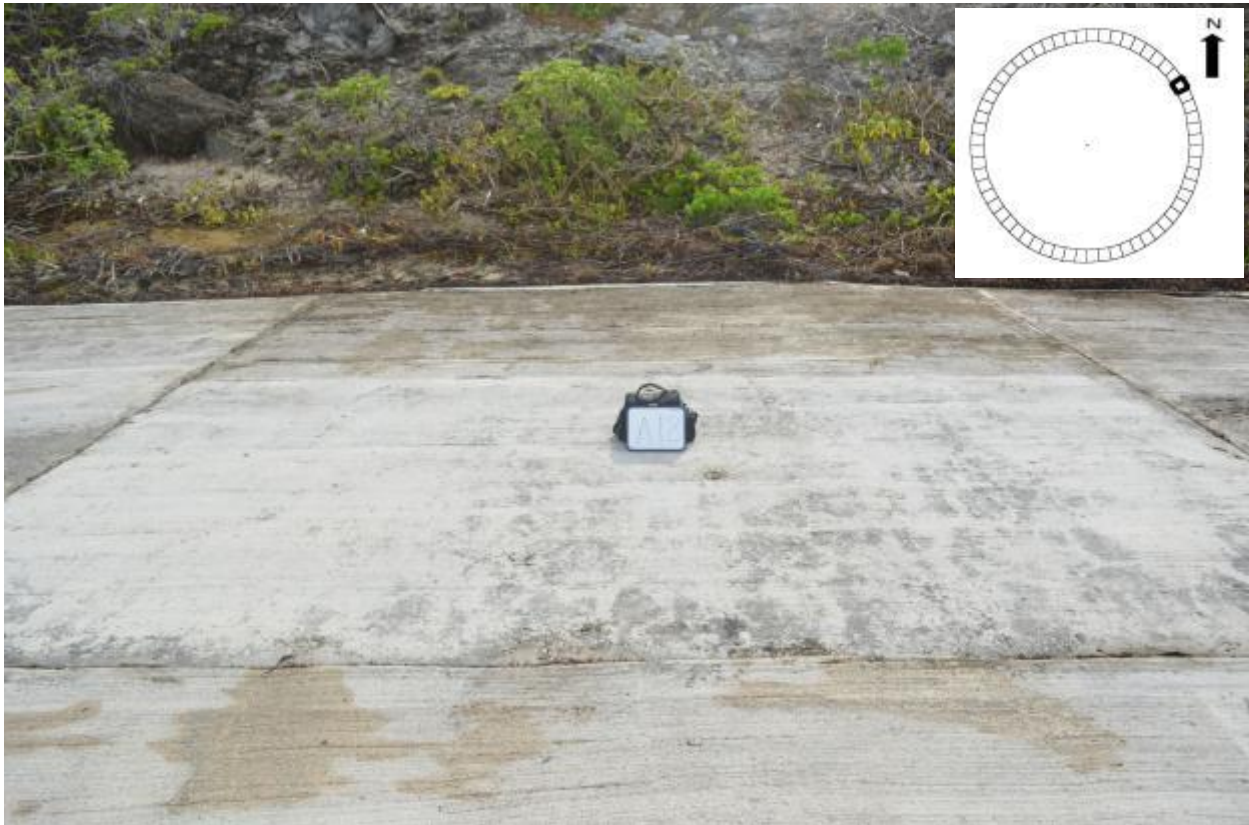
CAP SECTION LOCATION: Panel A19

The panel has a rough and weathered appearance. There is major spall of concrete along the base of the panel adjoining the keywall (app. 1.2 meters x 30-40 centimeters in area). There is also a visible crack in the concrete extending up through the middle of the panel, and minor spalls appearing along the left-hand seam.

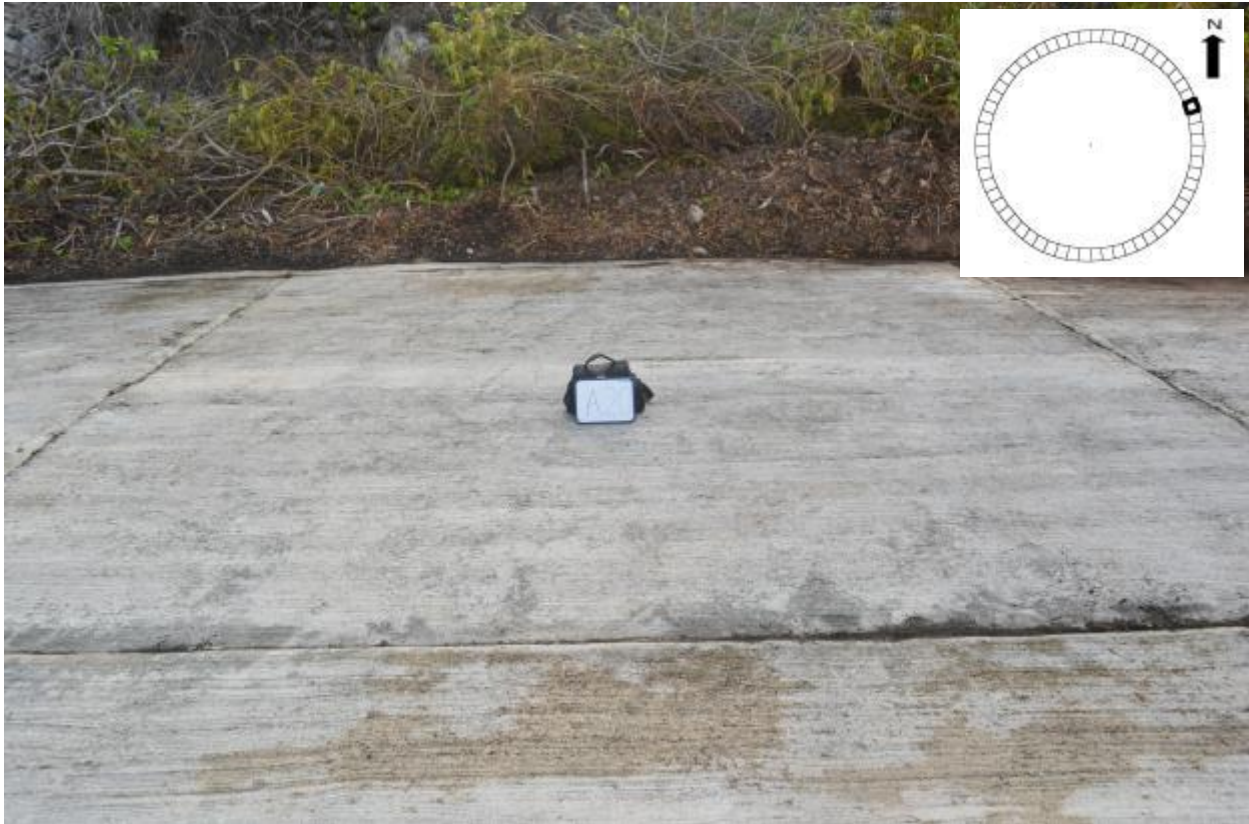
CAP SECTION LOCATION: Panel A21

No significant or obvious interior cracks extending across the top of the panel. The panel has a relatively rough appearance. Minor spalling of concrete observed along the bottom seam adjoining the keywall, and in the upper left-hand corner of the panel. Rooting vegetation removed from along the seams. A scrub tree overgrowing the keywall was cut down, and the stump removed.

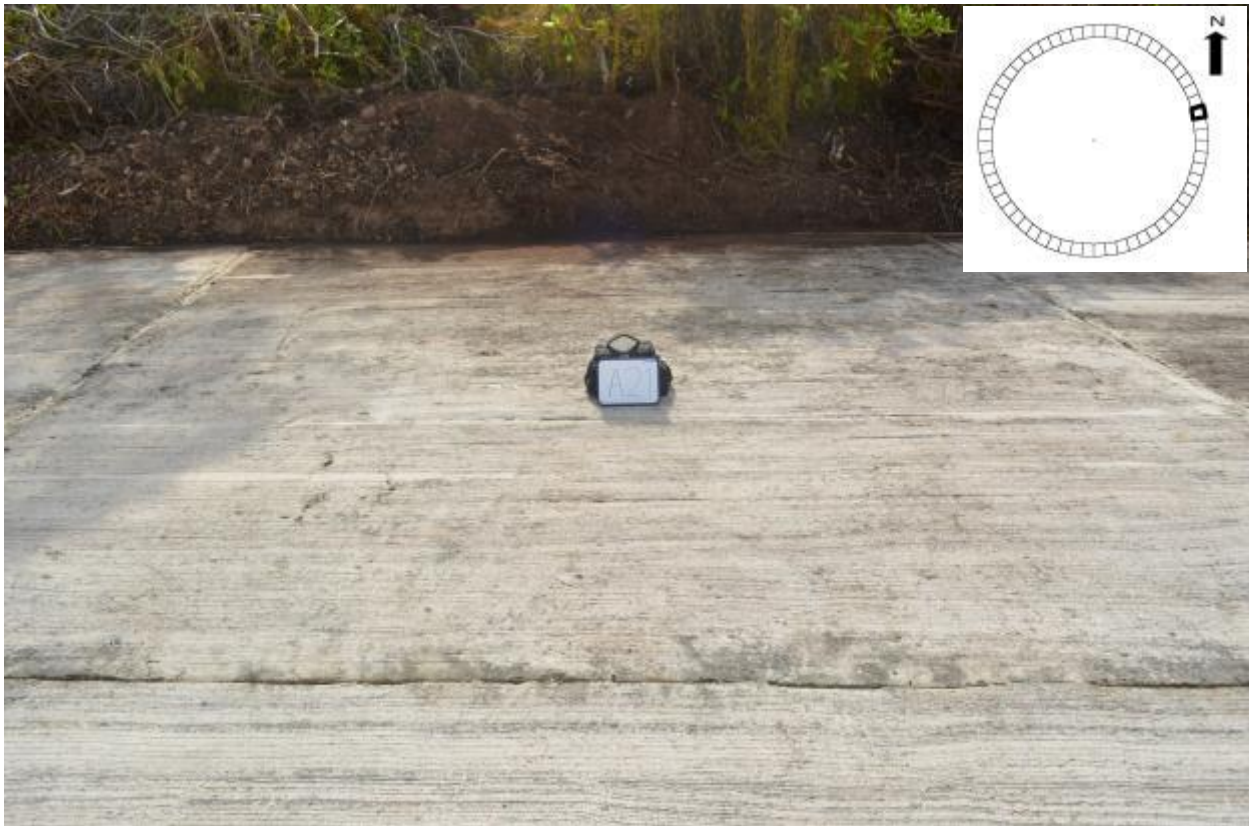
CAP SECTION LOCATION: Panel A22

No significant or obvious interior cracks extending across the top of the panel. The panel has a rough and weathered appearance. Rooting vegetation removed from along the seams. Minor spalling of concrete observed in the upper right-hand corner of the panel, and in the joint intersecting with panel B21. This panel contains a vertical elevation benchmark.

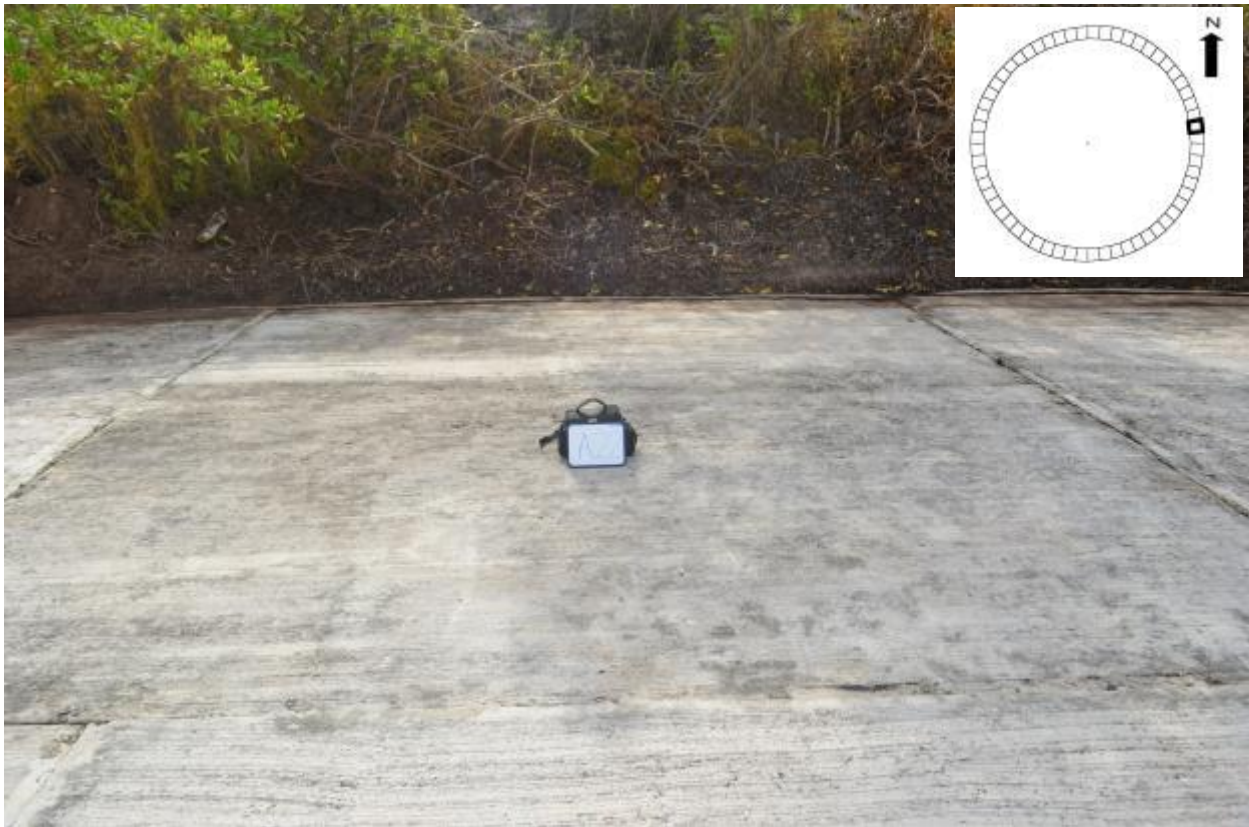
CAP SECTION LOCATION: Panel A23

No significant or obvious interior cracks extending across the top of the panel. The panel has a rough and weathered appearance. Rooting vegetation removed from along the seams.

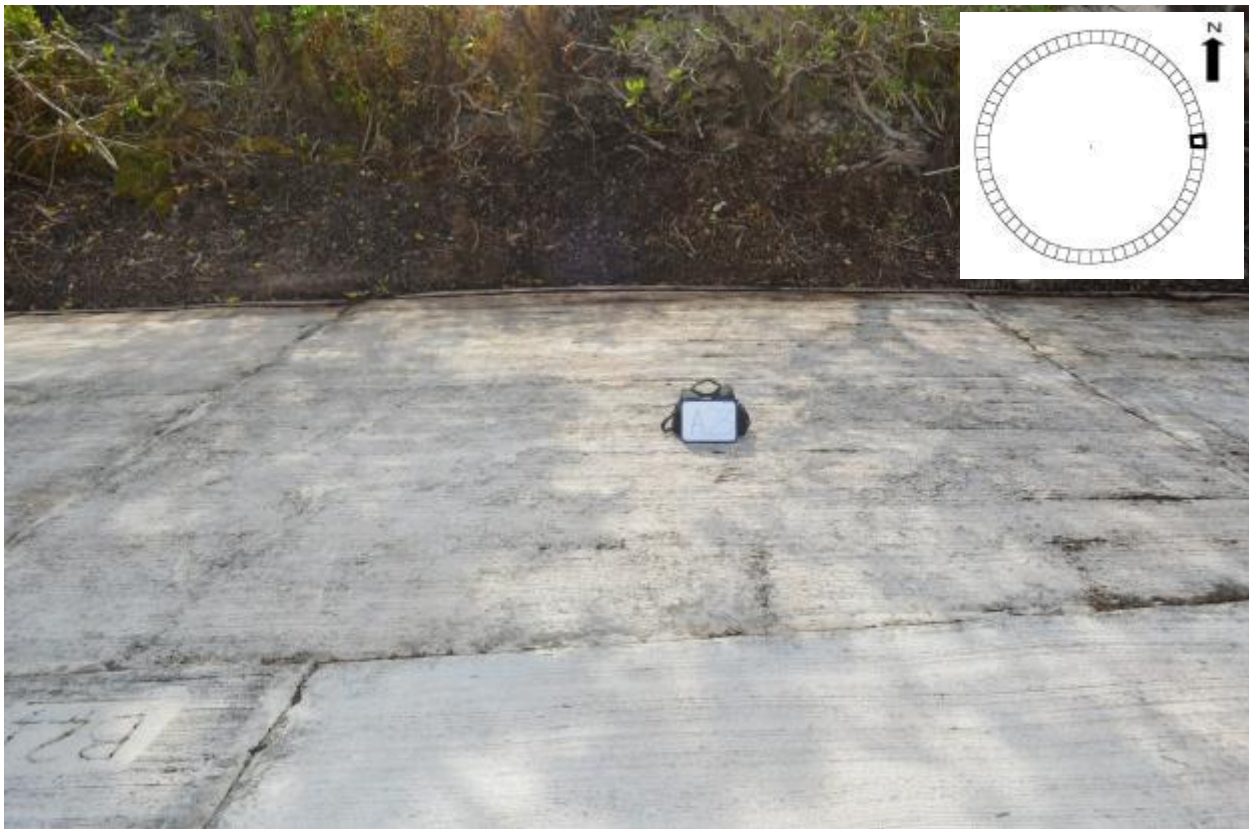
CAP SECTION LOCATION: Panel A24

The panel has a rough and weathered appearance. A significant spall of concrete is visible along the seam adjacent to the keywall (several centimeters deep, and about 80 x 30 centimeters in area).

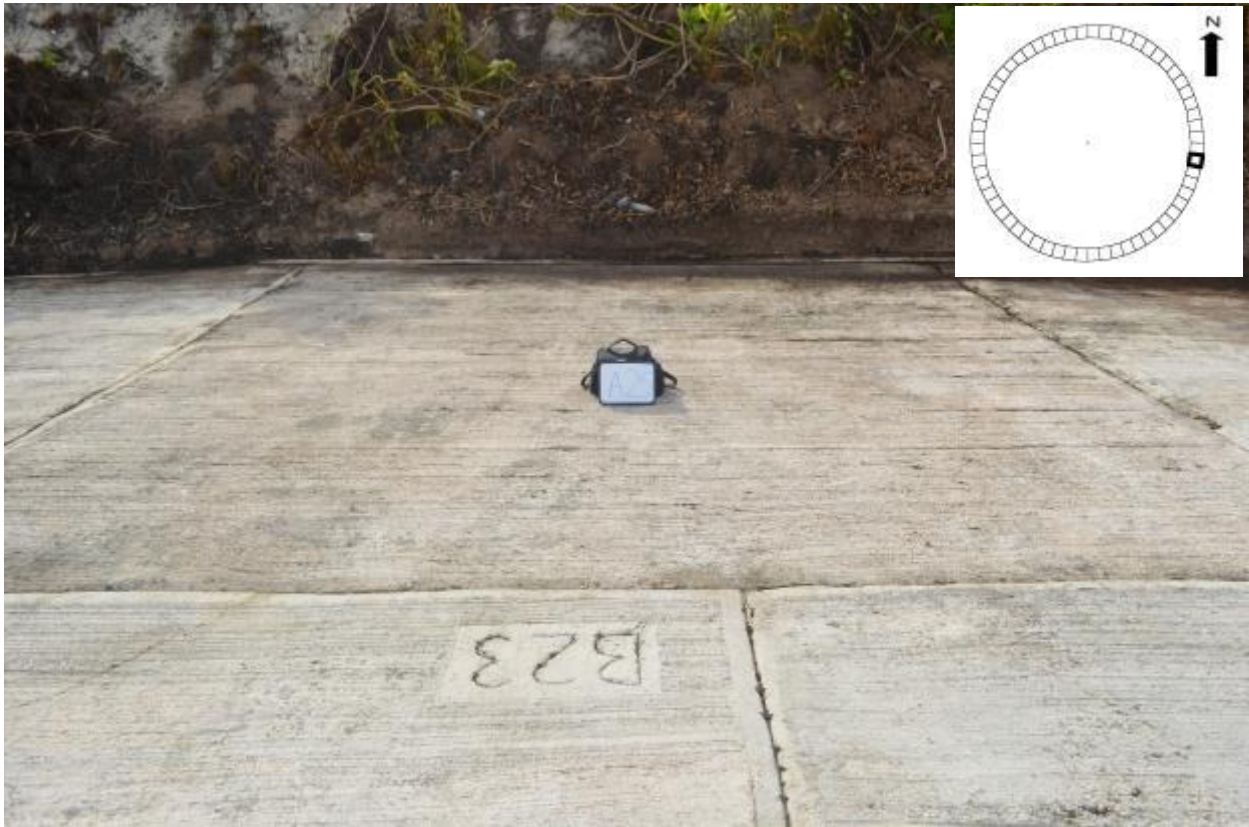
CAP SECTION LOCATION: Panel A26

The panel has a rough and weathered appearance. Some spalling of concrete observed along the bottom seam in contact with the keywall and along the top seam, and in the top left-hand corner, of the panel. A scrub tree overhanging the keywall was cut down and the stump removed. A crack was observed on left side of the panel, extending out for a distance of about 4 meters across the panel.

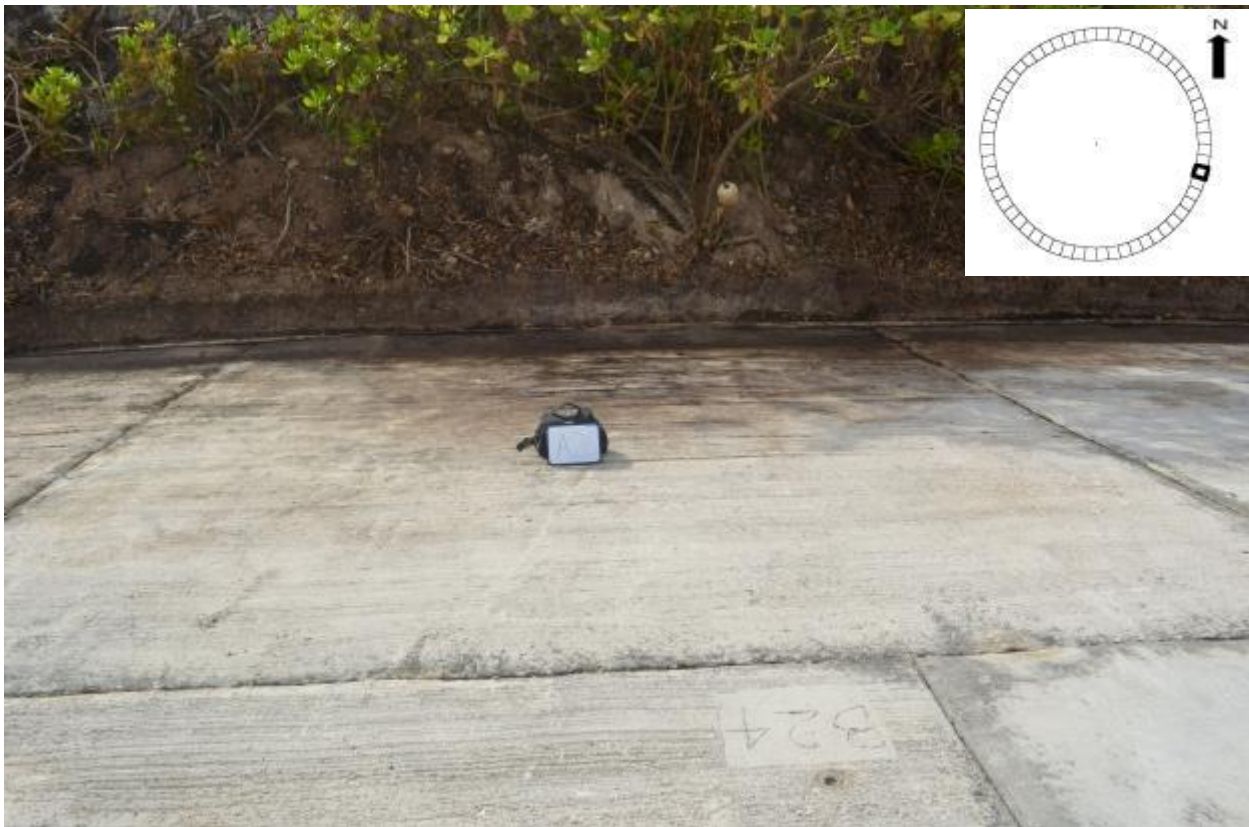
CAP SECTION LOCATION: Panel A27

There are only faint remnants of etched out panel ID marking still visible. There is a significant spall (several centimeters deep, and app. 70 x 40 centimeters in area) in the concrete in the lower left-hand corner, and several other minor spalls appearing both along the bottom and top seams of the panel.

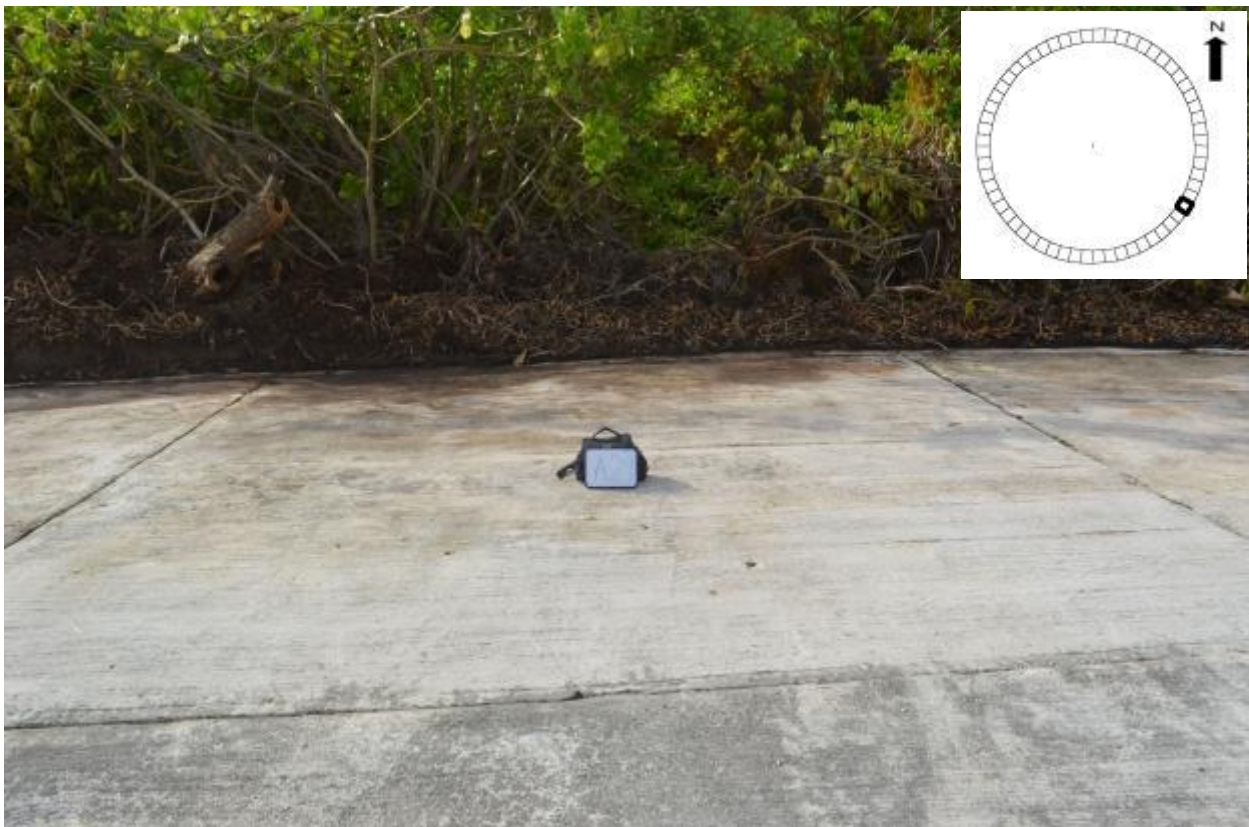
CAP SECTION LOCATION: Panel A30

No significant or obvious interior cracks extending across the top of the panel. Minor spalling of concrete observed in the top and bottom left-hand corners, and in the bottom right-hand corner, of the panel.

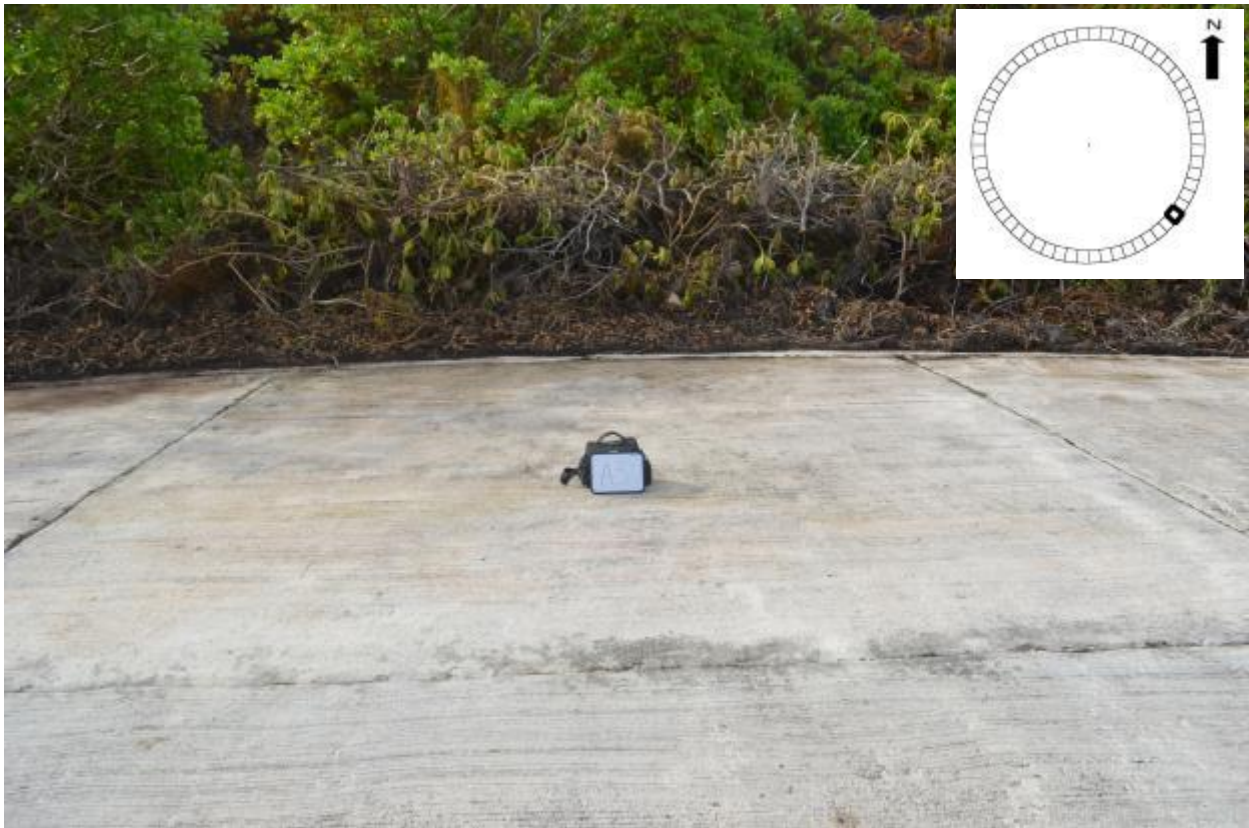
CAP SECTION LOCATION: Panel A31

The panel has a rough and weathered appearance. Rooting vegetation removed from along the seams. Some cracks observed in the lower left-hand corner with minor spalling of concrete in the top right-hand corner of the panel. There is significant spalling and cracks (extending more than 2 meters) appearing in the concrete along the bottom seam adjacent to keywall on the right side of the panel.

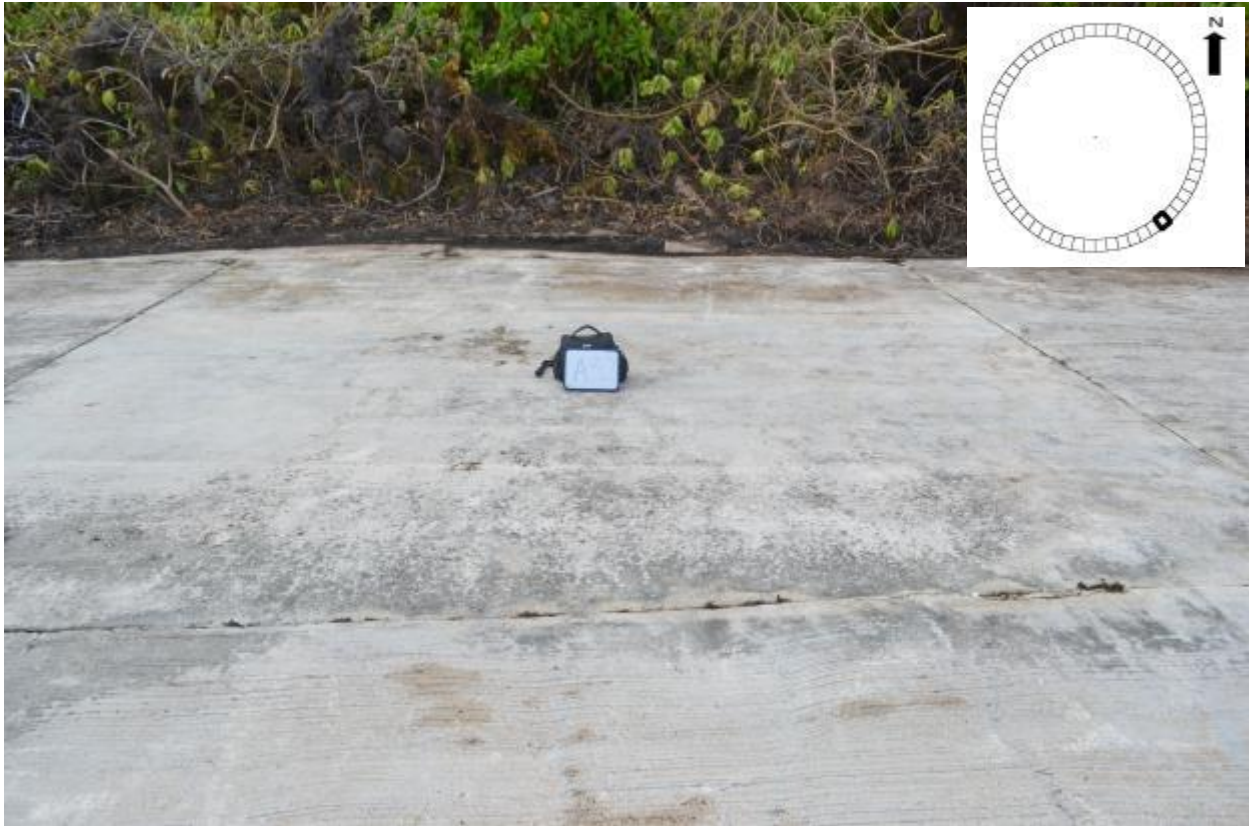
CAP SECTION LOCATION: Panel A33

No significant or obvious interior cracks extending across the top of the panel. The panel has a relatively rough and weathered appearance. Rooting vegetation removed from along the seams.

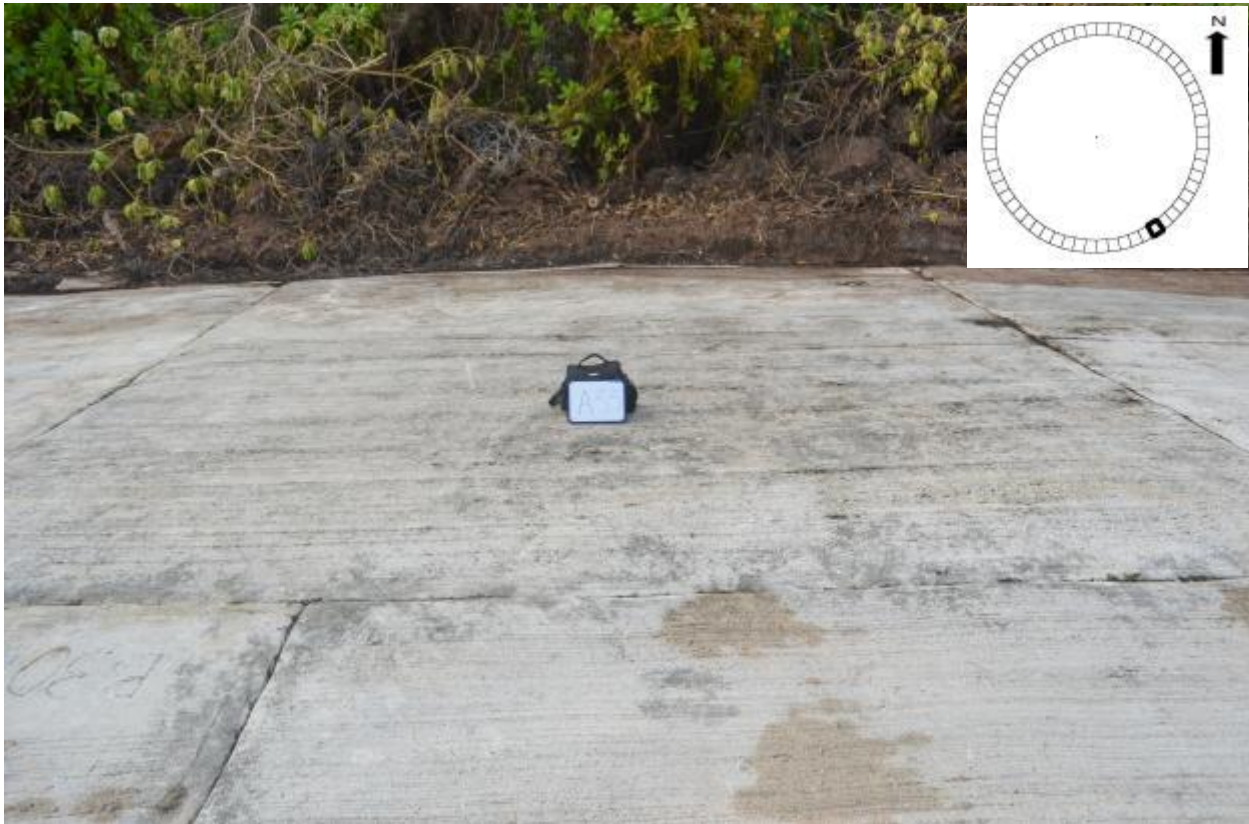
CAP SECTION LOCATION: Panel A34

A crack observed in the concrete extending down from the top of the panel – located about 20 to 25 centimeters inside the left edge of the panel and intersecting with the seam about half way down the panel.
