LLNL-TR-648143

A Visual Description of the Concrete Exterior of the Cactus Crater Containment Structure

Terry Hamilton

October 2013

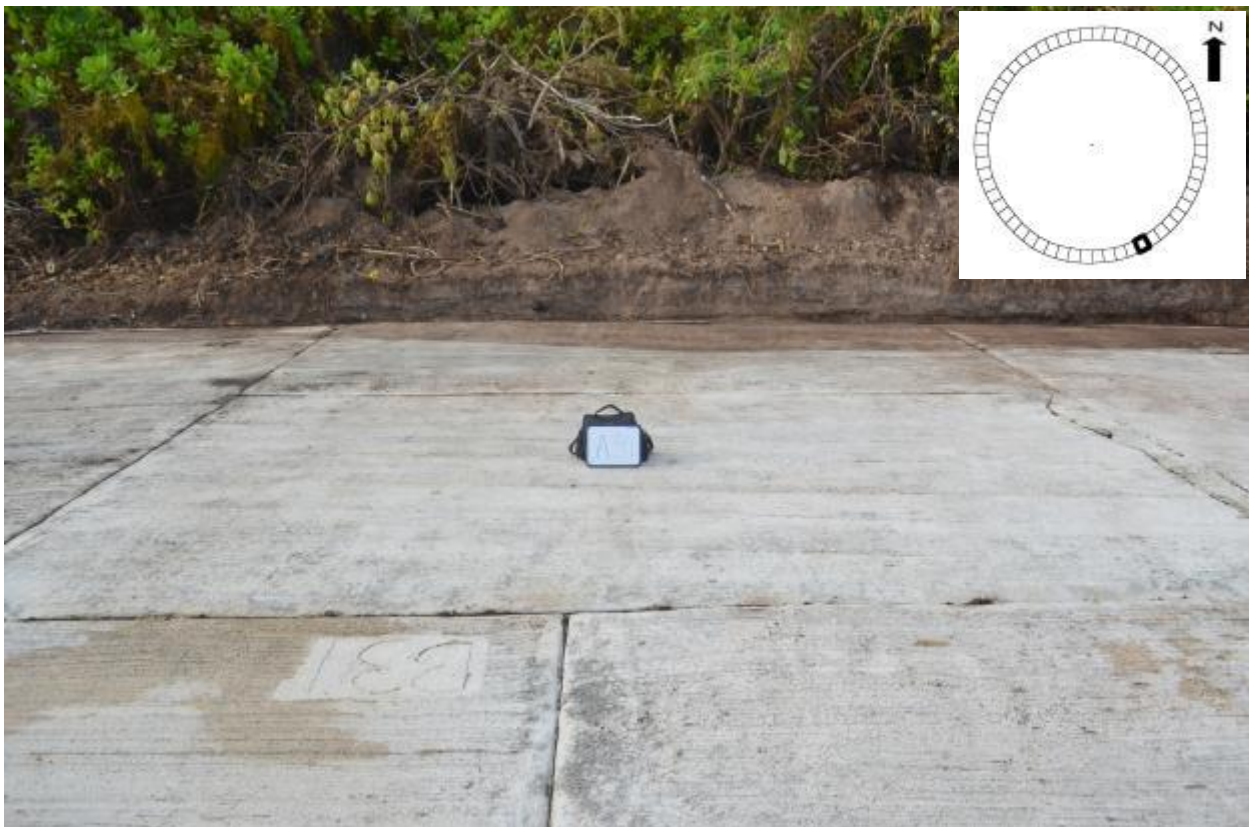
CAP SECTION LOCATION: Panel A35

No significant or obvious interior cracks extending across the top of the panel. The panel has a relatively rough appearance. Rooting vegetation removed from along the panel seams.

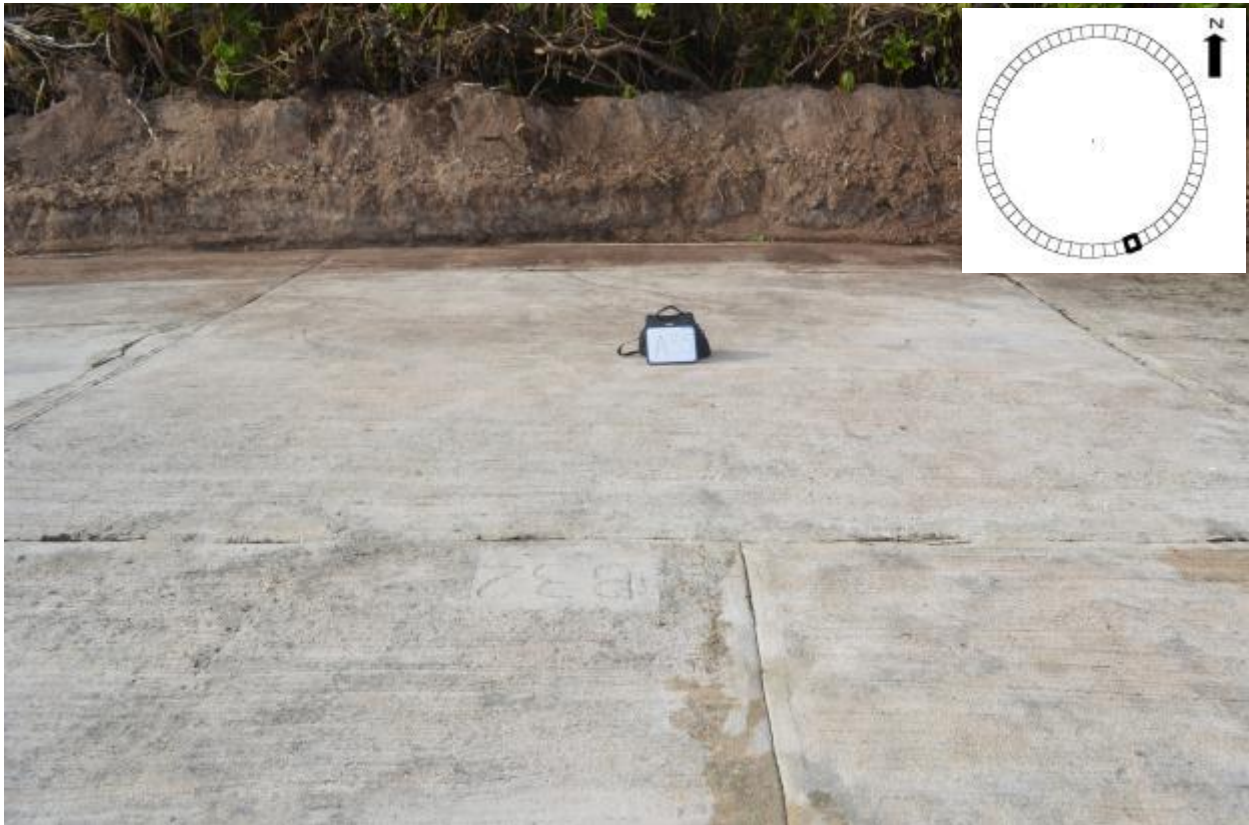
CAP SECTION LOCATION: Panel A36

The panel has a relatively rough and weathered appearance. Rooting vegetation removed from along the panel seams. Some minor spalling of concrete observed in the top left-hand corner, and along the top left seam, of the panel.

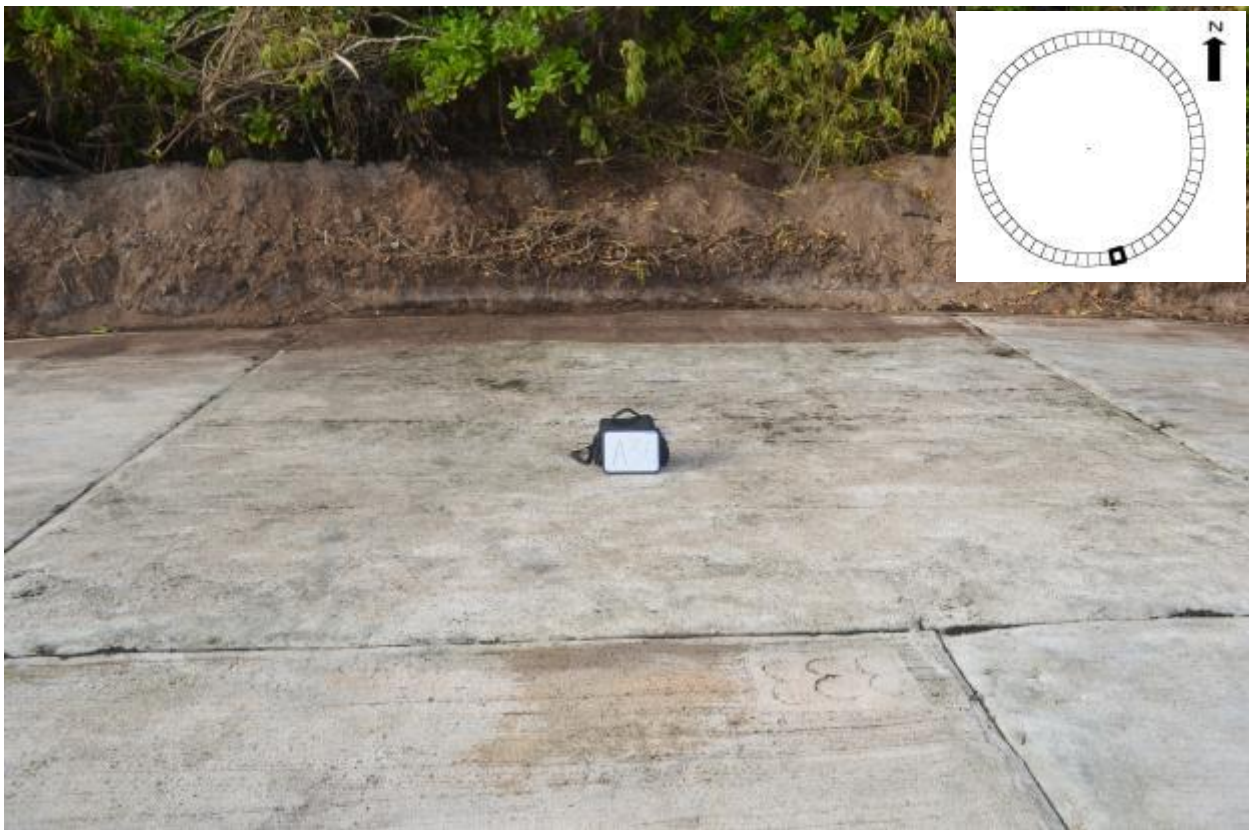
CAP SECTION LOCATION: Panel A37

The panel has a relatively rough and weathered appearance. Some minor spalling of concrete observed along the upper right seam of the panel. Significant spalling of concrete observed in the lower left-hand corner of the panel with the chipped out section extending more than 1 meter along the seam. Panel contains a vertical elevation benchmark.

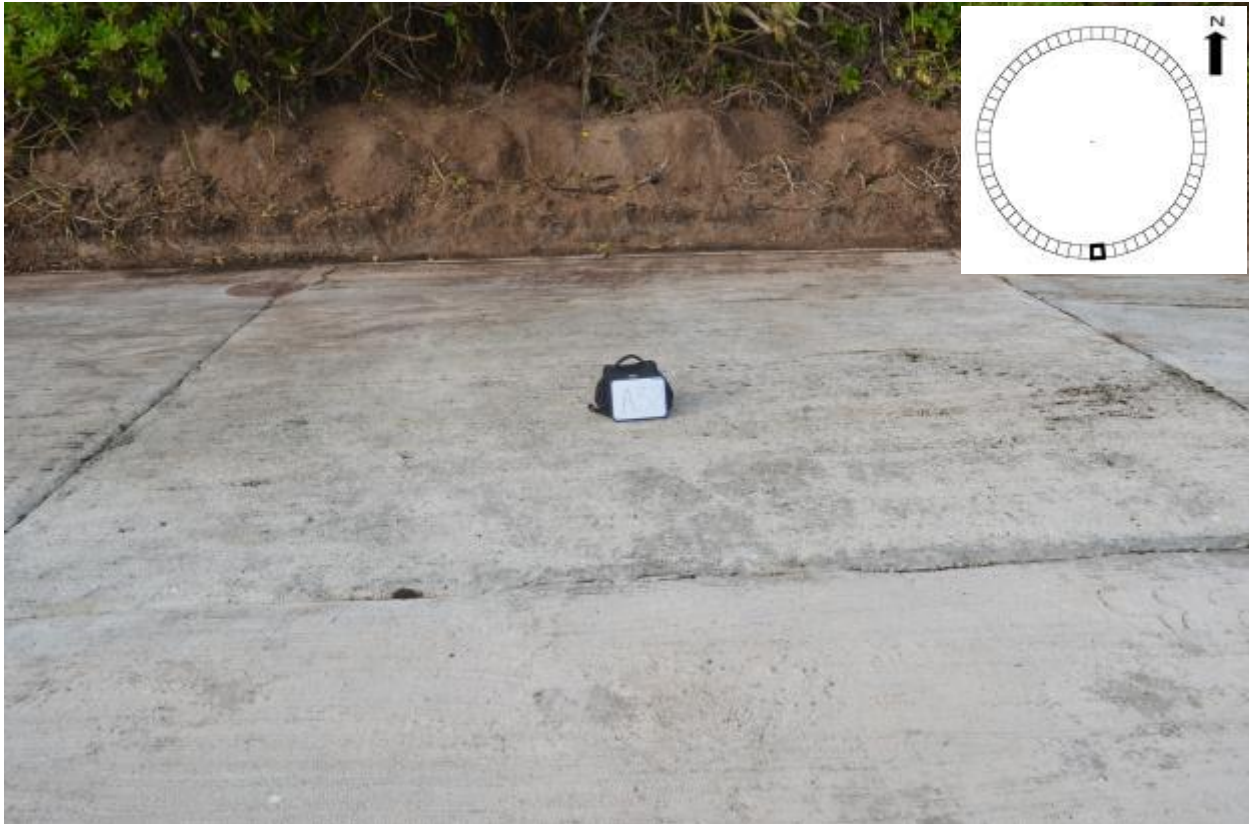
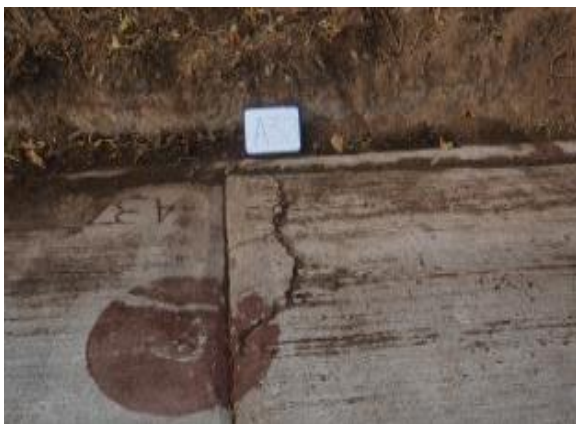
CAP SECTION LOCATION: Panel A39

No significant or obvious interior cracks extending across the top of the panel. The panel has a relatively rough and weathered appearance. Minor spalling observed in the upper left-hand corner of the panel.

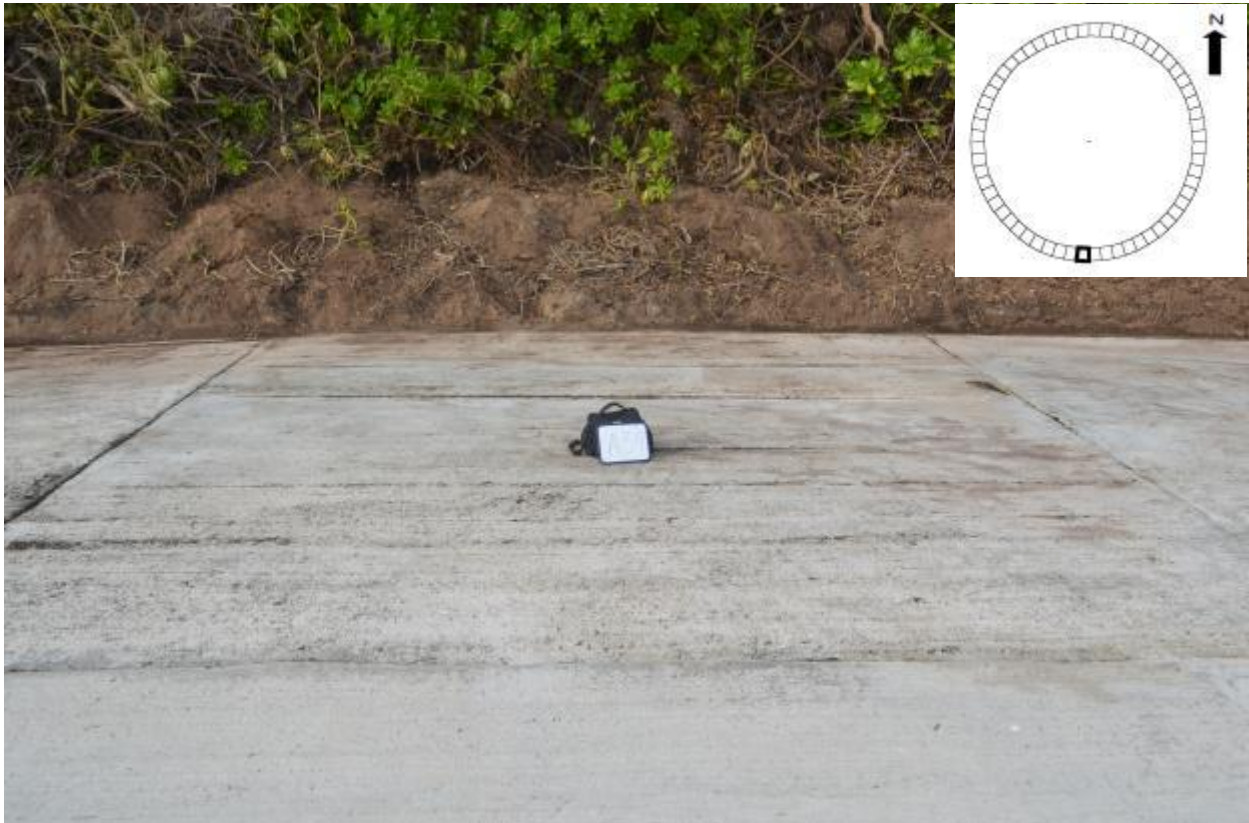
CAP SECTION LOCATION: Panel A40

No significant or obvious interior cracks extending across the top of the panel. The panel has a relatively rough and more weathered appearance. Rooting vegetation removed from along the panel seams.

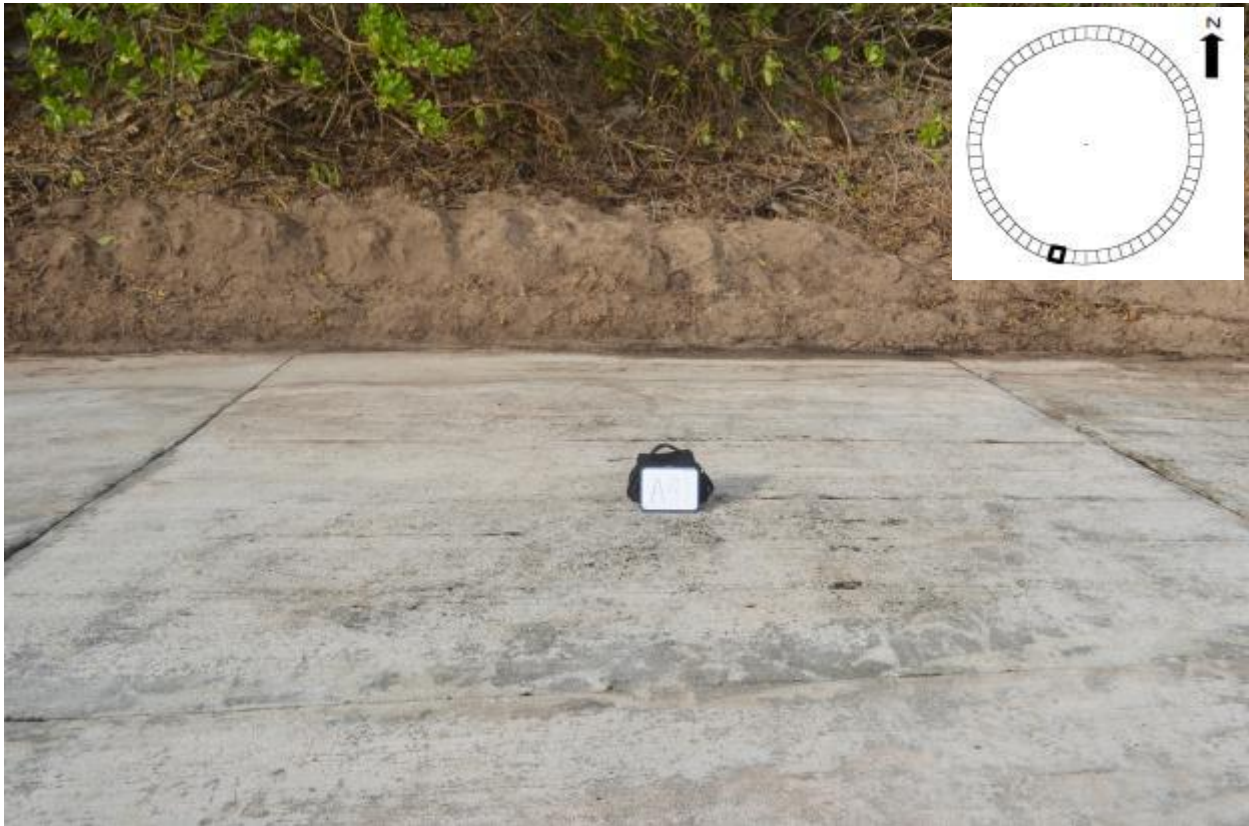
CAP SECTION LOCATION: Panel A42

No significant or obvious interior cracks extending across the top of the panel. The panel has a relatively rough and more weathered appearance. There is an indication from the GPR data that some areas under the panel are poorly supported or “voided”.

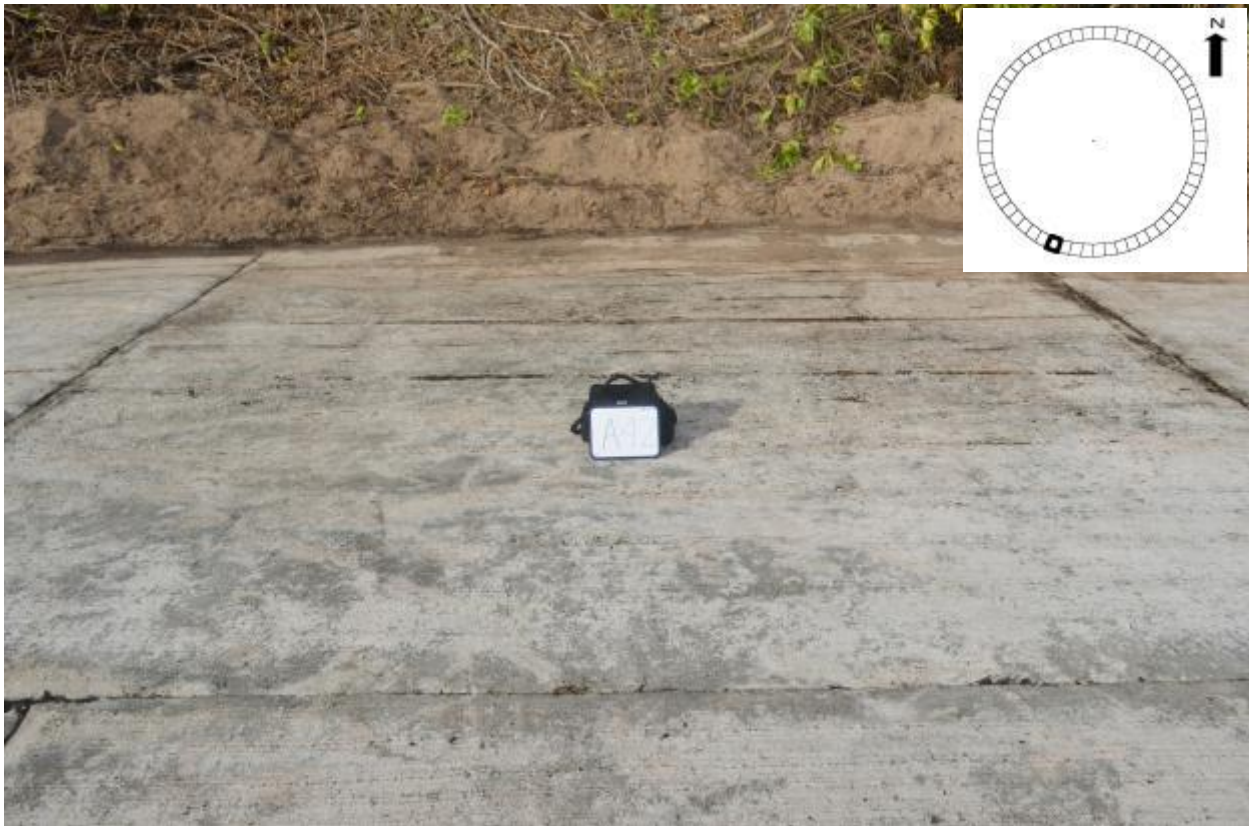
CAP SECTION LOCATION: Panel A43

No significant or obvious interior cracks extending across the top of the panel. The panel has a relatively rough and weathered appearance. Rooting vegetation removed from along the panel seams.

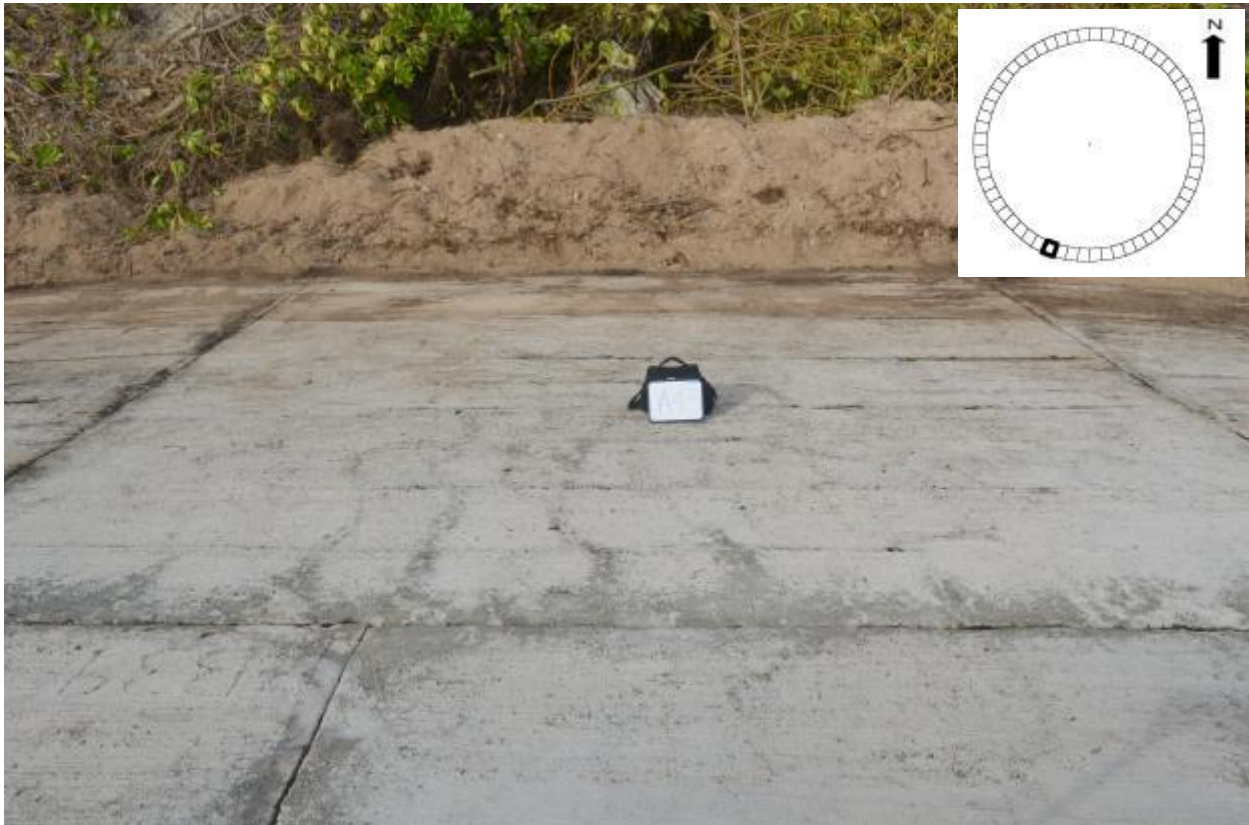
CAP SECTION LOCATION: Panel A44

No significant or obvious interior cracks extending across the top of the panel. The panel has a relatively rough and more weathered appearance. Rooting vegetation removed from along the panel seams..

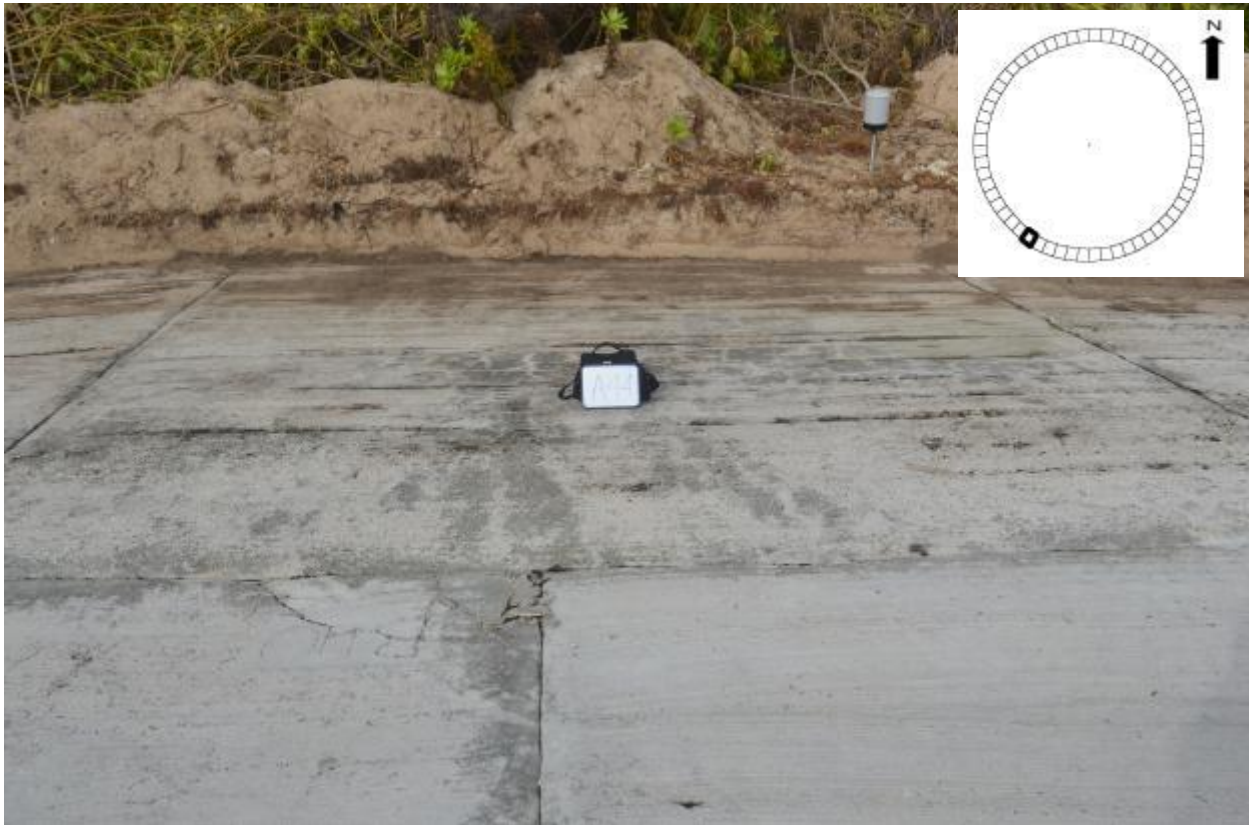
CAP SECTION LOCATION: Panel A45

No significant or obvious interior cracks extending across the top of the panel. Rooting vegetation removed from along the panel seams. There is indication from the GPR data that some areas under the panel are poorly supported or “voided”.

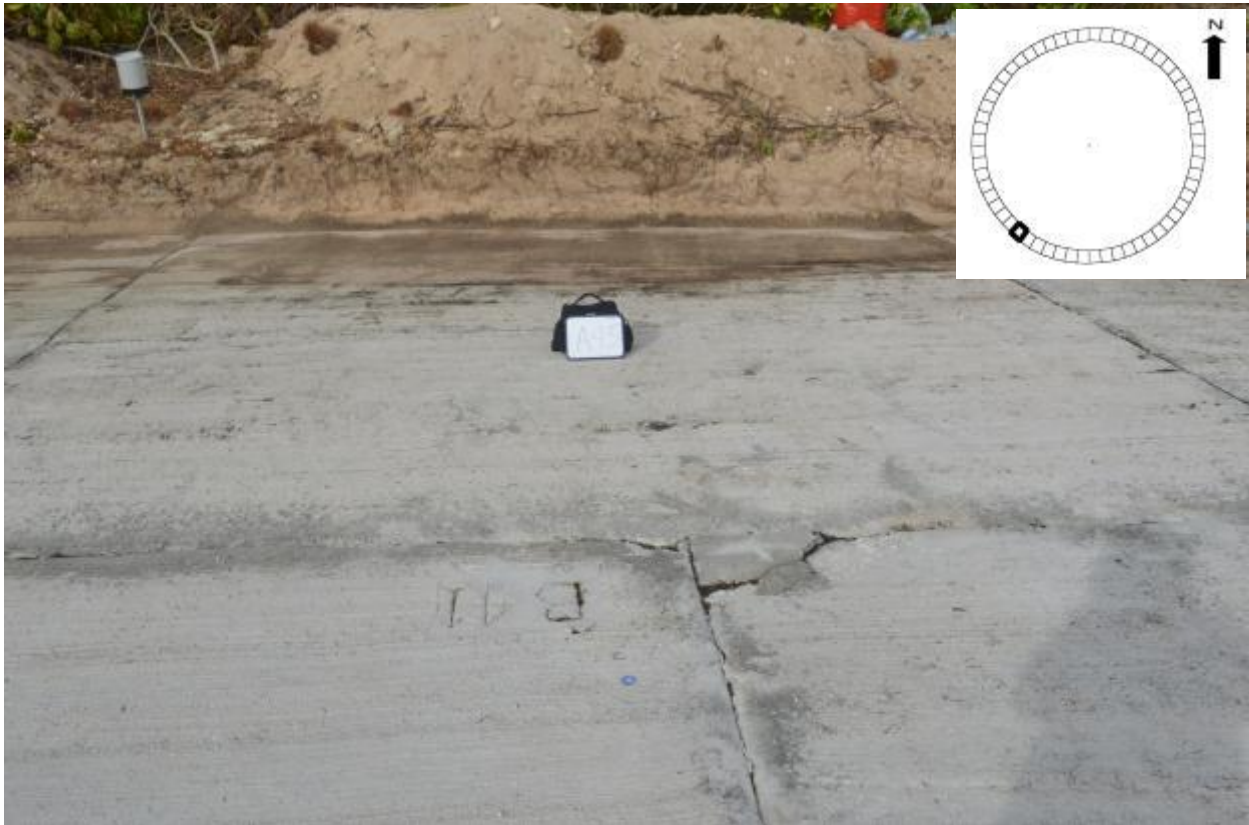
CAP SECTION LOCATION: Panel A46

No significant or obvious interior cracks extending across the top of the panel. Rooting vegetation removed from along the panel seams.

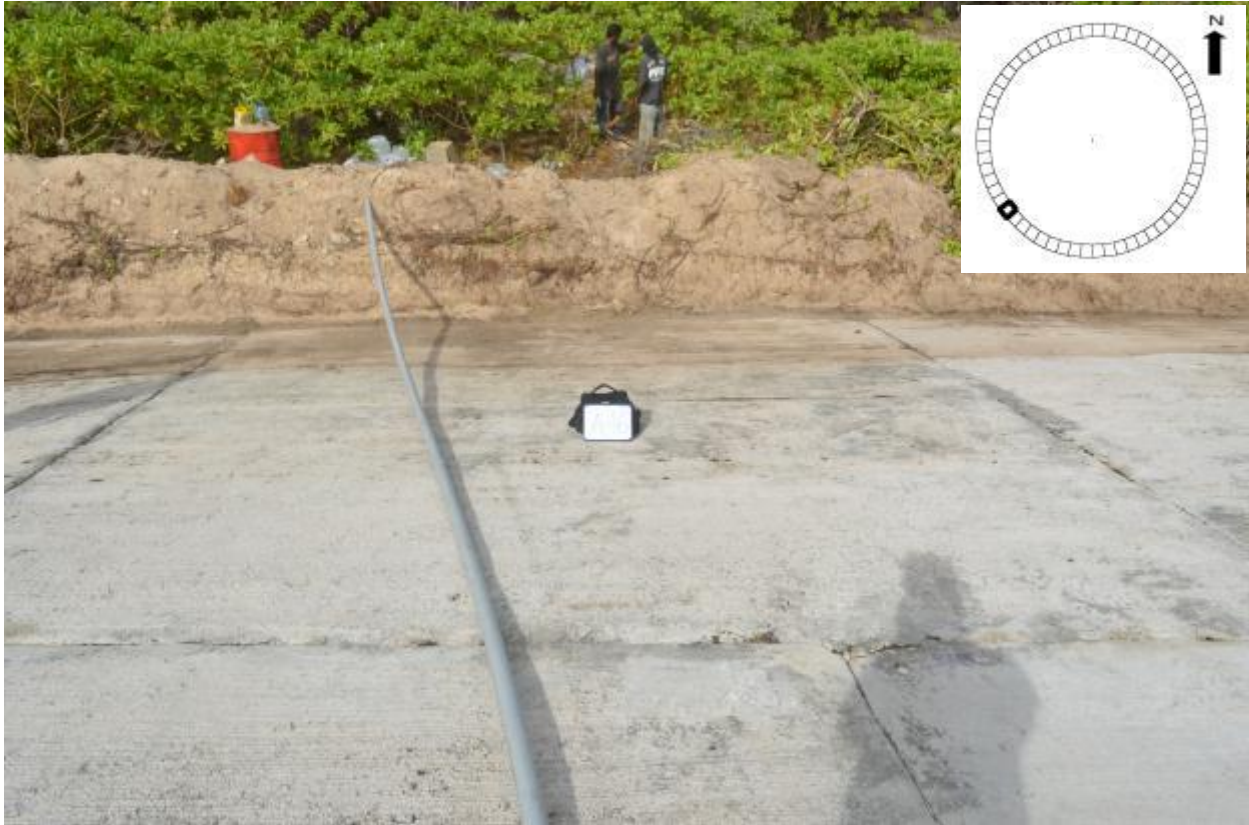
CAP SECTION LOCATION: Panel A47

No significant or obvious interior cracks extending across the top of the panel. Panel has a rough and weathered appearance. Rooting vegetation removed from along the panel seams.

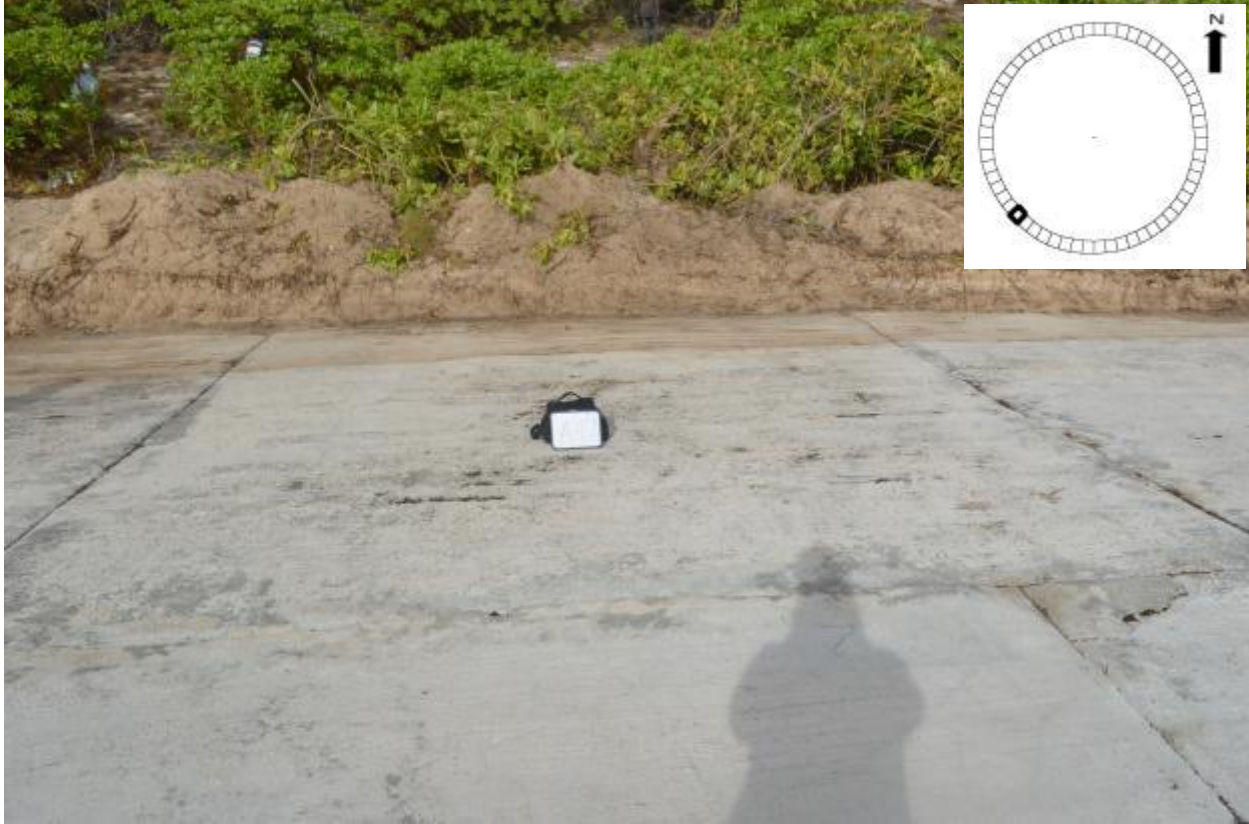
CAP SECTION LOCATION: Panel A48

No significant or obvious interior cracks extending across the top of the panel. Spalling/cracked concrete observed in the lower left-hand corner of the panel, and on the keywall.

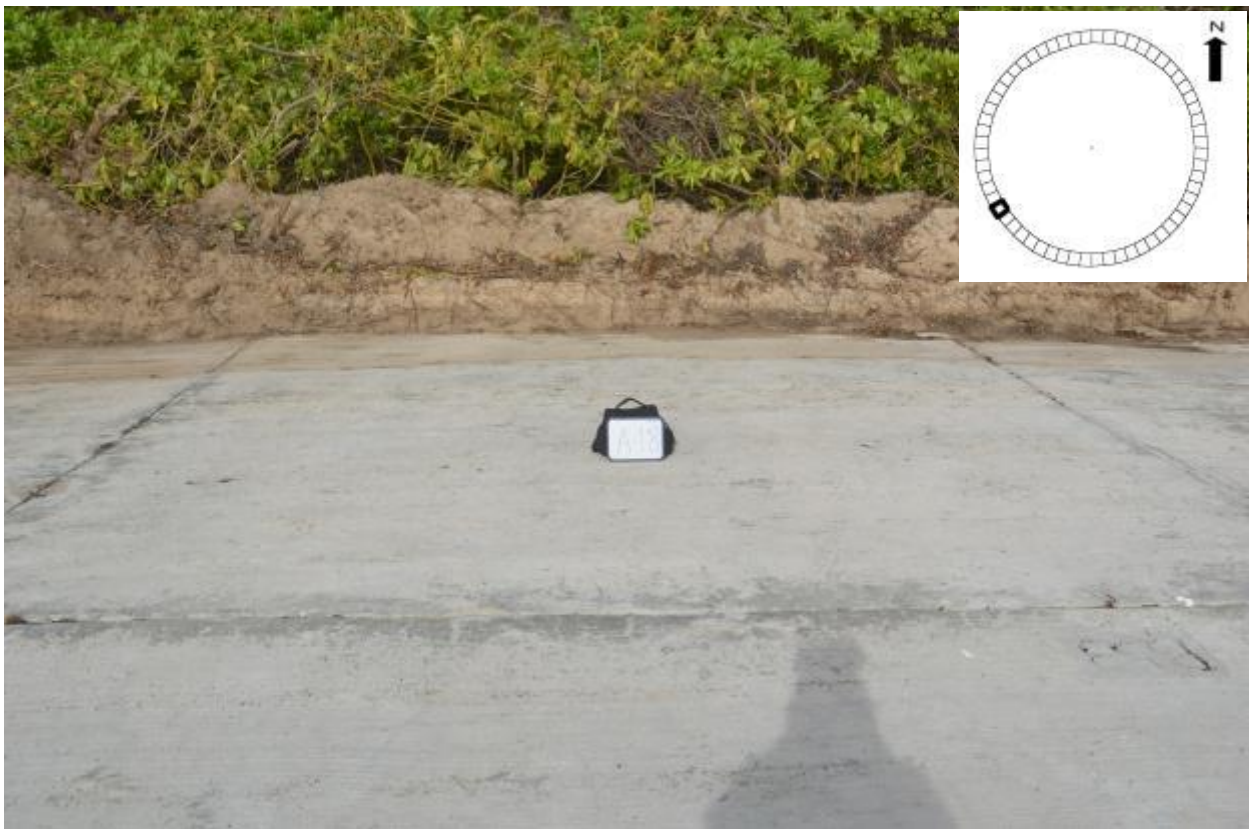
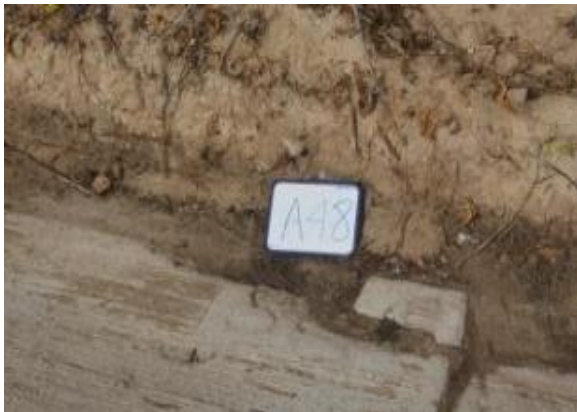
CAP SECTION LOCATION: Panel A49

No significant or obvious interior cracks extending across the top of the panel. Panel has a rough and weathered appearance. Rooting vegetation removed from along the panel seams.

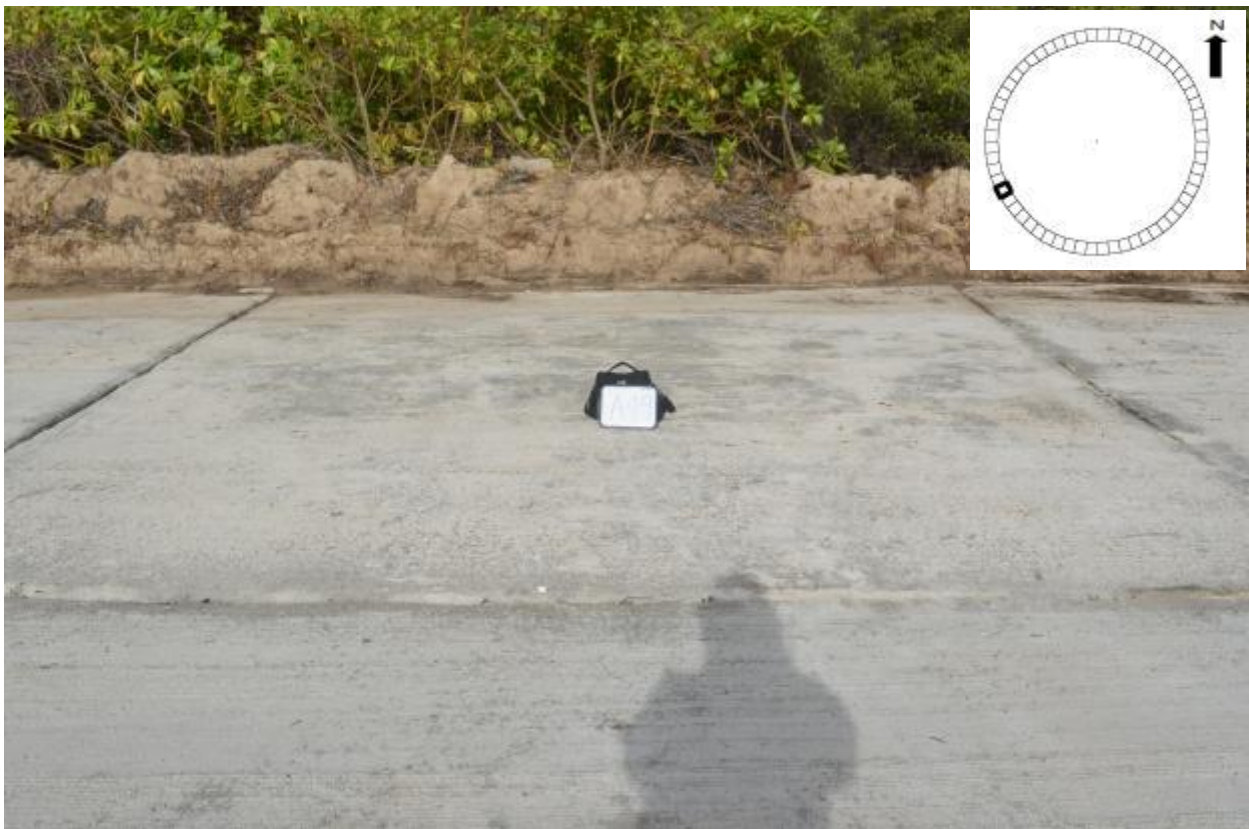
CAP SECTION LOCATION: Panel A50

No significant or obvious interior cracks extending across the top of the panel. Rooting vegetation removed from along the panel seams. Some spalling/chipping of concrete observed in the upper left and right-hand corners of the panel.

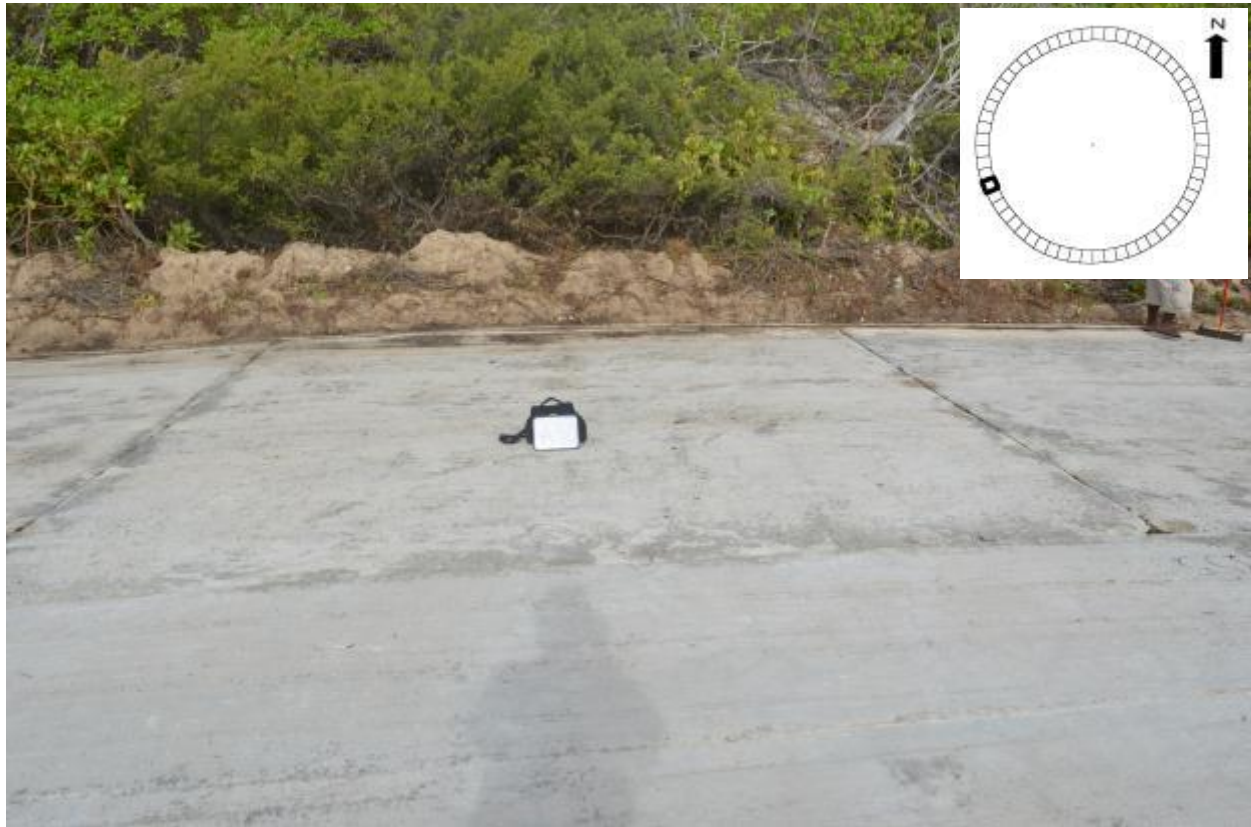
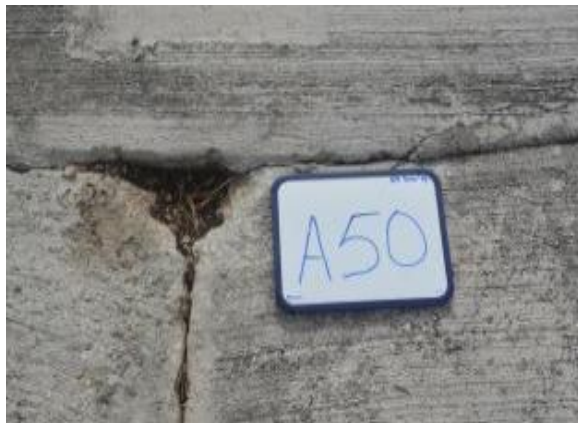
CAP SECTION LOCATION: Panel A51

No significant or obvious interior cracks extending across the top of the panel. The panel has a relatively rough appearance. Rooting vegetation removed from along the panel seams. Some minor spalling/chipping of concrete observed in the upper right-hand corner of the panel, and along the panel seams.

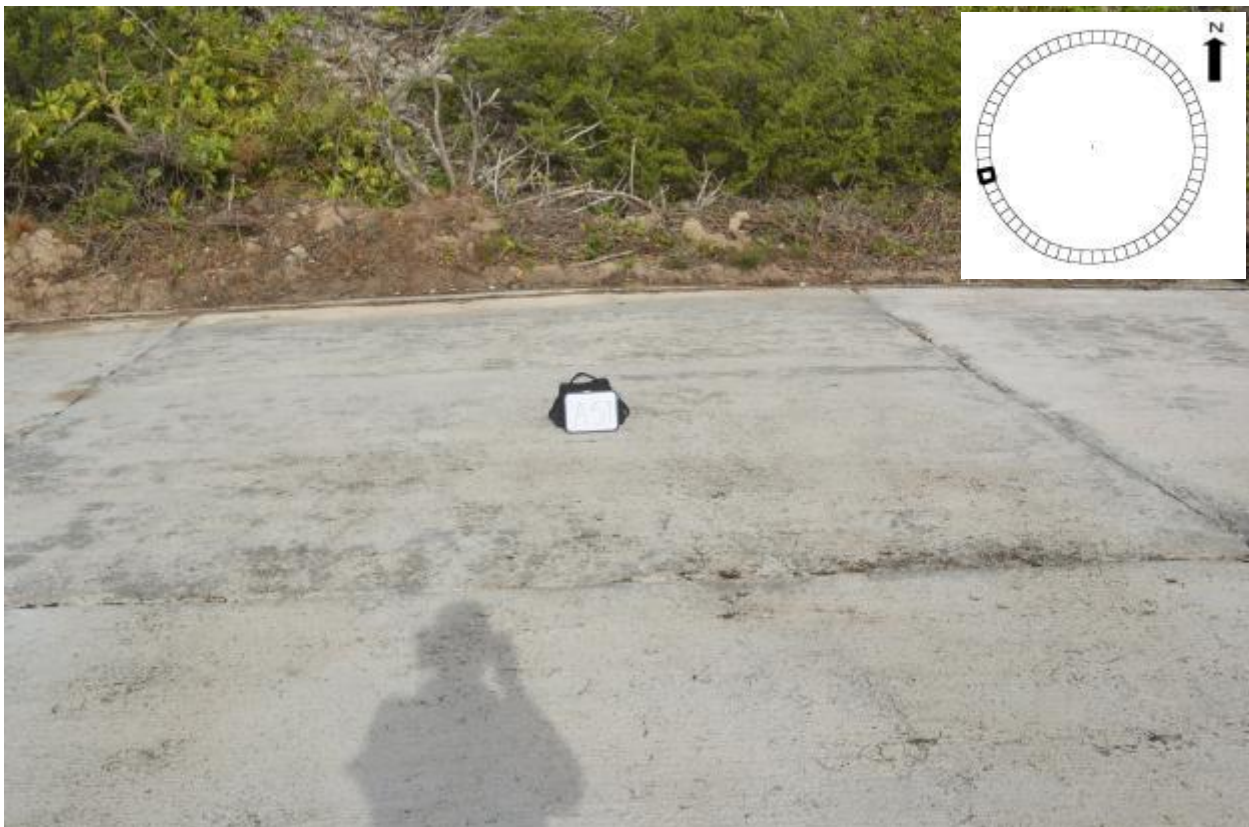
CAP SECTION LOCATION: Panel A52

No significant or obvious interior cracks extending across the top of the panel. The panel has a relatively rough appearance. Rooting vegetation removed from along the panel seams. Some minor spalling with small chipped out pieces of concrete observed along the left side of the top seam.

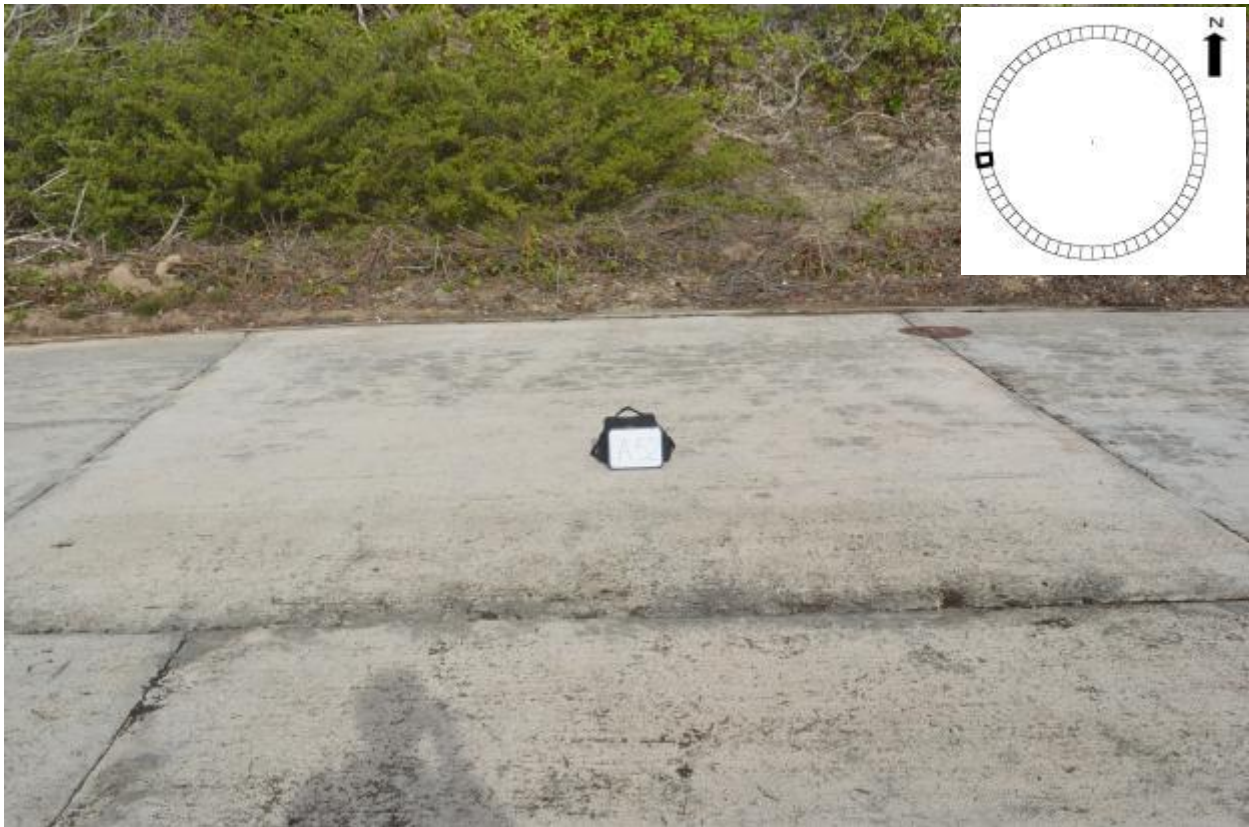
CAP SECTION LOCATION: Panel A53

No significant or obvious interior cracks extending across the top of the panel. Panel has a relatively rough appearance. Rooting vegetation removed from along the panel seams. Panel contains a vertical elevation benchmark.

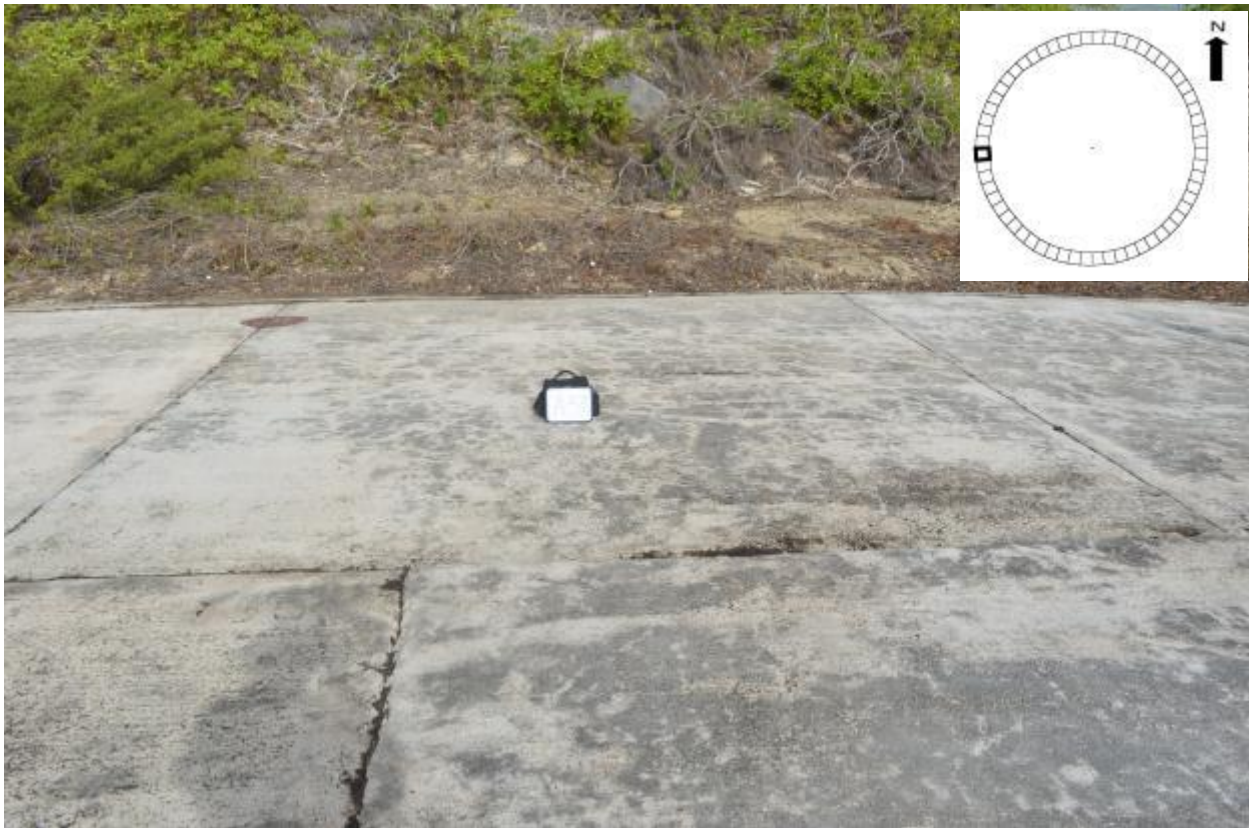
CAP SECTION LOCATION: Panel A54

No significant or obvious interior cracks extending across the top of the panel. Panel has a relatively rough appearance. Rooting vegetation removed from along the panel seams. Rooting vines appear to have caused some spalling/cracking of concrete in the upper left-hand corner. Panel contains a capped concrete bore-hole (CD-18) from the 1980 NAS investigation.

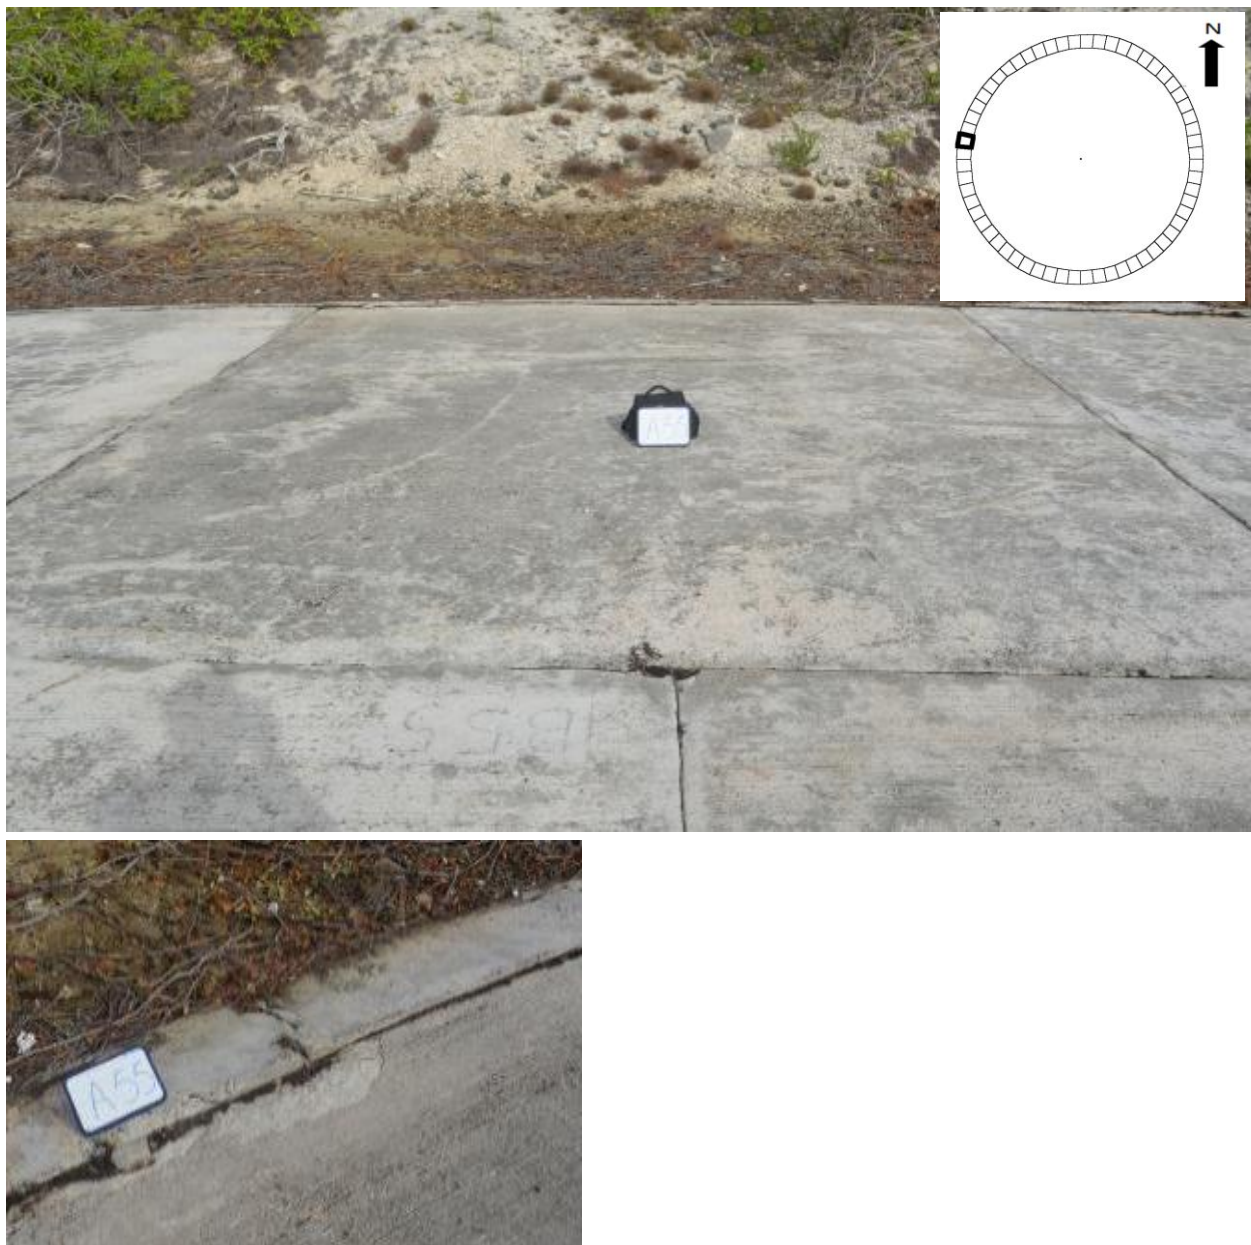
CAP SECTION LOCATION: Panel A55

No significant or obvious interior cracks extending across the top of the panel. Panel has a relatively rough appearance. Rooting vegetation removed from along the panel seams. Rooting vines appear to have caused some spalling/cracking of concrete in the upper right corner. Significant spalling of concrete appearing along the right bottom seam (chipped section is about 1.2 meters in length) adjacent to the keywall.
