LLNL-TR-648143

A Visual Description of the Concrete Exterior of the Cactus Crater Containment Structure

Terry Hamilton

October 2013

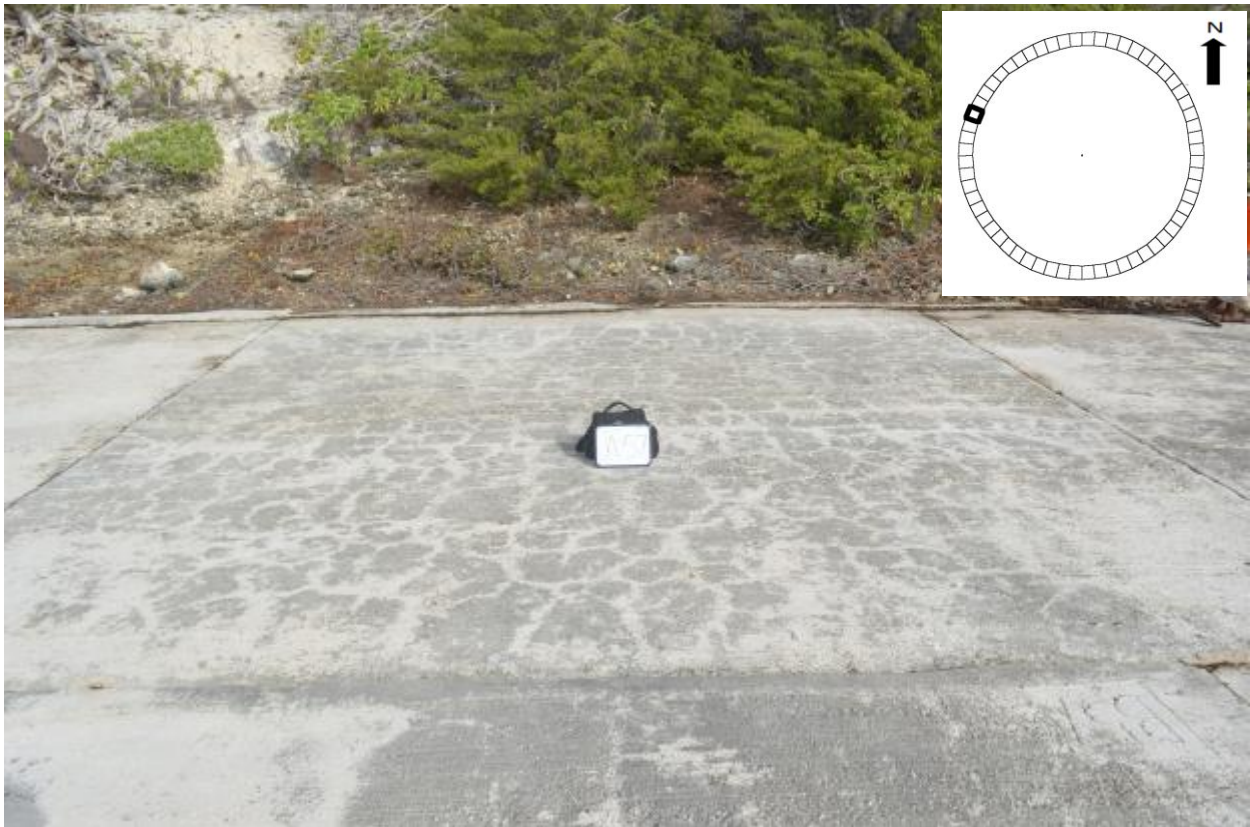
No significant or obvious interior cracks extending across the top of the panel. Panel has a relatively rough appearance. Rooting vegetation removed from along the panel seams.

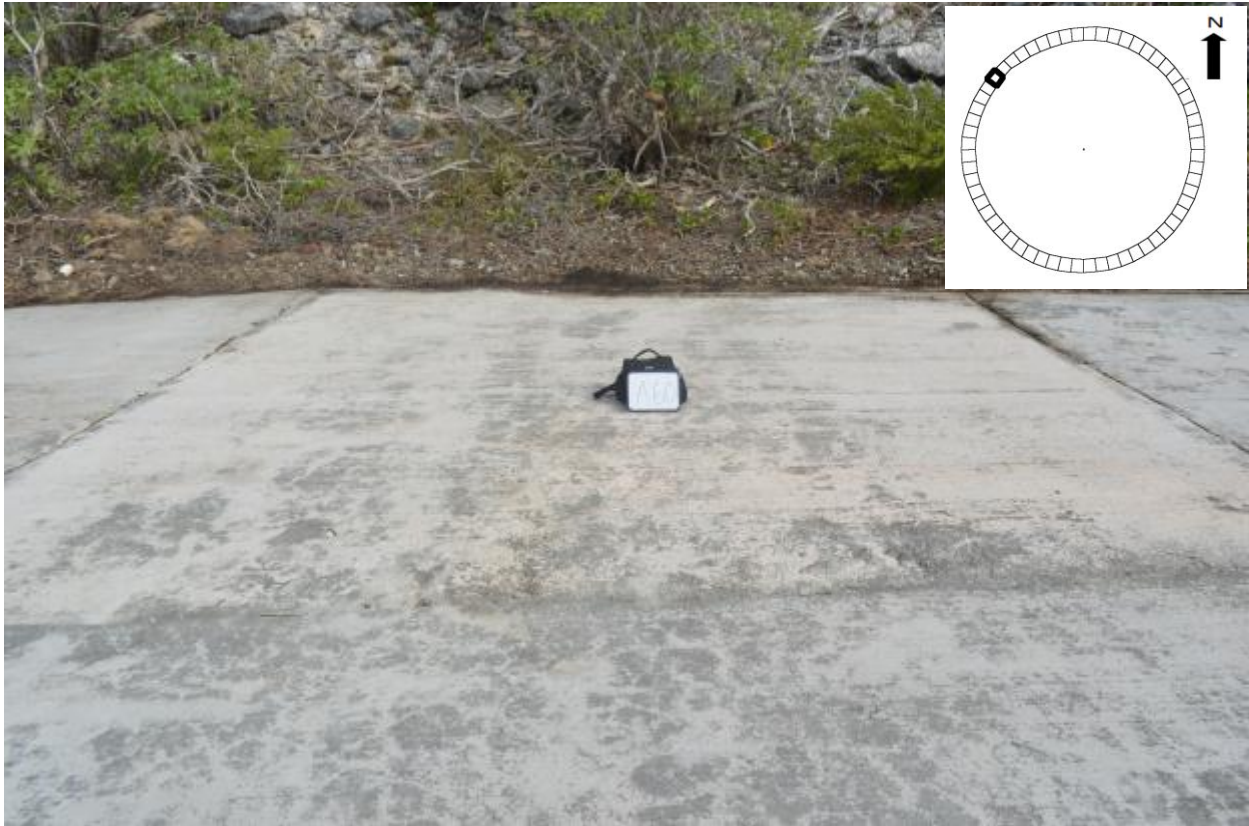
CAP SECTION LOCATION: Panel A60

No significant or obvious interior cracks extending across the top of the panel. Rooting vegetation removed from along the panel seams. Some very minor spalling of concrete observed in the lower right-hand corner of the panel.

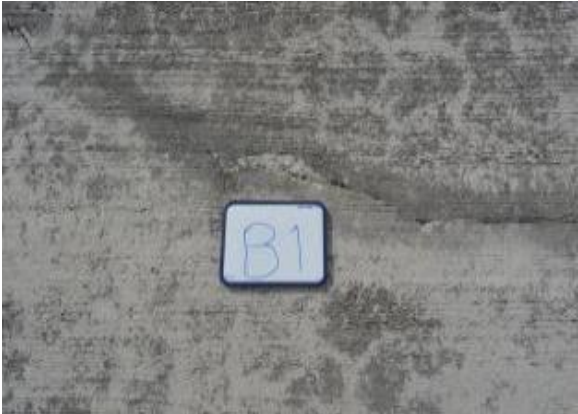
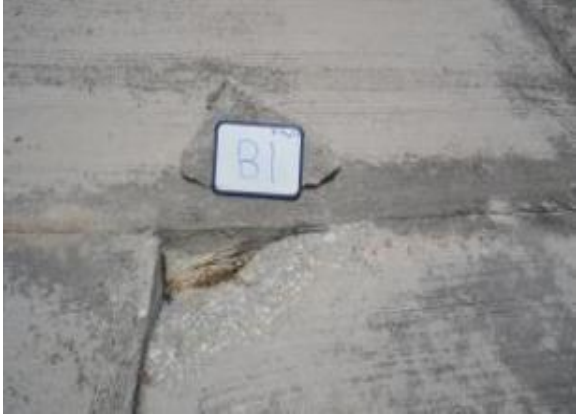
CAP SECTION LOCATION: Panel B1

Significant spalling of concrete observed in upper right corner where the chipped out piece of concrete extends down to contaminated soil – cement grout waste pile mixture below. Surface crack observed running across the full width of the panel at a mid-point up the segment. Rooting vegetation removed from along the panel seams. Panel recommended for priority repair.

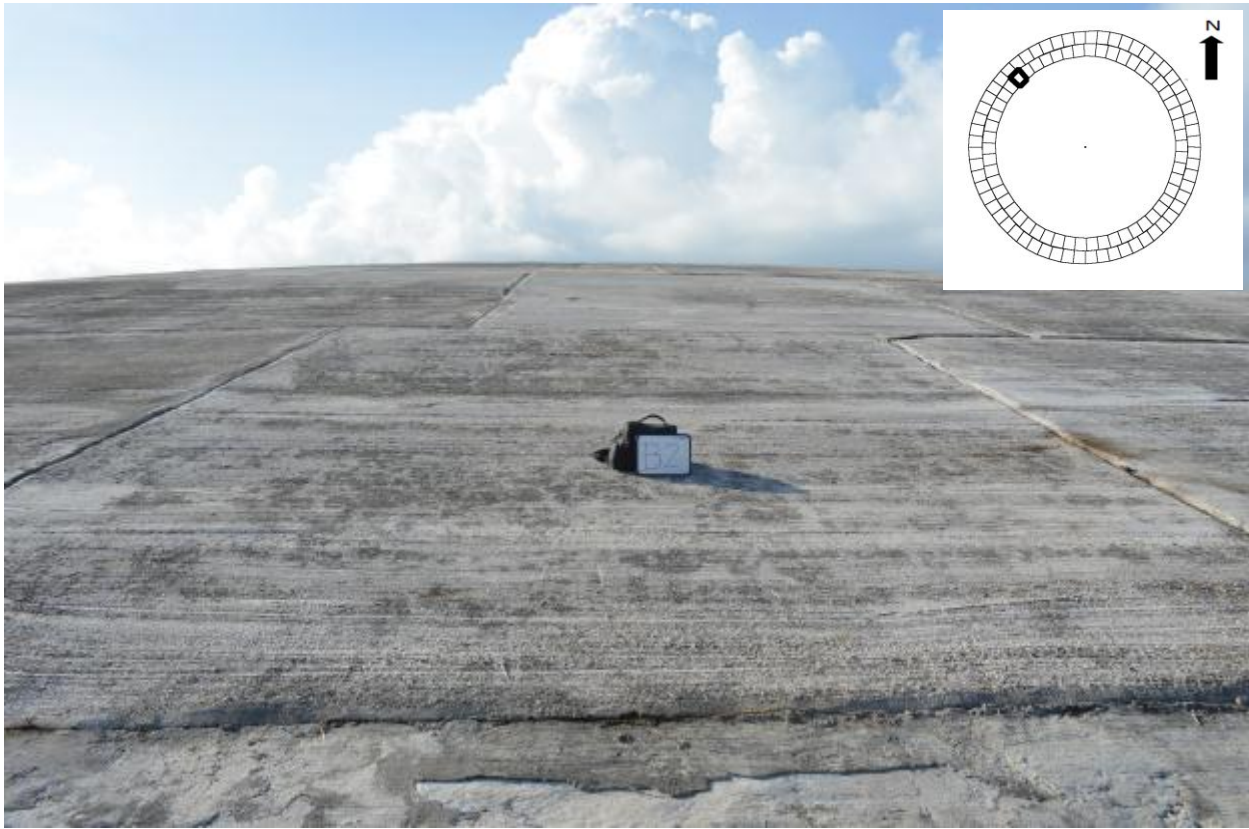
CAP SECTION LOCATION: Panel B2

A obvious crack observed running across the full width of the panel in the upper portion of the segment. Rooting vegetation removed from along the panel seams.

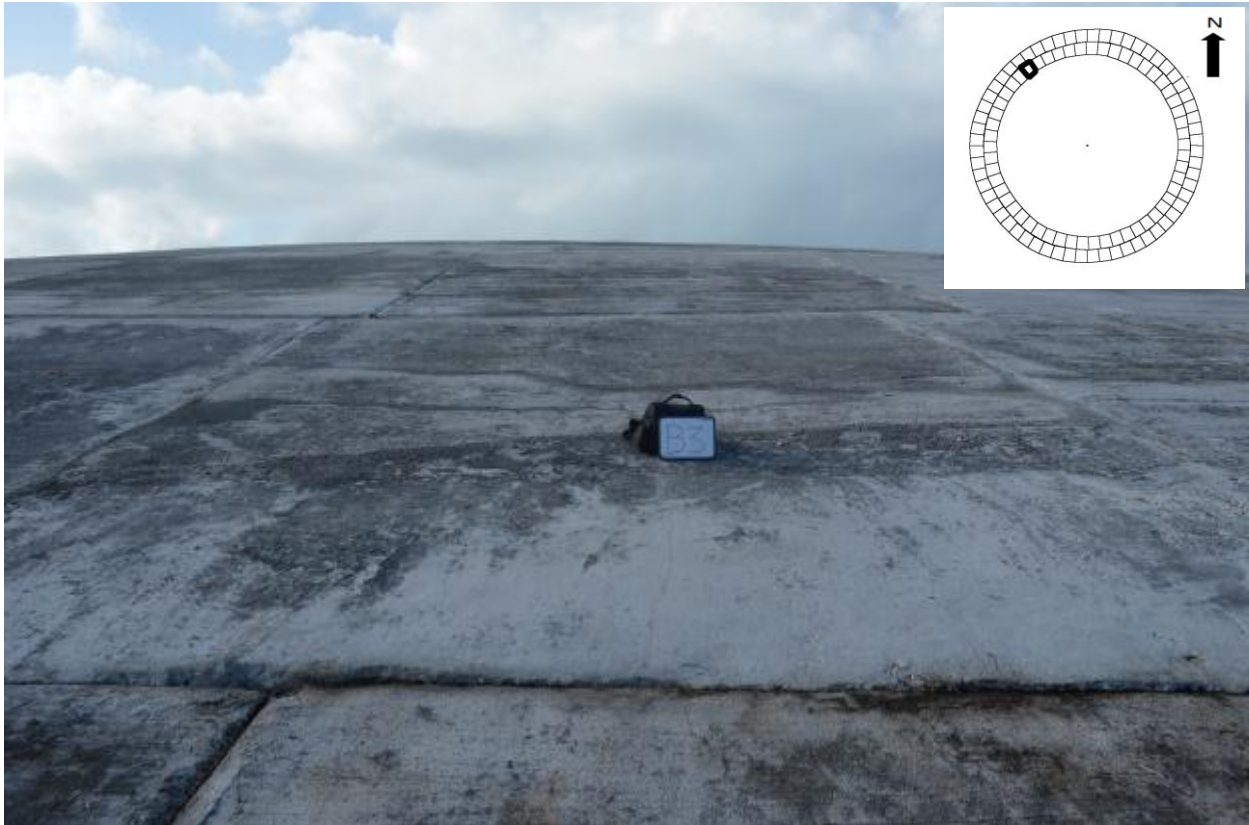
CAP SECTION LOCATION: Panel B3

A crack observed extending up from a mid-point along the bottom seam of the panel branching into a fork at a mid-point up the segment. The panel has a relatively dark and weathered appearance. Rooting vegetation removed from along the panel seams.

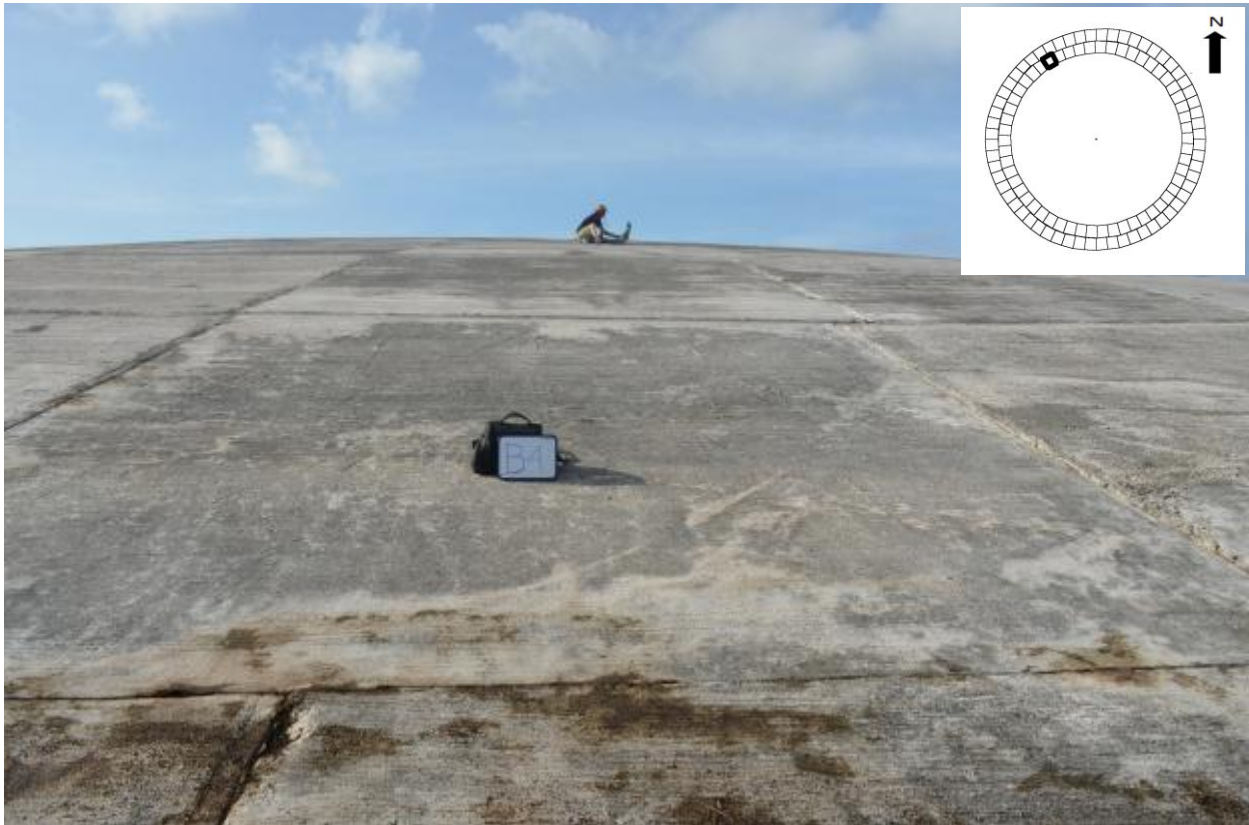
CAP SECTION LOCATION: Panel B4

No significant or obvious interior cracks extending across the top of the panel. The panel appears dark and weathered. Rooting vegetation removed from along the panel seams.

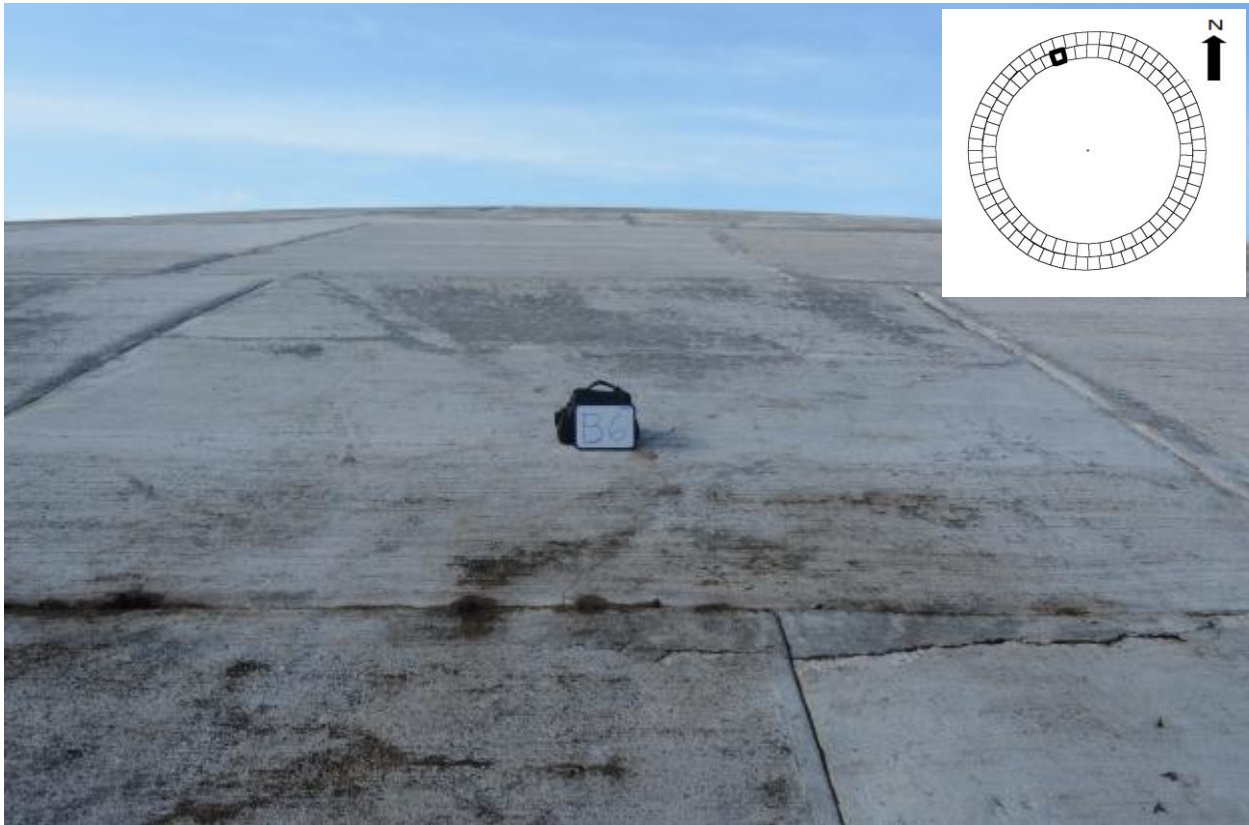
CAP SECTION LOCATION: Panel B6

A crack observed extending up about 1.5 meters from a mid-point along the bottom seam of the panel and branching out to the left and right. The right fork intersects the right edge at a mid-point up the panel while the left fork extends up towards the upper left-hand corner. Rooting vegetation removed from along the panel seams.

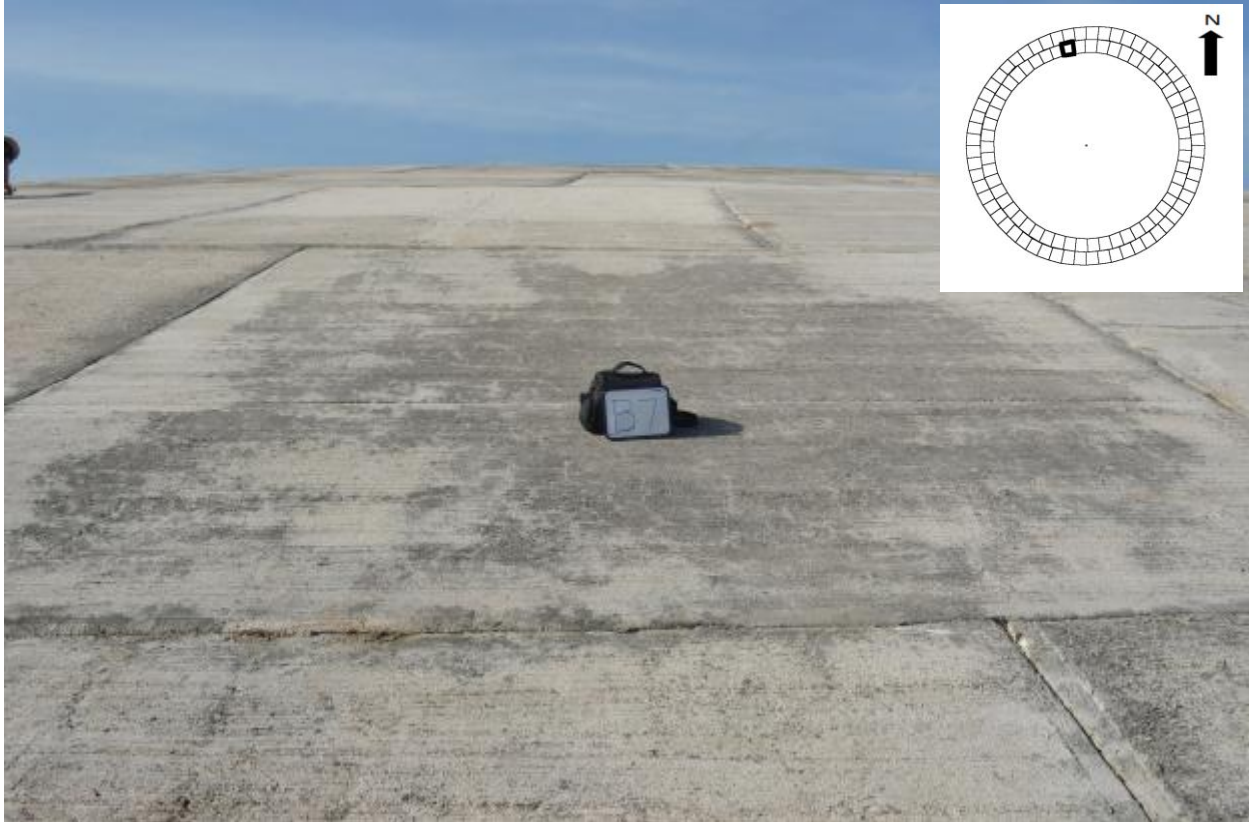
CAP SECTION LOCATION: Panel B7

No significant or obvious interior cracks extending across the top of the panel. Rooting vegetation removed from along the panel seams.

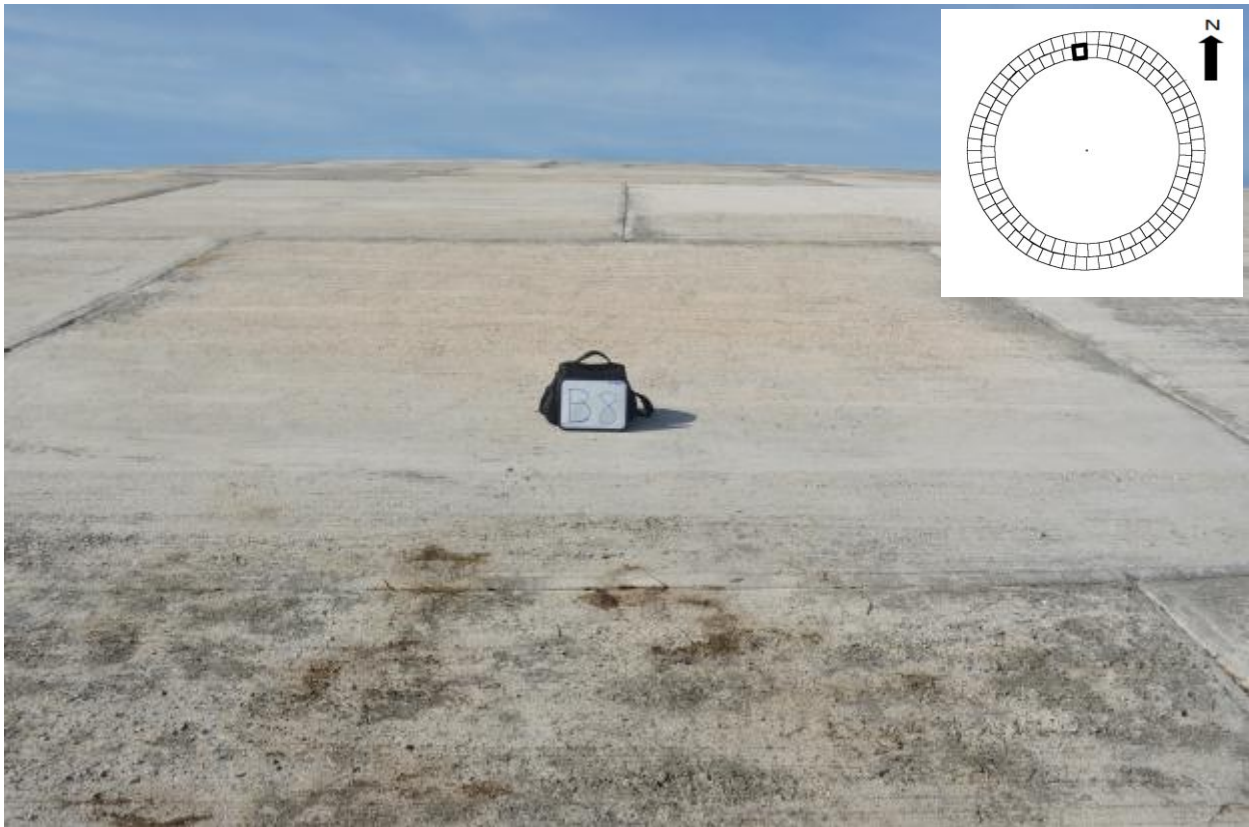
CAP SECTION LOCATION: Panel B8

No significant or obvious interior cracks extending across the top of the panel. Rooting vegetation removed from along the panel seams.

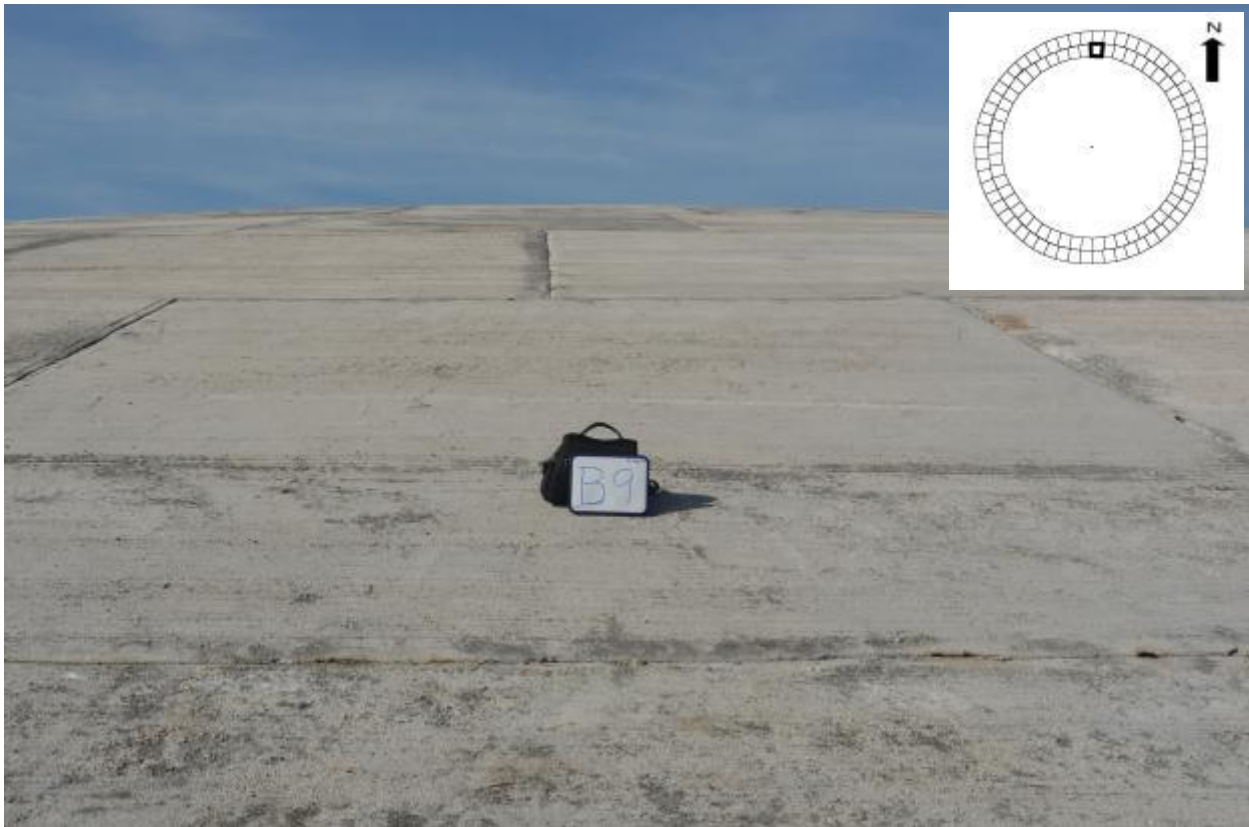
CAP SECTION LOCATION: Panel B9

Rooting vegetation removed from along the panel seams. No significant or obvious interior cracks extending across the top of the panel.

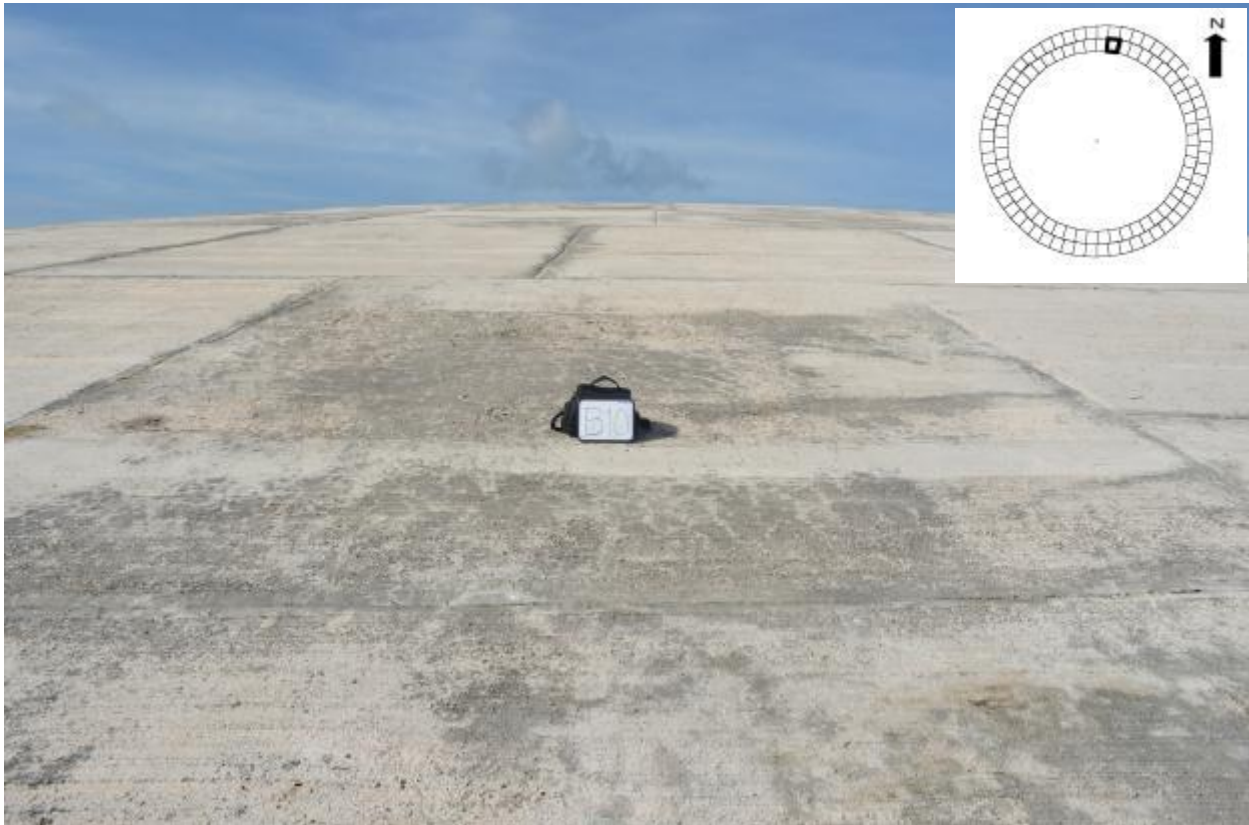
CAP SECTION LOCATION: Panel B10

No significant or obvious interior cracks extending across the top of the panel. Panel appears rough and weathered. There appears to be deeper and more obvious cracks appearing along the seams compared with those appearing around adjoining panels. Some minor spalling of concrete observed along the bottom left seam at intersection corner with panel A9/A10.

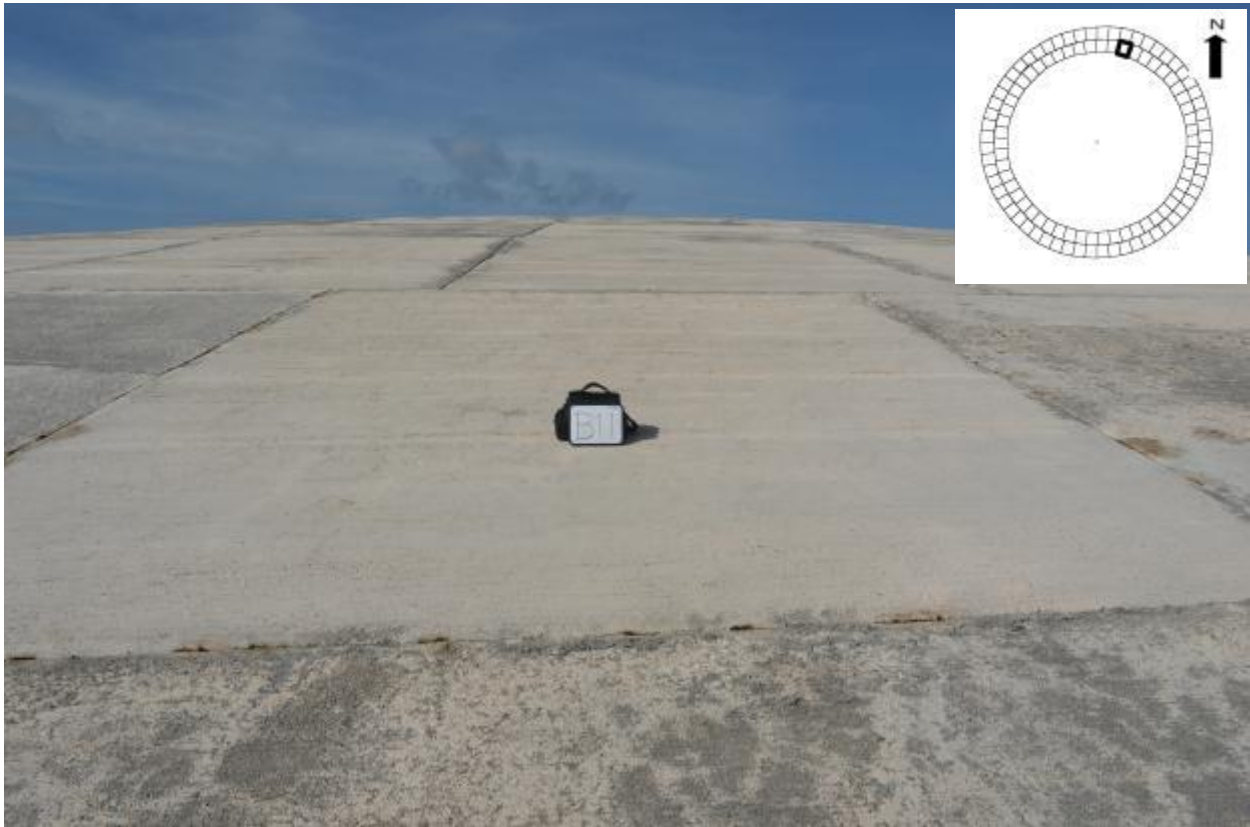
CAP SECTION LOCATION: Panel B11

No significant or obvious interior cracks extending across the top of the panel. Rooting vegetation removed from along the panel seams.

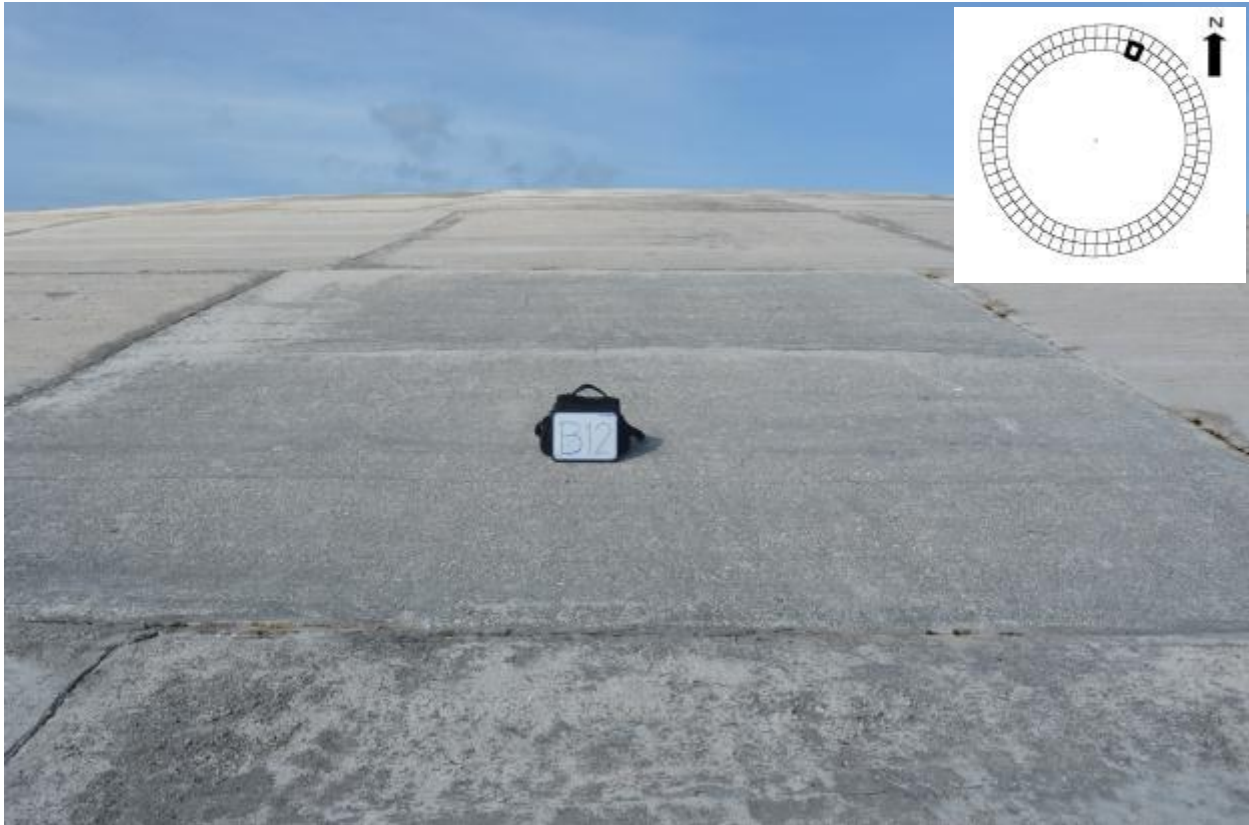
CAP SECTION LOCATION: Panel B12

Rooting vegetation removed from along the panel seams. Some minor spalling of concrete observed along the bottom seam of the panel. A surface crack can be seen running across the segment at a mid-point up the panel.

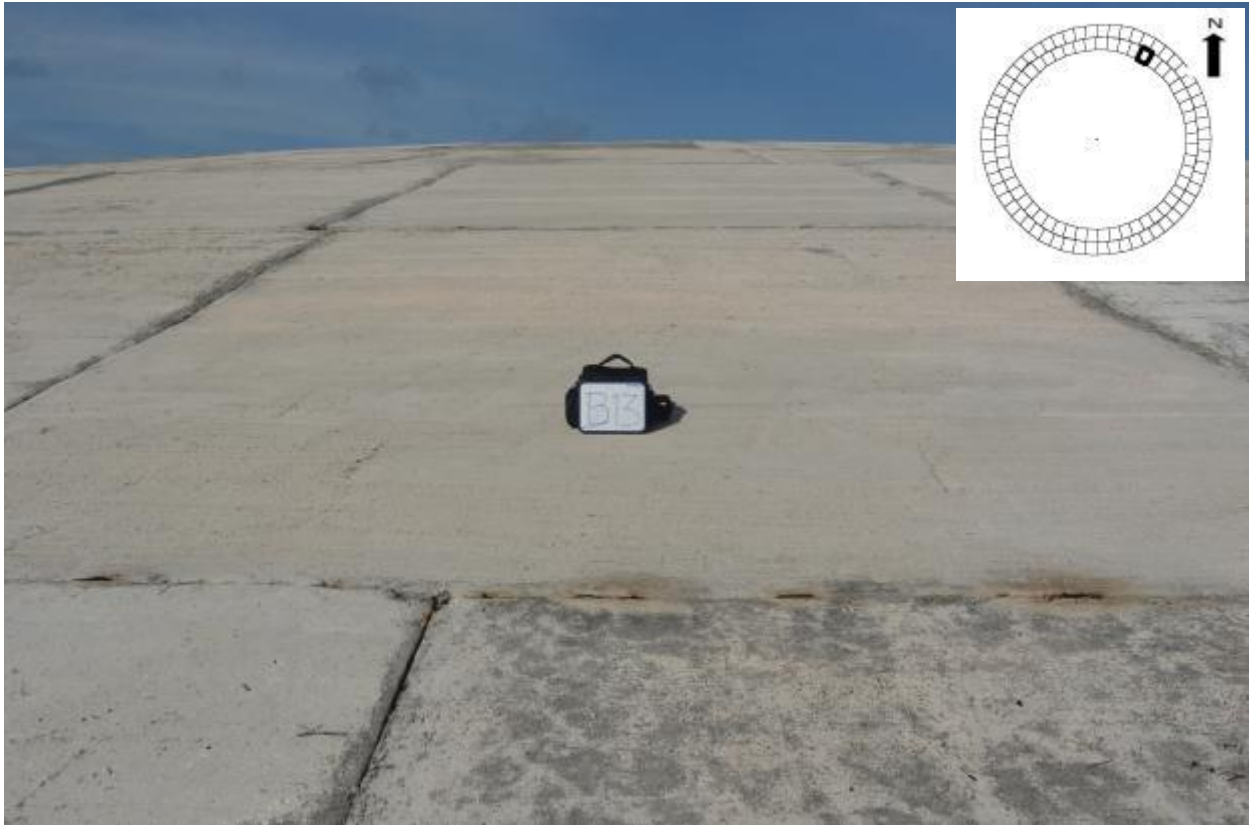
CAP SECTION LOCATION: Panel B13

No significant or obvious interior cracks extending across the top of the panel. Rooting vegetation removed from along the panel seams.

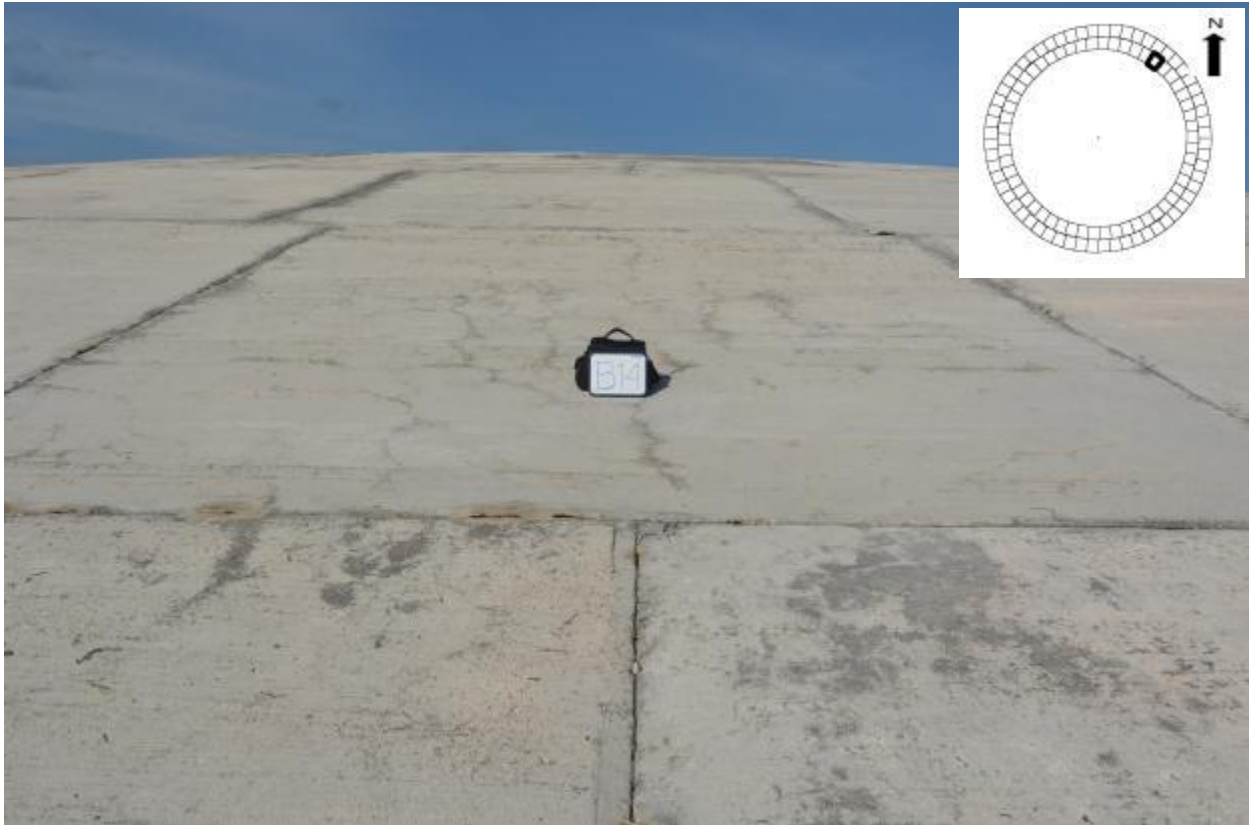
CAP SECTION LOCATION: Panel B14

Obvious spalling of concrete observed in the bottom left-hand corner of the panel. Rooting vegetation removed from along the panel seams. A surface crack can also be seen extending up from the bottom seam intersection with other surface cracks branching to the left and right side at a mid-point up the panel.

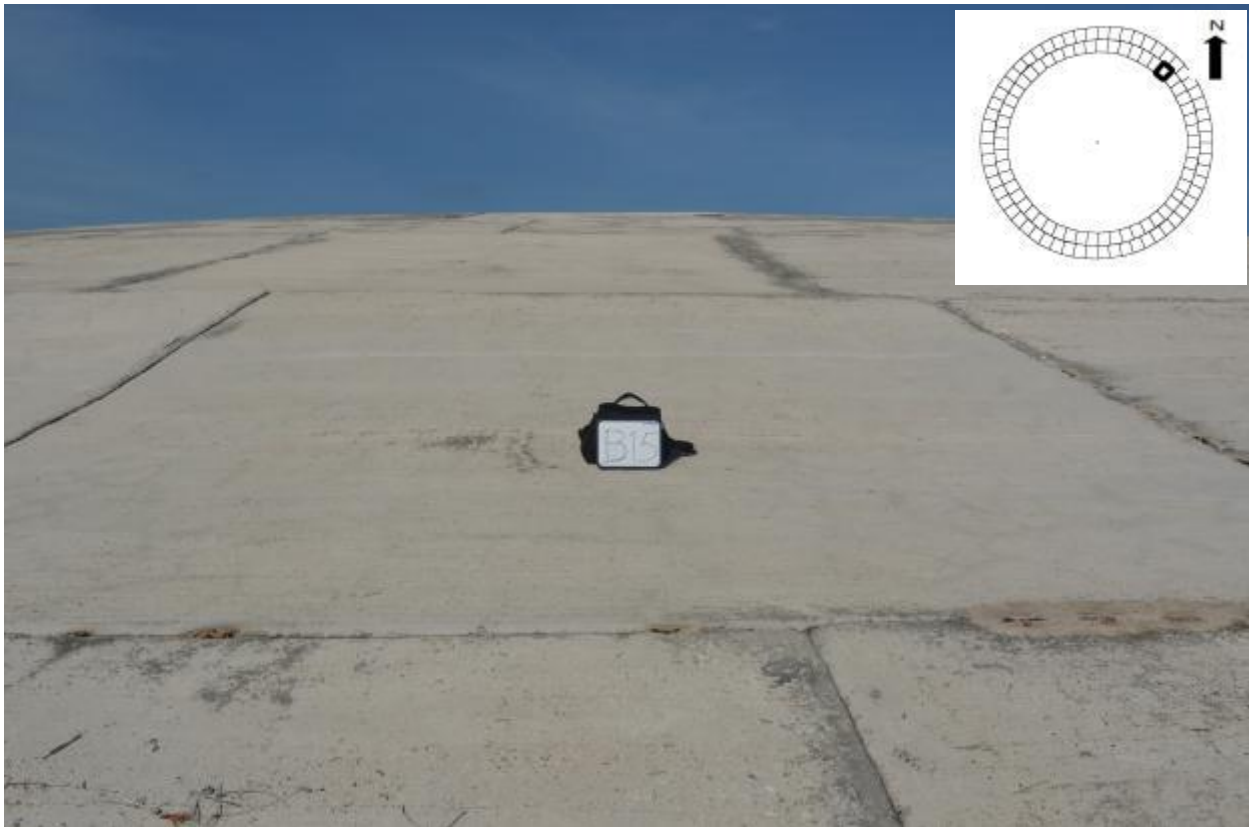
CAP SECTION LOCATION: Panel B15

No significant or obvious interior cracks extending across the top of the panel. Minor spalling of concrete observed along the bottom seam of the panel. Rooting vegetation removed from along the panel seams.

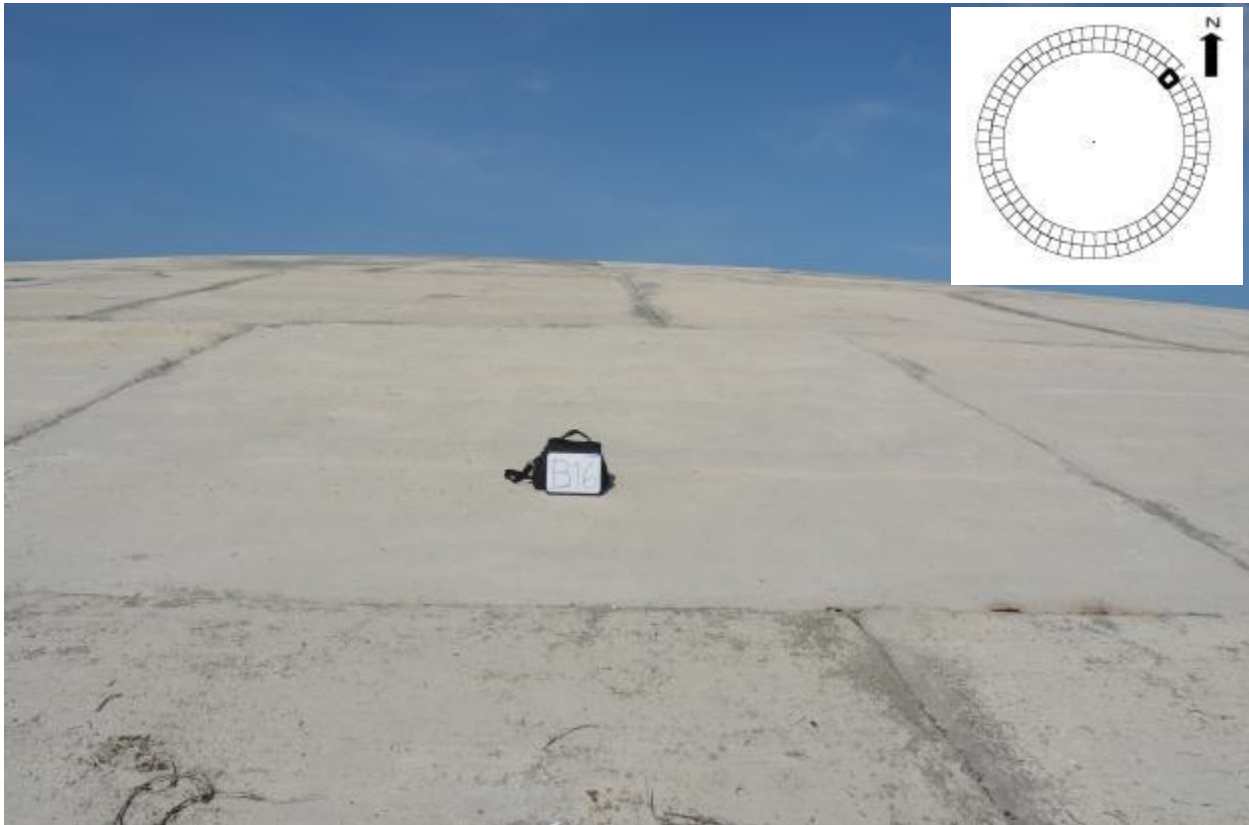
CAP SECTION LOCATION: Panel B16

No significant or obvious interior cracks extending across the top of the panel. Some minor spalling of concrete observed in the upper right-hand corner of the panel. Rooting vegetation removed from along the panel seams.

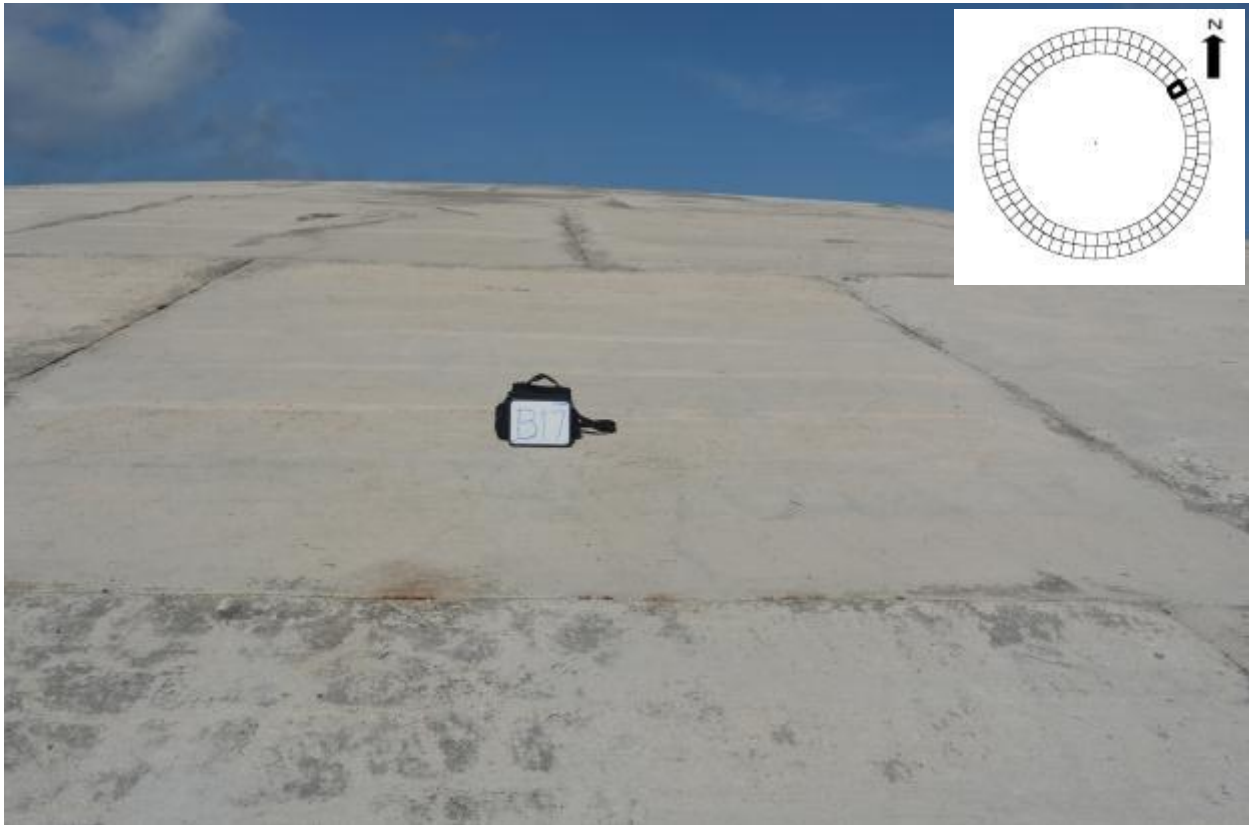
CAP SECTION LOCATION: Panel B17

No significant or obvious interior cracks extending across the top of the panel. Minor spalling of concrete observed in the lower right-hand corner of the panel. Rooting vegetation removed from along the panel seams.

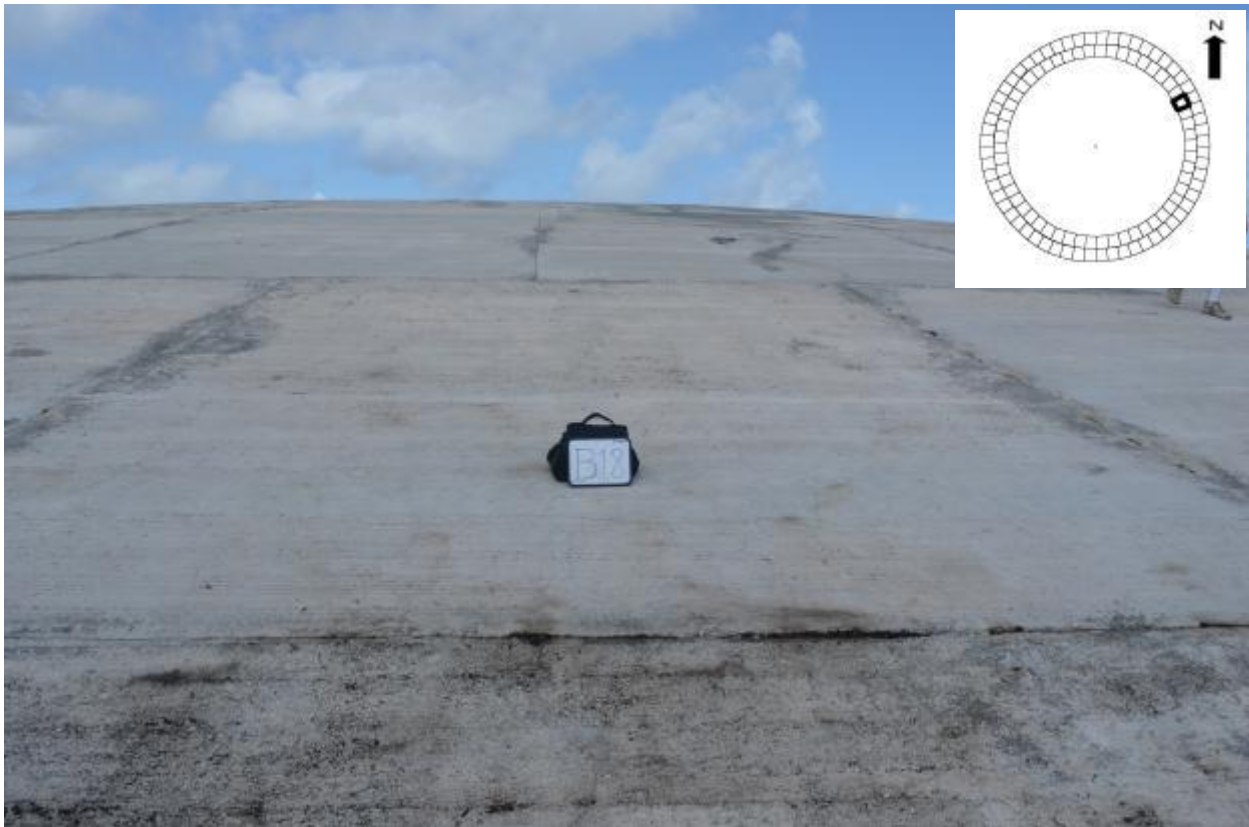
CAP SECTION LOCATION: Panel B18

No significant or obvious interior cracks extending across the top of the panel. Some minor spalling of concrete observed in the upper left-hand corner of the panel, and along the bottom seam overhanging panel A19. Rooting vegetation removed from along the panel seams.

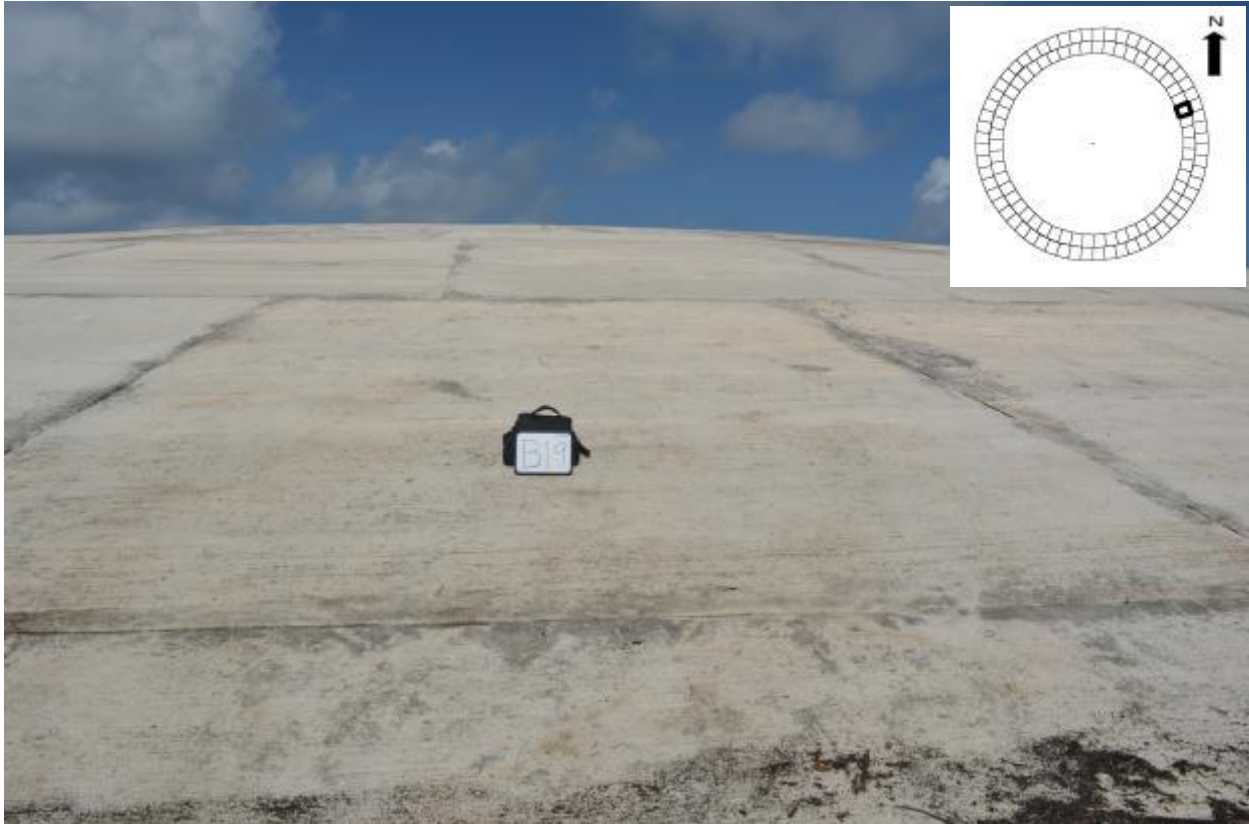
CAP SECTION LOCATION: Panel B19

No significant or obvious interior cracks extending across the top of the panel. Rooting vegetation removed from along the panel seams.

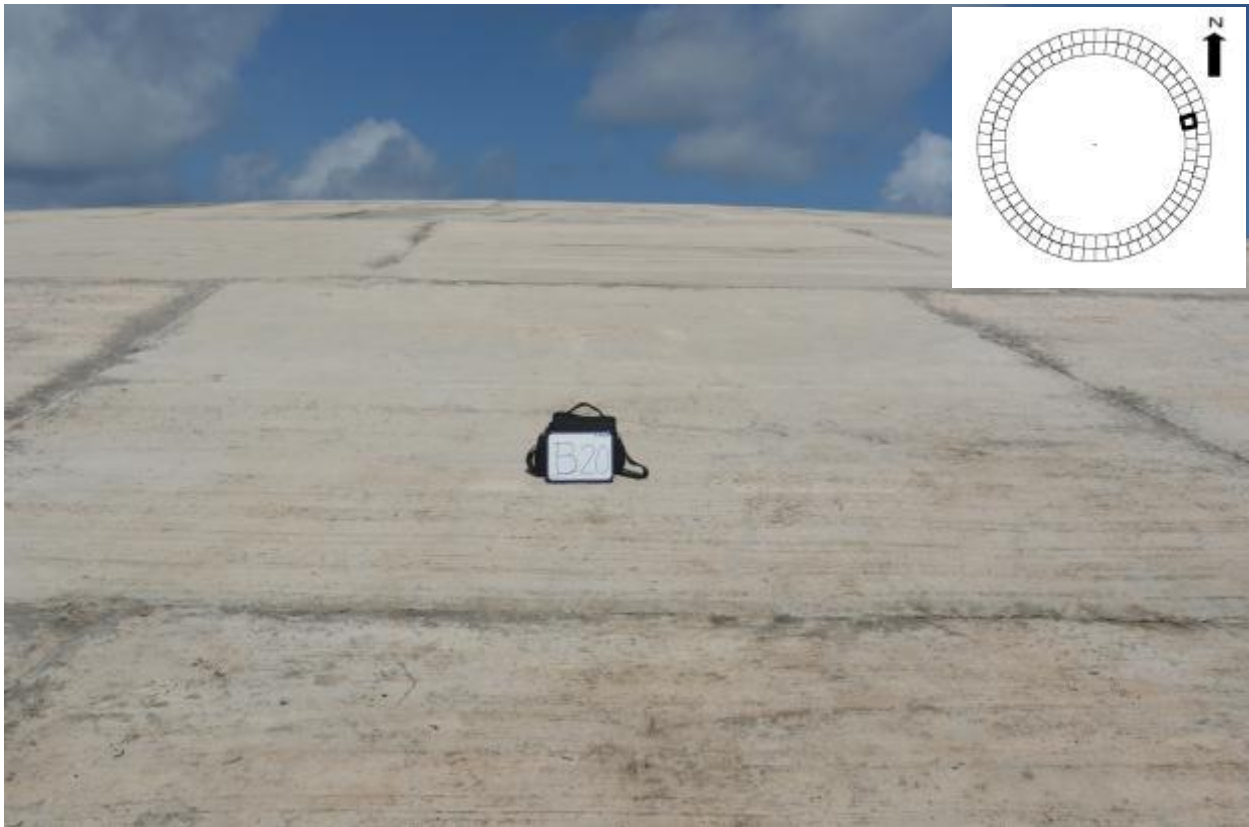
CAP SECTION LOCATION: Panel B20

No significant or obvious interior cracks extending across the top of the panel. Rooting vegetation removed from along the panel seams.
