LLNL-TR-648143

A Visual Description of the Concrete Exterior of the Cactus Crater Containment Structure

Terry Hamilton

October 2013

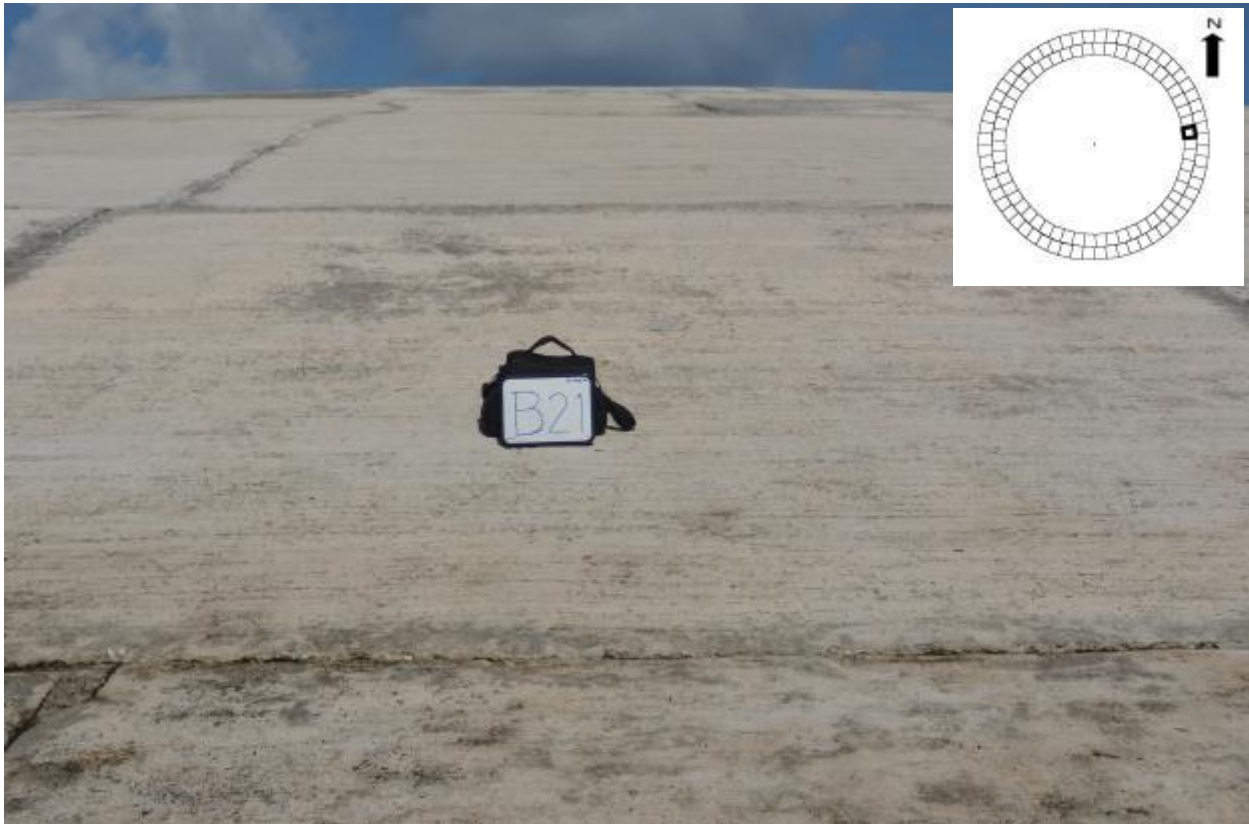
CAP SECTION LOCATION: Panel B21

No significant or obvious interior cracks extending across the top of the panel. Some minor spalling of concrete observed along the bottom seam overhanging the A panel below. Panel contains a filled concrete bore-hole (CD-3) from the 1980 NAS investigation.

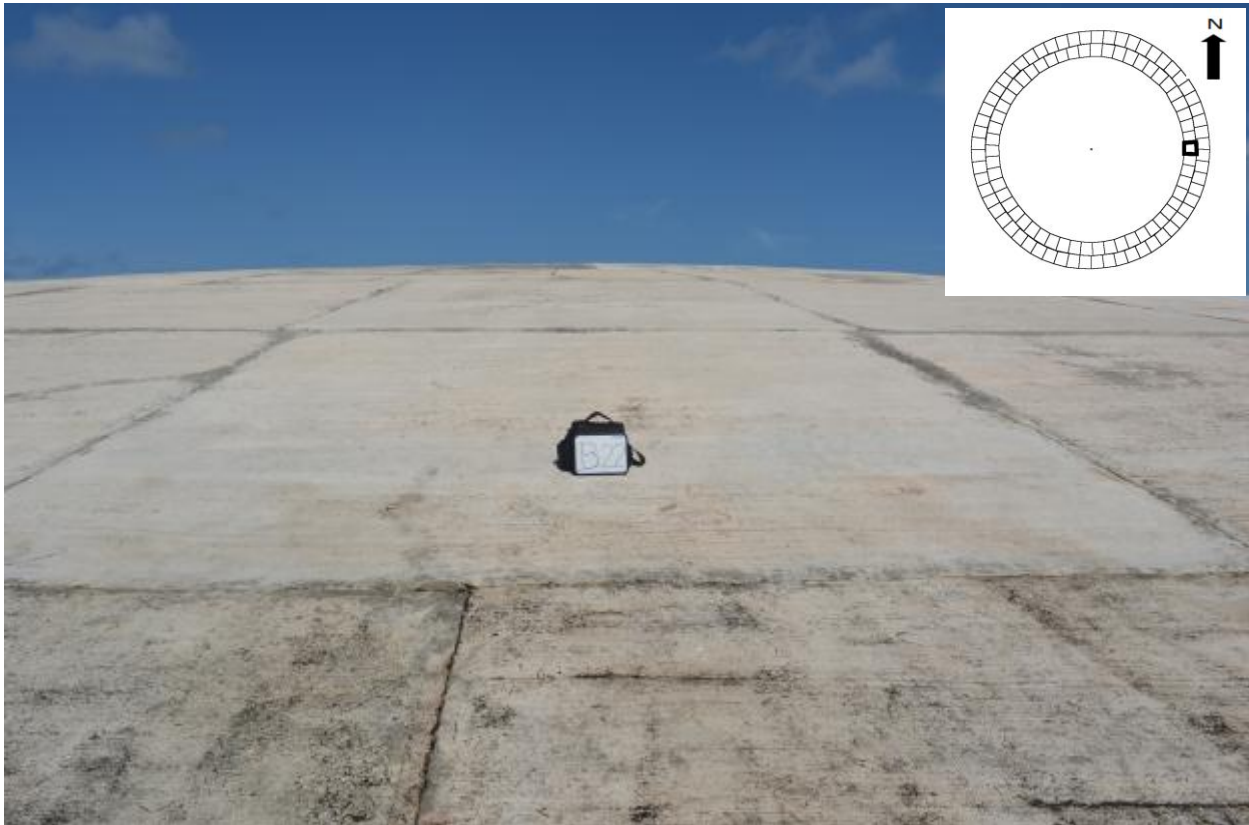
CAP SECTION LOCATION: Panel B22

No significant or obvious interior cracks extending across the top of the panel. Rooting vegetation removed from along the panel seams. Some minor spalling of concrete in the bottom left-hand corner of the panel, and along the bottom seam at intersecting corner of the A panels below.

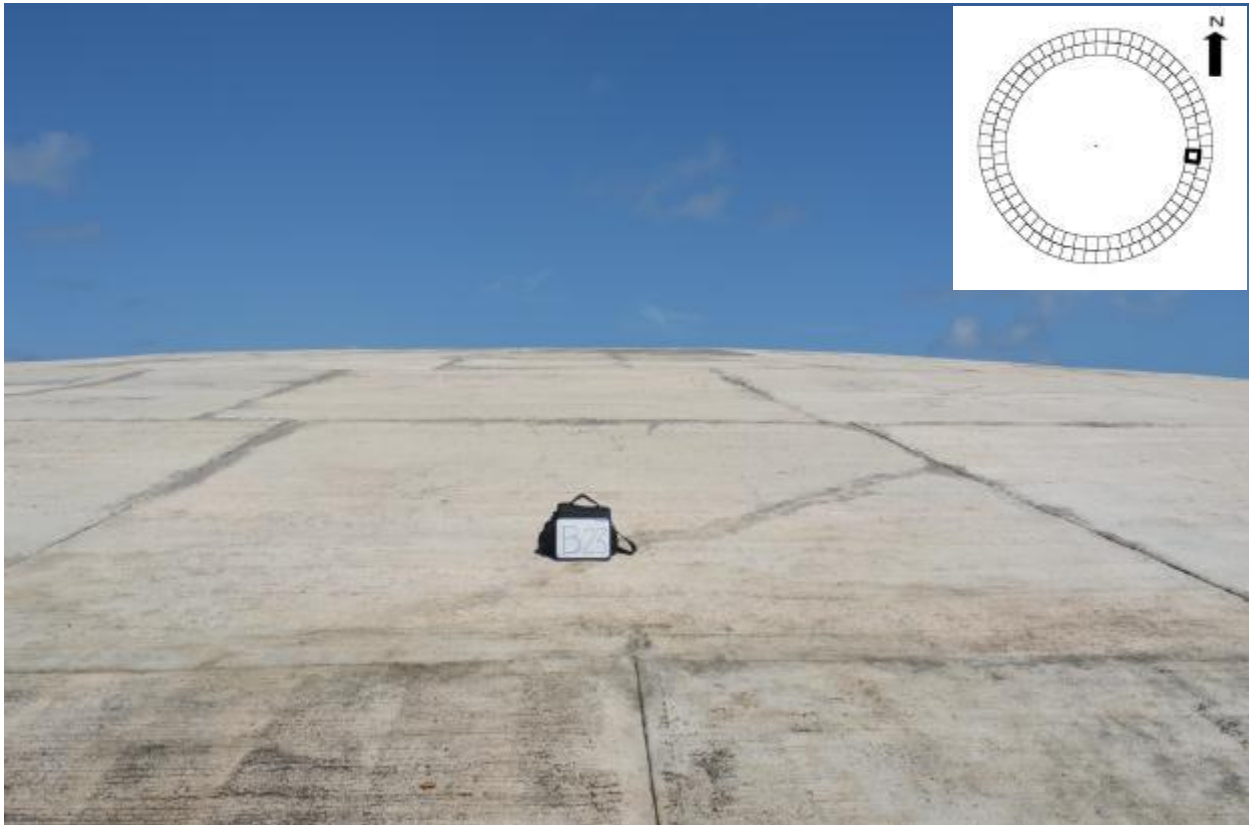
CAP SECTION LOCATION: Panel B23

No significant or obvious interior cracks extending across the top of the panel. Rooting vegetation removed from along the panel seams. There is some minor spalling of concrete in the upper left corner of the panel. There appears to be deeper and more obvious cracks running along the seam joints compared with those observed on adjacent panels.

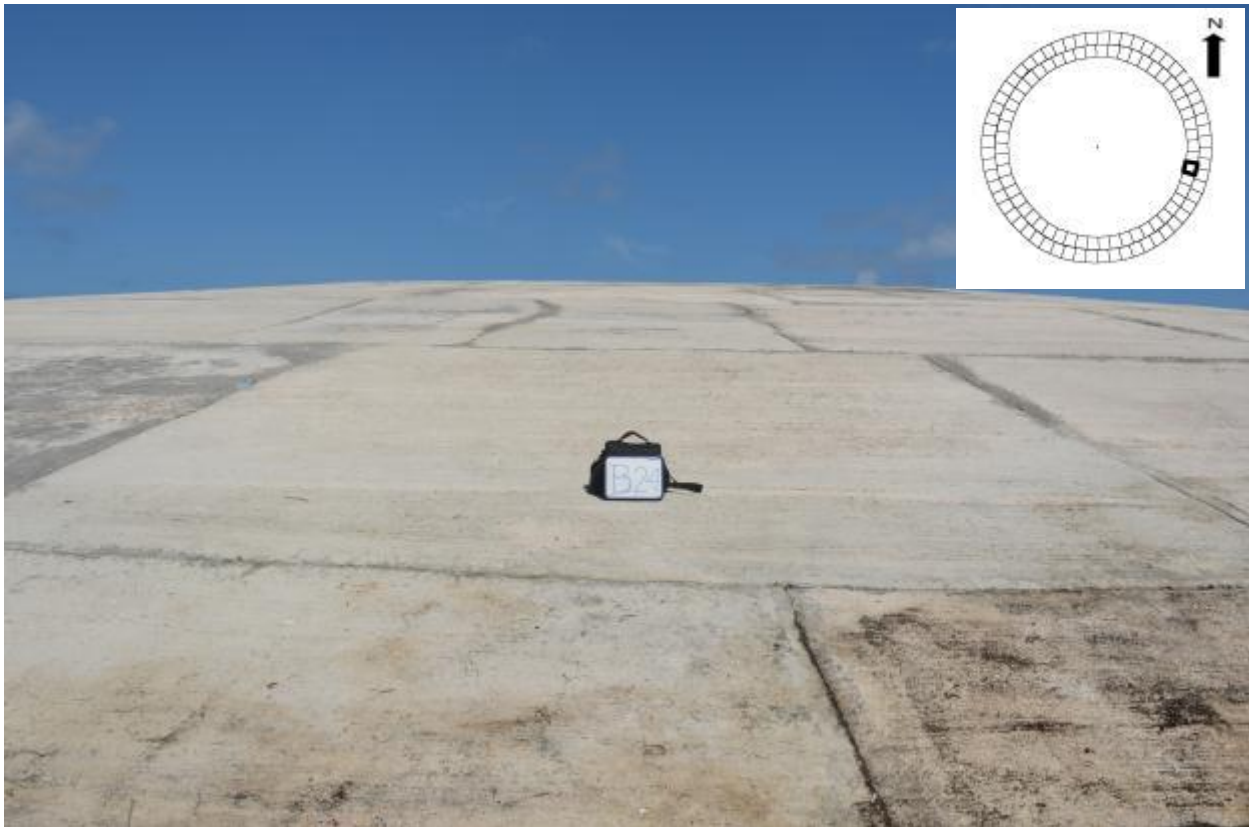
CAP SECTION LOCATION: Panel B24

No significant or obvious interior cracks extending across the top of the panel. Rooting vegetation removed from along the panel seams.

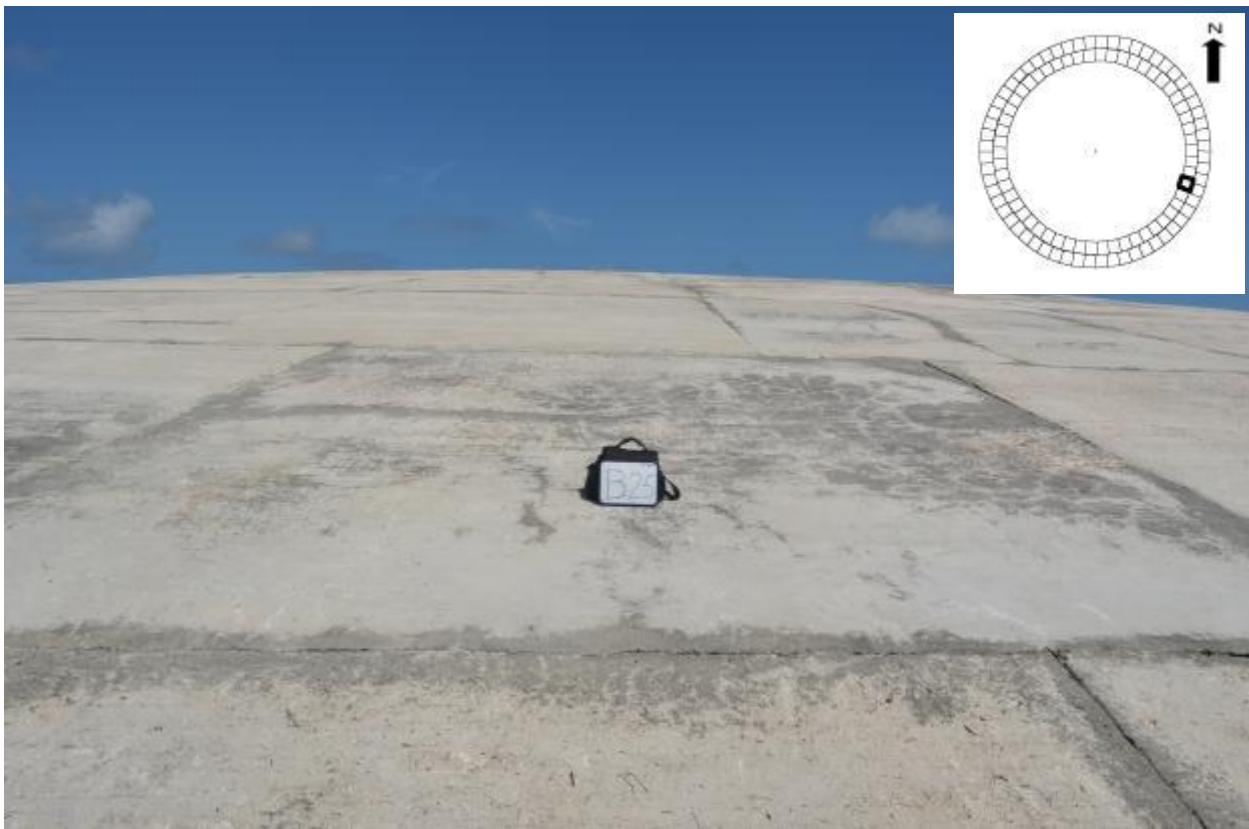
CAP SECTION LOCATION: Panel B25

No significant or obvious interior cracks extending across the top of the panel. The panel appears rough and weathered. There is some minor spalling of concrete along the bottom seam. There also appears to be deeper and more obvious cracks running along the seam joints compared with those appearing around the majority of panels.

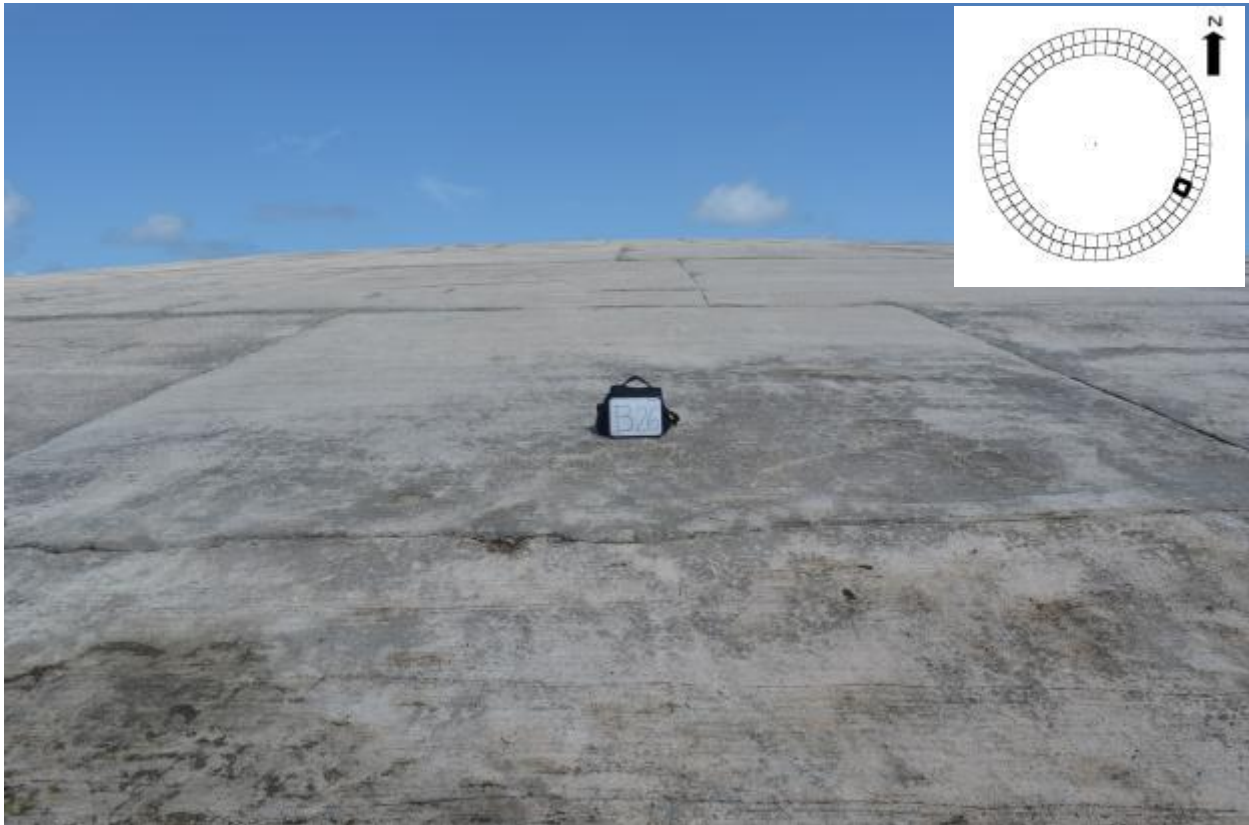
CAP SECTION LOCATION: Panel B26

No significant or obvious interior cracks extending across the top of the panel. The panel appears to have a dark and weathered appearance. There is some minor spalling of concrete along the bottom seam. There appears to be deeper and more obvious cracks running along the seam joints compared to those appearing around the majority of panels.

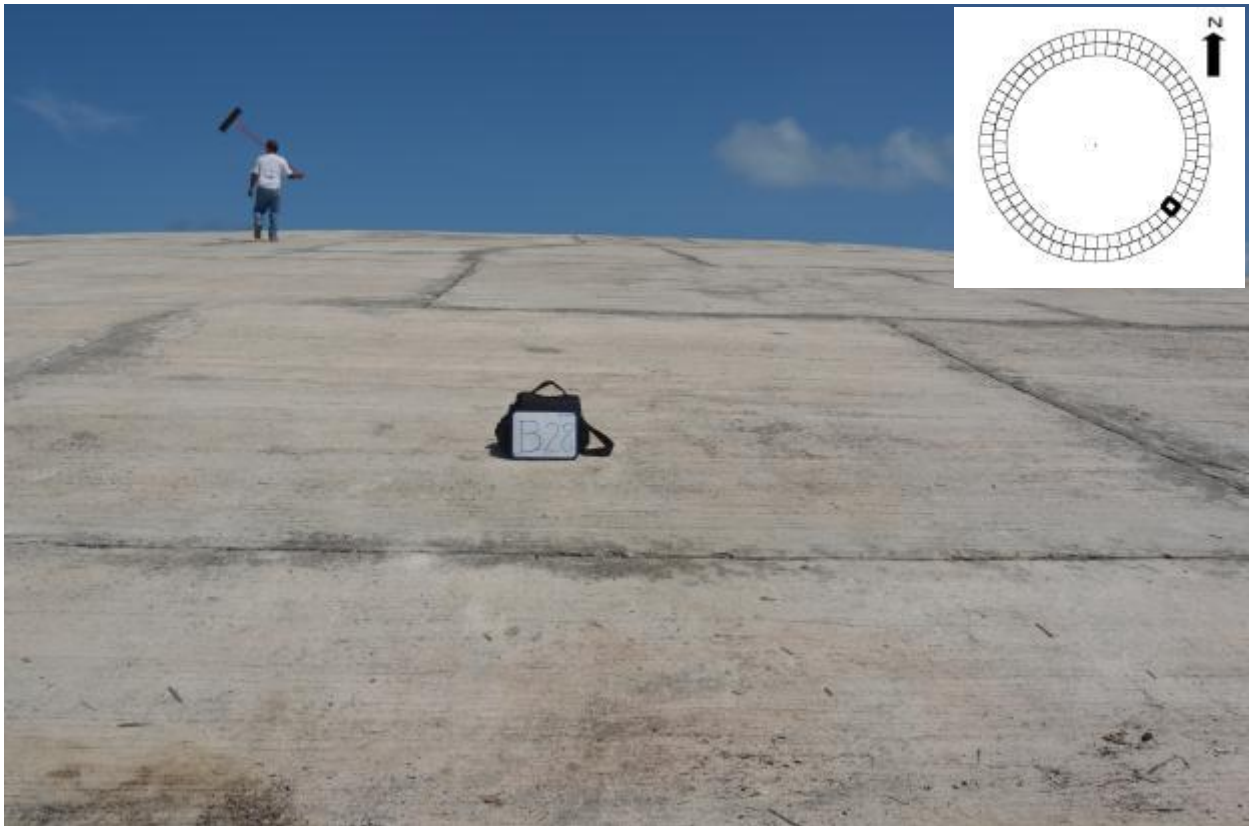
CAP SECTION LOCATION: Panel B28

No significant or obvious interior cracks extending across the top of the panel. The panel appears to have a relatively rough appearance. Rooting vegetation removed from along the panel seams.

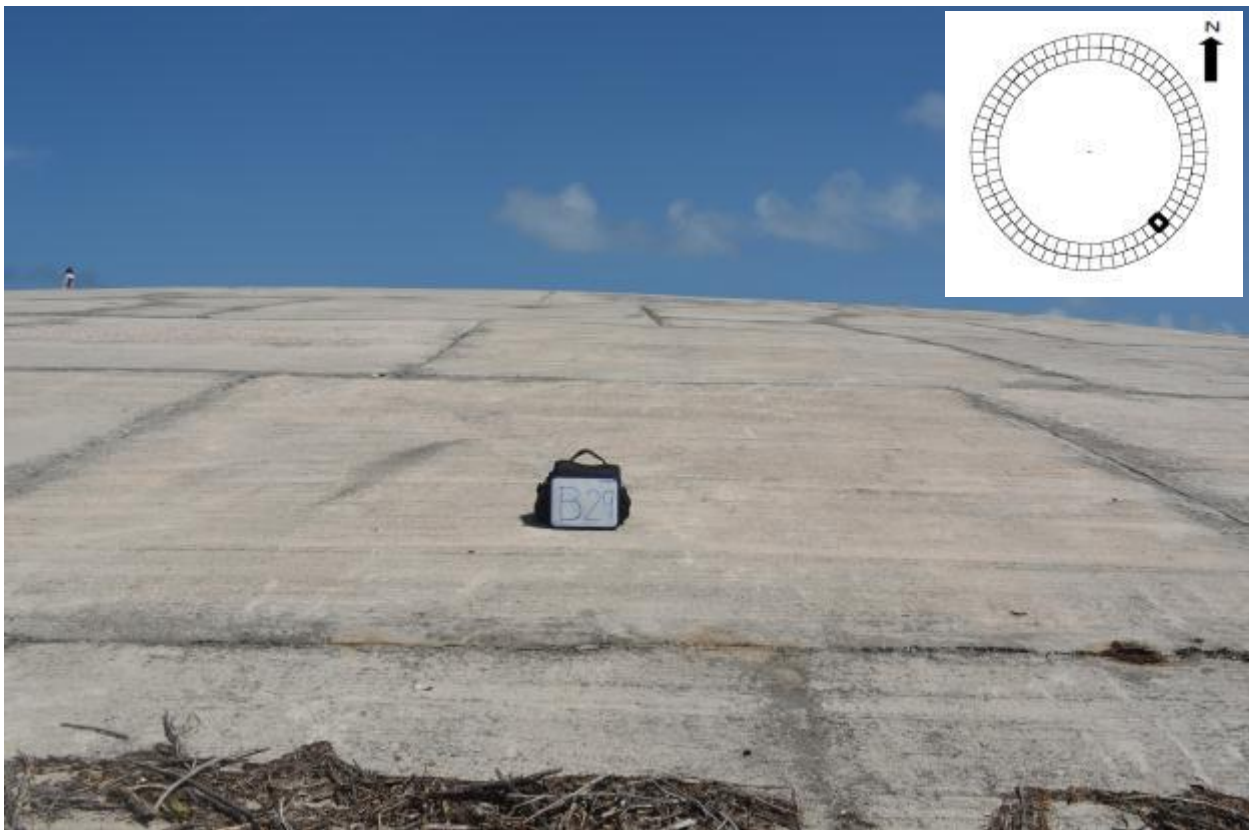
CAP SECTION LOCATION: Panel B29

No significant or obvious interior cracks extending across the top of the panel. The panel appears to have a relatively rough appearance. Rooting vegetation removed from along the panel seams. Some minor spalling of concrete observed along the bottom left seam overhanging the A panel below.

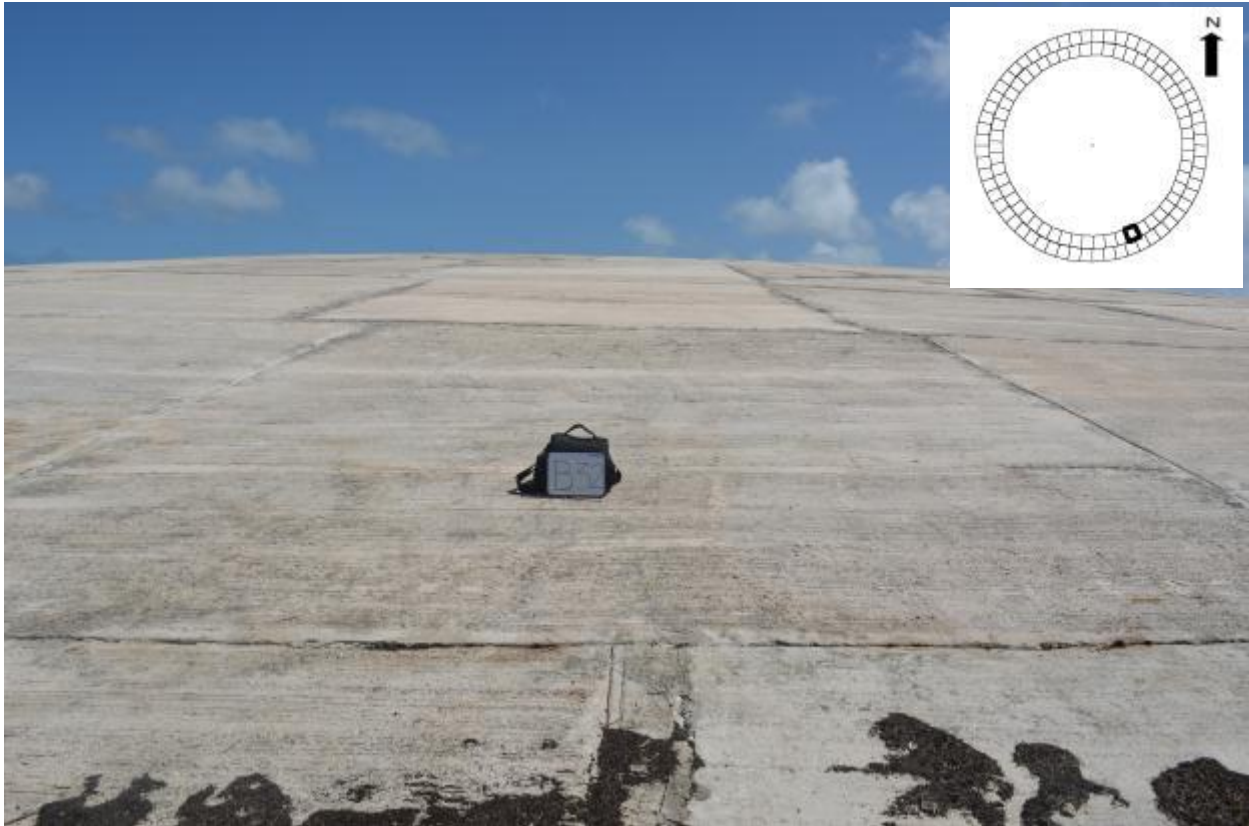
No significant or obvious interior cracks extending across the top of the panel. The upper section of the panel has a relatively rough appearance. Rooting vegetation removed from along the panel seams.

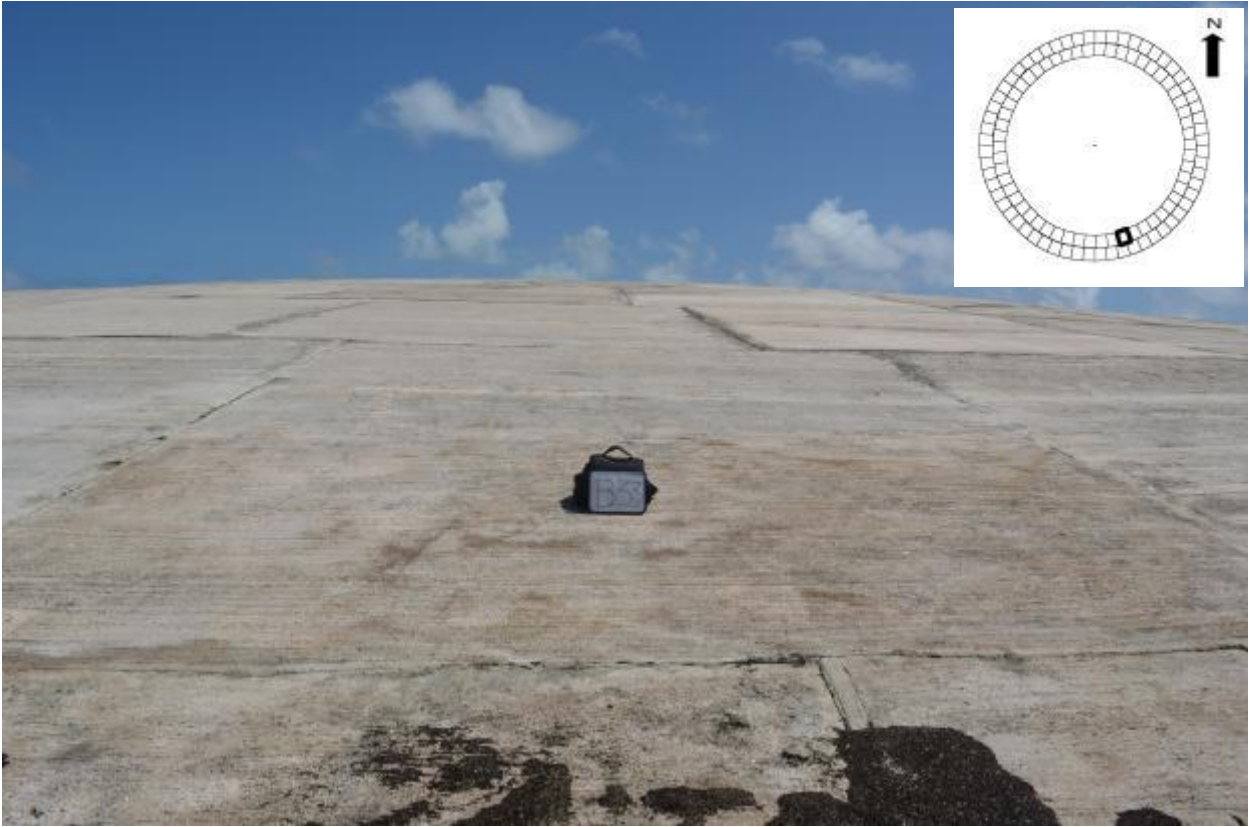
CAP SECTION LOCATION: Panel 33

No significant or obvious interior cracks extending across the top of the panel. The panel has a rough and weathered appearance. Some minor spalling of concrete observed in the upper left-hand corner of the panel, and along the bottom left seam adjacent to the intersecting corners between the A panels below.

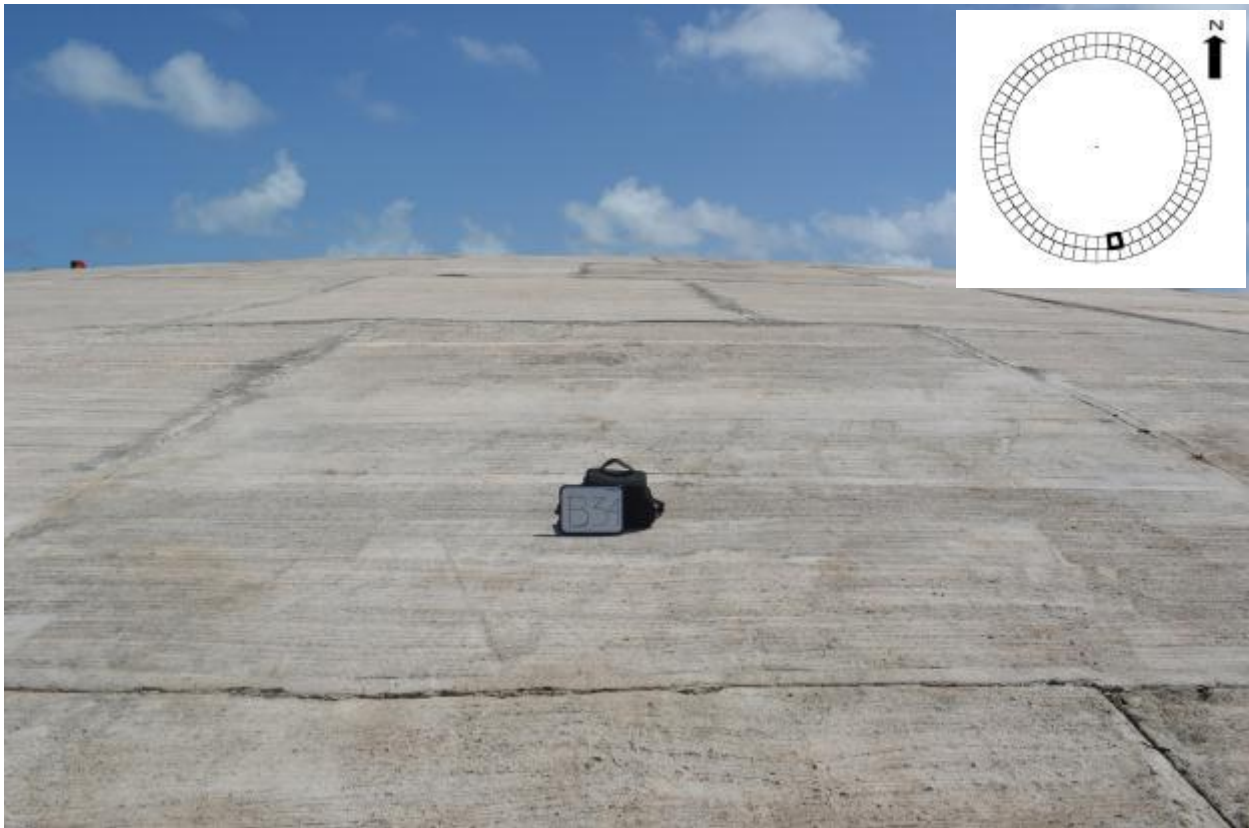
CAP SECTION LOCATION: Panel B34

No significant or obvious interior cracks extending across the top of the panel. The upper portion of the panel appears to have a relatively rough appearance. Rooting vegetation removed from along the panel seams. Some minor spalling of concrete observed along the upper seam of the panel.

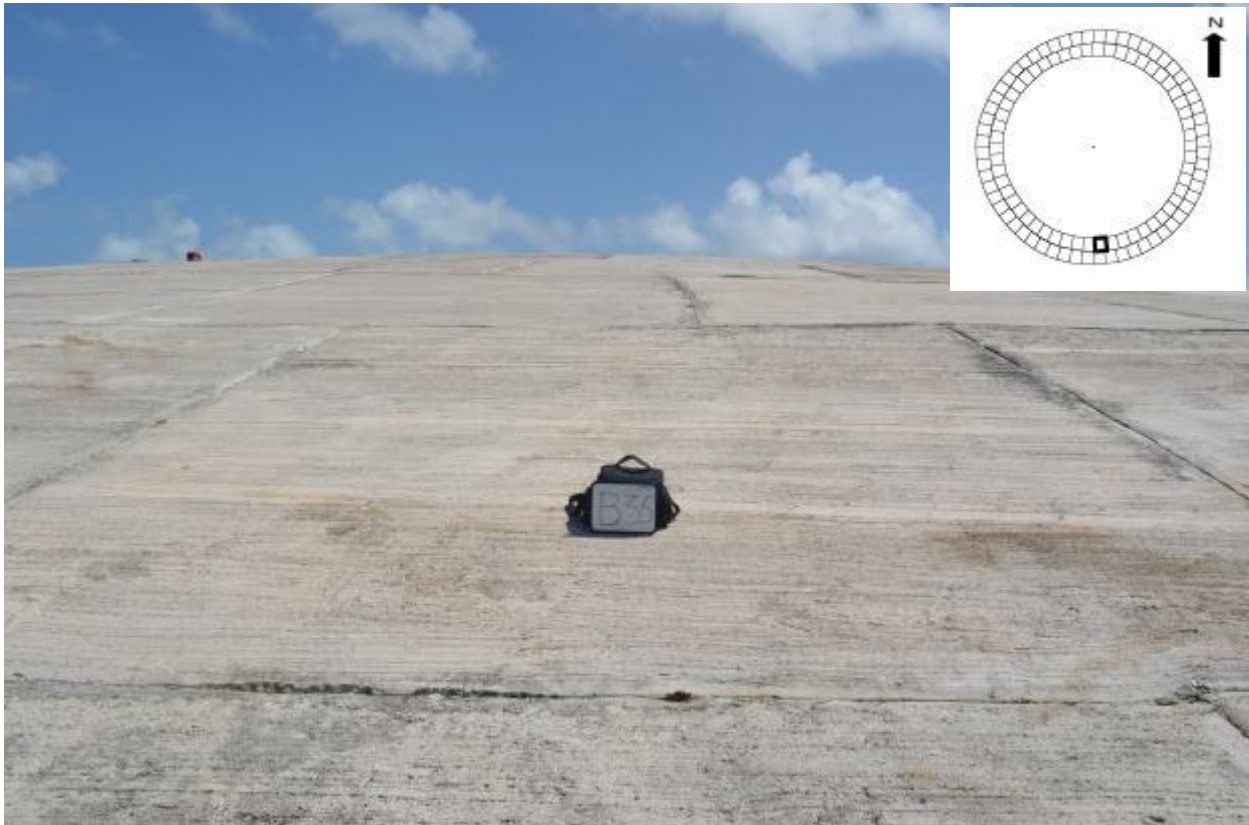
CAP SECTION LOCATION: Panel B36

No significant or obvious interior cracks extending across the top of the panel. The panel appears to have a relatively rough appearance. Rooting vegetation removed from along the panel seams. Some minor spalling of concrete observed along the bottom seam of the panel.

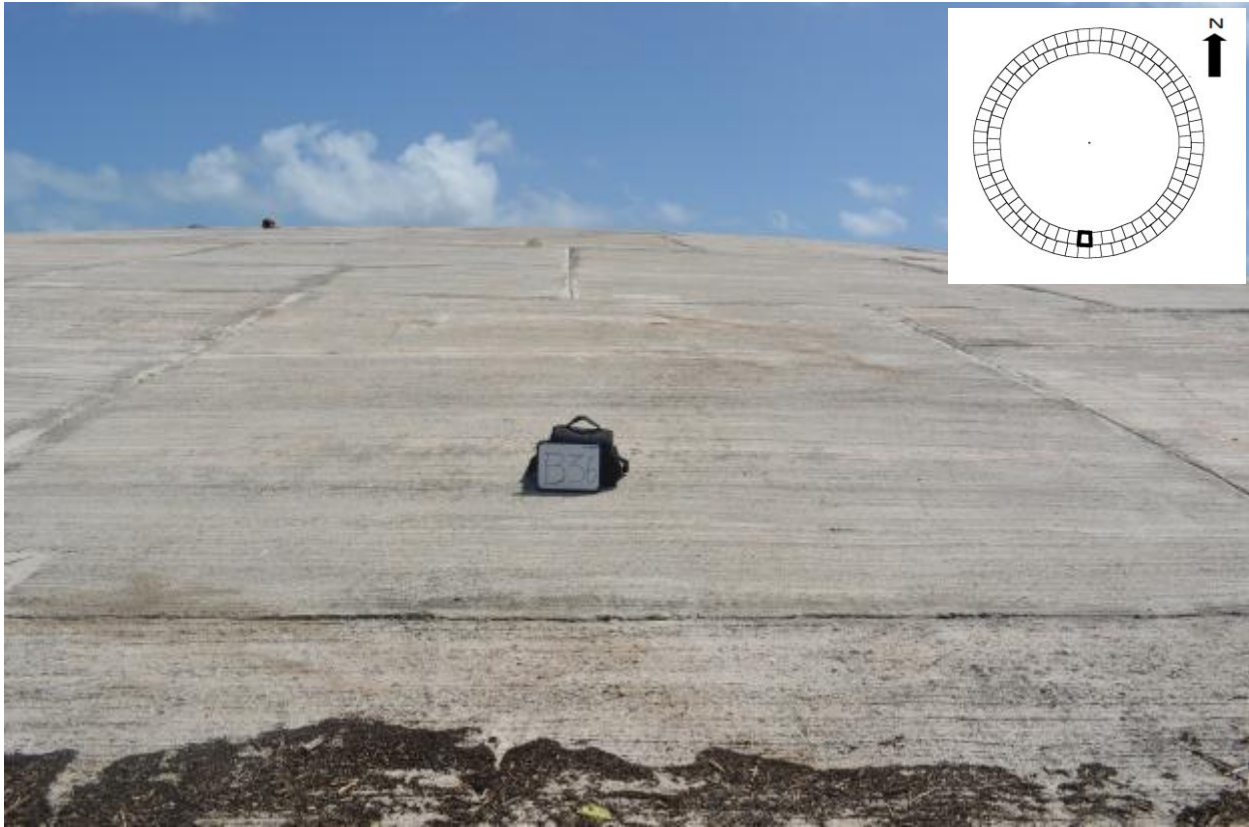
CAP SECTION LOCATION: Panel B37

No significant or obvious interior cracks extending across the top of the panel. The panel appears to have a relatively rough appearance. Rooting vegetation removed from along the panel seams.

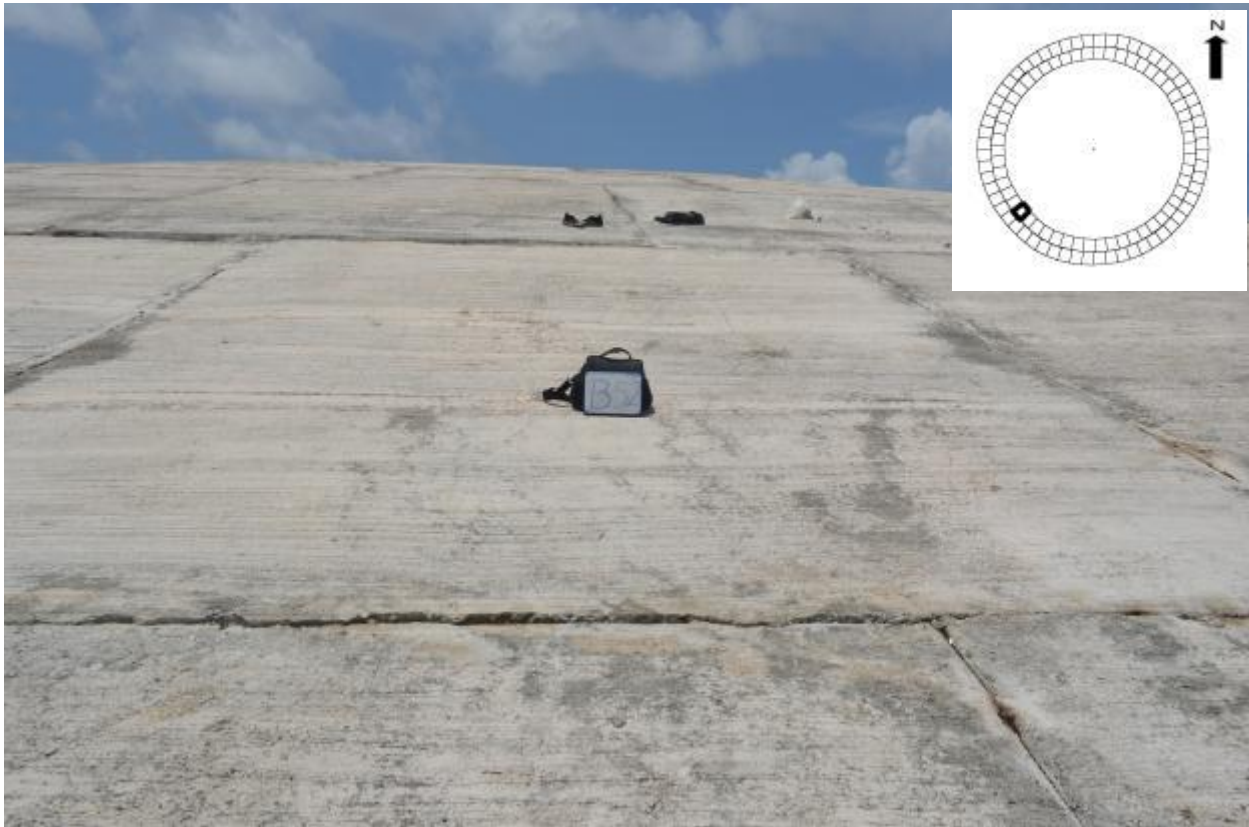
CAP SECTION LOCATION: Panel B53

No significant or obvious interior cracks extending across the top of the panel. Rooting vegetation removed from along the panel seams. Some spalling of concrete observed in the lower right-hand corner of the panel.

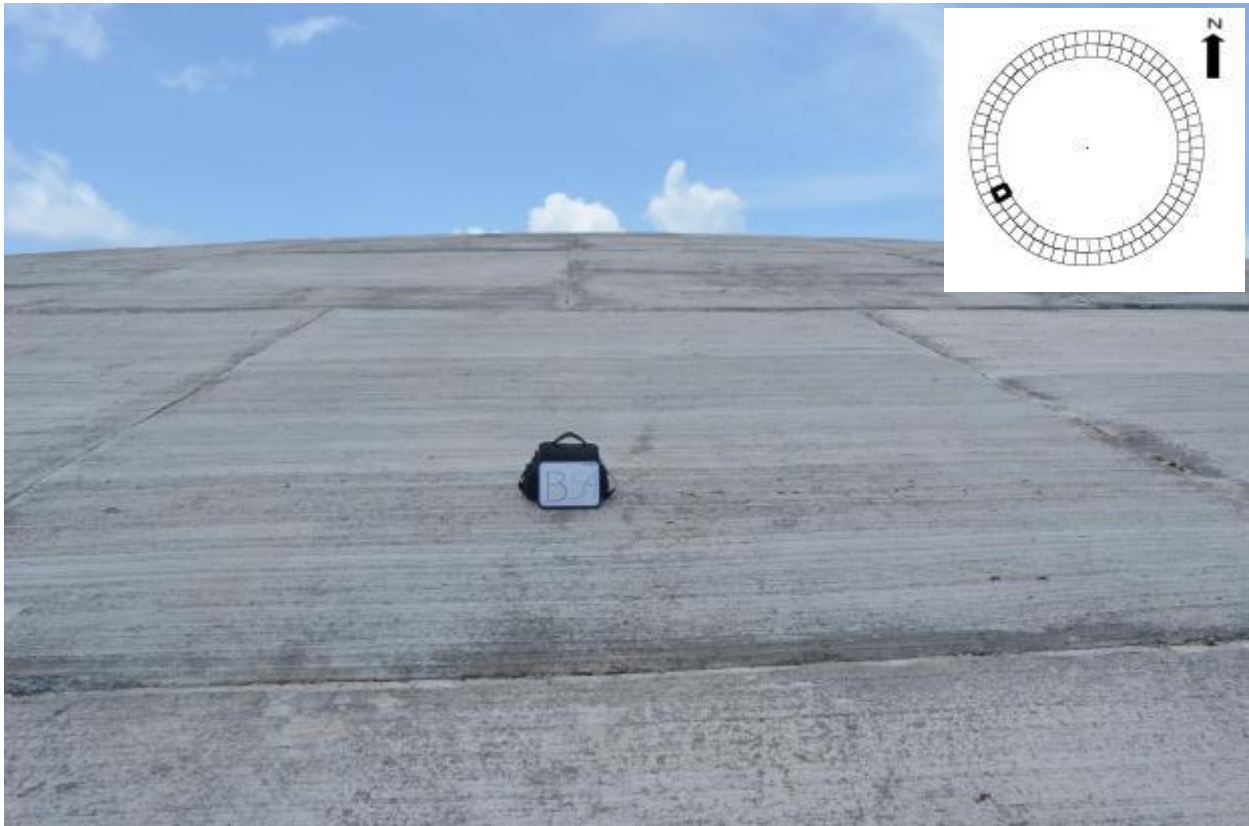
CAP SECTION LOCATION: Panel B55

No significant or obvious interior cracks extending across the top of the panel. Rooting vegetation removed from along the panel seams. Some minor spalling of concrete observed along the bottom edge of the panel overhanging the A rig row.

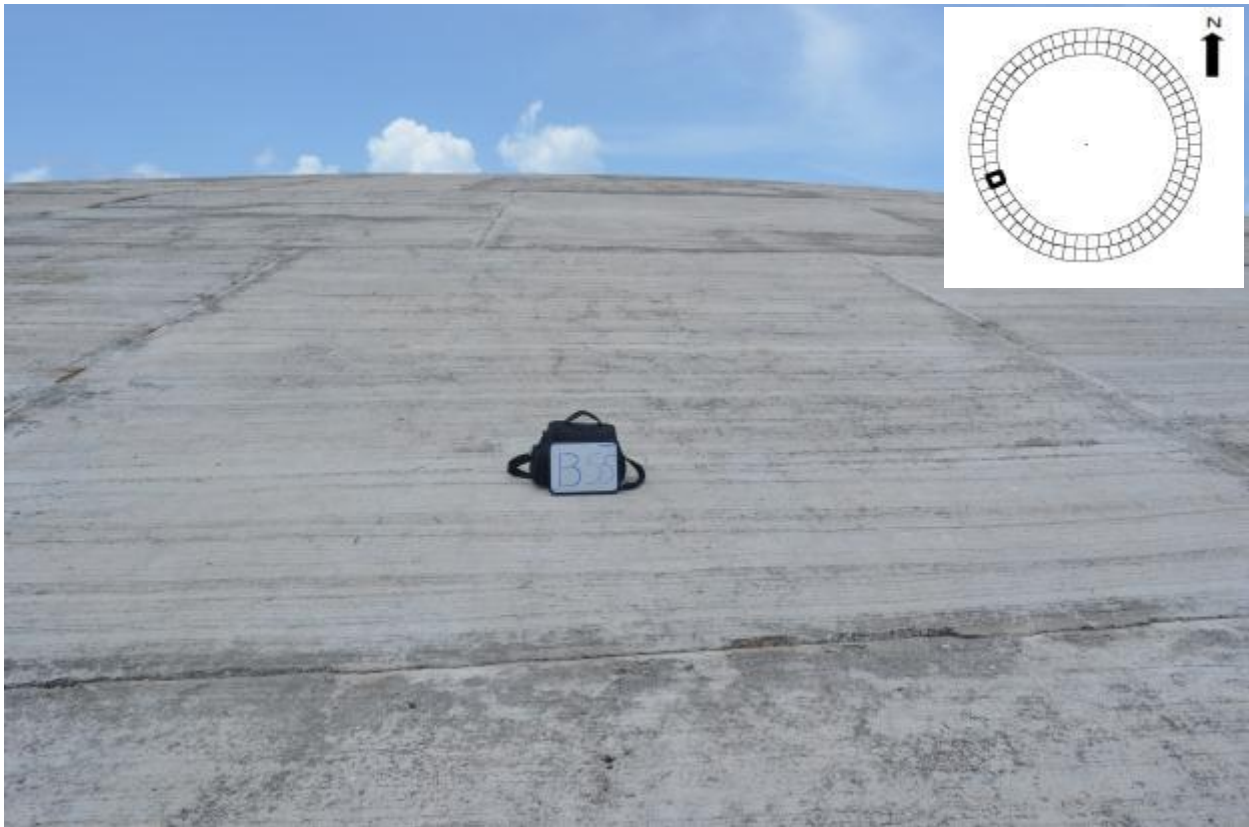
CAP SECTION LOCATION: Panel B56

No significant or obvious interior cracks extending across the top of the panel. The panel has a rough and weathered appearance. Cracking/spalling of concrete observed along the upper right-hand seam. Rooting vegetation (grass and vines) removed from along the panel seams.

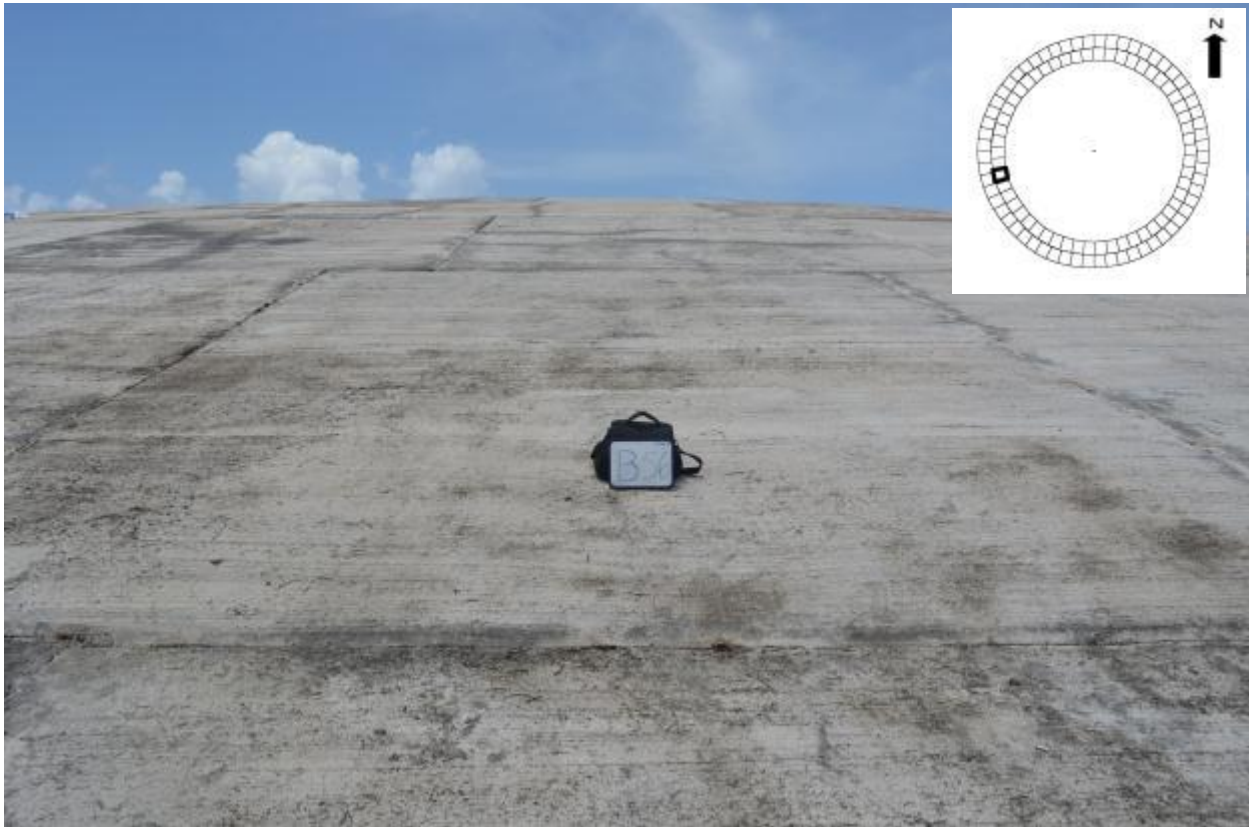
CAP SECTION LOCATION: Panel B57

No significant or obvious interior cracks extending across the top of the panel. The panel has a rough and weathered appearance. Rooting vegetation removed from along the panel seams.

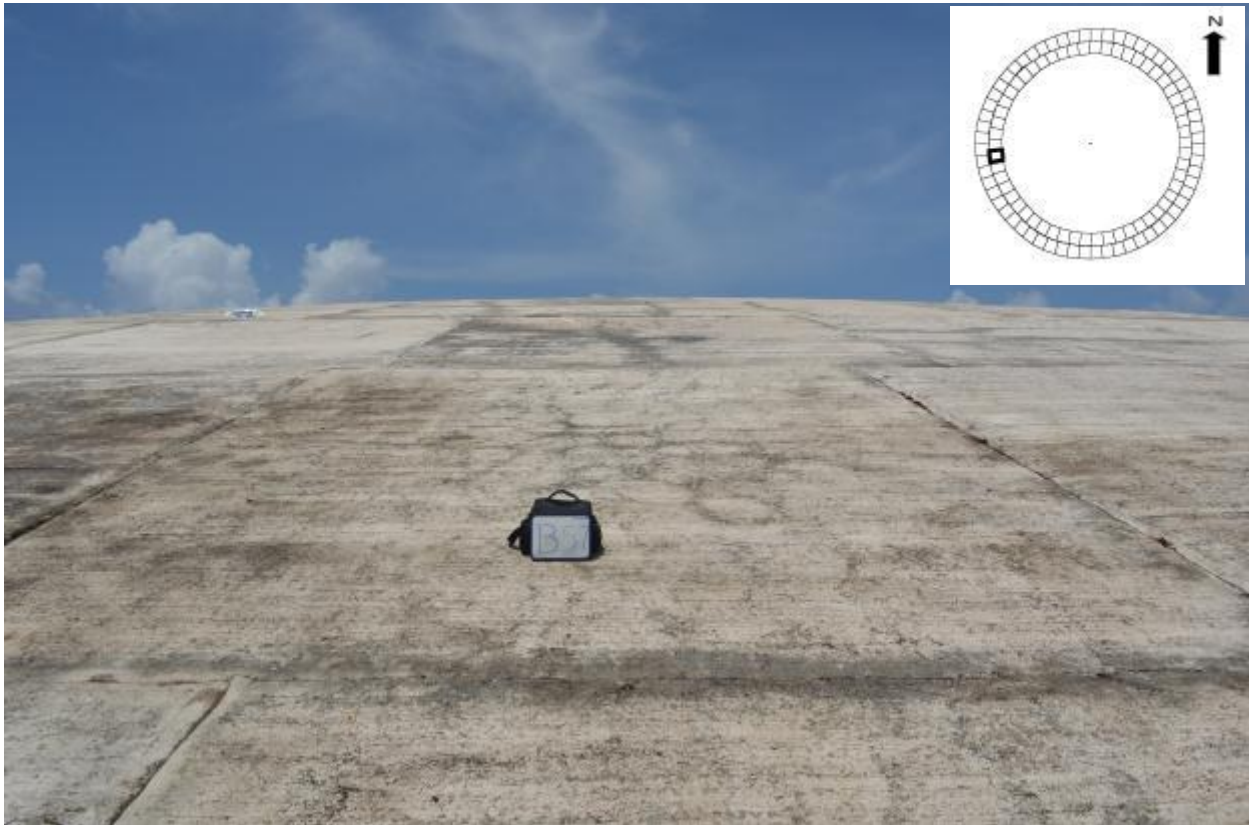
CAP SECTION LOCATION: Panel B58

No significant or obvious interior cracks extending across the top of the panel. The panel has a rough and weathered appearance. There is some minor spalling of concrete in the upper left and right-hand corners of the panel, and along the bottom seam adjacent to intersecting corner of the A panels below.

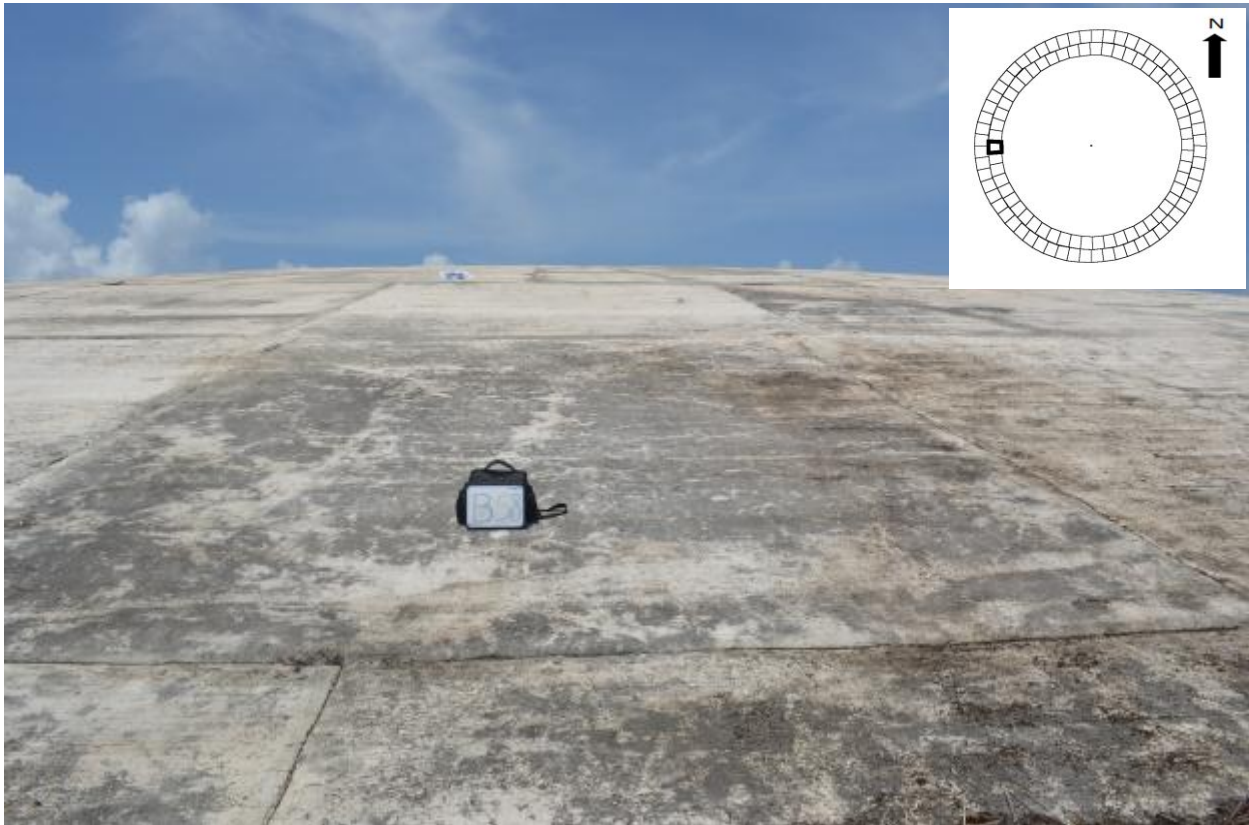
CAP SECTION LOCATION: Panel B55_duplicate

No significant or obvious interior cracks extending across the top of the panel. Rooting vegetation removed from along the panel seams.

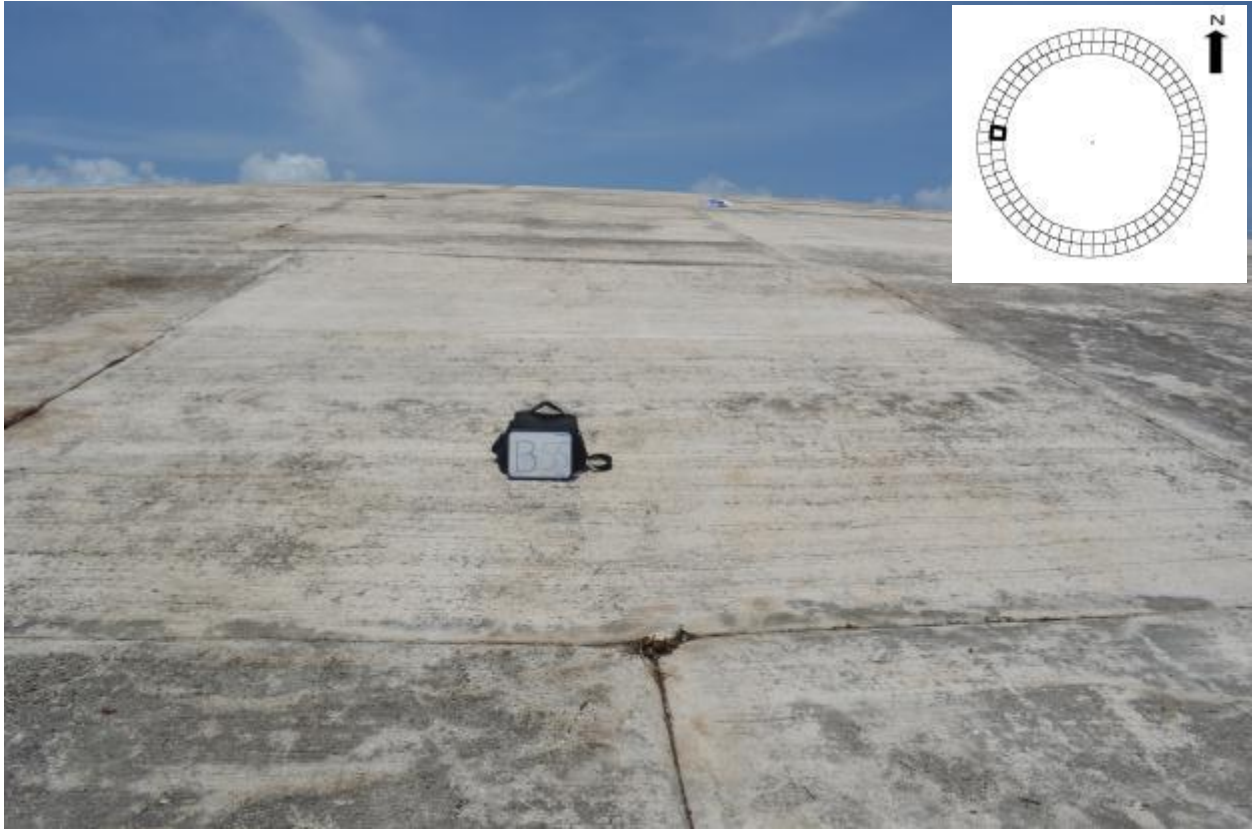
CAP SECTION LOCATION: Panel B56_duplicate

The panel has a relatively rough and weathered appearance.. Rooting vegetation removed from along the panel seams. A minor crack observed traversing across the segment at about a mid-point up the panel.
