LLNL-TR-648143

A Visual Description of the Concrete Exterior of the Cactus Crater Containment Structure

Terry Hamilton

October 2013

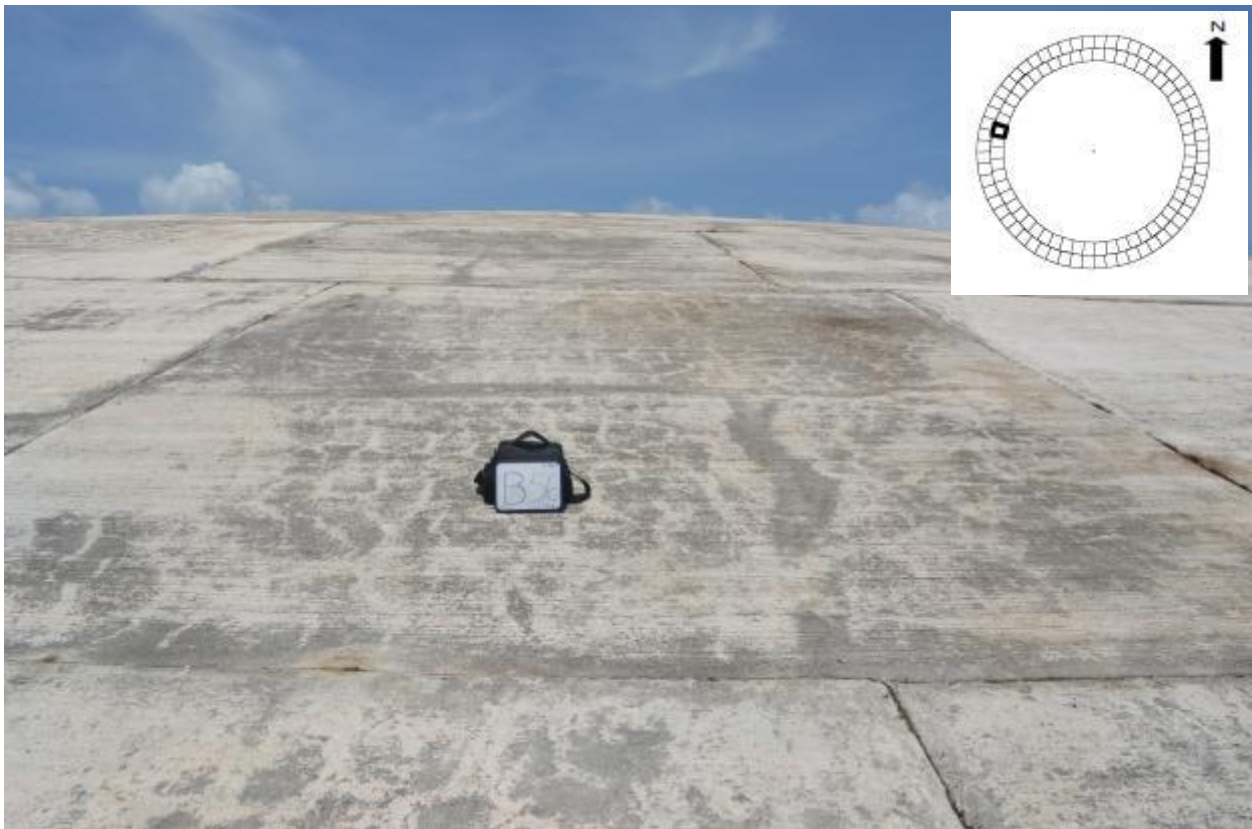
CAP SECTION LOCATION: Panel B57_duplicate

Rooting vegetation removed from along the panel seams. A crack observed traversing across the segment between 2 to 3 meters up from the bottom of the panel.

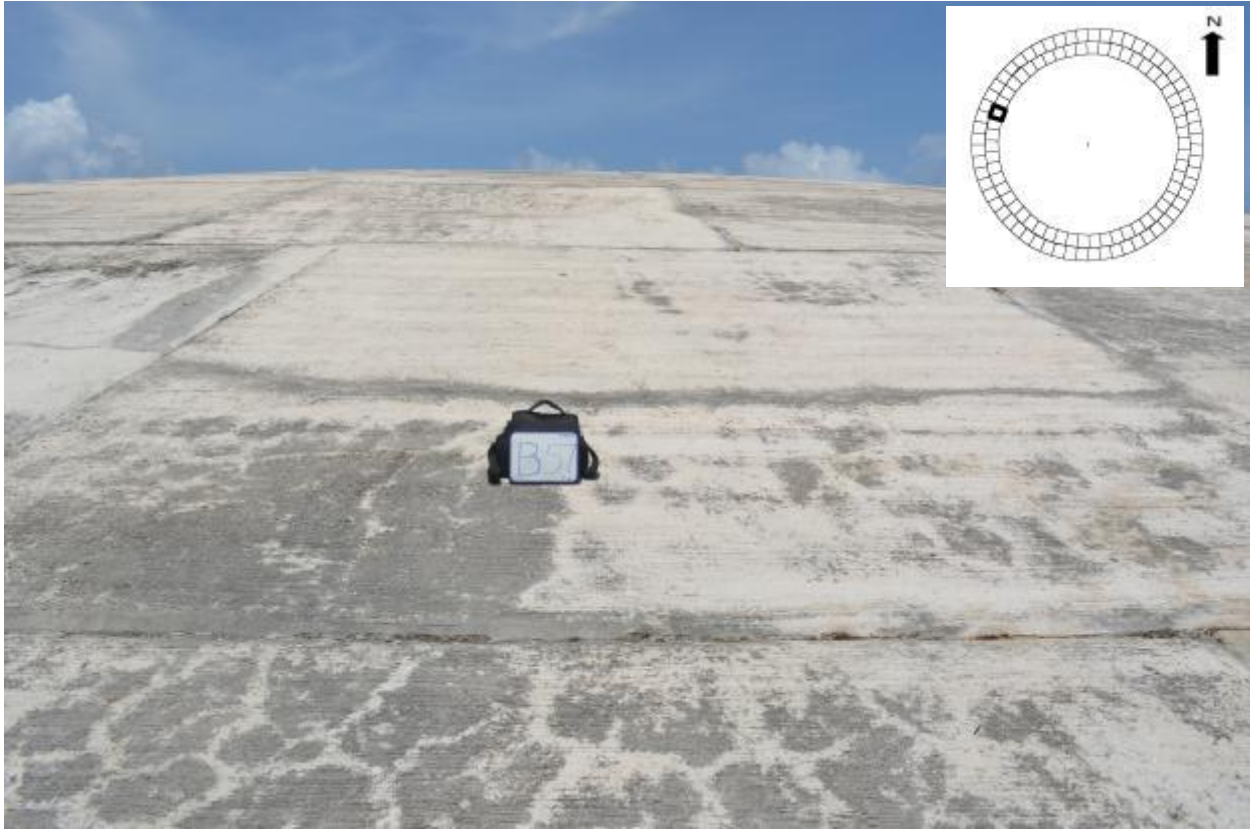
CAP SECTION LOCATION: Panel No ID

Rooting vegetation removed from along the panel seams. A crack observed traversing across the segment at about a mid-point up the panel. Some spalling of concrete observed in the bottom right-hand corner of the panel as well as along the bottom seam at the intersecting corner with the A panels below.

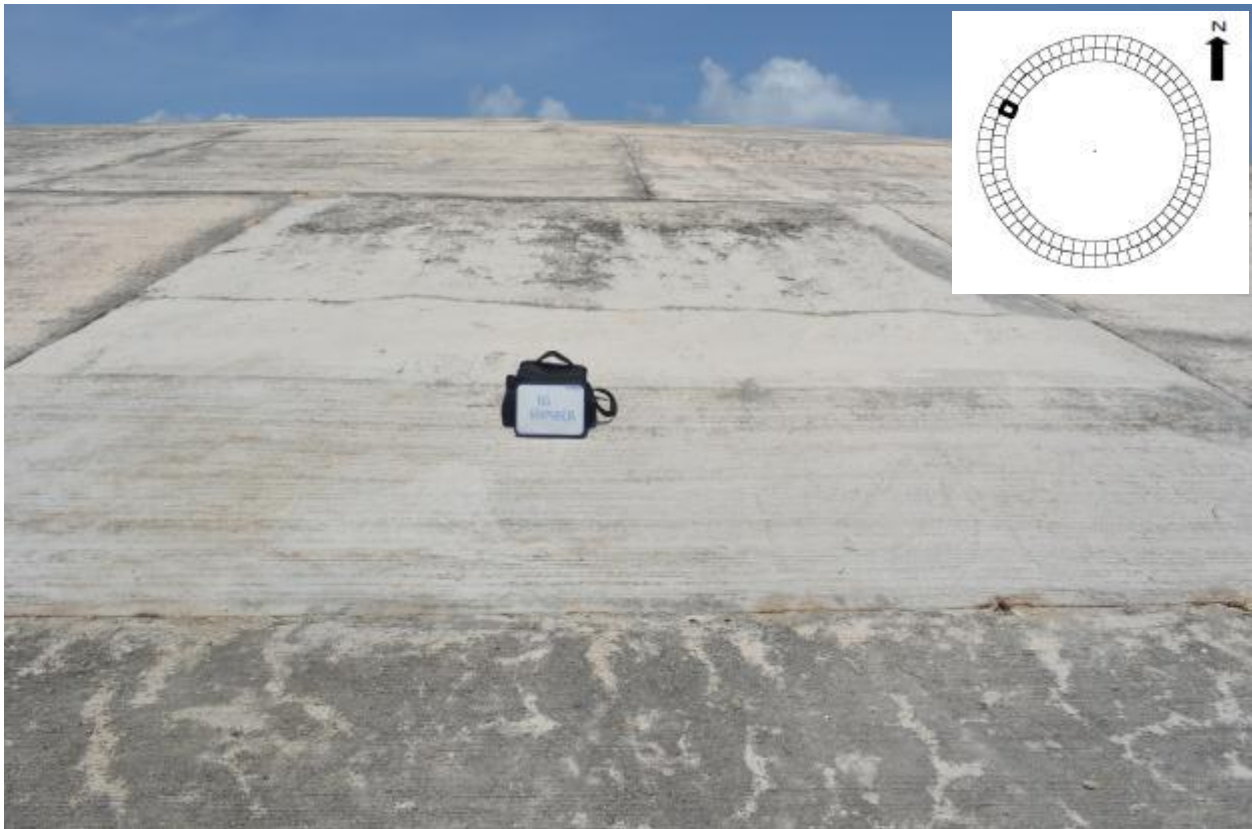
CAP SECTION LOCATION: Panel B59

No significant or obvious interior cracks extending across the top of the panel. The panel has a rough and weathered appearance. Rooting vegetation removed from along the panel seams. Some spalling of concrete observed along the lower left and right-hand seams, and along the bottom seam at the intersecting corner with the A panels below. There is some indication of a secondary patch of concrete overlaying the panel at about a mid-point up the panel on the right side (refer to photo).

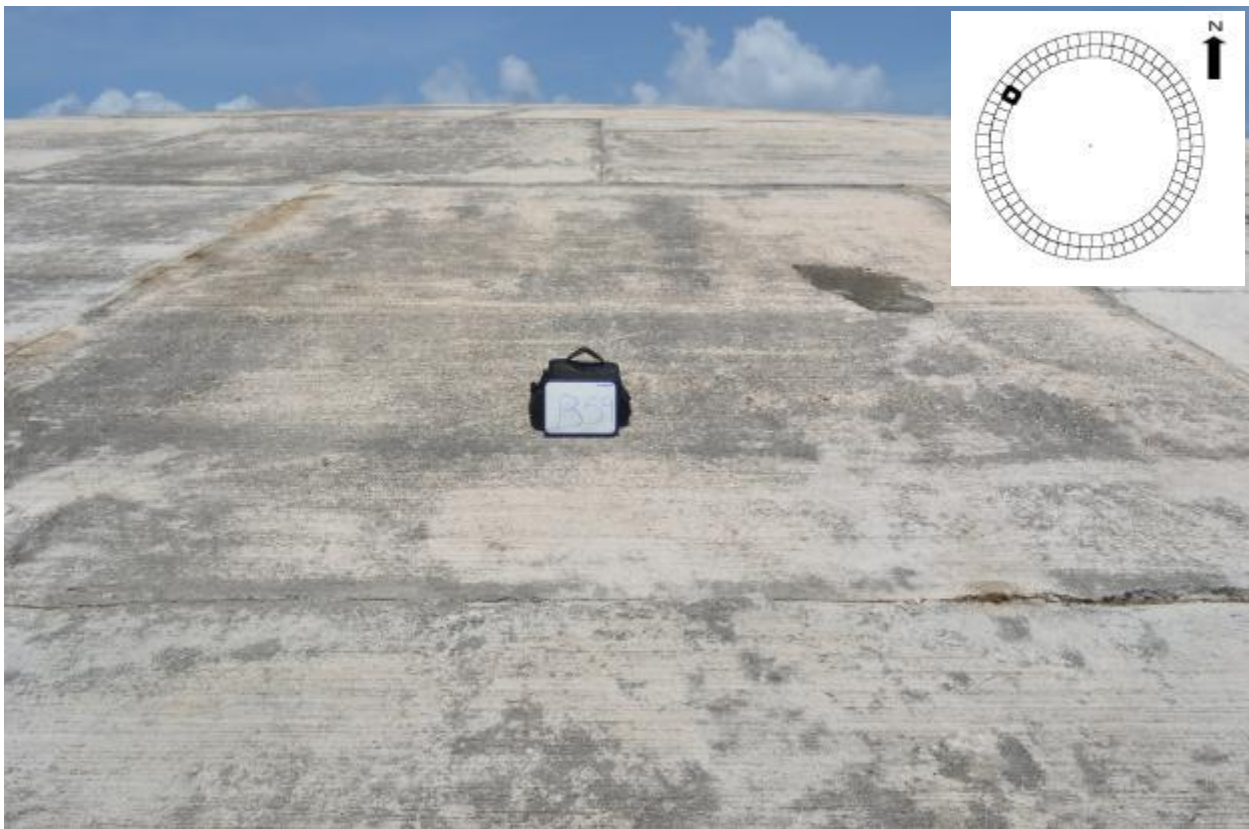
CAP SECTION LOCATION: Panel C1

No significant or obvious interior cracks extending across the top of the panel. Rooting vegetation removed from along the panel seams. Some minor spalling of concrete observed along the upper seam overlapping the D panel above.

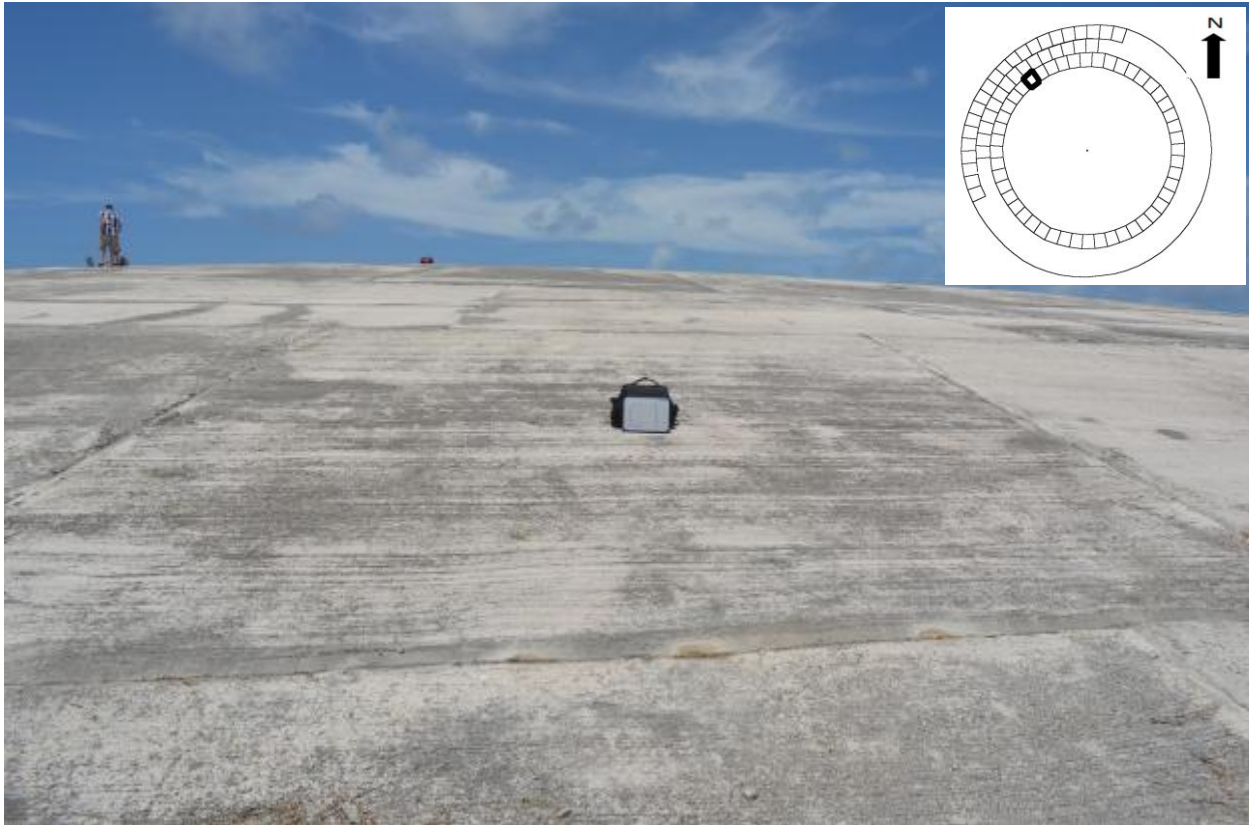
CAP SECTION LOCATION: Panel C2

No significant or obvious interior cracks extending across the top of the panel. The panel has a slightly more rough and weathered appearance. Rooting vegetation removed from along the panel seams.

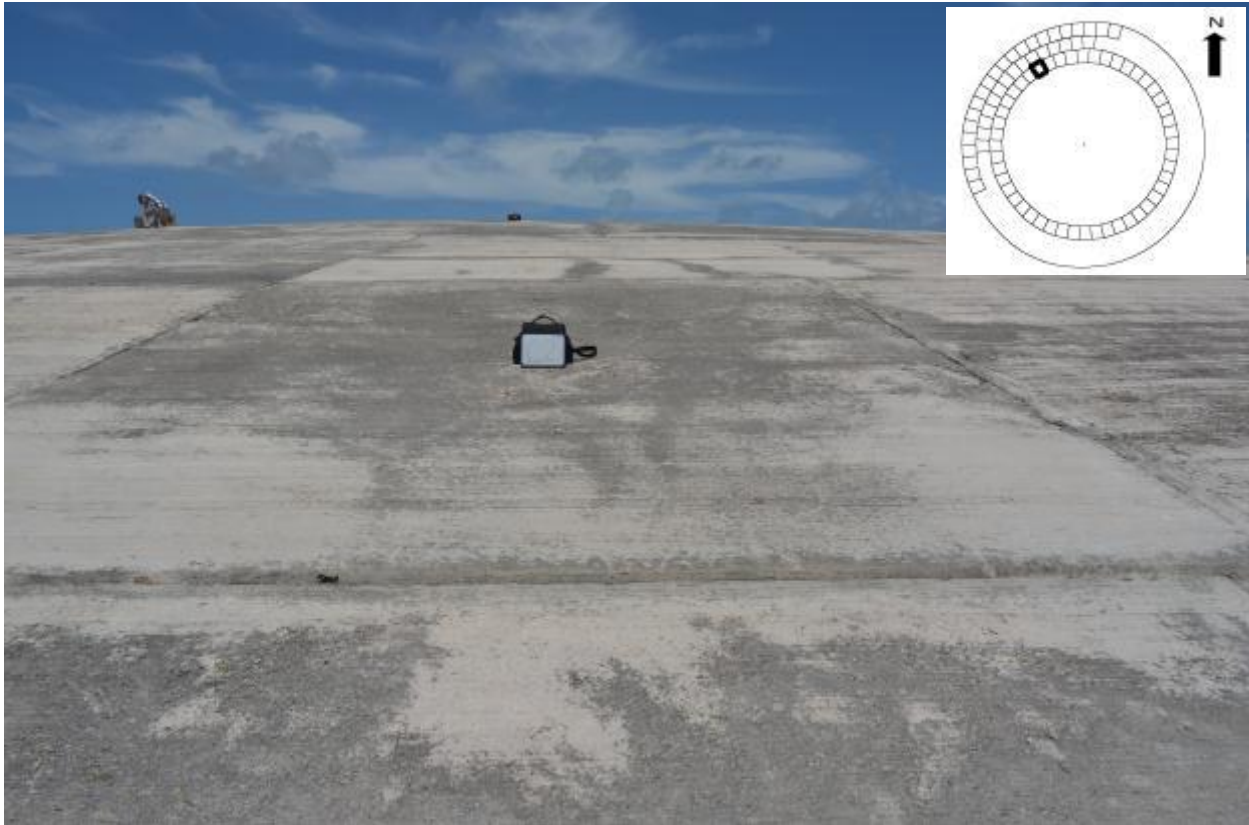
CAP SECTION LOCATION: Panel C3

No significant or obvious interior cracks extending across the top of the panel. Rooting vegetation removed from along the panel seams.

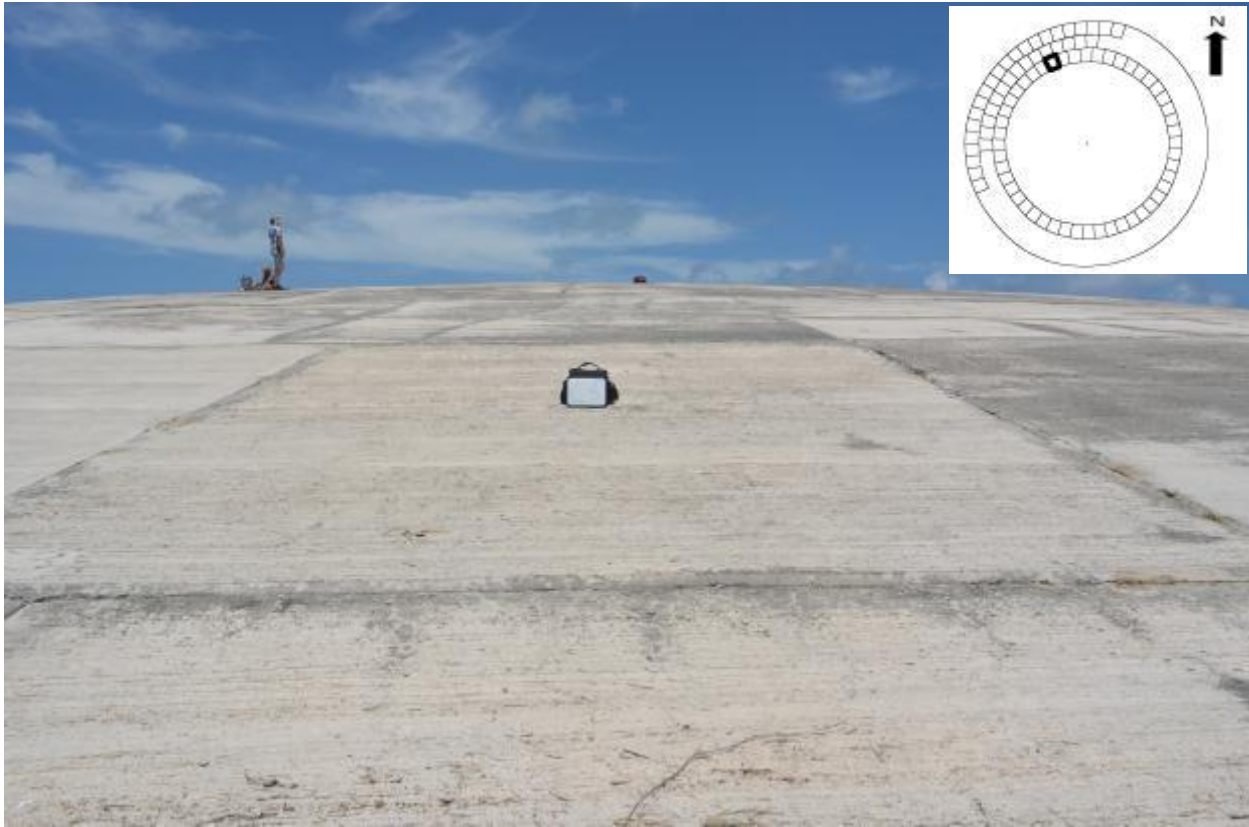
CAP SECTION LOCATION: Panel C4

No significant or obvious interior cracks extending across the top of the panel. Rooting vegetation removed from along the panel seams.

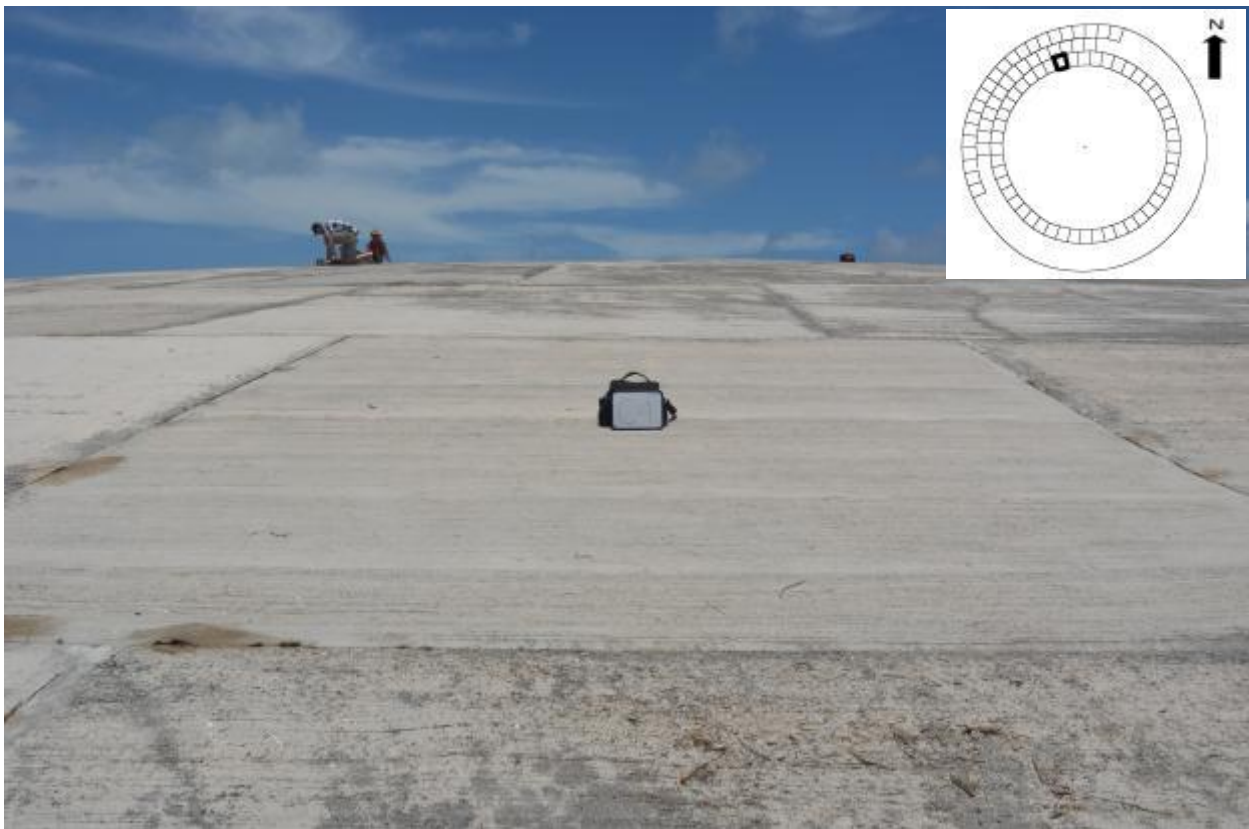
CAP SECTION LOCATION: Panel C5

No significant or obvious interior cracks extending across the top of the panel. Rooting vegetation removed from along the panel seams. Some minor spalling of concrete observed in the upper left-hand corner and along the upper seam overlapping the D panels above.

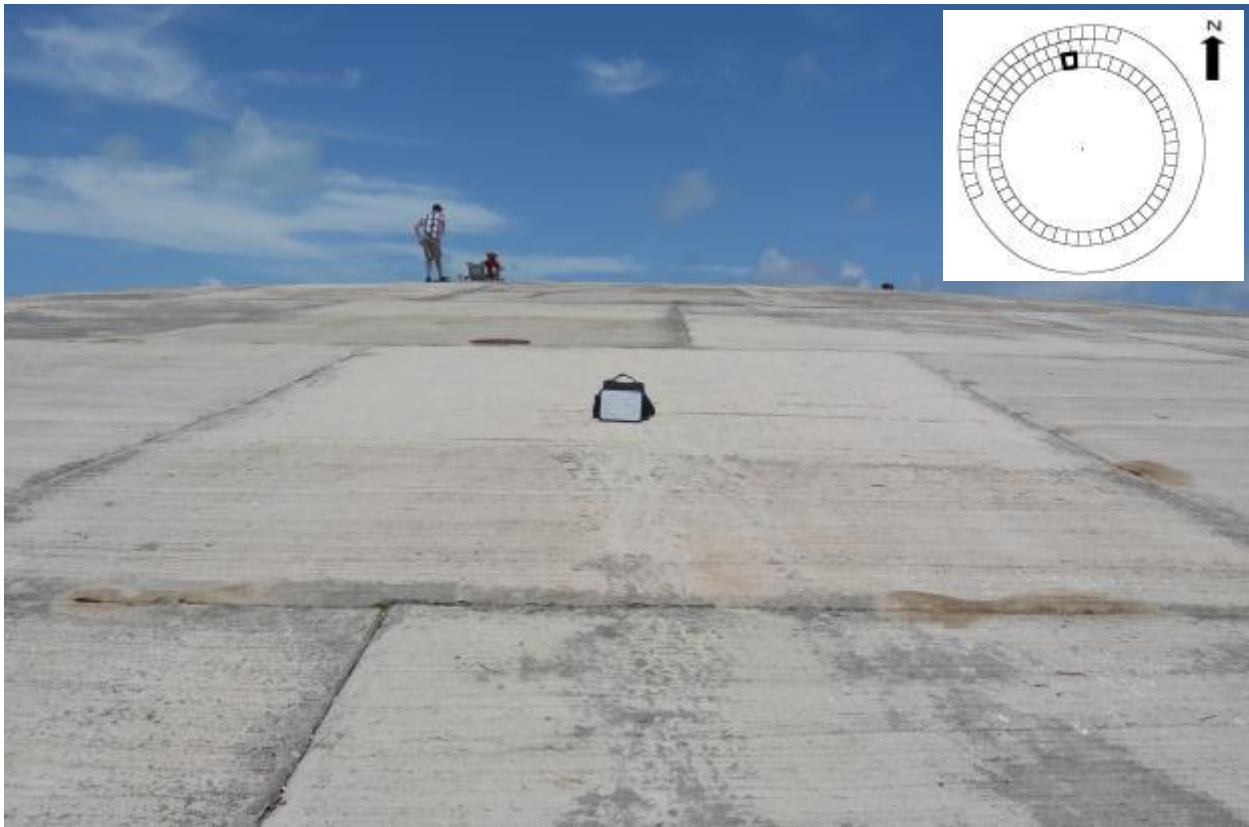
CAP SECTION LOCATION: Panel C6

No significant or obvious interior cracks extending across the top of the panel. Rooting vegetation removed from along the panel seams.

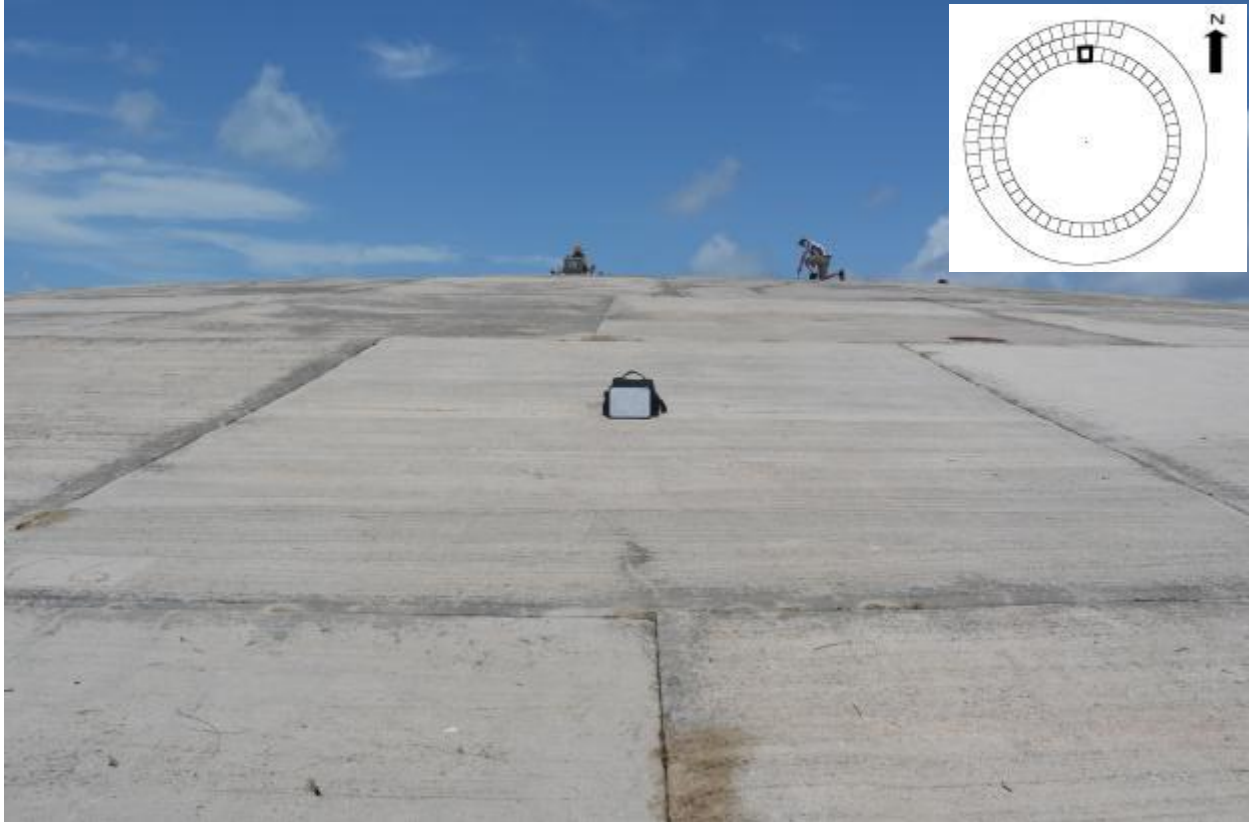
CAP SECTION LOCATION: Panel C7

No significant or obvious interior cracks extending across the top of the panel. Panel appears rough and weathered. Rooting vegetation removed from along the panel seams. Some minor spalling of concrete observed in the upper left-hand corner of the panel.

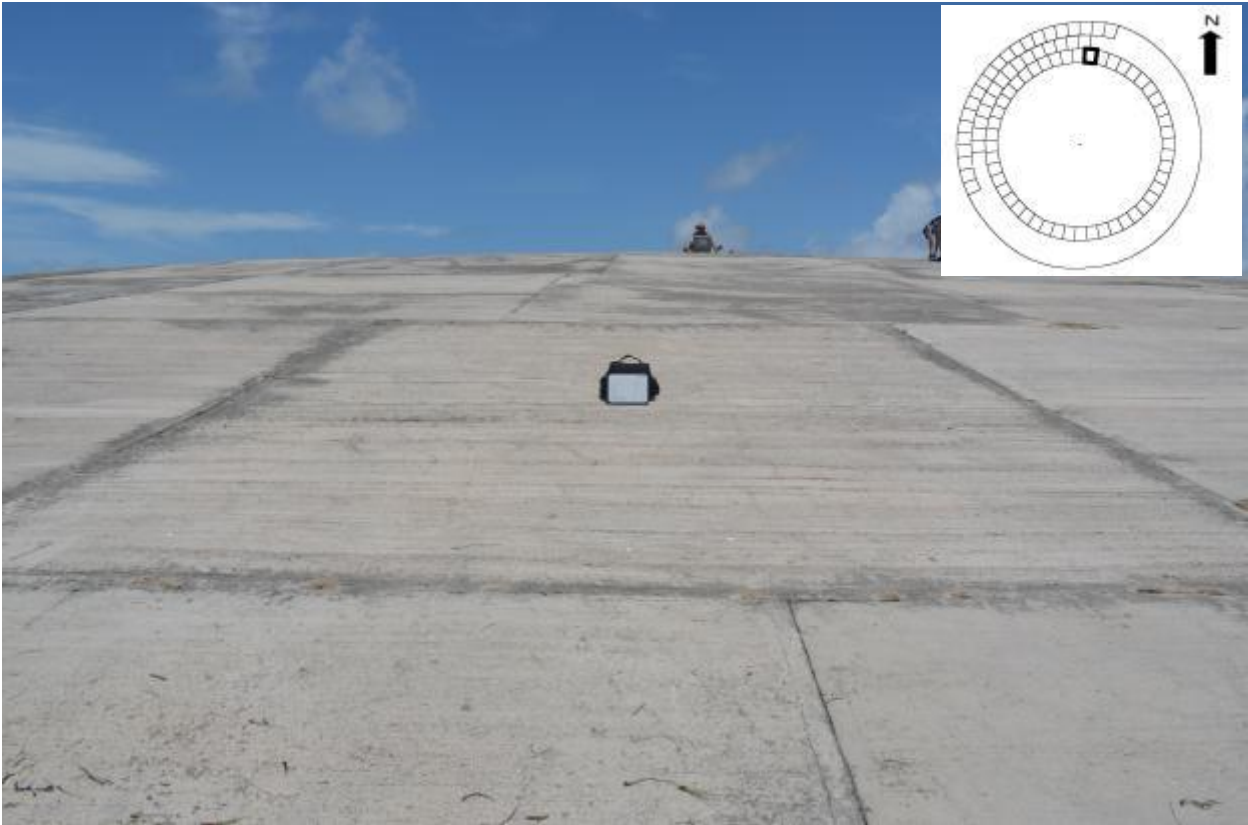
CAP SECTION LOCATION: Panel C8

No significant or obvious interior cracks extending across the top of the panel. Rooting vegetation removed from along the panel seams.

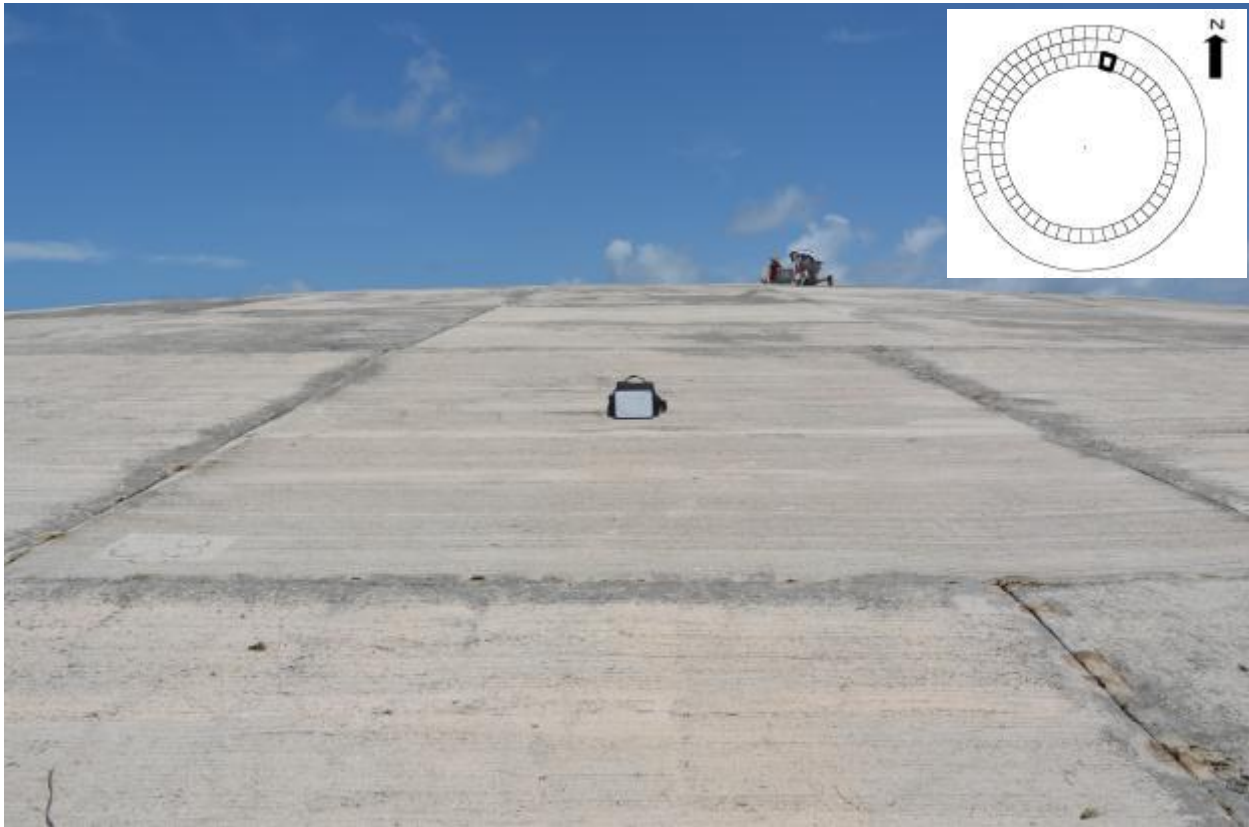
CAP SECTION LOCATION: Panel C9

No significant or obvious interior cracks extending across the top of the panel. Rooting vegetation removed from along the panel seams.

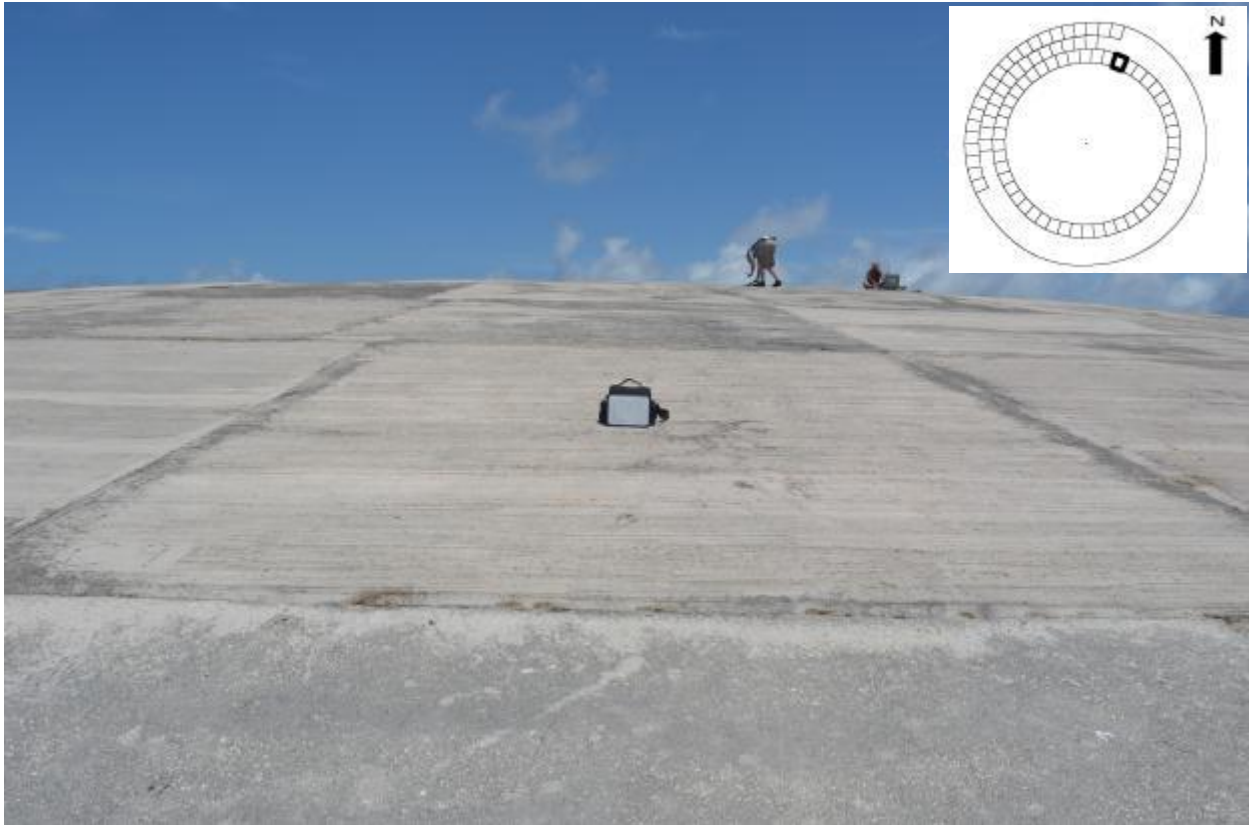
CAP SECTION LOCATION: Panel C10

No significant or obvious interior cracks extending across the top of the panel. Rooting vegetation removed from along the panel seams.

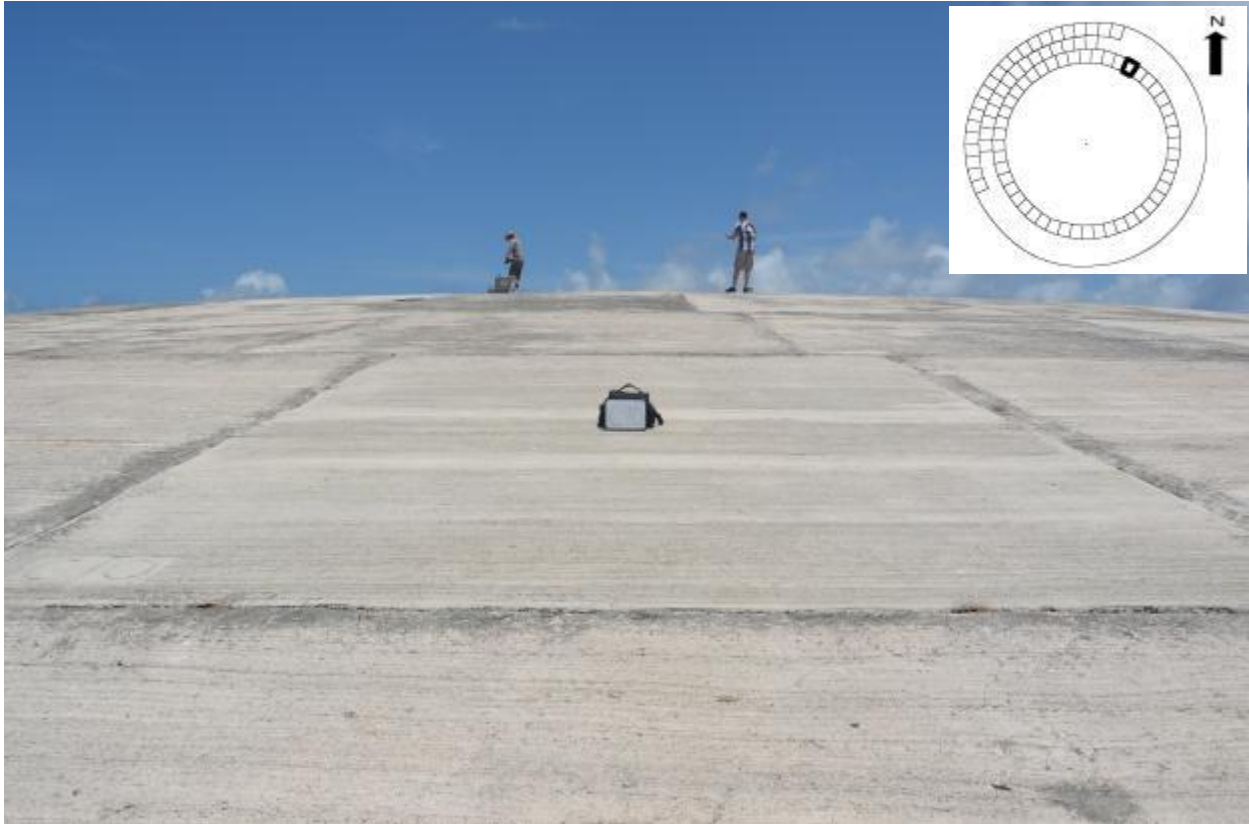
CAP SECTION LOCATION: Panel C11

No significant or obvious interior cracks extending across the top of the panel. The panel has a rough and weathered appearance. Rooting vegetation removed from along the panel seams.

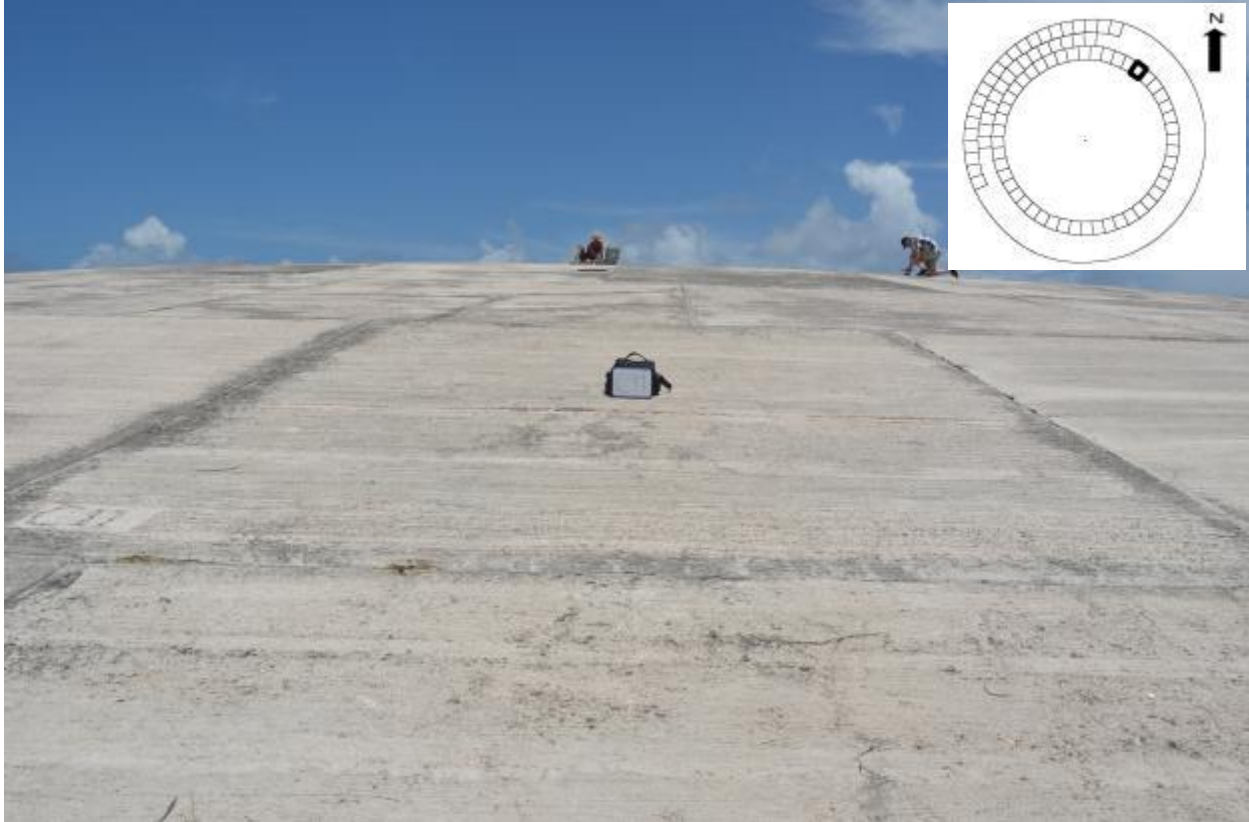
CAP SECTION LOCATION: Panel C12

No significant or obvious interior cracks extending across the top of the panel. Some minor spalling/chipping of concrete observed in the lower left-hand corner of the panel.

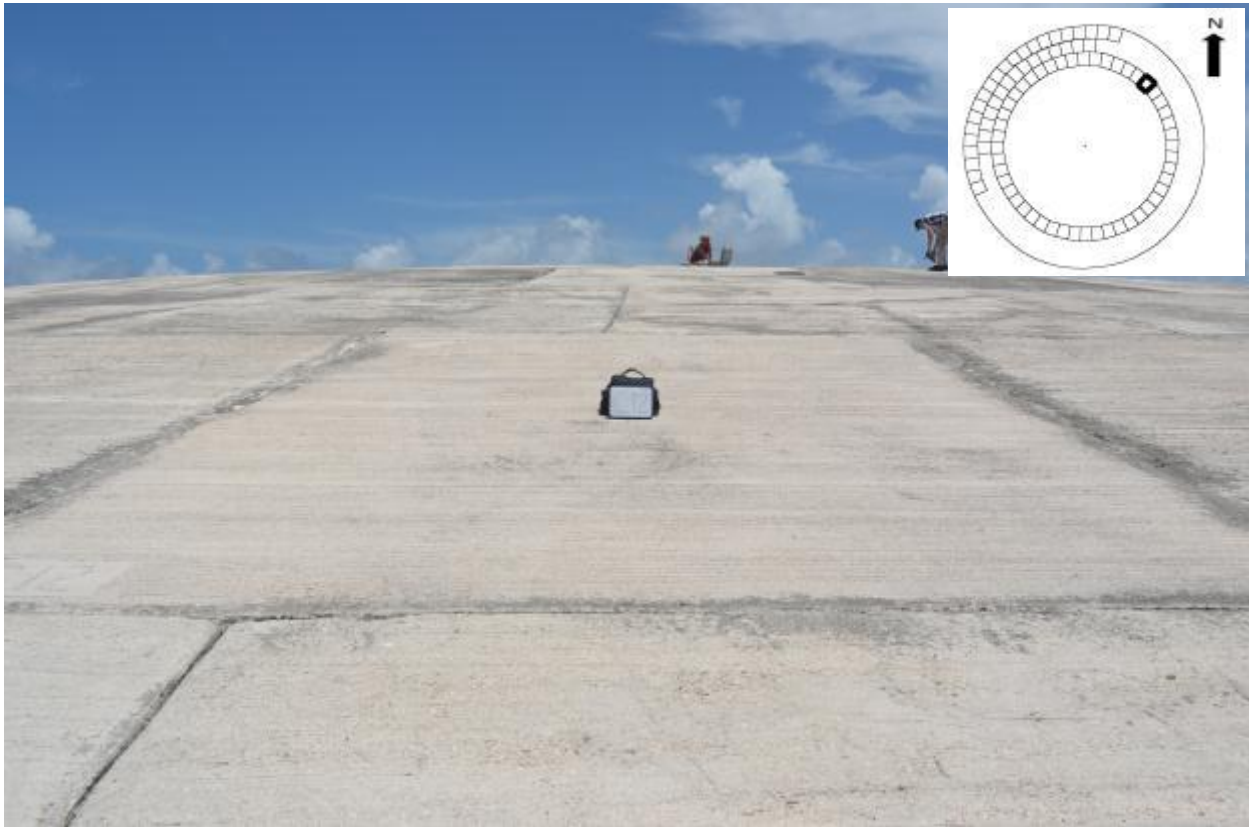
CAP SECTION LOCATION: Panel C13

No significant or obvious interior cracks extending across the top of the panel. The panel has a rough and weathered appearance.

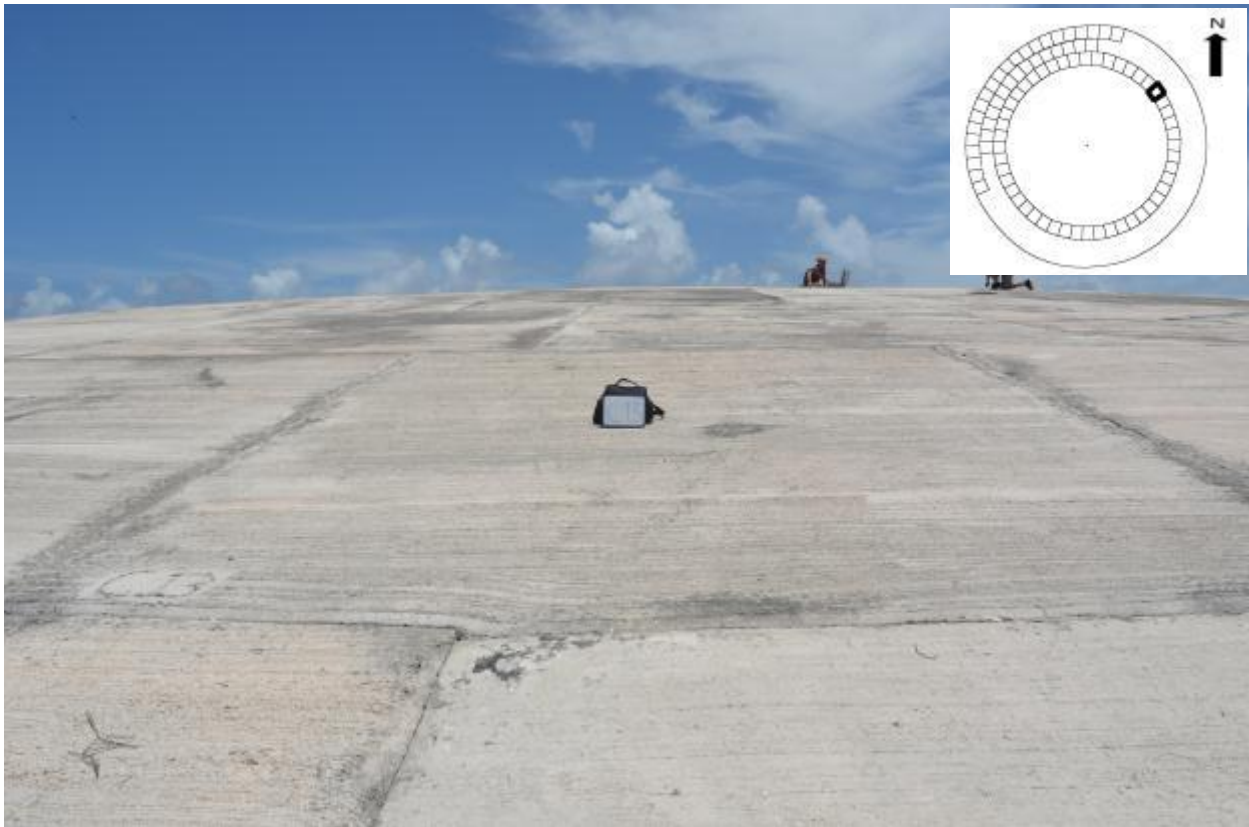
CAP SECTION LOCATION: Panel C14

No significant or obvious interior cracks extending across the top of the panel with exception of a small void found in the concrete app. 2 centimeters deep and about 2 x 1.5 centimeters in area. Rooting vegetation removed from along the panel seams. This panel contains a filled drill-hole (CD-12) from the 1980 NAS investigation.

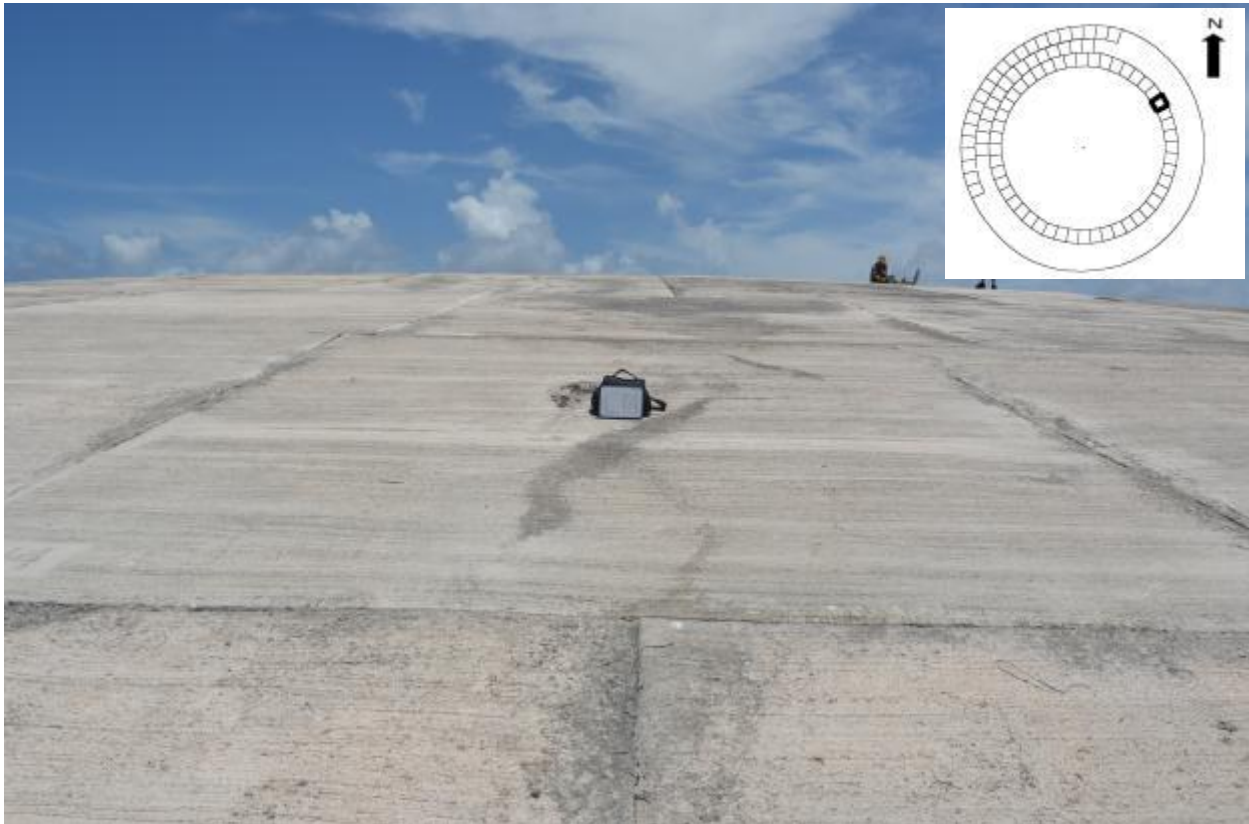
CAP SECTION LOCATION: Panel C15

No significant or obvious interior cracks extending across the top of the panel. Some minor spalling/chipping of concrete observed in the lower and top left-hand corners of the panel.

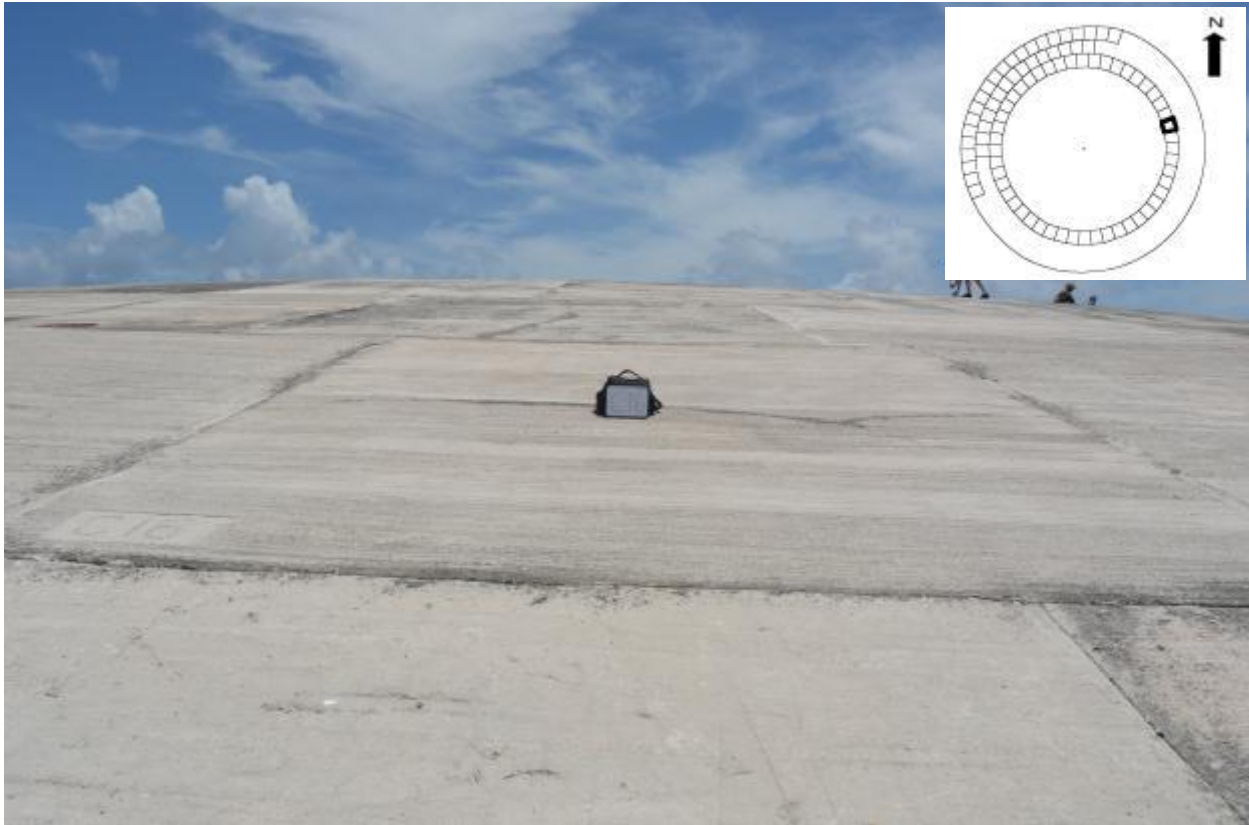
CAP SECTION LOCATION: Panel C17

No significant or obvious interior cracks extending across the top of the panel. Rooting vegetation removed from along the panel seams. Some minor spalling/chipping of concrete observed in the lower right-hand corner of the panel.

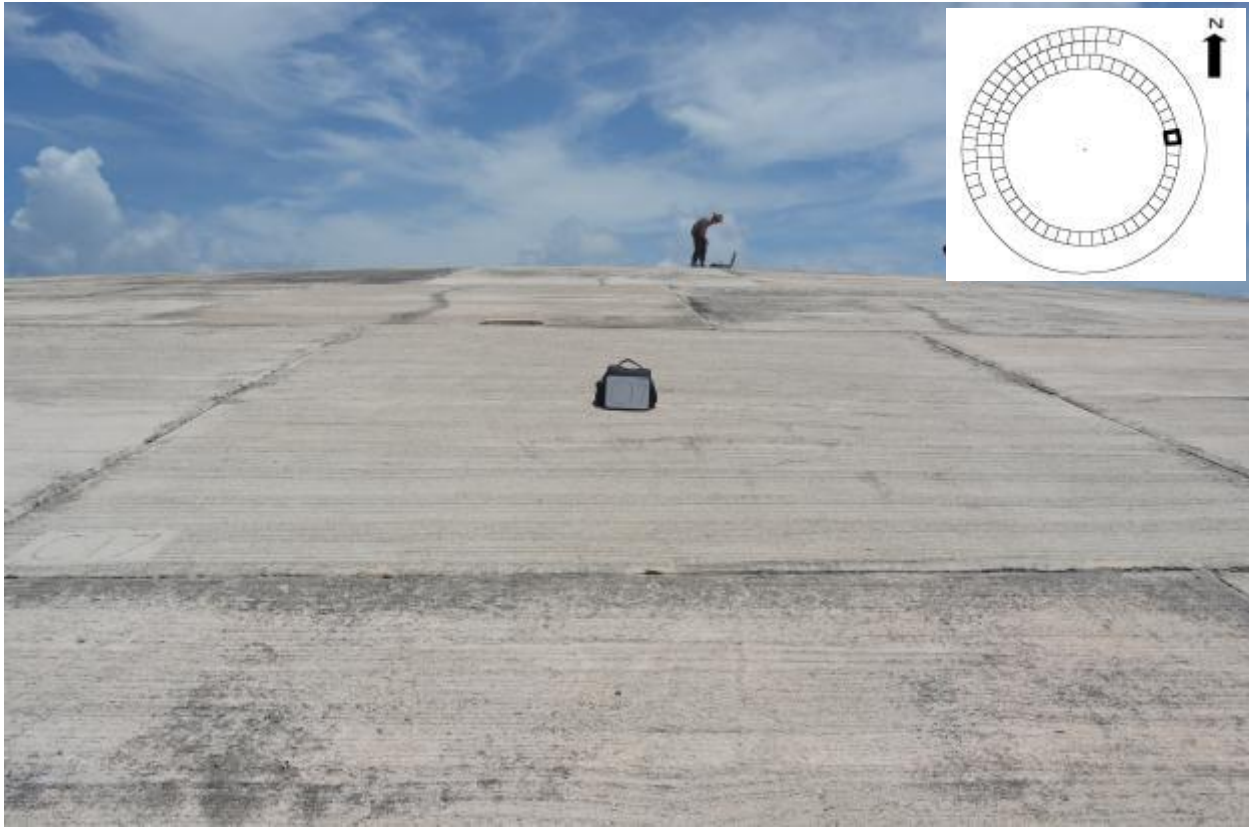
CAP SECTION LOCATION: Panel C18

No significant or obvious interior cracks extending across the top of the panel. The panel has a rough and weathered appearance, especially in the upper portion of the panel. Rooting vegetation removed from along the panel seams.

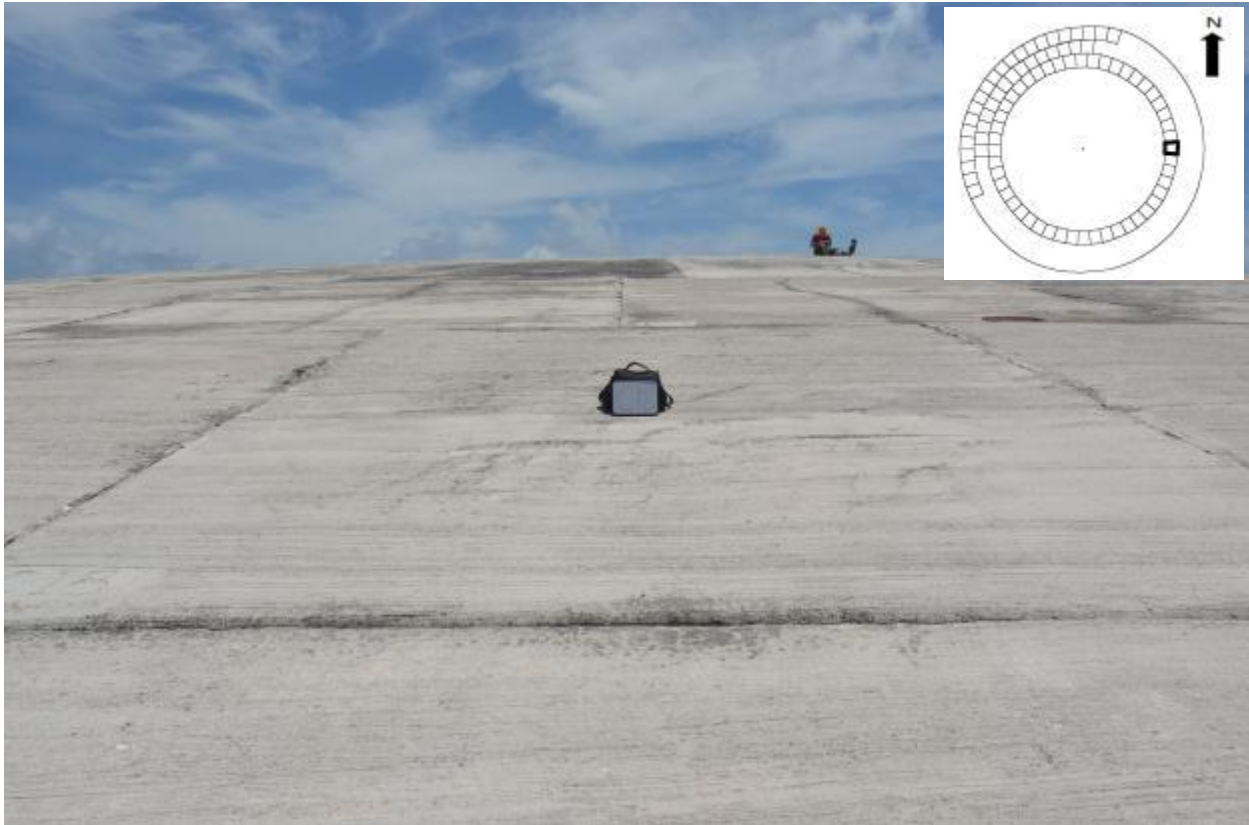
CAP SECTION LOCATION: Panel C19

No significant or obvious interior cracks extending across the top of the panel. Some minor spalling/chipping of concrete observed in the lower right-hand corner of the panel. The right-hand side of the panel appears to be slightly undulated – perhaps due to panel settlement. This is supported by the observation that there appears to be more separation (i.e., a larger gap) along the seams compared with any adjacent panels.
