LLNL-TR-648143

A Visual Description of the Concrete Exterior of the Cactus Crater Containment Structure

Terry Hamilton

October 2013

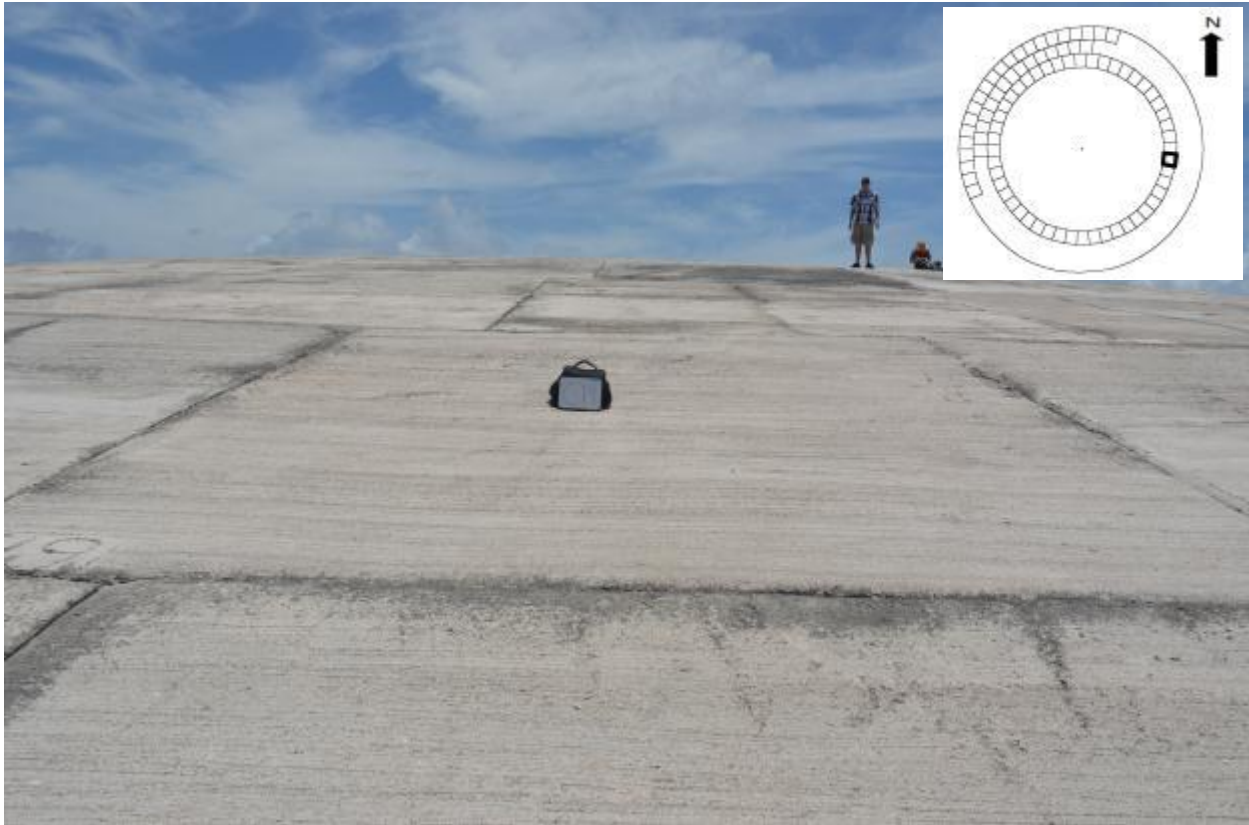
CAP SECTION LOCATION: Panel C20

No significant or obvious interior cracks extending across the top of the panel. The panel has a rough weathered appearance, especially across the upper portion of the panel. Some minor spalling/chipping of concrete observed in the upper right-hand corner, and along the bottom seam of the panel – especially around the intersecting corner with panel B24/B25 on the ring row below.

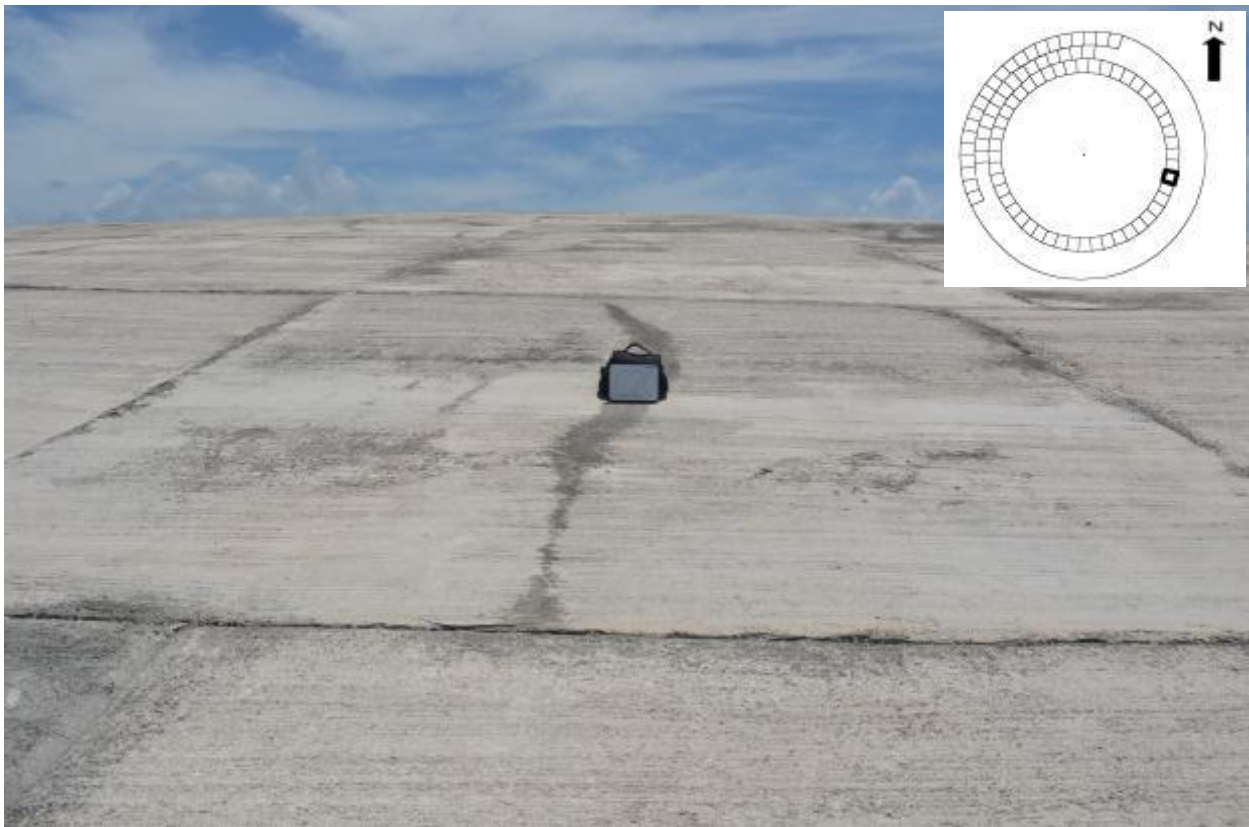
CAP SECTION LOCATION: Panel C21

No significant or obvious interior cracks extending across the top of the panel. Minor spalling/cracking of concrete observed in the upper left-hand corner and along the right side of the bottom seam.

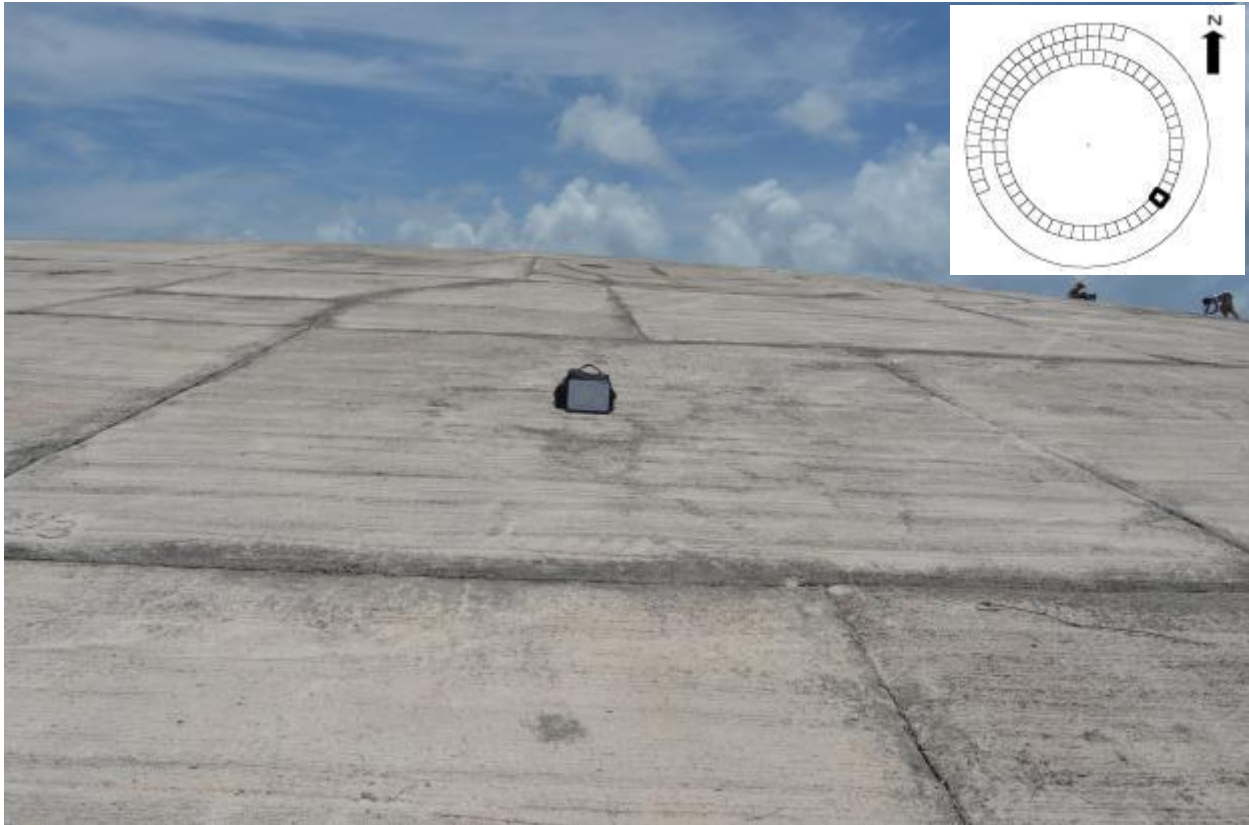
CAP SECTION LOCATION: Panel C22_duplicate (position C24)

The panel occupies position C24. Cracks along the seam lines appear to be deeper and more obvious. Spalling of concrete in the lower right-hand corner – the affected section of concrete occupies an area approaching 1 m². A small void about 2 centimeters deep and 2 x 1-1.5 centimeters in area was also observed on the upper right-hand side of the panel.

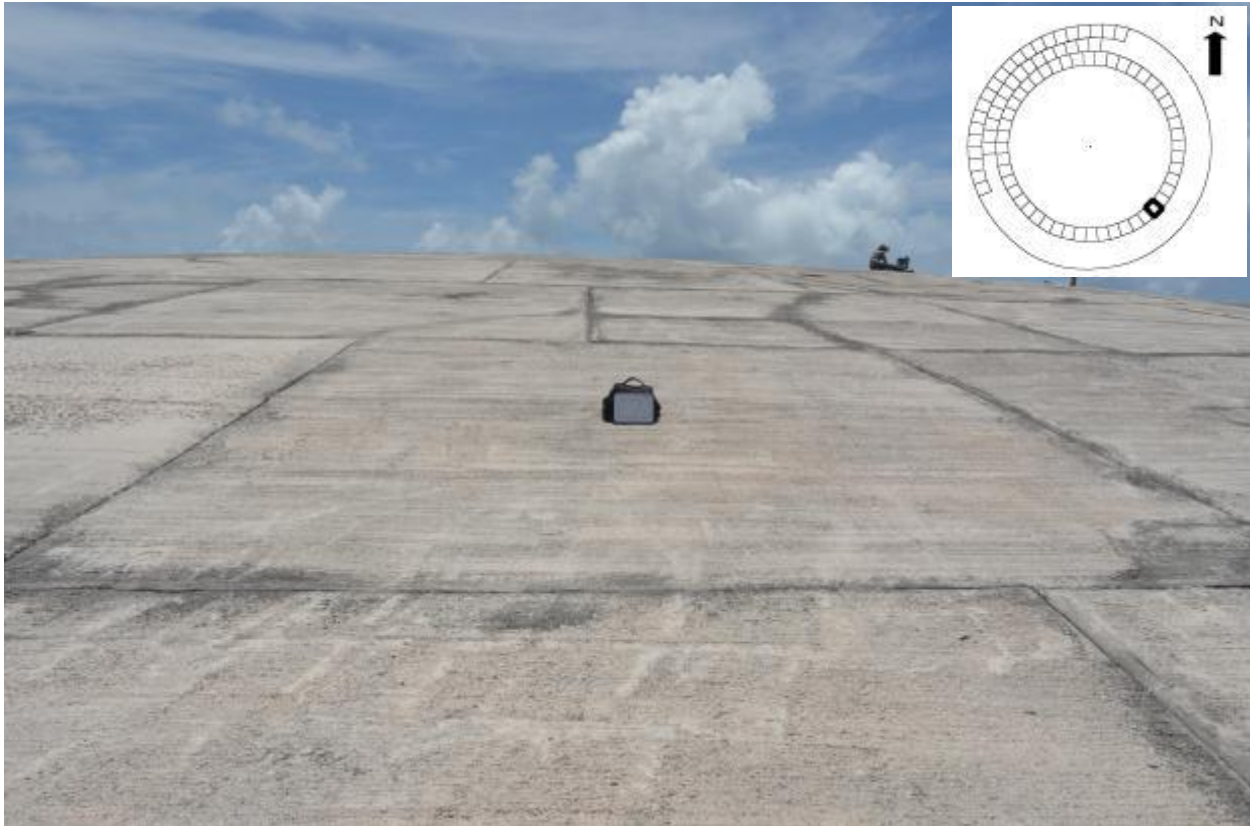
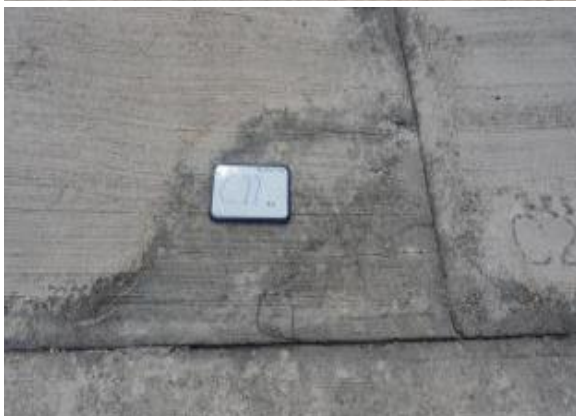
CAP SECTION LOCATION: Panel C25

No significant or obvious interior cracks extending across the top of the panel. The cracks along the panel joints appear to be deeper and more obvious compared with panels in adjacent ring rows. Some spalling/cracking of concrete observed in the lower right-hand corner of the panel.

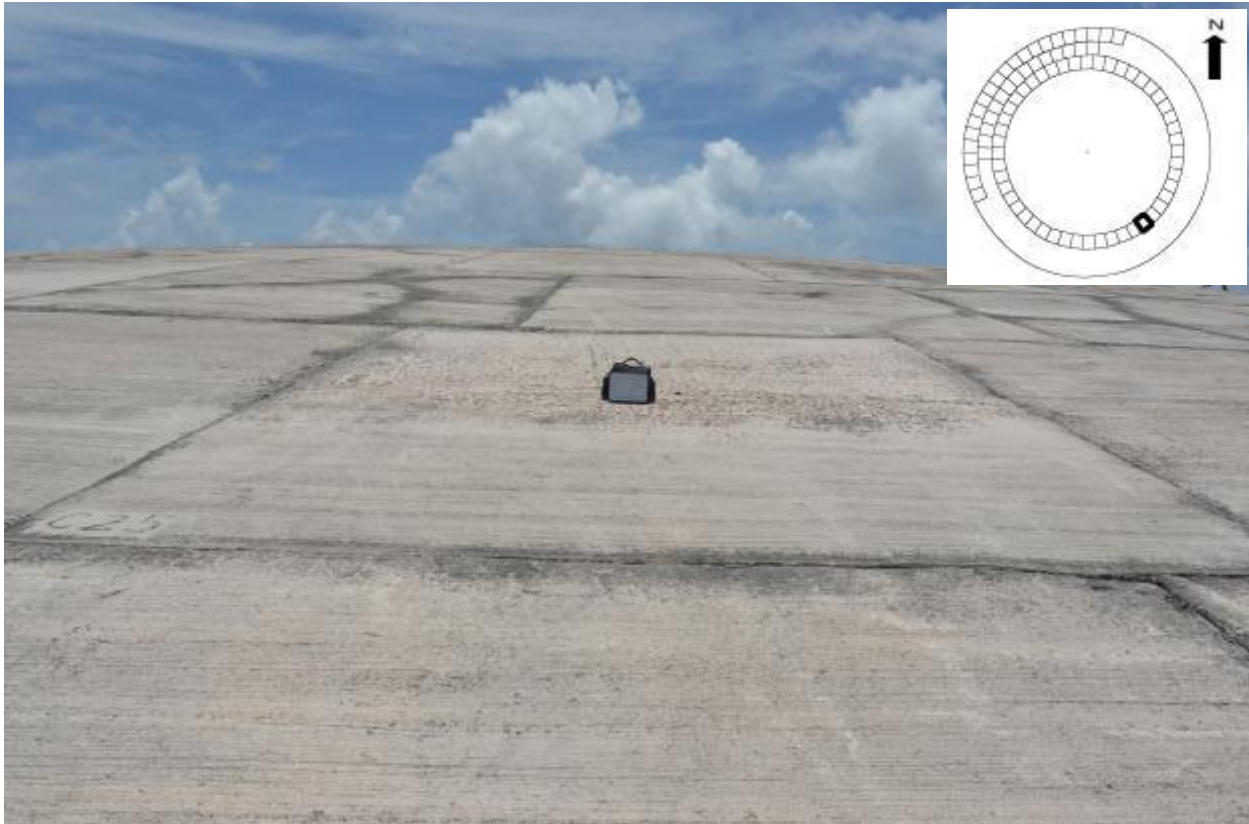
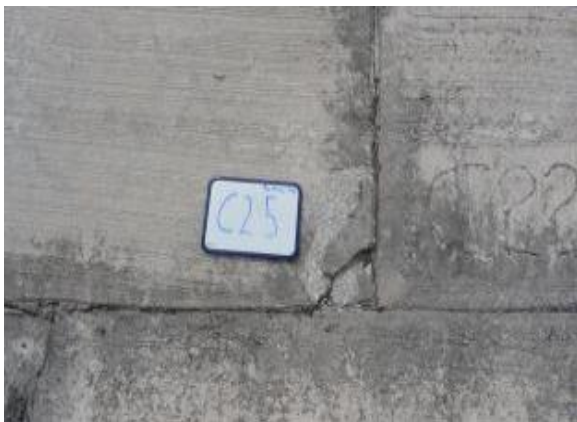
CAP SECTION LOCATION: Panel C26

No significant or obvious interior cracks extending across the top of the panel. Very minor spalling of concrete observed in the lower right-hand corner of the panel. Rooting vegetation removed from along the panel seams.

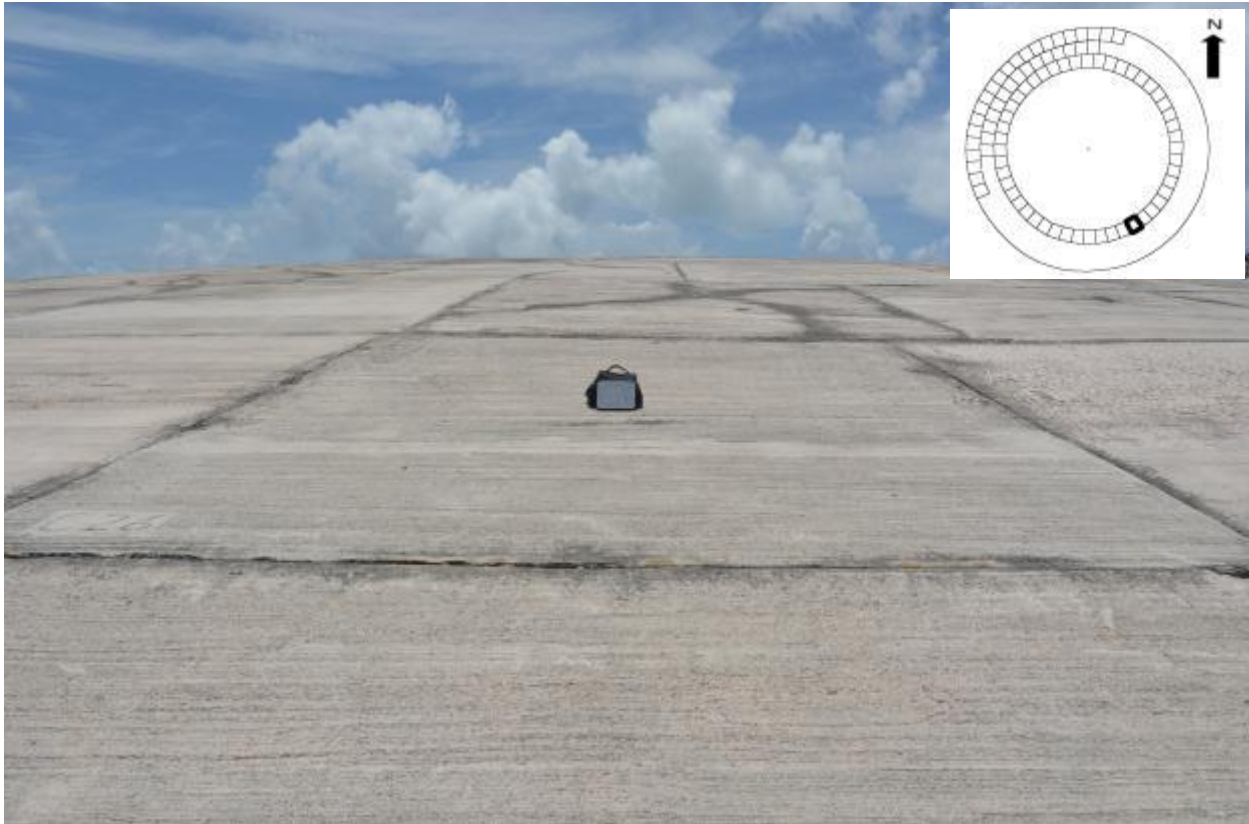
CAP SECTION LOCATION: Panel C27

No significant or obvious interior cracks extending across the top of the panel. Very minor spalling of concrete observed in the lower right corner. Some minor spalling of concrete is evident along the lip overhanging the upper left seam of the panel. Rooting vegetation removed from along the panel seams.

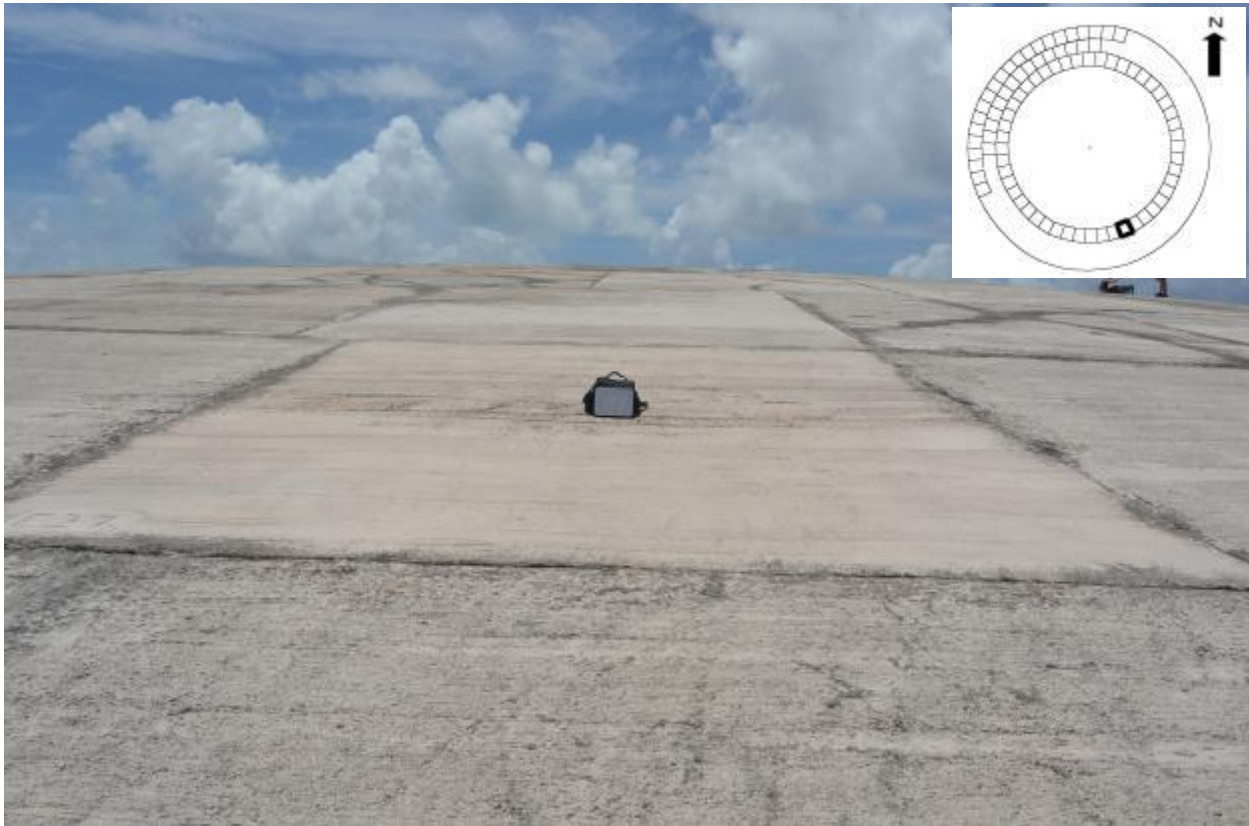
CAP SECTION LOCATION: Panel C28

No significant or obvious interior cracks extending across the top of the panel. The cracks along the seam lines appear to be deeper and more obvious compared with panels in adjacent ring rows. Very minor spalling of concrete observed in the lower right-hand corner of the panel. Some minor spalling of concrete observed along the bottom seam forming the intersecting corner between panel B33 and B34 below.

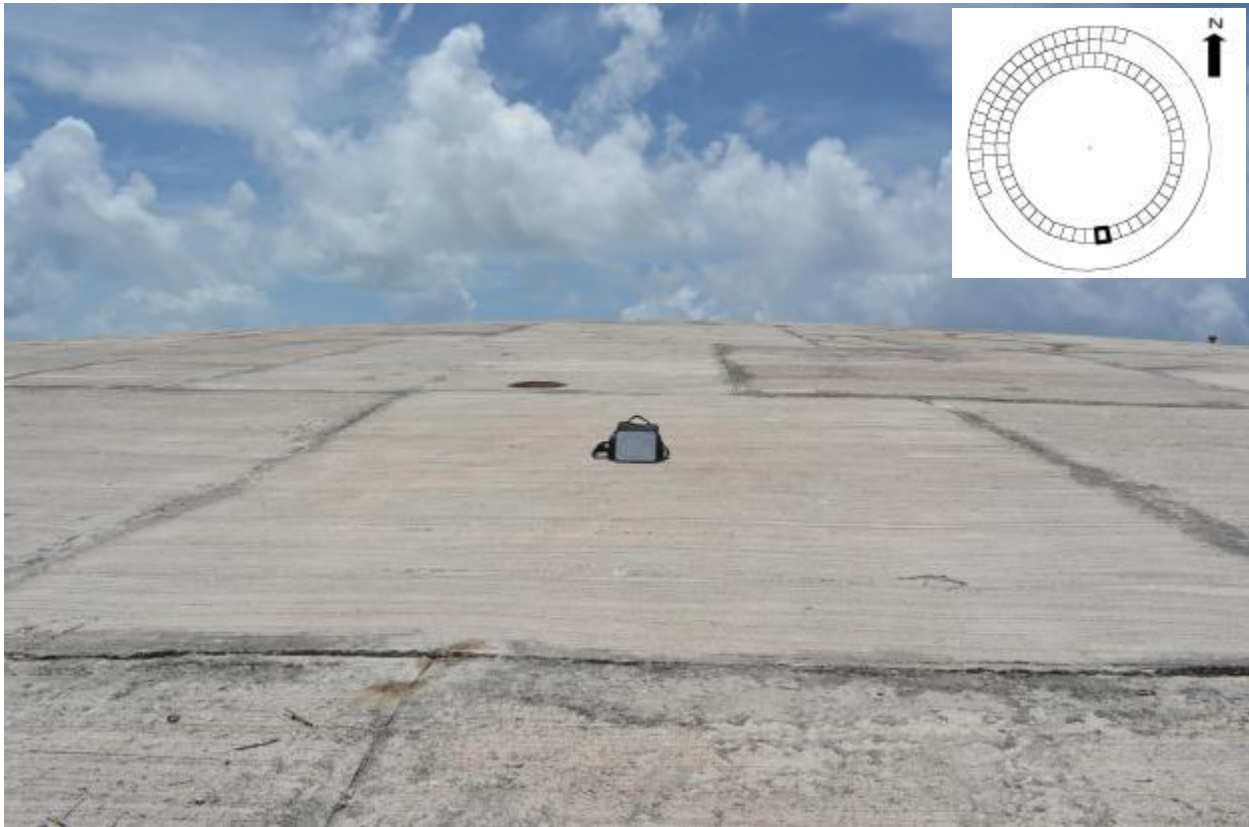
CAP SECTION LOCATION: Panel C30

No significant or obvious interior cracks extending across the top of the panel. The cracks along the panel joints appear to be deeper and more obvious compared with panels in adjacent ring rows.

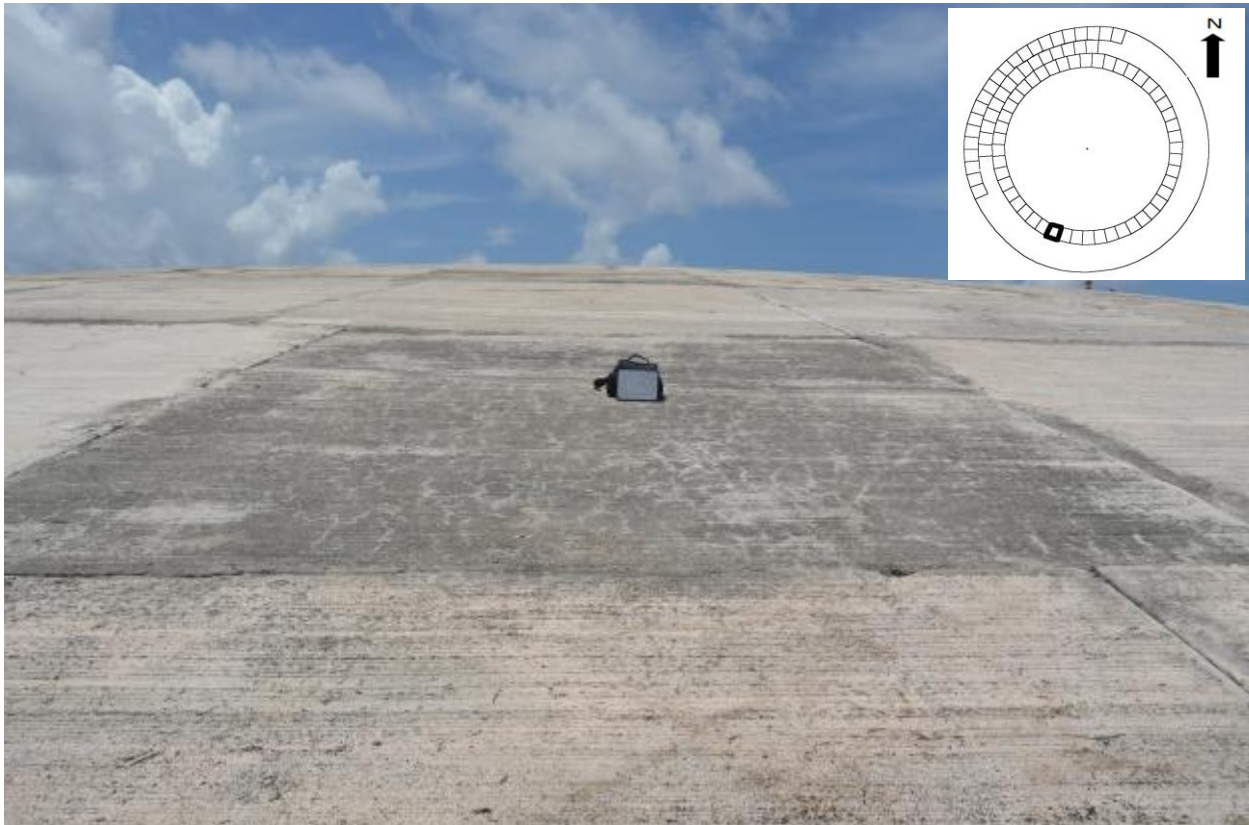
CAP SECTION LOCATION: Panel C34

No significant or obvious interior cracks extending across the top of the panel. The cracks along the panel joints appear to be deeper and more obvious compared with those appearing around panels on adjacent ring rows. Some spalling/cracking of concrete observed in the upper right-hand corner of the panel.

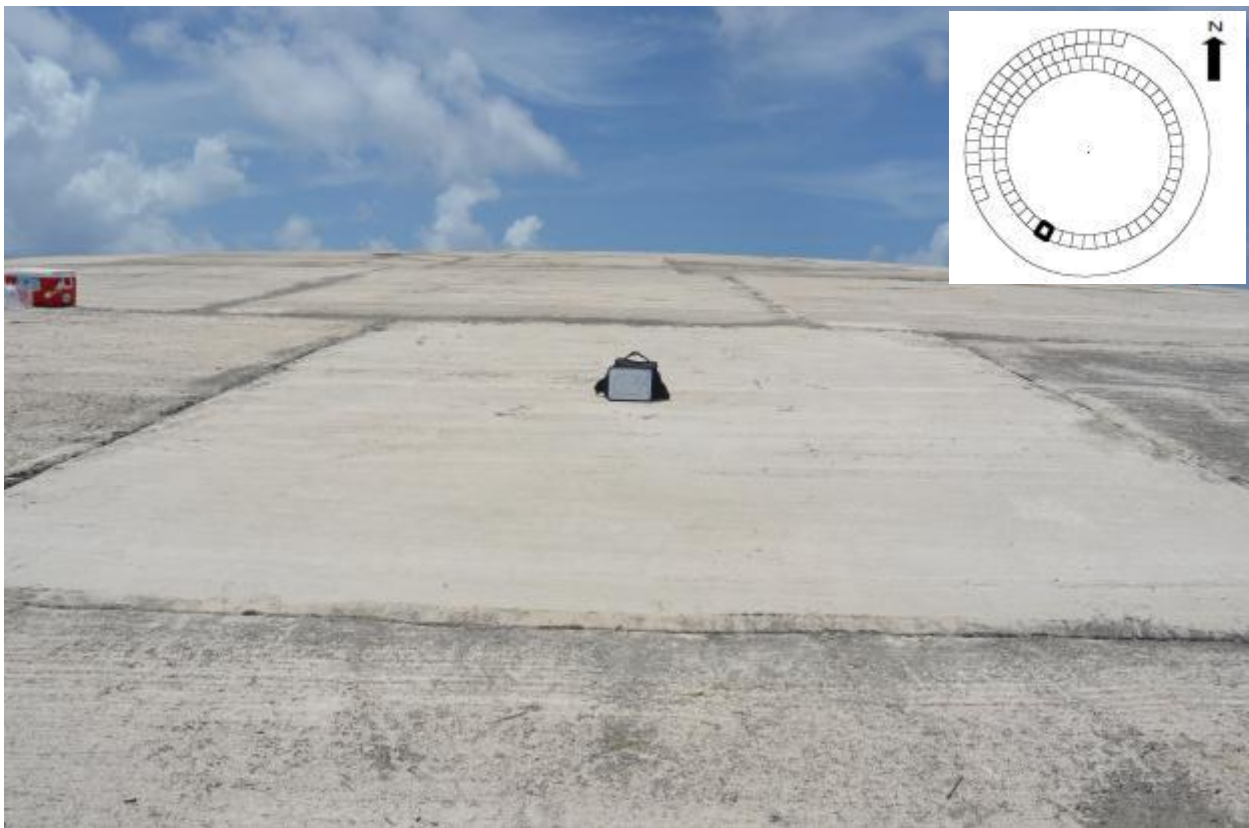
CAP SECTION LOCATION: Panel C35

No significant or obvious interior cracks extending across the top of the panel. Panel has a rough and weathered appearance. The cracks along the panel joints appear to be deeper and more obvious compared with those appearing around panels on adjacent ring rows. Some spalling/cracking of concrete observed in the upper left-hand corner of the panel. Rooting vegetation removed from along the panel seams.

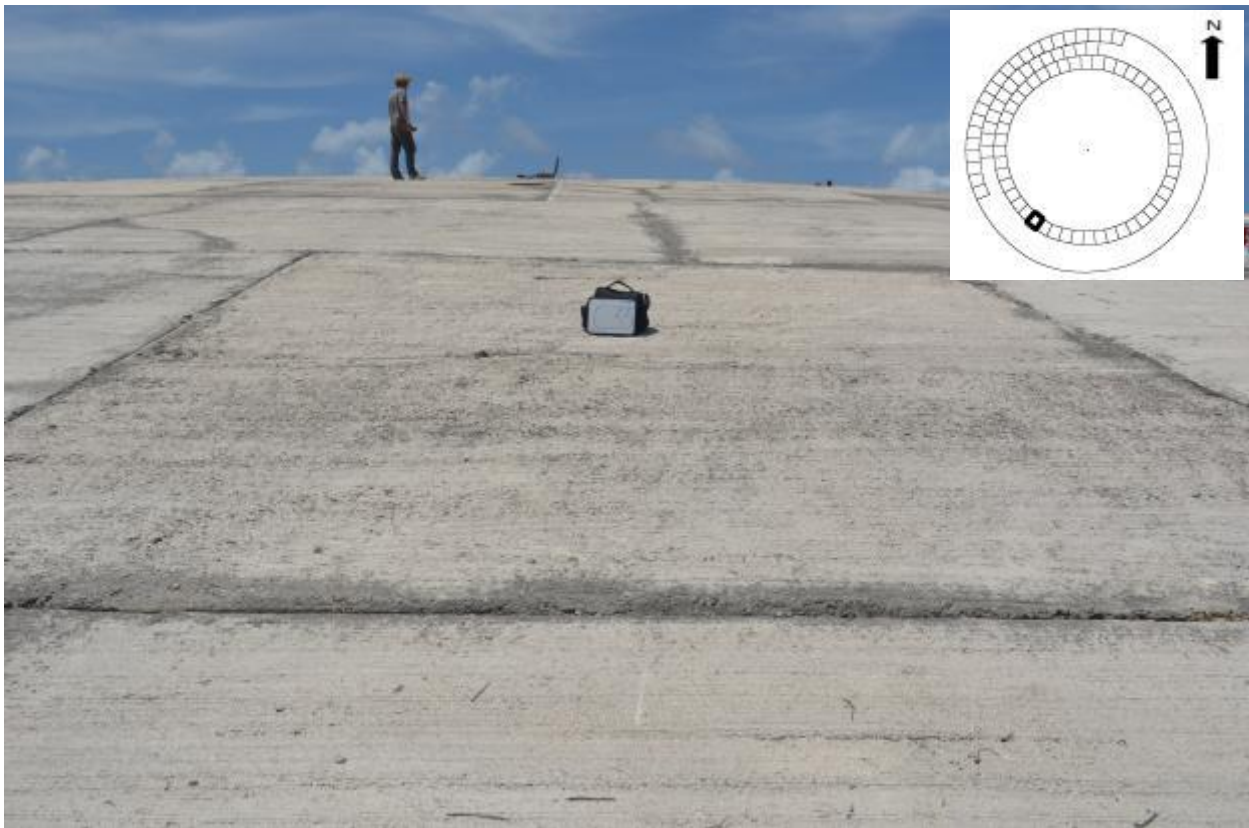
CAP SECTION LOCATION: Panel C36

No significant or obvious interior cracks extending across the top of the panel. Some spalling/cracking of concrete observed in the upper right-hand corner of the panel. Rooting vegetation removed from along the panel seams. This panel contained a capped slotted PVC pipe bore-hole (CD-17) from the 1980 NAS investigation. The bore-hole was re-established during this visual survey for possible use as a groundwater sampling well.

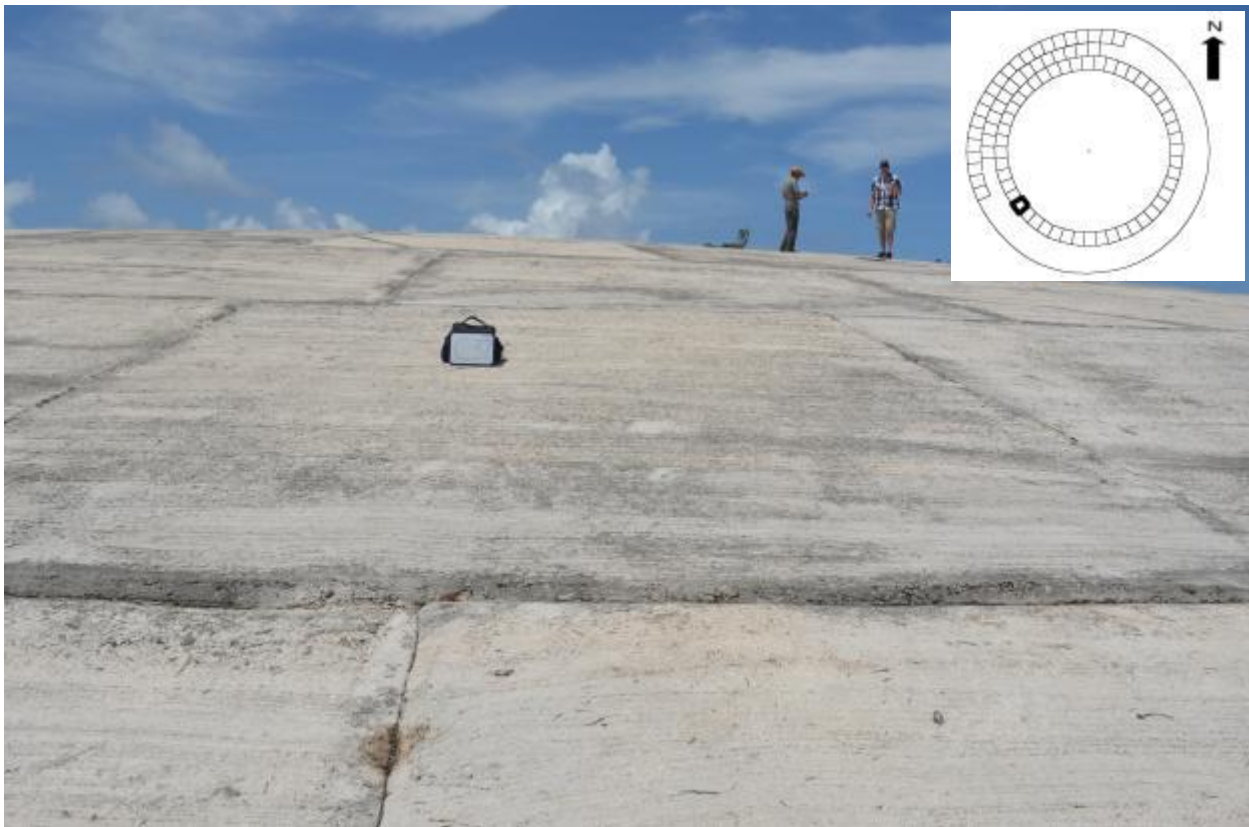
CAP SECTION LOCATION: Panel C38

No significant or obvious interior cracks extending across the top of the panel. Rooting vegetation removed from along the panel seams. Some spalling/cracking of concrete observed along the upper seam of the panel.

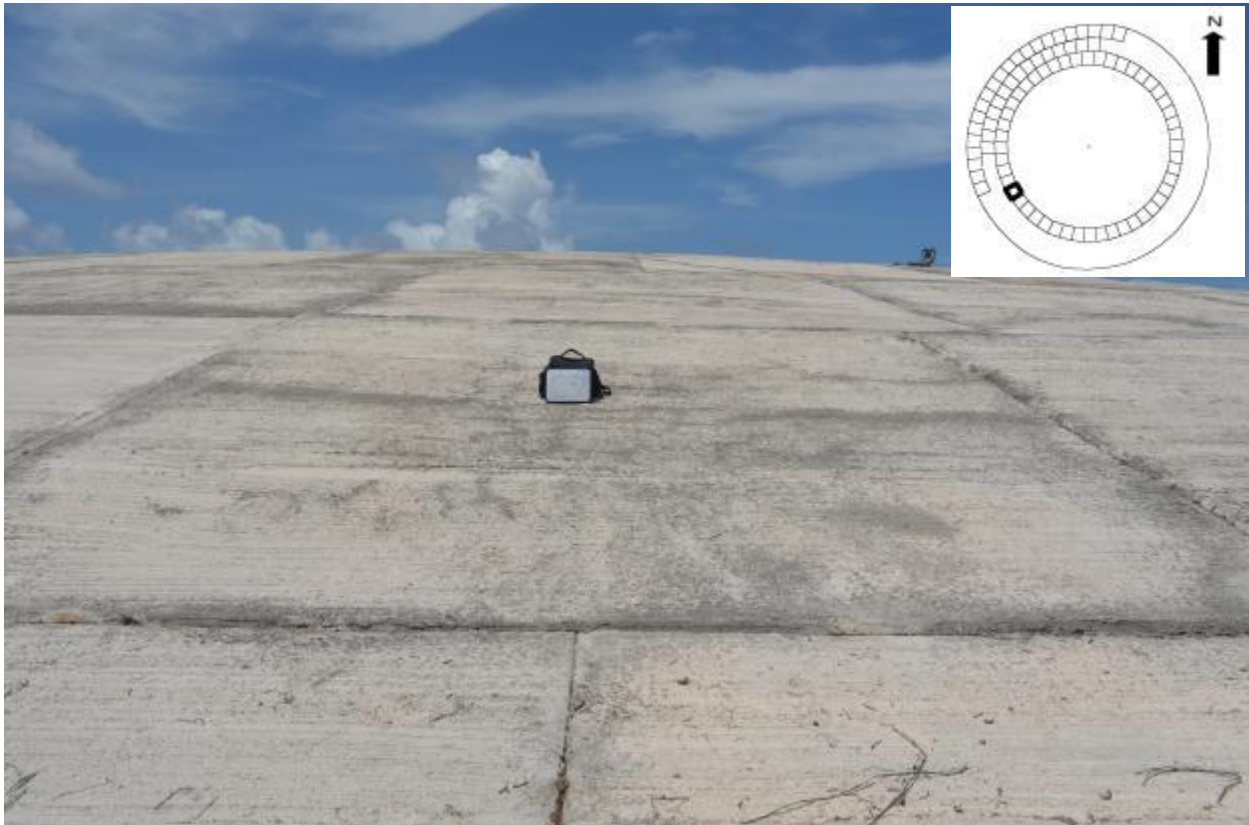
CAP SECTION LOCATION: Panel C39

No significant or obvious interior cracks extending across the top of the panel. Rooting vegetation removed from along the panel seams. Some spalling/cracking of concrete observed in the lower left-hand corner of the panel.

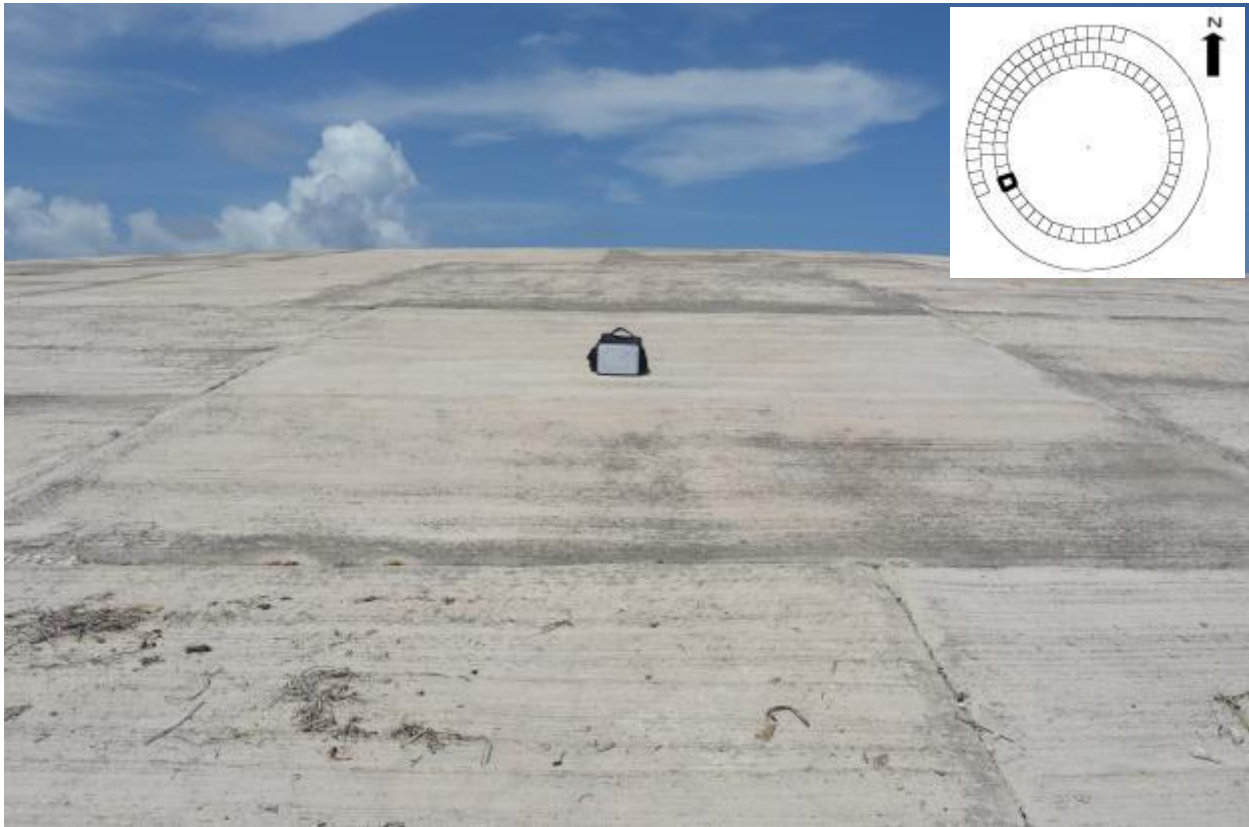
CAP SECTION LOCATION: Panel C40

Rooting vegetation removed from along the panel seams. Some minor surface cracks traversing across the panel that appear to coincide with the dark shaded areas shown in the photo below.

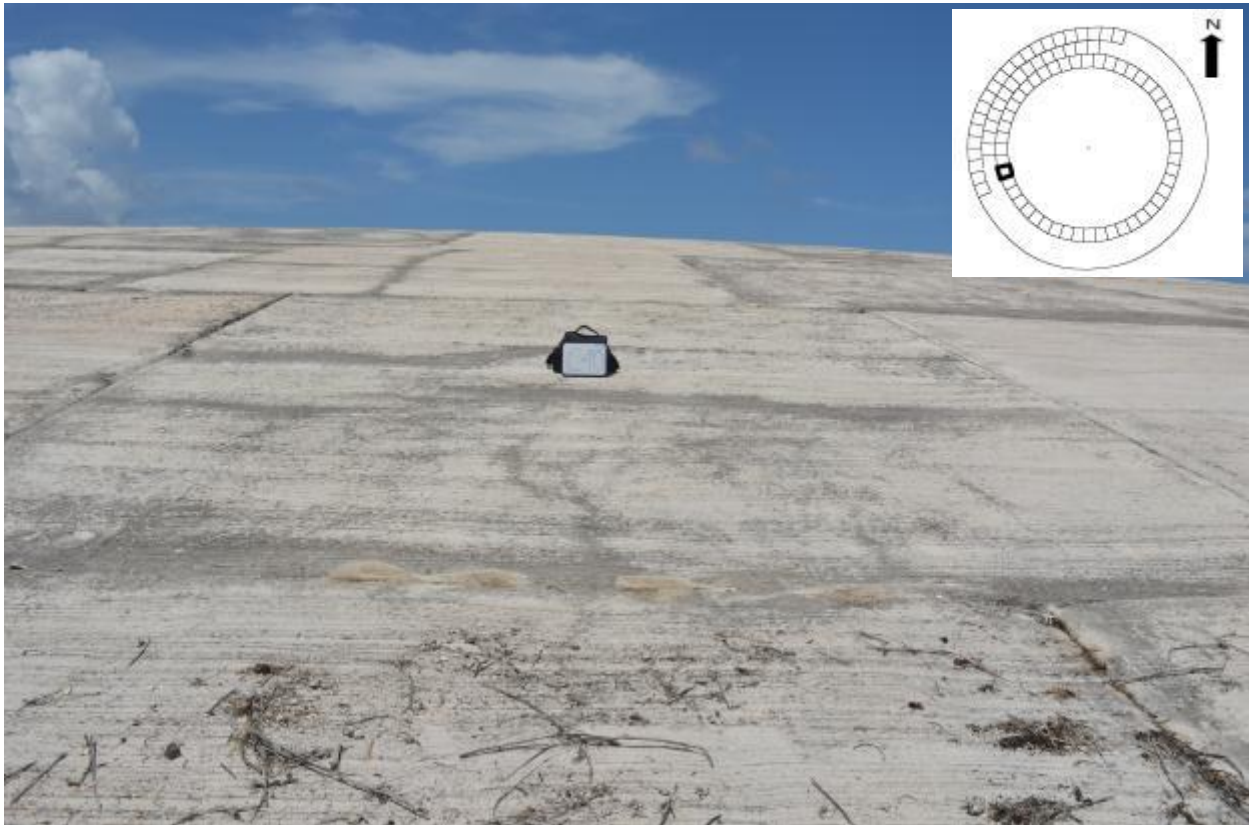
CAP SECTION LOCATION: Panel C41

The panel has a rough and weathered appearance across the upper portion of the panel. Some spalling/cracking of concrete observed in the upper left-hand corner of the panel. Rooting vegetation removed from along the panel seams. Surface crack observed extending up from a central location along the bottom seam up to a distance of about 2 meters away from the top of the panel.

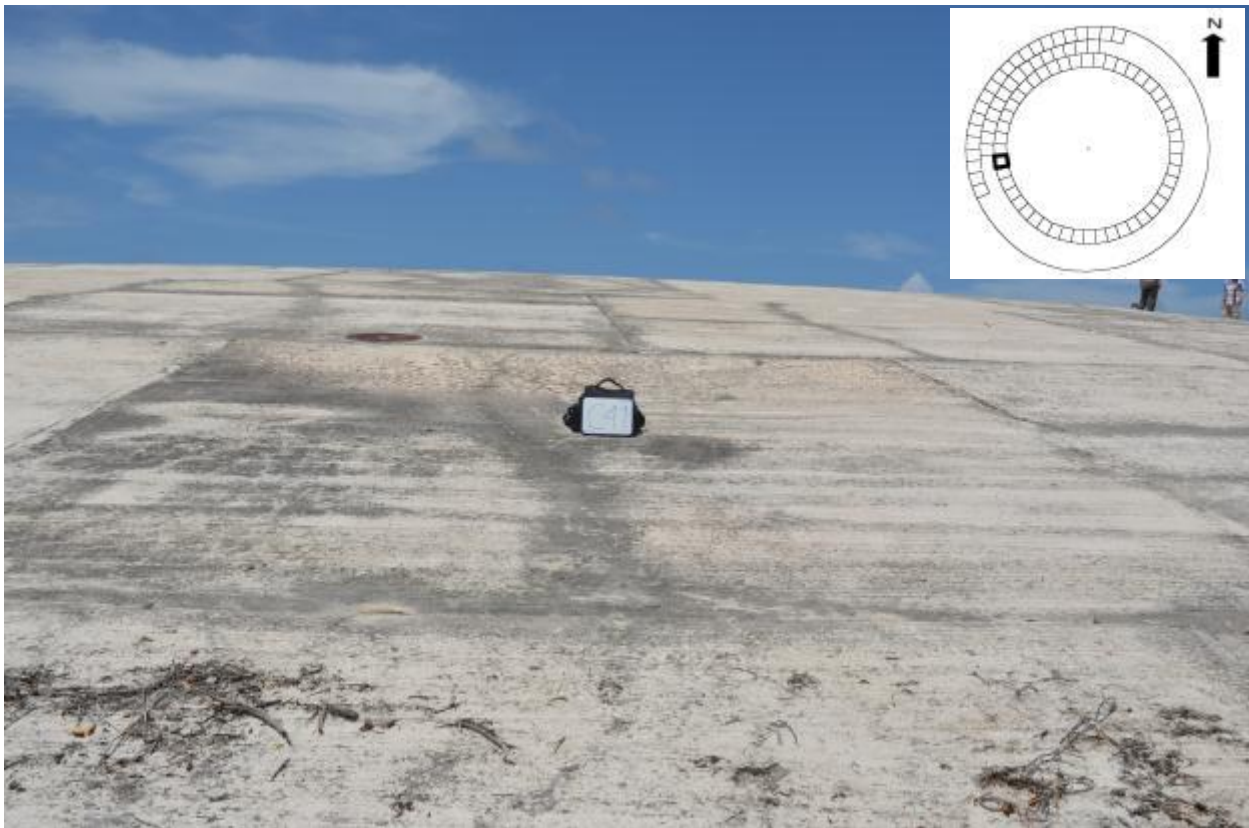
CAP SECTION LOCATION: Panel C42

No significant or obvious interior cracks extending across the top of the panel. Rooting vegetation removed from along the panel seams.

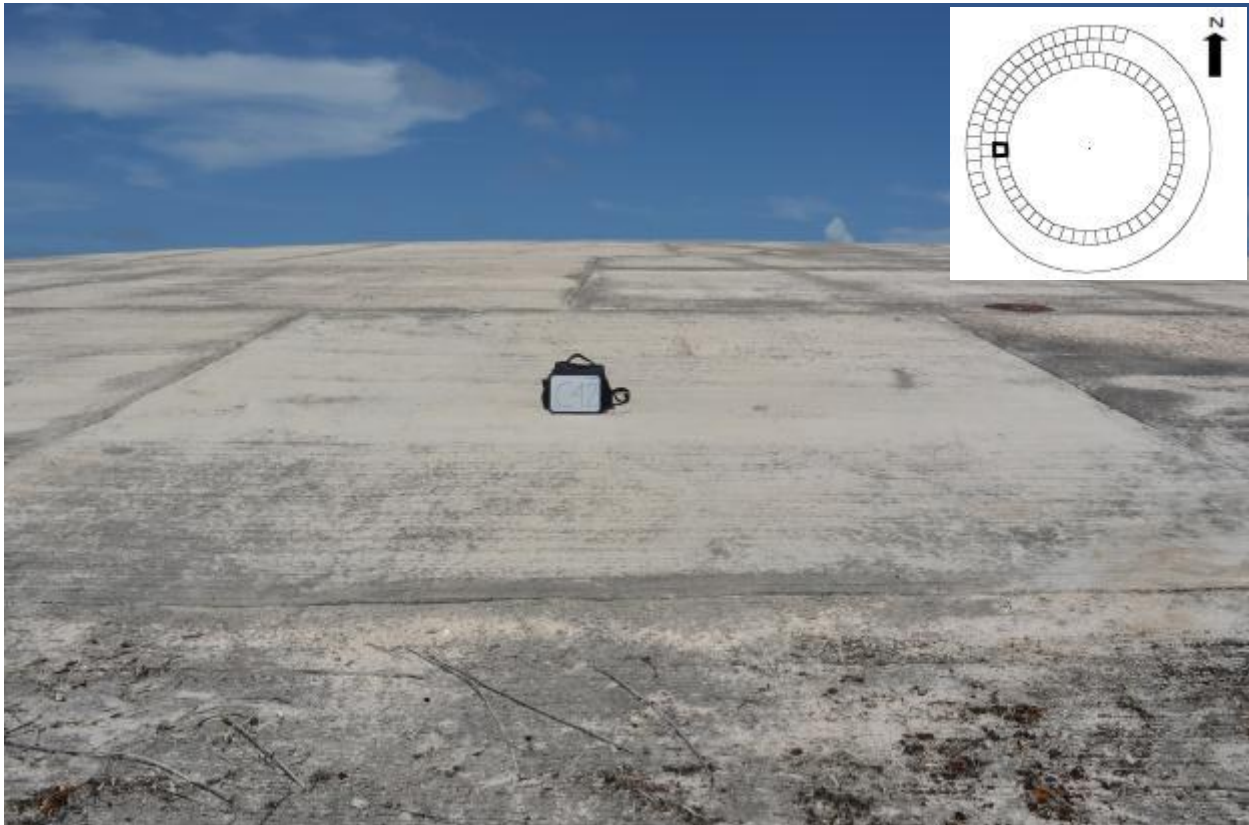
CAP SECTION LOCATION: Panel C43

Significant spalling of concrete observed in the upper left corner of the panel where the chipped out piece of concrete extends down to contaminated soil – cement grout waste pile mixture below. Some minor spalling/cracking of concrete also observed in the lower right-hand corner of the panel. Panel recommended for priority repair.

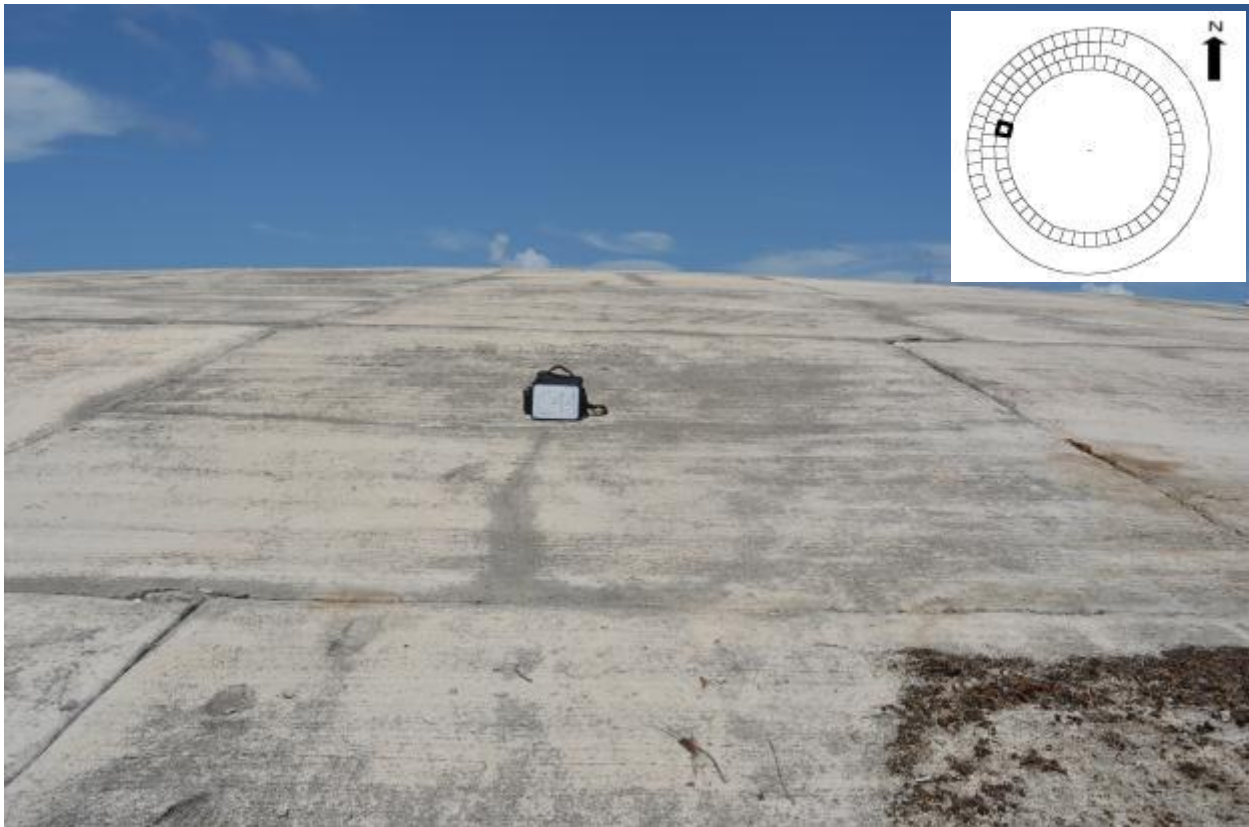
CAP SECTION LOCATION: Panel C45

The panel has a rough and weathered appearance. Also, the cracks along the panel joints appear to be deeper and more obvious compared with those appearing around panels on adjacent ring rows. A visible crack can be seen originating at intersecting corner between panel B57 and B58 on the bottom seam and extending up the panel for a distance of about 1 meter. There is also an visible crack traversing across the panel.

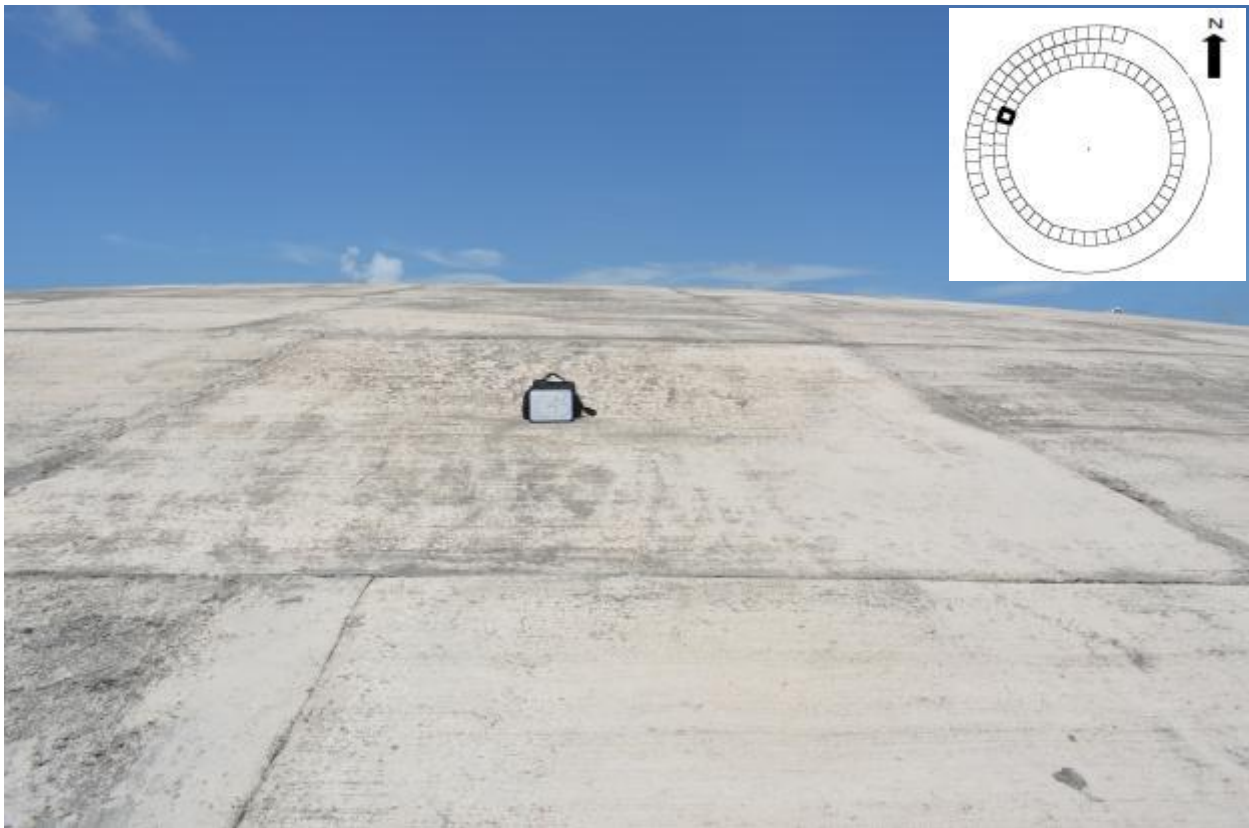
CAP SECTION LOCATION: Panel C46

No significant or obvious interior cracks extending across the top of the panel. Rooting vegetation removed from along the panel seams. Some spalling/cracking of concrete observed in the upper left-hand corner of the panel.

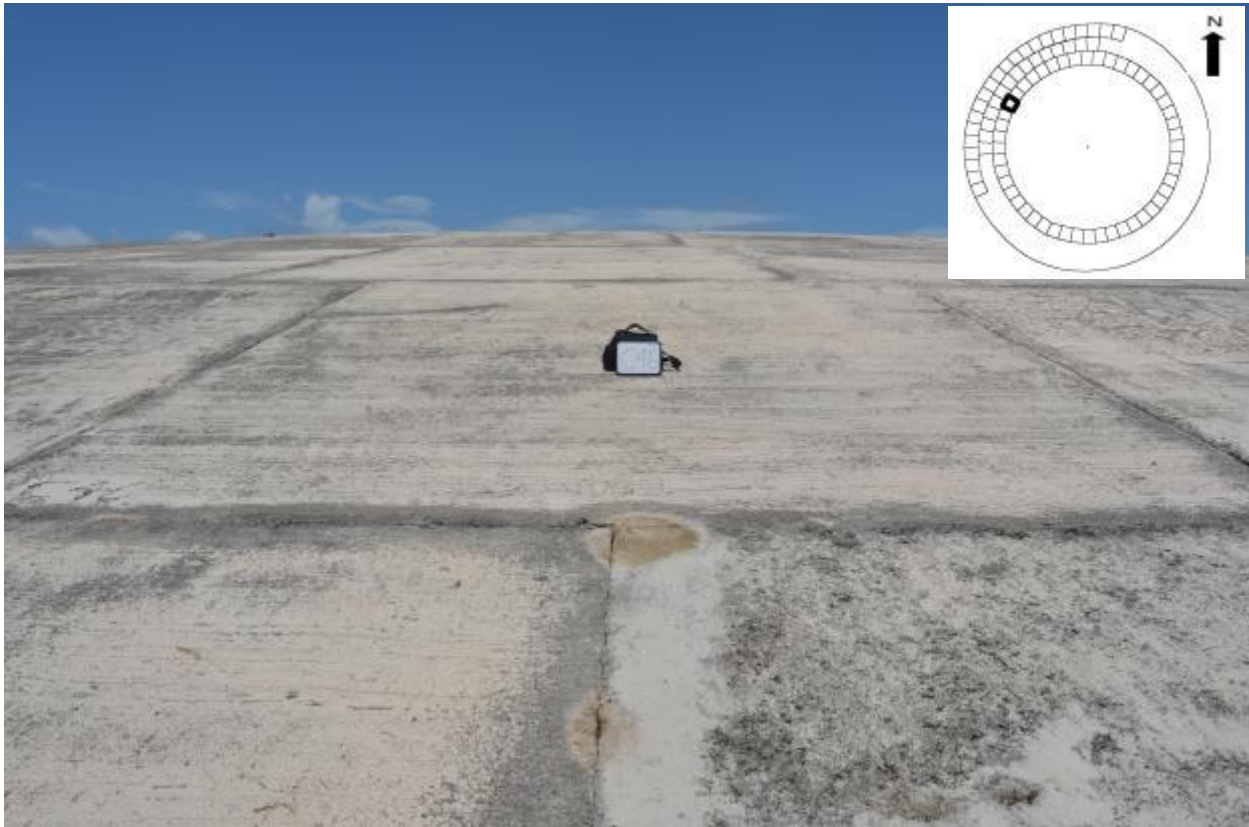
CAP SECTION LOCATION: Panel C47

No significant or obvious interior cracks extending across the top of the panel. The panel has a rough and weathered appearance. The cracks along the panel joints appear to be deeper and more obvious compared with those appearing around panels on adjacent ring rows. Rooting vegetation removed from along the panel seams.
