LLNL-TR-648143

A Visual Description of the Concrete Exterior of the Cactus Crater Containment Structure

Terry Hamilton

October 2013

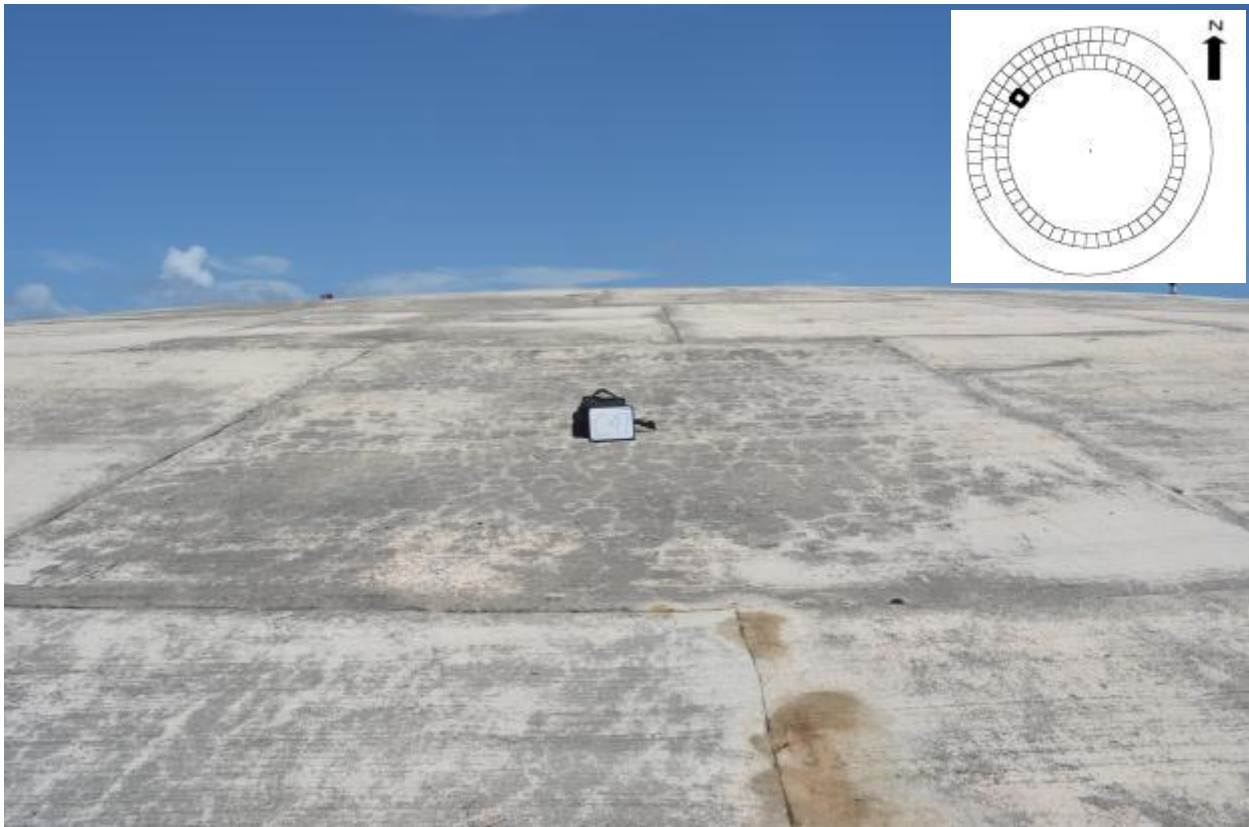
CAP SECTION LOCATION: Panel C48

No significant or obvious interior cracks extending across the top of the panel. The cracks along the panel joints appear to be deeper and more obvious compared with those appearing around panels on adjacent ring rows. Rooting vegetation removed from along the panel seams.

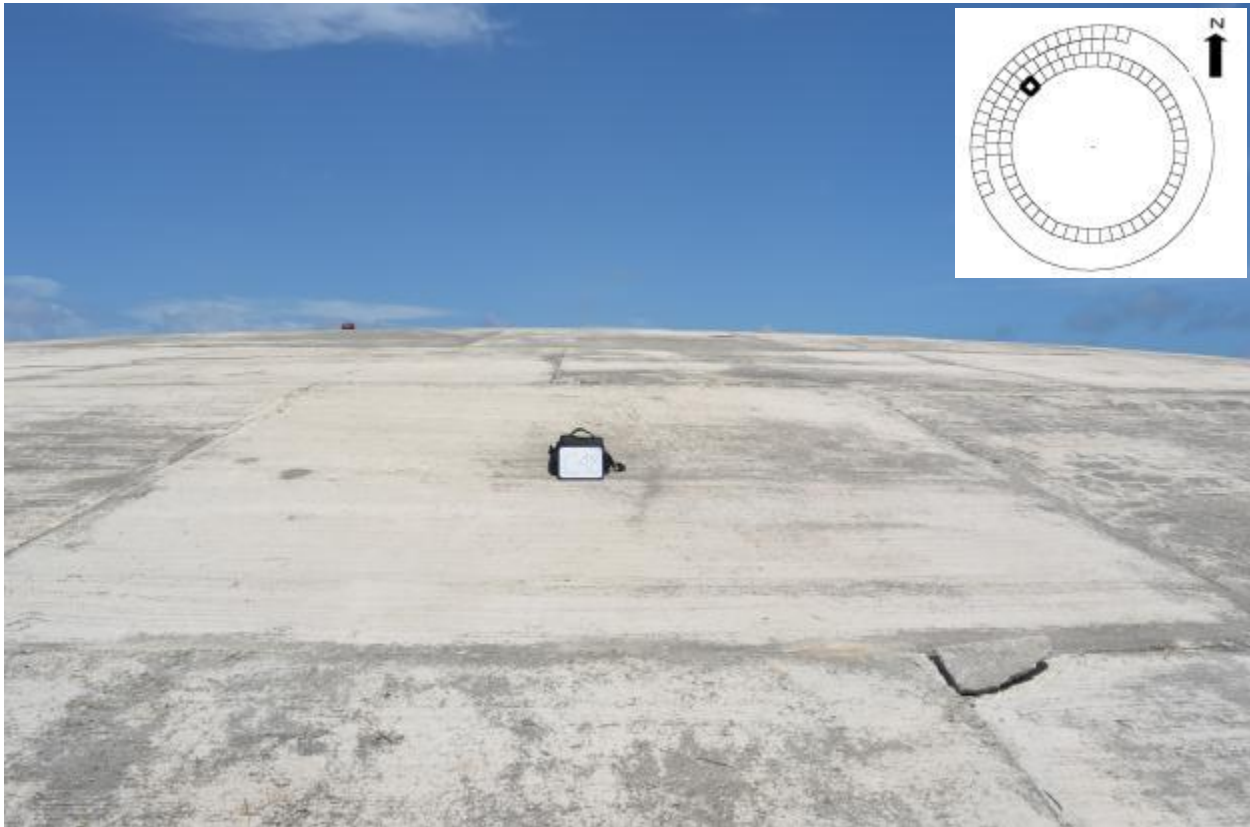
CAP SECTION LOCATION: Panel D1

Two main surface cracks extending up from the bottom seam intersecting with another crack traversing across the segment at about a mid-point up the panel. Rooting vegetation removed from along the panel seams. Minor spalling/cracking of concrete observed in the lower left-hand corner of the panel.

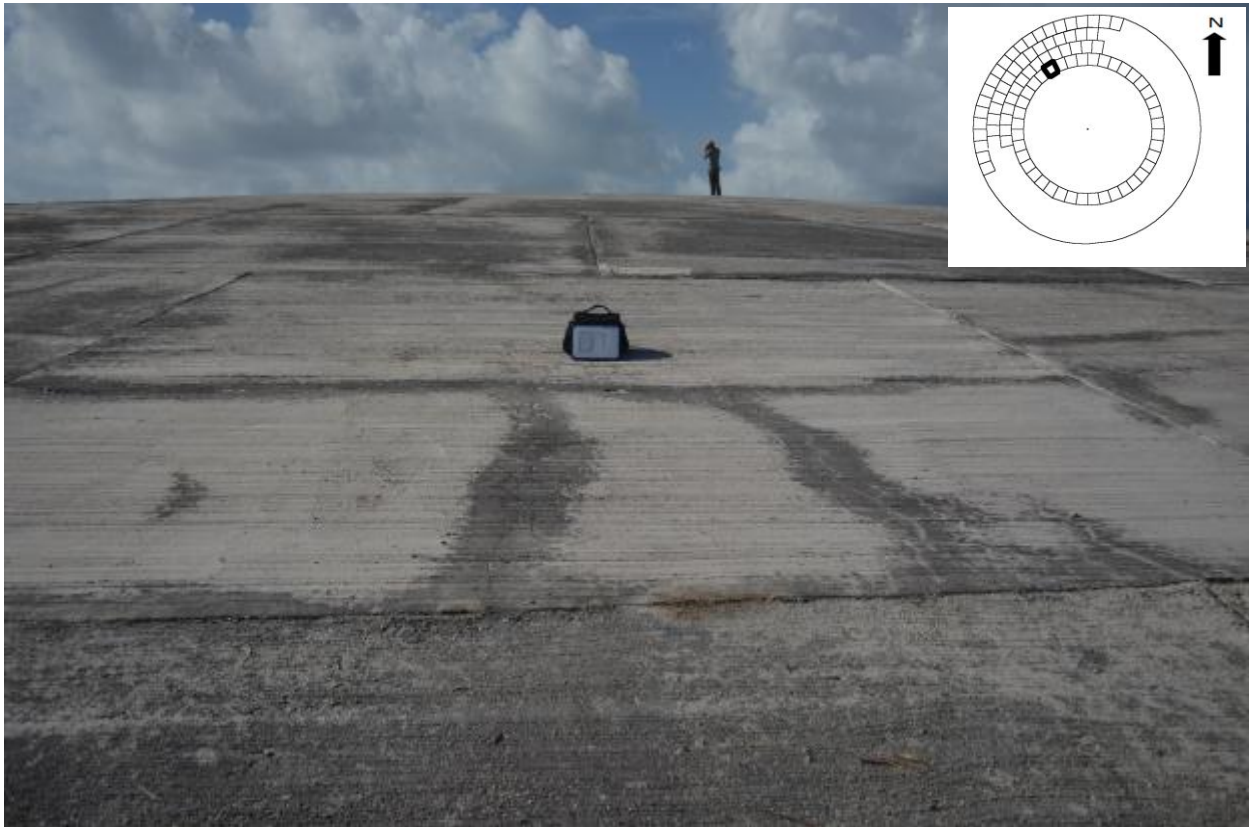
CAP SECTION LOCATION: Panel D2

Rooting vegetation removed from along the panel seams. Surface crack observed extending from left side of the bottom seam traveling up towards the upper seam intersecting at corner E1/E36 on the ring row above with a fork branching out to the left and right sides of the panel.

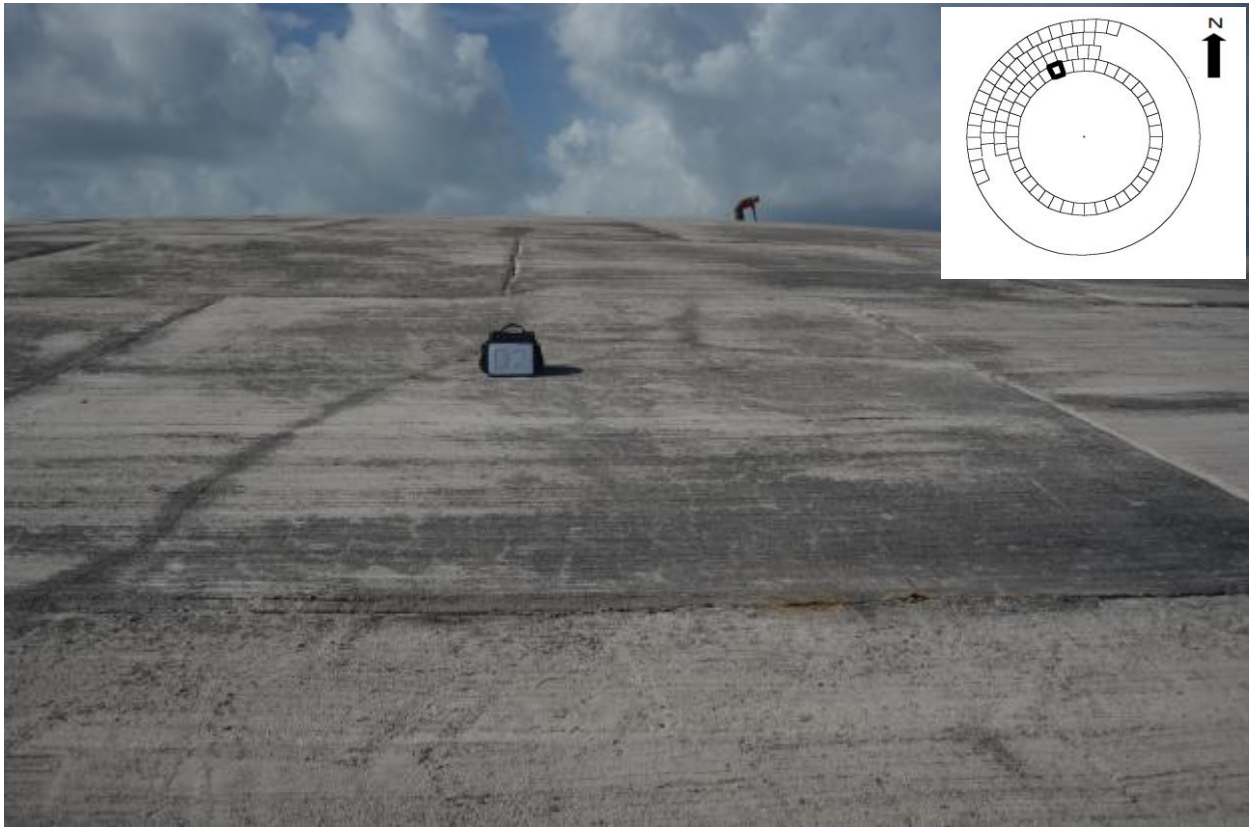
CAP SECTION LOCATION: Panel D3

No significant or obvious interior cracks extending across the top of the panel. The upper portion of the panel has a rough and weathered appearance. Rooting vegetation removed from along the panel seams. Some spalling/cracking of concrete observed in the upper left-hand corner of the panel with some indication that some post-construction work was conducted in an apparent attempt to repair the spill.

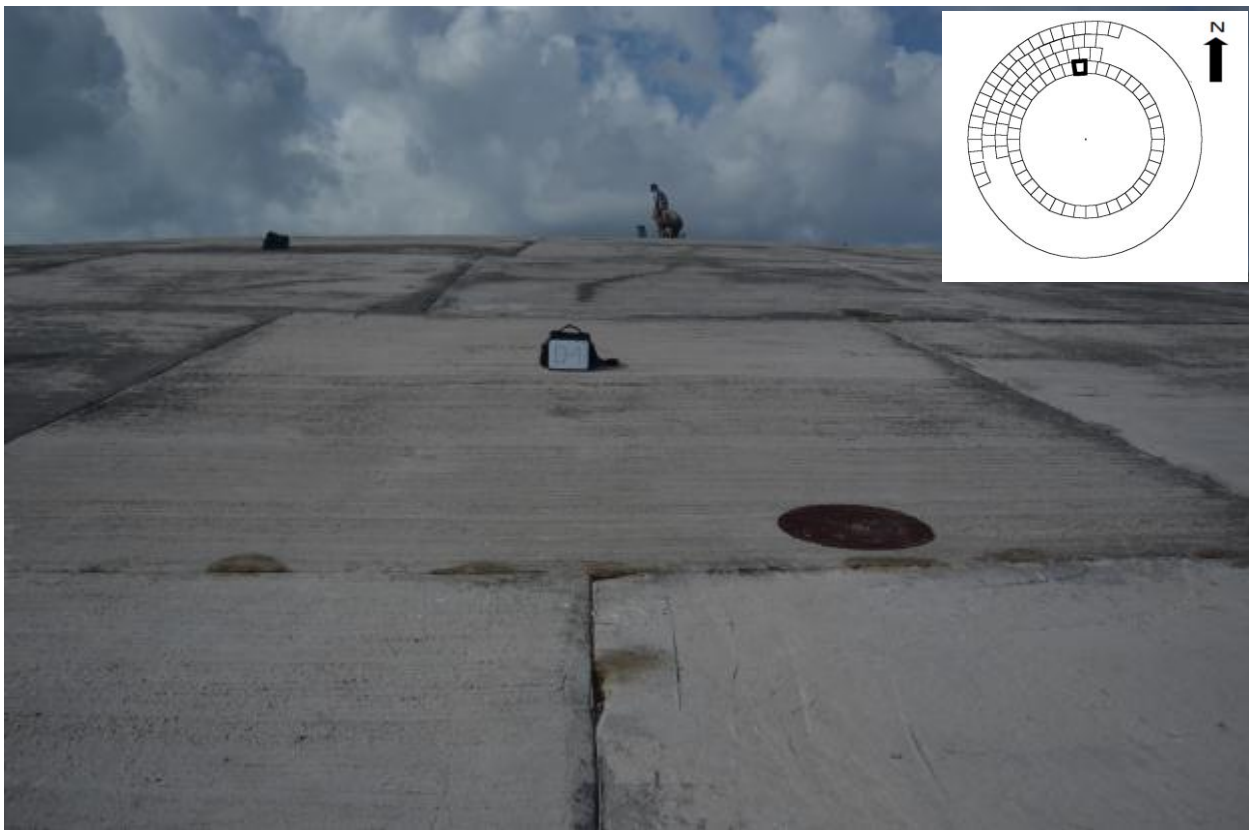
CAP SECTION LOCATION: Panel D5

No significant or obvious interior cracks extending across the top of the panel. The panel has a rough and weathered appearance. Some spalling/cracking of concrete observed in the lower right-hand corner of the panel. Rooting vegetation removed from along the panel seams. Panel contains a filled concrete bore-hole (CD-1) from the 1980 NAS investigation.

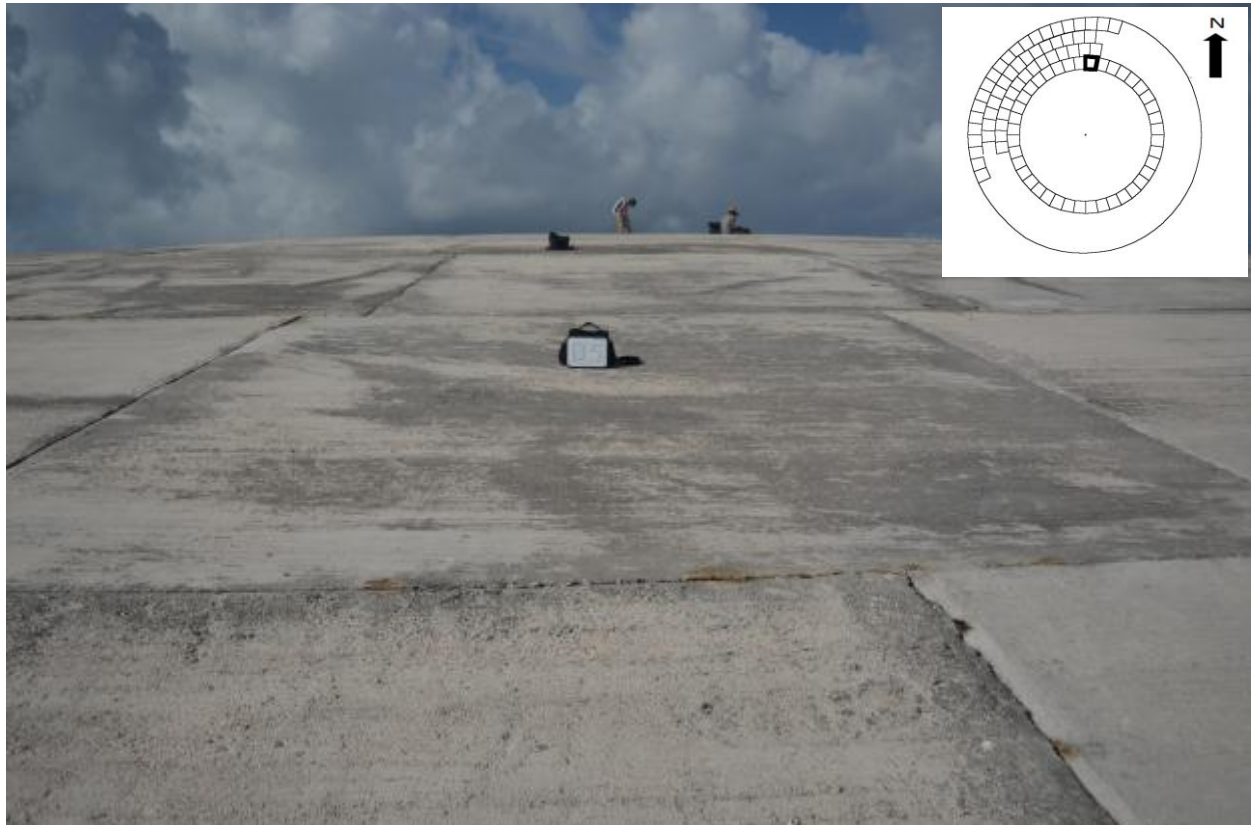
CAP SECTION LOCATION: Panel D6

A surface crack observed extending across the segment at mid-point up the panel. Rooting vegetation removed from along the panel seams.

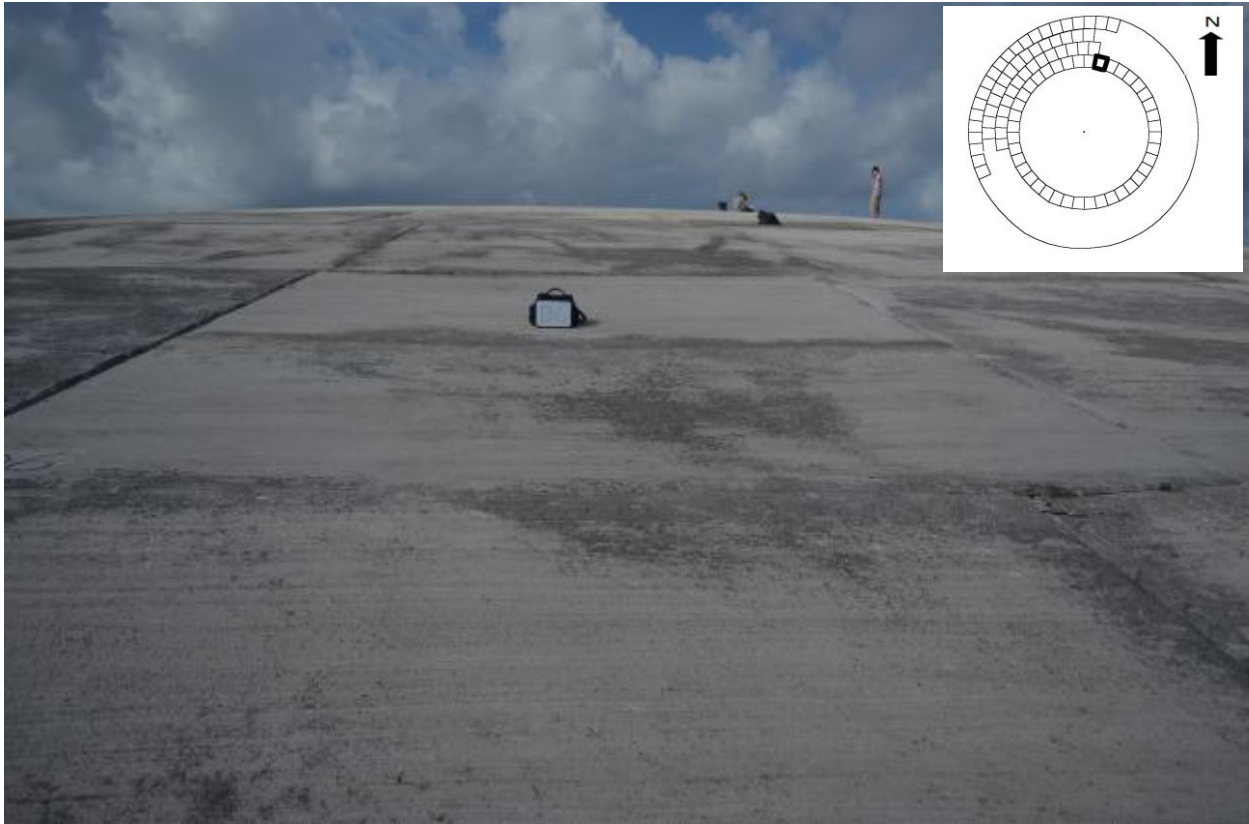
CAP SECTION LOCATION: Panel D7

No significant or obvious interior cracks extending across the top of the panel. The panel has a rough and weathered appearance. Rooting vegetation removed from along the panel seams.

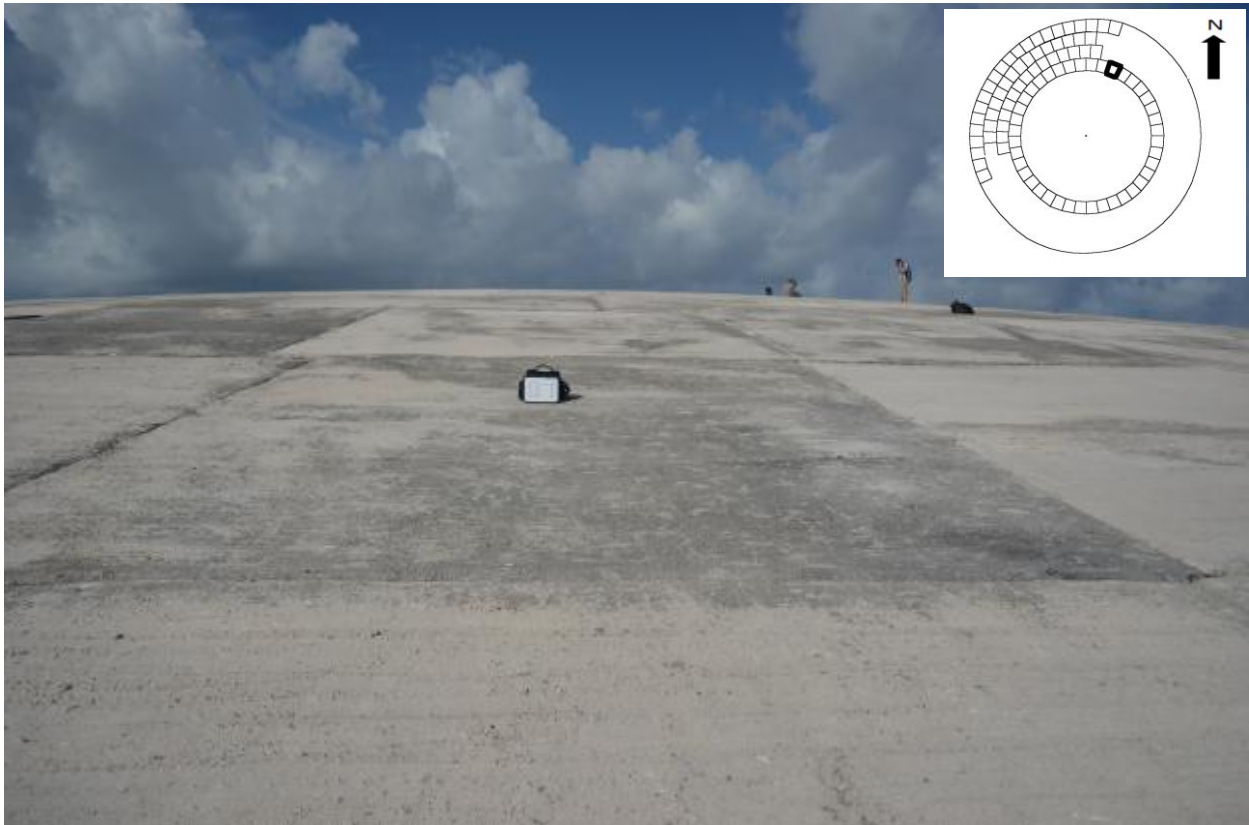
CAP SECTION LOCATION: Panel D8

No significant or obvious interior cracks extending across the top of the panel. The lower left side of the panel has a weathered appearance. Rooting vegetation removed from along the panel seams.

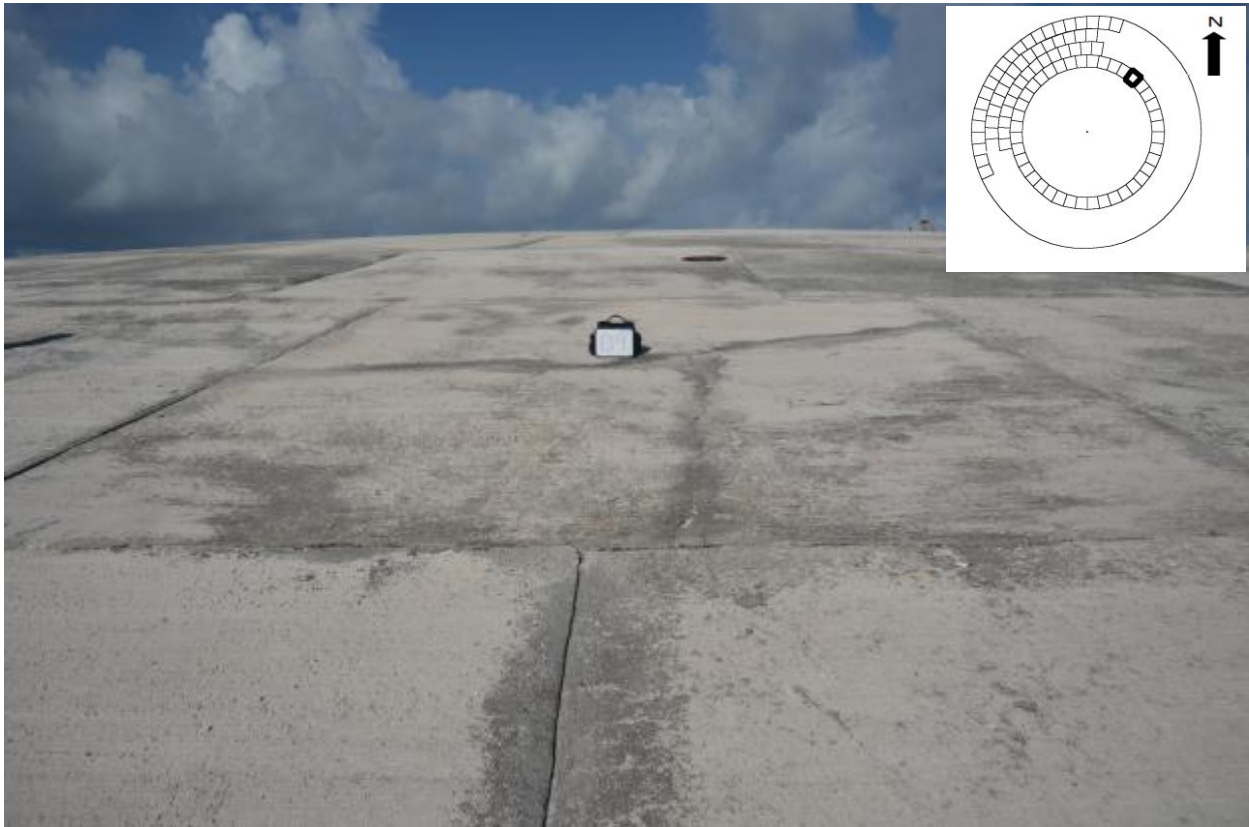
CAP SECTION LOCATION: Panel D9

The panel has a rough and weathered appearance. Rooting vegetation removed from along the panel seams. A surface crack observed extending from the bottom seam branching into fork at about the mid-point up the panel out to the left and right edges.

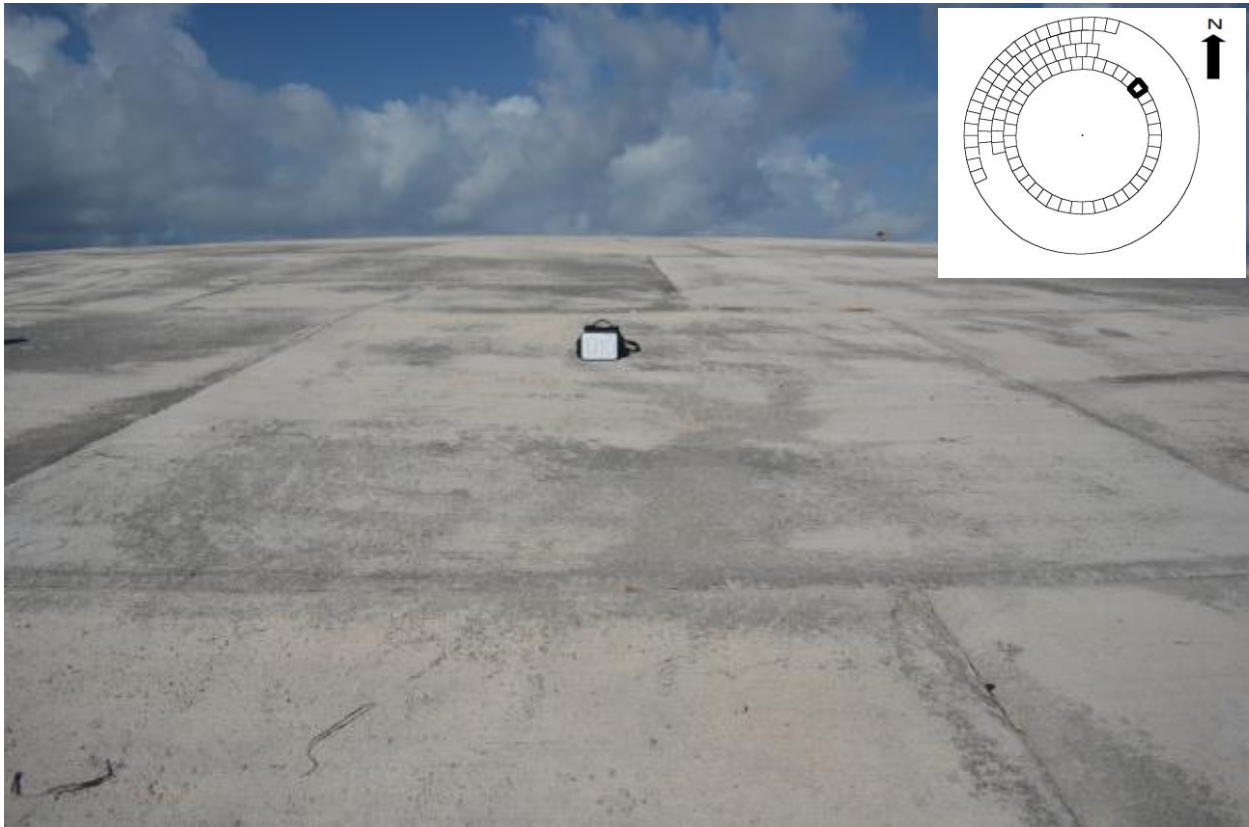
CAP SECTION LOCATION: Panel D10

No significant or obvious interior cracks extending across the top of the panel. The panel has a rough and weathered appearance. Rooting vegetation removed from along the panel seams. Some minor spalling/cracking of concrete observed along the right side of the bottom seam.

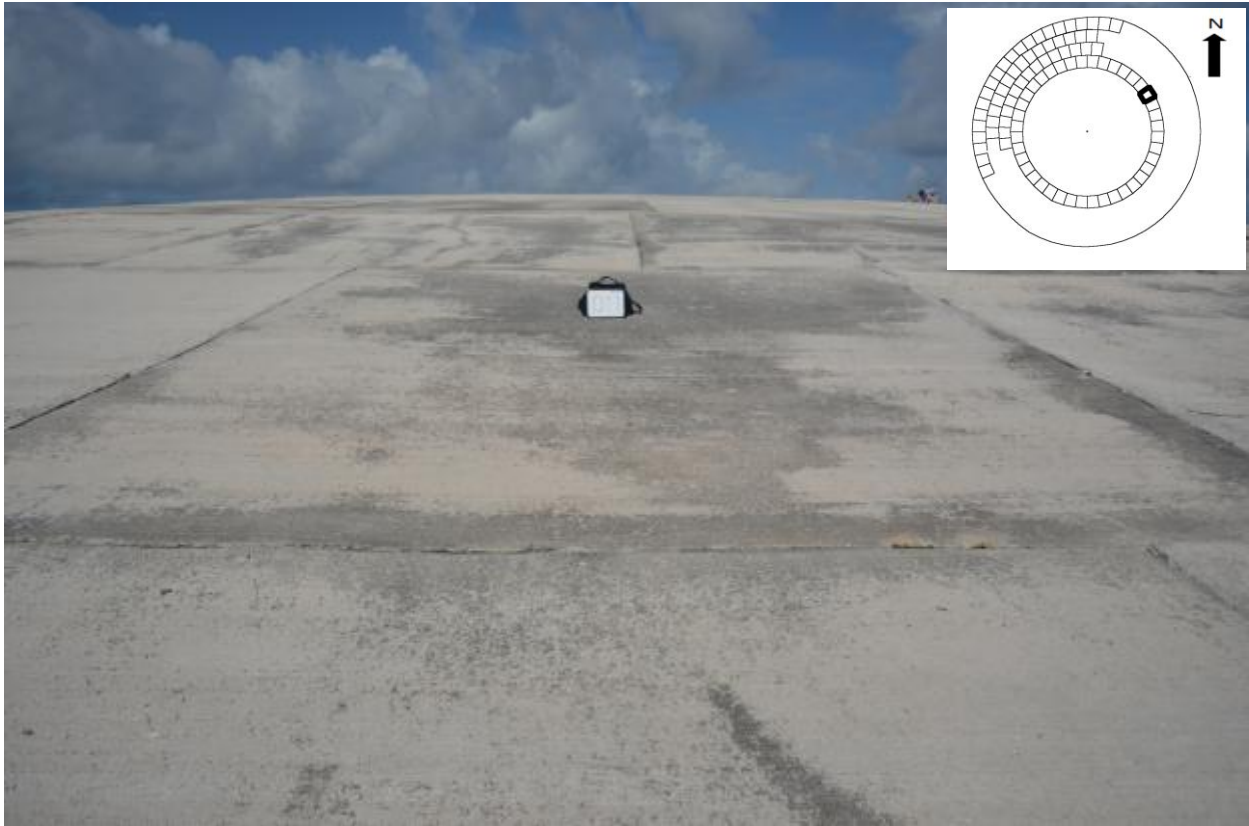
CAP SECTION LOCATION: Panel D11

No significant or obvious interior cracks extending across the top of the panel. The panel has a rough and weathered appearance. Rooting vegetation removed from along the panel seams.

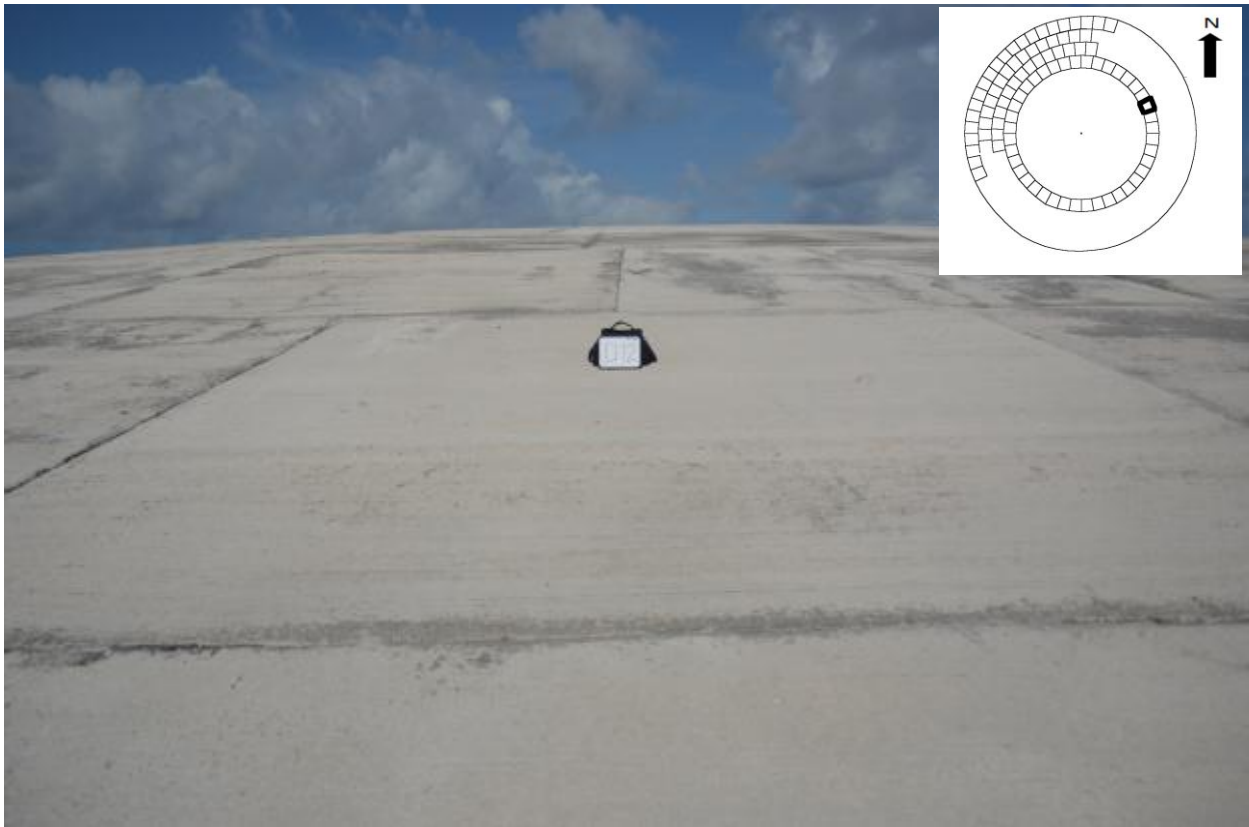
CAP SECTION LOCATION: Panel D12

No obvious interior cracks extending across the top of the panel. Some spalling/cracking of concrete observed in the lower right-hand corner of the panel.

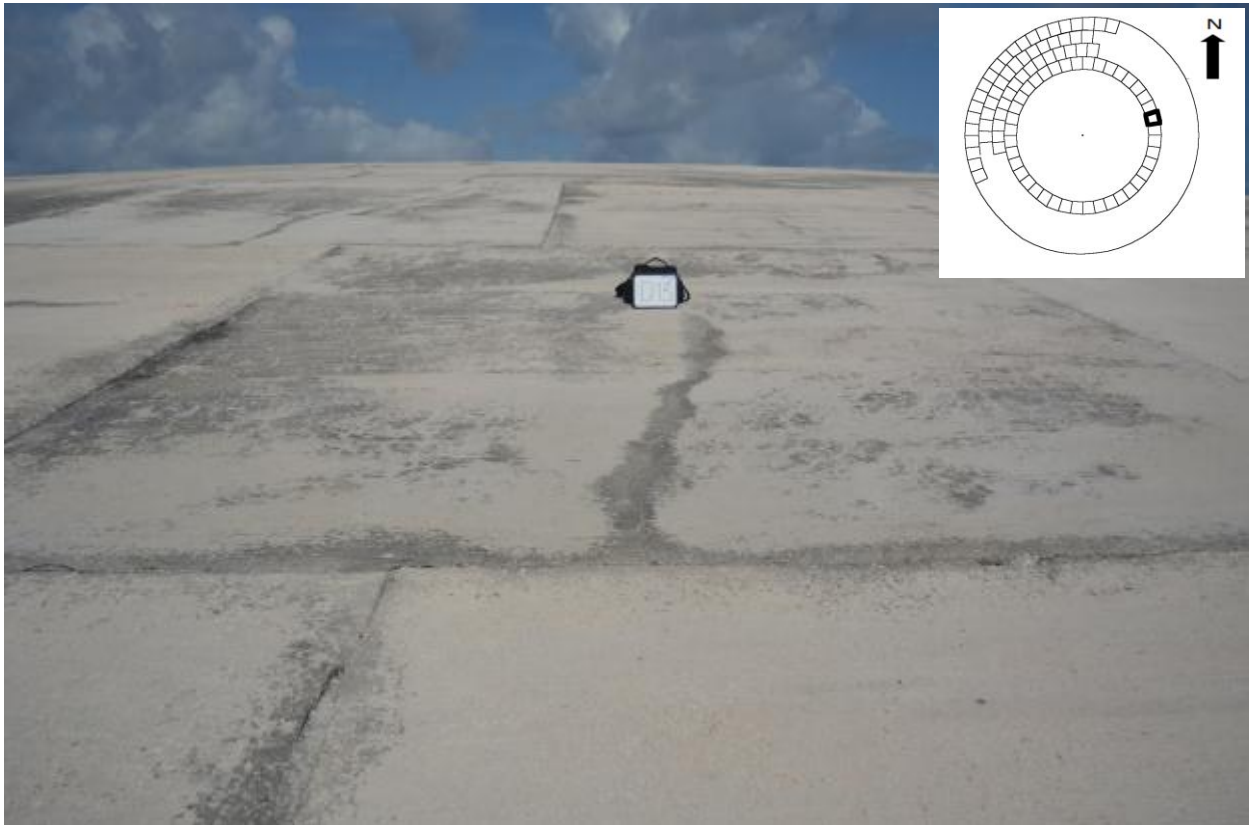
CAP SECTION LOCATION: Panel D13

The panel has a rough and weathered appearance. Surface crack observed extending up from the bottom seam on top edge adjacent to corner intersection E10/E11.

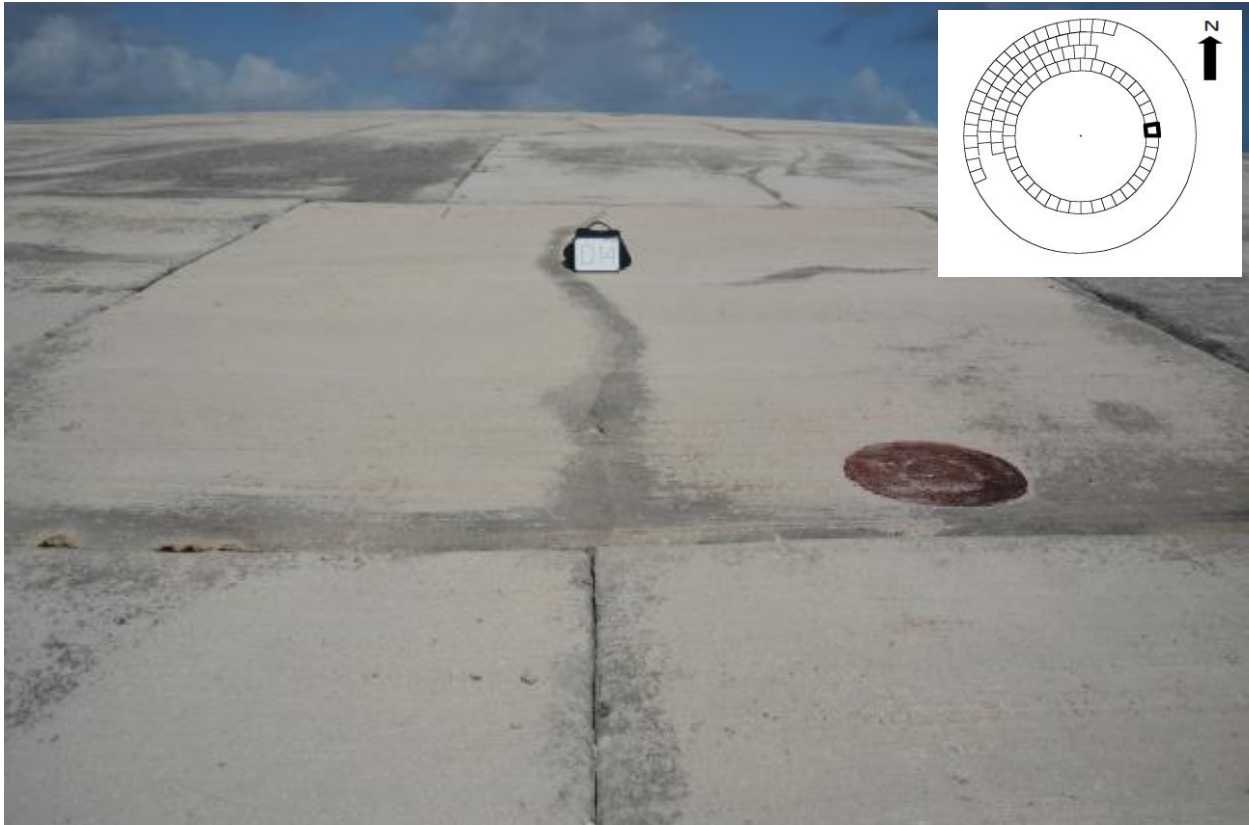
CAP SECTION LOCATION: Panel D14

The panel has a rough and weathered appearance. A surface crack observed extending up from bottom seam adjacent to the corner intersection C17/C18. Panel contains a vertical elevation benchmark.

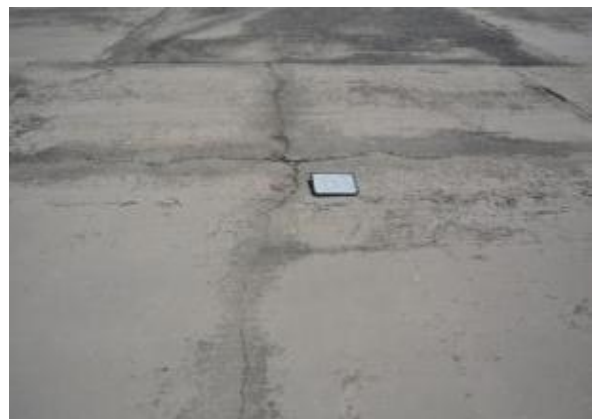
CAP SECTION LOCATION: Panel D15

This panel contains the most severe crack of any segment on the dome. The crack width exceeds several millimeters in some areas, and runs left to right at about a mid-point up the panel as well as up and down the panel from an intersection point in the middle. The crack contained chipped 'spalled' edges. Panel is listed as a priority for any repair work.

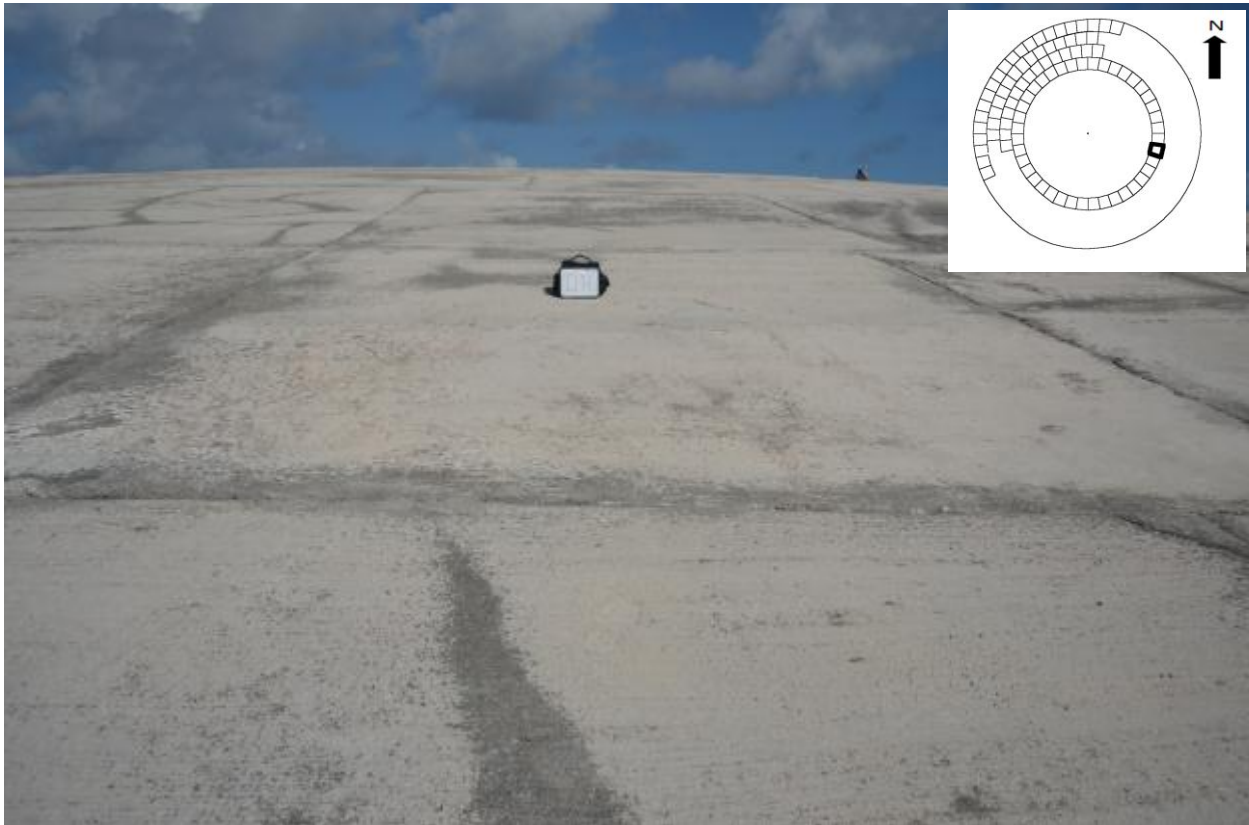
CAP SECTION LOCATION: Panel D16

No obvious interior cracks extending across the top of the panel. Some spalling/cracking of concrete observed along the lower seam on both the left and right sides of the panel.

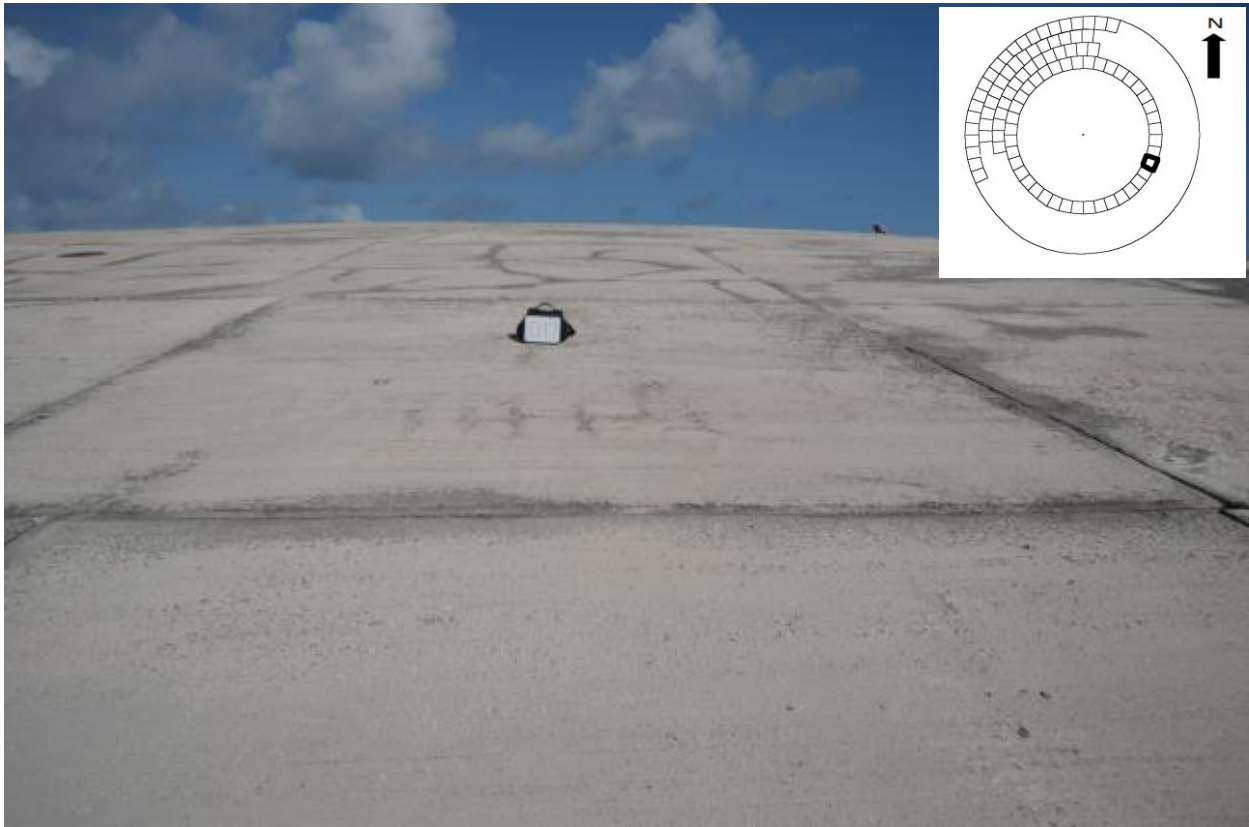
CAP SECTION LOCATION: Panel D17

No obvious interior cracks extending across the top of the panel. Some spalling/cracking of concrete observed in the bottom left corner and along lower seam adjacent to the intersecting corner between panel C21 and C22 on the left side of the panel.

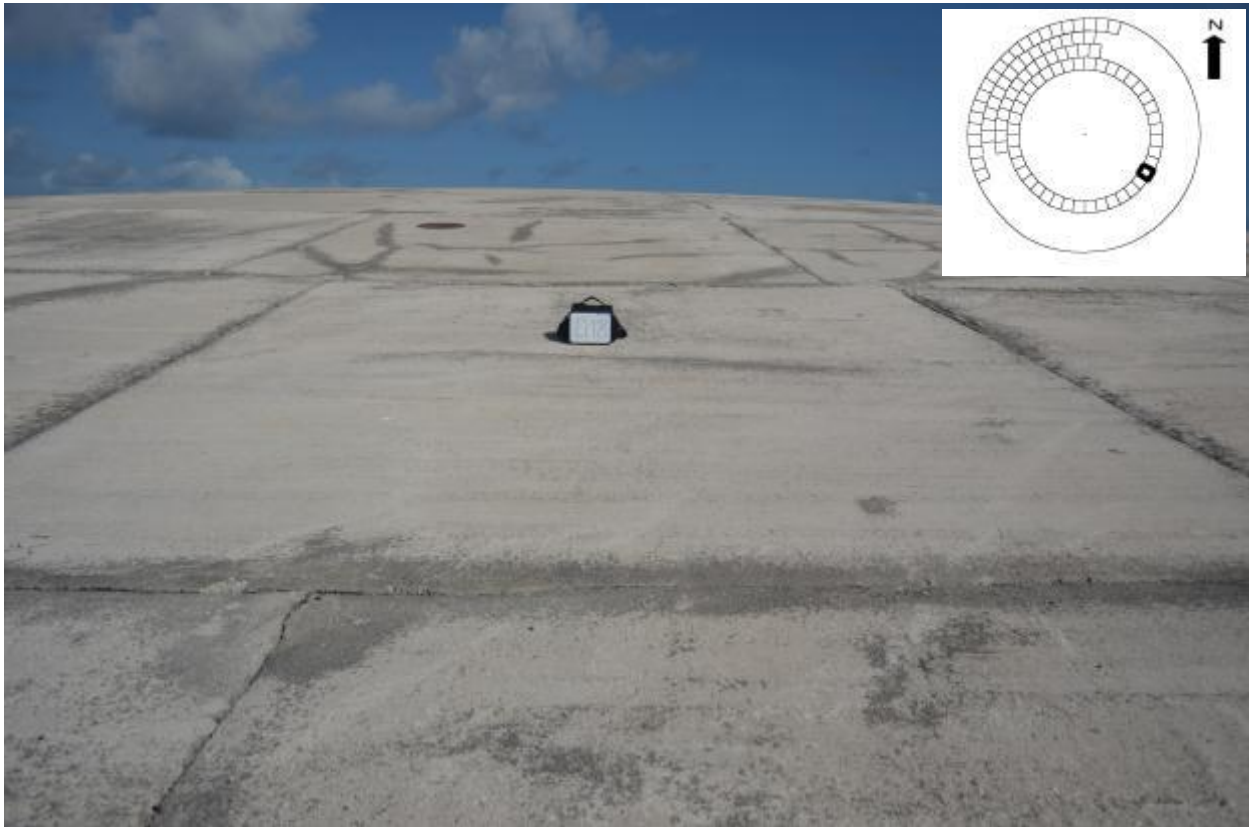
CAP SECTION LOCATION: Panel D18

No obvious interior cracks extending across the top of the panel. Some spalling/cracking of concrete observed in the right-hand corner of the panel. Panel labels D19 and D20 were skipped.

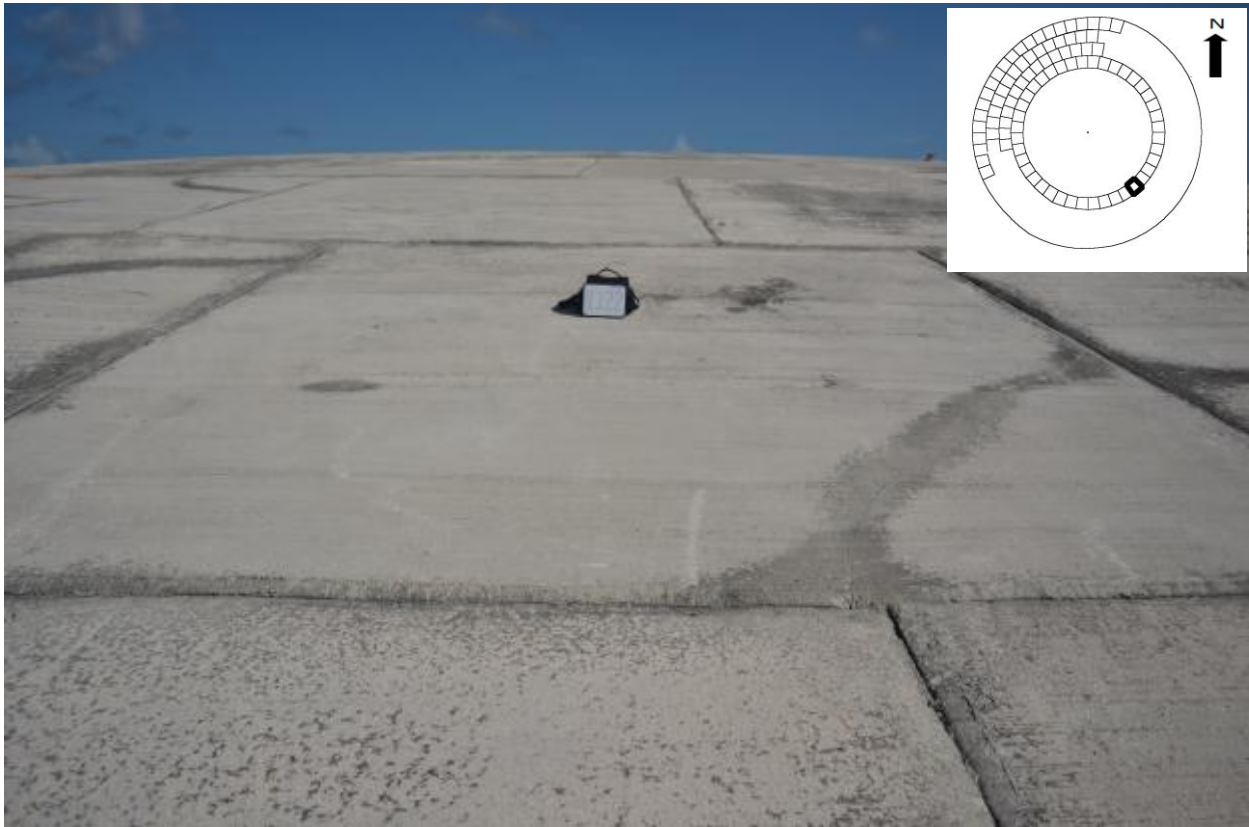
CAP SECTION LOCATION: Panel D22

A surface crack observed originating from the corner intersection C22/C25 along the bottom seam and intersecting with the right edge of the panel at a distance of about 3 meters up from the base of the panel. Some spalling/cracking of concrete observed in the lower left-hand corner and along the upper left edge of the panel.

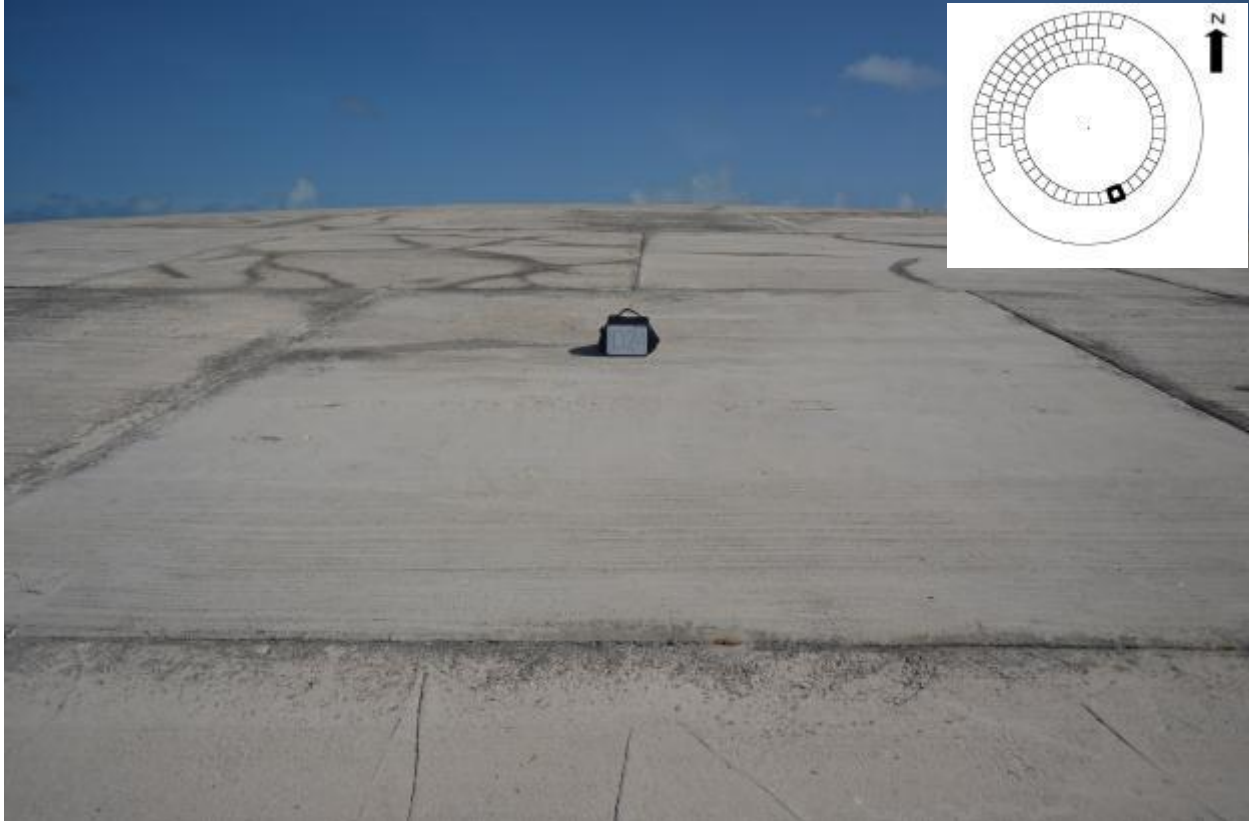
CAP SECTION LOCATION: Panel D24

No significant or obvious interior cracks extending across the top of the panel.

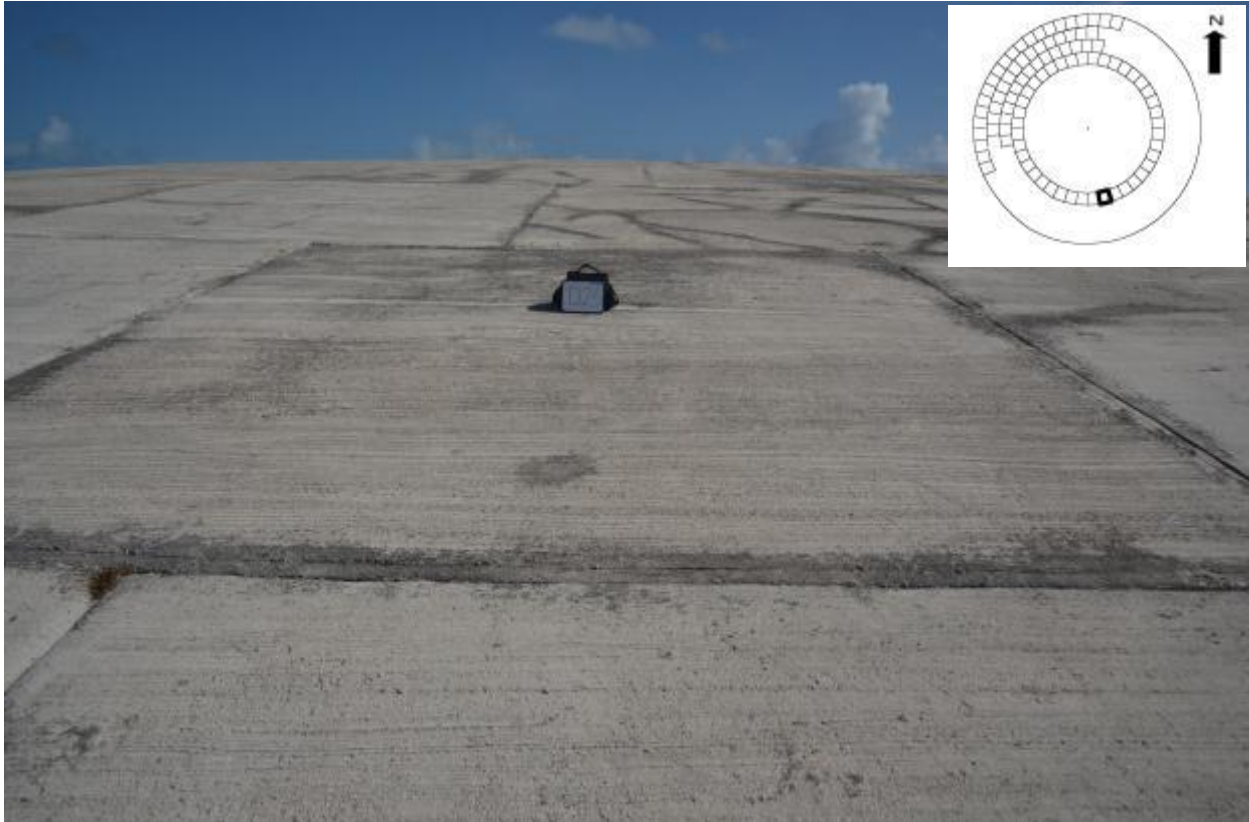
CAP SECTION LOCATION: Panel D25

No significant or obvious interior cracks extending across the top of the panel. The upper portion of the panel has a rough and weathered appearance. Rooting vegetation removed from along the panel seams.
