LLNL-TR-648143

A Visual Description of the Concrete Exterior of the Cactus Crater Containment Structure

Terry Hamilton

October 2013

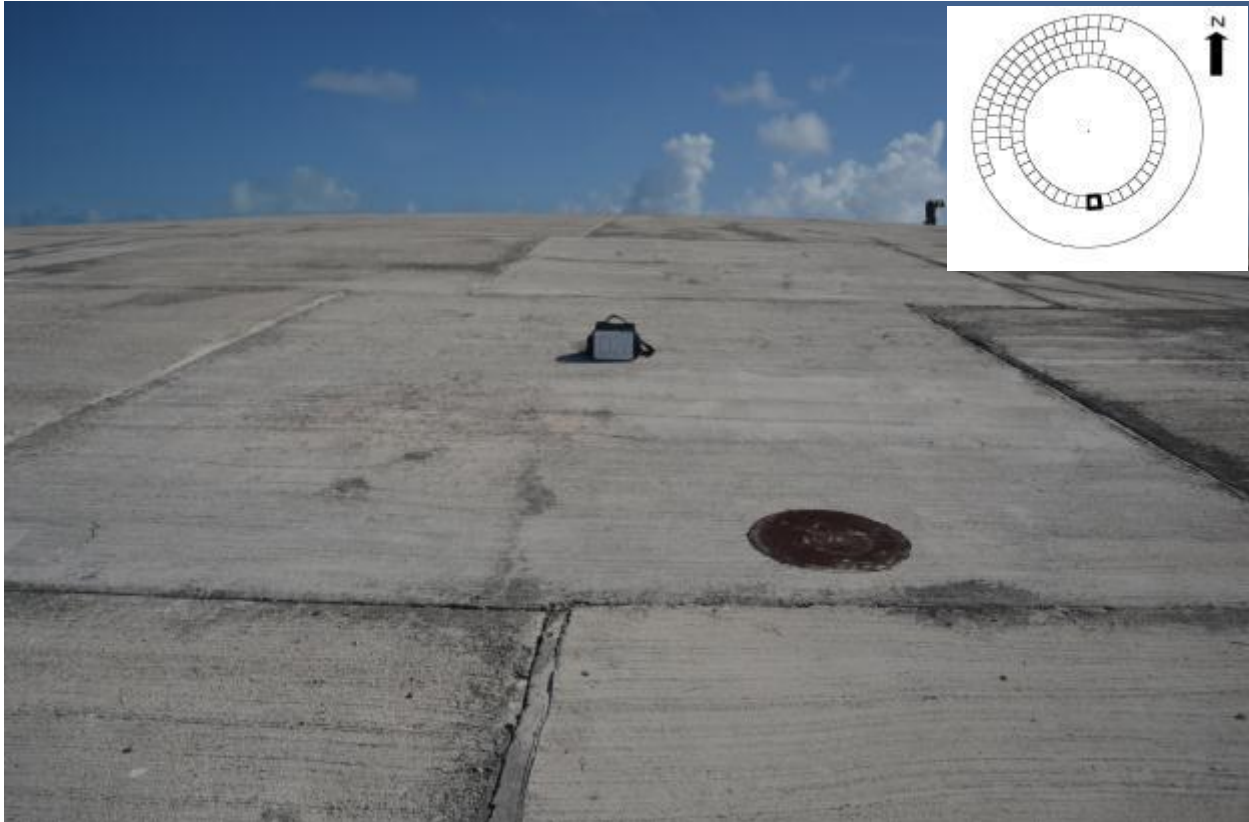
CAP SECTION LOCATION: Panel D26

A minor surface crack observed extending up from a central position adjacent to the corner intersection C29/C30 on the ring row below for a distance of about 1 meter . The panel contains a vertical elevation benchmark.

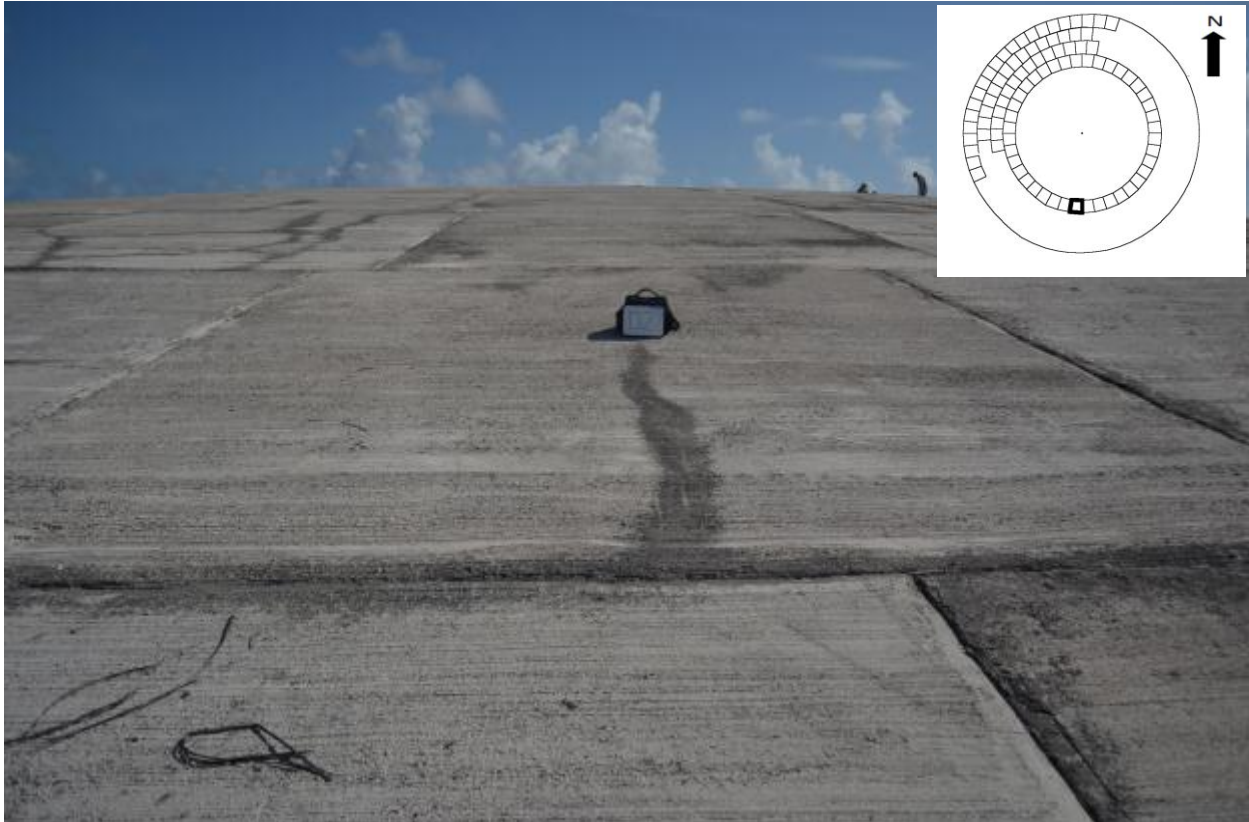
CAP SECTION LOCATION: Panel D27

The panel has a rough and weathered appearance. Some minor spalling/cracking of concrete observed along the right-hand side of the bottom seam. A surface crack observed running straight up the panel about 5 meters from a central position along the bottom seam.

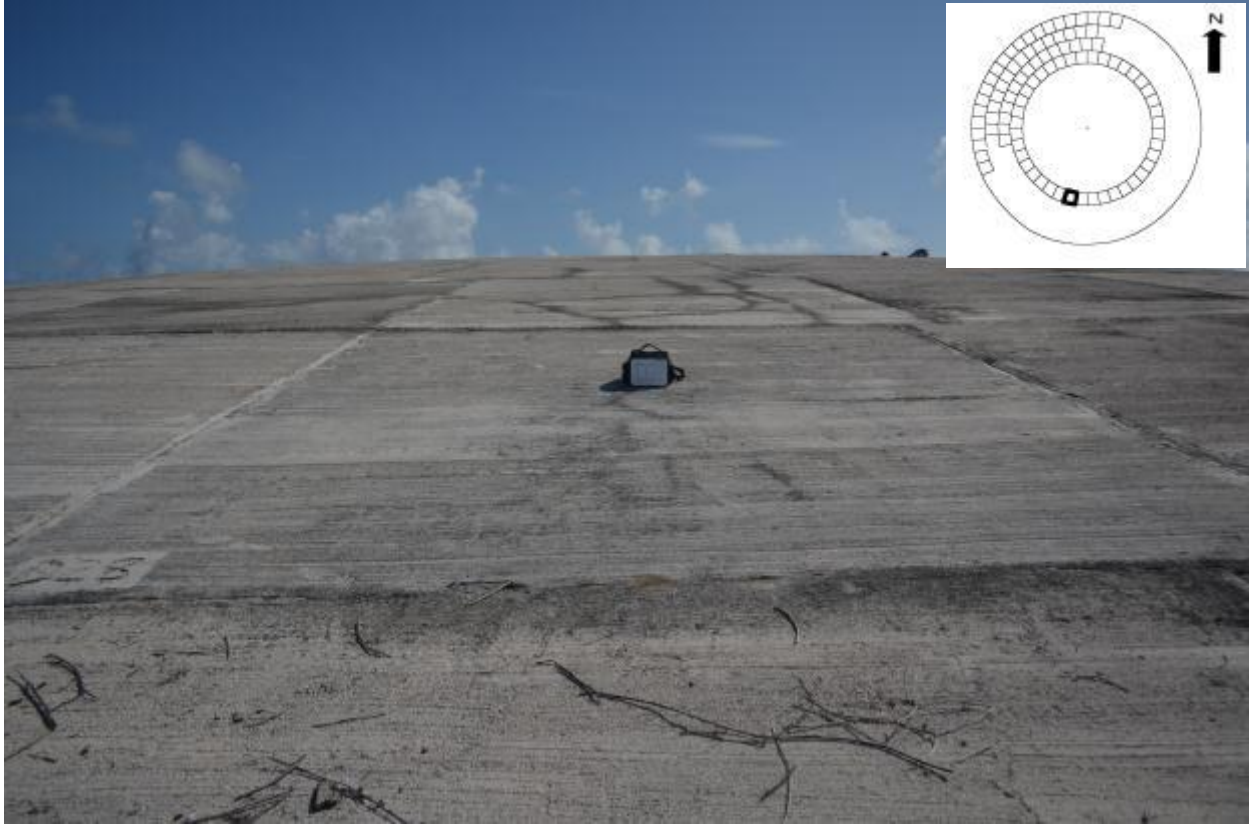
CAP SECTION LOCATION: Panel D28

No significant or obvious interior cracks extending across the top of the panel. Rooting vegetation removed from along the panel seams.

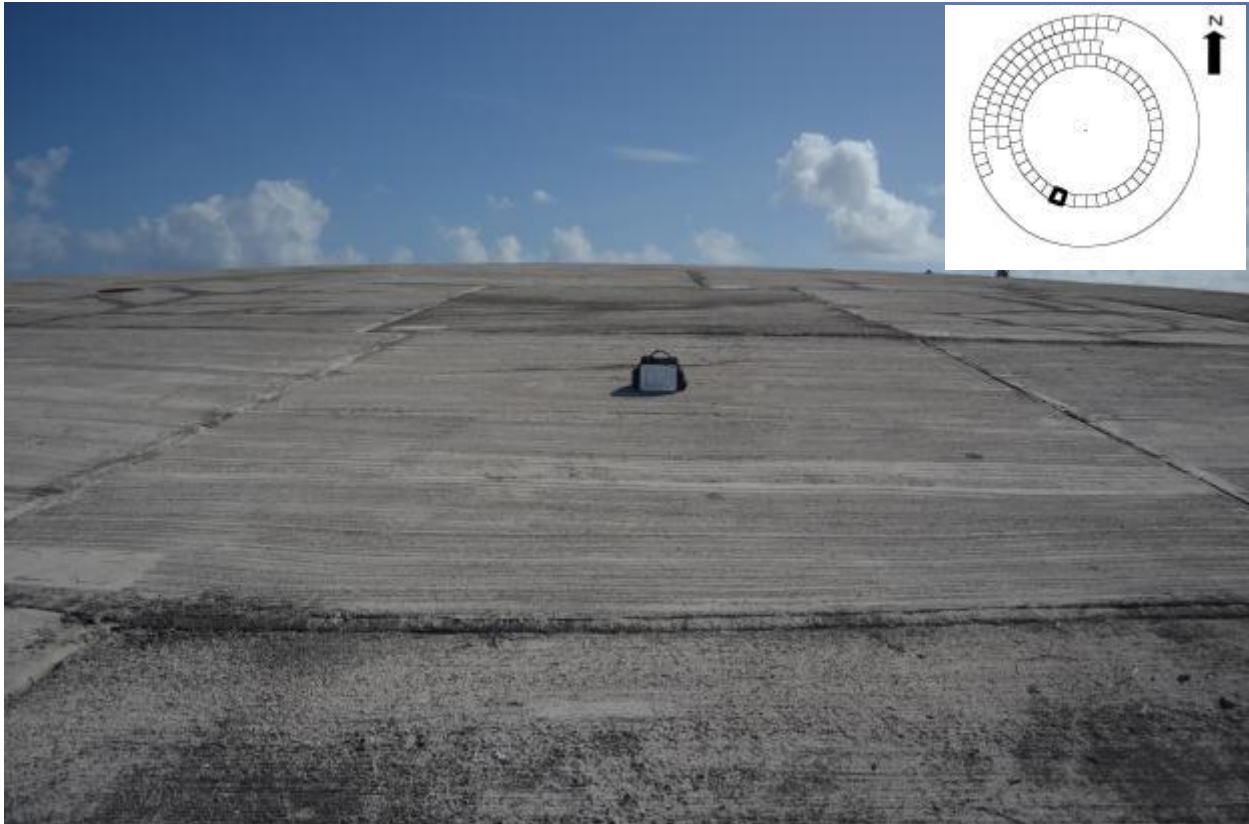
CAP SECTION LOCATION: Panel D29

The upper portion of the panel has a rough and weathered appearance. A minor surface crack observed traversing across the upper portion of the panel.

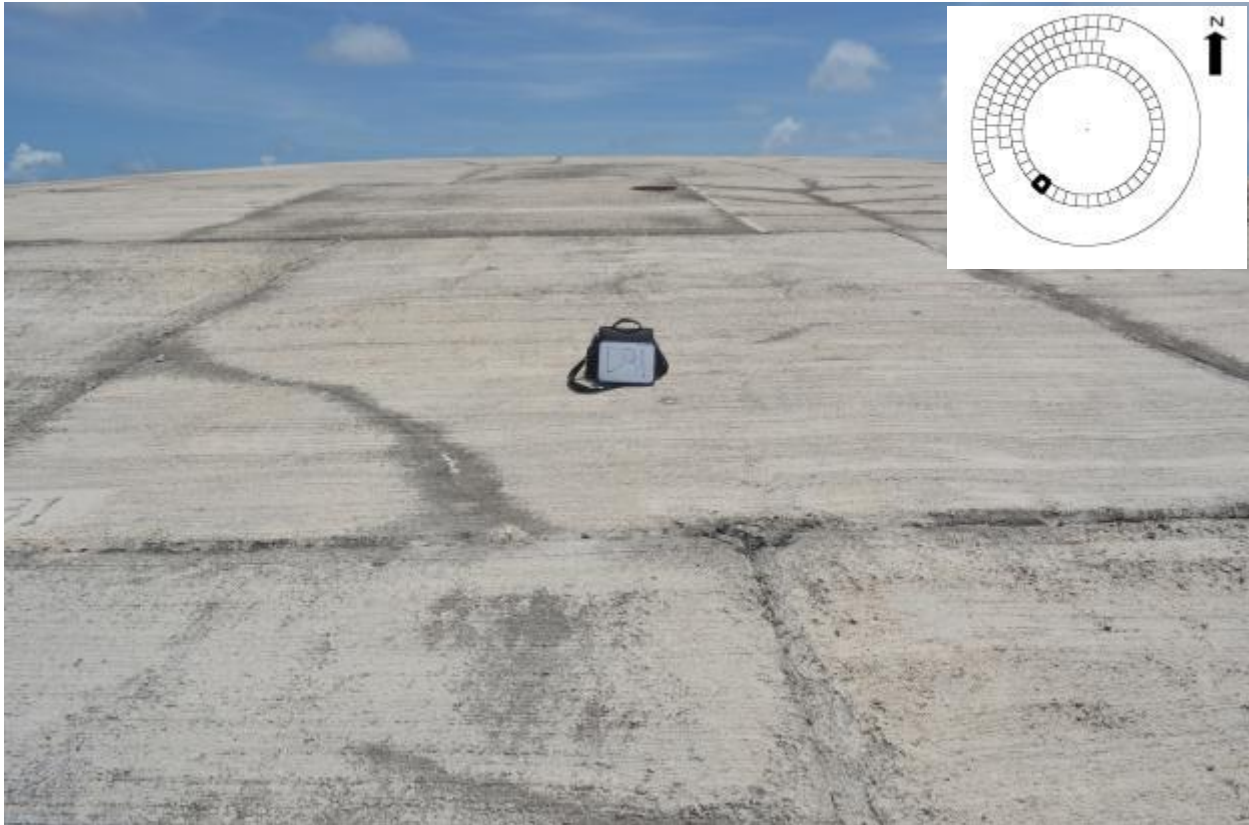
CAP SECTION LOCATION: Panel D31

The panel has a rough and weathered appearance. Rooting vegetation removed from along the panel seams. A surface crack observed traversing across the left corner of the panel intersecting the bottom and left seams about 2.5 to 3 meters away from the corner of the panel.

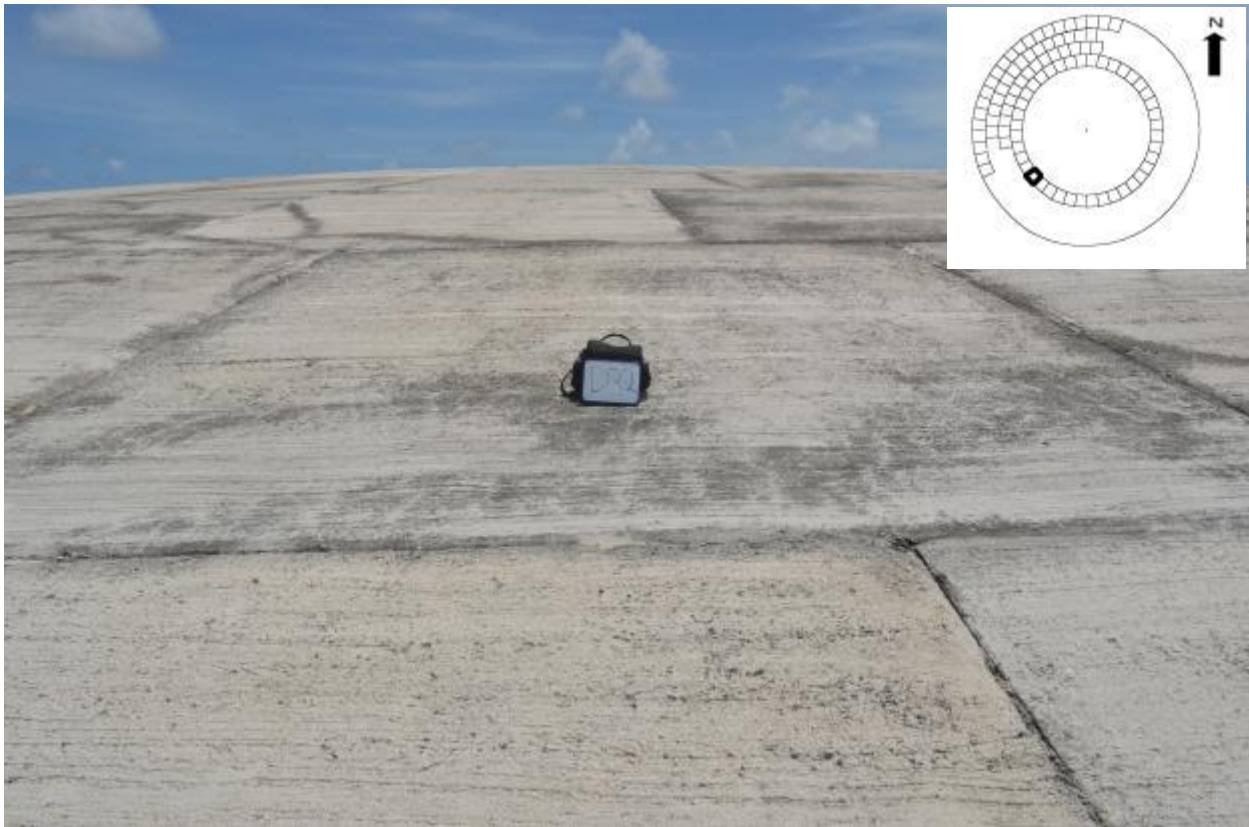
CAP SECTION LOCATION: Panel D32

No significant or obvious interior cracks extending across the top of the panel. The panel has a rough and weathered appearance. Rooting vegetation removed from along the panel seams.

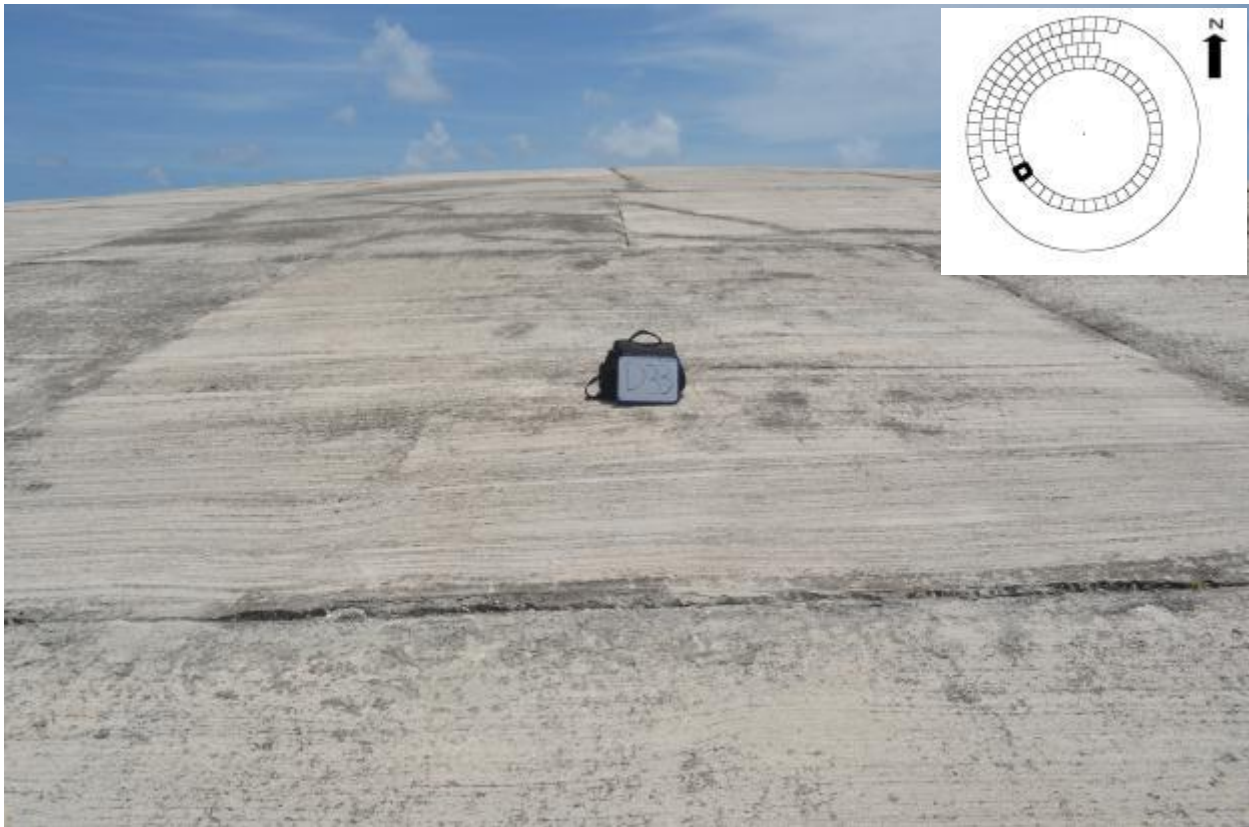
CAP SECTION LOCATION: Panel D33

No significant or obvious interior cracks extending across the top of the panel. The panel has a rough and weathered appearance.

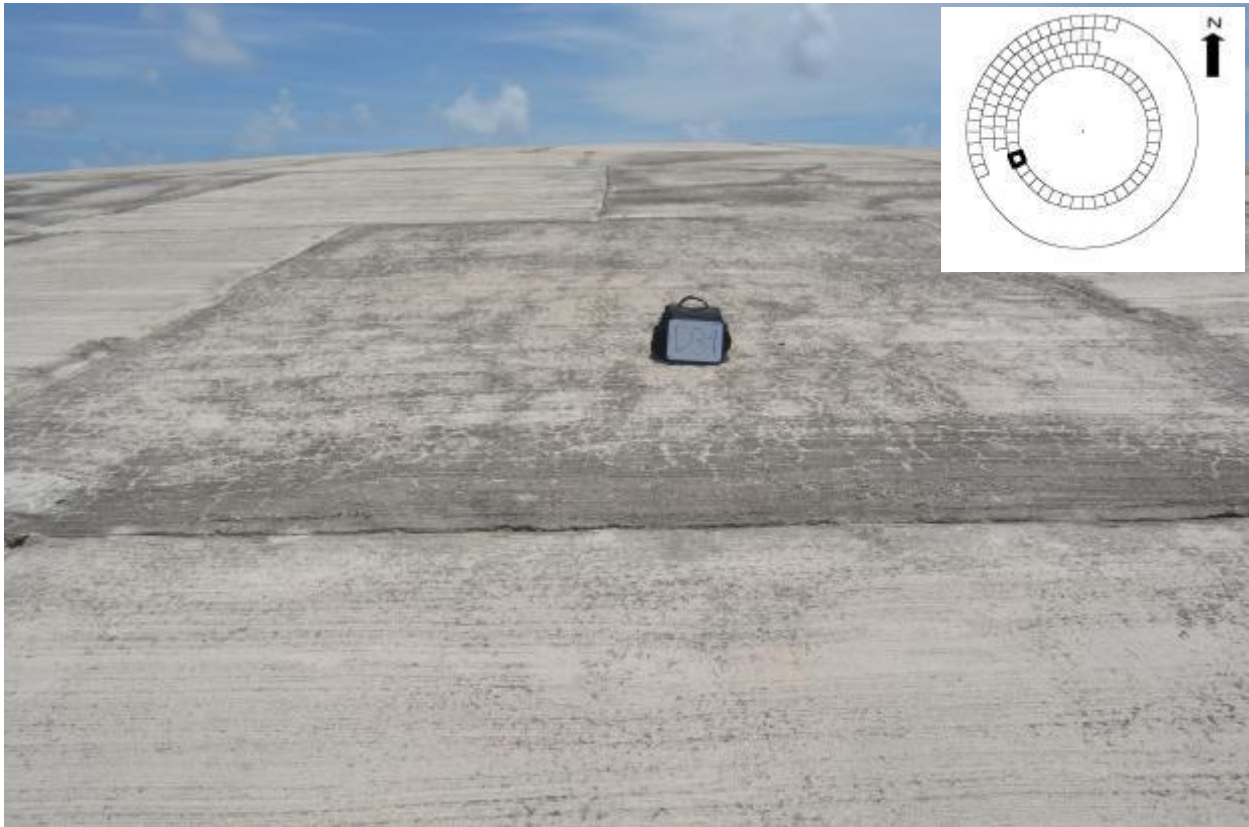
CAP SECTION LOCATION: Panel D34

No significant or obvious interior cracks extending across the top of the panel. The panel has a rough and weathered appearance. Some spalling/cracking of concrete observed in the upper left-hand corner of the panel. Rooting vegetation removed from along the panel seams.

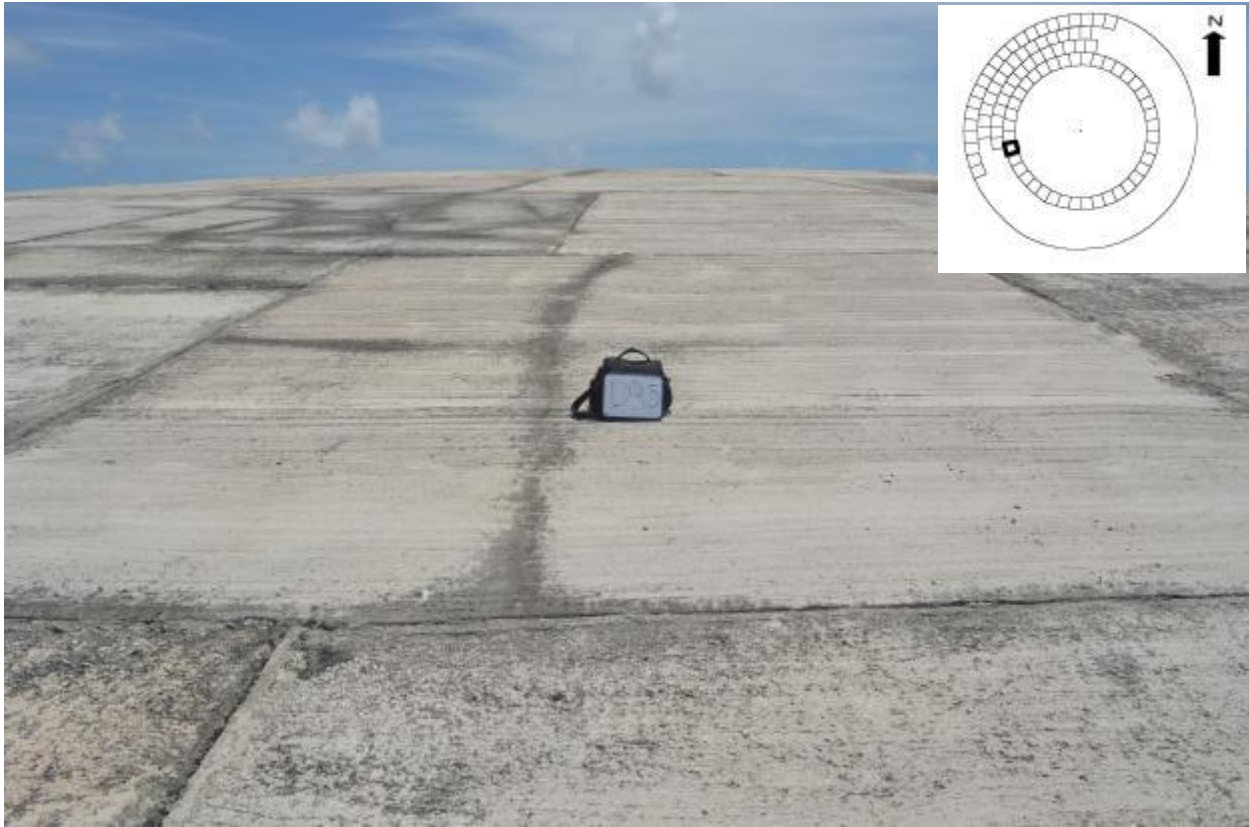
CAP SECTION LOCATION: Panel D35

Some spalling/cracking of concrete observed in the lower left-hand corner of the panel. Rooting vegetation removed from along the panel seams. A surface crack observed extending up from a central position along the bottom seam intersecting the upper seam adjacent corner E28/E29 on the ring row above with a branch off to the left side at a mid-point up the panel.

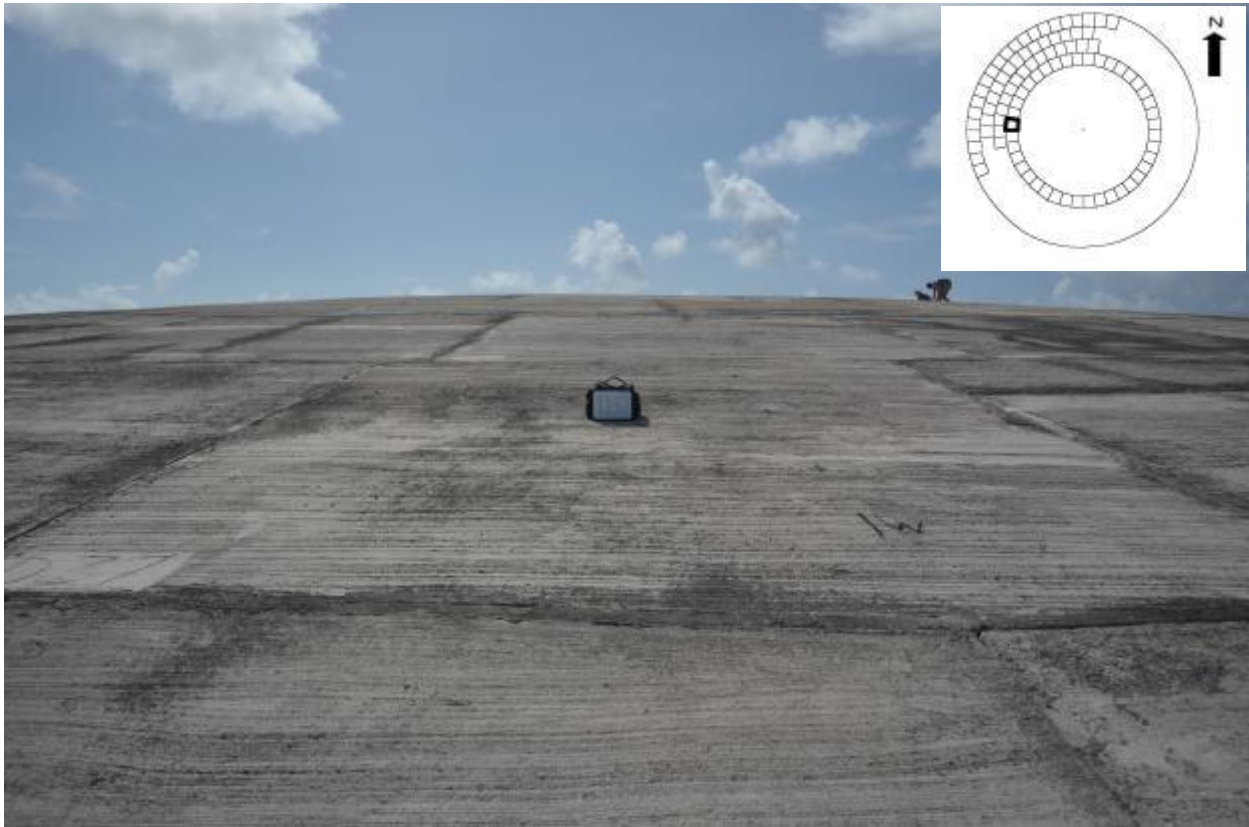
No significant or obvious interior cracks extending across the top of the panel. The panel has a slightly more rough and weathered appearance. Some spalling/cracking of concrete observed along the right side of the bottom seam.

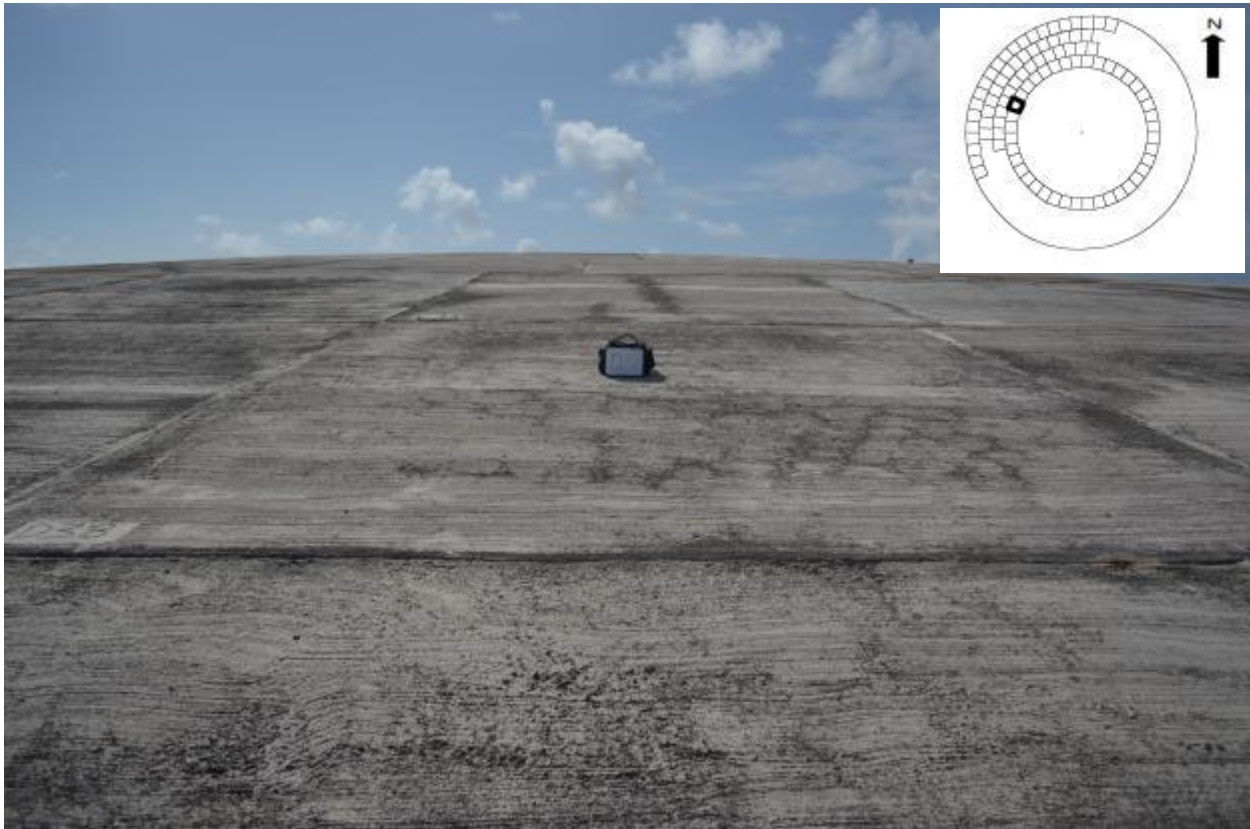
CAP SECTION LOCATION: Panel D38

No significant or obvious interior cracks extending across the top of the panel. The panel has a slightly more rough and weathered appearance. Some spalling/cracking of concrete observed in the upper left-hand corner and along the right side of the upper seam of the panel. Rooting vegetation removed from along the panel seams.

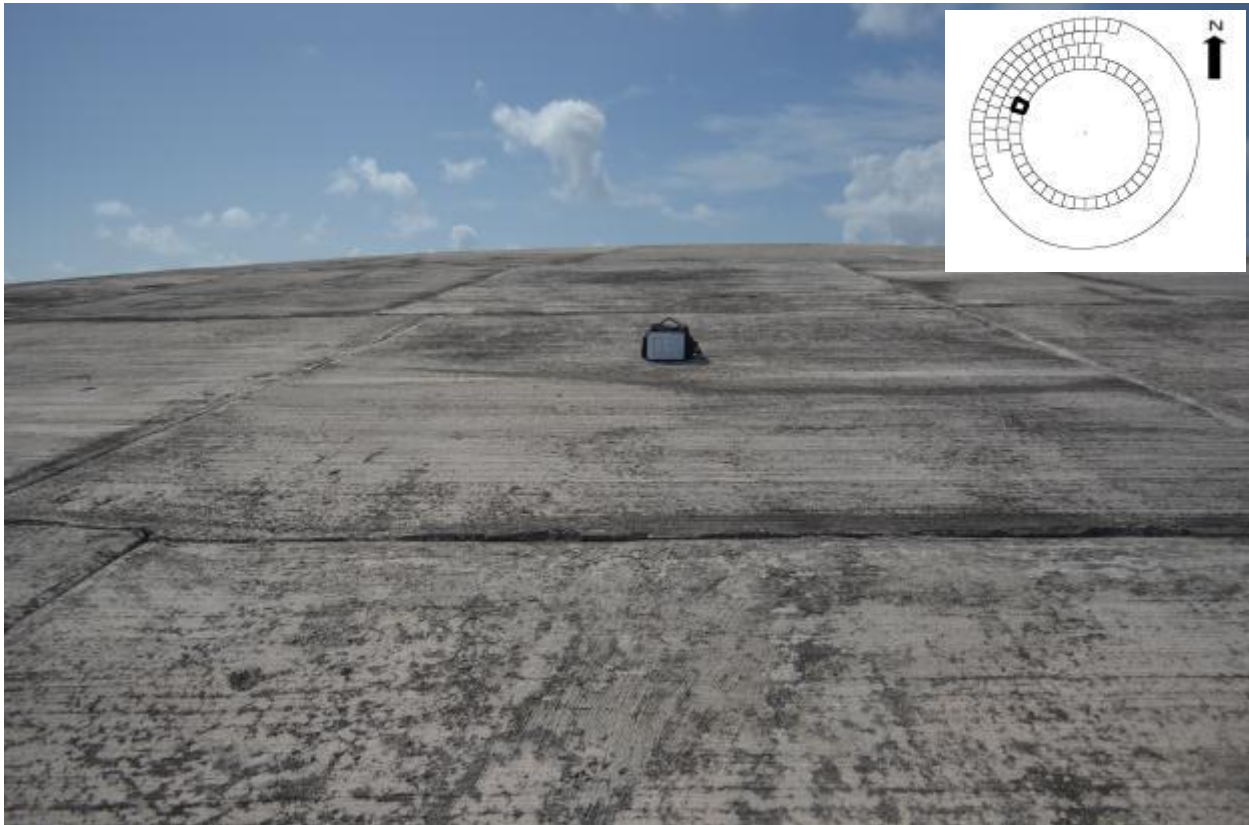
CAP SECTION LOCATION: Panel D39

No significant or obvious interior cracks extending across the top of the panel. The panel has a rough and weathered appearance. Some spalling/cracking of concrete observed in the upper and lower left corners.

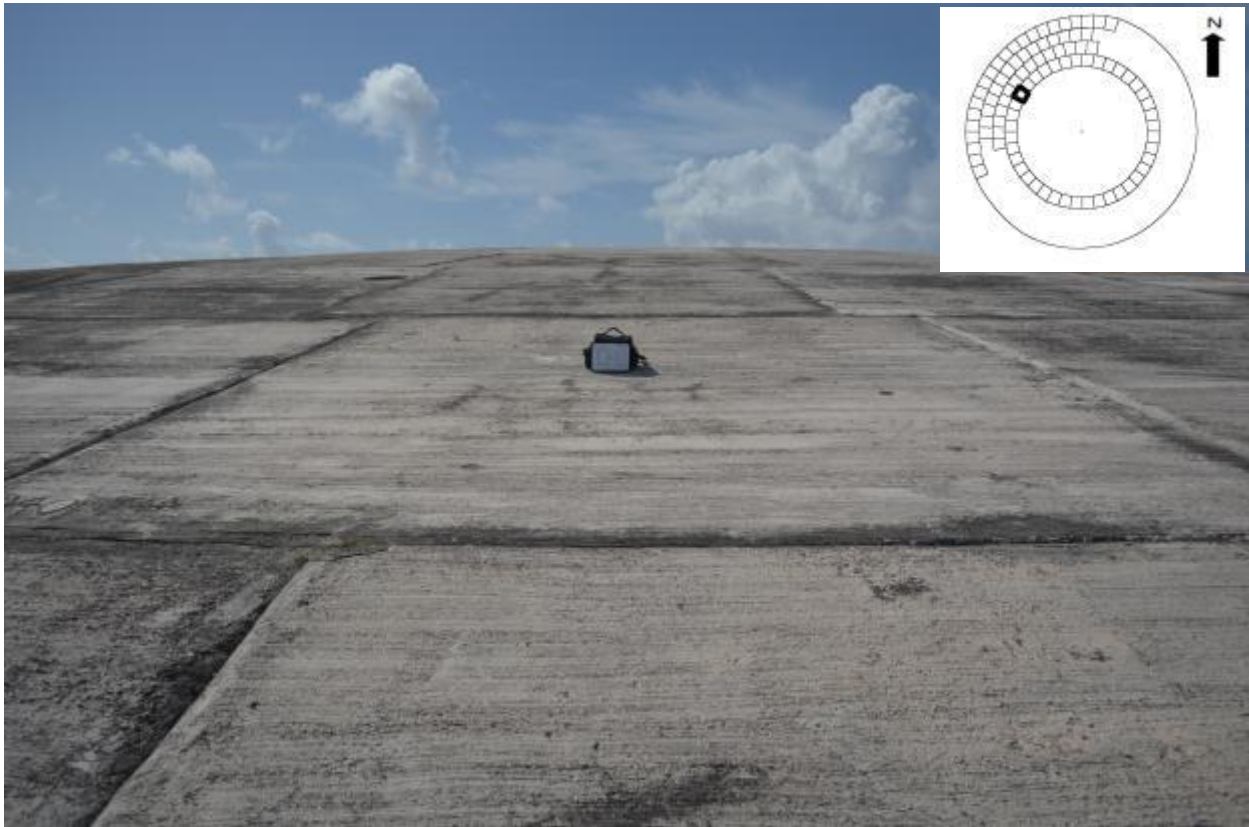
CAP SECTION LOCATION: Panel D40

No significant or obvious interior cracks extending across the top of the panel. The panel has a slightly more rough and weathered appearance. Rooting vegetation removed from along the panel seams.

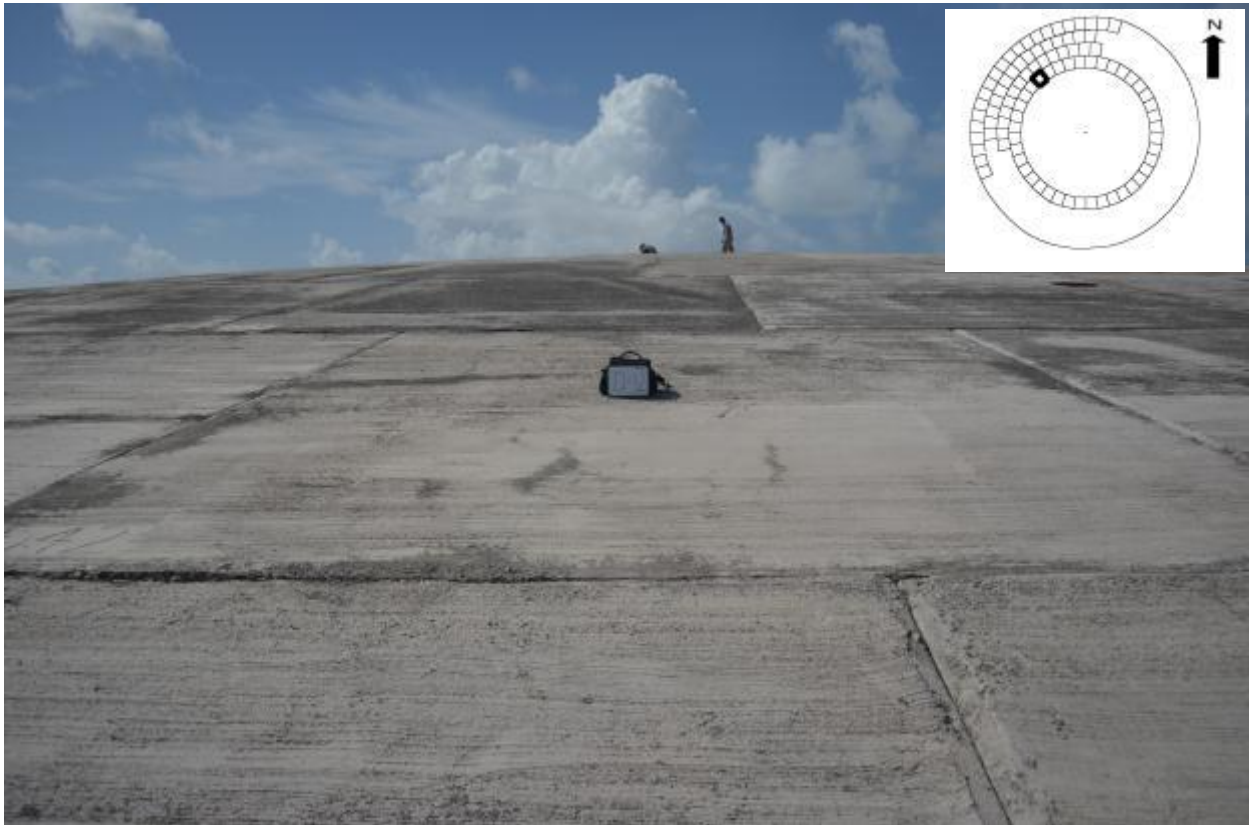
CAP SECTION LOCATION: Panel D42

No significant or obvious interior cracks extending across the top of the panel. Some minor spalling/cracking of concrete observed near the left corner of bottom beam

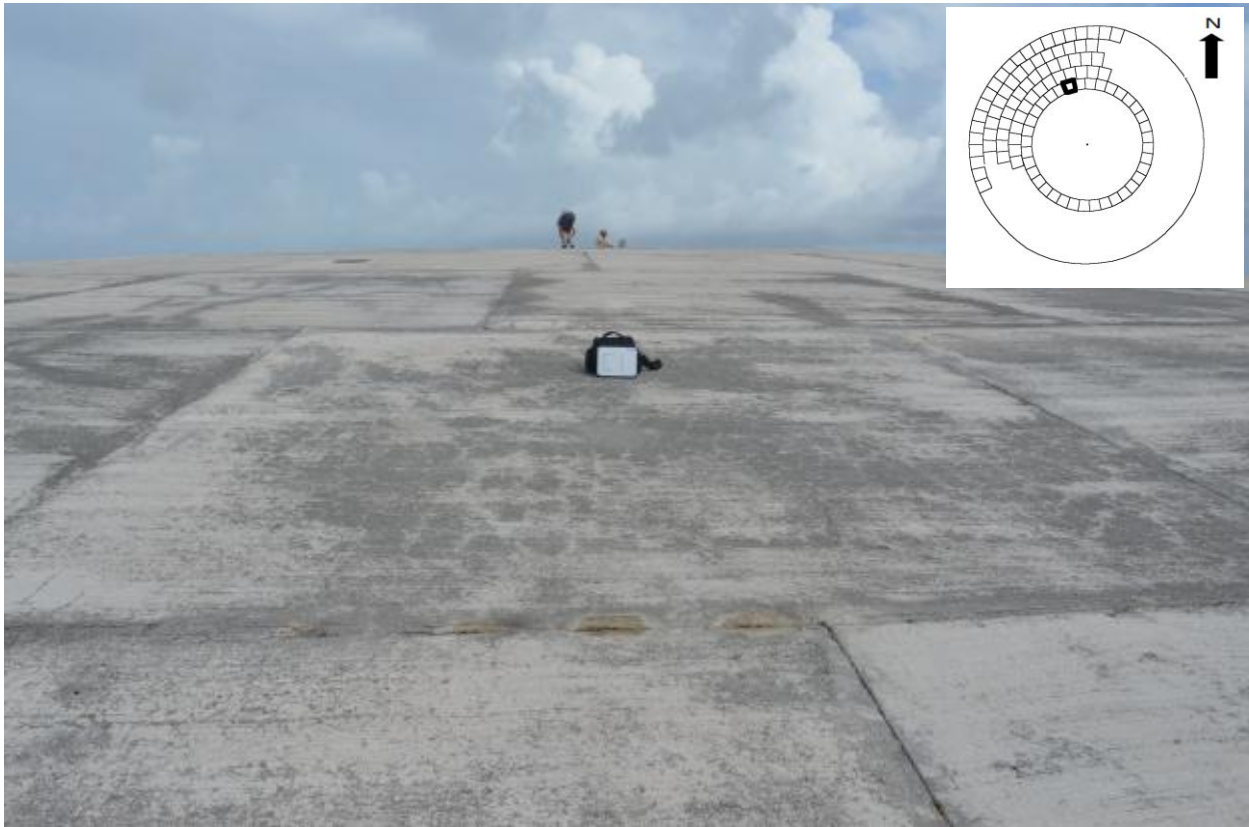
CAP SECTION LOCATION: Panel E1

No significant or obvious interior cracks extending across the top of the panel. Some minor spalling/cracking of concrete observed in the upper left-hand corner of the panel. Rooting vegetation removed from along the panel seams.

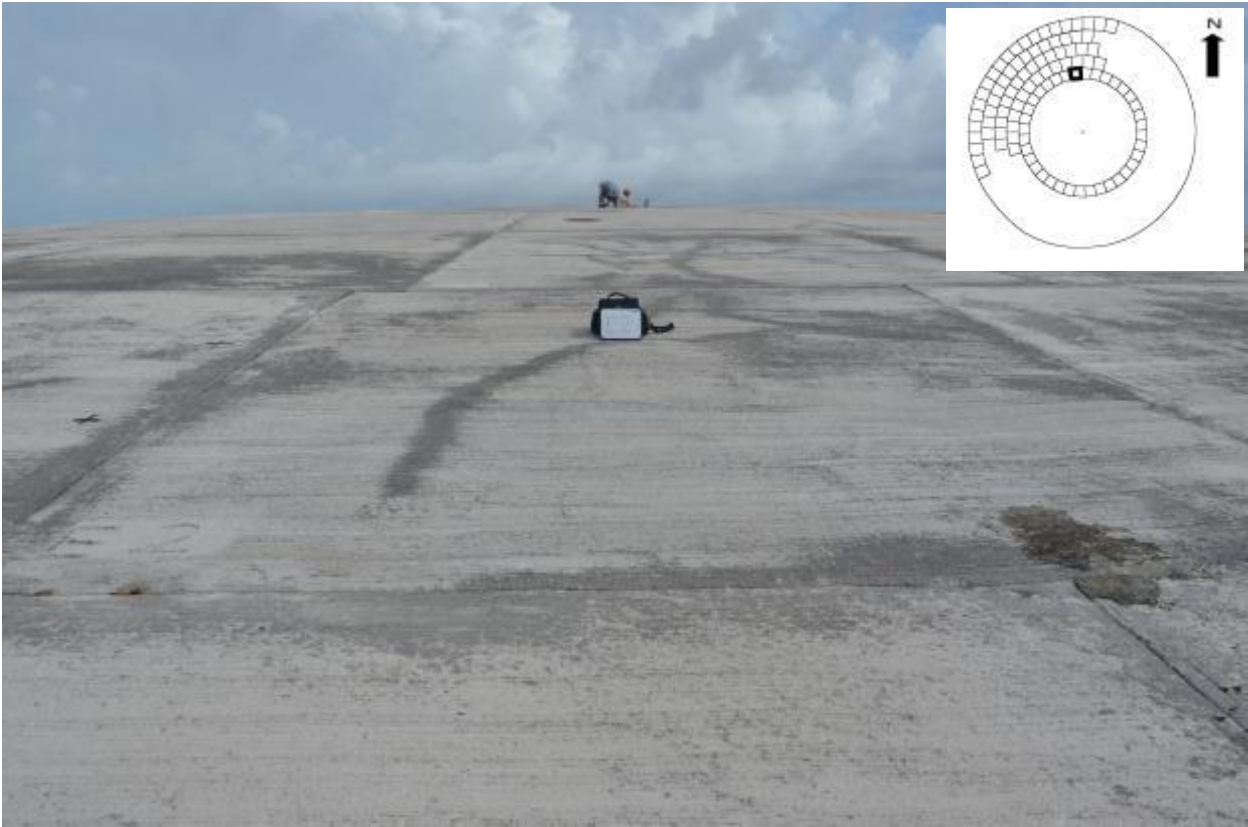
CAP SECTION LOCATION: Panel E2

No significant or obvious interior cracks extending across the top of the panel. Some minor spalling/cracking of concrete observed along the lower side of the right seam. Rooting vegetation removed from along the panel seams.

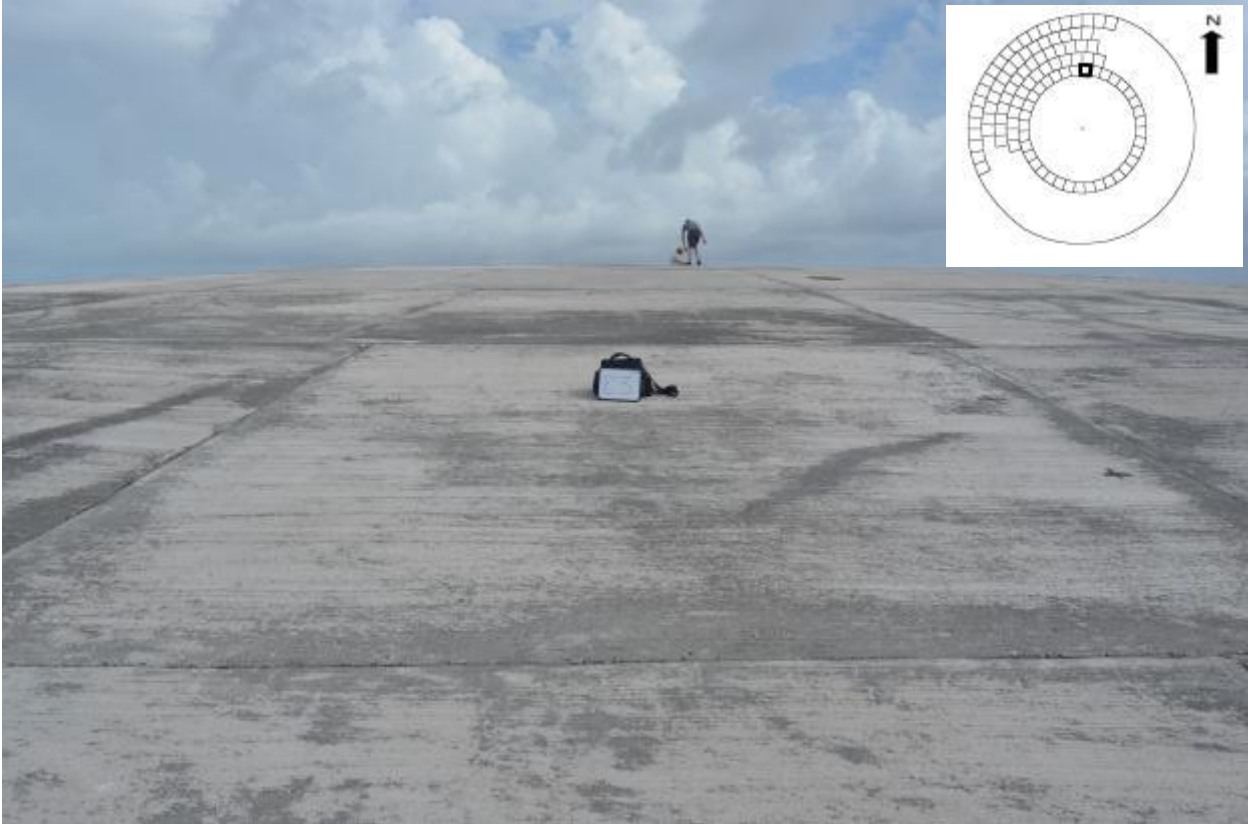
CAP SECTION LOCATION: Panel E3

No significant or obvious interior cracks extending across the top of the panel. Some minor spalling/cracking of concrete observed near the upper right-hand corner of the panel.

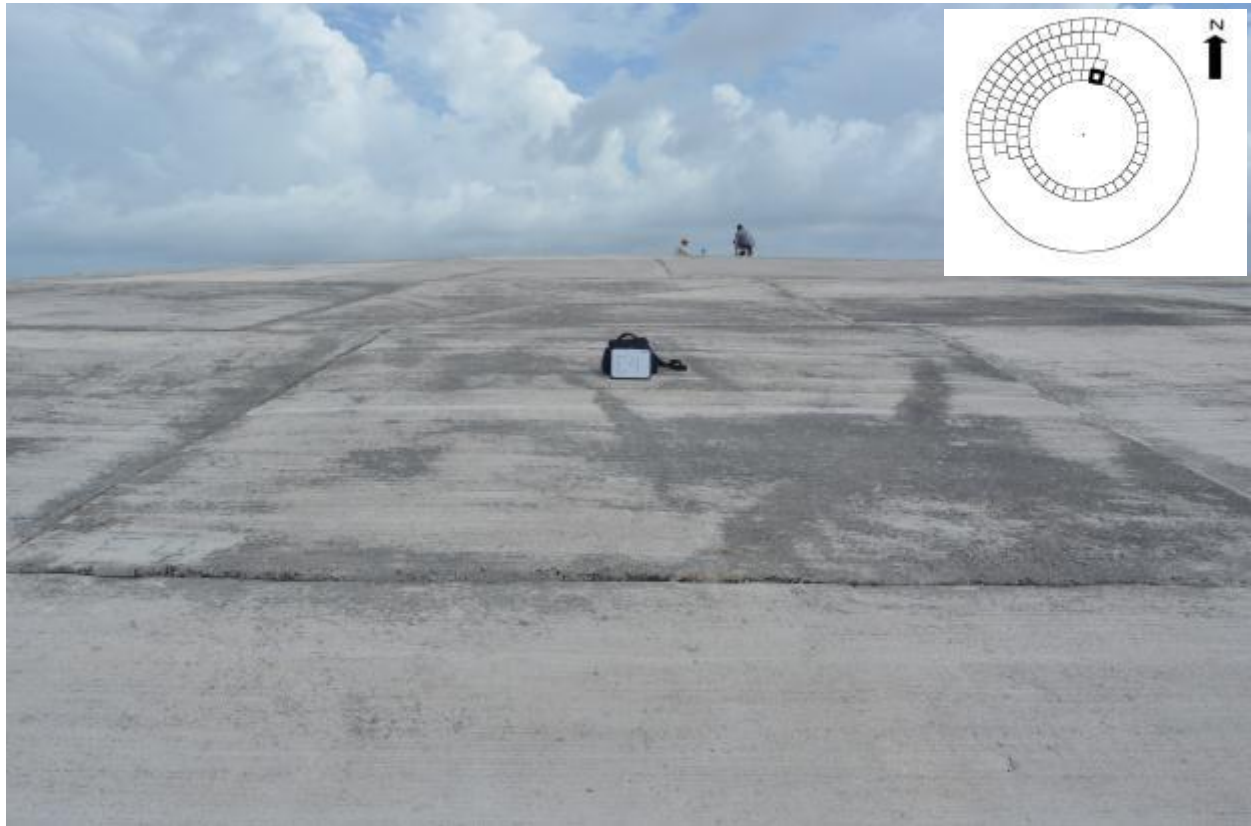
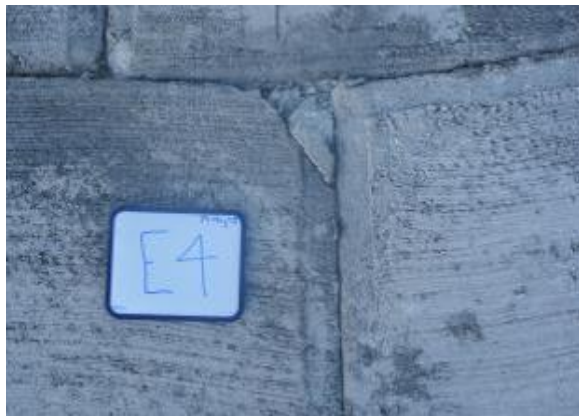
No significant or obvious interior cracks extending across the top of the panel. The bottom right side of the panel has a rough and weathered appearance. Some spalling/cracking of concrete observed in the upper left and right-hand corners of the panel.

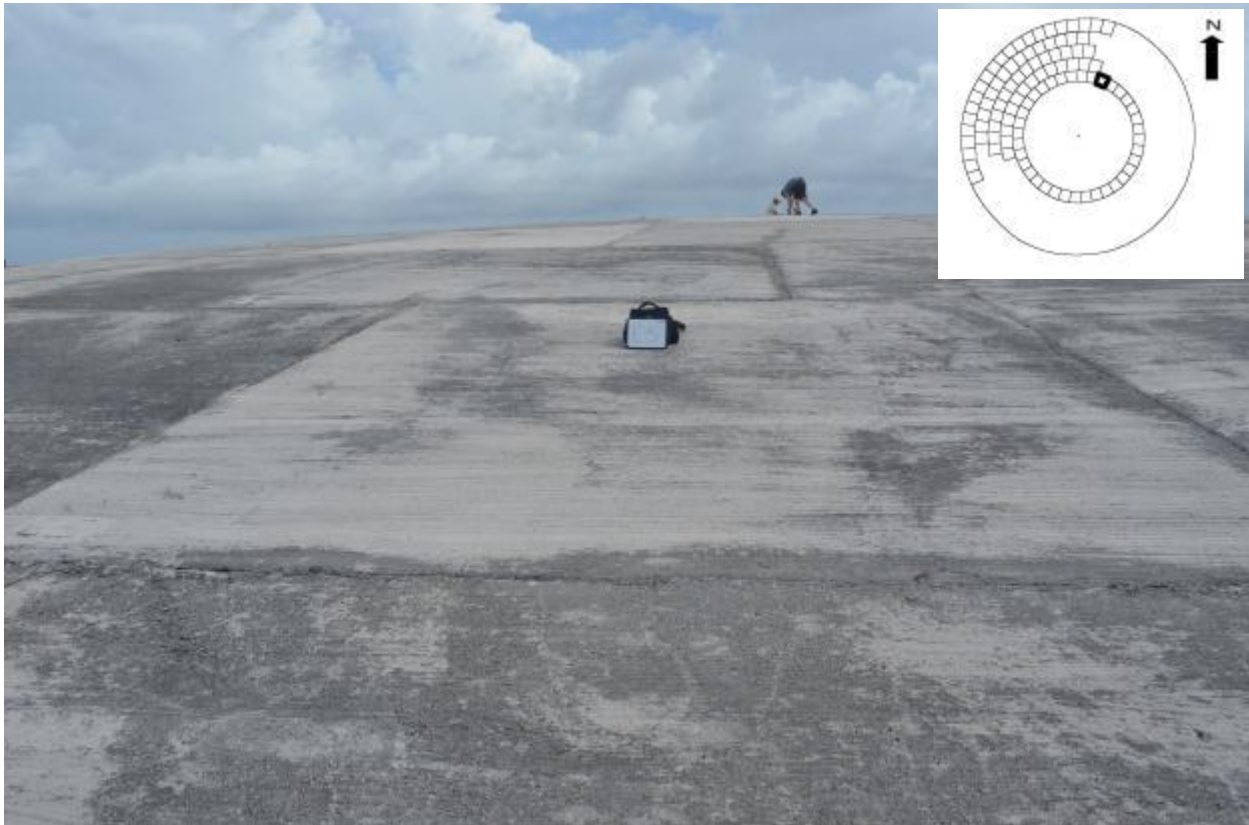
CAP SECTION LOCATION: Panel E5

No significant or obvious interior cracks extending across the top of the panel. Some minor spalling/cracking of concrete observed in the lower right corner of the panel. Rooting vegetation removed from along the panel seams.

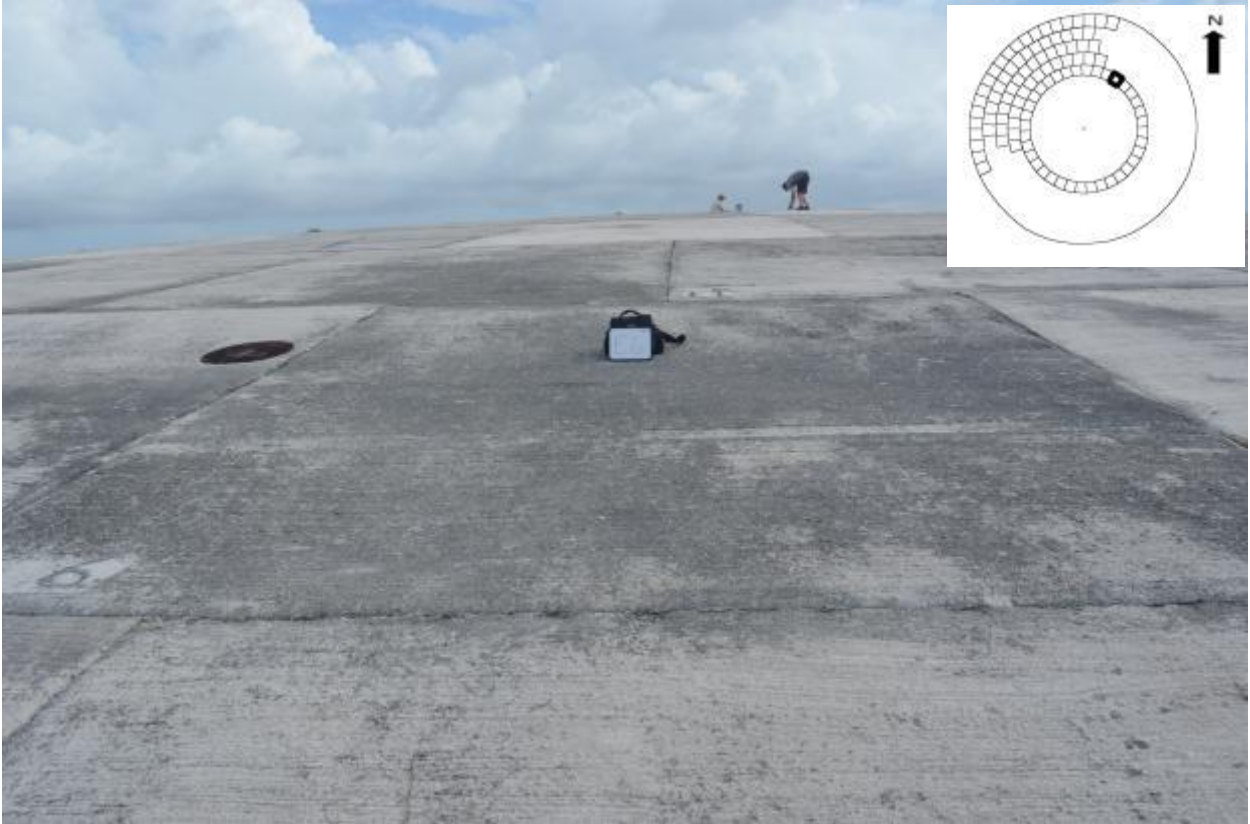
CAP SECTION LOCATION: Panel E6

No significant or obvious interior cracks extending across the top of the panel. Panel has a rough and weathered appearance.
