LLNL-TR-648143

A Visual Description of the Concrete Exterior of the Cactus Crater Containment Structure

Terry Hamilton

October 2013

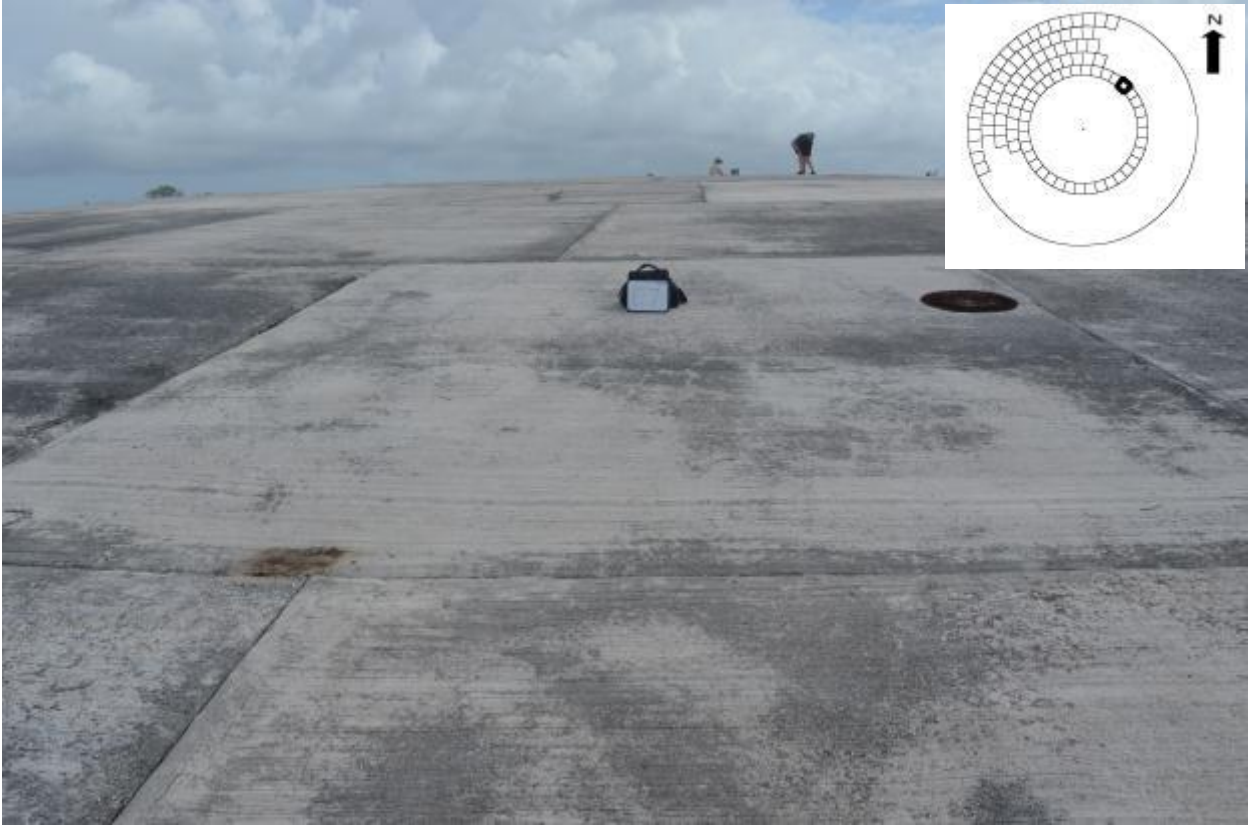
CAP SECTION LOCATION: Panel E7

No significant or obvious interior cracks extending across the top of the panel. Rooting vegetation (mainly grasses) removed from along the panel seams. Panel contains a vertical elevation benchmark.

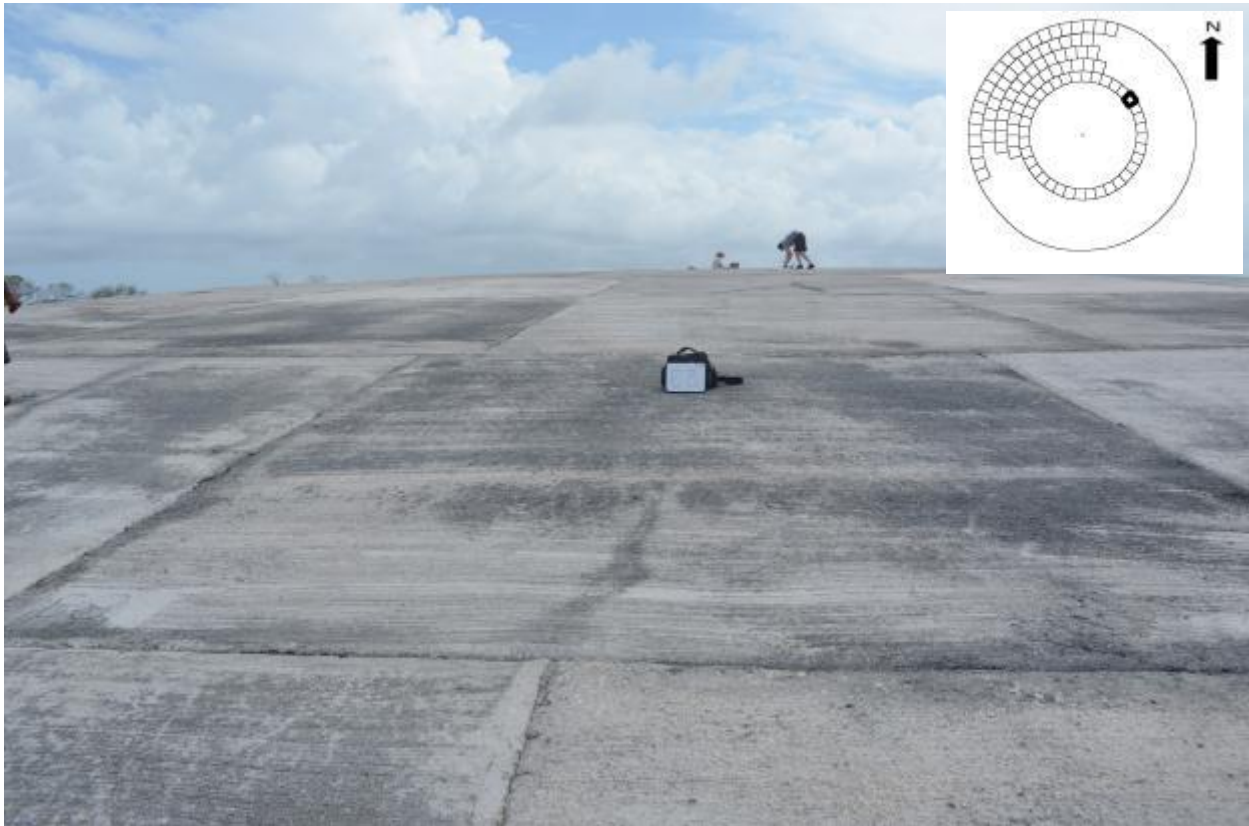
CAP SECTION LOCATION: Panel E8

No significant or obvious interior cracks extending across the top of the panel. Panel has a rough and weathered appearance. Some spalling/cracking of concrete observed in the upper left-hand corner of the panel and along the lower left seam

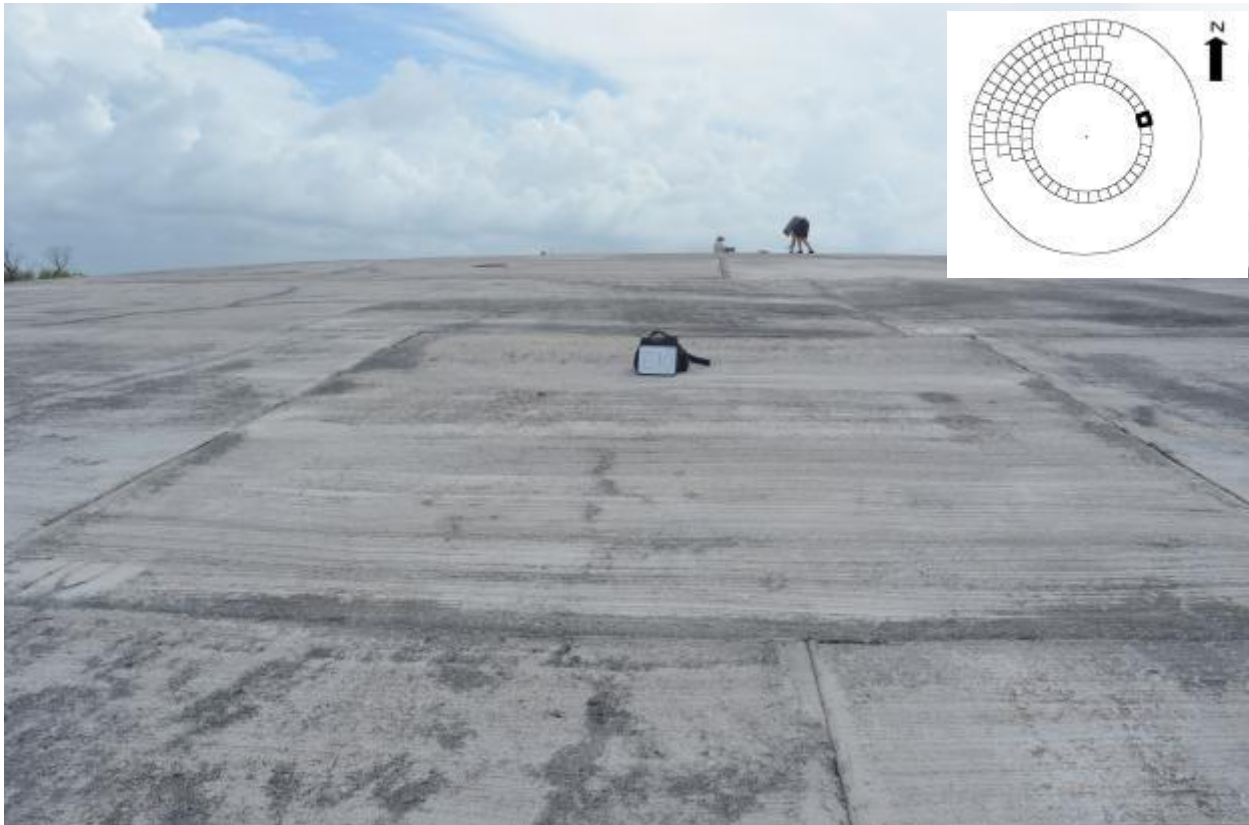
CAP SECTION LOCATION: Panel E10

No significant or obvious interior cracks extending across the top of the panel. Panel has a rough and weathered appearance. Some spalling/cracking of concrete observed in the upper right-hand corner of the panel.

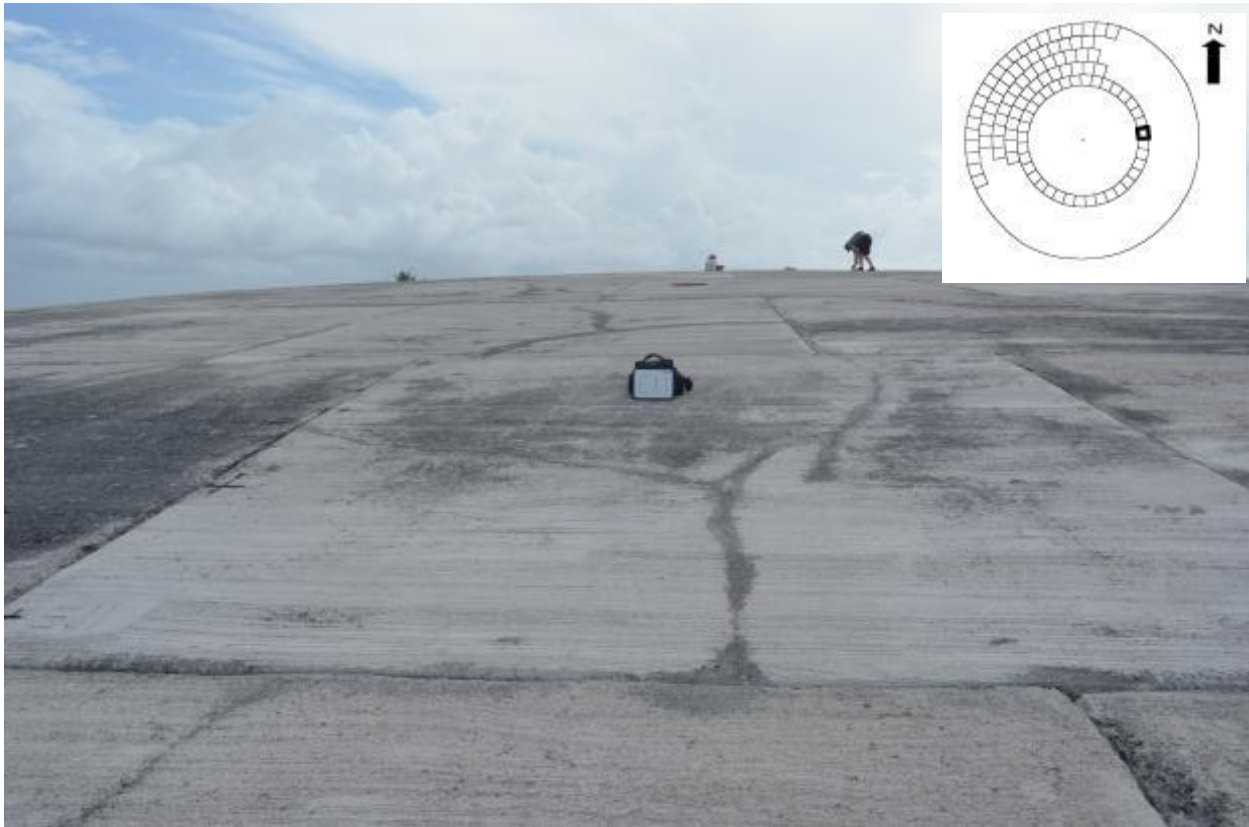
CAP SECTION LOCATION: Panel E11

Some spalling/cracking of concrete observed in the upper left-hand corner of the panel. Surface crack observed traversing up through the middle of the panel splitting off to the left-hand seam and extending to the upper right-hand side of the panel.

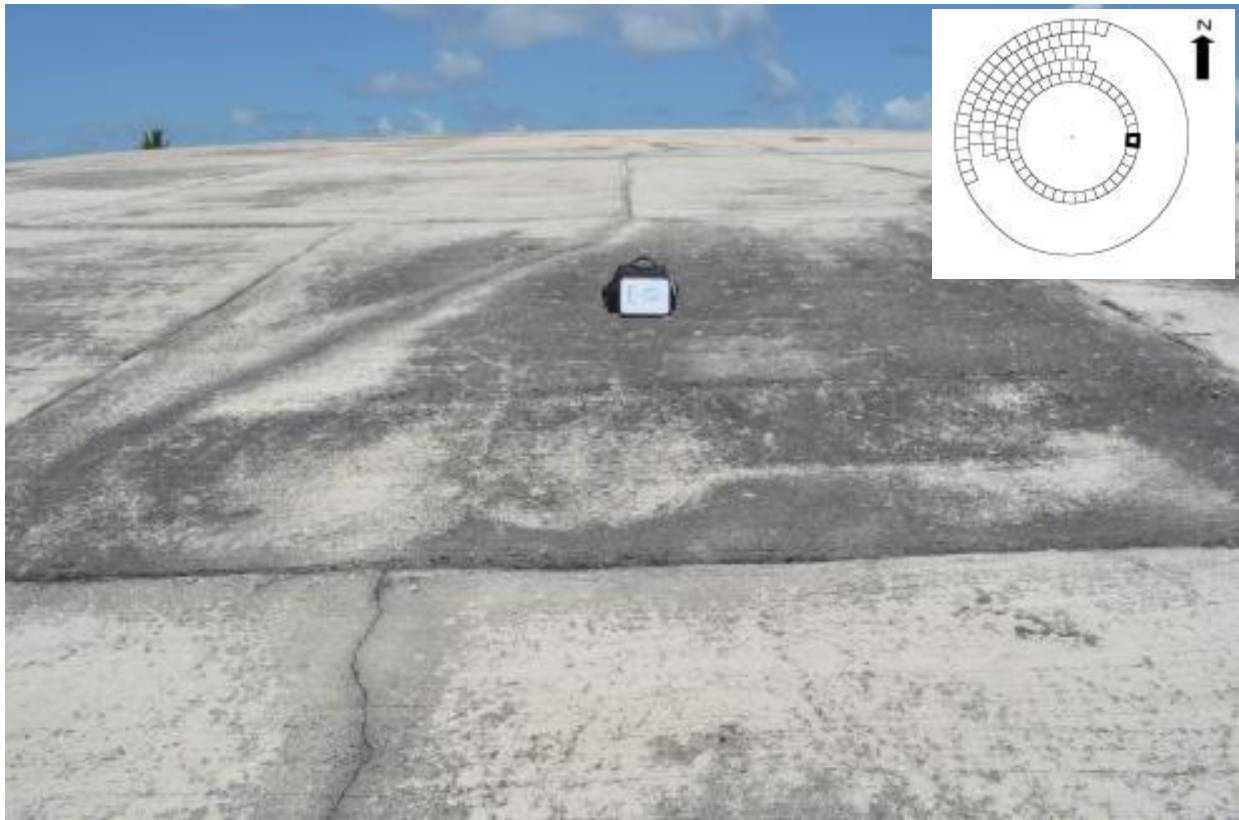
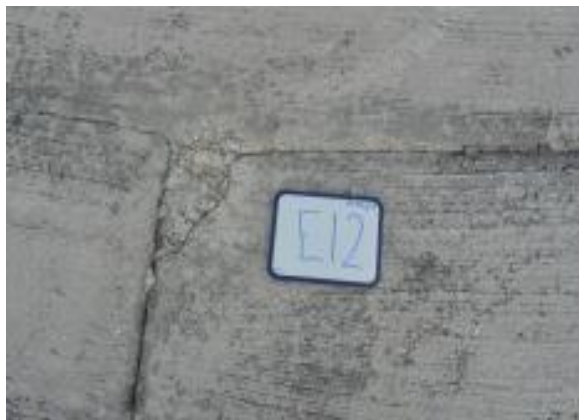
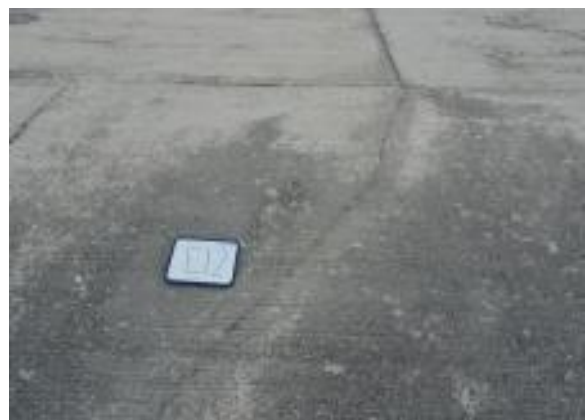
CAP SECTION LOCATION: Panel E12

Panel has a rough and weathered appearance. Significant spalling/cracking of concrete observed in the upper left corner. The panel also contains a distinguishable crack extending up from the bottom left-side of the panel and intersecting the upper seam at a position adjacent to the corner F9/F10 on the ring row above. Panel recommended for priority repair.

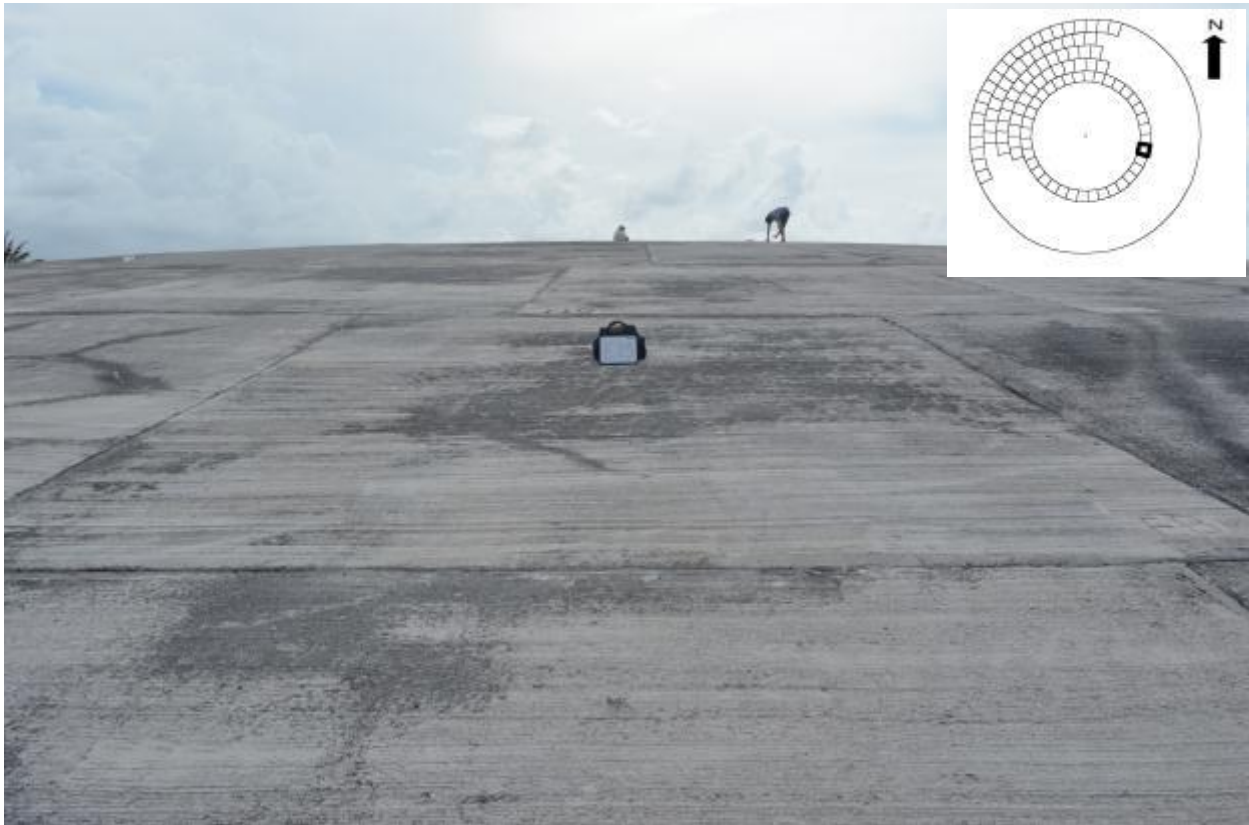
CAP SECTION LOCATION: Panel E13

No significant or obvious interior cracks extending across the top of the panel. Some minor spalling/cracking of concrete observed in the lower left-hand corner of the panel. Panel contains a capped concrete bore-hole (CD-4) from the 1980 NAS investigation.

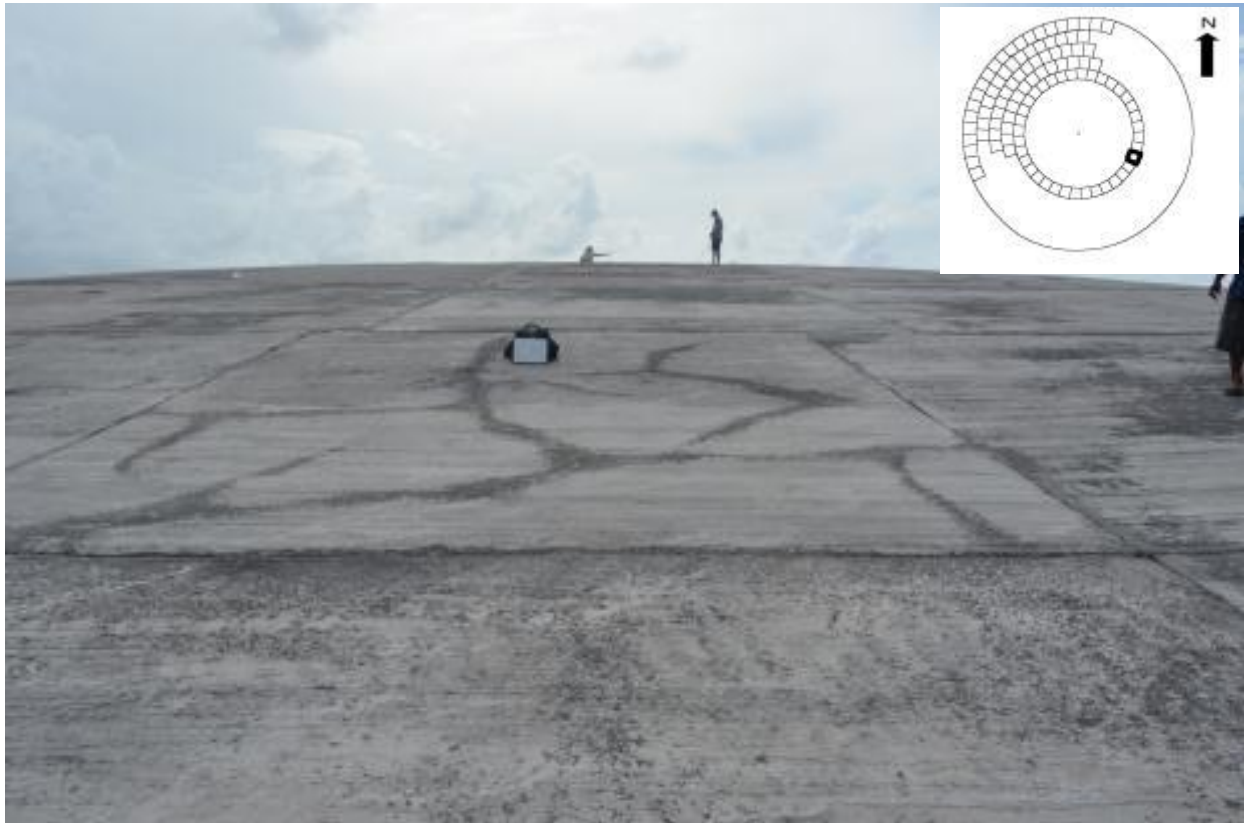
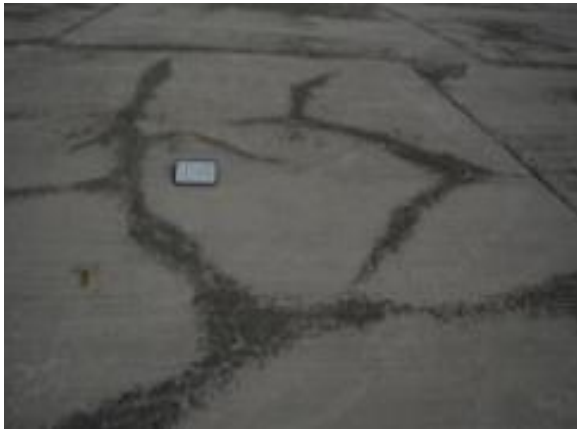
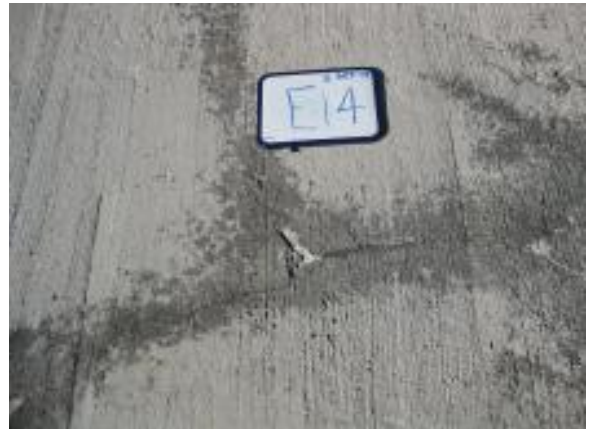
CAP SECTION LOCATION: Panel E14

Some spalling/cracking of concrete observed in the upper left-hand corner of the panel. Numerous cracks appearing in a crisscross pattern extending both up and down, and across the panel (following the shaded lines in the photo – see below).

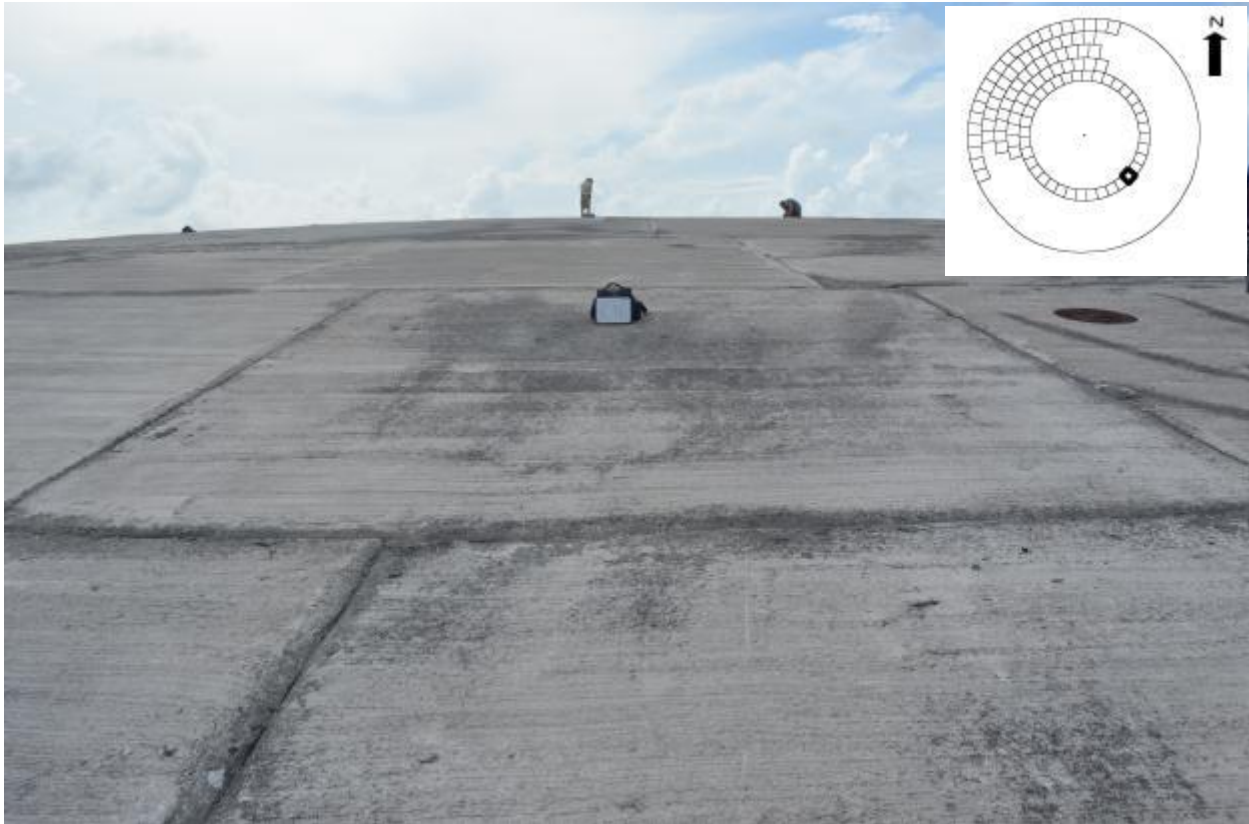
CAP SECTION LOCATION: Panel E16

No significant or obvious interior cracks extending across the top of the panel. The upper portion of the panel has a rough and weathered appearance.

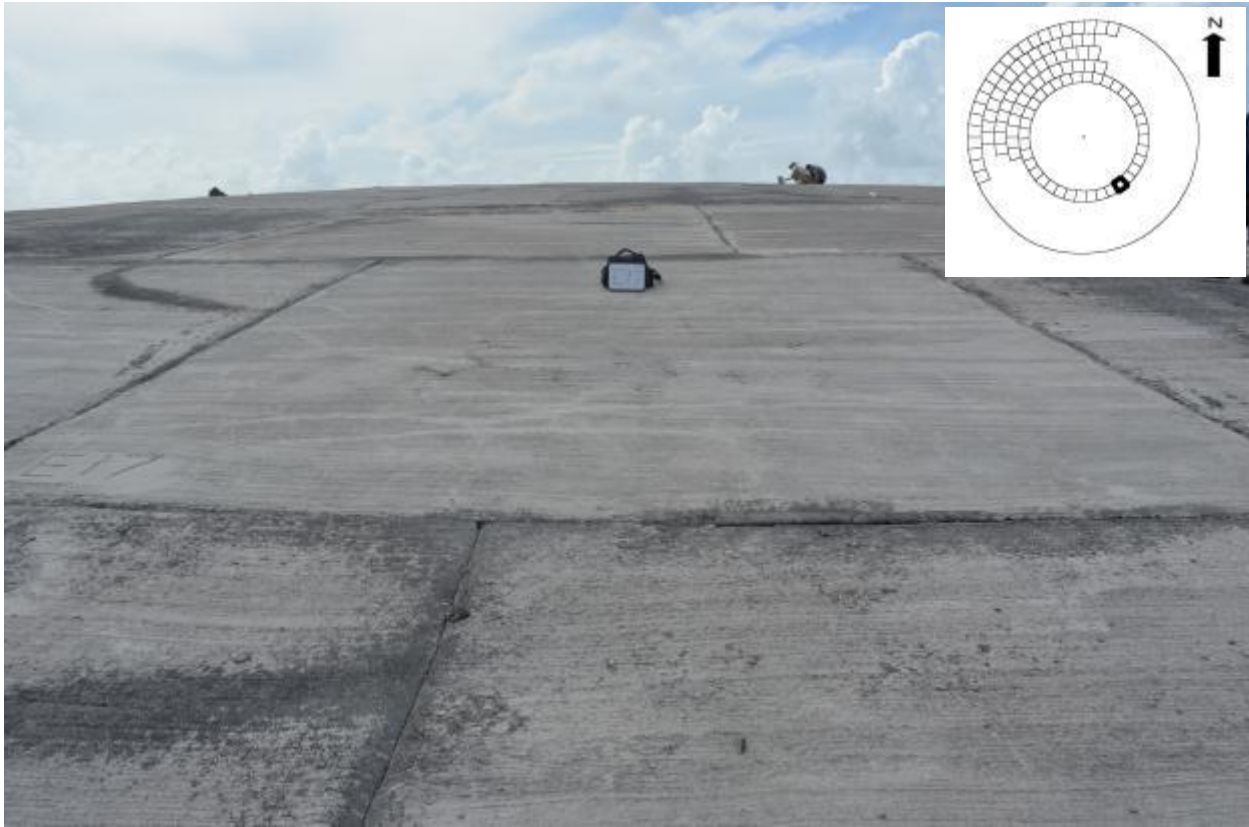
CAP SECTION LOCATION: Panel E17

Significant spalling/chipping of concrete observed along the lower seam of the panel. The panel contains no other significant or obvious spalls or cracks.

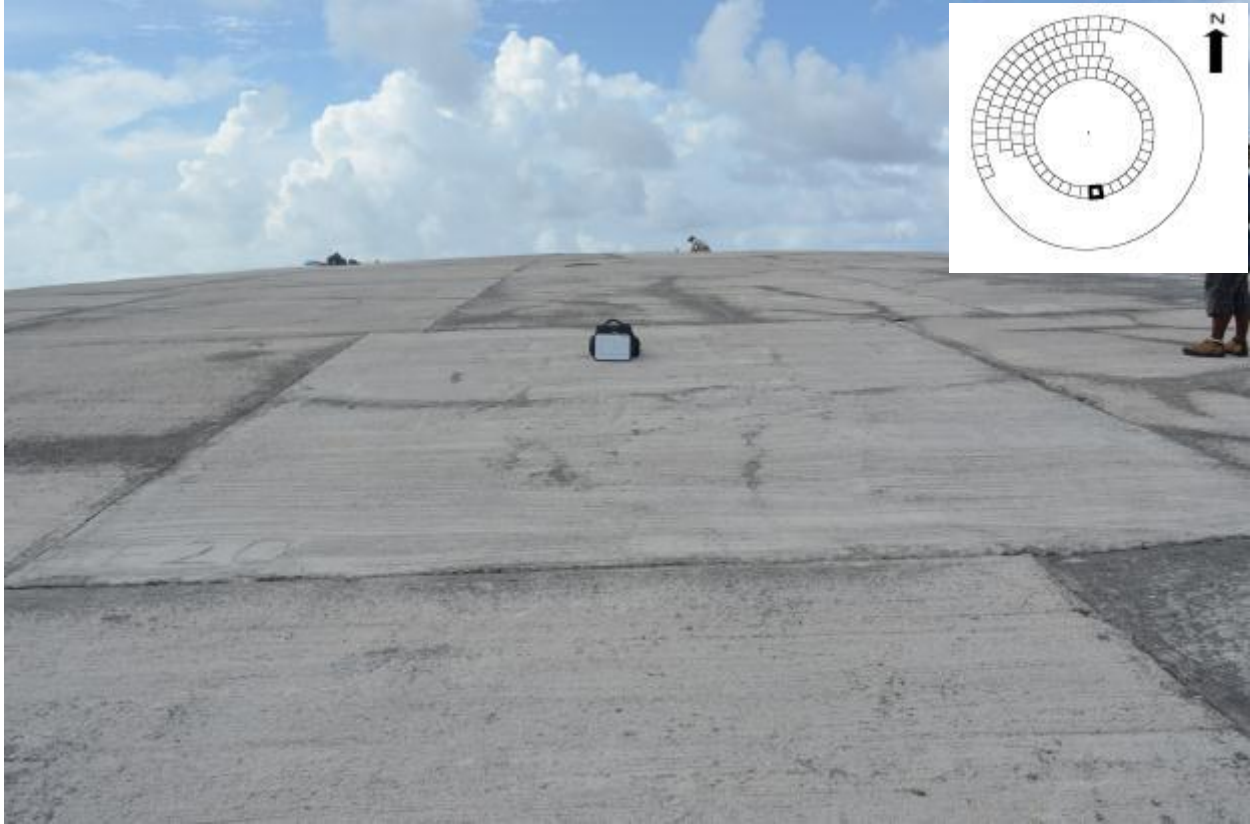
CAP SECTION LOCATION: Panel E20

No significant or obvious interior cracks extending across the top of the panel.

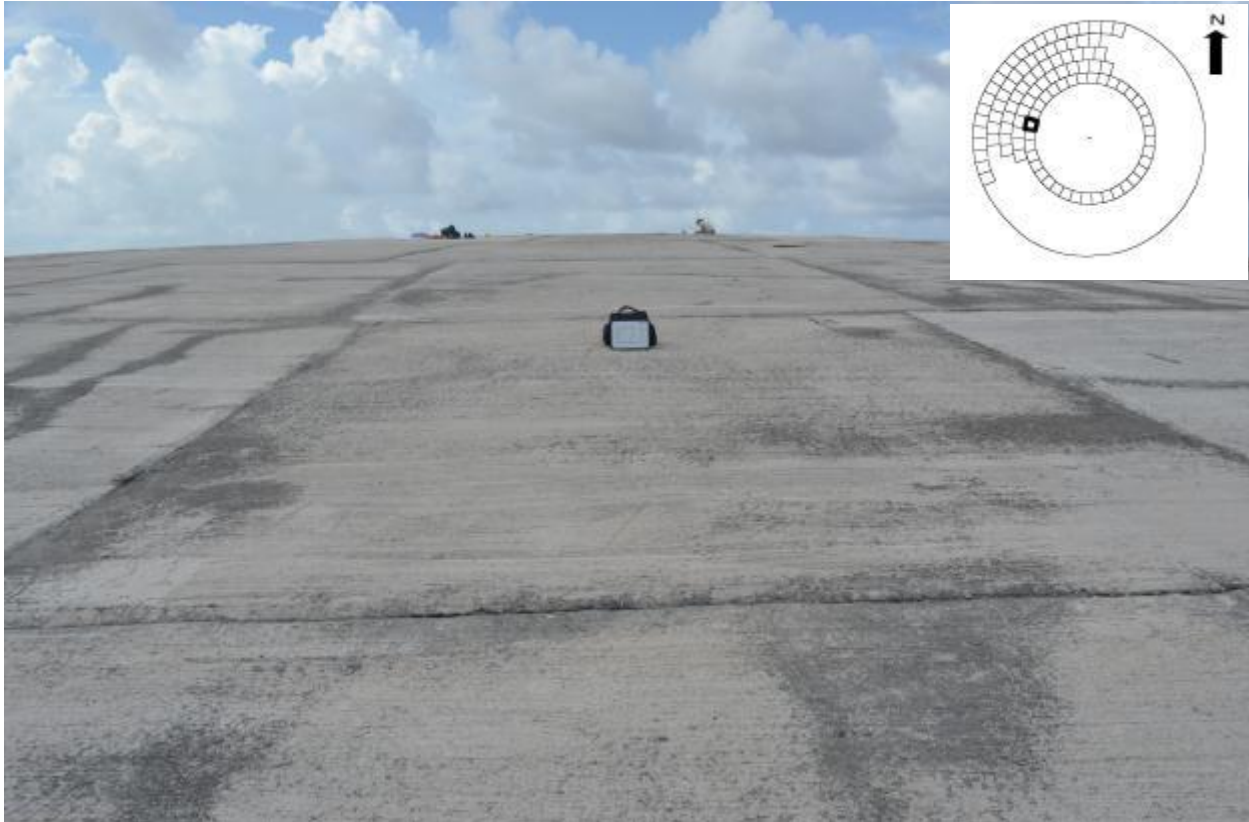
CAP SECTION LOCATION: Panel E21

Some spalling/cracking of concrete observed in the upper left-hand corner of the panel. No obvious interior cracks or spalls extending across the top of the panel with exception of a small voided piece of concrete in the upper right corner (app. 4 x 2-2.5 centimeters in area).

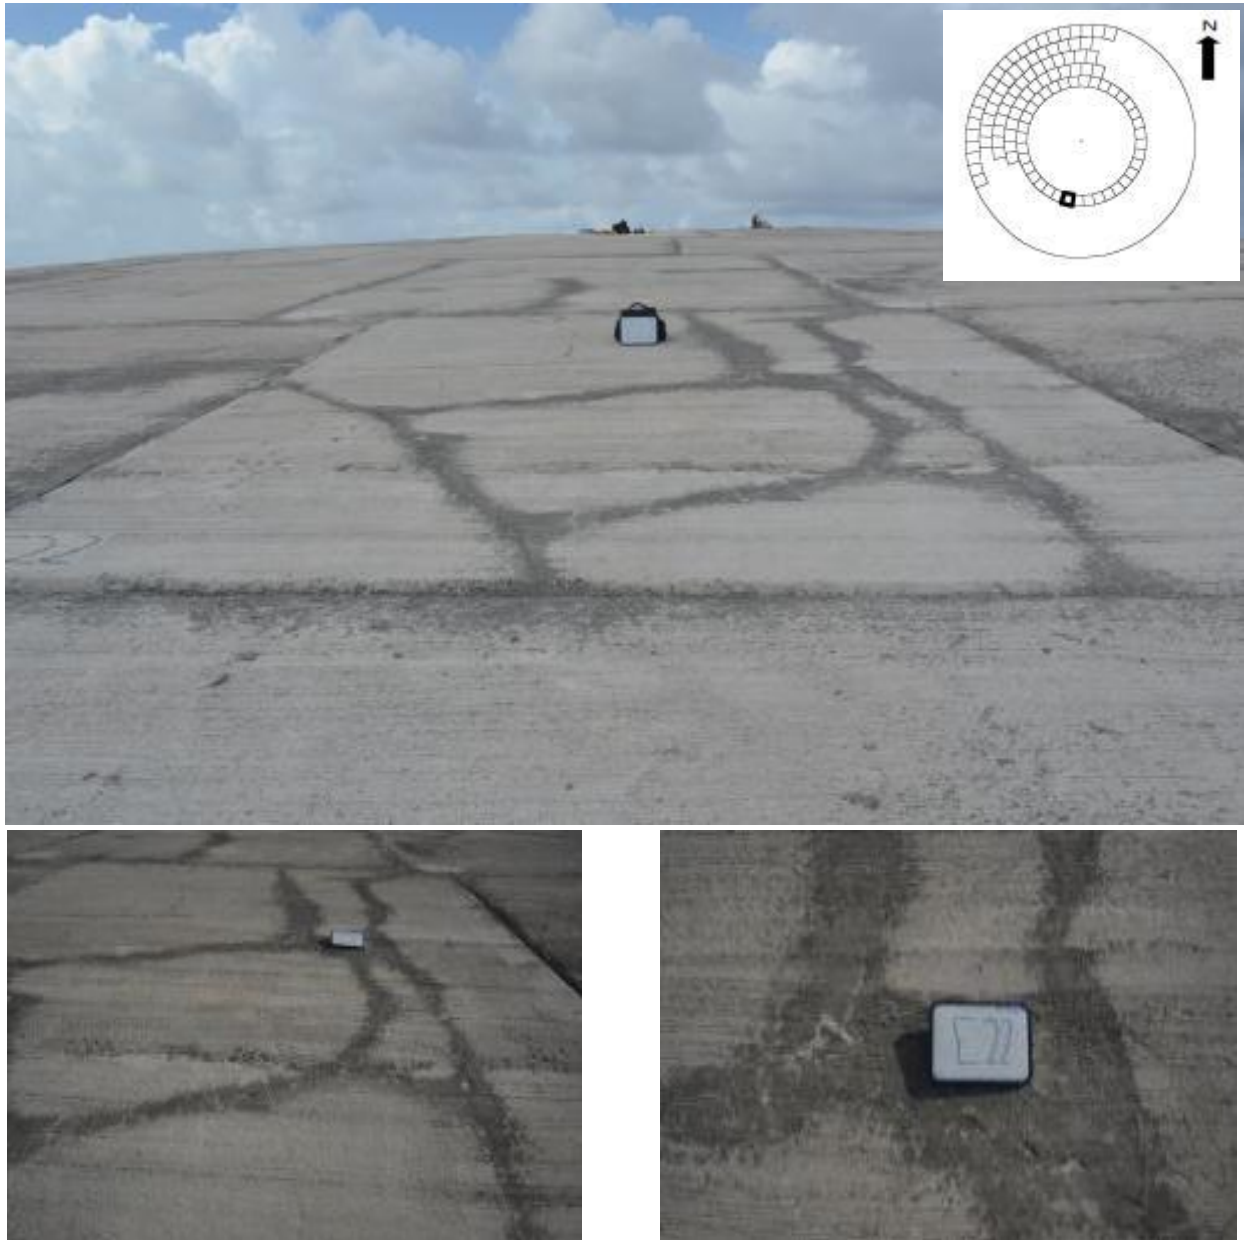
CAP SECTION LOCATION: Panel E22

Some spalling/cracking of concrete observed in the upper right-hand corner of the panel. Numerous cracks were observed extending up and down as well as across the panel (as observed by the shaded areas in the photo below). Panel recommended for priority repair!

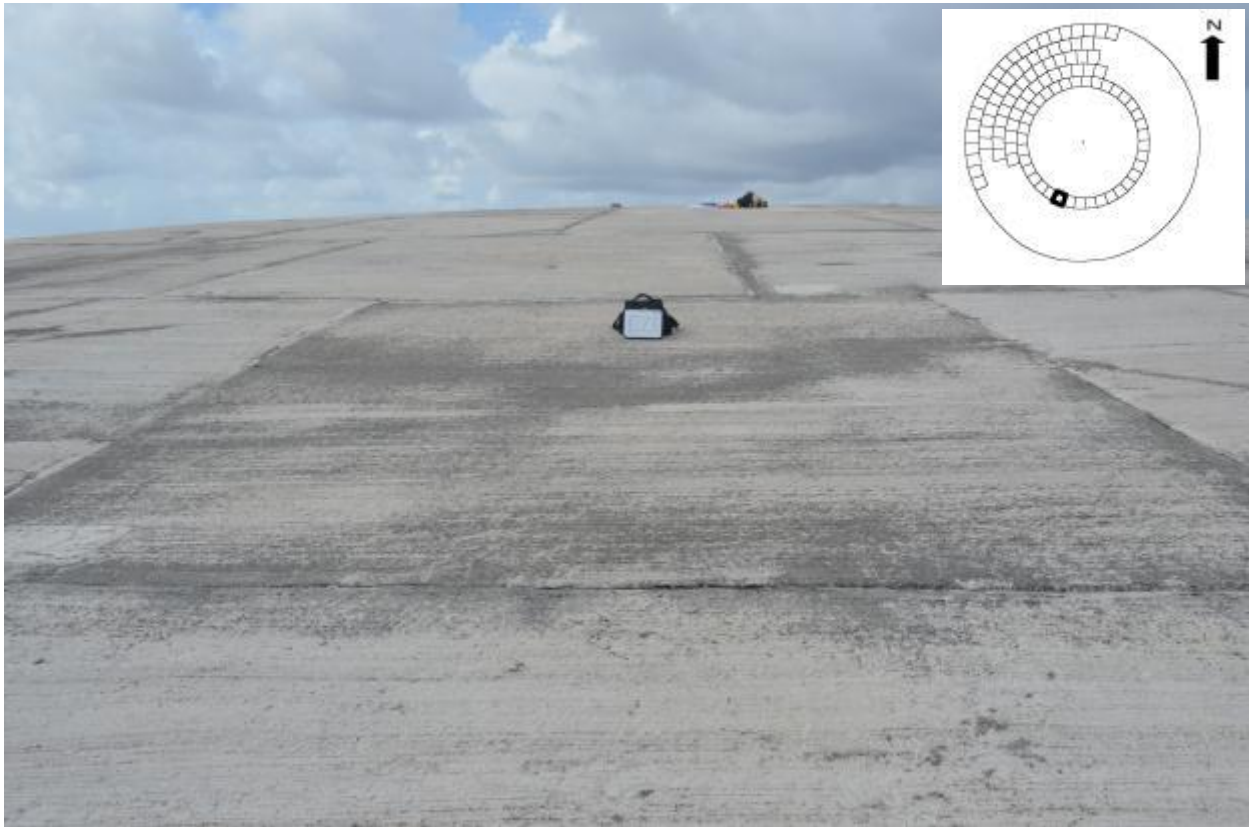
CAP SECTION LOCATION: Panel E23

No significant or obvious interior cracks extending across the top of the panel. Panel has a rough and weathered appearance. Concrete in the upper left-hand corner of the panel appears to be more highly weathered than other areas.

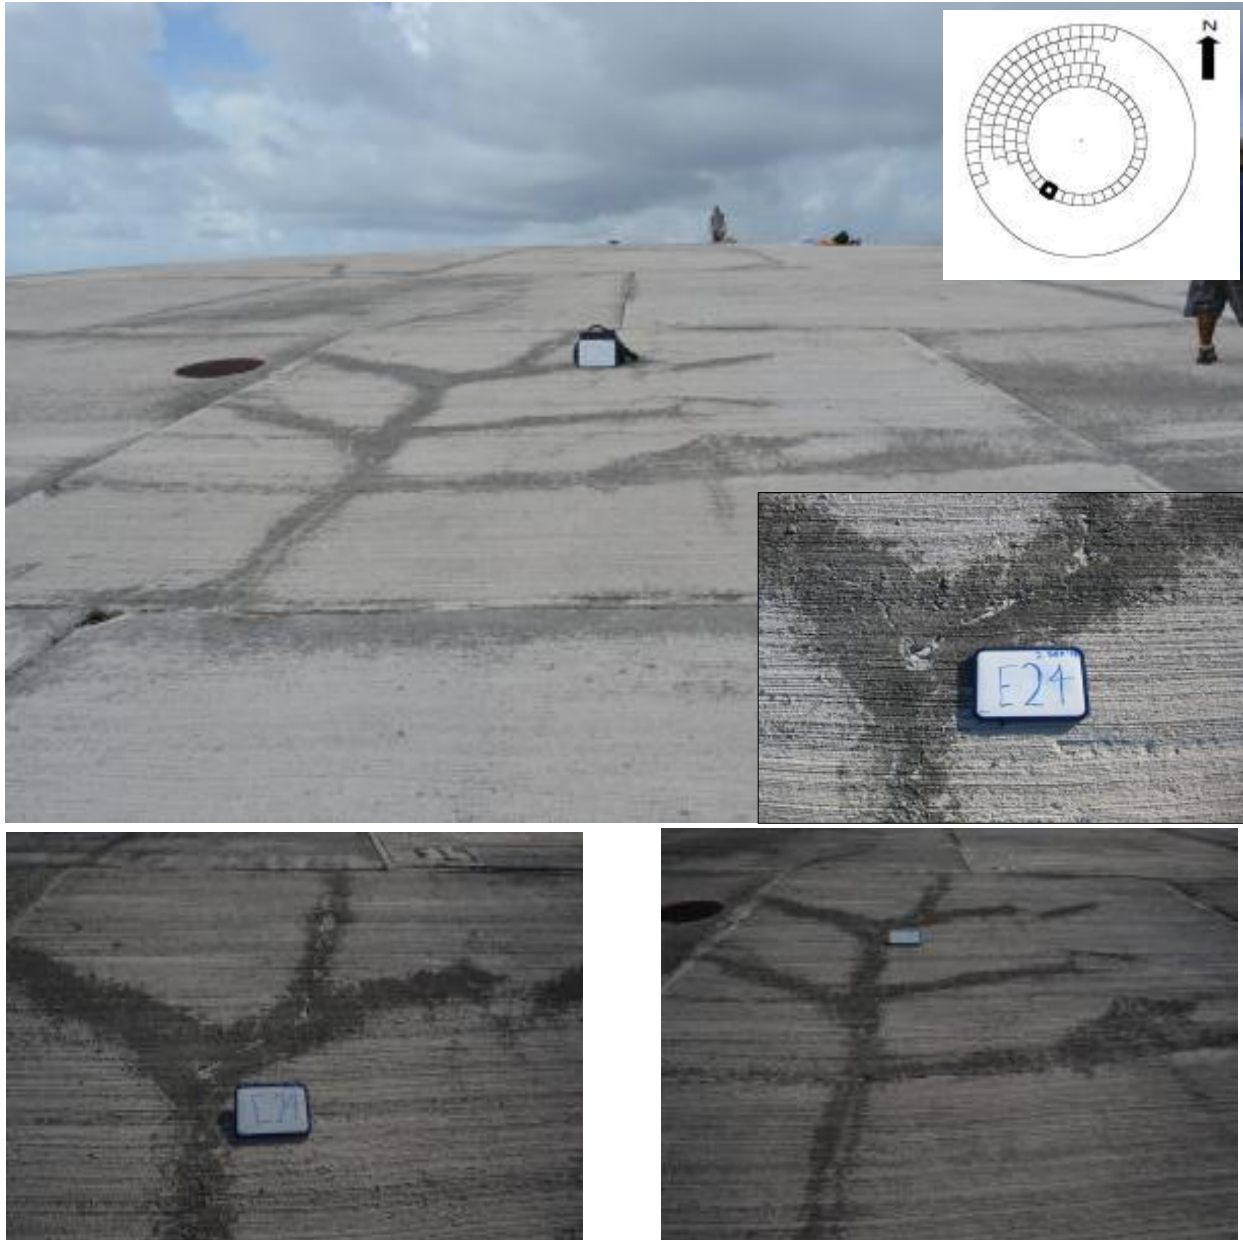
CAP SECTION LOCATION: Panel E24

Some spalling/cracking of concrete observed along the lower left and right seams of the panel. Surface cracks observed crisscrossing up and down as well as across the panel. Most cracks have chipped “spalled” edges and can be visualized by following the pattern of discoloration across the panel (refer to photo below). Panel is recommended for priority repair.

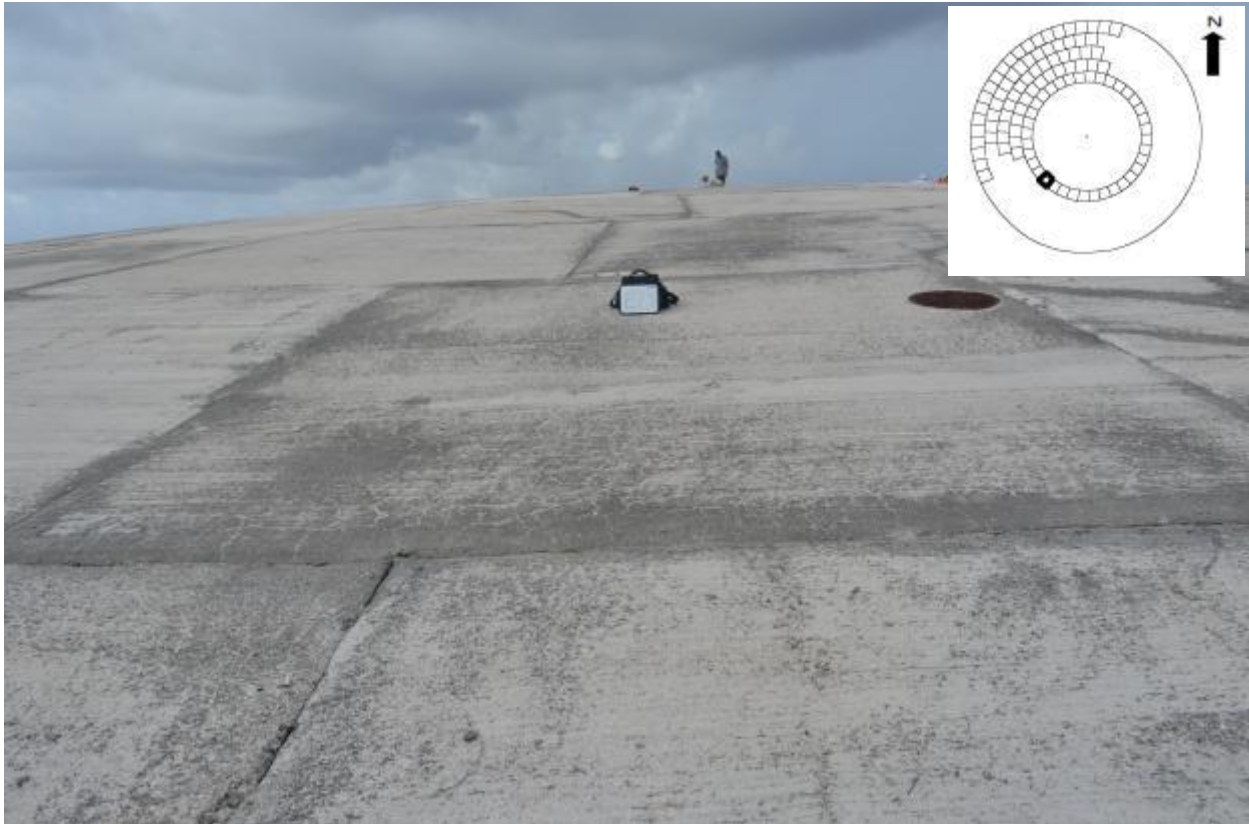
CAP SECTION LOCATION: Panel E25

No significant or obvious interior cracks extending across the top of the panel. Panel has a rough and weathered appearance. Panel contains a vertical elevation benchmark.

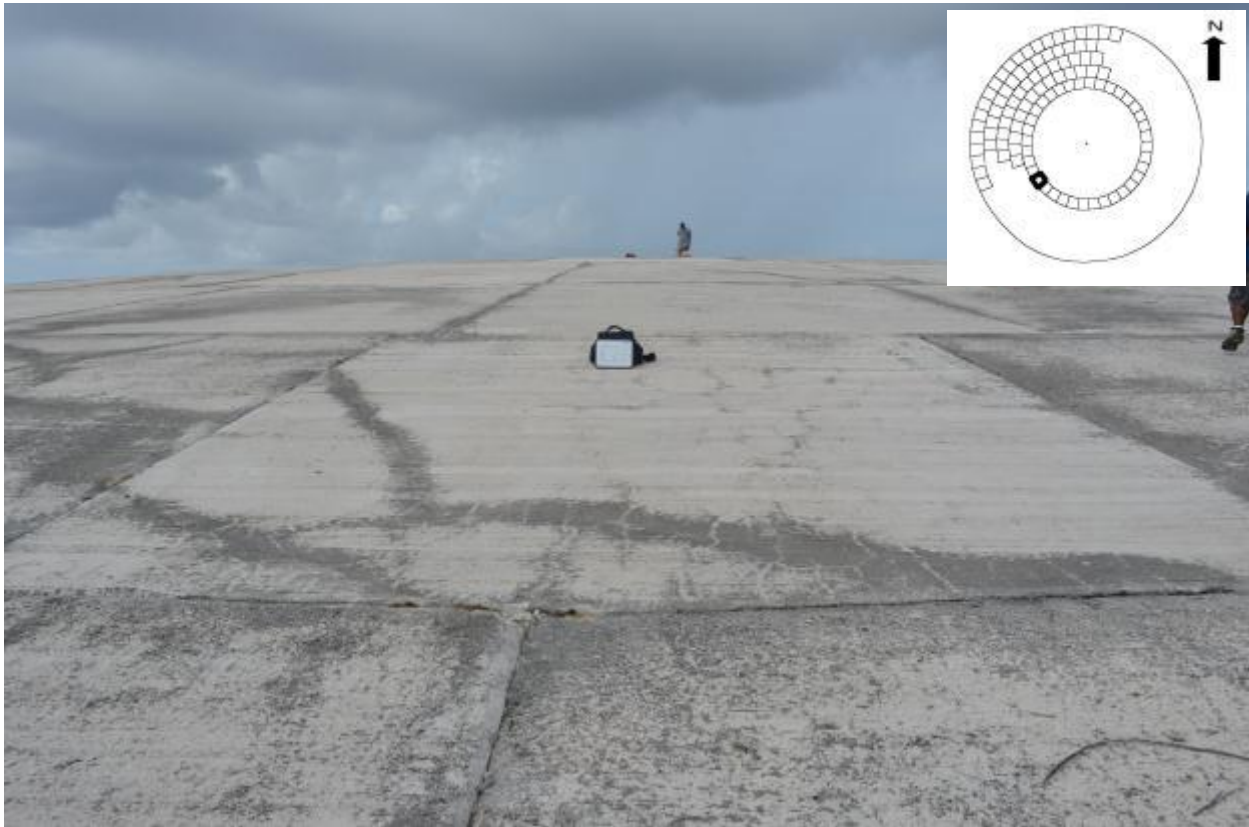
CAP SECTION LOCATION: Panel E26

Some spalling/cracking of concrete observed on the left-hand side of the lower seam. Surface cracks observed in the lower left-hand corner of the panel. Additional minor cracks have formed up and across the panel, the most significant of which intersects the left side seam about 2 meters from the top of the panel. Rooting vegetation removed from along the panel seams.

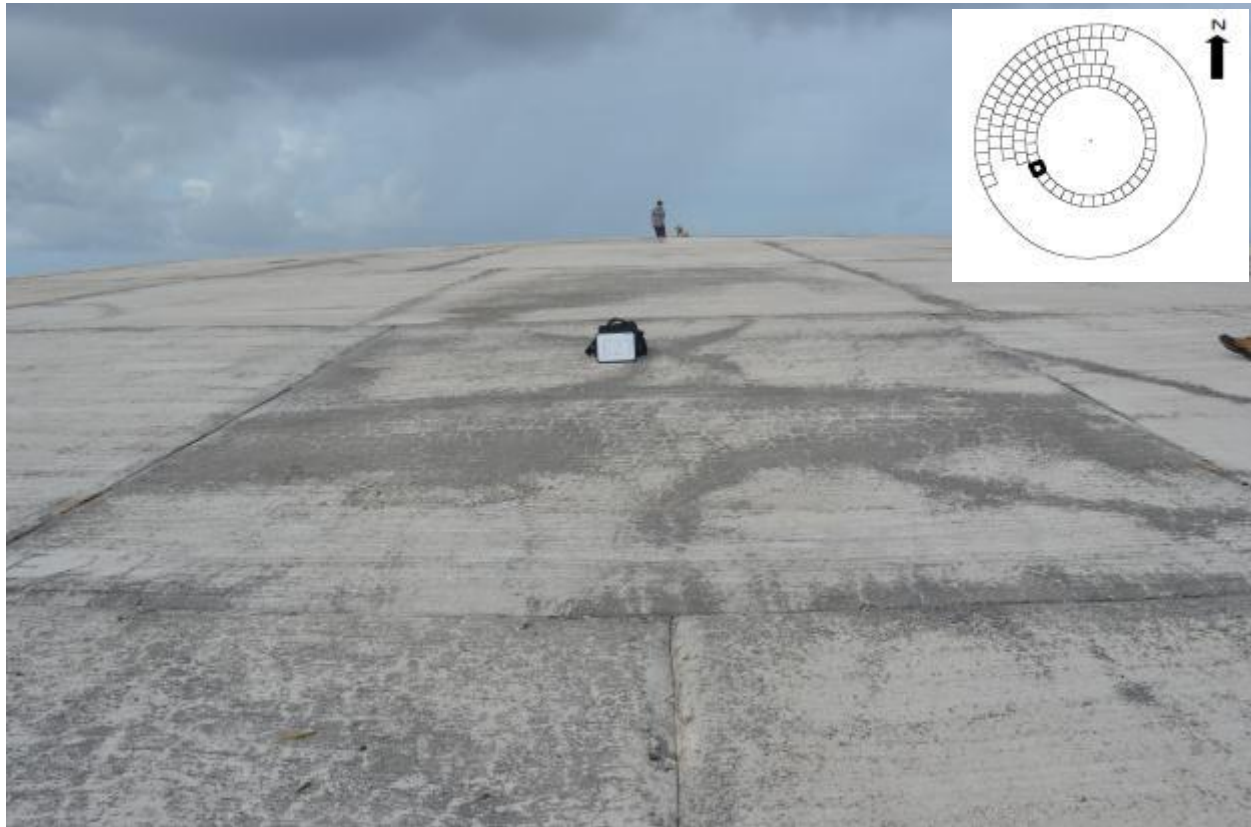
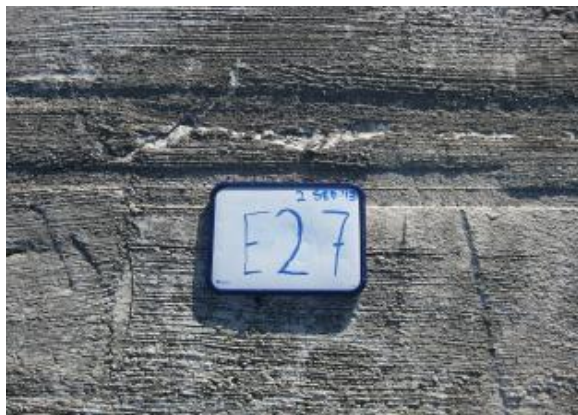
CAP SECTION LOCATION: Panel E27

Panel has a rough and weathered appearance. The main observable feature is a surface crack running left to right at a mid-point up the panel. Cracks have chipped “spalled” edges. Other very minor cracks observed forming a crisscrossing pattern around the panel. Rooting vegetation removed from along the panel seams.

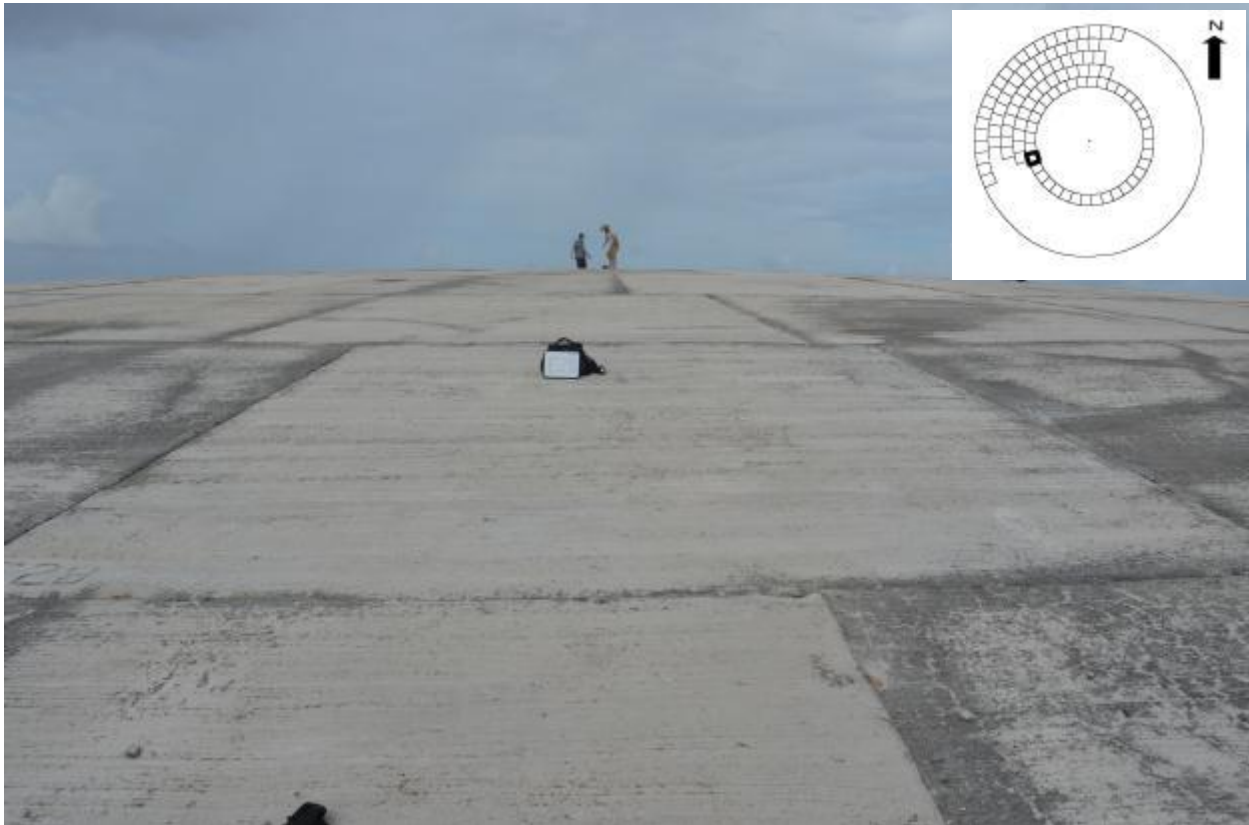
CAP SECTION LOCATION: Panel E28

No significant or obvious interior cracks extending across the top of the panel. The panel has a rough and weathered appearance. Rooting vegetation removed from along the panel seams.
