LLNL-TR-648143

A Visual Description of the Concrete Exterior of the Cactus Crater Containment Structure

Terry Hamilton

October 2013

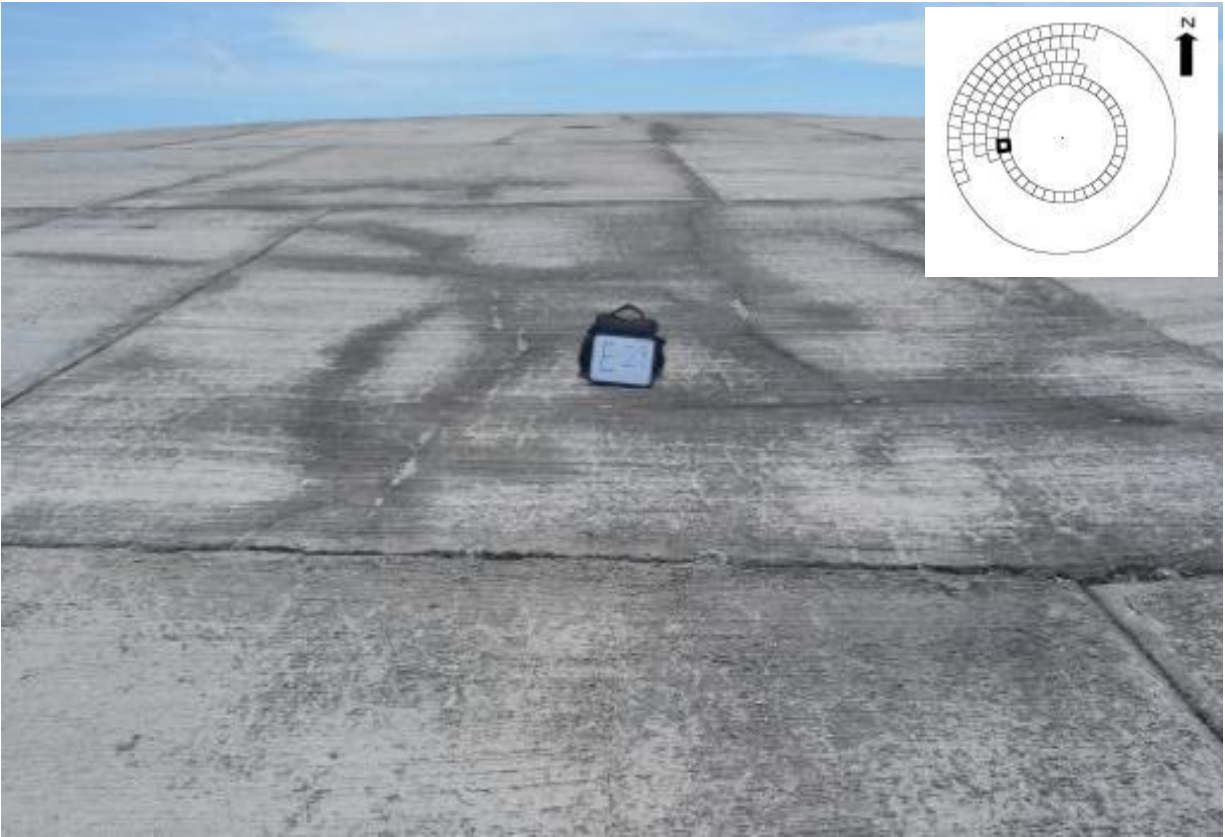
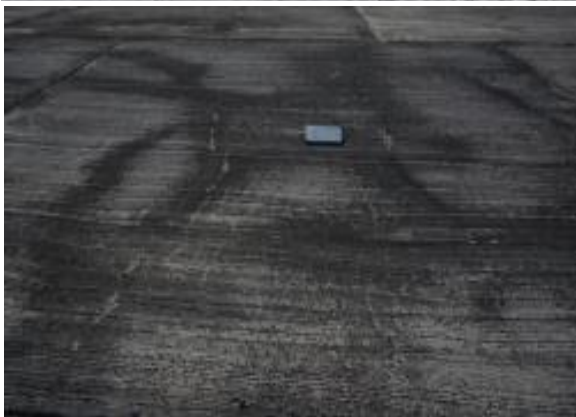
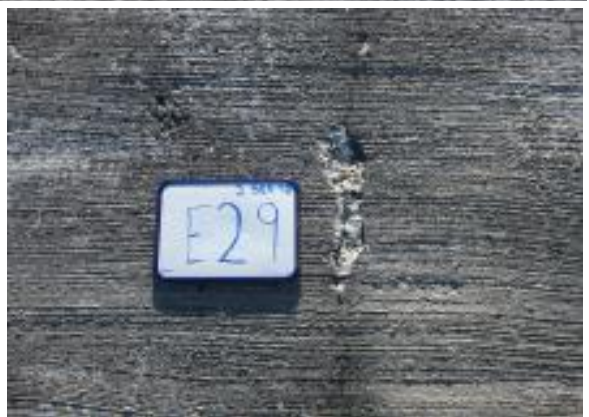
CAP SECTION LOCATION: Panel E29

There are numerous cracks with chipped “spalled” edges crisscrossing up and across the panel. Some spalling/cracking of concrete observed in the right-hand corner of the panel.

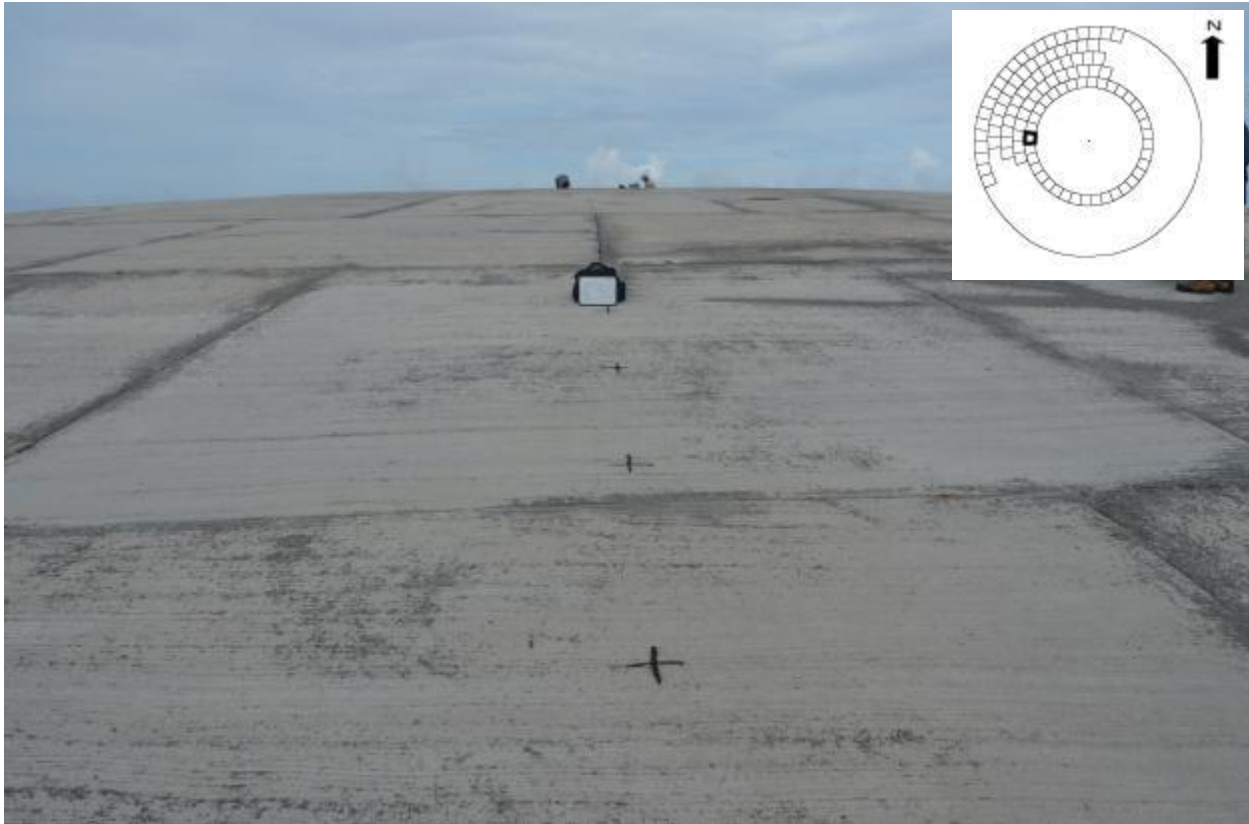
CAP SECTION LOCATION: Panel E30

No significant or obvious interior cracks extending across the top of the panel. Panel has a rough and weathered appearance. Rooting vegetation removed from along the panel seams.

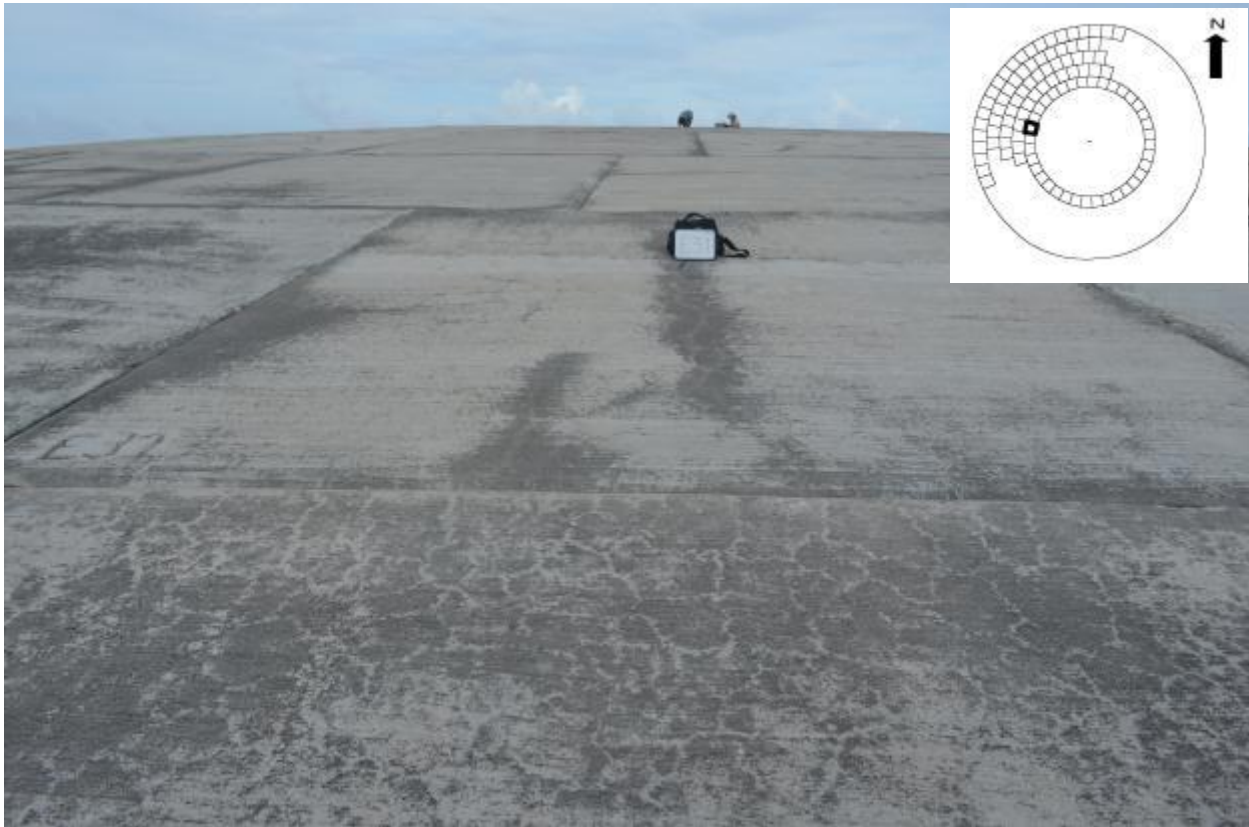
CAP SECTION LOCATION: Panel E31

No significant or obvious interior cracks extending across the top of the panel. The upper portion of the panel has a rough and weathered appearance. Rooting vegetation removed from along the panel seams.

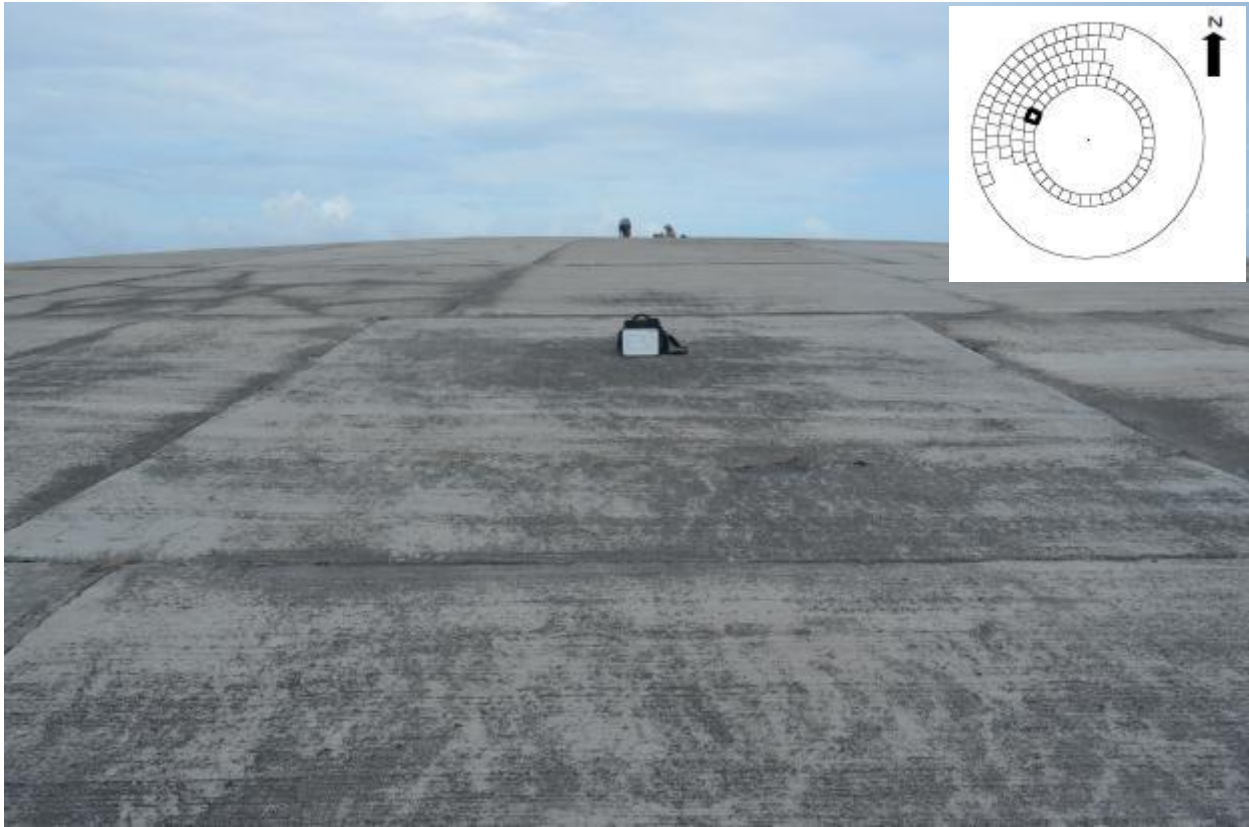
CAP SECTION LOCATION: Panel E32

No significant or obvious interior cracks extending across the top of the panel. Panel has a rough and weathered appearance. Rooting vegetation removed from along the panel seams.

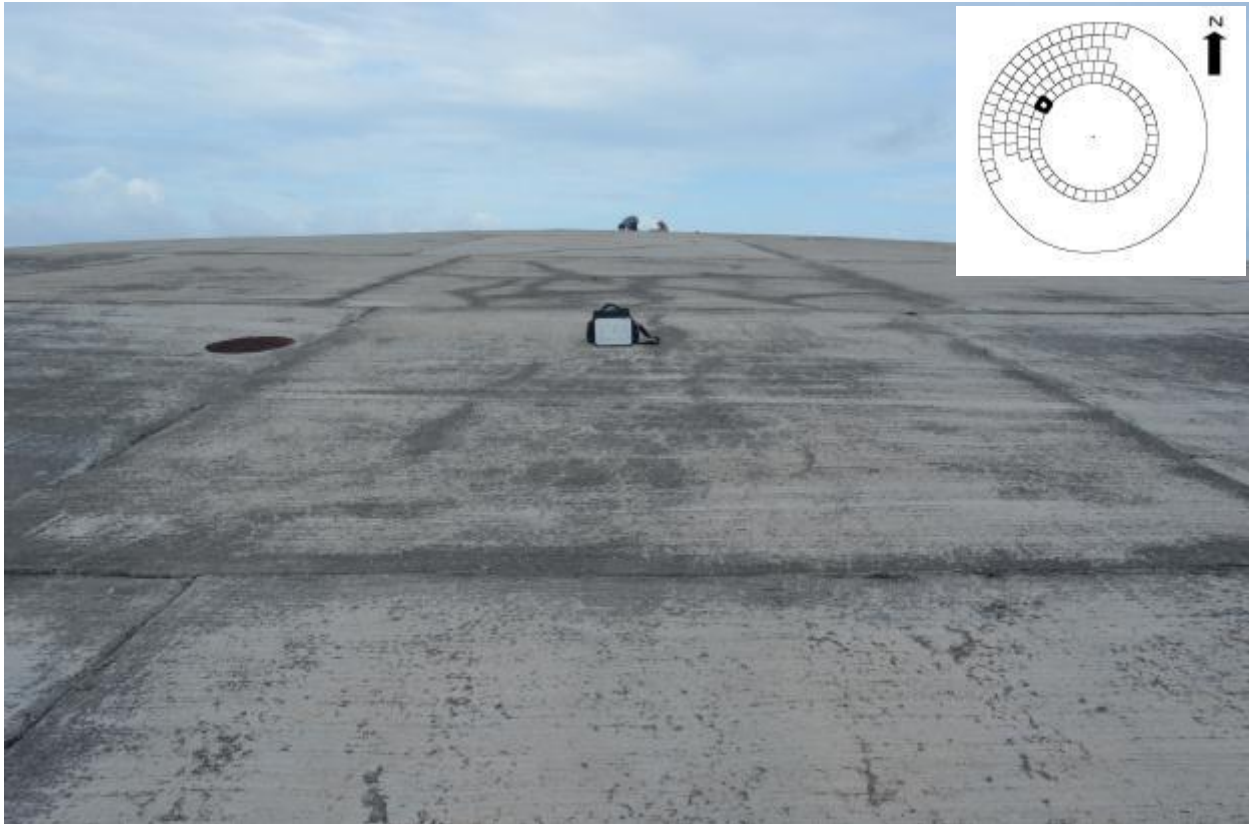
CAP SECTION LOCATION: Panel E33

No significant or obvious interior cracks extending across the top of the panel. The panel has a rough and weathered appearance.

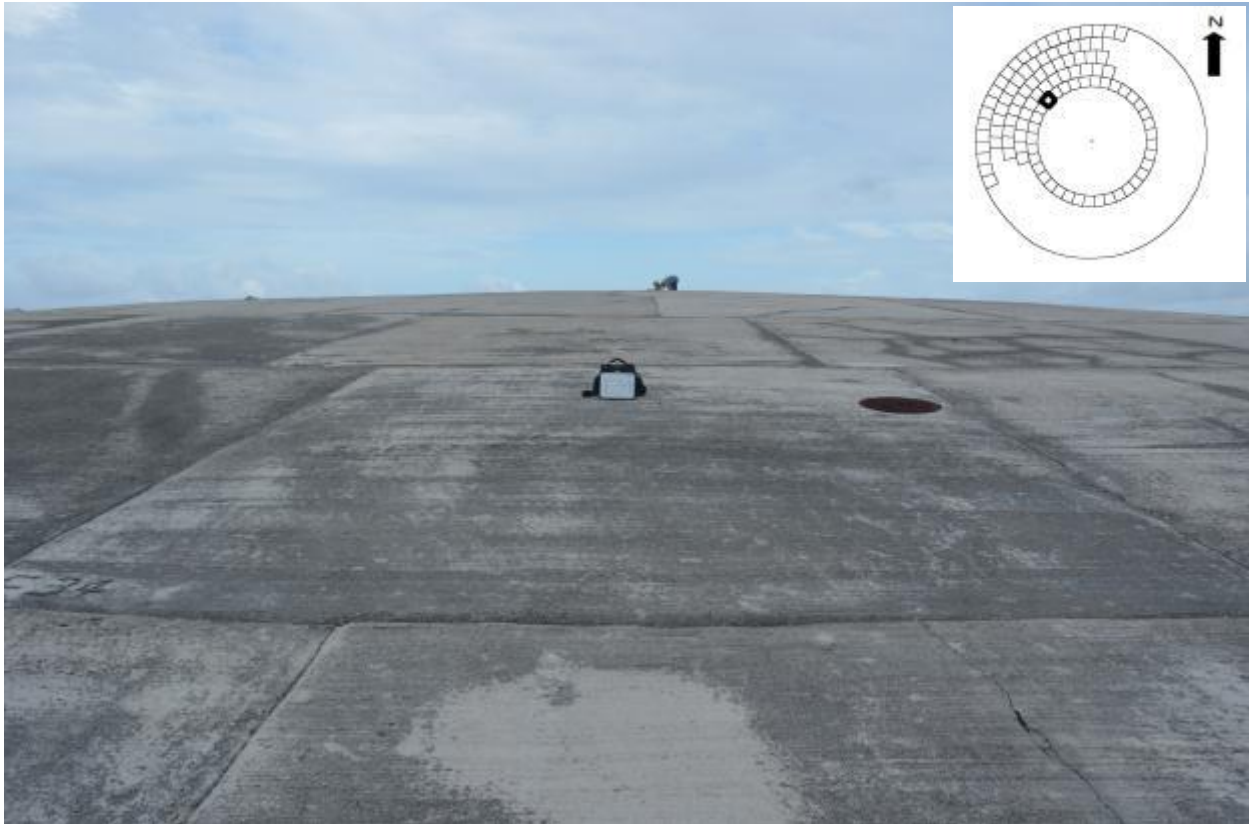
CAP SECTION LOCATION: Panel E34

No significant or obvious interior cracks extending across the top of the panel. The panel has a rough and weathered appearance. Panel contains a vertical elevation benchmark.

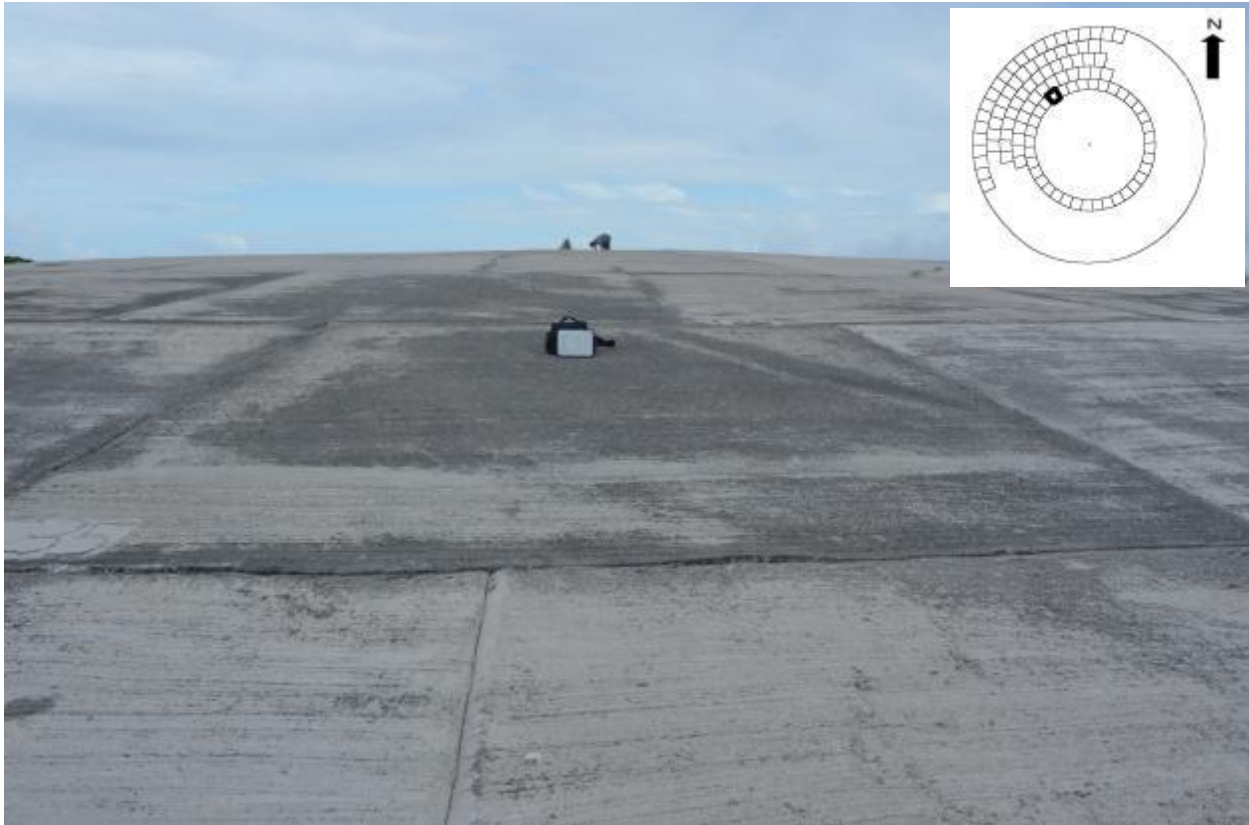
CAP SECTION LOCATION: Panel E35

No significant or obvious interior cracks extending across the top of the panel. The panel has a rough and weathered appearance.

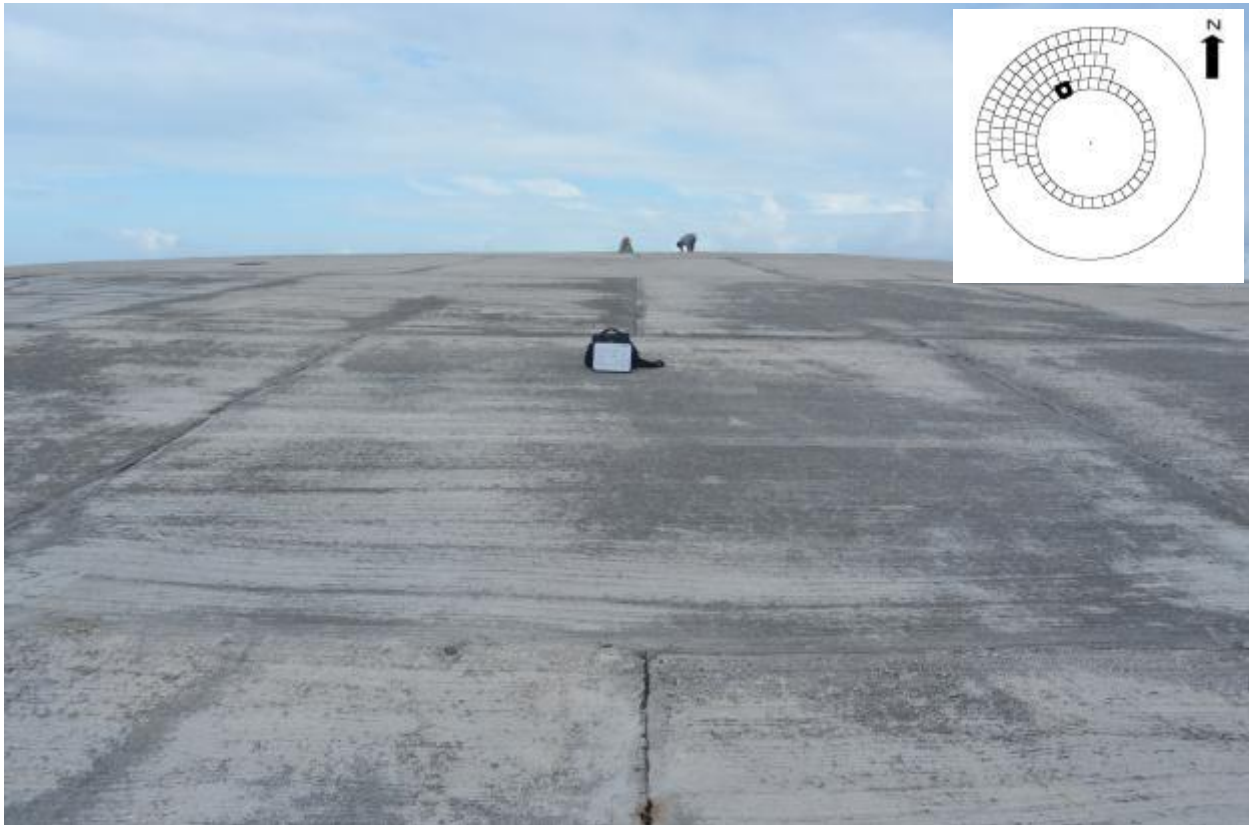
The panel has a rough and weathered appearance. Some spalling/cracking of concrete observed along the upper and lower right seams, and in the upper right-hand corner, of the panel.

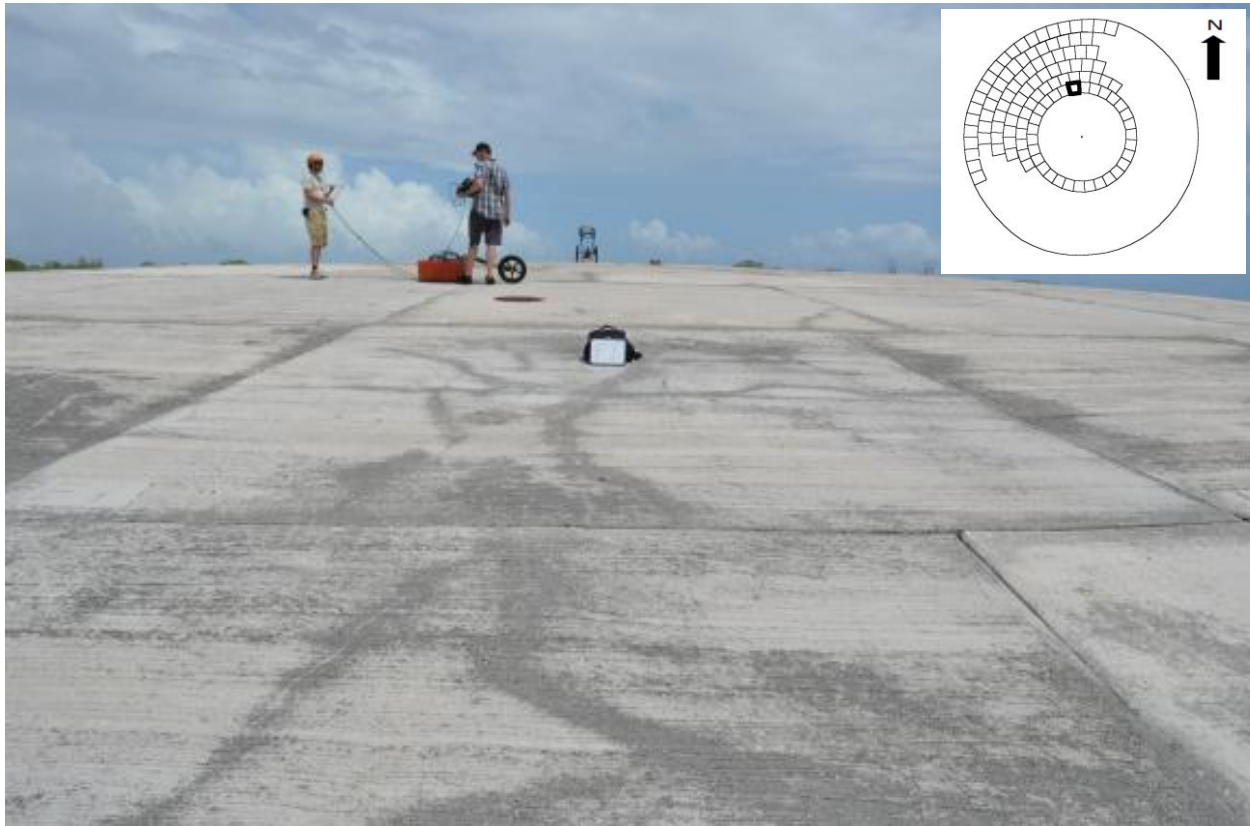
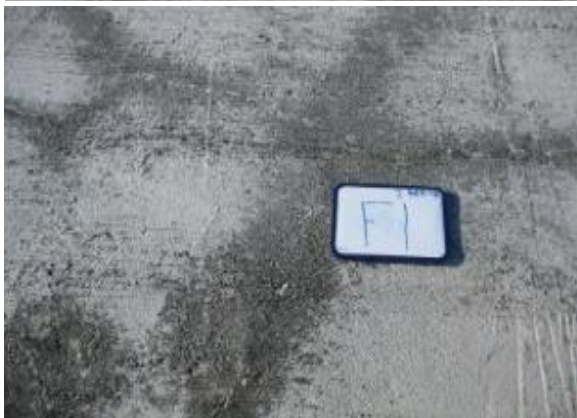
CAP SECTION LOCATION: Panel F1

Some spalling/cracking of concrete observed in the upper left-hand corner of the panel. Minor surface cracks extending up from the bottom seam in a crisscross pattern, and intersecting with the upper and left seams of the panel.

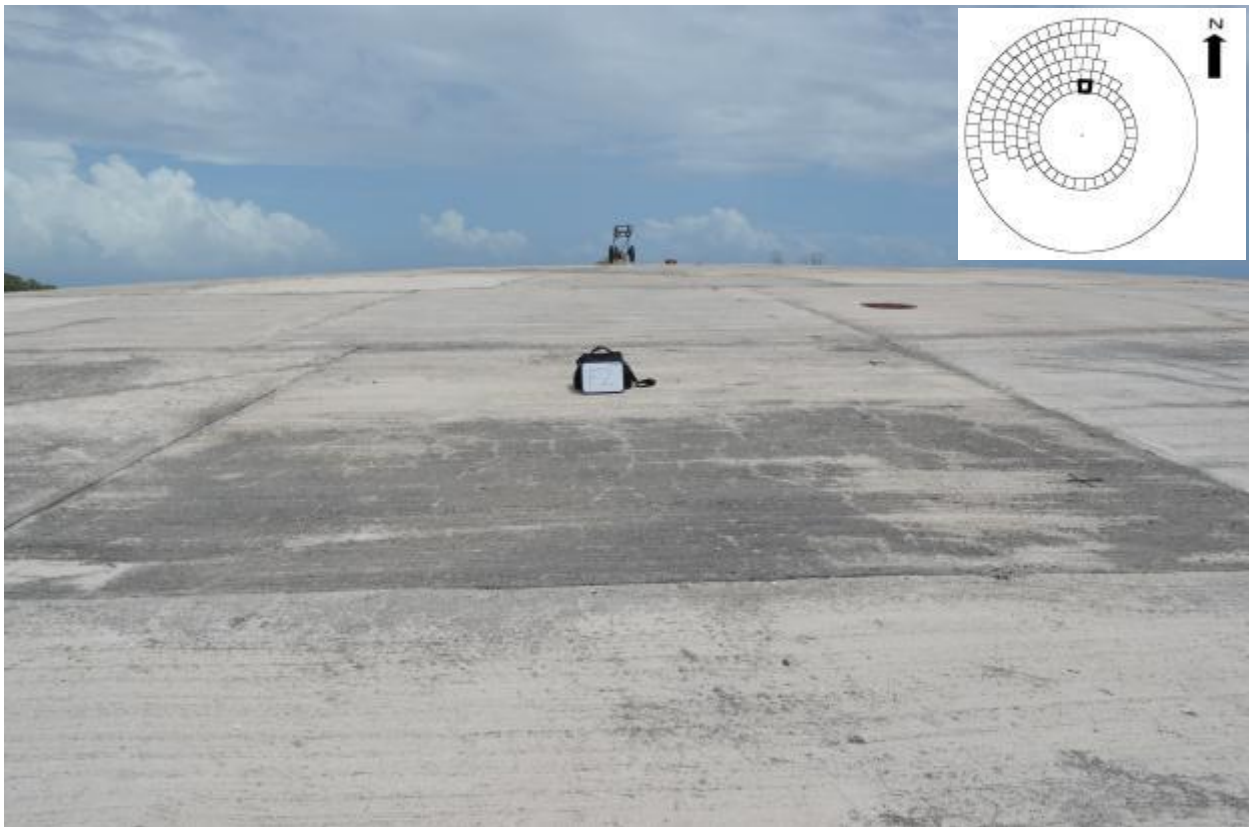
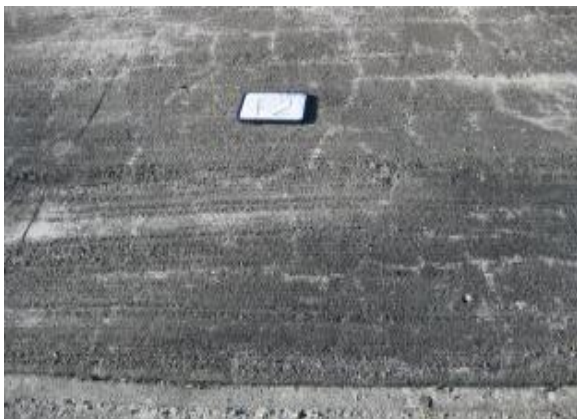
CAP SECTION LOCATION: Panel F2

The panel contains patches of discolored concrete. Some spalling/cracking of concrete observed in the upper left and right-hand corners of the panel. No significant or obvious interior cracks or spalls extending across the top of the panel with exception of numerous very minor cracks. Also, there is a small void in the concrete appearing near the upper left-hand corner (app. 4 centimeters deep, and 1 x 3 centimeters in area).

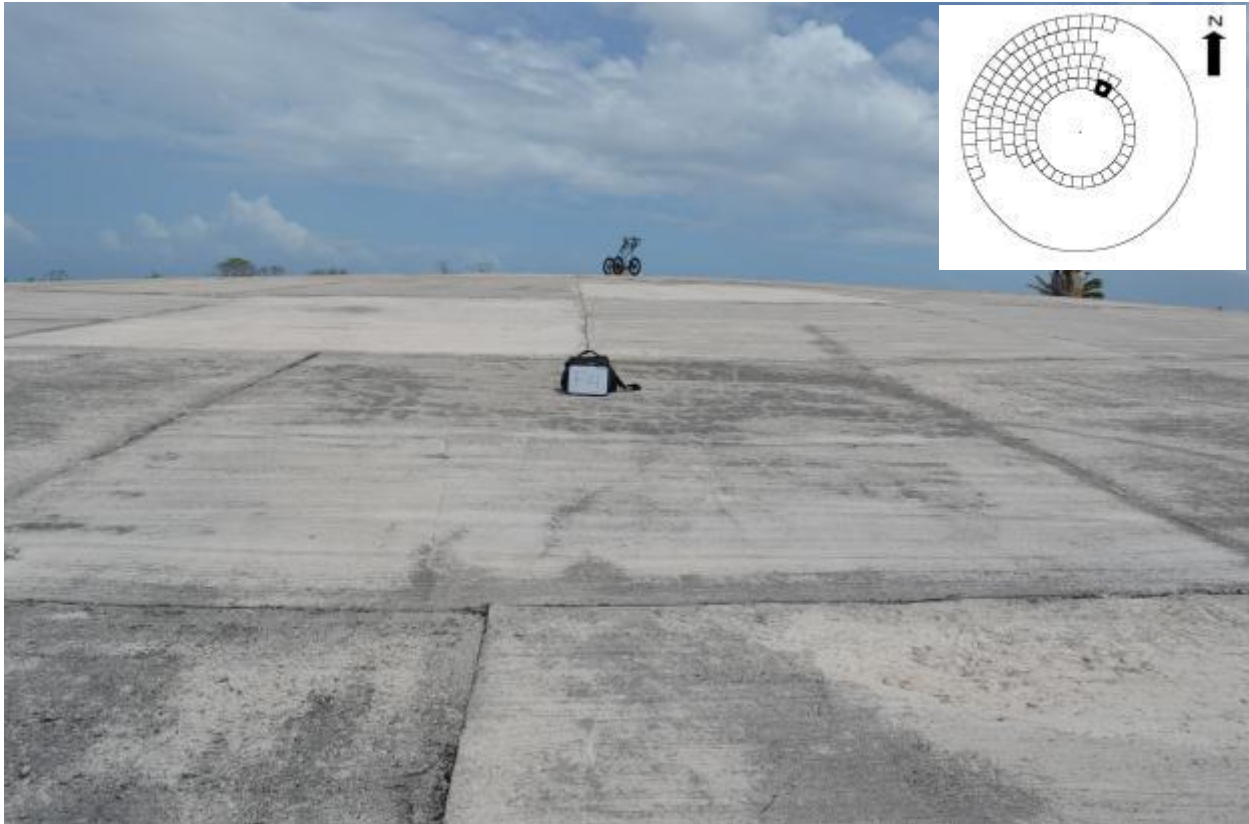
CAP SECTION LOCATION: Panel F4

A surface crack is visible traversing up from the bottom seam from a point adjacent to the corner intersection of the E5/E6 panels on the ring rows below. Some spalling/chipping of concrete observed in the upper left-hand corner of the panel.

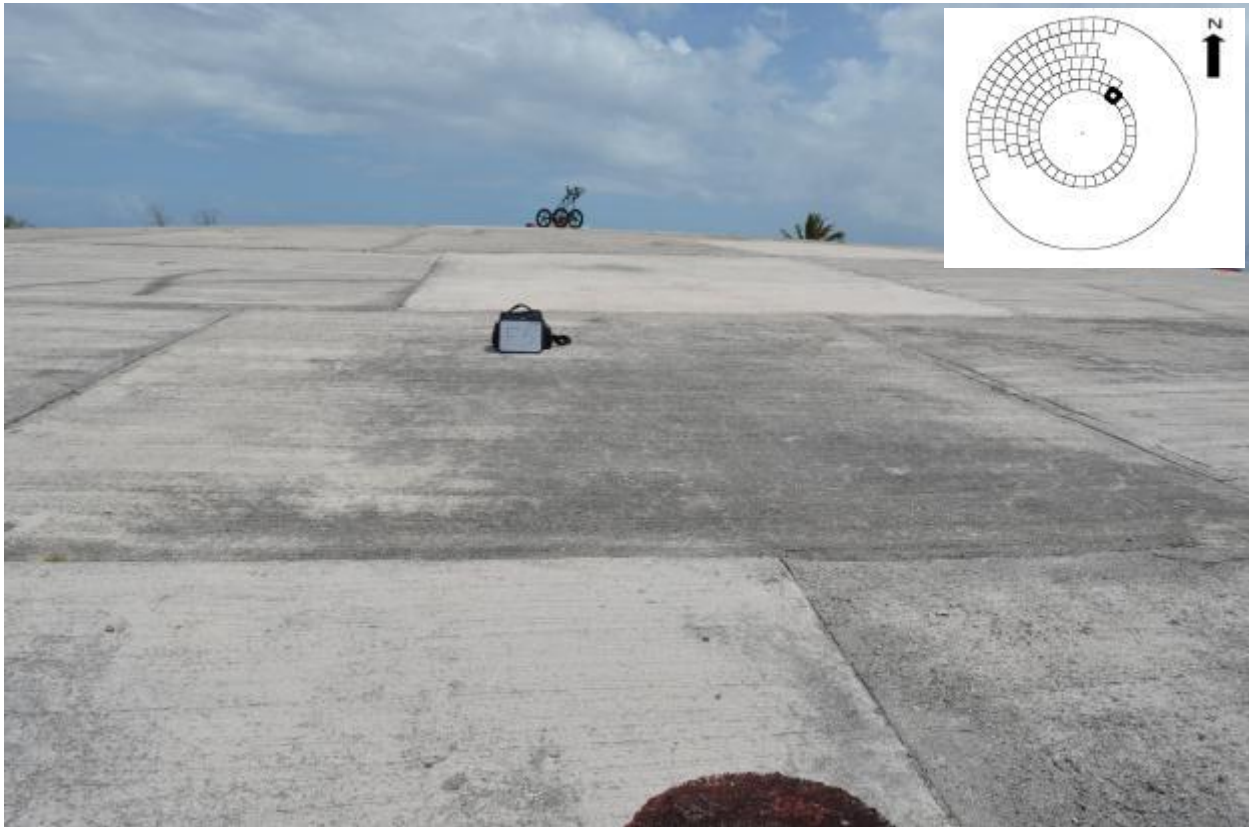
CAP SECTION LOCATION: Panel F5

No significant or obvious interior cracks or spall elements identified but there does appear to be a little more separation along the seams with the adjoining panels, especially in the upper right corner of the panel. In this instance, the edge of the panel is overhanging the bottom of panel G5 on the ring row above.

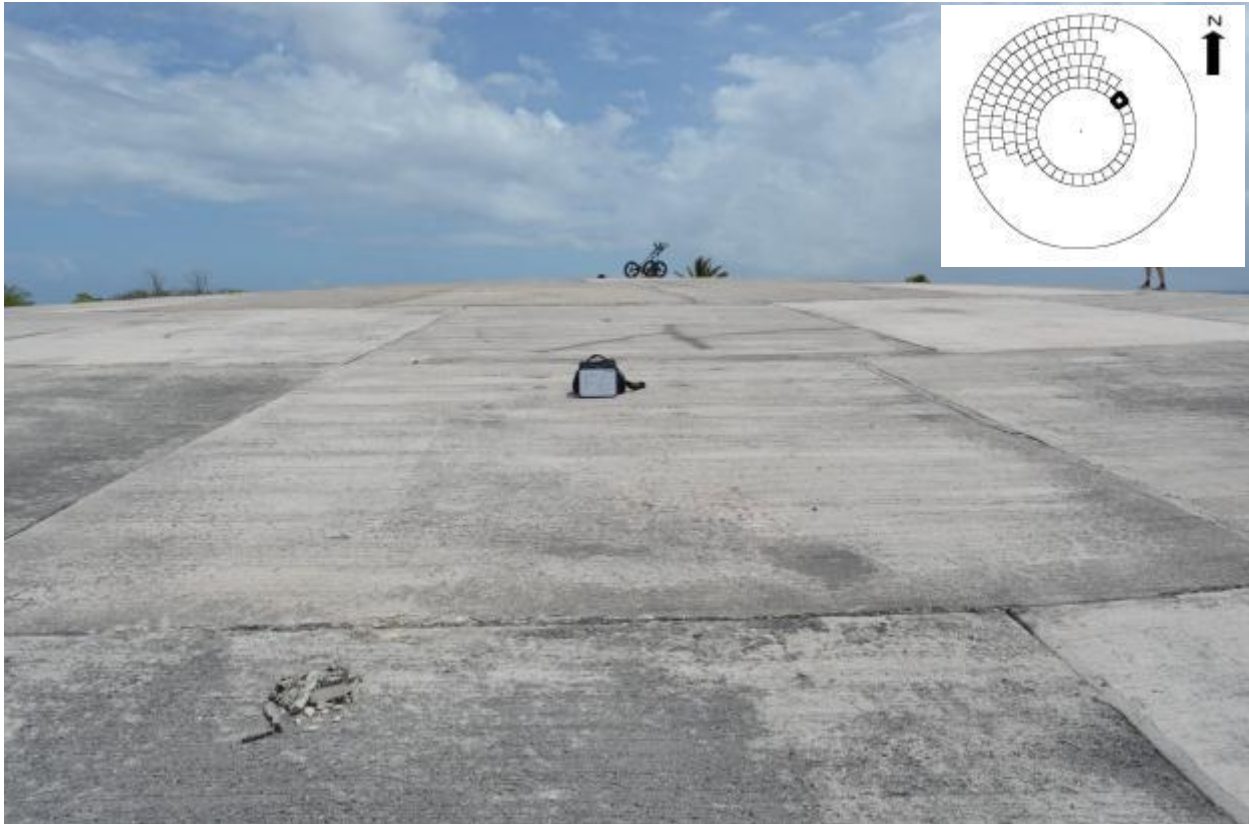
CAP SECTION LOCATION: Panel F6

No significant or obvious interior cracks or spall elements identified. Some spalling/cracking of concrete in the upper left-hand corner and along the bottom seam of the panel.

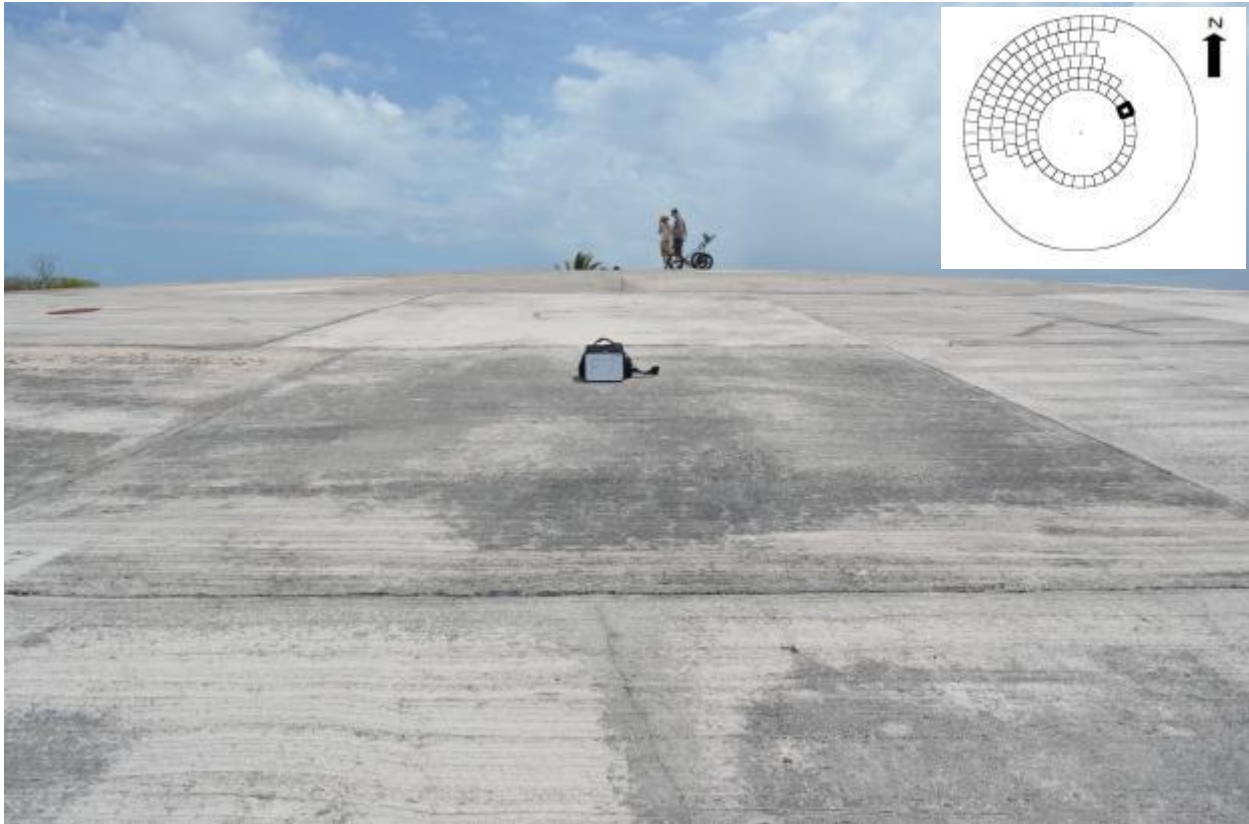
CAP SECTION LOCATION: Panel F7

No significant or obvious interior cracks or spall elements identified.

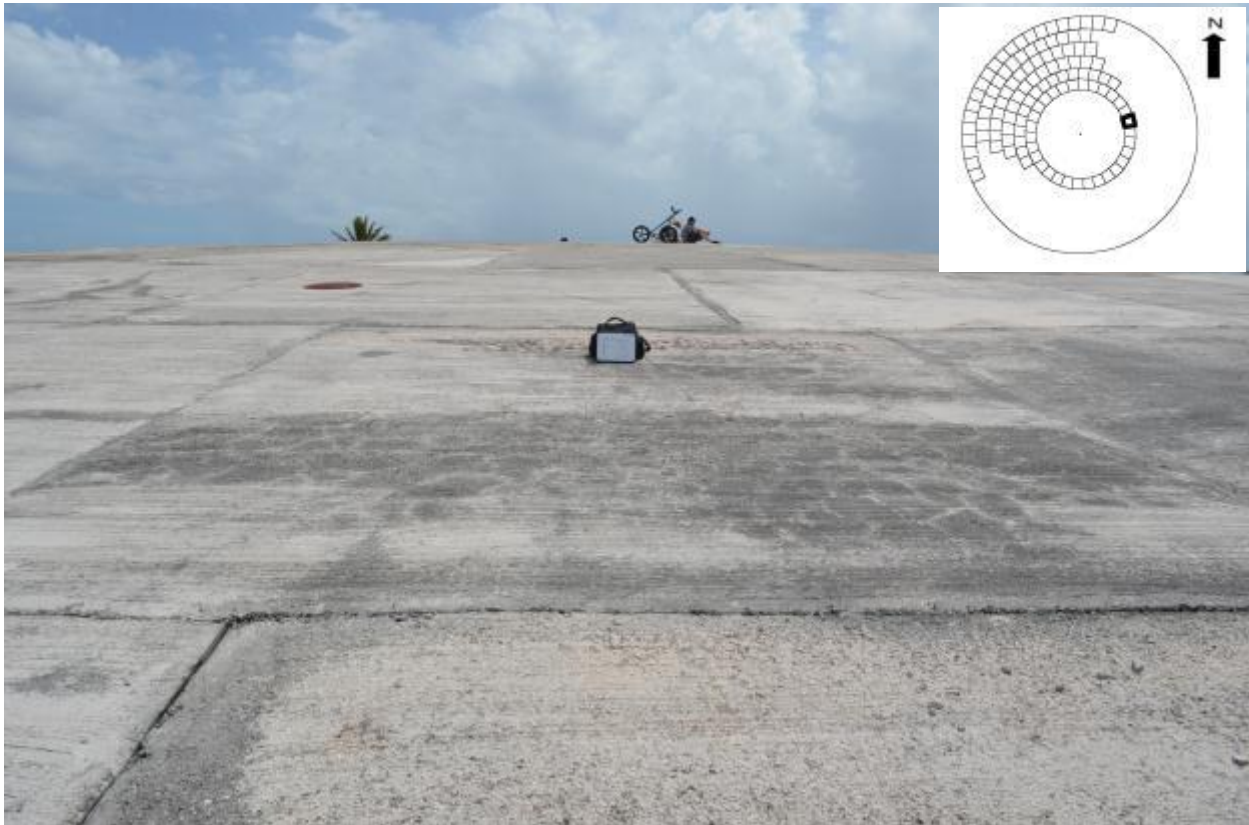
CAP SECTION LOCATION: Panel F8

The panel has a slightly weathered appearance across the bottom of the segment. No significant or obvious interior cracks or spall elements identified. Some minor spalling/cracking of concrete along the upper seam of the panel.

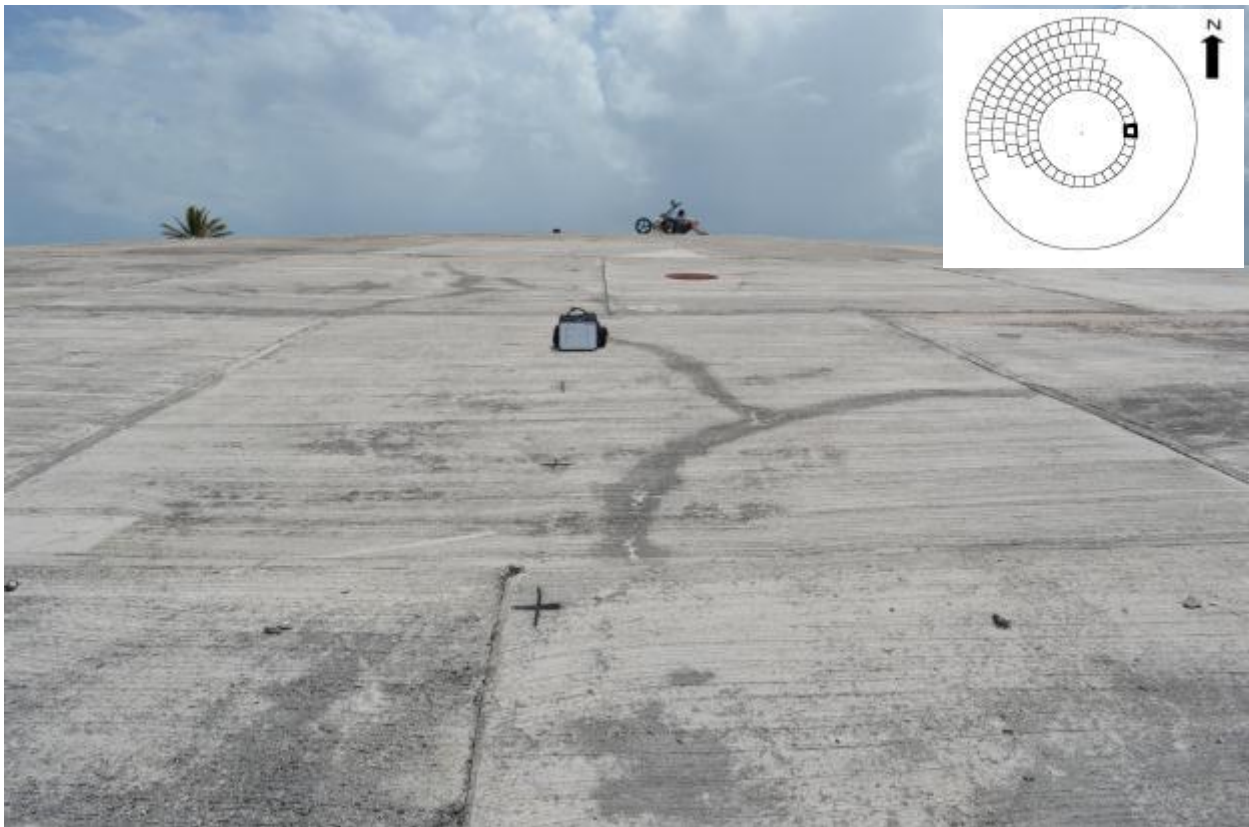
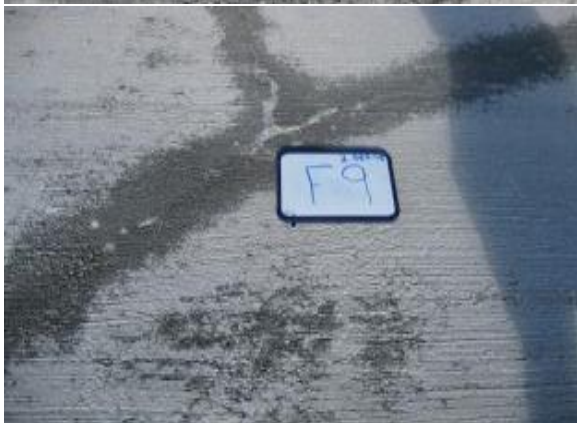
CAP SECTION LOCATION: Panel F9

Some spalling/cracking of concrete observed in the upper and lower left-hand corners of the panel. A surface crack is visible traversing up from the bottom seam from a point adjacent to the corner intersection of the E11/E12 panels on the ring row below, and traveling up the panel towards the right before branching into a fork extending upwards and out to the right side of the panel.

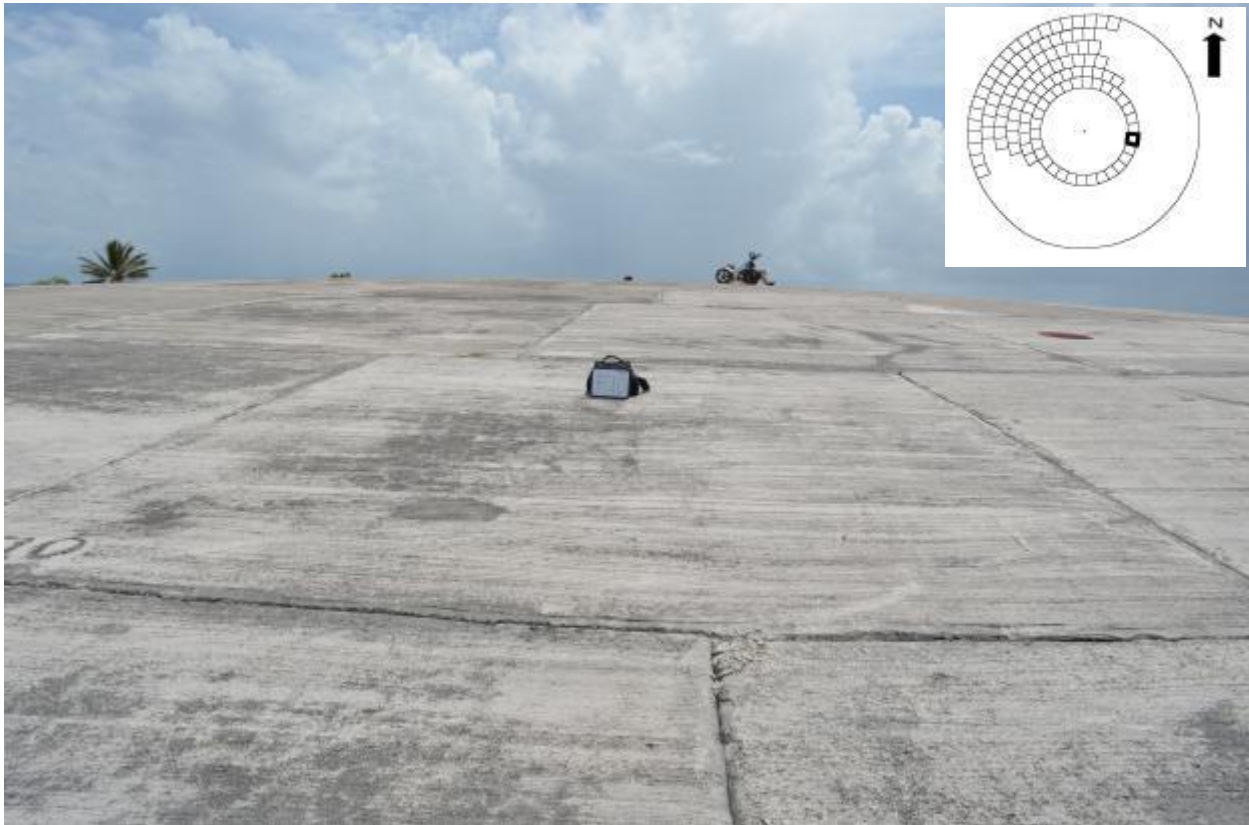
CAP SECTION LOCATION: Panel F10

No significant or obvious interior cracks or spall elements identified. Some spalling/cracking of concrete observed along the bottom seam of the panel.

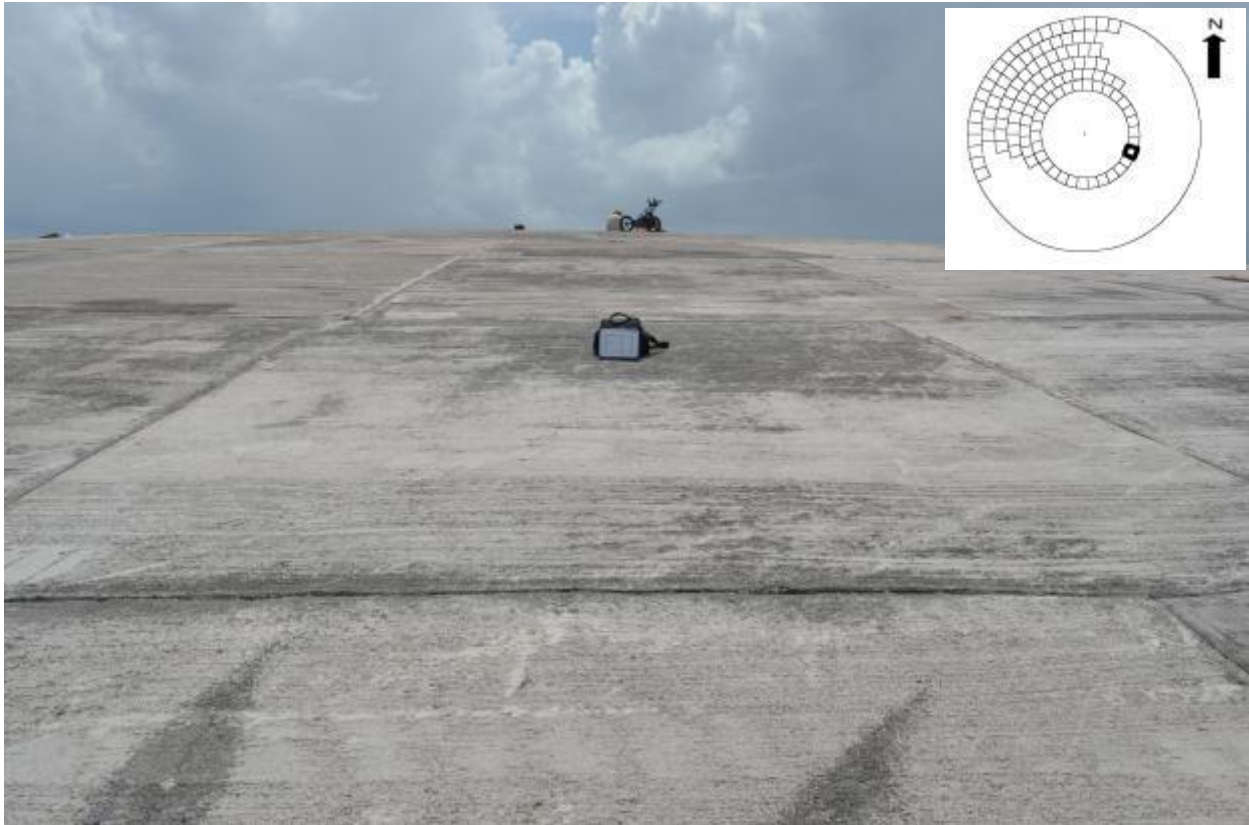
CAP SECTION LOCATION: Panel F11

The panel contains patches of discolored concrete. No significant or obvious interior cracks or spall elements identified. Rooting vegetation removed from along the panel seams.

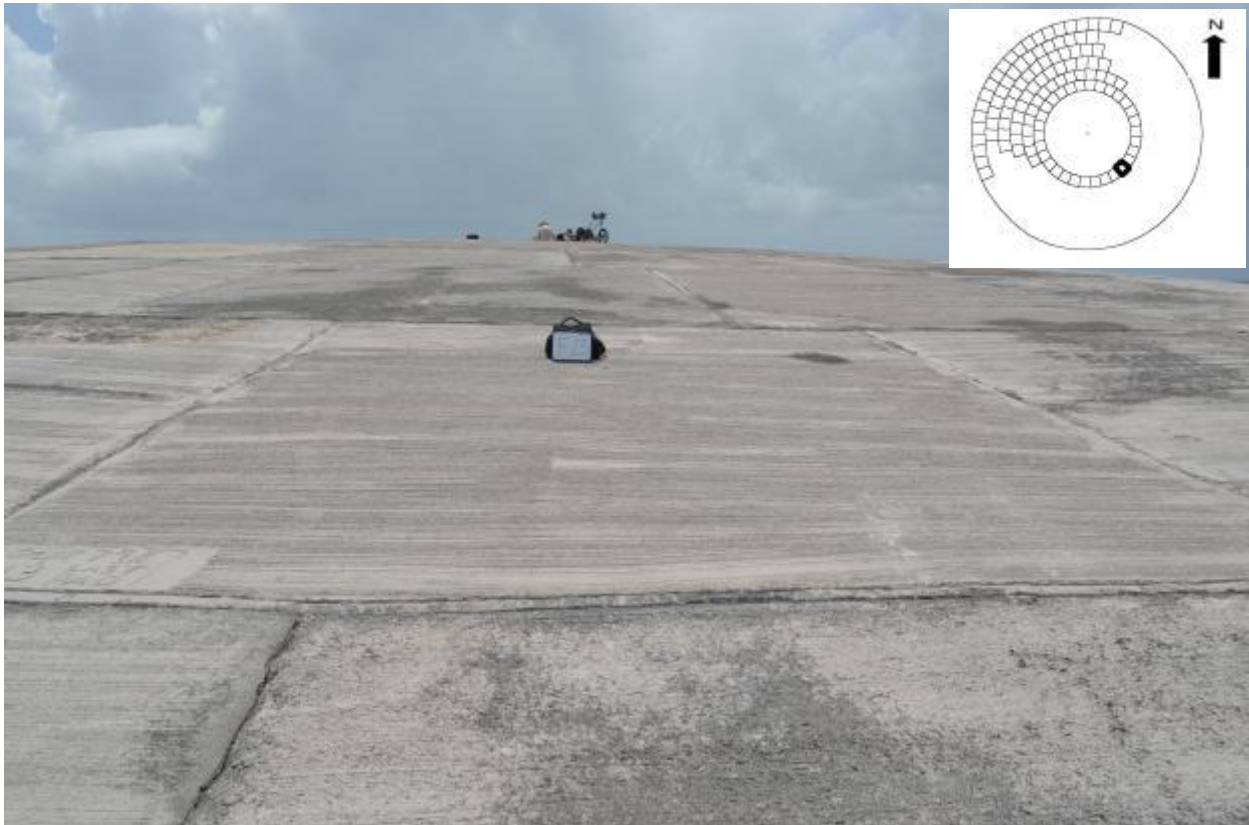
CAP SECTION LOCATION: Panel F13

No significant or obvious interior cracks or spall elements identified. Some minor spalling/chipping of concrete in the top and bottom left-hand corners of the panel.

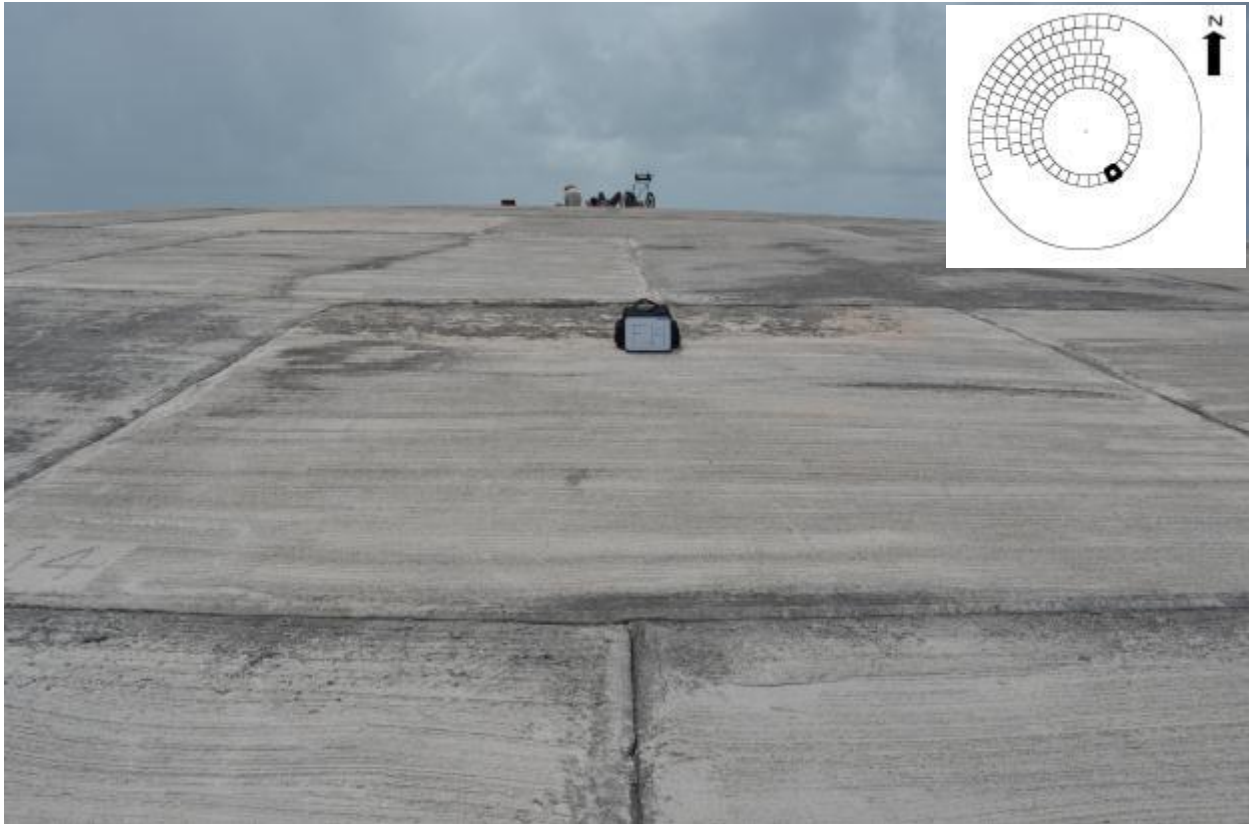
CAP SECTION LOCATION: Panel F14

Top portion of the panel has a rough and weathered appearance. No significant or obvious interior cracks or spall elements identified.
