LLNL-TR-648143

A Visual Description of the Concrete Exterior of the Cactus Crater Containment Structure

Terry Hamilton

October 2013

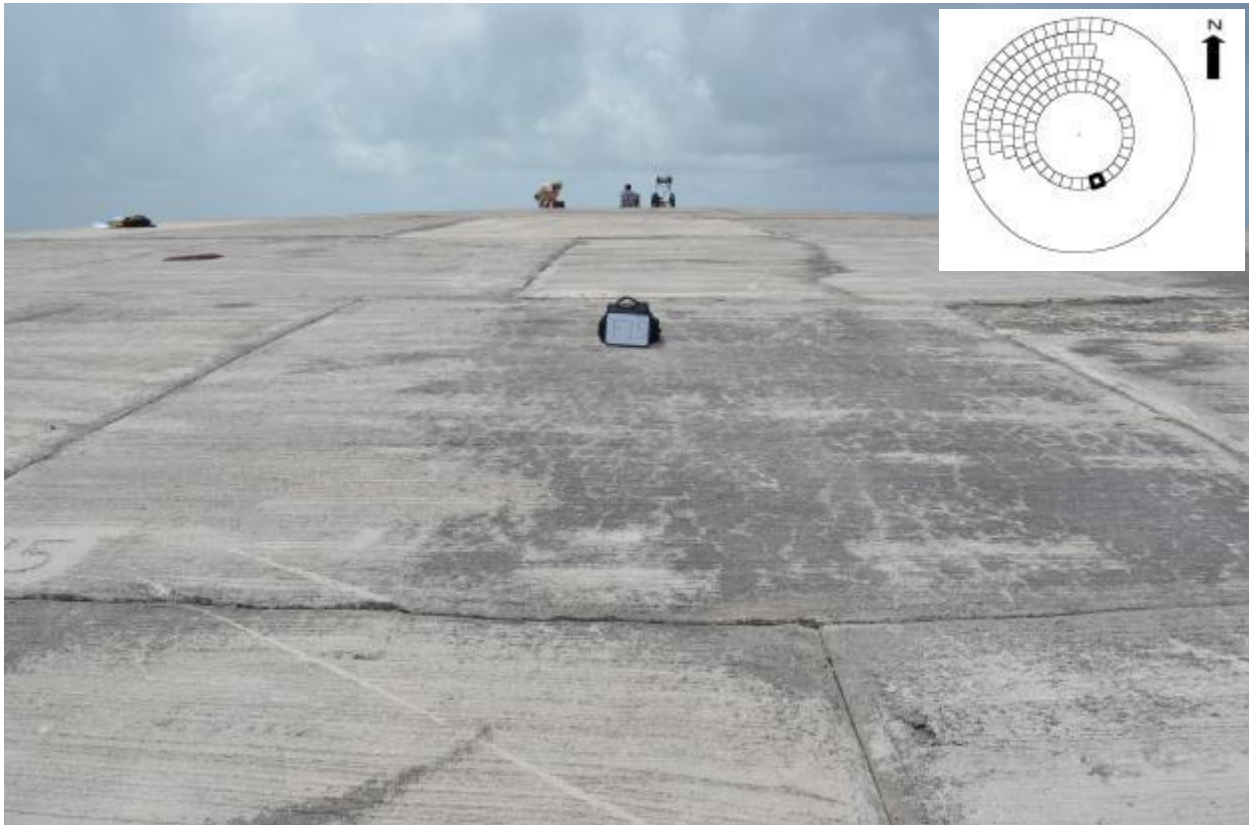
CAP SECTION LOCATION: Panel F15

The panel contains patches of discolored concrete. No significant or obvious interior cracks or spall elements identified.

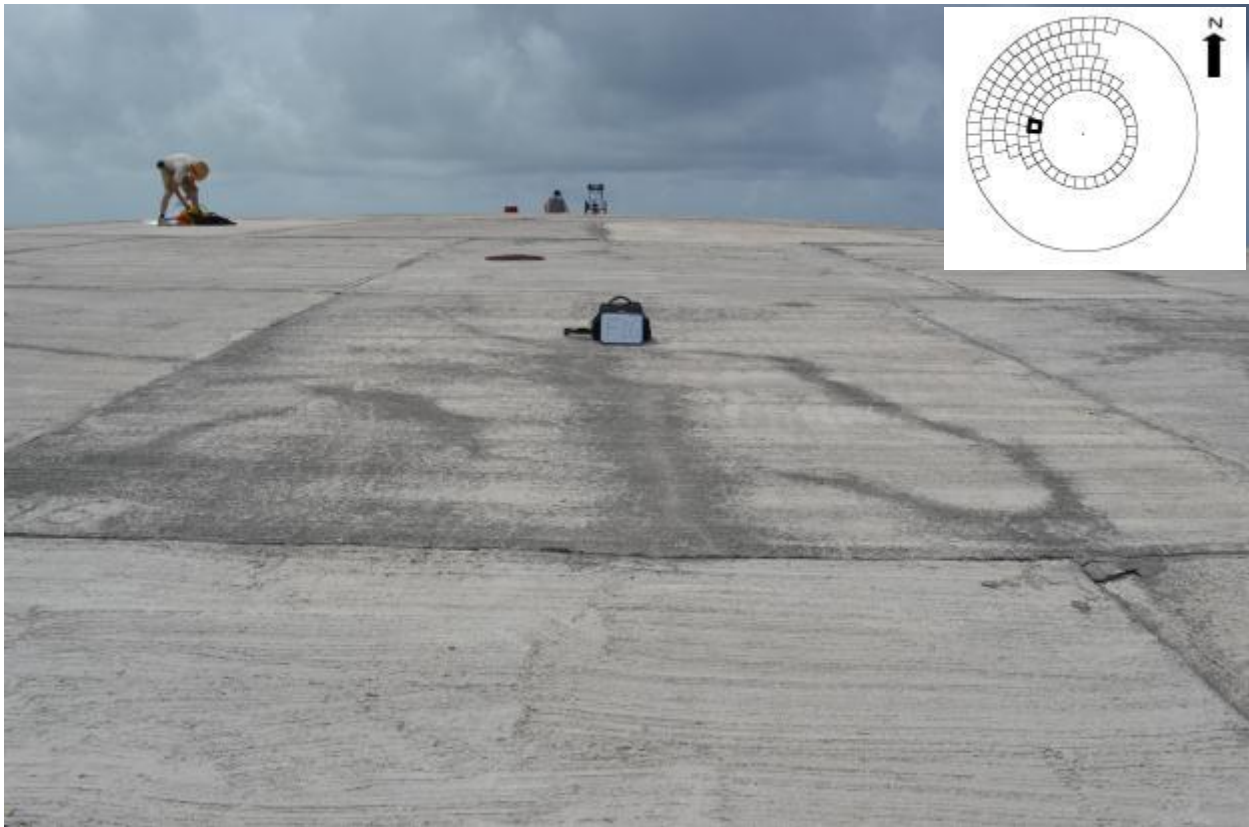
CAP SECTION LOCATION: Panel F16

Rooting vegetation removed from along the panel seams. A surface crack with spalled edges is clearly visible traversing up from the bottom seam from a point adjacent to the corner intersection of the E19/E20 panels on the ring rows below. There is a separate crack traversing up through the middle of the panel from a central position along the bottom seam.

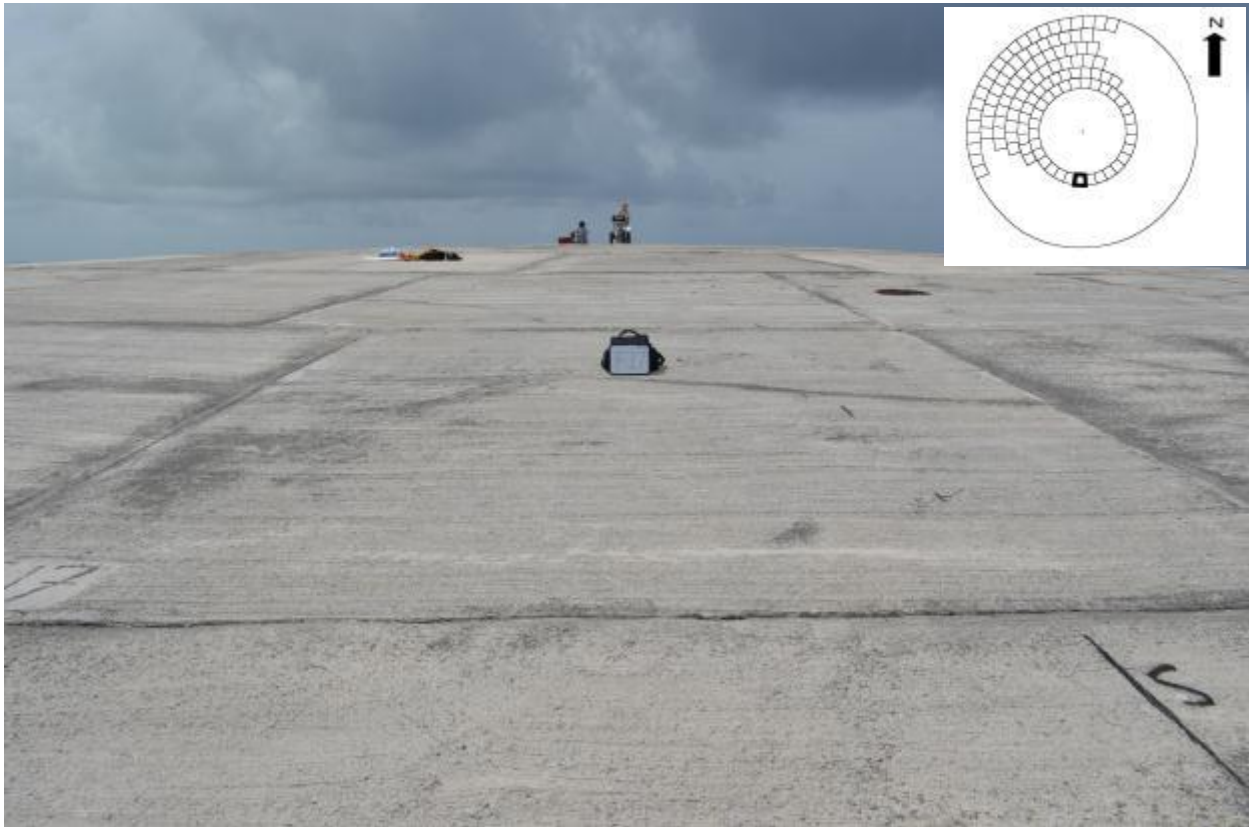
CAP SECTION LOCATION: Panel F17

No significant or obvious interior cracks or spall elements identified. Rooting vegetation removed from along the panel seams. Some minor spalling/chipping of concrete in bottom right-hand corner of the panel.

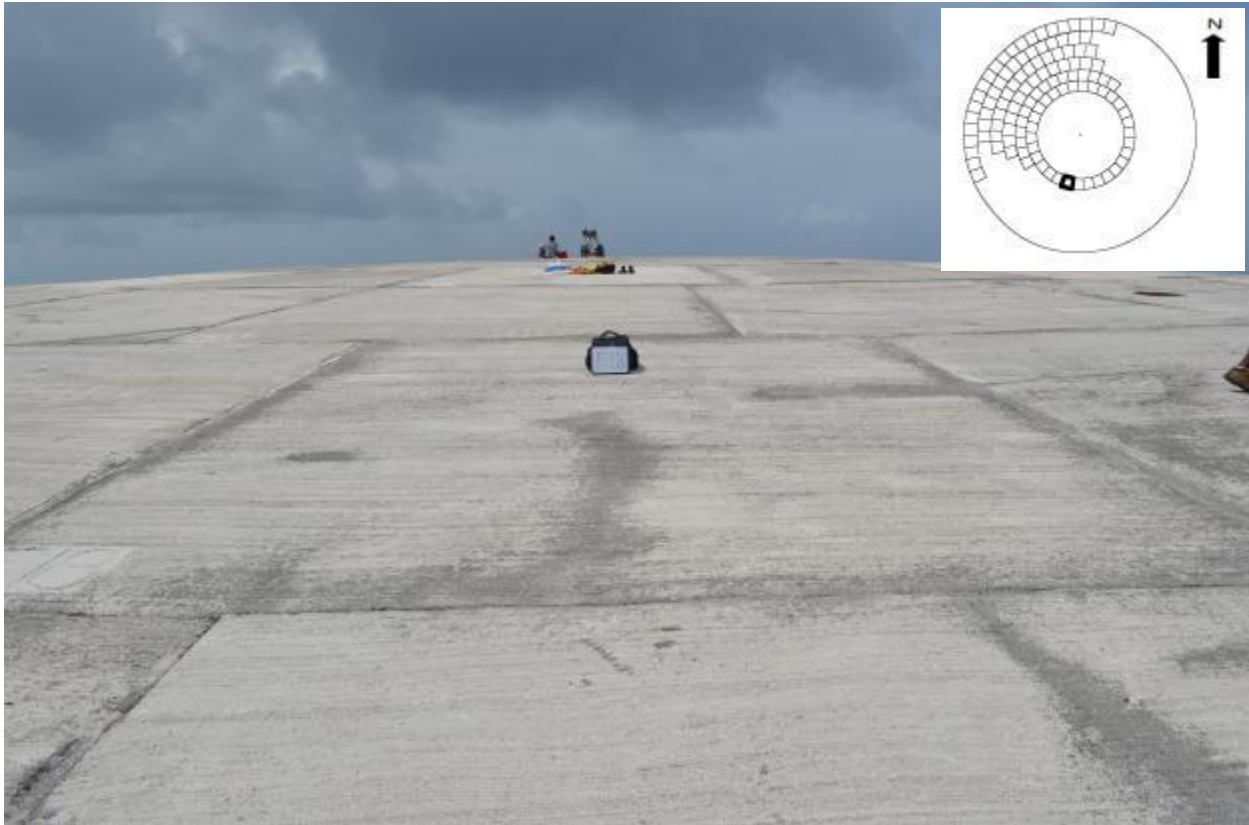
CAP SECTION LOCATION: Panel F18

Rooting vegetation removed from along the panel seams. There is a surface crack traversing up through the middle of the panel from a central position along the bottom seam.

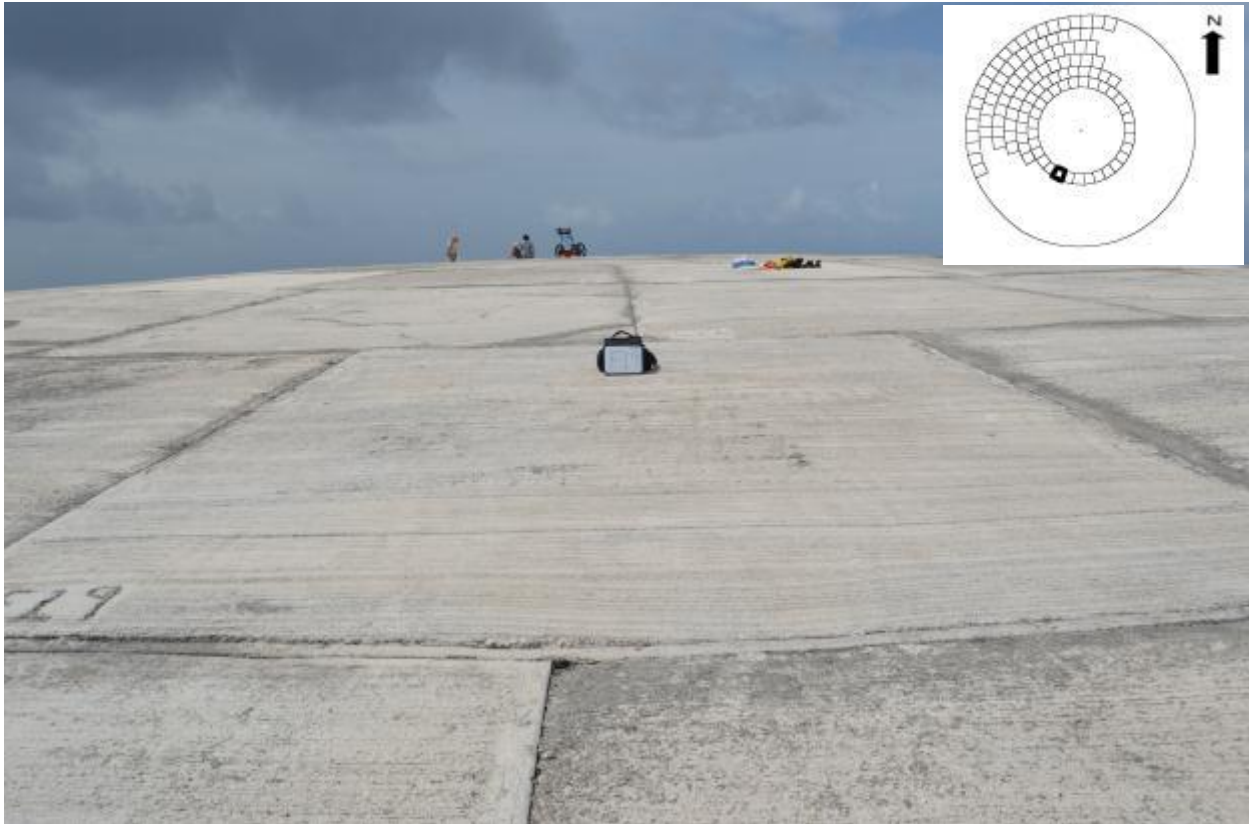
CAP SECTION LOCATION: Panel F19

No significant or obvious interior cracks or spall elements identified.

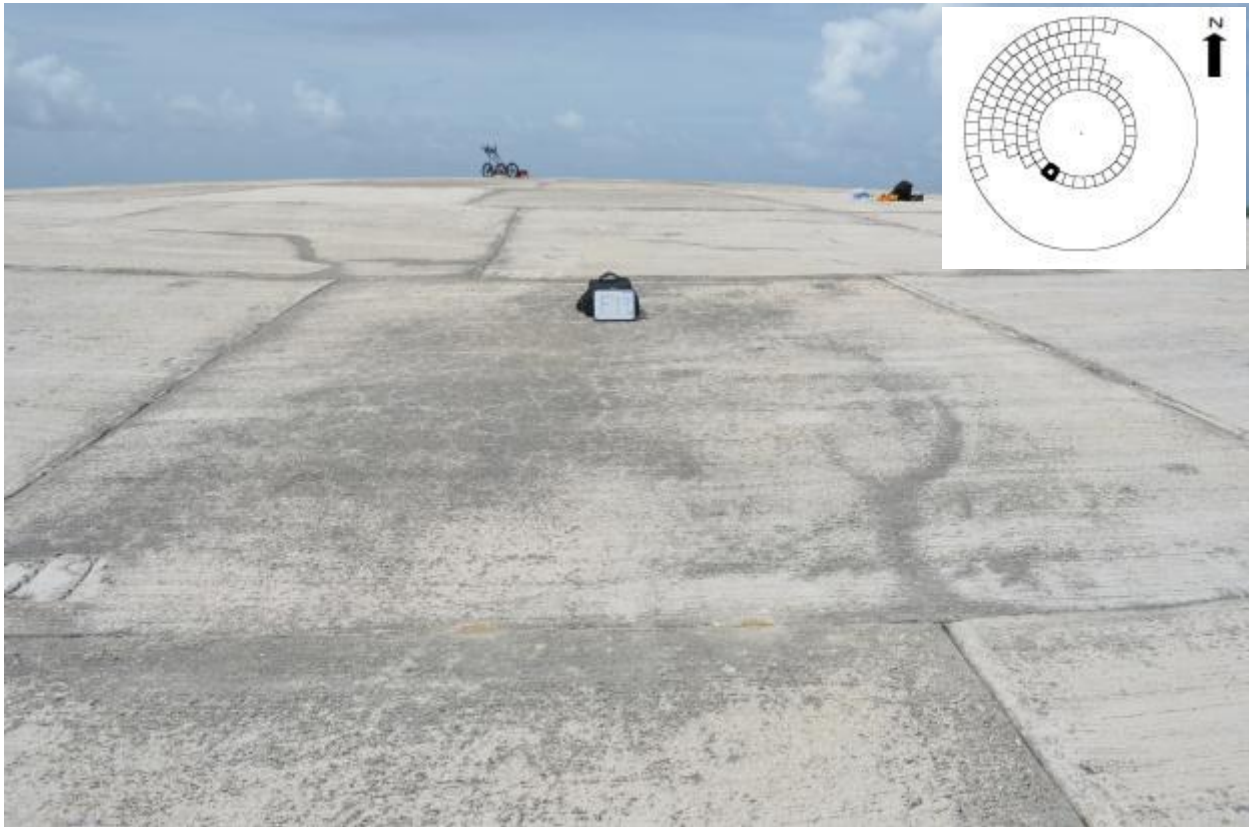
CAP SECTION LOCATION: Panel F19_duplicate (F20)

The panel has a rough and weathered appearance. There is a surface crack traveling up the panel for about 2 meters from a point adjacent to the corner intersection of the E19/E20 panels on the ring rows below.

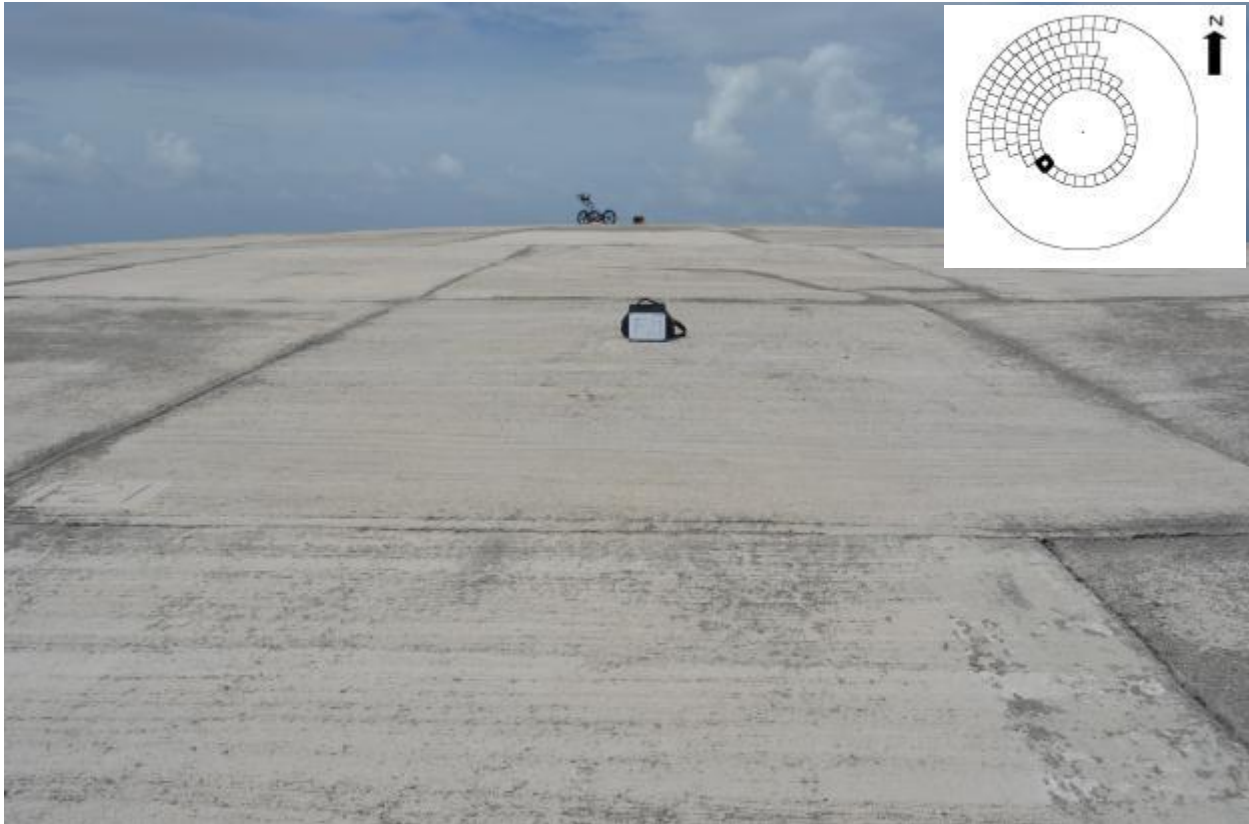
CAP SECTION LOCATION: Panel F21

No significant or obvious interior cracks or spall elements identified.

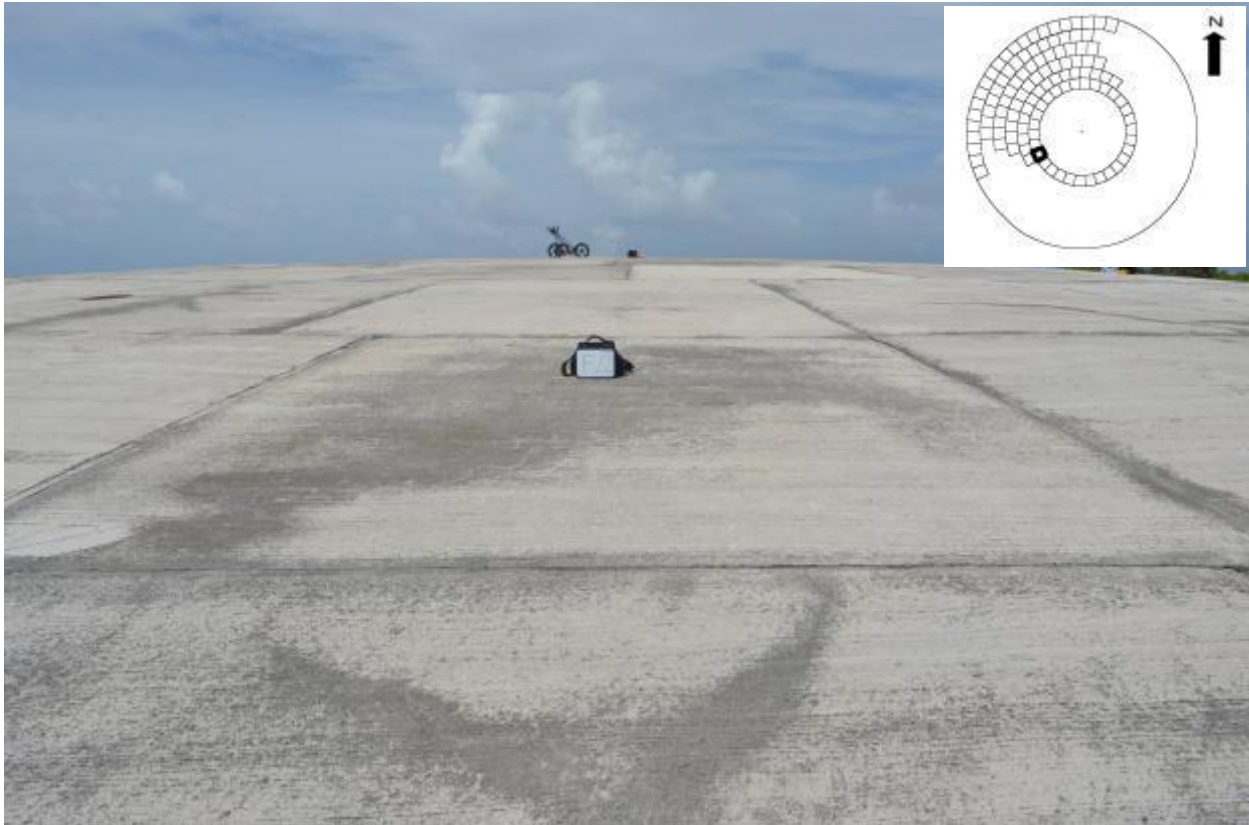
CAP SECTION LOCATION: Panel F22

No significant or obvious interior cracks or spall elements identified. Some minor spalling/chipping of concrete in the upper left-hand corner of the panel.

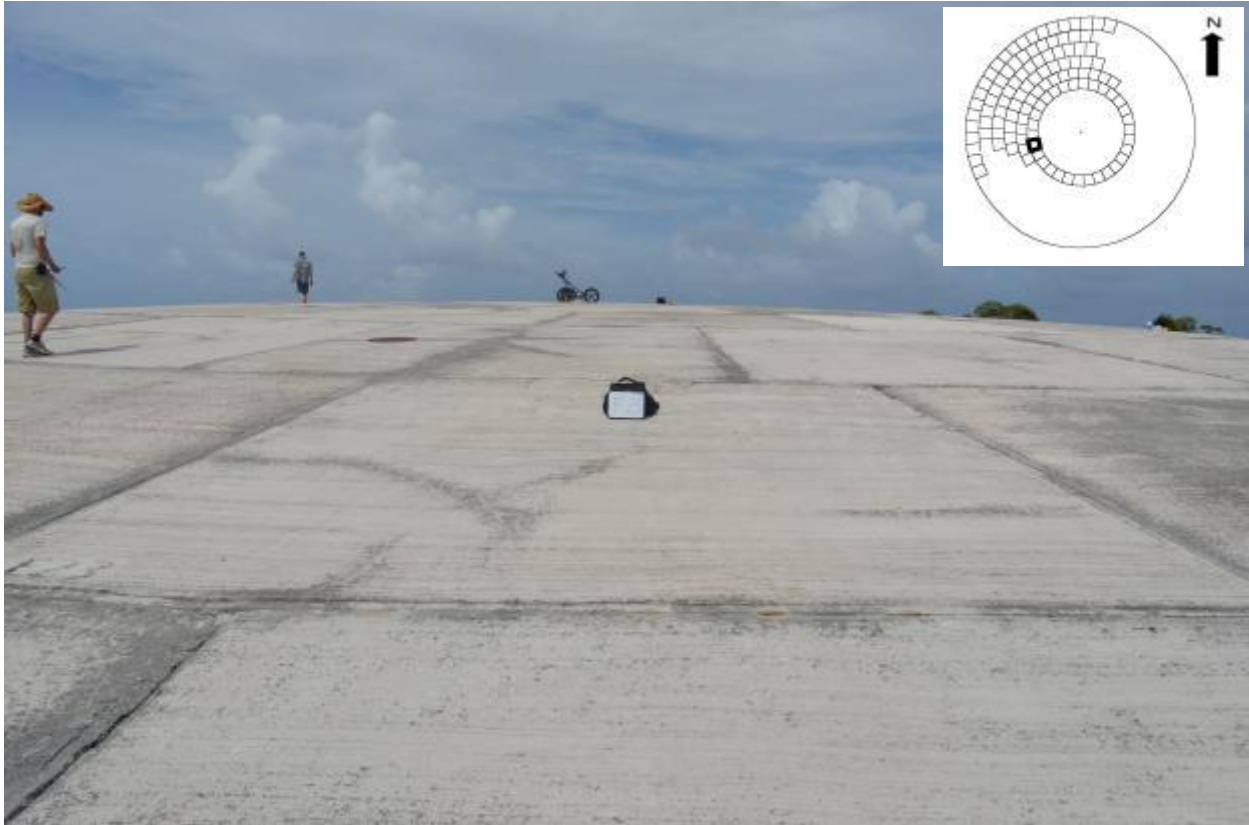
CAP SECTION LOCATION: Panel F23

No significant or obvious interior cracks or spall elements identified.

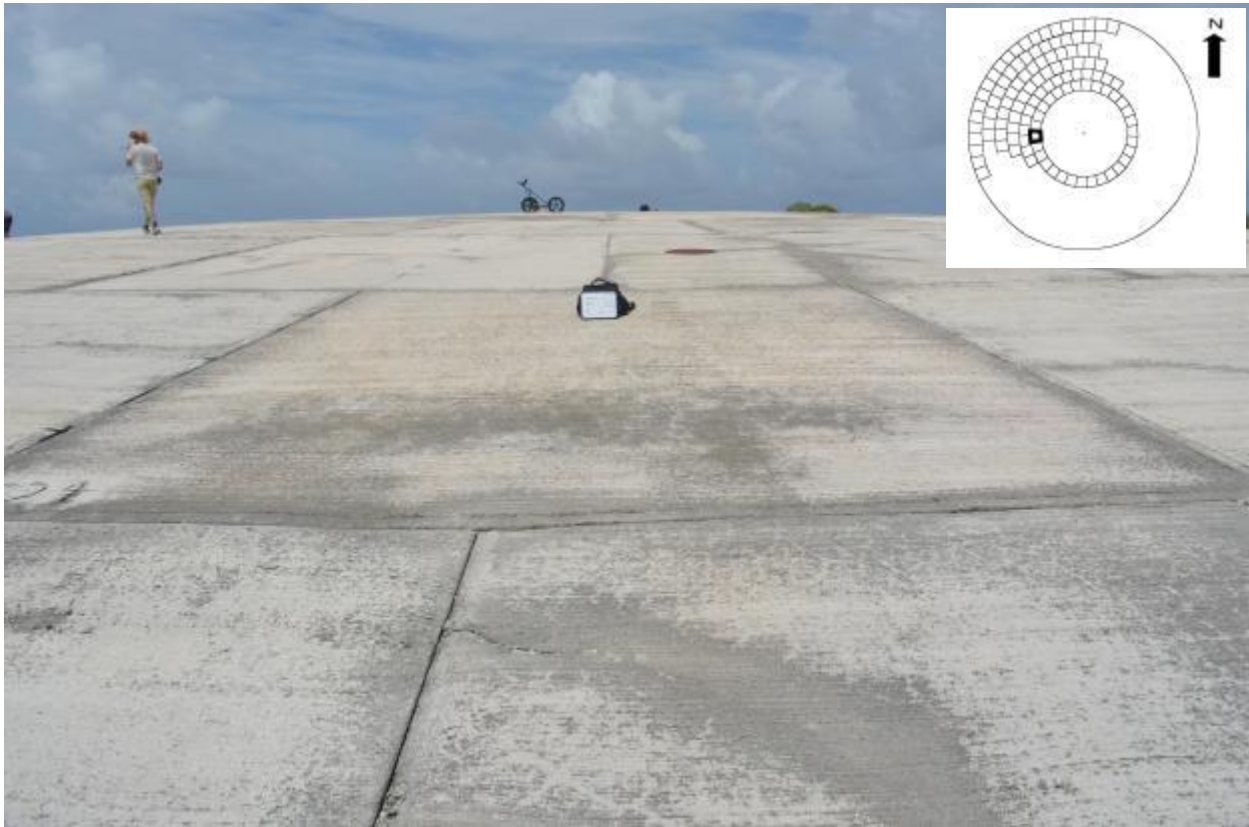
CAP SECTION LOCATION: Panel F24

The panel has a rough and weathered appearance. No significant or obvious interior cracks or spall elements identified. Some spalling/chipping of concrete in the bottom left-hand corner of the panel.

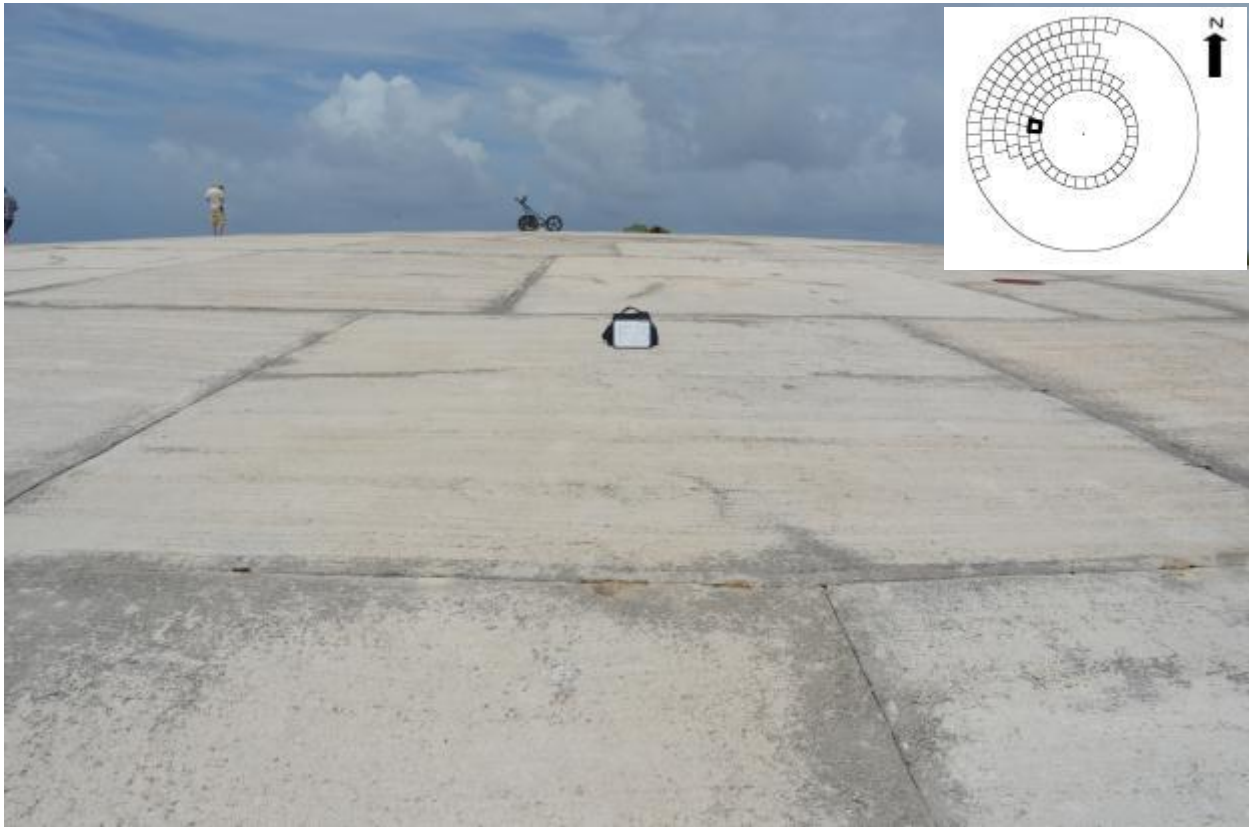
CAP SECTION LOCATION: Panel F25

No significant or obvious interior cracks or spall elements identified. Some spalling/chipping of concrete in the bottom right and left-hand corners of the panel. Rooting vegetation removed from along the panel seams.

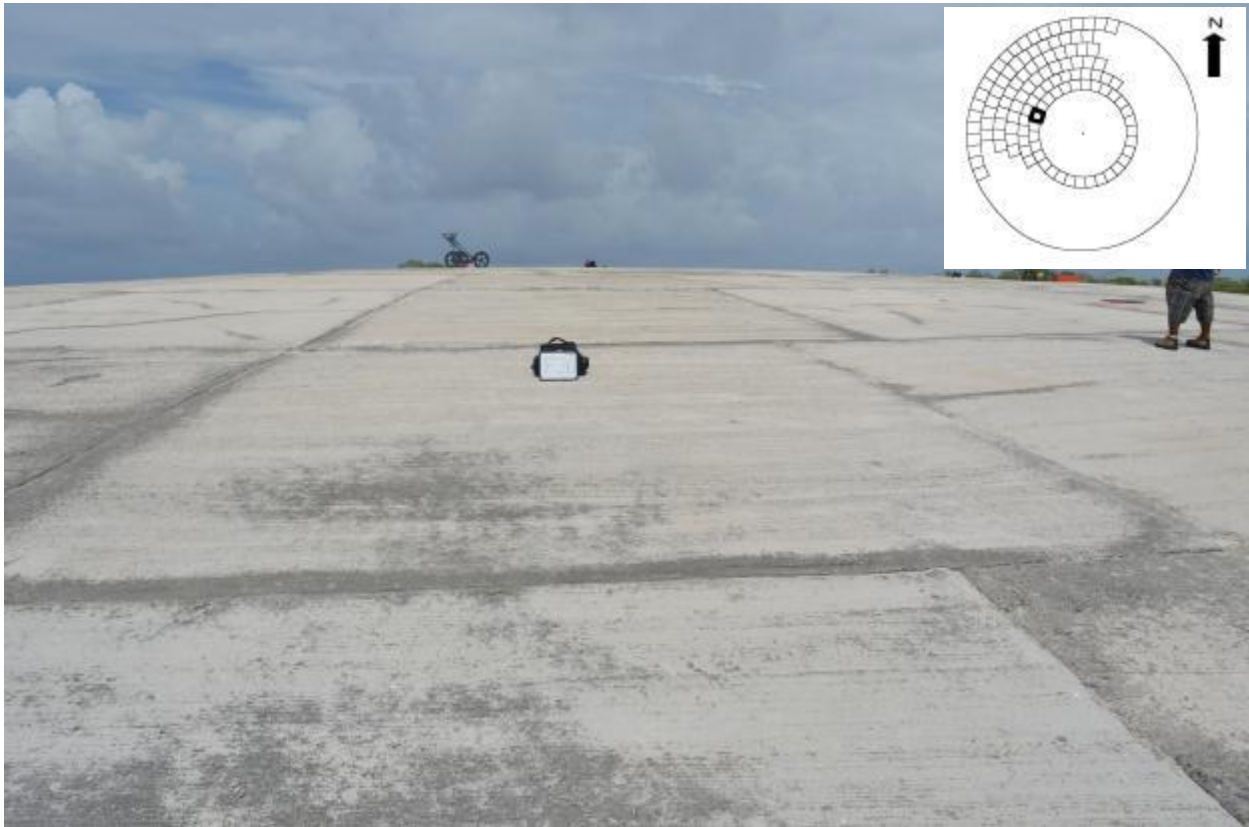
CAP SECTION LOCATION: Panel F26

No significant or obvious interior cracks or spall elements identified. Some spalling/chipping of concrete in the bottom right-hand corner. Rooting vegetation removed from along the panel seams.

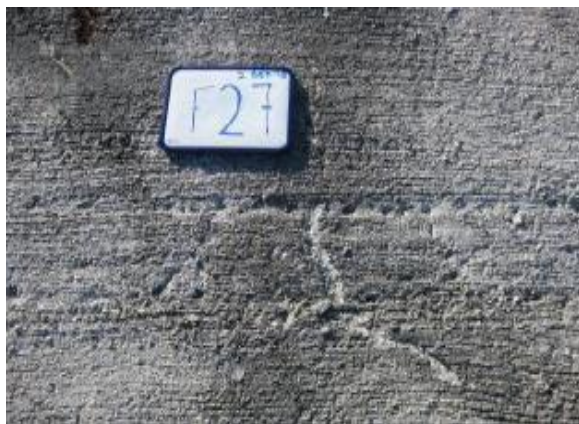
CAP SECTION LOCATION: Panel F27

The panel has a rough and weathered appearance. Multiple surface cracks observed crisscrossing up through the middle of the panel with intersections reaching out to the bottom, top, left and right-hand edges. Some spalling/chipping of concrete along the panel seams.

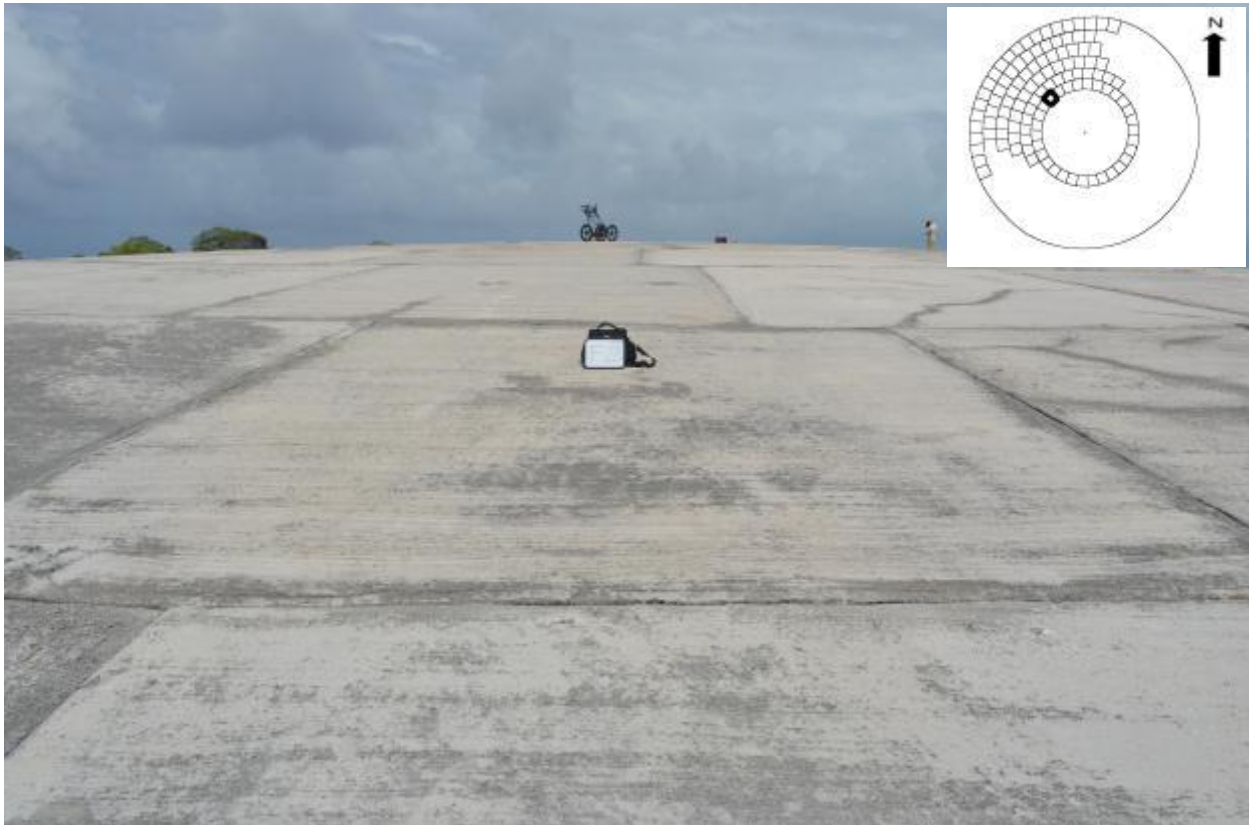
CAP SECTION LOCATION: Panel F28

No significant or obvious interior cracks or spall elements identified. Some spalling/chipping of concrete along the upper right-hand seam of the panel.

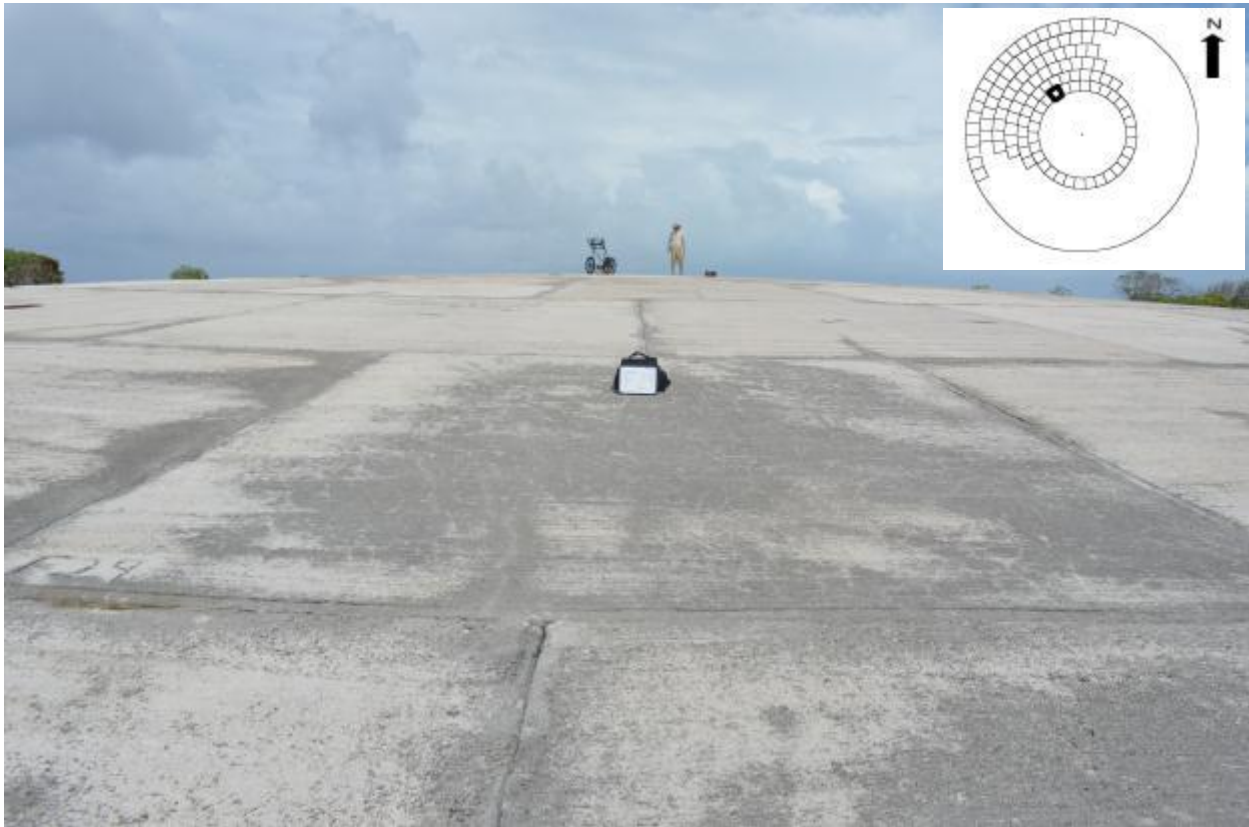
CAP SECTION LOCATION: Panel F29

The panel has a rough weathered appearance. No significant cracks or spall elements identified. Some spalling/chipping of concrete in upper right-hand corner and along the seams of the panel.

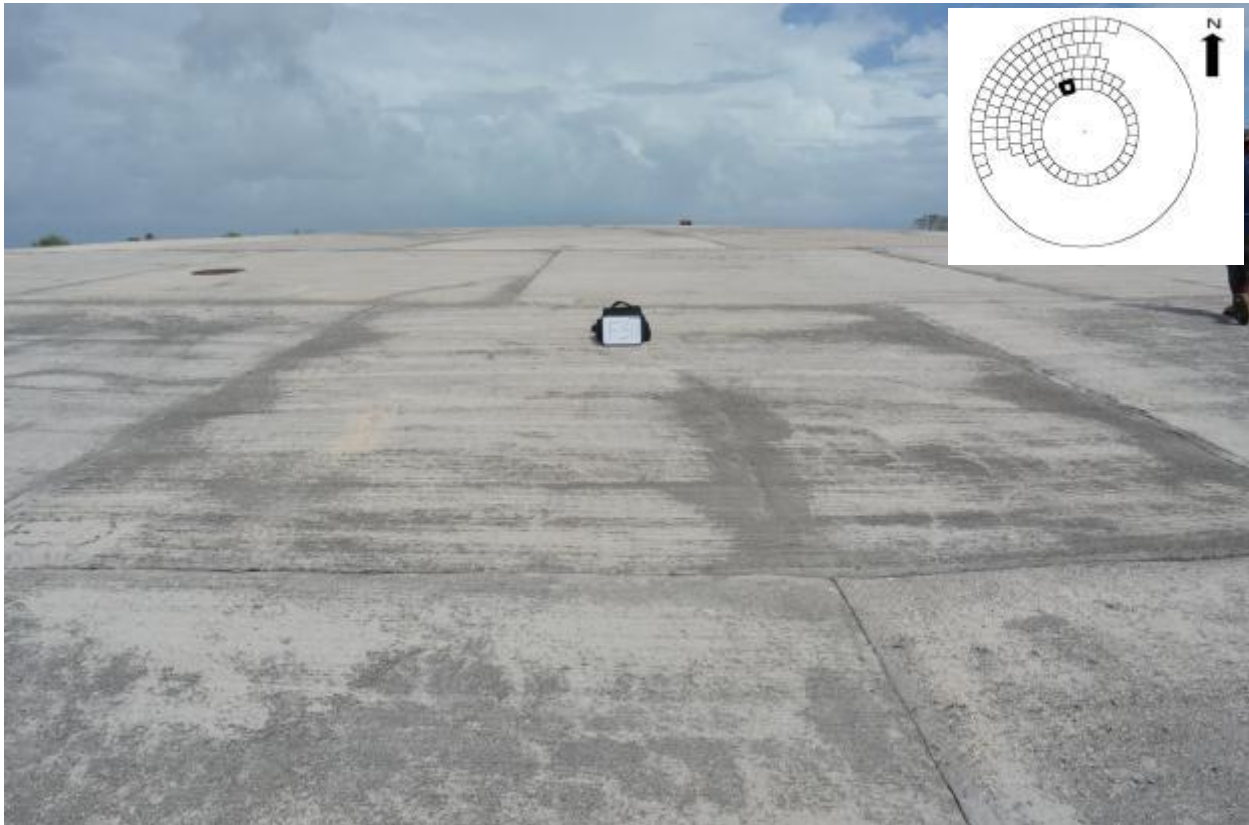
CAP SECTION LOCATION: Panel F30

No significant cracks or spall elements identified. Some spalling/chipping of concrete in upper left-hand corner and along the seams of the panel.

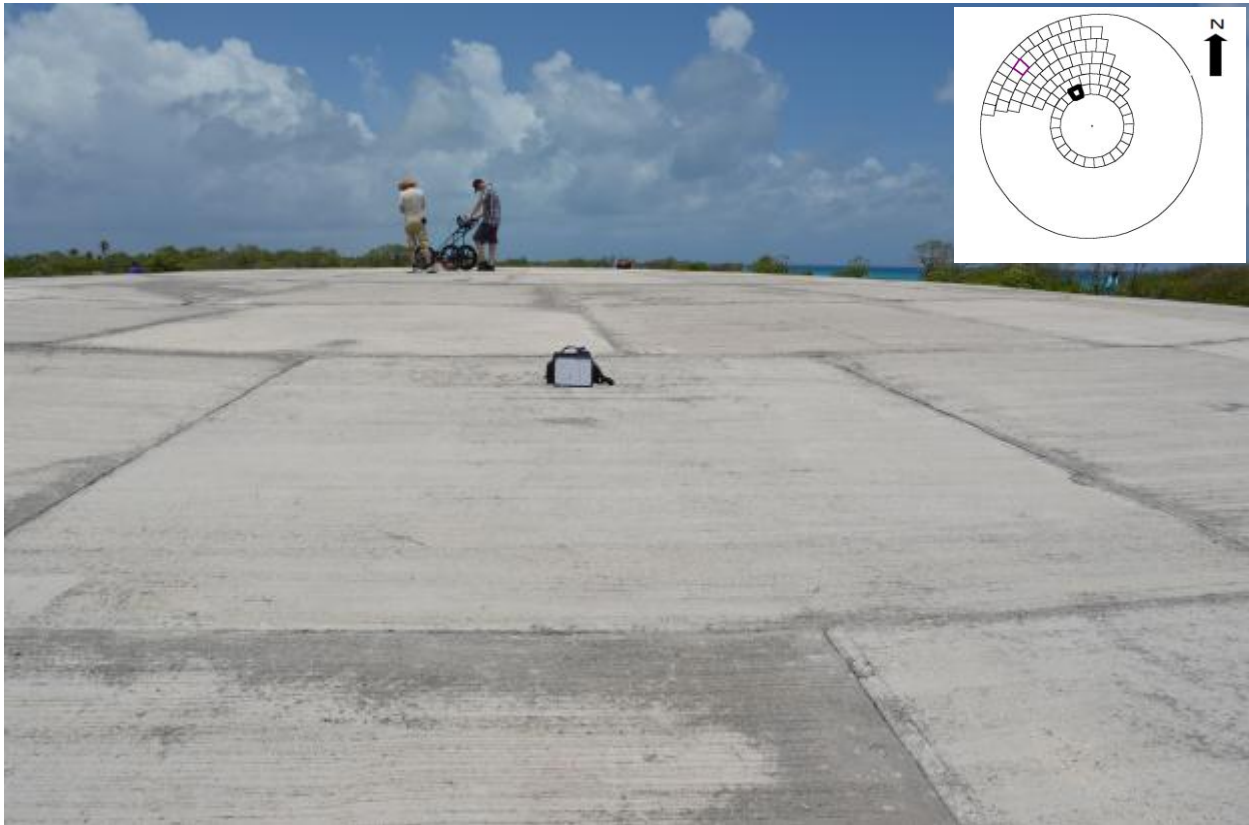
CAP SECTION LOCATION: Panel G1

No significant or obvious interior cracks or spall elements identified. Minor spalling/cracking of concrete in the upper left-hand corner of the panel.

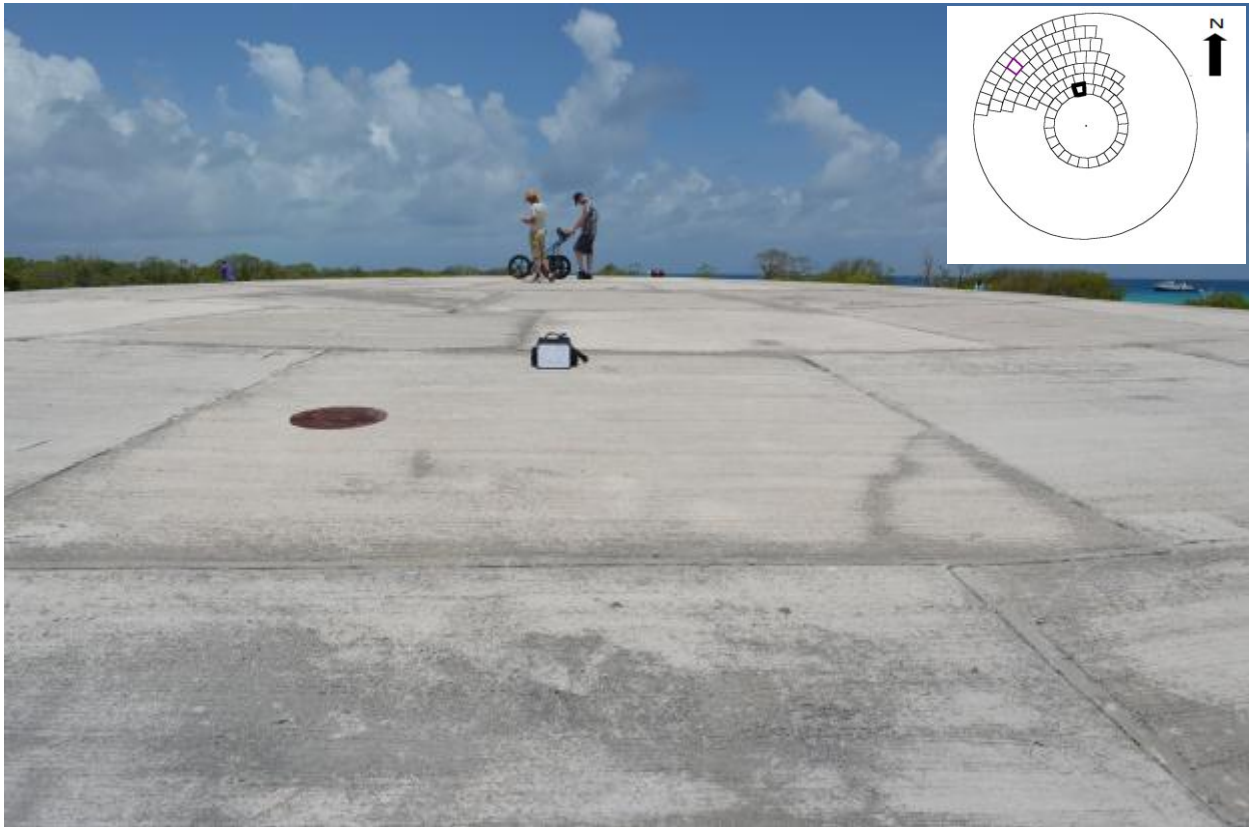
CAP SECTION LOCATION: Panel G2

Surface crack observed traversing across the bottom right-hand corner of the panel. The crack intersects the bottom and left-hand seams of the panel at a distance of about 1.2 meters and 2 meters from the right-hand corner, respectively. The panel contains a vertical elevation benchmark.

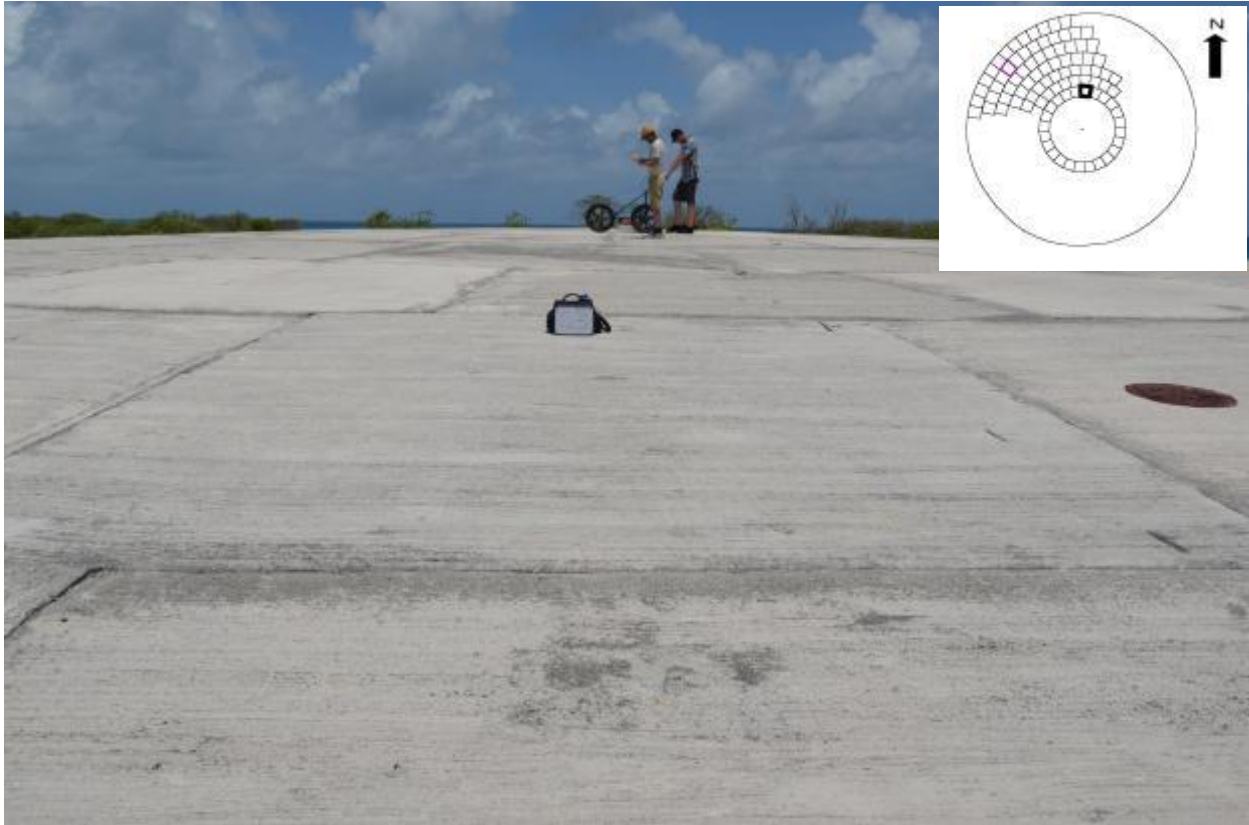
CAP SECTION LOCATION: Panel G3

No significant or obvious interior cracks or spall elements identified.

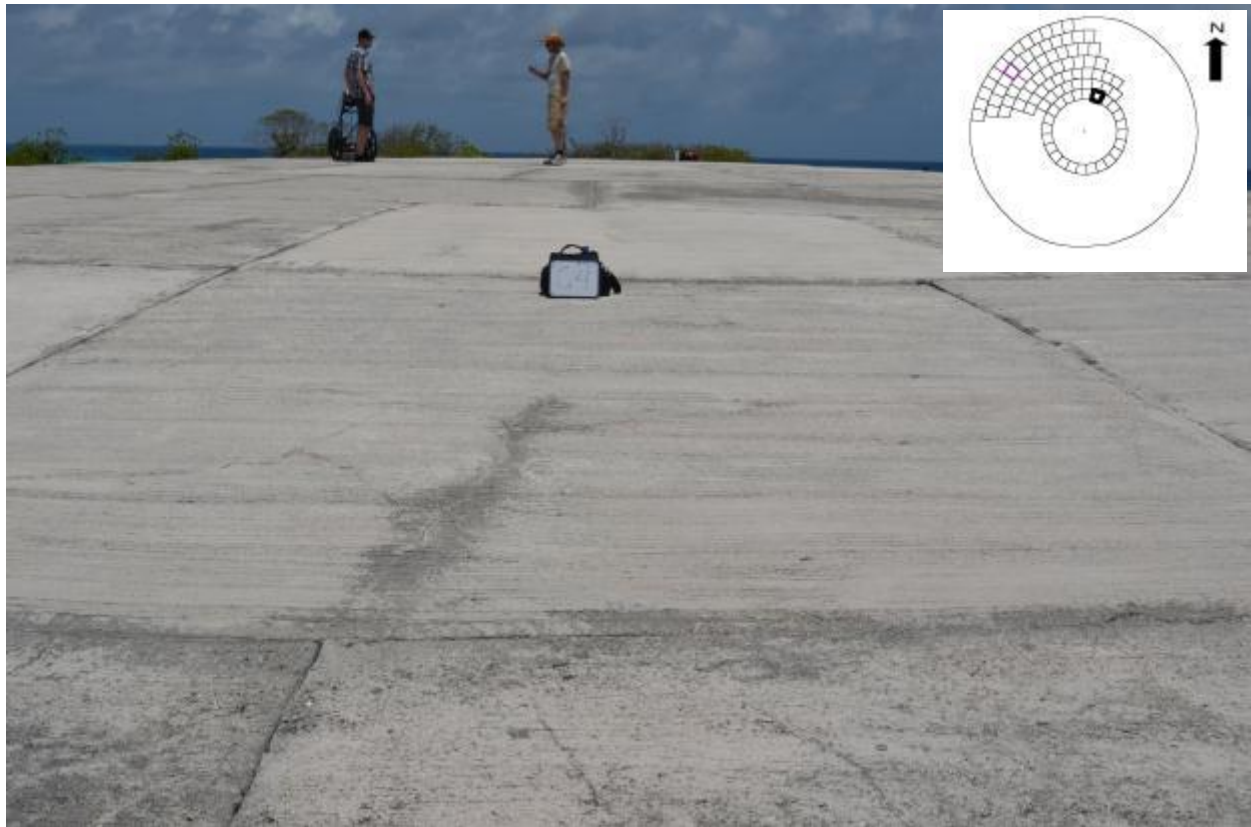
CAP SECTION LOCATION: Panel G4

Multiple surface cracks crisscrossing the bottom portion of the panel. Minor spalling/chipping of concrete observed in the upper left-hand corner of the panel.

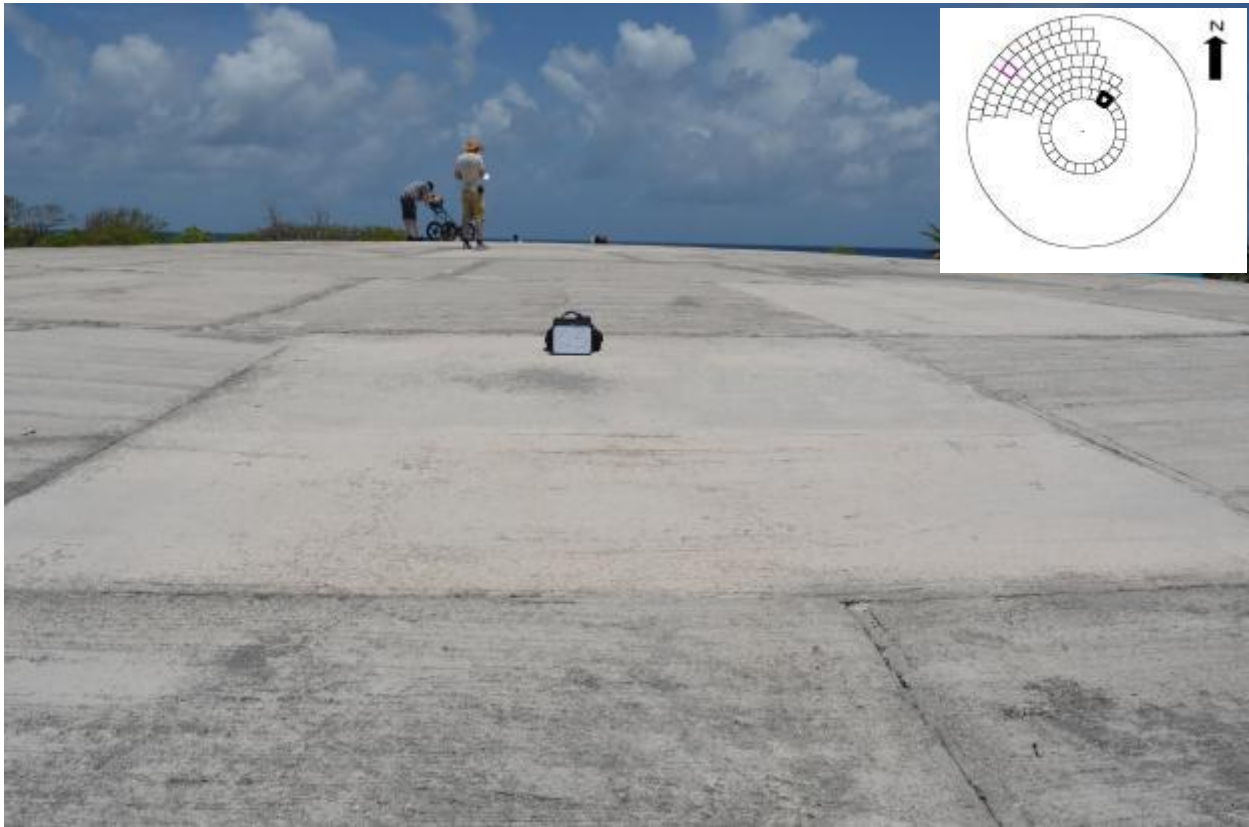
CAP SECTION LOCATION: Panel G5

Minor surface crack observed traversing up from a central position along the bottom seam of the panel for a distance of about 2 meters.

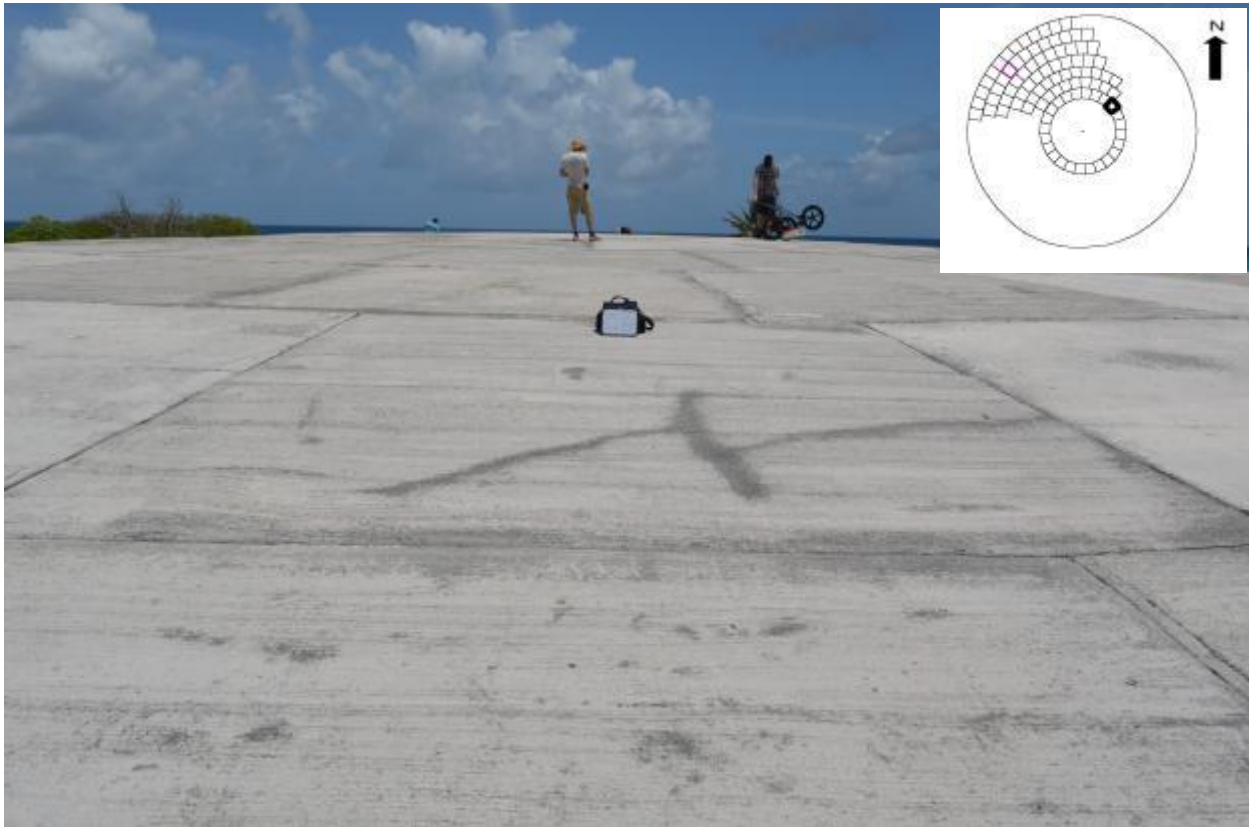
There is a surface crack on the bottom, right-hand side of the panel along with a small weathered out void (or hole) in the concrete. The void is about 5 centimeters long and 1.5 centimeters wide.
