LLNL-TR-648143

A Visual Description of the Concrete Exterior of the Cactus Crater Containment Structure

Terry Hamilton

October 2013

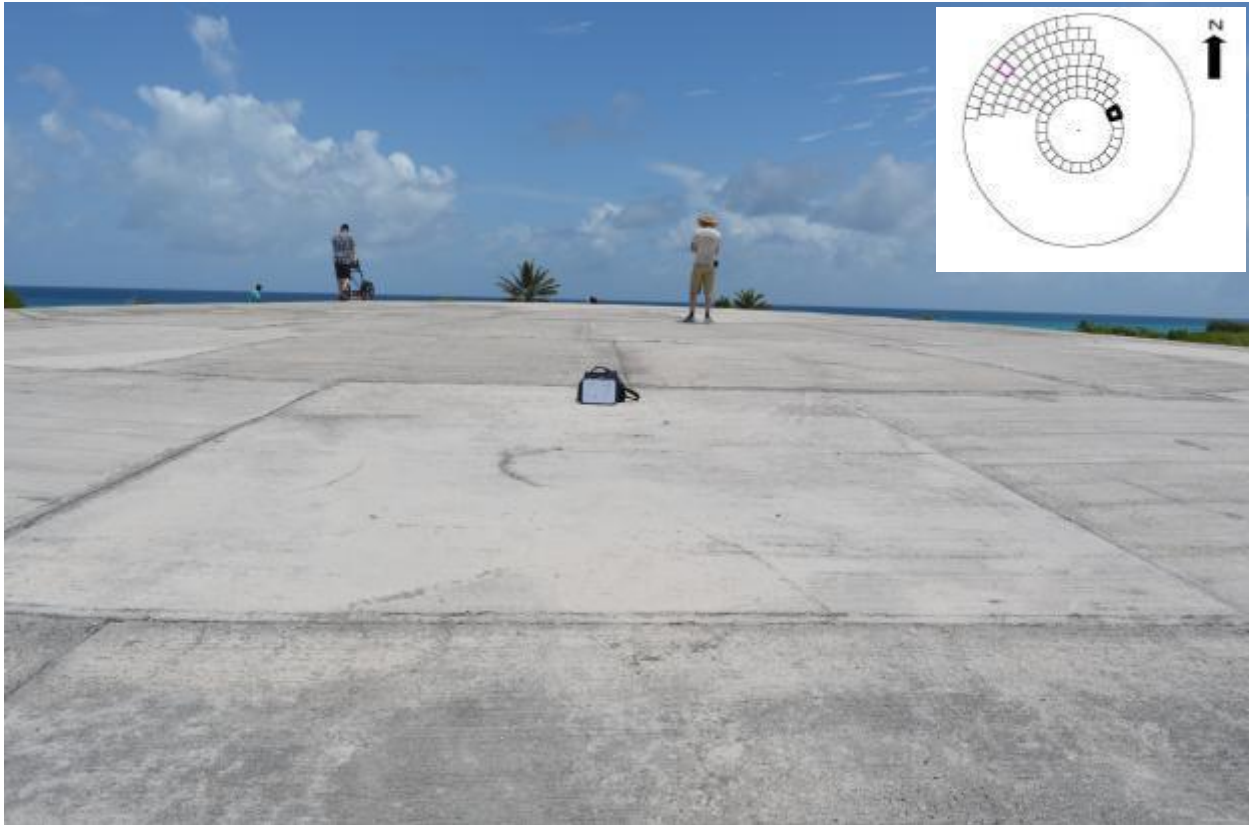
CAP SECTION LOCATION: Panel G7

A surface crack identified traversing up through the center of the panel with branches out to the left and right-hand sides of the panel.

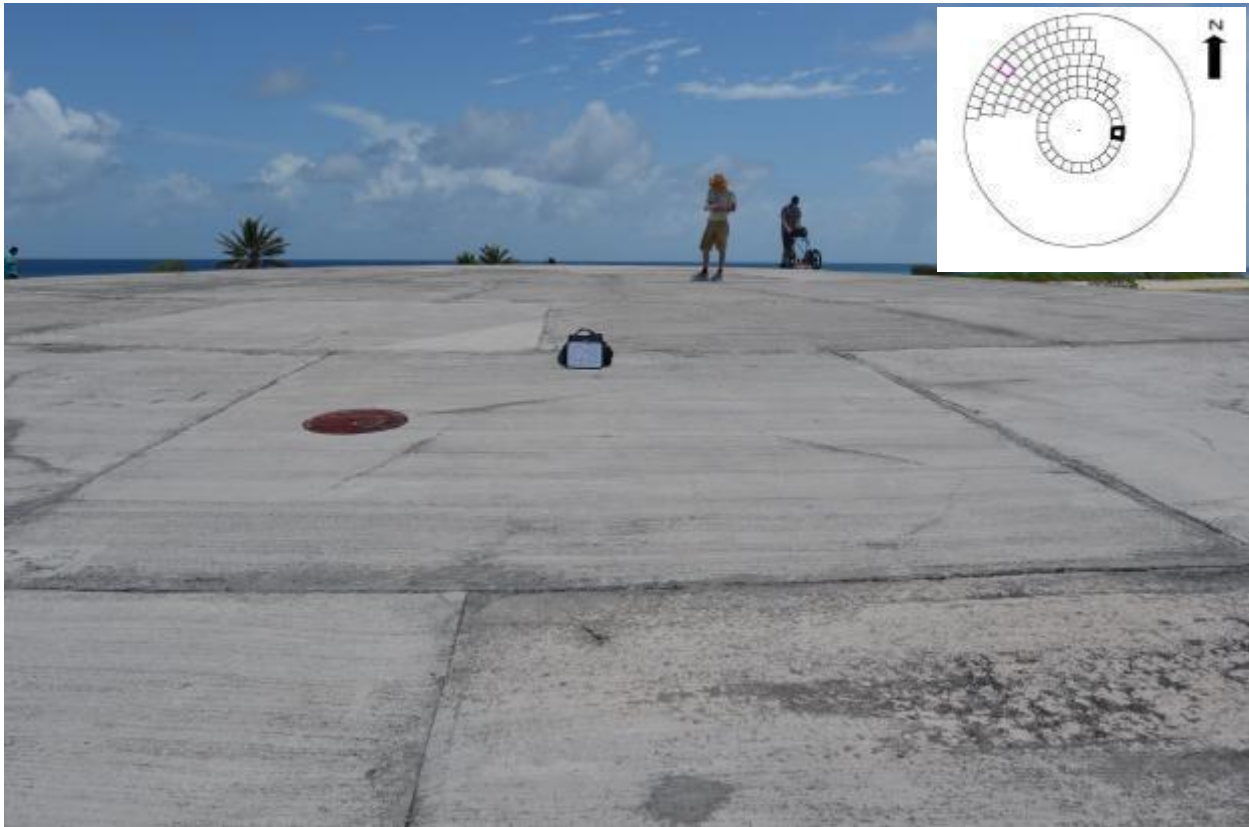
CAP SECTION LOCATION: Panel G8

A fork shaped surface crack identified extending out from the right-hand seam commencing about 1.2 meters from the bottom of the panel. The panel contains a vertical elevation benchmark.

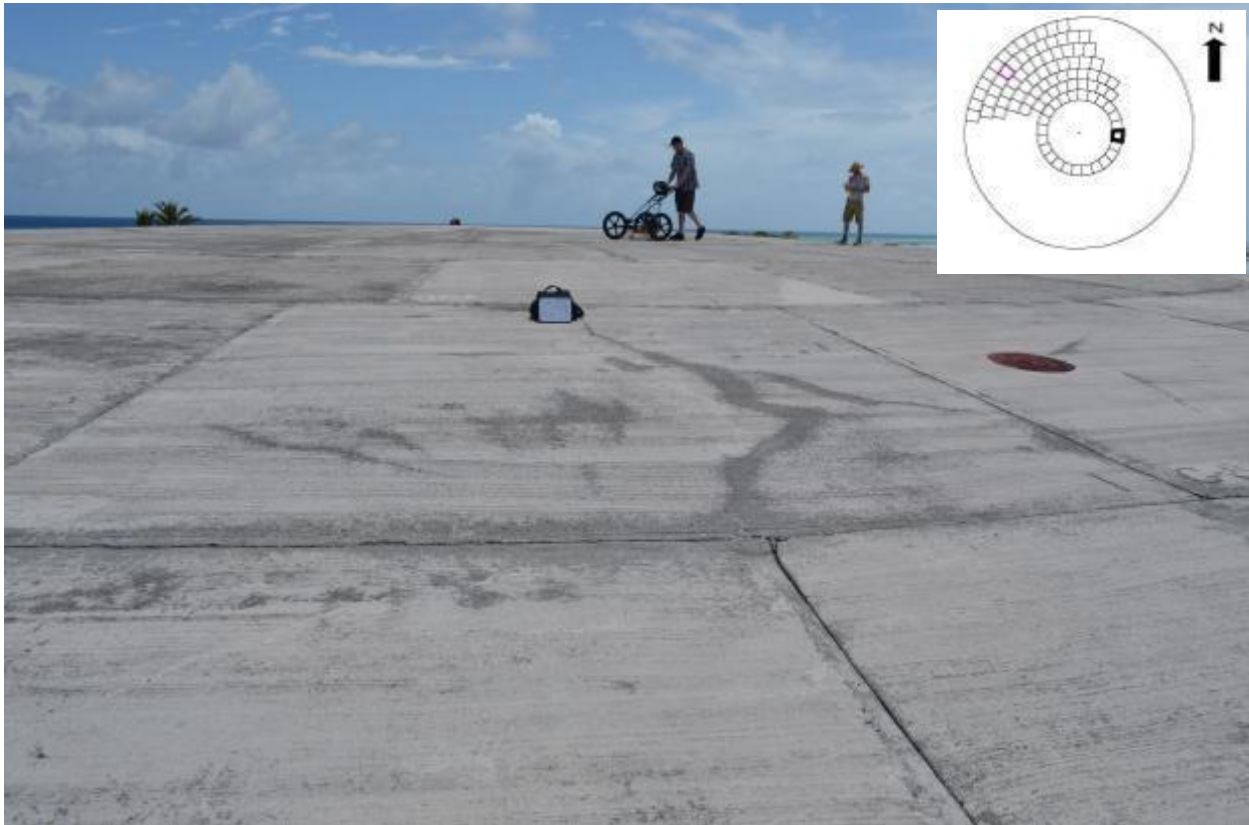
CAP SECTION LOCATION: Panel G9

No significant or obvious interior cracks or spall elements identified. Minor spalling/cracking of concrete in the upper right-hand corner of the panel.

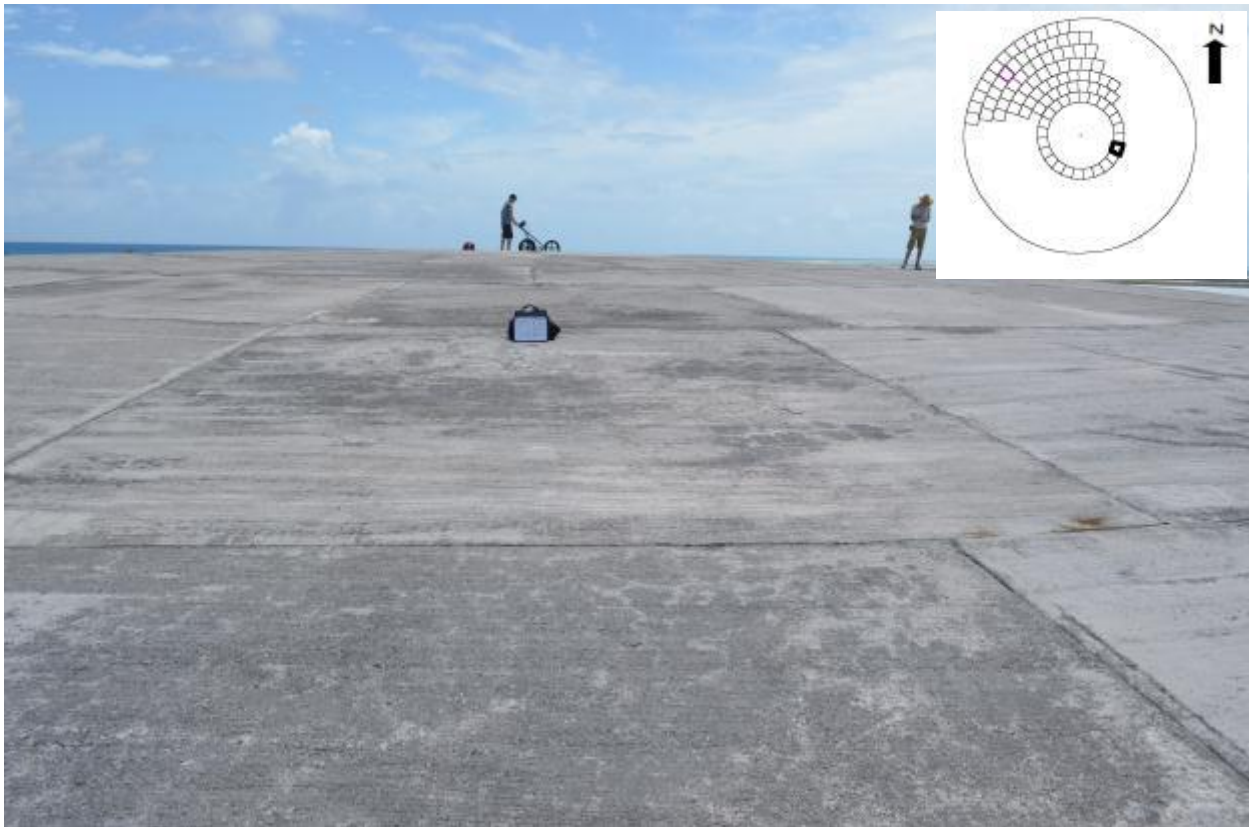
CAP SECTION LOCATION: Panel G10

No significant or obvious interior cracks or spall elements identified. Minor spalling/cracking of concrete in the upper left-hand corner of the panel.

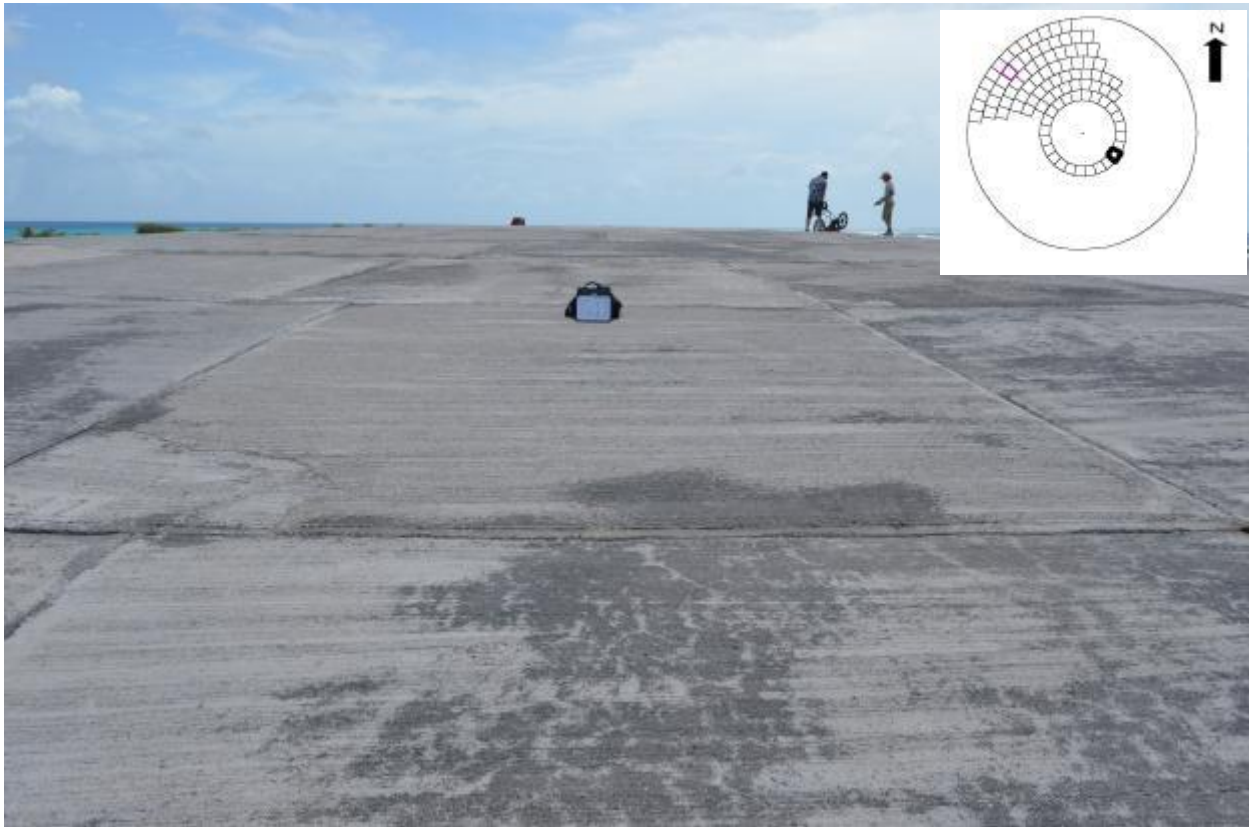
CAP SECTION LOCATION: Panel G11

The panel contains no significant or obvious interior cracks or spall elements. Rooting vegetation removed from along the panel seams. Minor spalling/cracking of concrete in the lower right-hand corner of the panel.

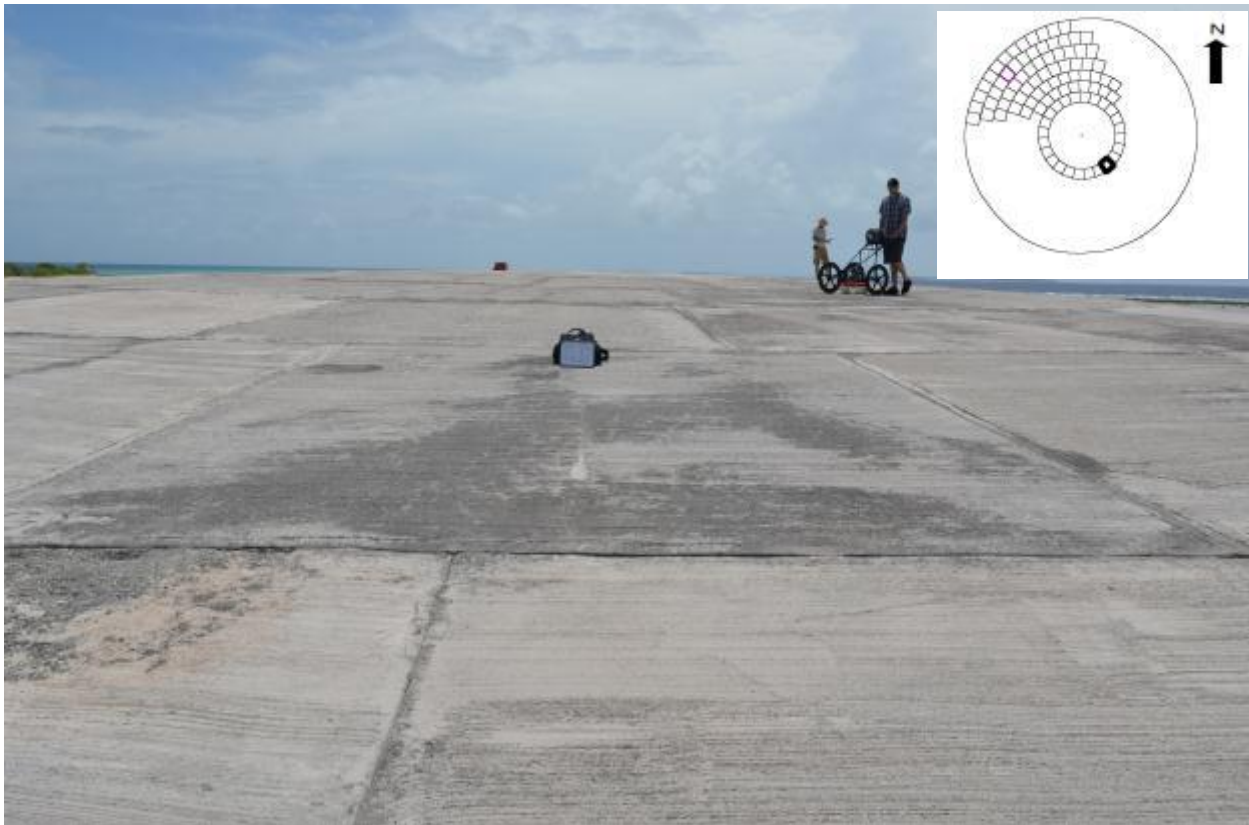
CAP SECTION LOCATION: Panel G12

The panel contains no significant or obvious interior cracks or spall elements. Please note that there are no panels labeled G13 through G18.

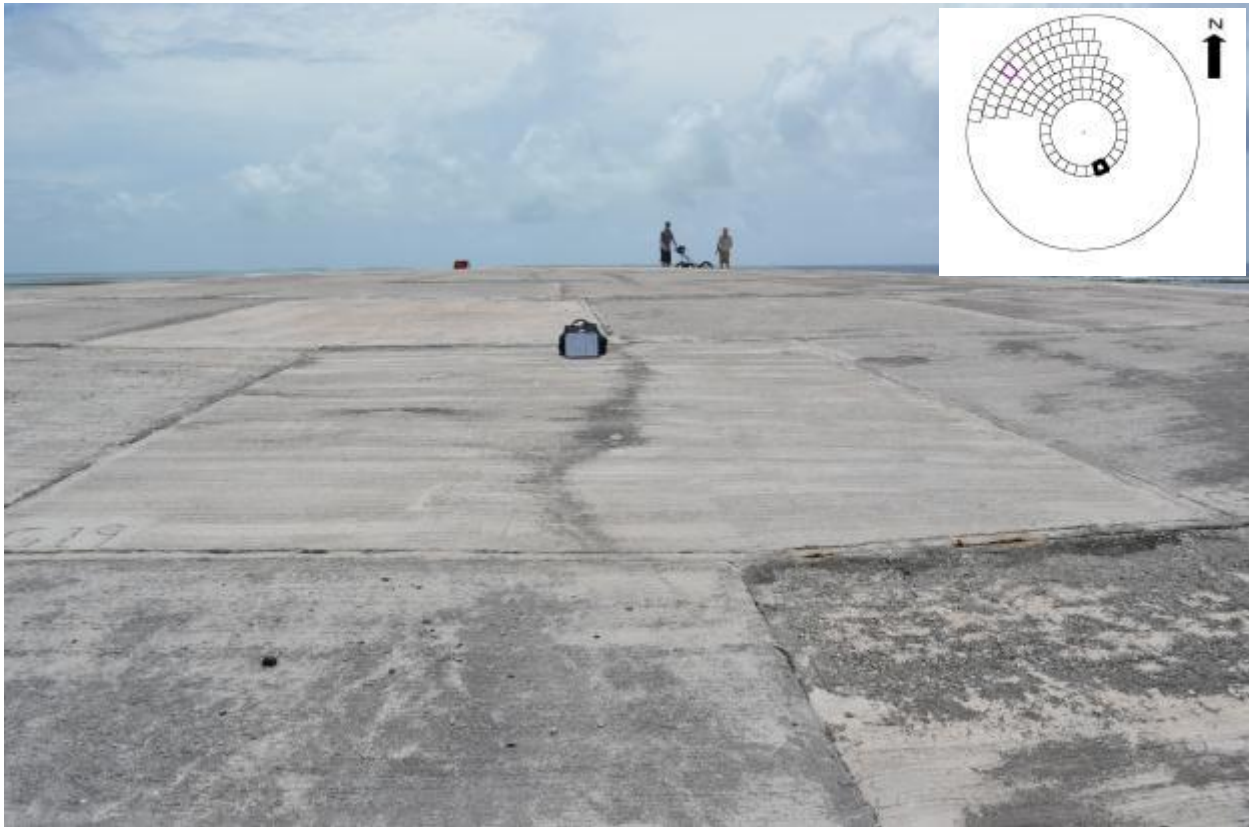
CAP SECTION LOCATION: Panel G19

Surface crack observed extending up through the middle of the panel intersecting the upper seam at corner H11/H12 on the ring row above. Panel contains a capped concrete bore-hole (CD-6) from the 1980 NAS investigation.

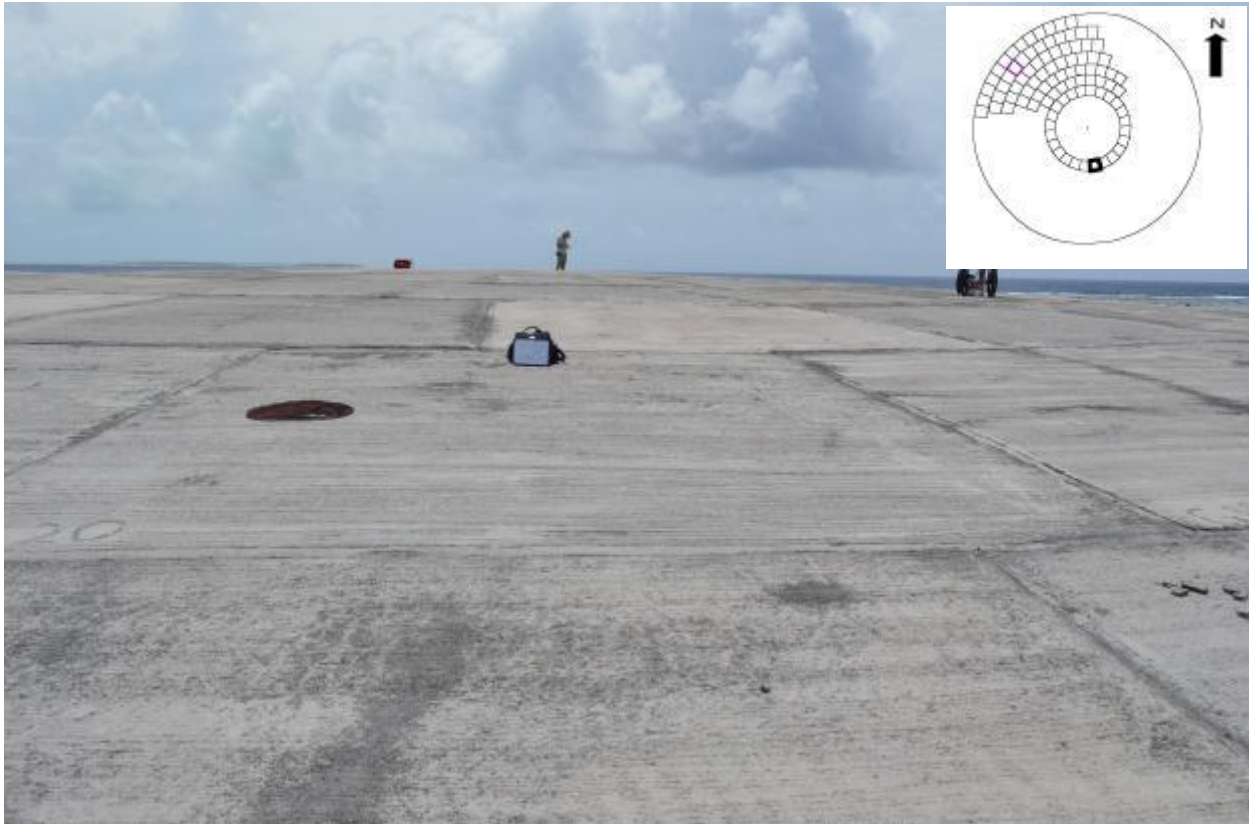
CAP SECTION LOCATION: Panel G20

The panel contains no significant or obvious interior cracks or spall elements. Panel contains a vertical elevation benchmark.

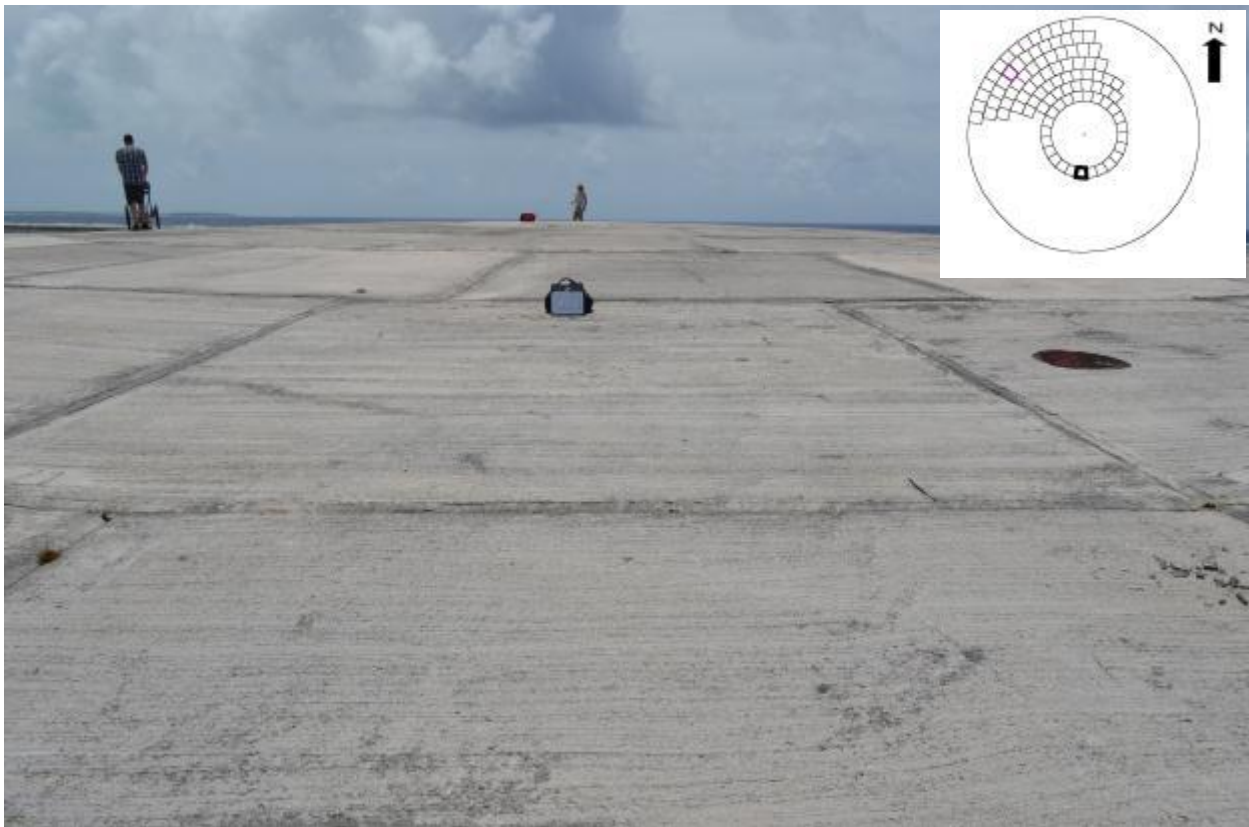
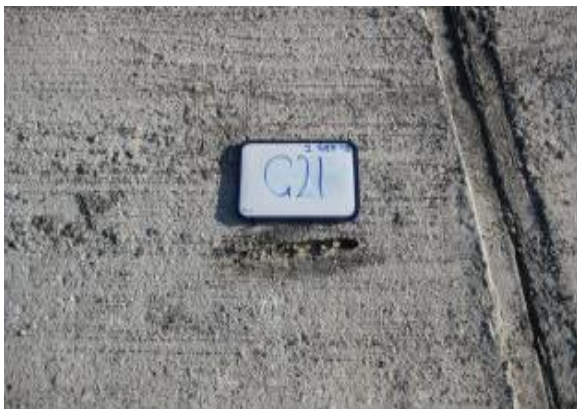
CAP SECTION LOCATION: Panel G21

The panel contains no significant or obvious interior cracks or spall elements. Some minor spalling/chipping of concrete along the upper left-hand seam. A small void observed in the concrete close to the right-side seam (refer photo). There some indication that the cracks along the panel joints are becoming more prominent compared with other panels contained in this ring row.

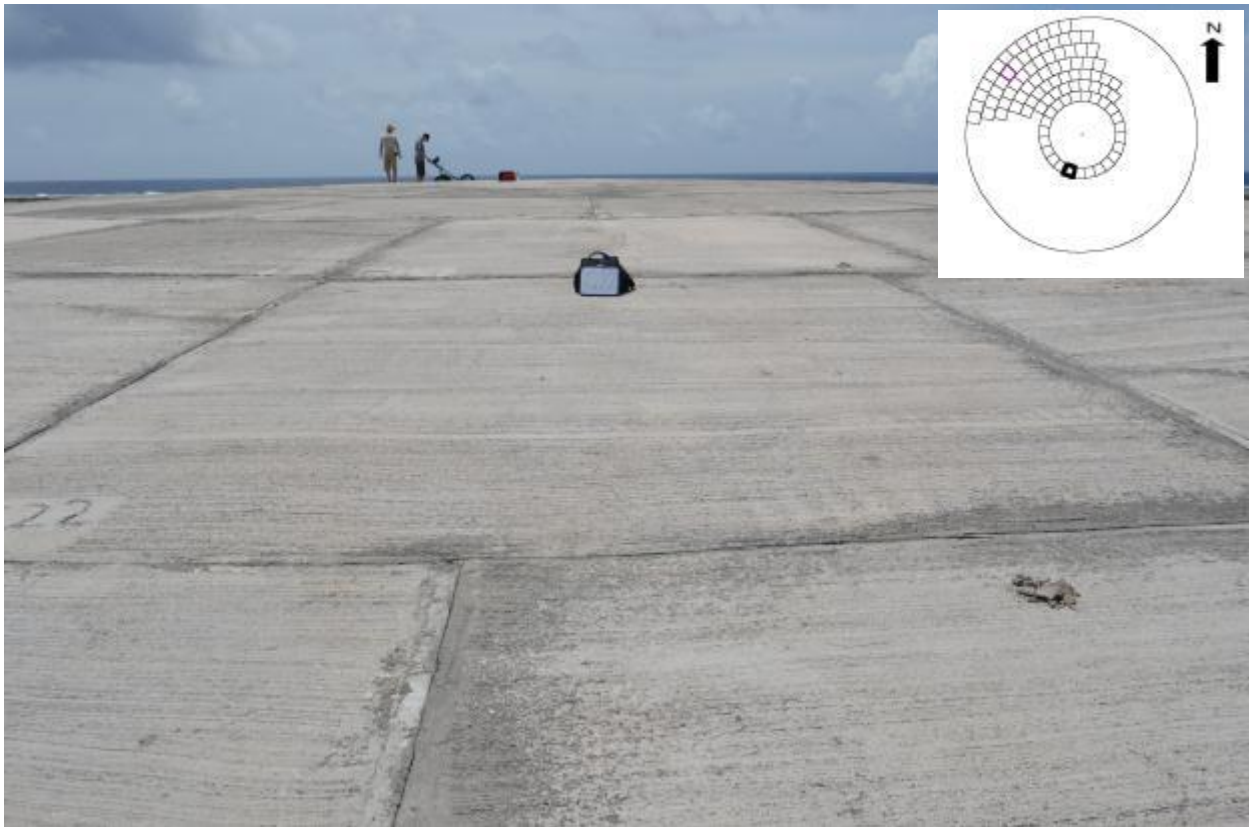
CAP SECTION LOCATION: Panel G22

The panel contains no significant or obvious interior cracks or spall elements. The cracks opening up along the panel joints appear to be a little prominent compared with other panels located in this ring row.

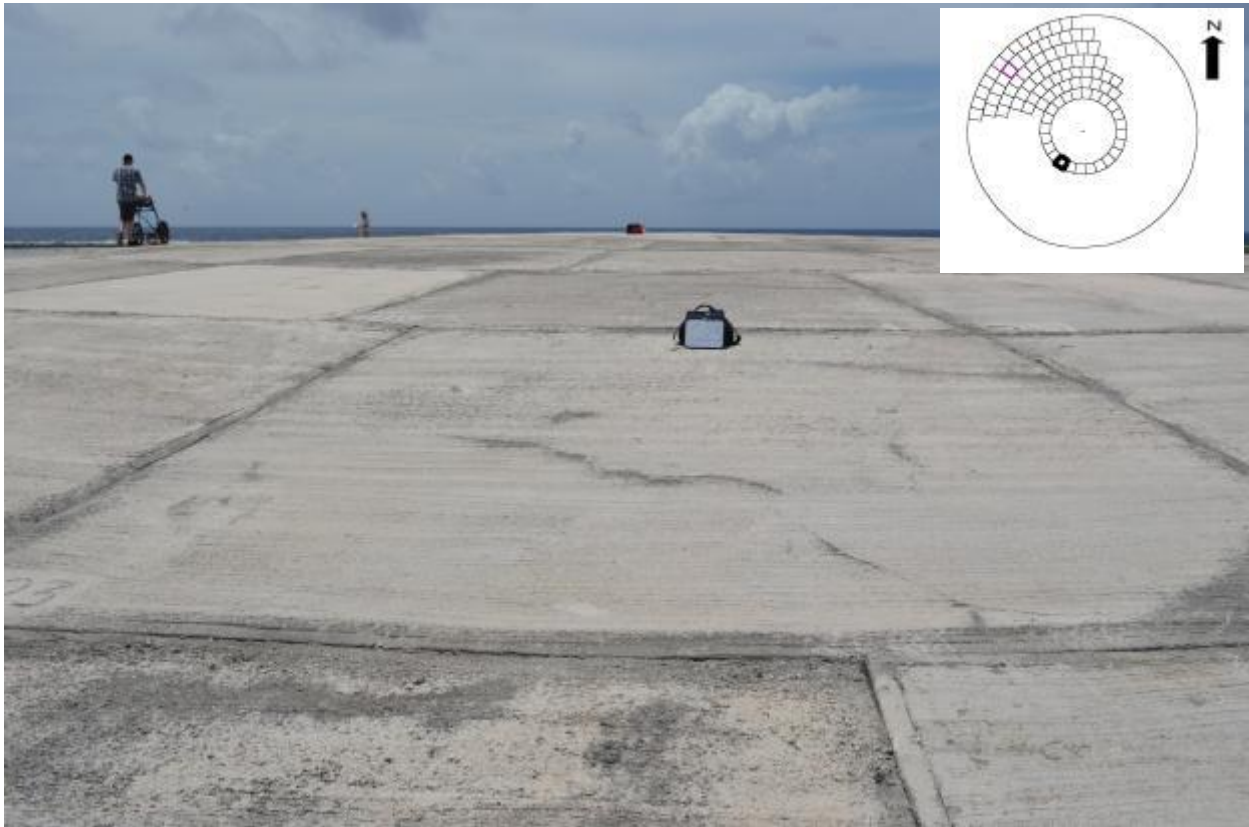
CAP SECTION LOCATION: Panel G23

The panel contains no significant or obvious interior cracks or spall elements. Some spalling/cracking of concrete along the bottom left-hand corner of the panel.

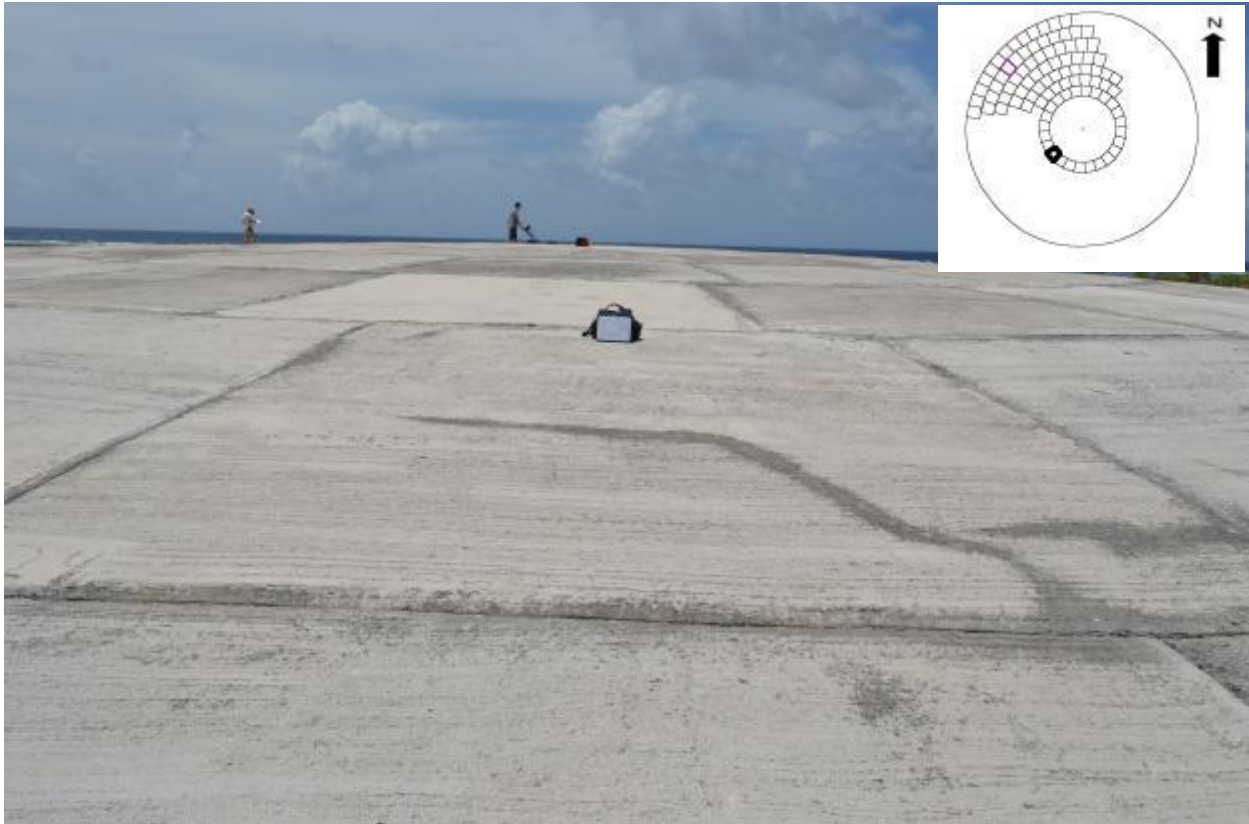
CAP SECTION LOCATION: Panel G24

Some spalling/cracking of concrete observed in the upper left-hand corner of the panel. Minor crack observed about 1.2 meters from the bottom right-hand corner and traversing up the face of the panel for a distance of about 5 meters.

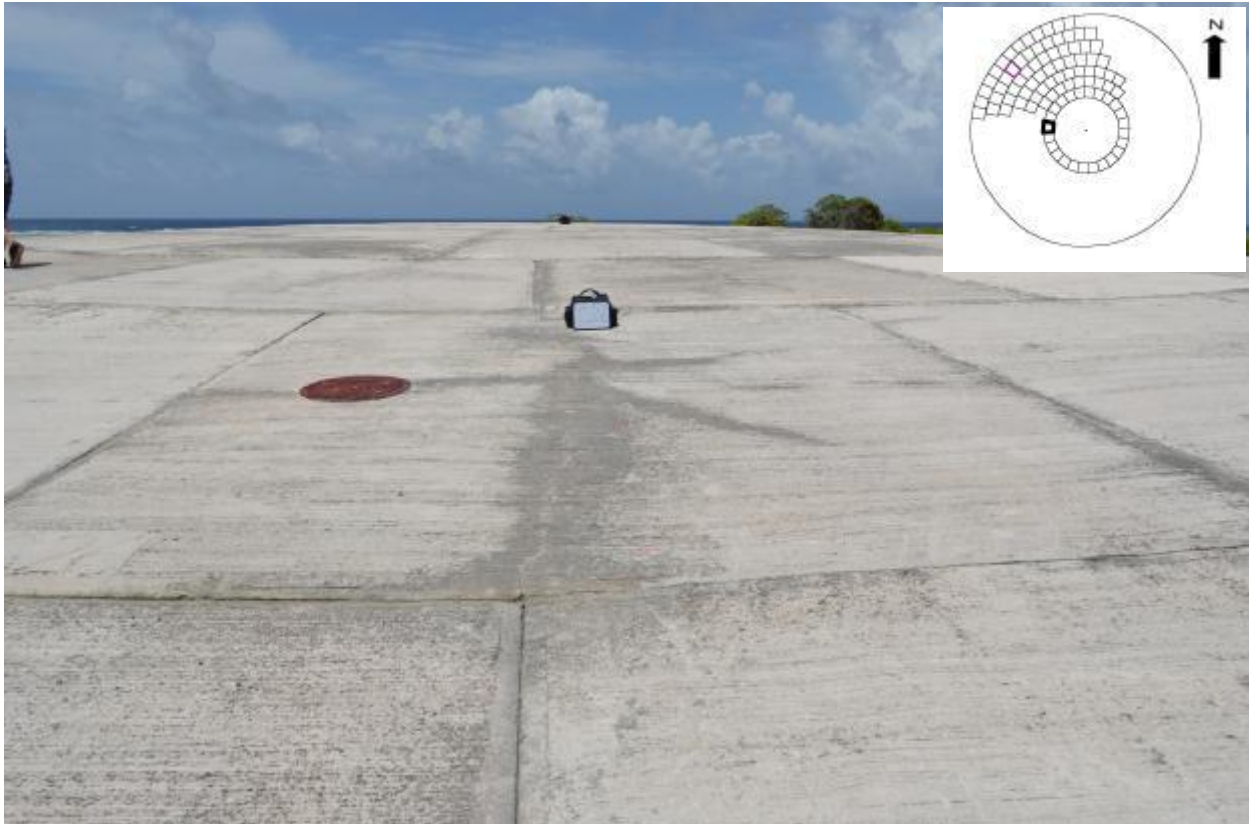
CAP SECTION LOCATION: Panel G26

Surface crack observed traversing up through the middle of the panel with a fork branching out to the left at a mid-point up the panel. Panel contains a vertical elevation benchmark.

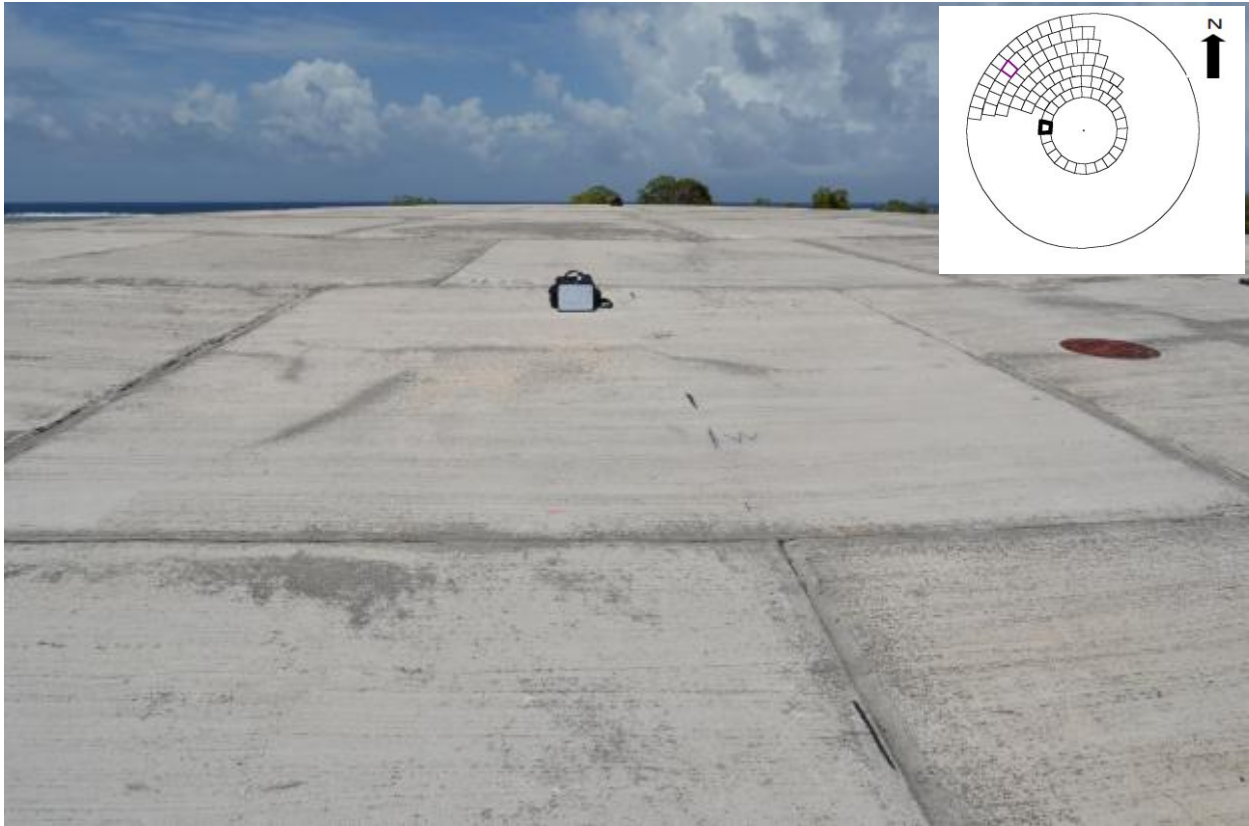
CAP SECTION LOCATION: Panel G27

Some spalling/cracking of concrete observed in the upper left corner. Surface crack observed traversing across the panel.

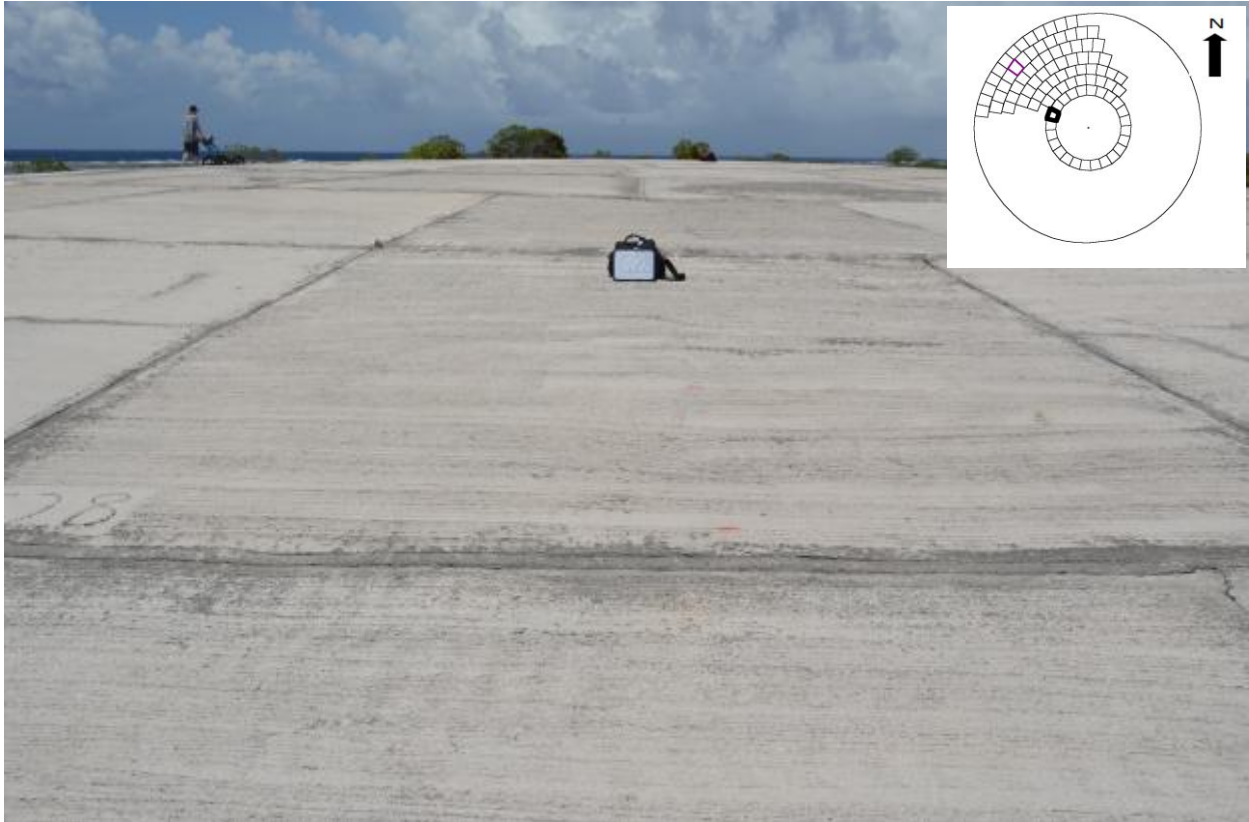
CAP SECTION LOCATION: Panel G28

Rooting vegetation removed from along the panel seams. No significant or obvious interior cracks or spall elements identified with exception of spalling/cracking of concrete in the upper right-hand corner of the panel.

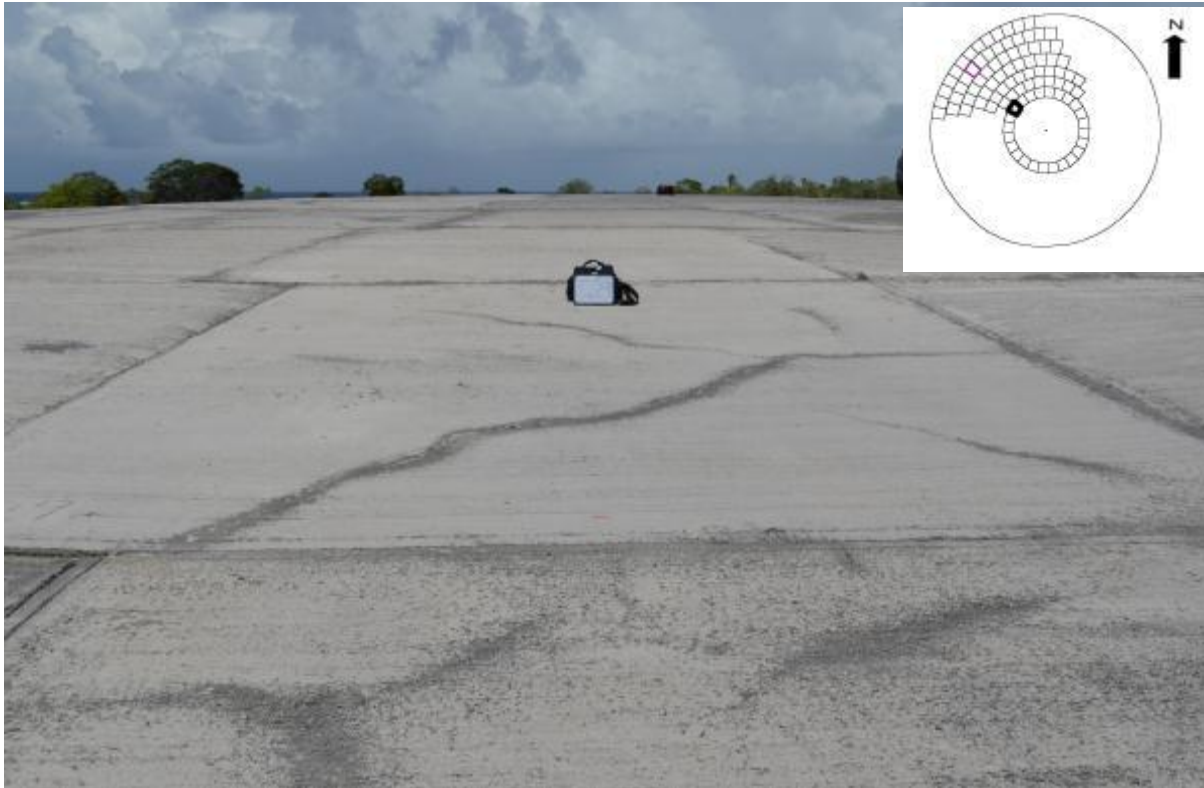
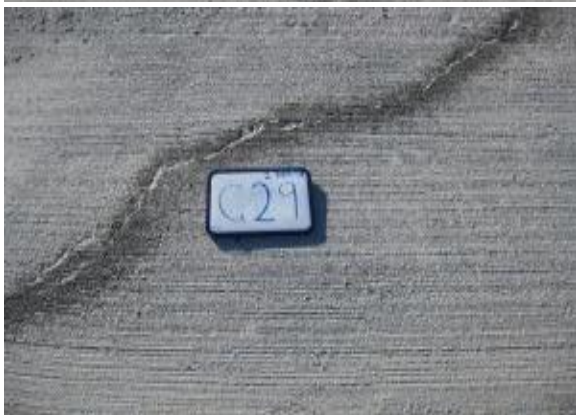
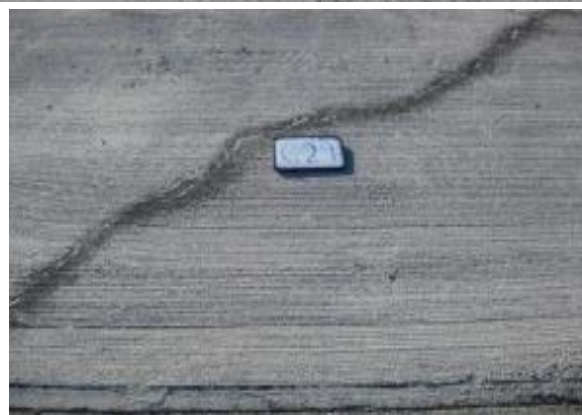
CAP SECTION LOCATION: Panel G29

Surface crack observed extending up through the middle of the panel from the left side of the bottom seam towards the upper right-hand corner with forks branching out to the left and right sides at about a mid-point up the panel. Rooting vegetation removed from along the panel seams.

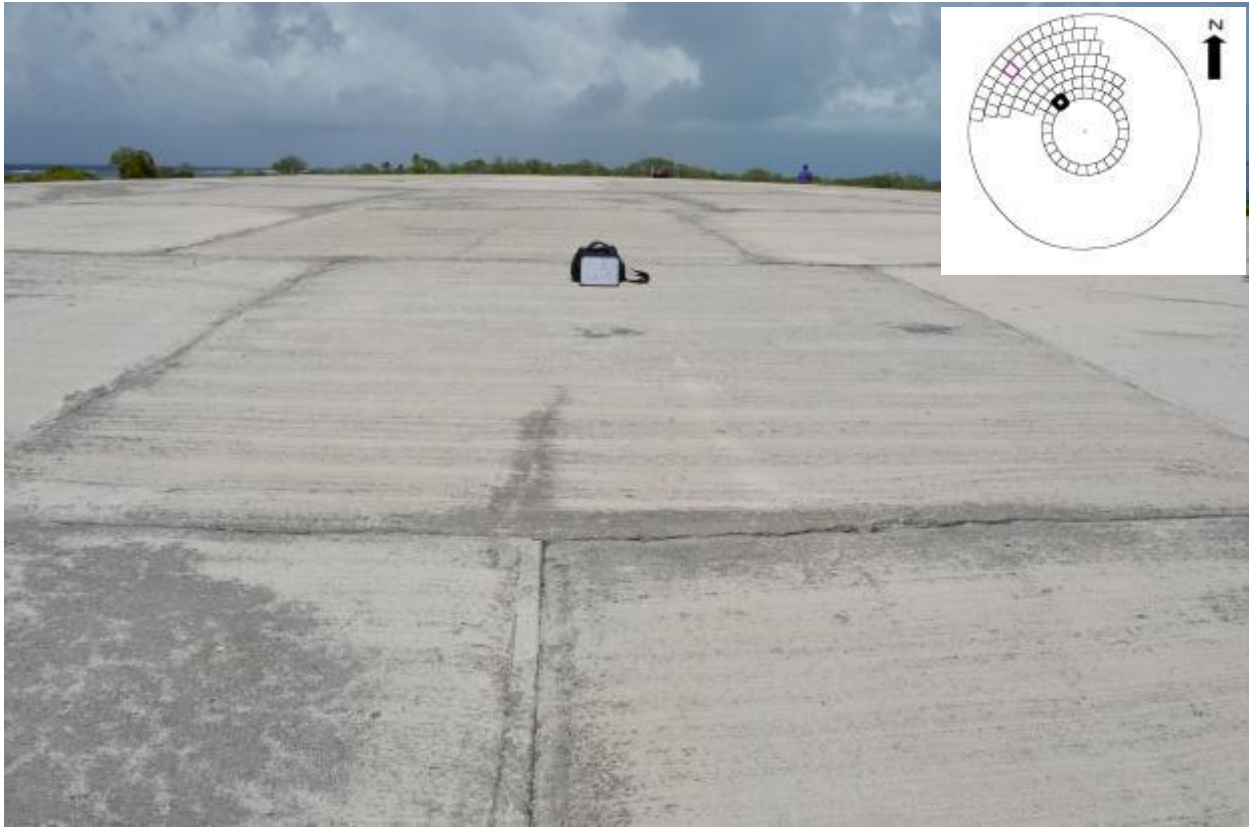
CAP SECTION LOCATION: Panel G30

No significant or obvious interior cracks or spall elements identified with exception of very minor spalling/cracking of concrete along the top seam or panel joint. There are signs of a minor crack traversing up from the bottom seam near the intersecting corner of the panels on the ring row below.

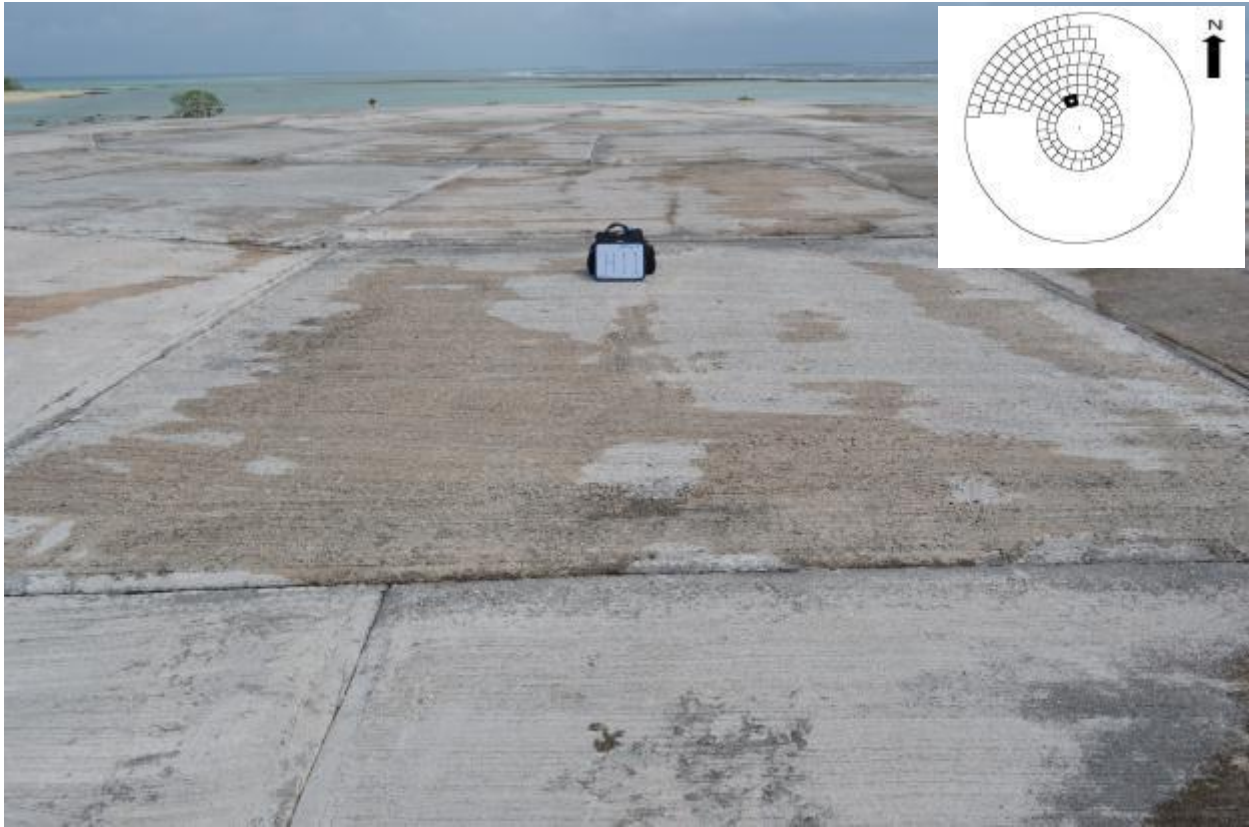
CAP SECTION LOCATION: Panel H2

No significant or obvious interior cracks or spall elements identified.

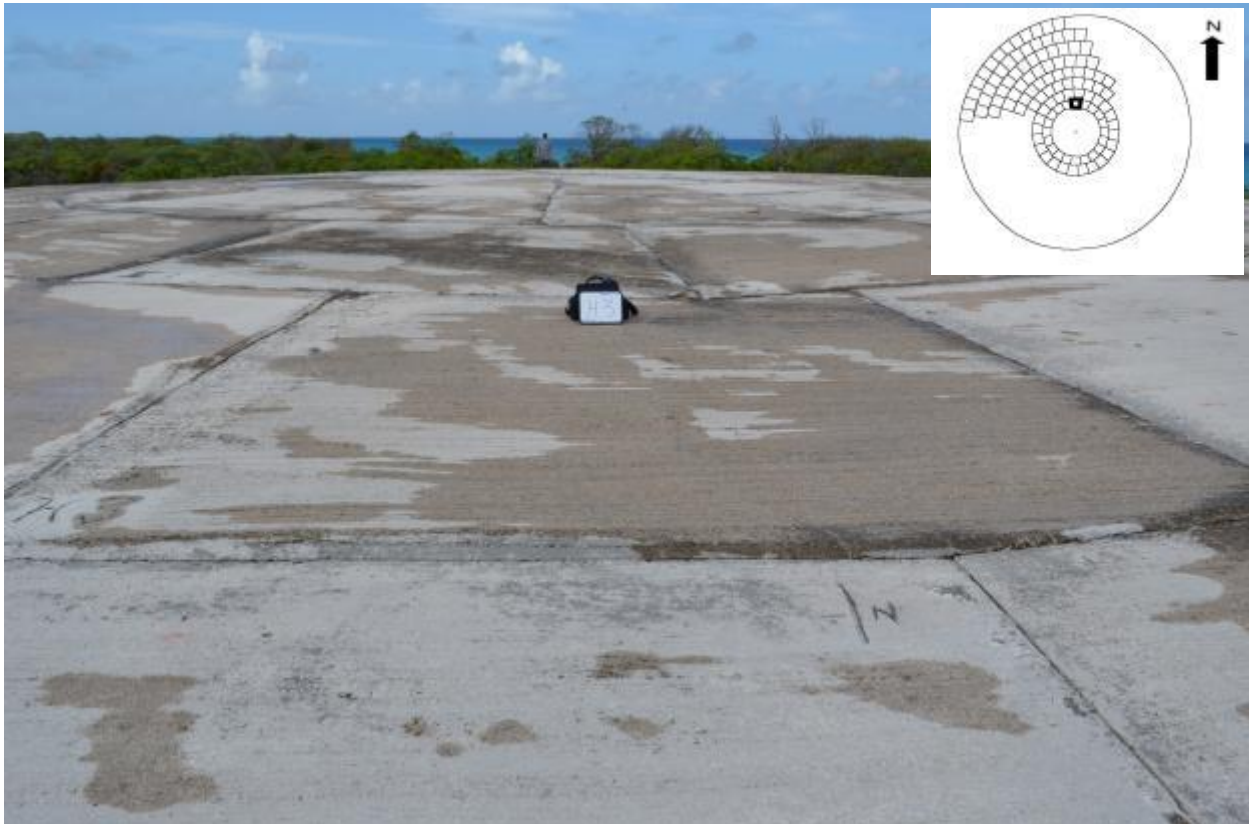
CAP SECTION LOCATION: Panel H3

No significant or obvious interior cracks or spall elements identified.

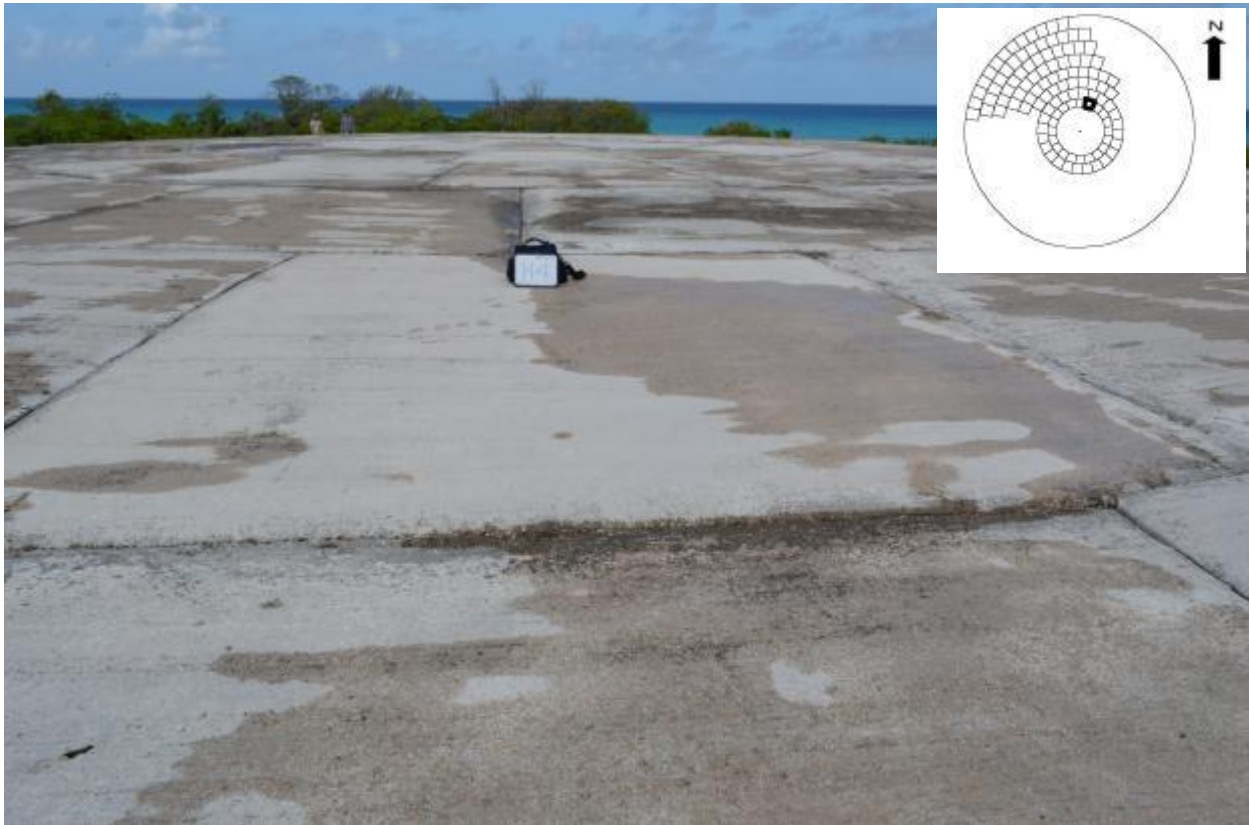
CAP SECTION LOCATION: Panel H4

No significant or obvious interior cracks or spall elements. Minor spalling/chipping of concrete in the bottom right-hand corner of the panel.
