LLNL-TR-648143

A Visual Description of the Concrete Exterior of the Cactus Crater Containment Structure

Terry Hamilton

October 2013

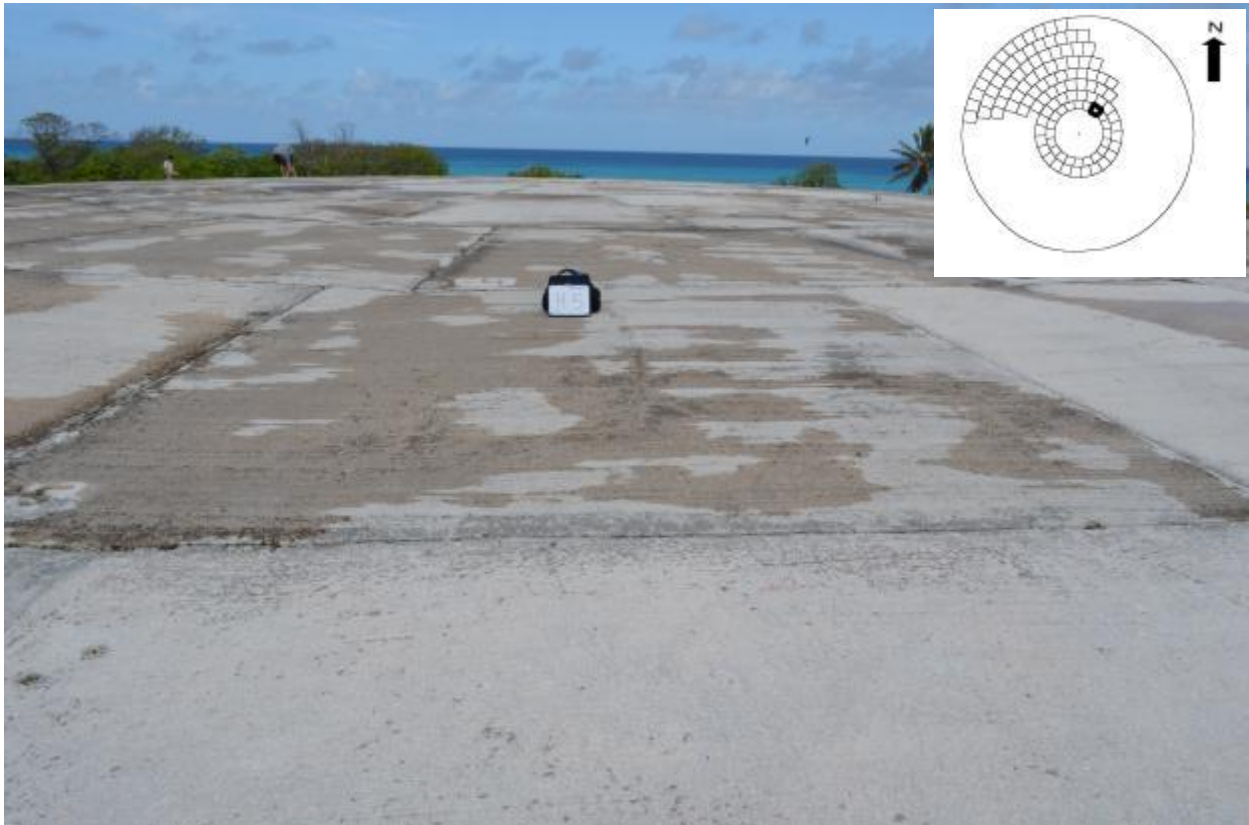
CAP SECTION LOCATION: Panel H5

No significant or obvious interior cracks or spall elements identified. Minor spalling/chipping of concrete in the bottom left-hand corner of the panel.

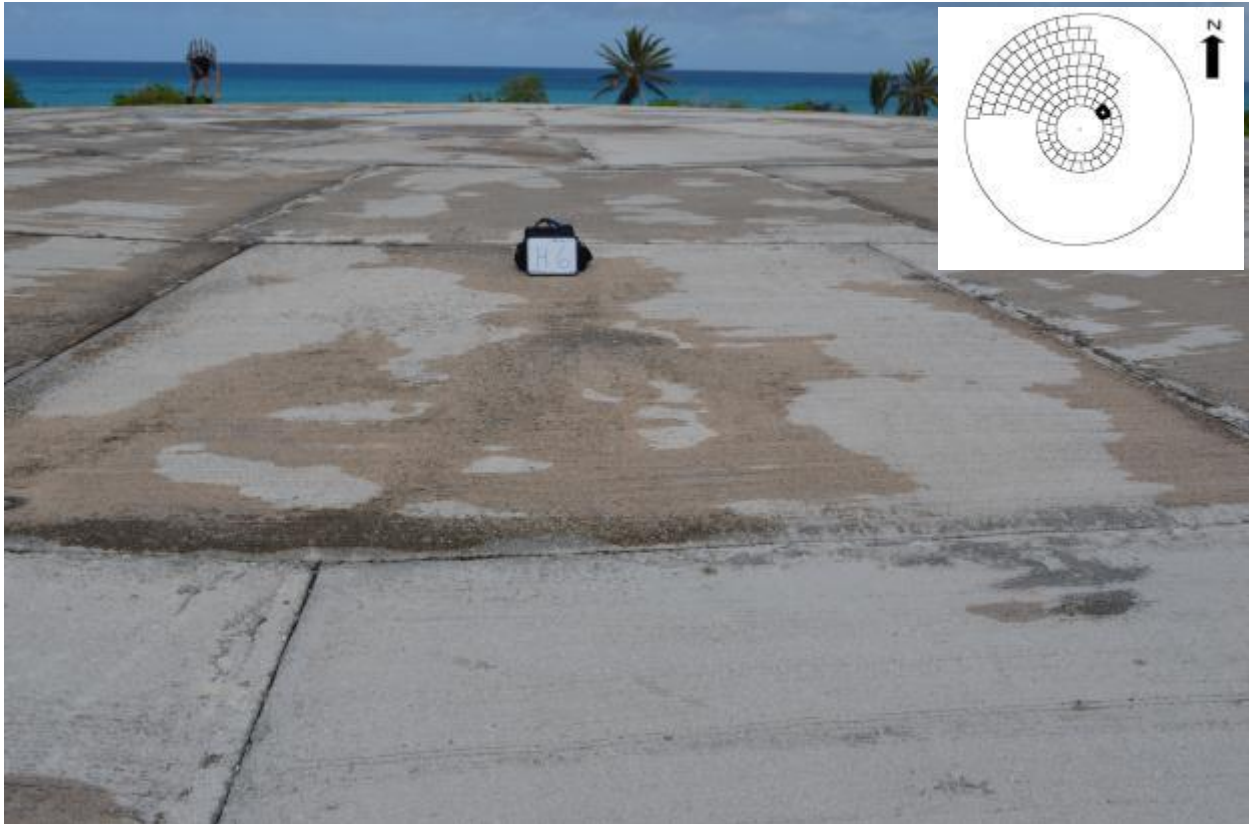
CAP SECTION LOCATION: Panel H6

No significant or obvious interior cracks or spall elements identified. Minor spalling/chipping of concrete in the bottom right-hand corner of the panel.

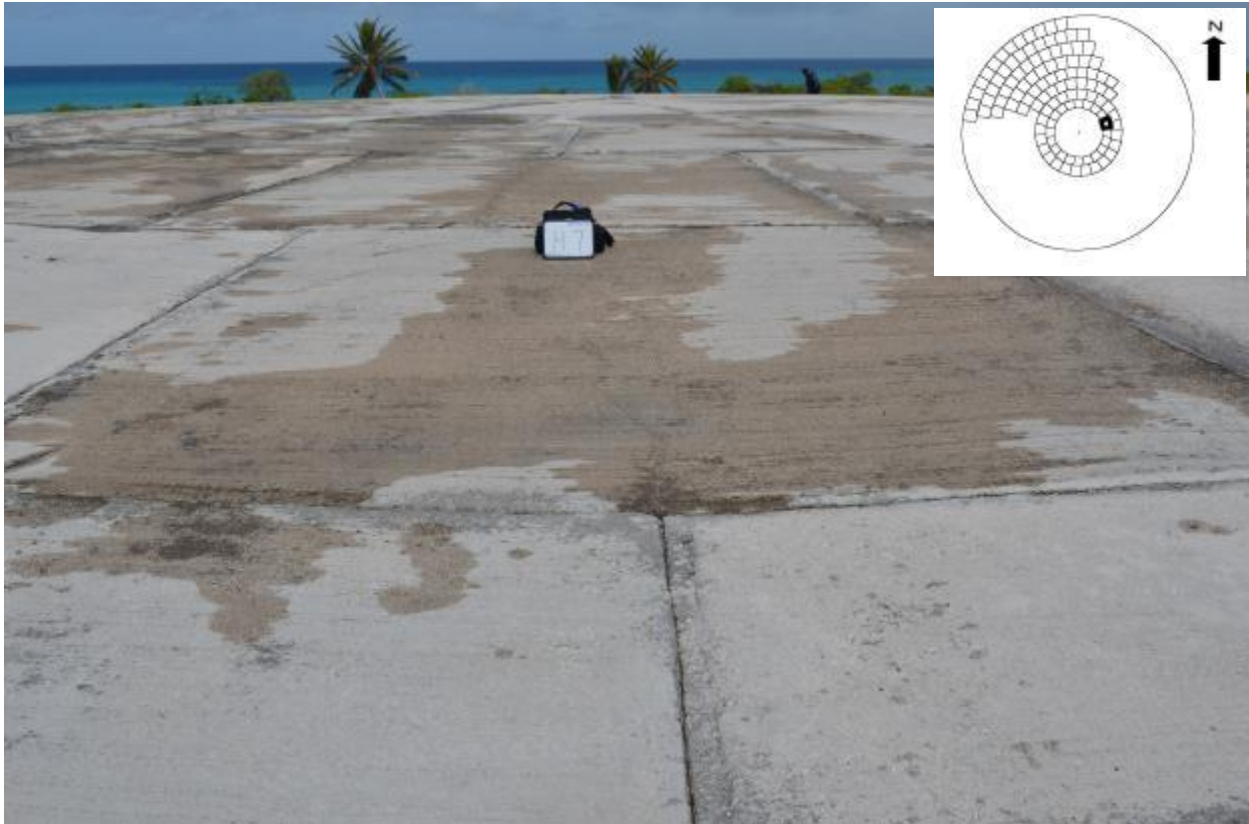
CAP SECTION LOCATION: Panel H7

No significant or obvious interior cracks or spall elements identified. Minor spalling/chipping of concrete in the bottom right-hand corner of the panel.

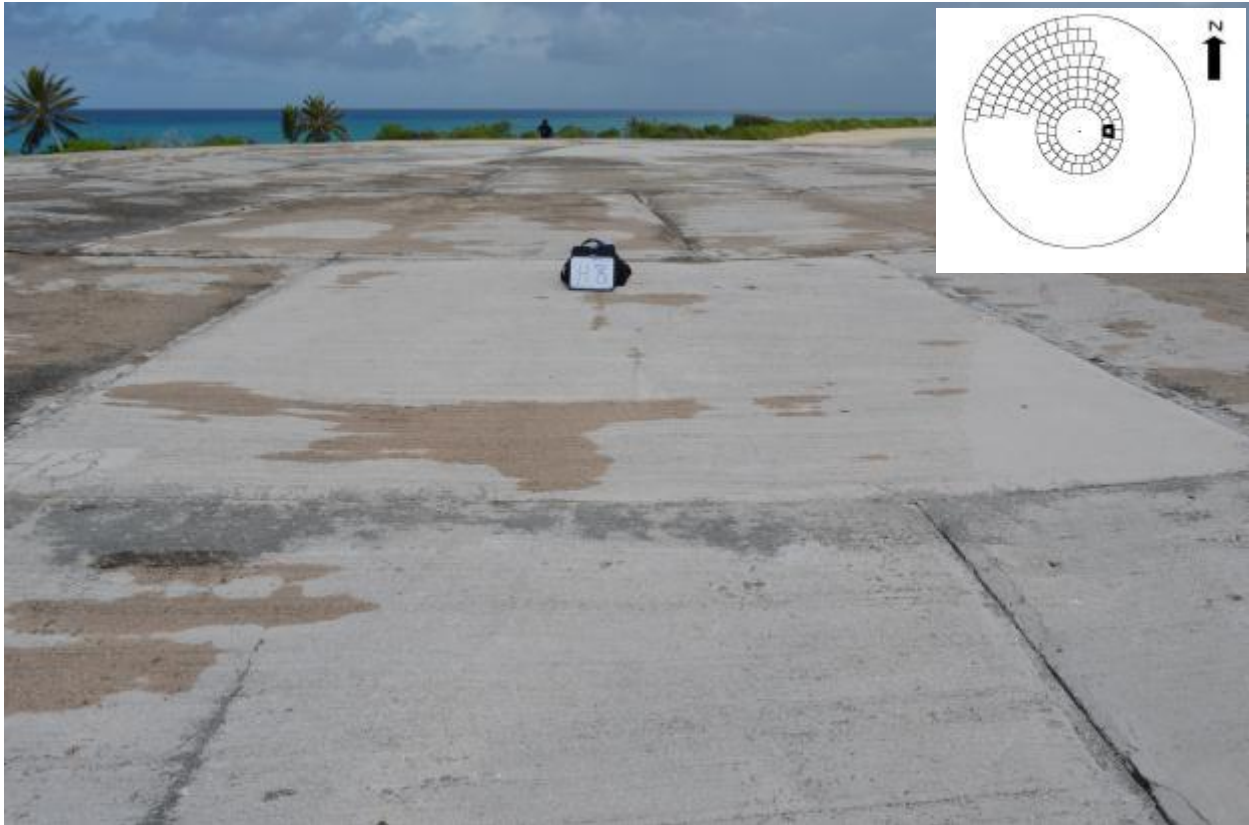
CAP SECTION LOCATION: Panel H8

No significant or obvious interior cracks or spall elements identified.

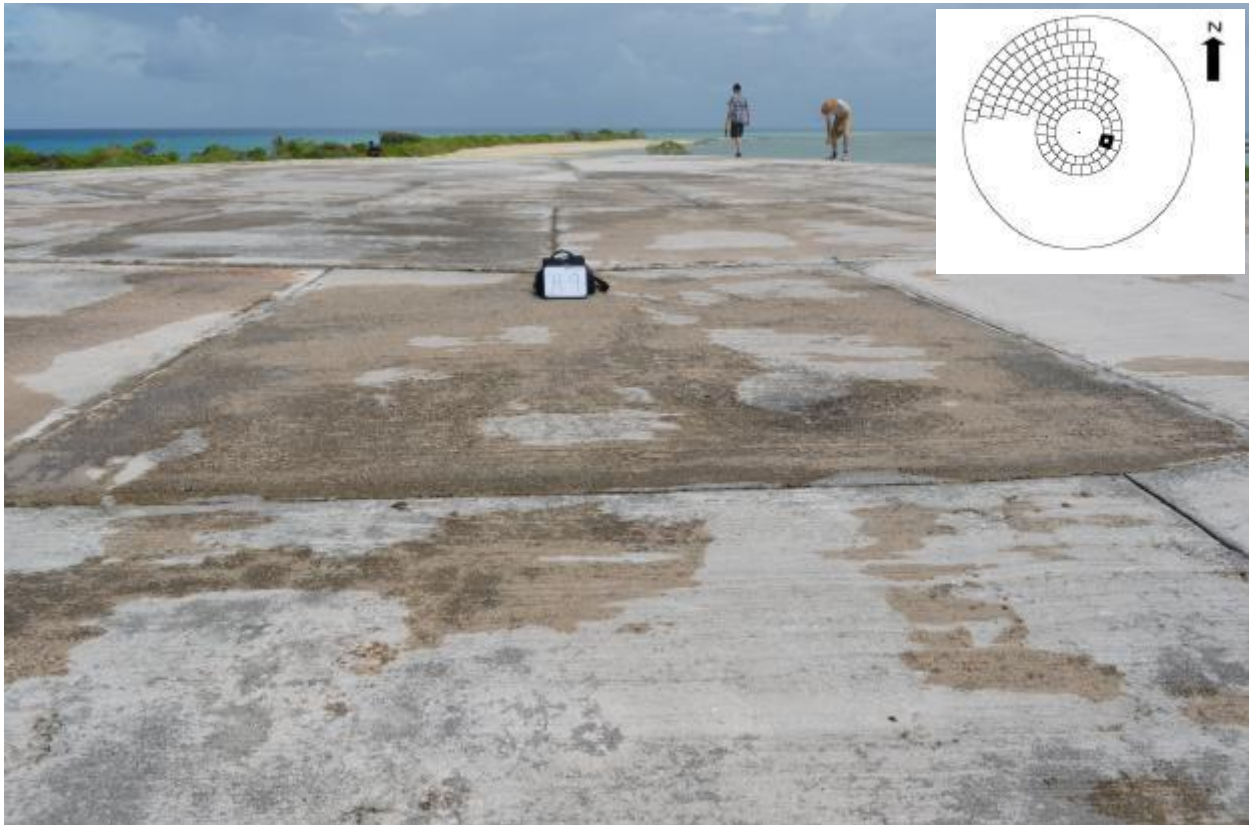
CAP SECTION LOCATION: Panel H9

No significant or obvious interior cracks or spall elements identified. Minor spalling/chipping of concrete in the bottom right-hand corner.

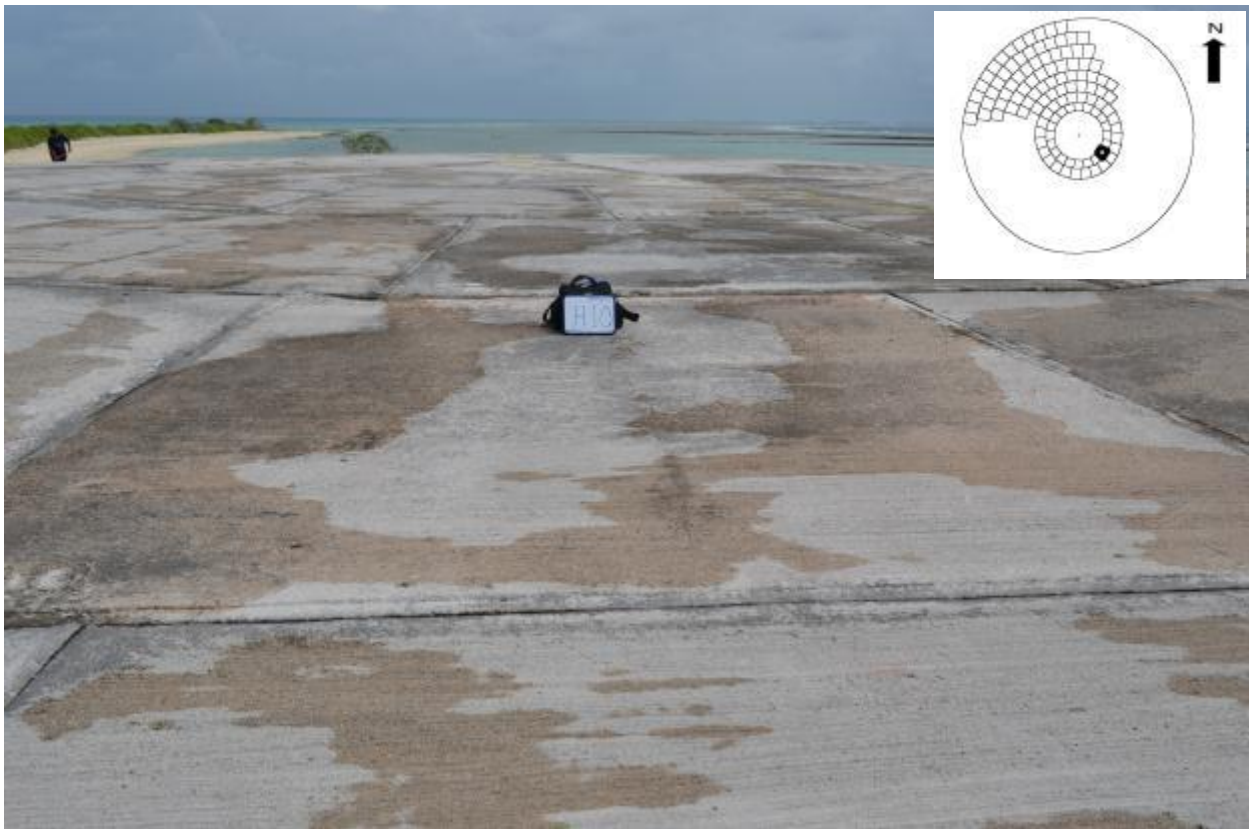
CAP SECTION LOCATION: Panel H10

No significant or obvious interior cracks or spall elements identified. Minor spalling/chipping of concrete in the bottom right and left-hand corners of the panel.

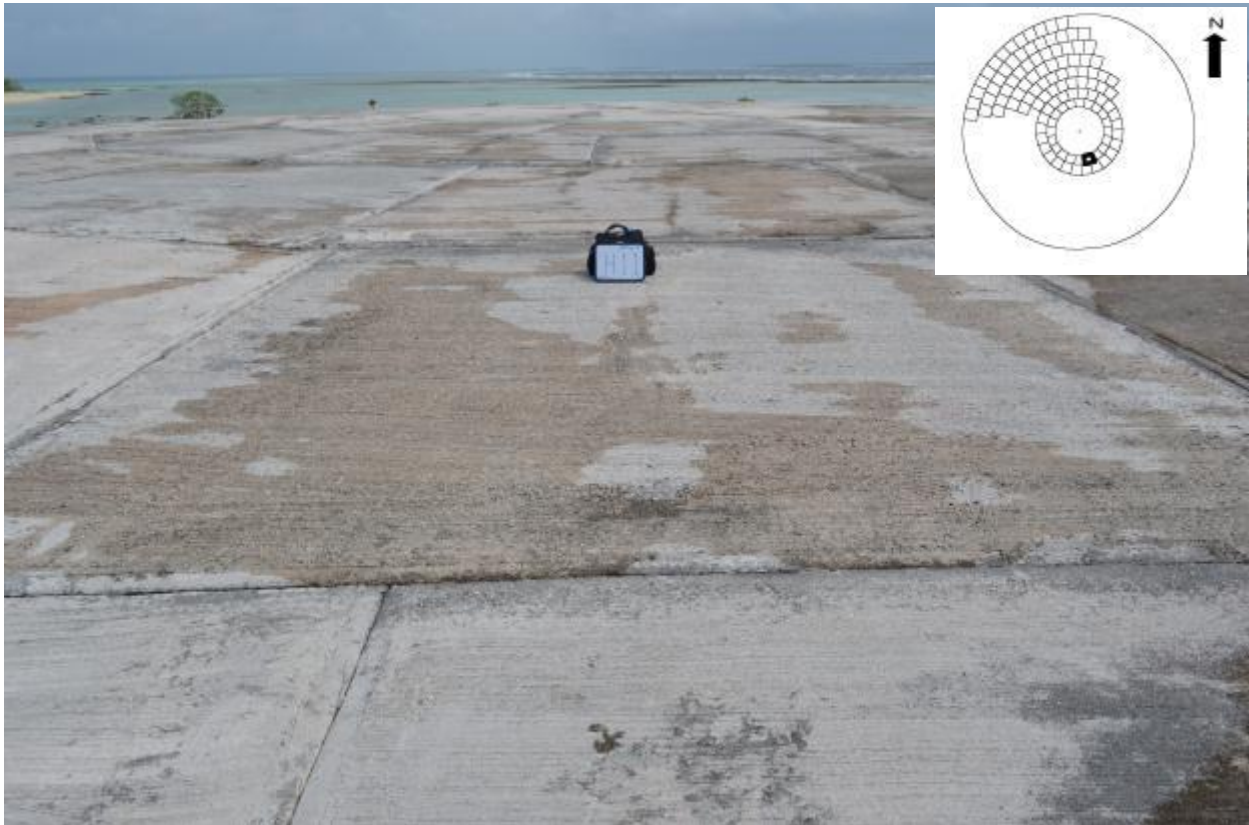
CAP SECTION LOCATION: Panel H11

No significant or obvious interior cracks or spall elements identified. Minor spalling/chipping of concrete in the upper left-hand corner of the panel.

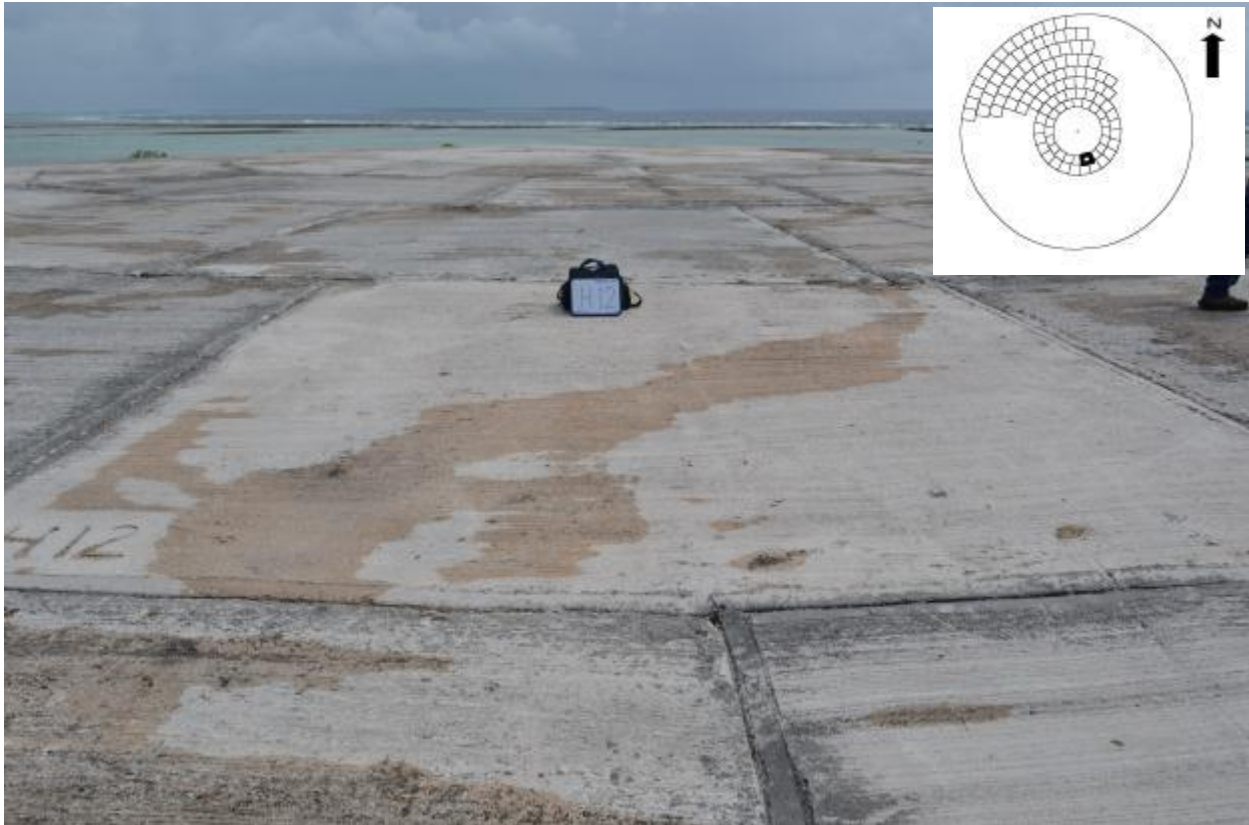
CAP SECTION LOCATION: Panel H12

No significant or obvious interior cracks or spall elements identified.

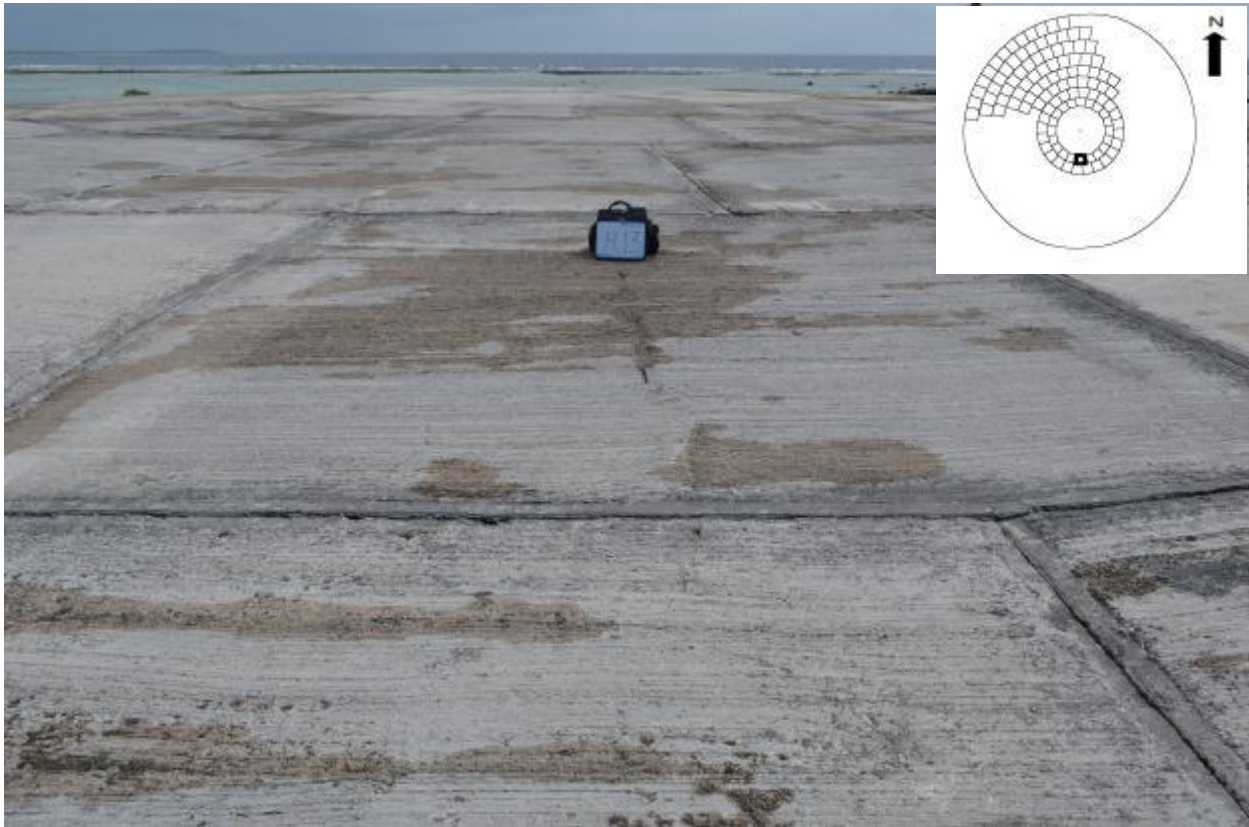
CAP SECTION LOCATION: Panel H13

No significant or obvious interior cracks or spall elements identified.

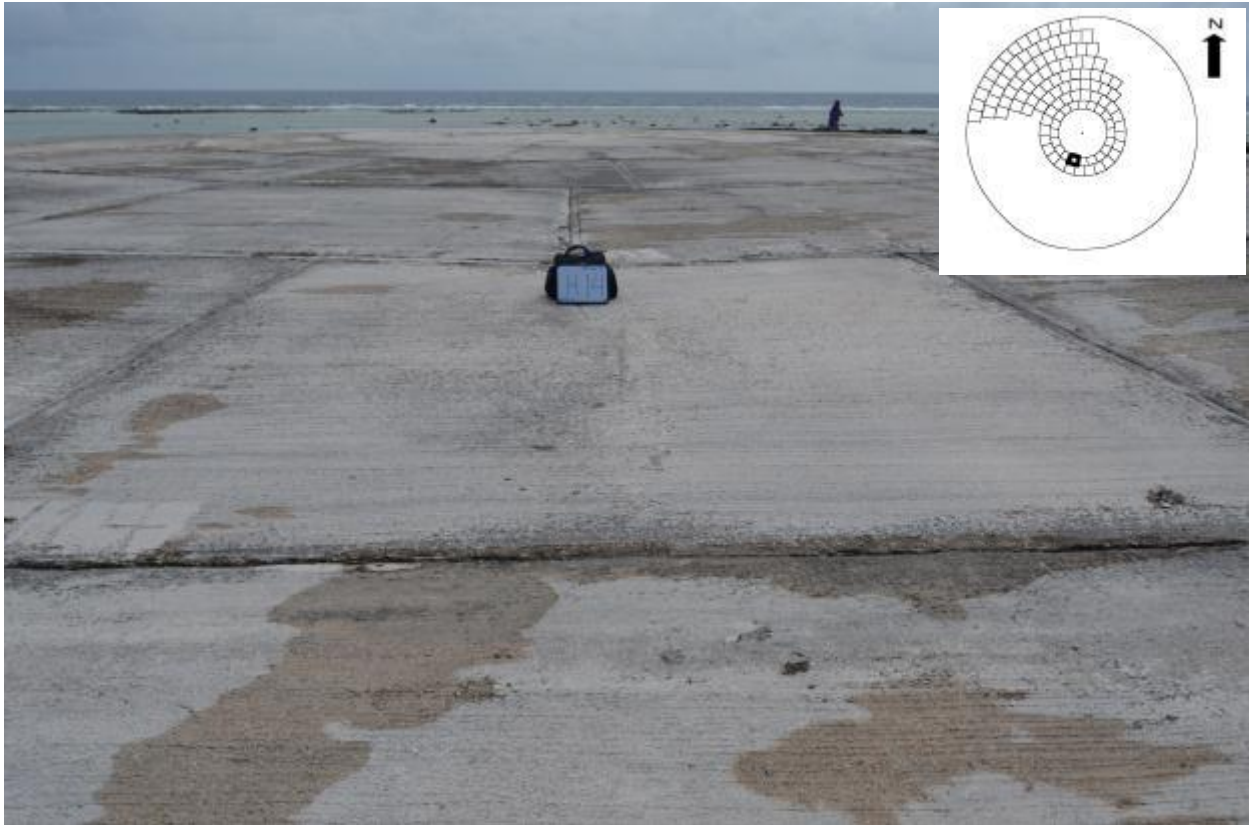
CAP SECTION LOCATION: Panel H14

No significant or obvious interior cracks or spall elements. Minor spalling/chipping of concrete in the upper left-hand corner.

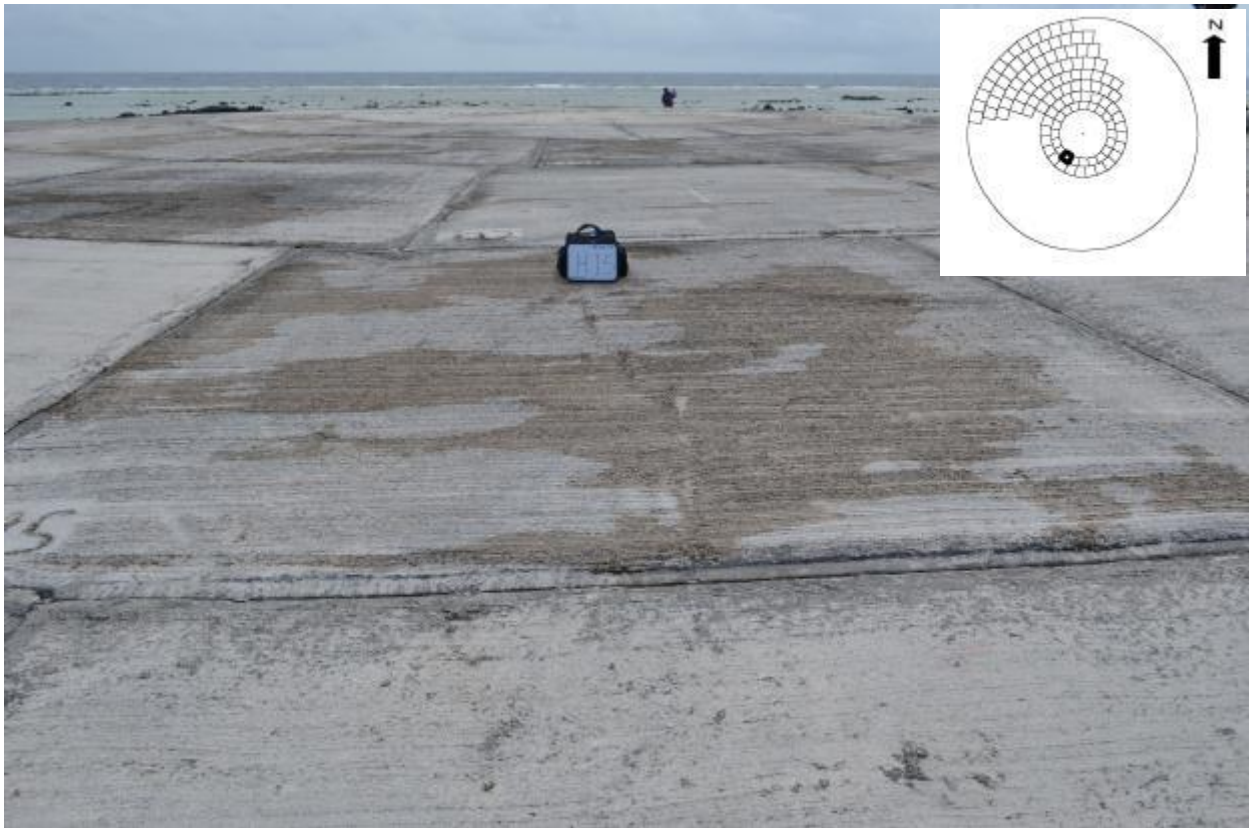
CAP SECTION LOCATION: Panel H15

No significant or obvious interior cracks or spall elements identified.

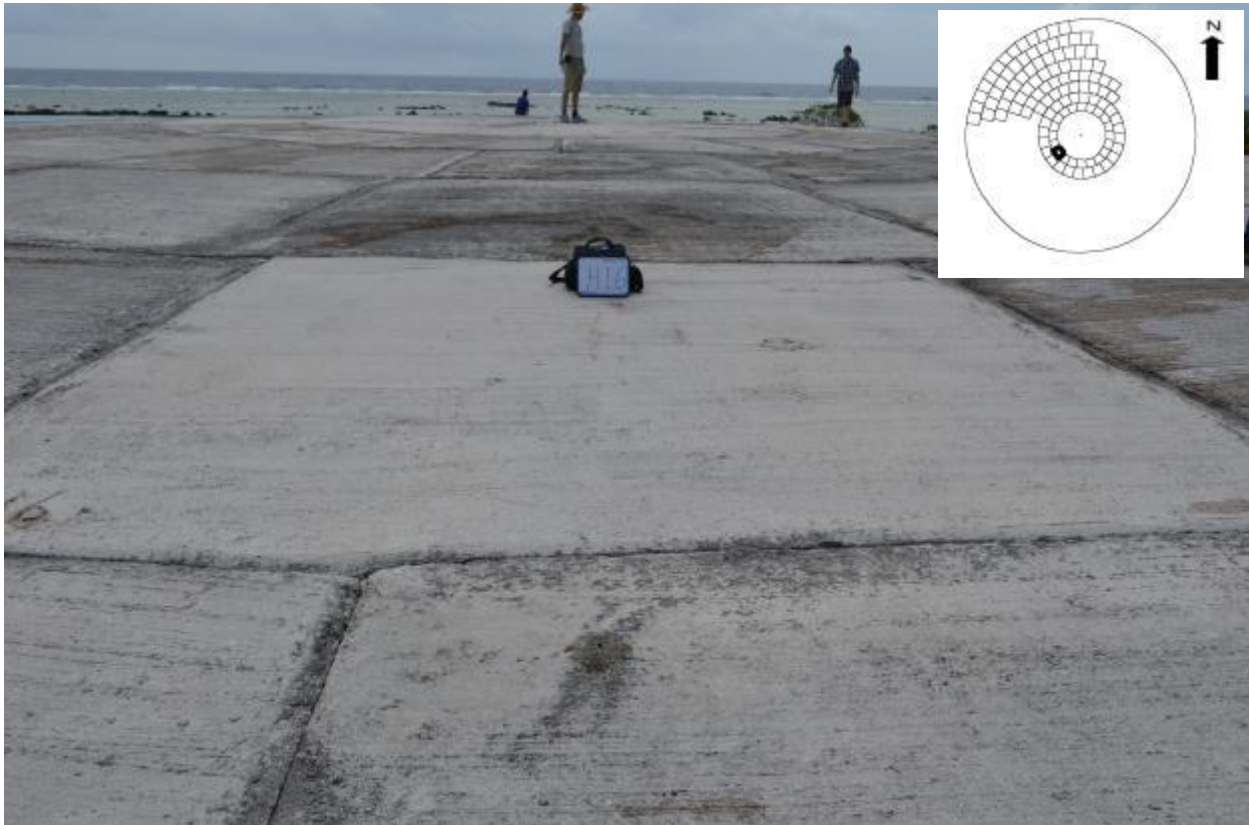
CAP SECTION LOCATION: Panel H16

No significant or obvious interior cracks or spall elements identified. Panel contains a filled concrete bore-hole (CD-7) from the 1980 NAS investigation.

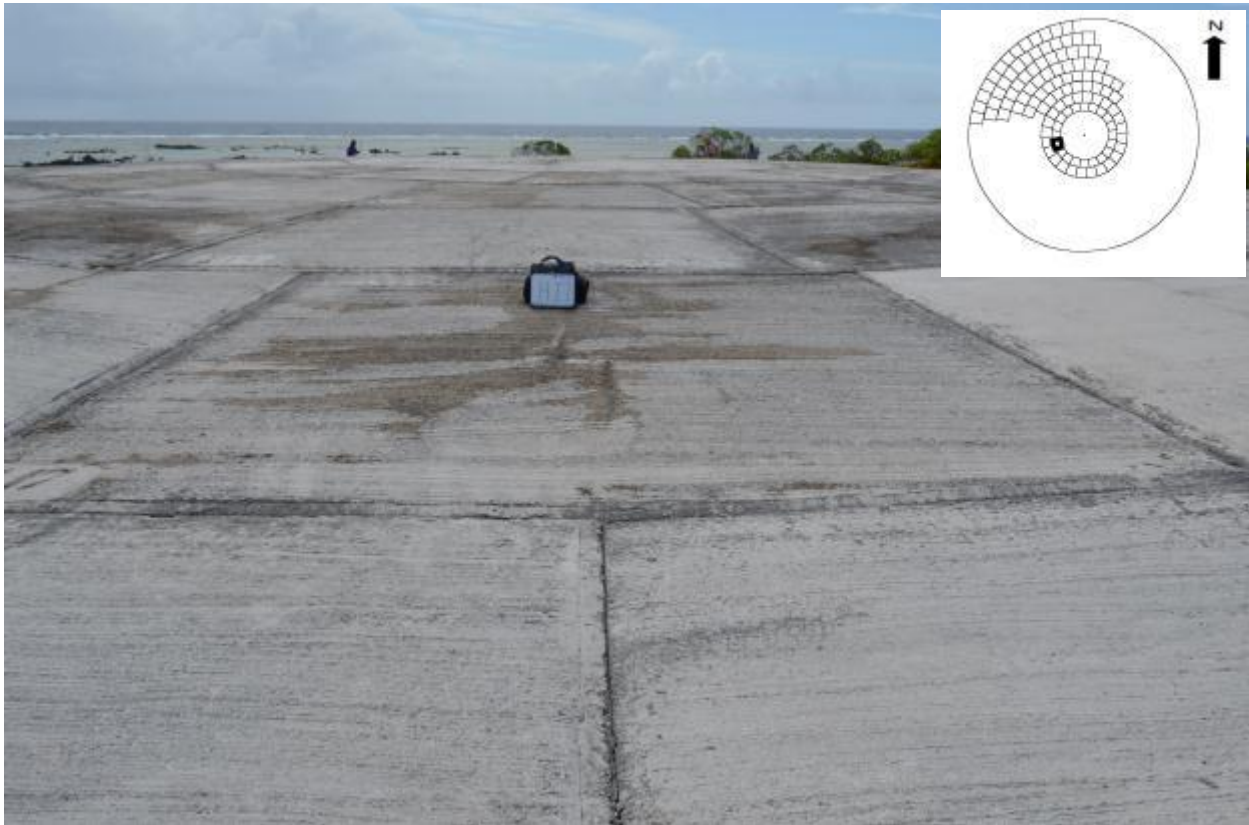
CAP SECTION LOCATION: Panel H17

No significant or obvious interior cracks or spall elements identified. Minor spalling/chipping of concrete in the upper right-hand corner.

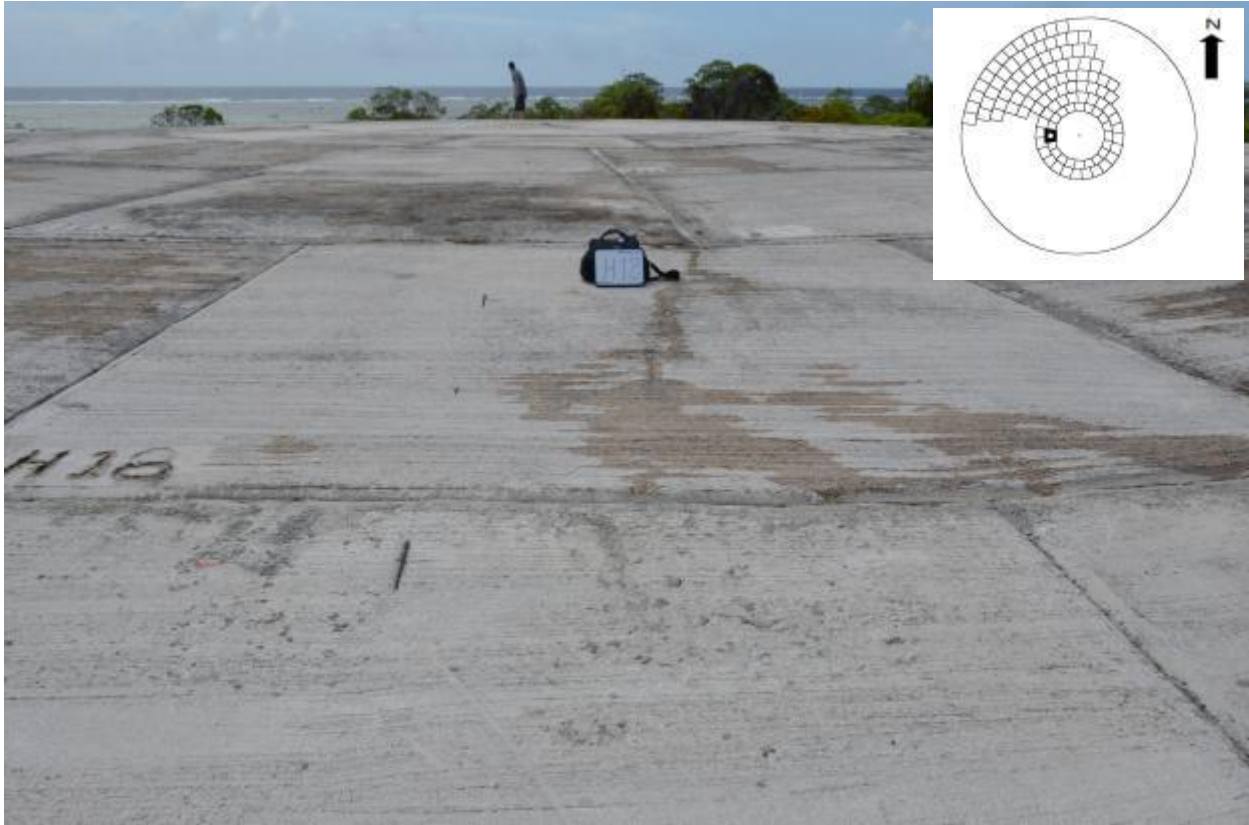
CAP SECTION LOCATION: Panel H18

No significant or obvious interior cracks or spall elements identified.

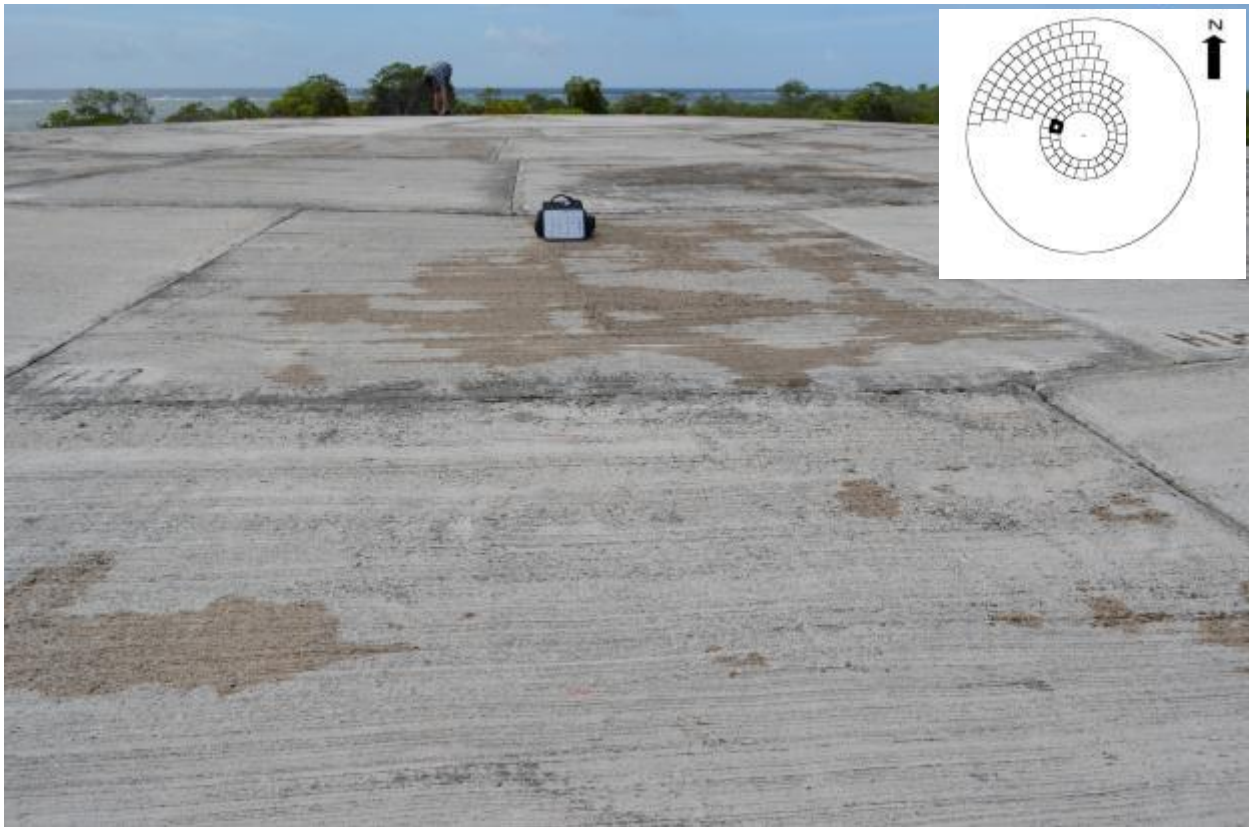
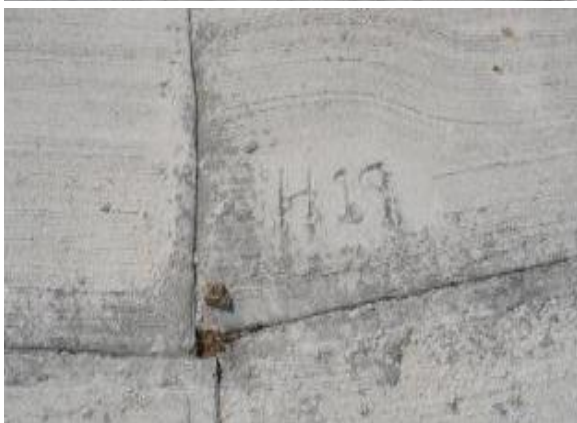
No significant or obvious interior cracks or spall elements identified. Minor spalling/chipping of concrete in the top and bottom left-hand corners of the panel.

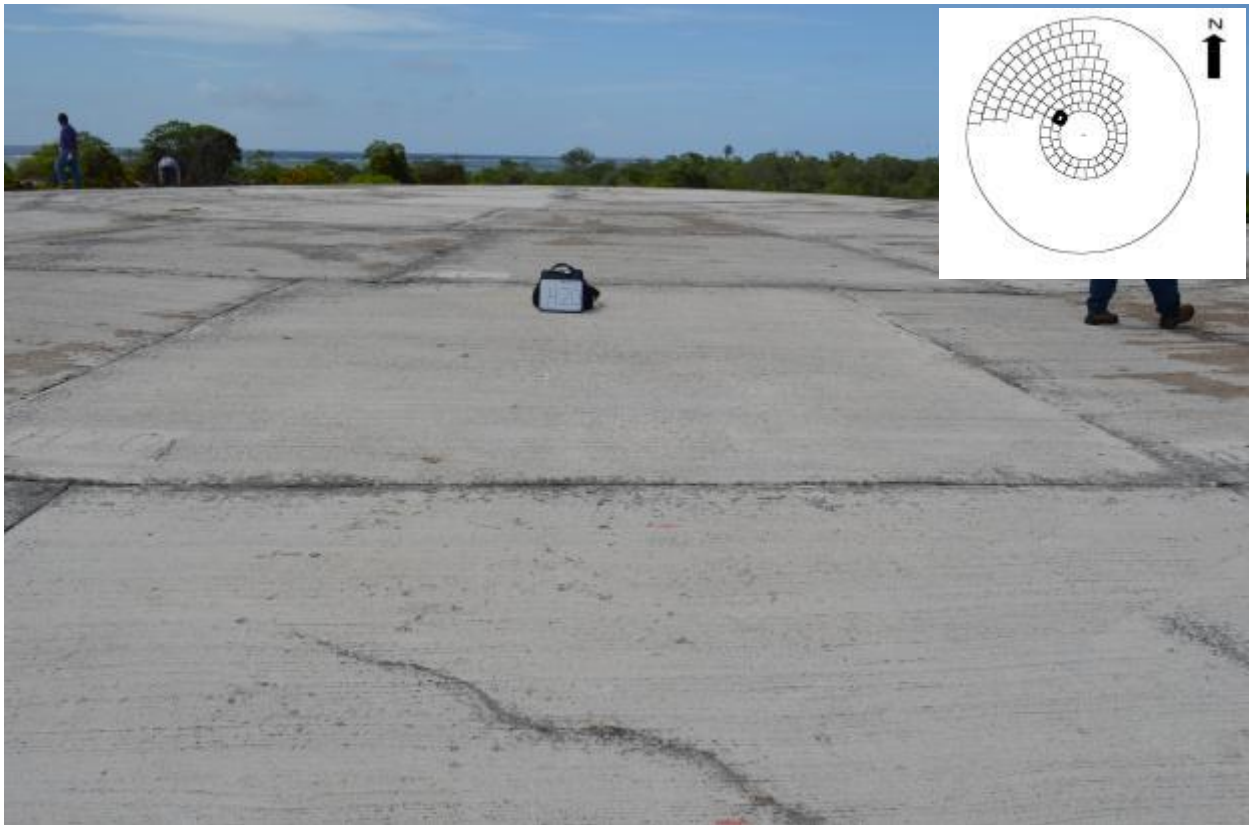
CAP SECTION LOCATION: Panel H20

No significant or obvious interior cracks or spall elements identified.

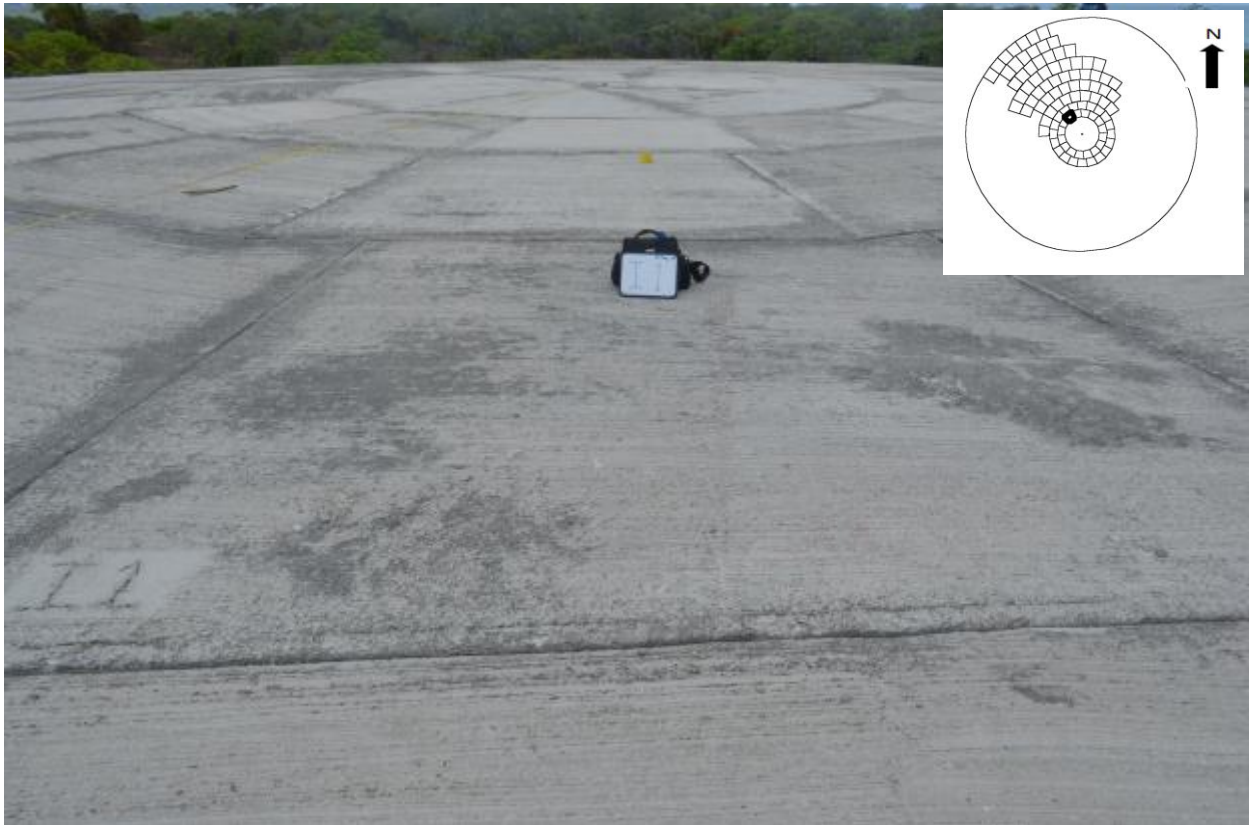
CAP SECTION LOCATION: Panel I1

No significant or obvious interior cracks or spall elements identified with exception of very minor spalling/chipping of concrete along the right side of the upper seam or panel joint.

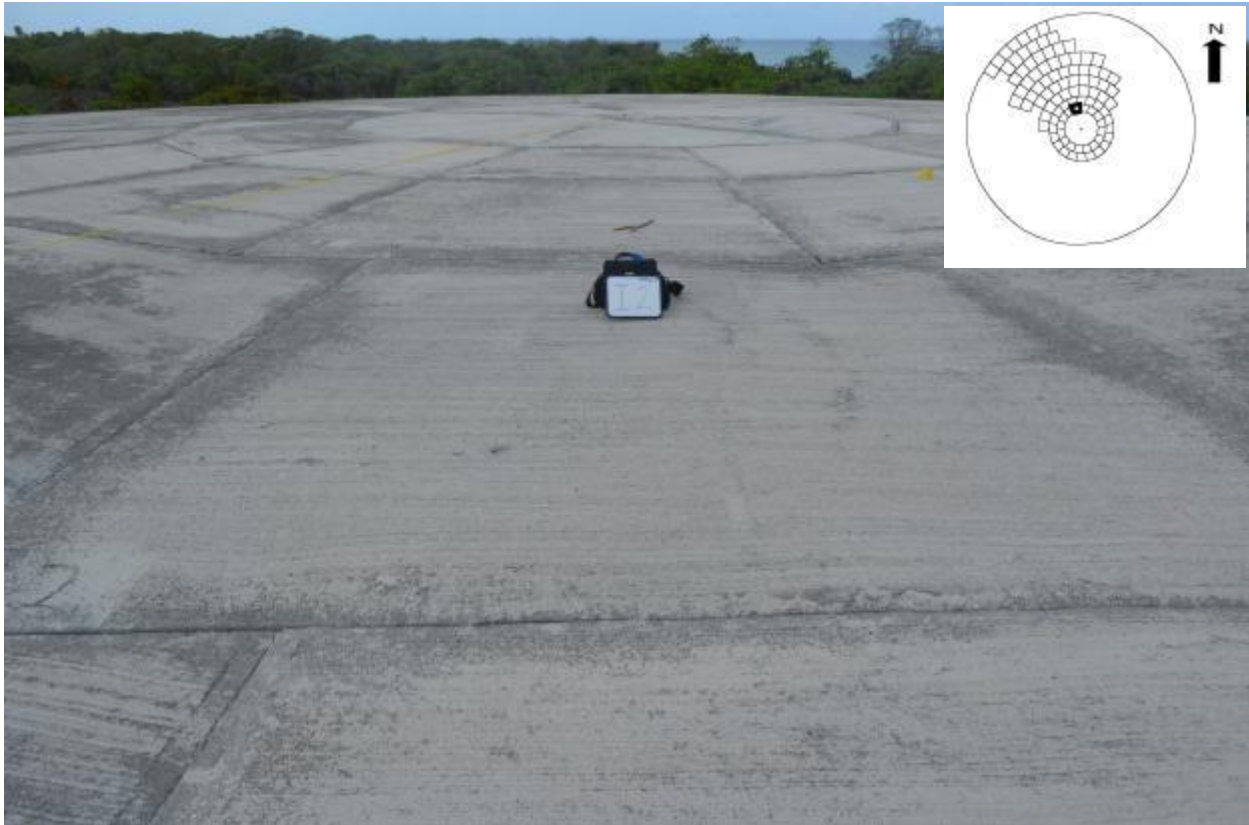
CAP SECTION LOCATION: Panel I2

No significant or obvious interior cracks or spall elements identified.

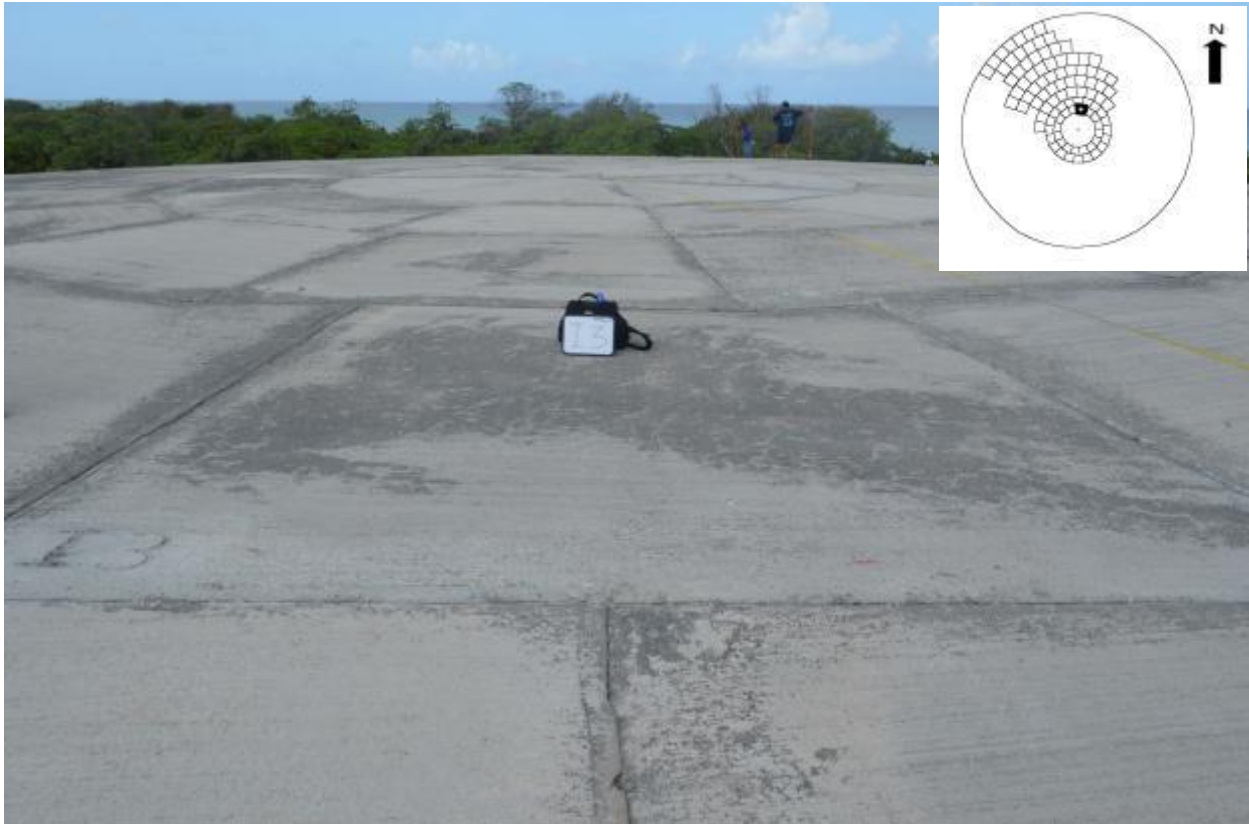
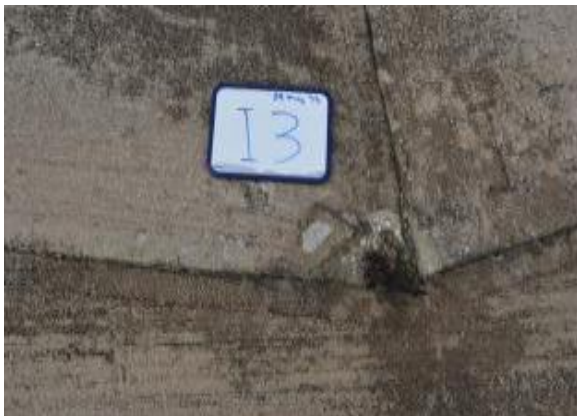
CAP SECTION LOCATION: Panel I3

No significant or obvious interior cracks or spall elements identified with exception of spalling/chipping of concrete in the bottom right-hand corner of the panel.

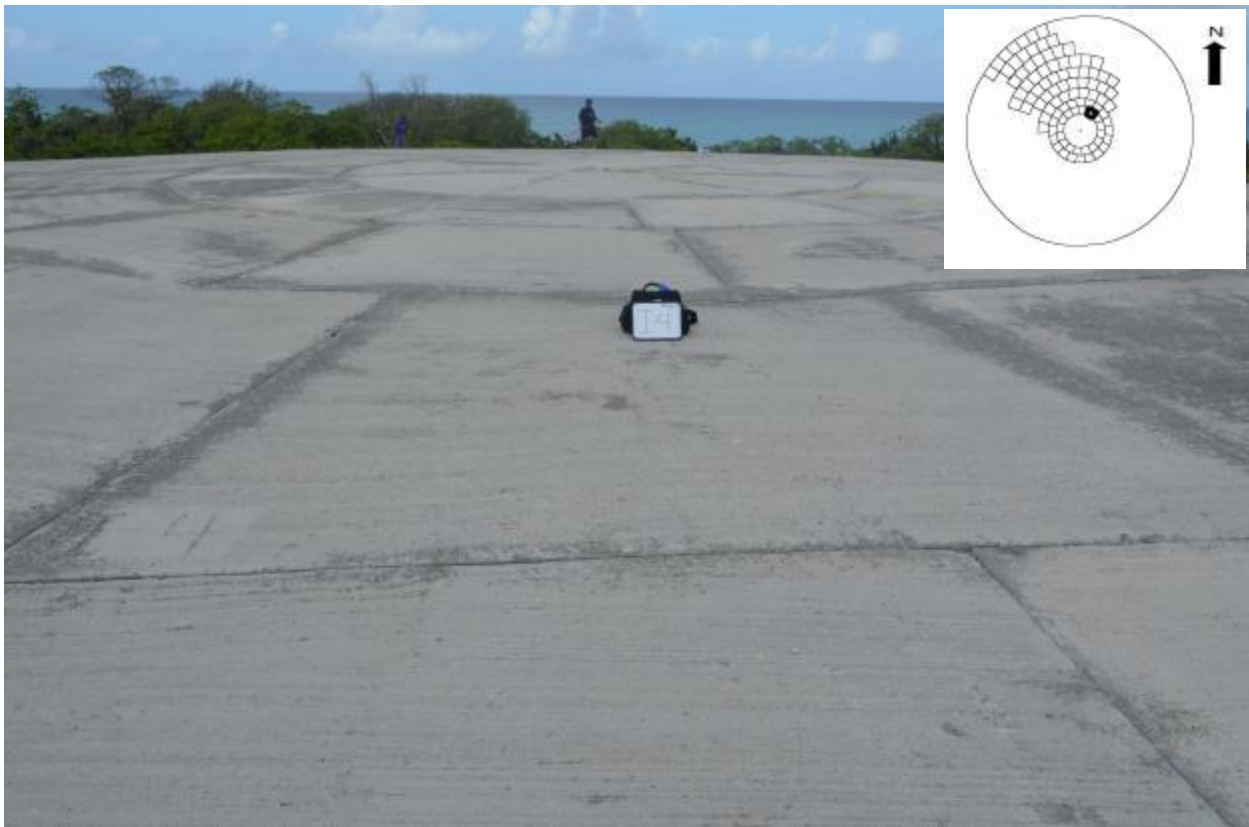
CAP SECTION LOCATION: Panel I4

No significant or obvious interior cracks or spall elements identified.

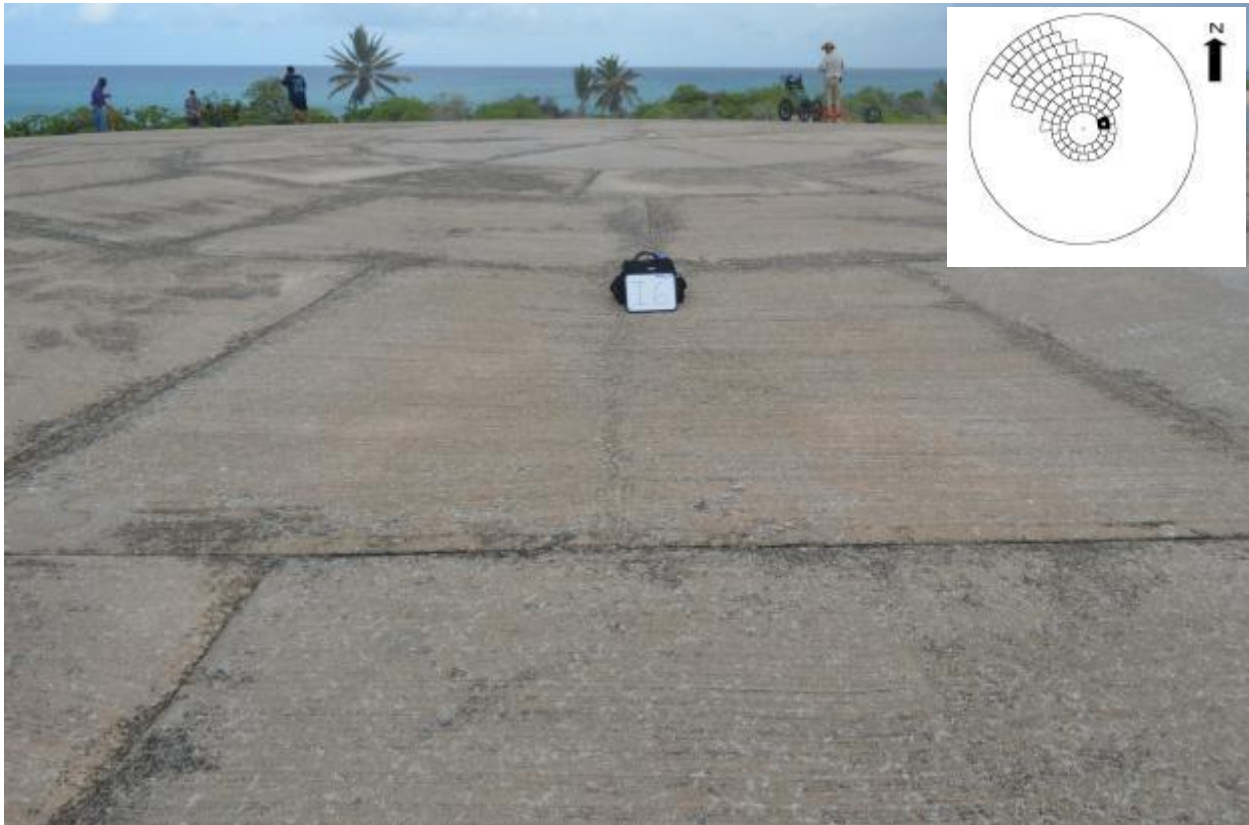
CAP SECTION LOCATION: Panel I6

No significant or obvious interior cracks or spall elements identified with exception of very minor spalling/chipping of concrete in the lower left-hand corner of the panel.
