LLNL-TR-648143

A Visual Description of the Concrete Exterior of the Cactus Crater Containment Structure

Terry Hamilton

October 2013

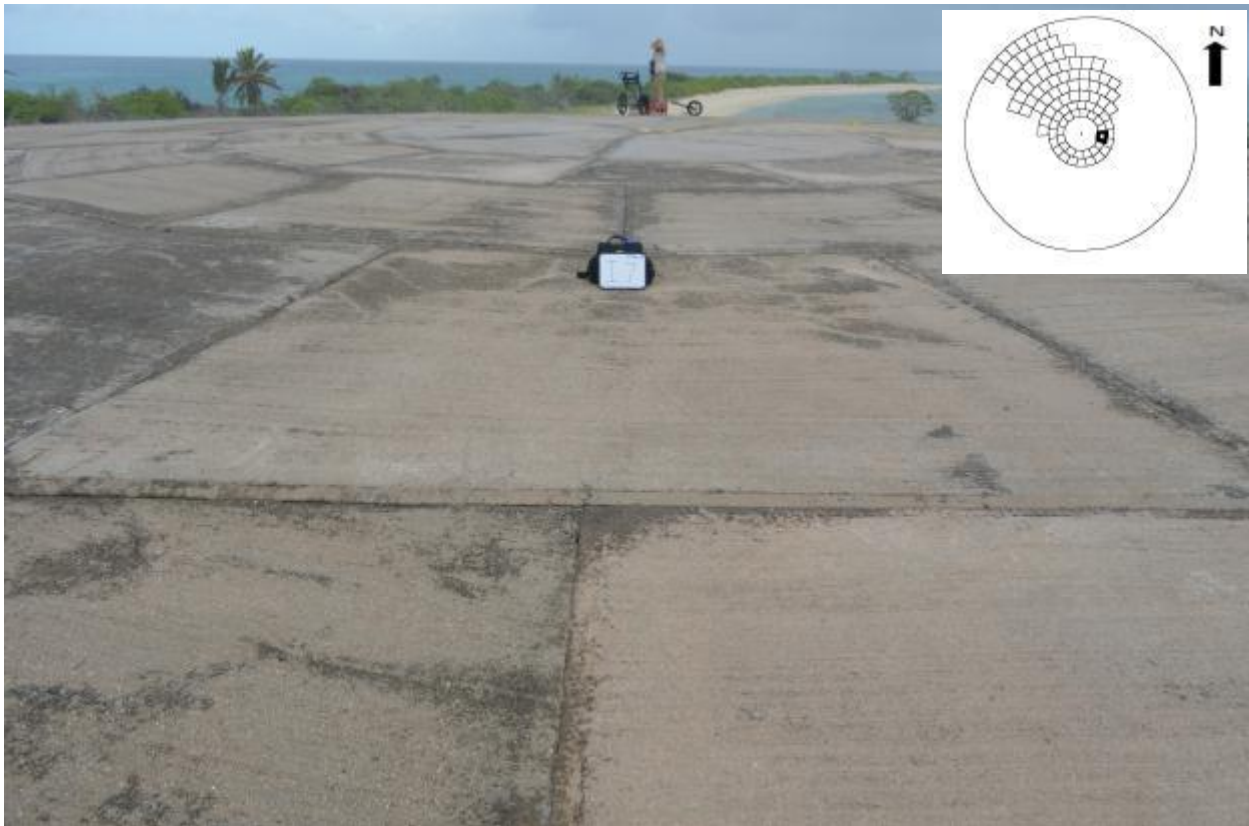
CAP SECTION LOCATION: Panel I7

No significant or obvious interior cracks or spall elements identified.

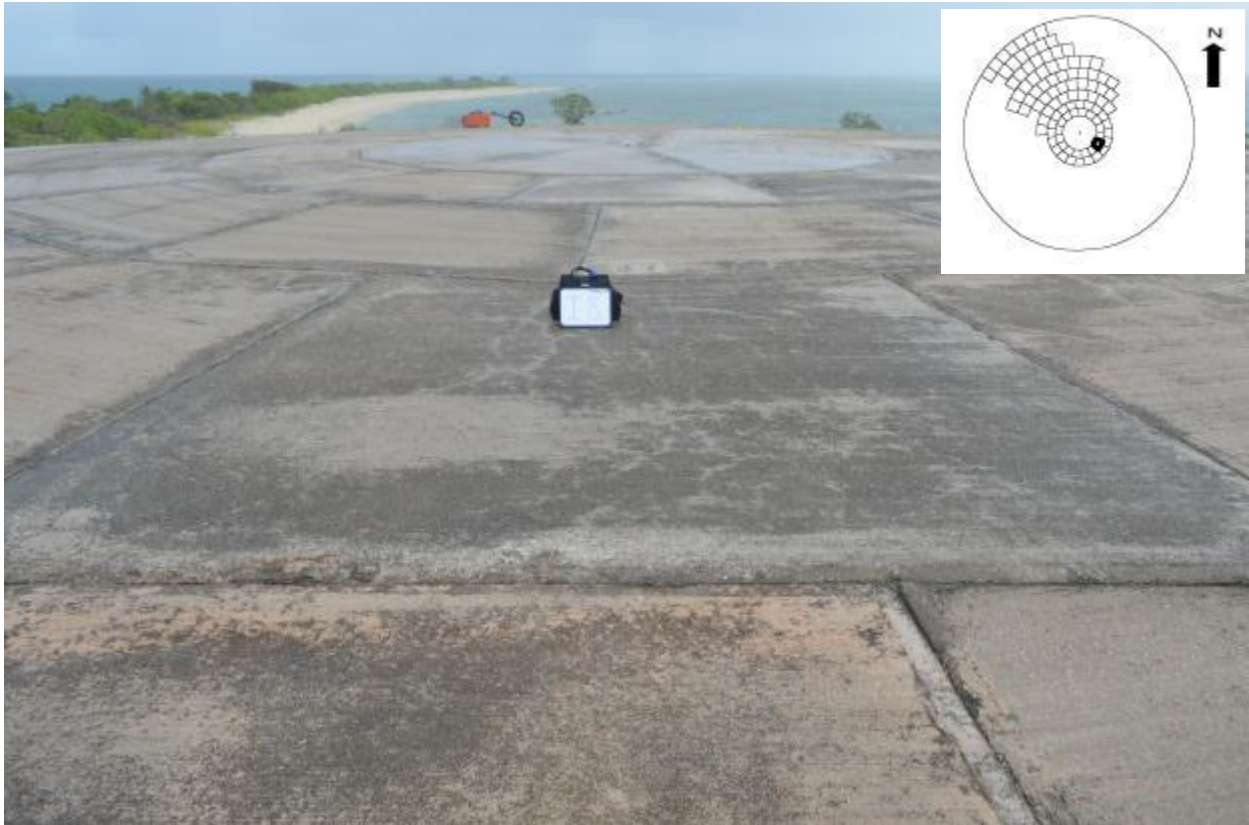
CAP SECTION LOCATION: Panel I8

No significant or obvious interior cracks or spall elements identified with exception of very minor spalling/chipping of concrete in the bottom left-hand corner of the panel.

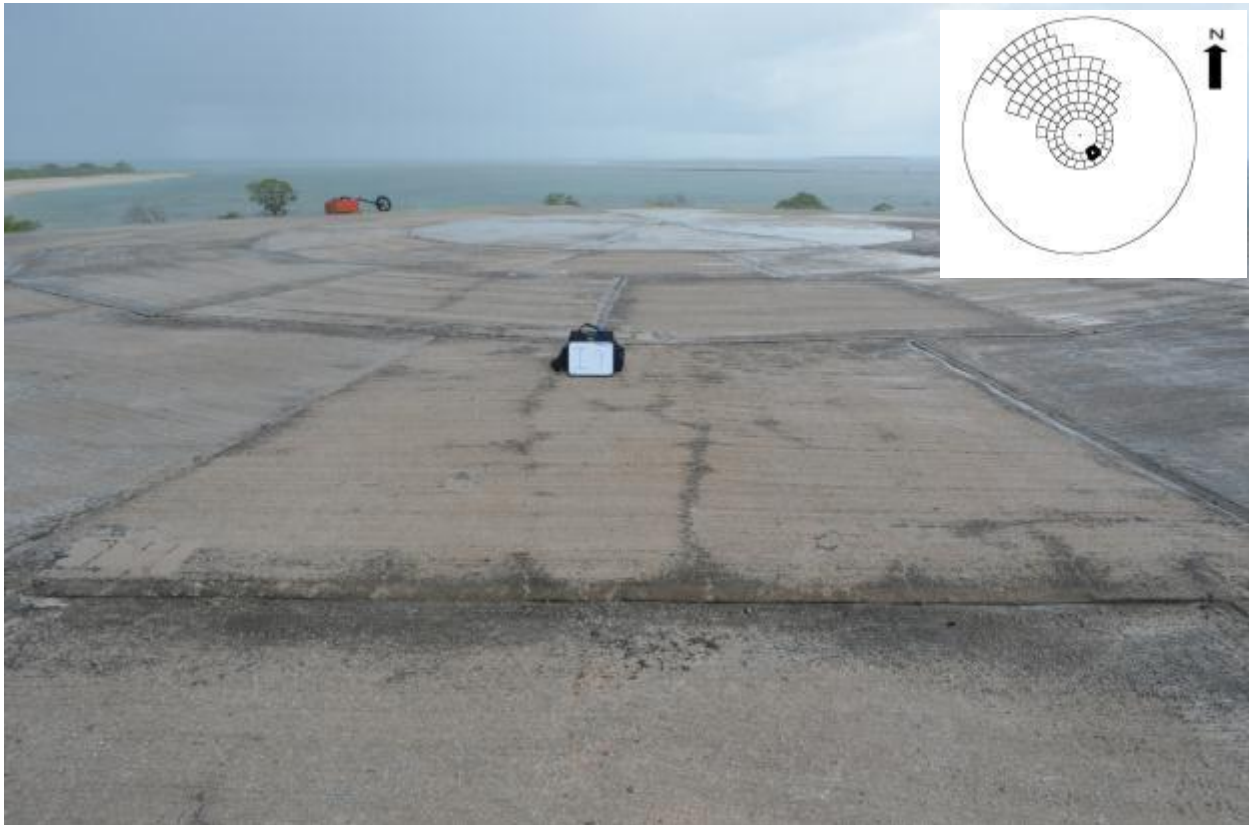
CAP SECTION LOCATION: Panel I9

No significant or obvious interior cracks or spall elements identified with exception of spalling/chipping of concrete in the bottom left-hand corner of the panel.

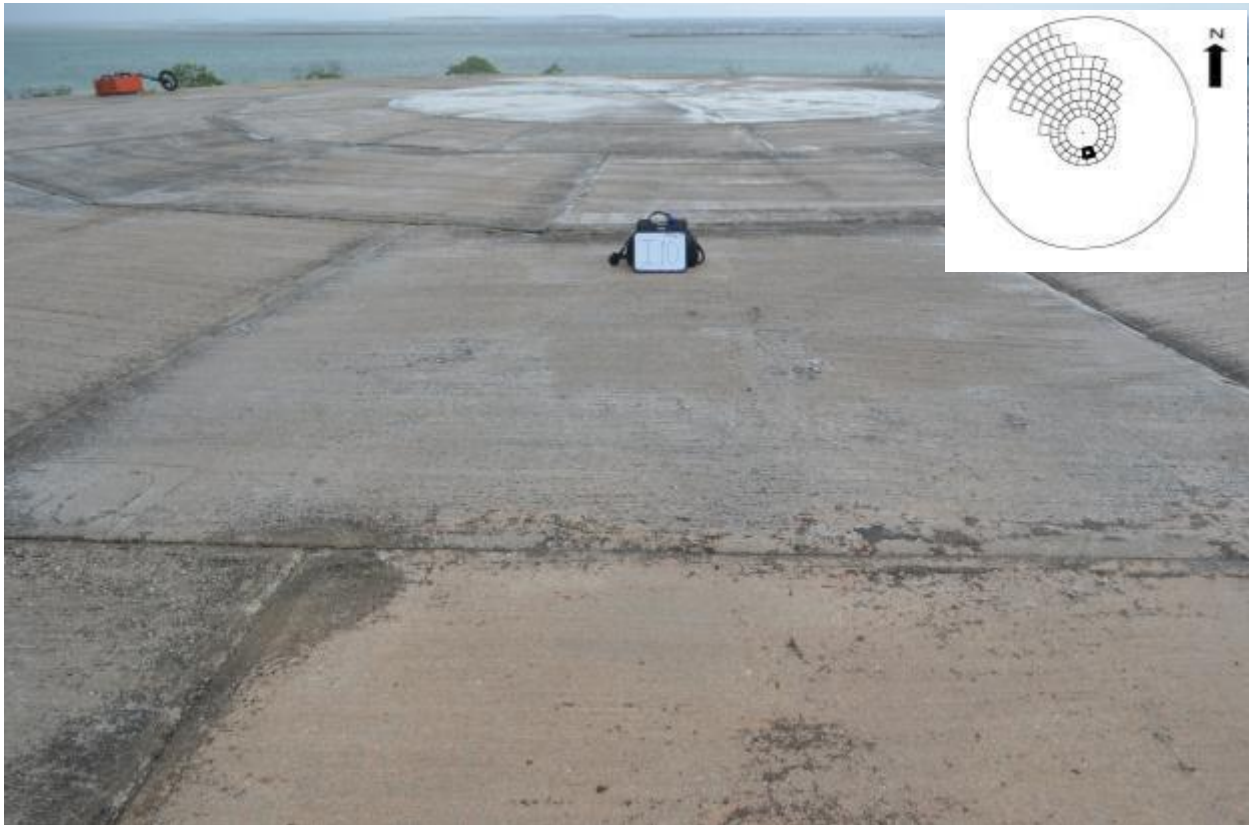
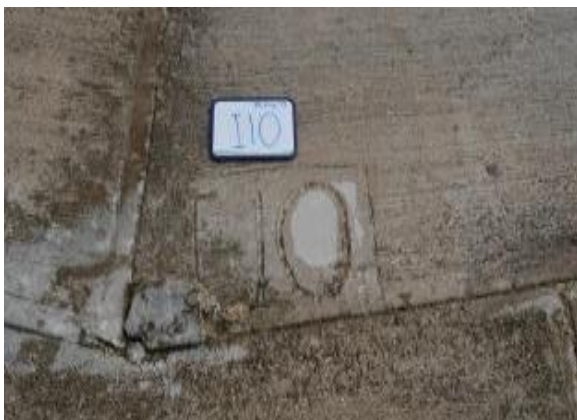
CAP SECTION LOCATION: Panel I10

No significant or obvious interior cracks or spall elements identified with exception of spalling/chipping of concrete in the bottom left-hand corner of the panel.

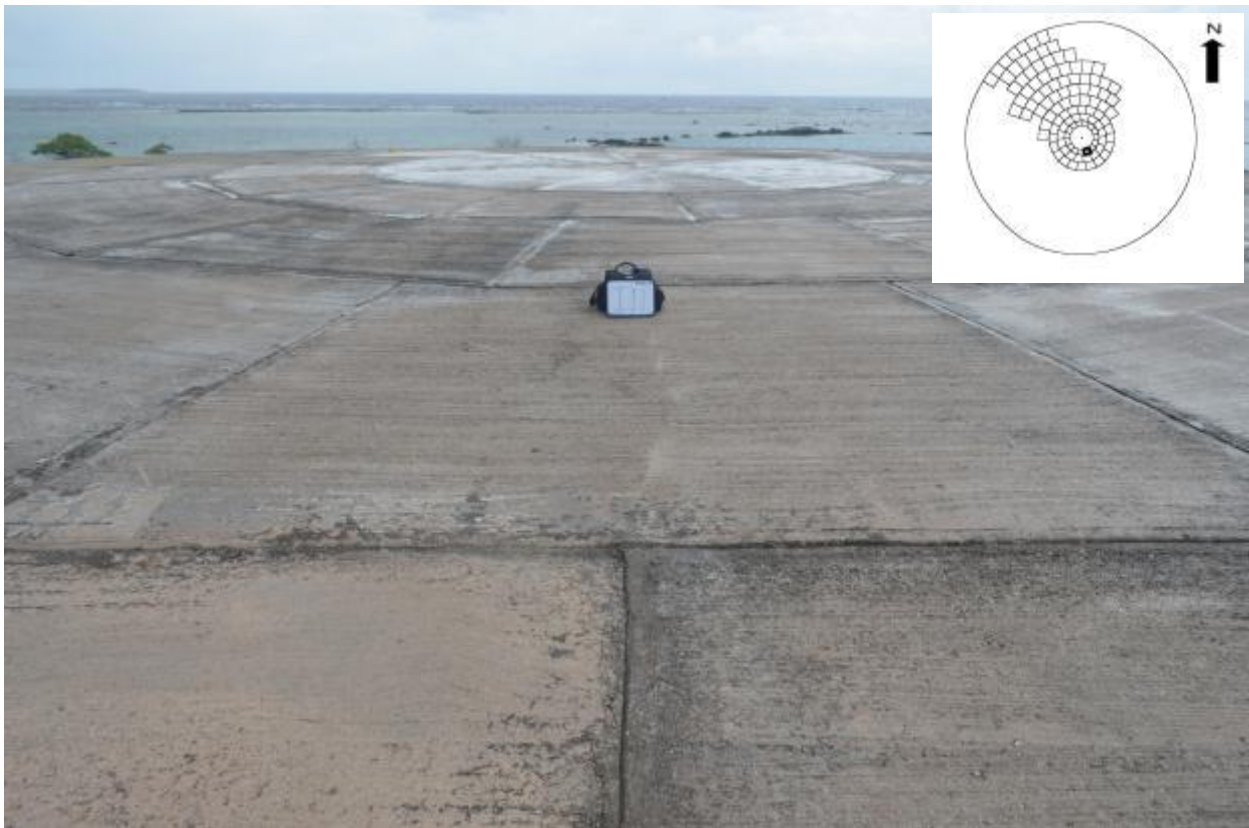
CAP SECTION LOCATION: Panel I11

No significant or obvious interior cracks or spall elements identified with exception of minor spalling/chipping of concrete in the bottom left-hand corner of the panel.

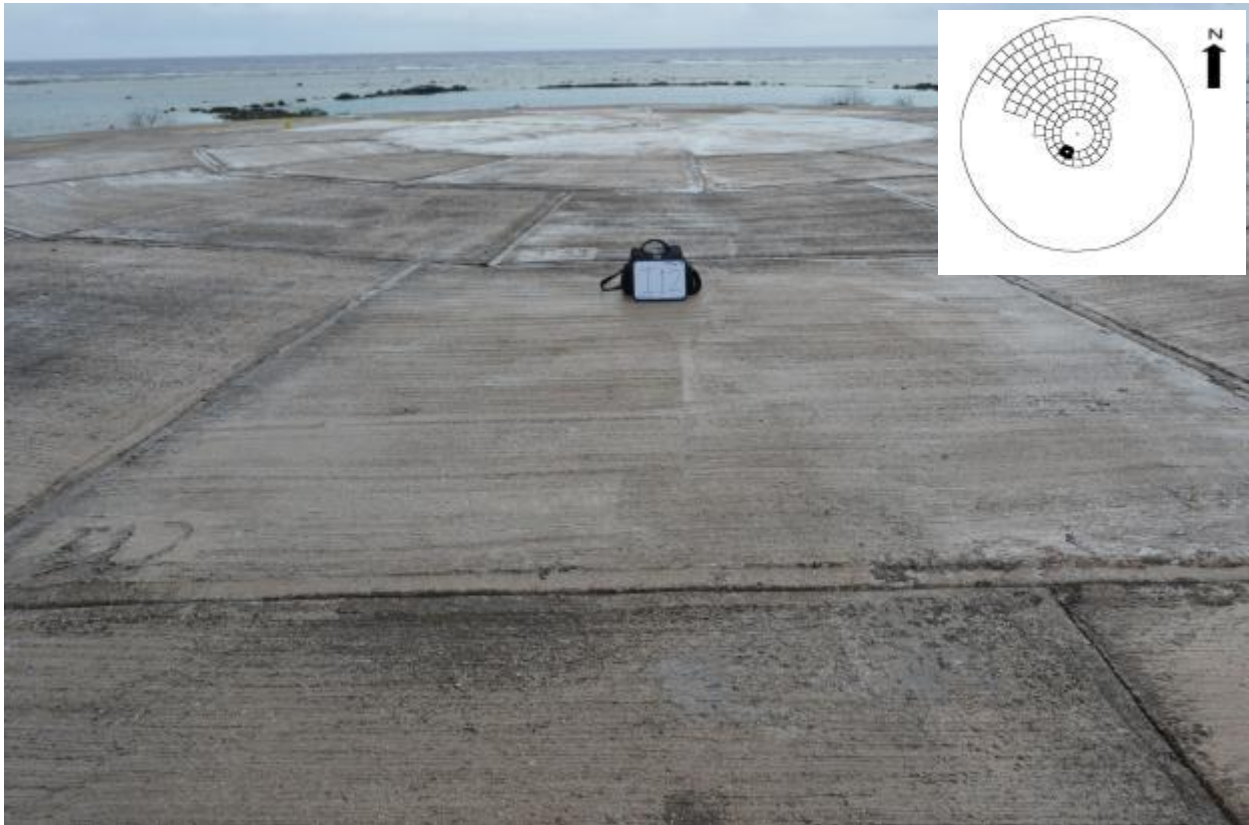
CAP SECTION LOCATION: Panel I12

No significant or obvious interior cracks or spall elements identified.

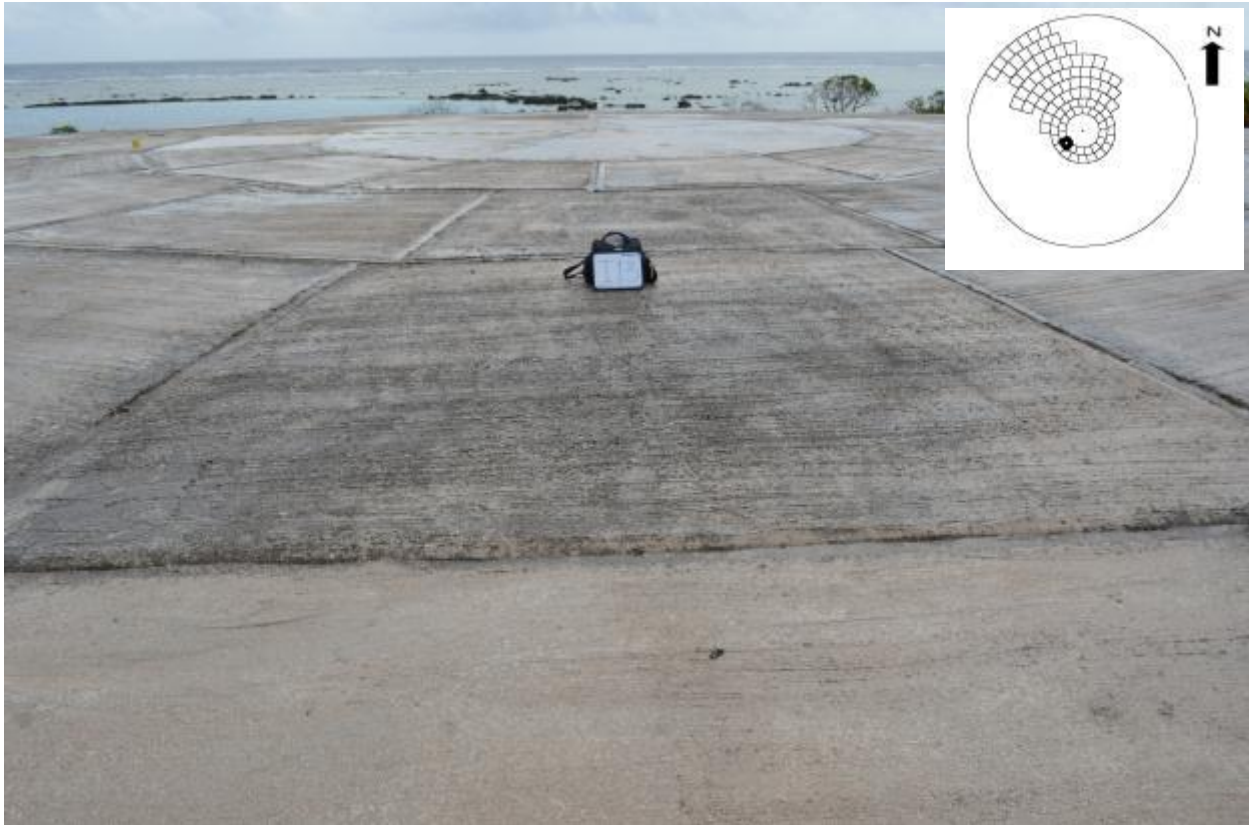
CAP SECTION LOCATION: Panel I13

No significant or obvious interior cracks or spall elements identified.

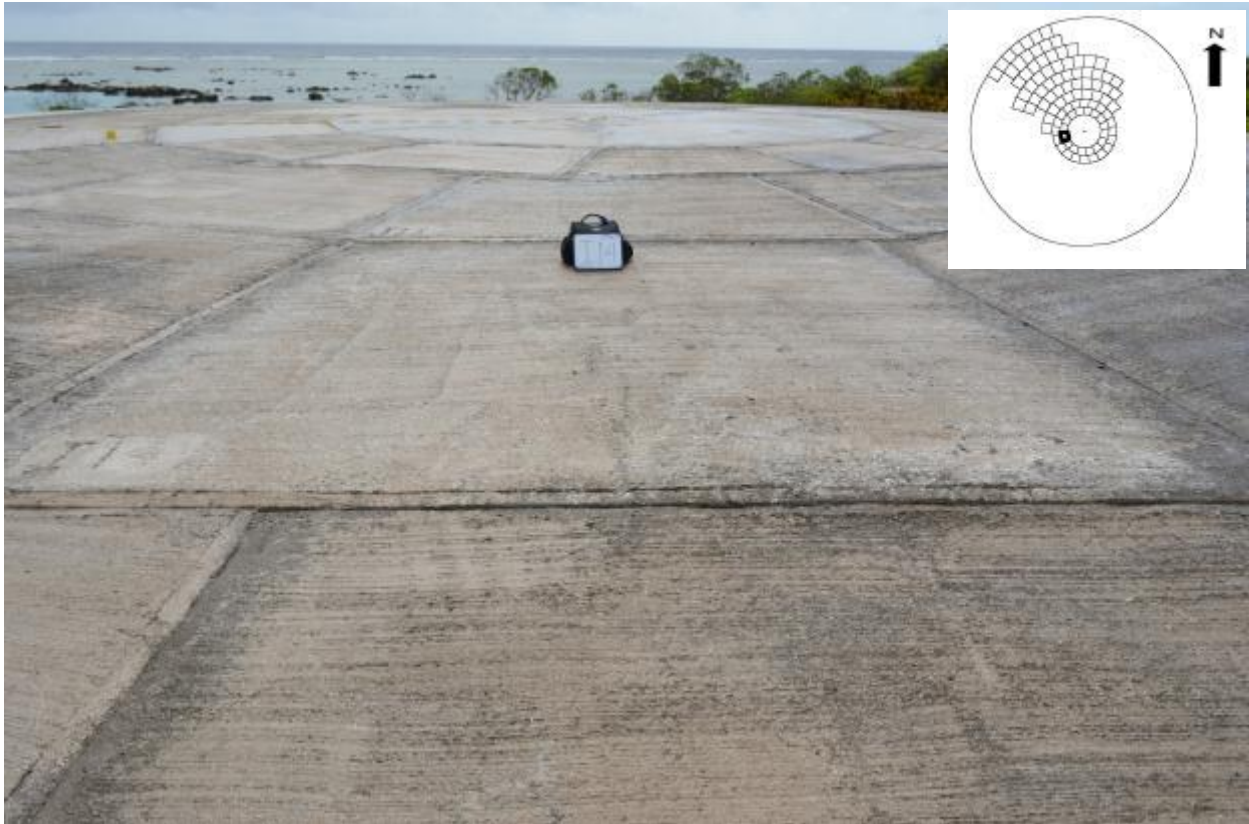
CAP SECTION LOCATION: Panel I14

No significant or obvious interior cracks or spall elements identified.

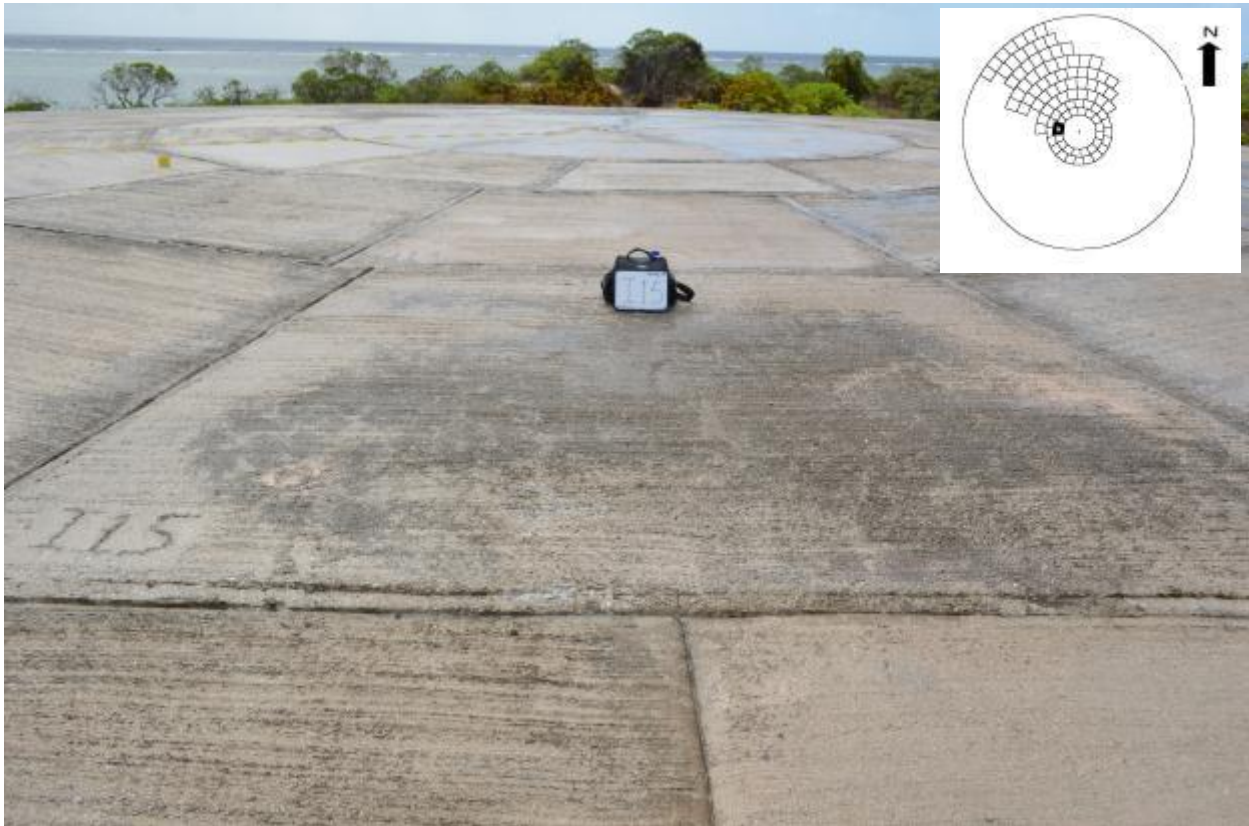
CAP SECTION LOCATION: Panel I15

No significant or obvious interior cracks or spall elements identified with exception of spalling/chipping of concrete in the left-hand corner of the panel. Panel contains a filled concrete bore-hole (CD-8) from the 1980 NAS investigation.

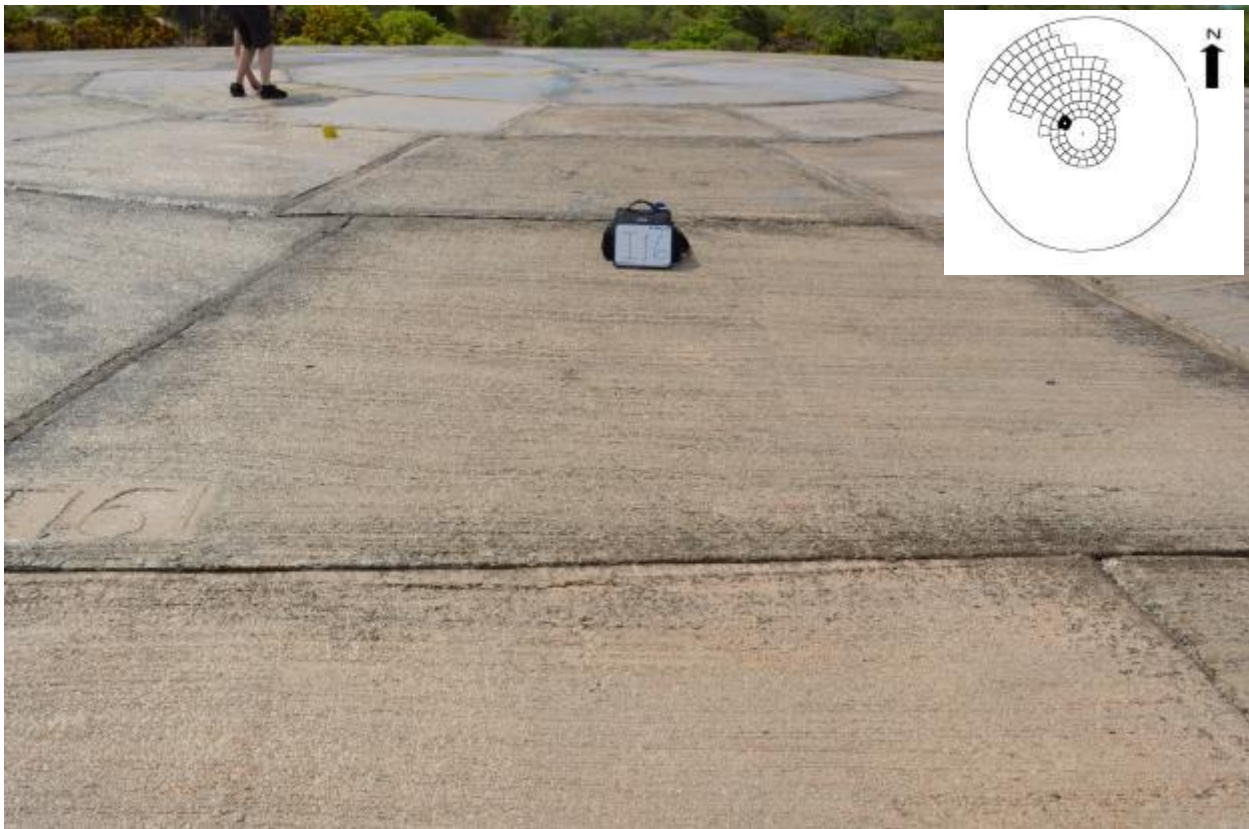
CAP SECTION LOCATION: Panel I16

No significant or obvious interior cracks or spall elements identified with exception of minor spalling/chipping of concrete in the left-hand corner of the panel.

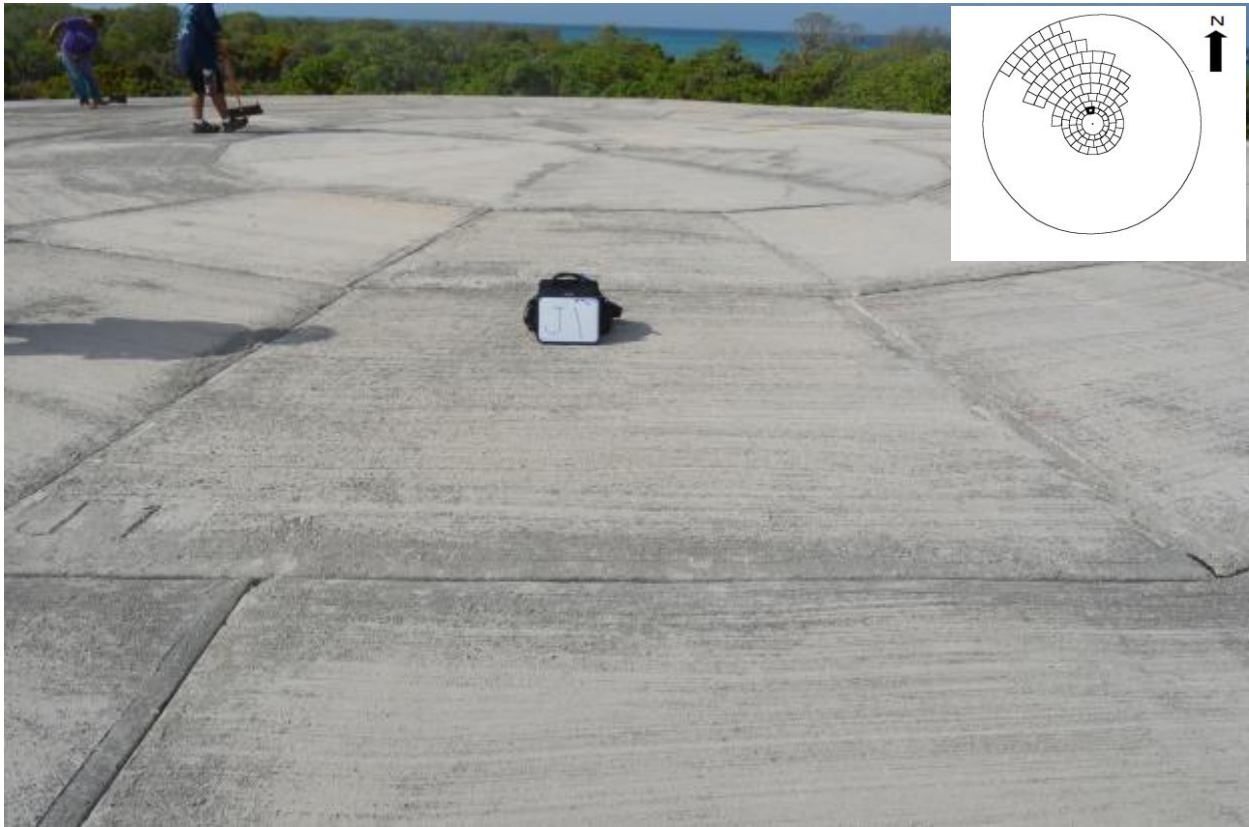
CAP SECTION LOCATION: Panel J1

No significant or obvious interior cracks or spall elements identified.

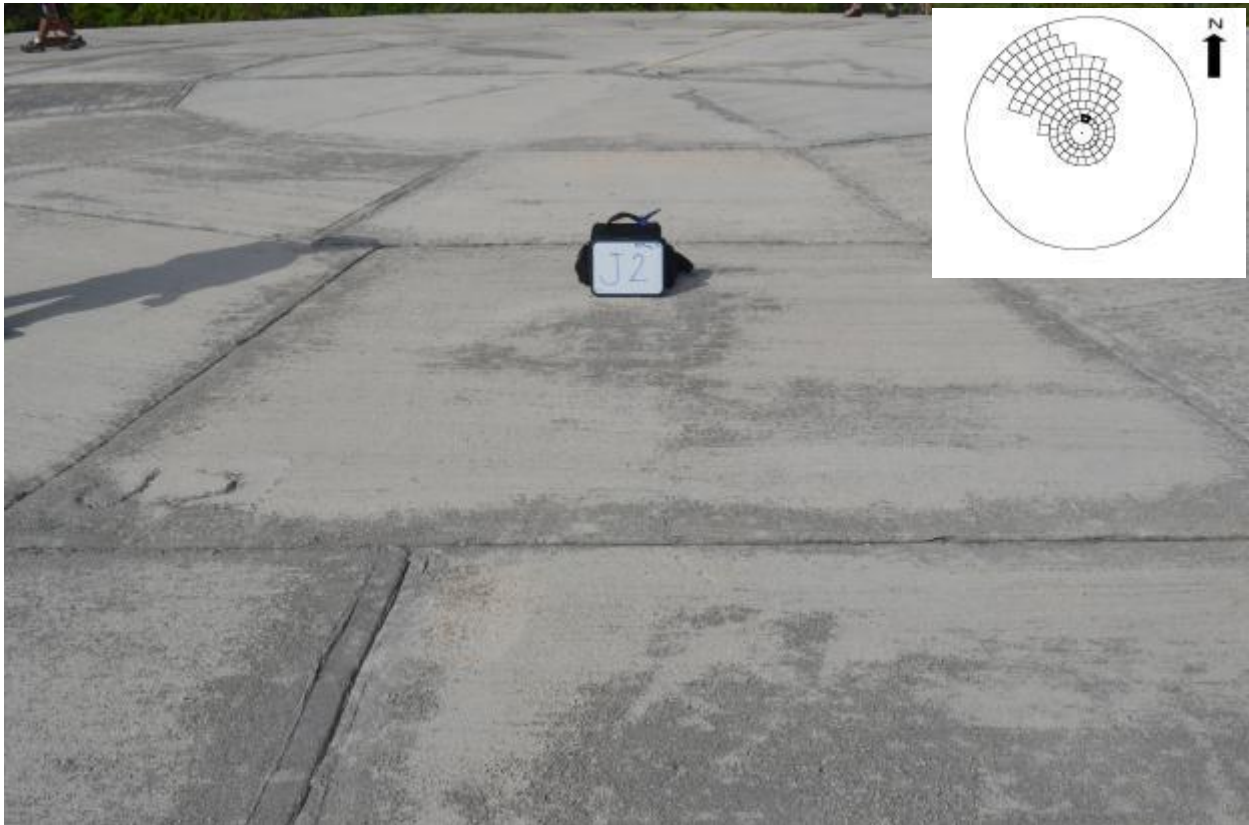
CAP SECTION LOCATION: Panel J2

No significant or obvious interior cracks or spall elements identified.

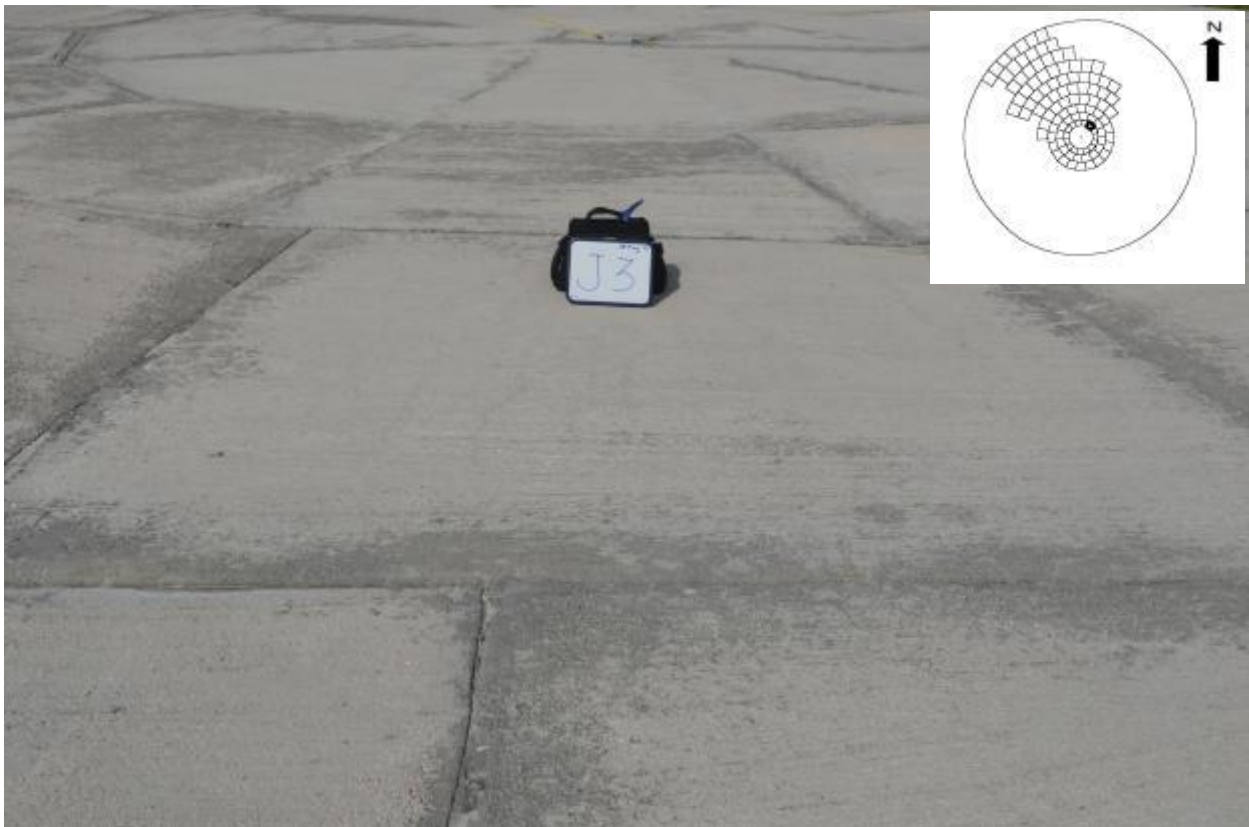
CAP SECTION LOCATION: Panel J3

No significant or obvious interior cracks or spall elements identified.

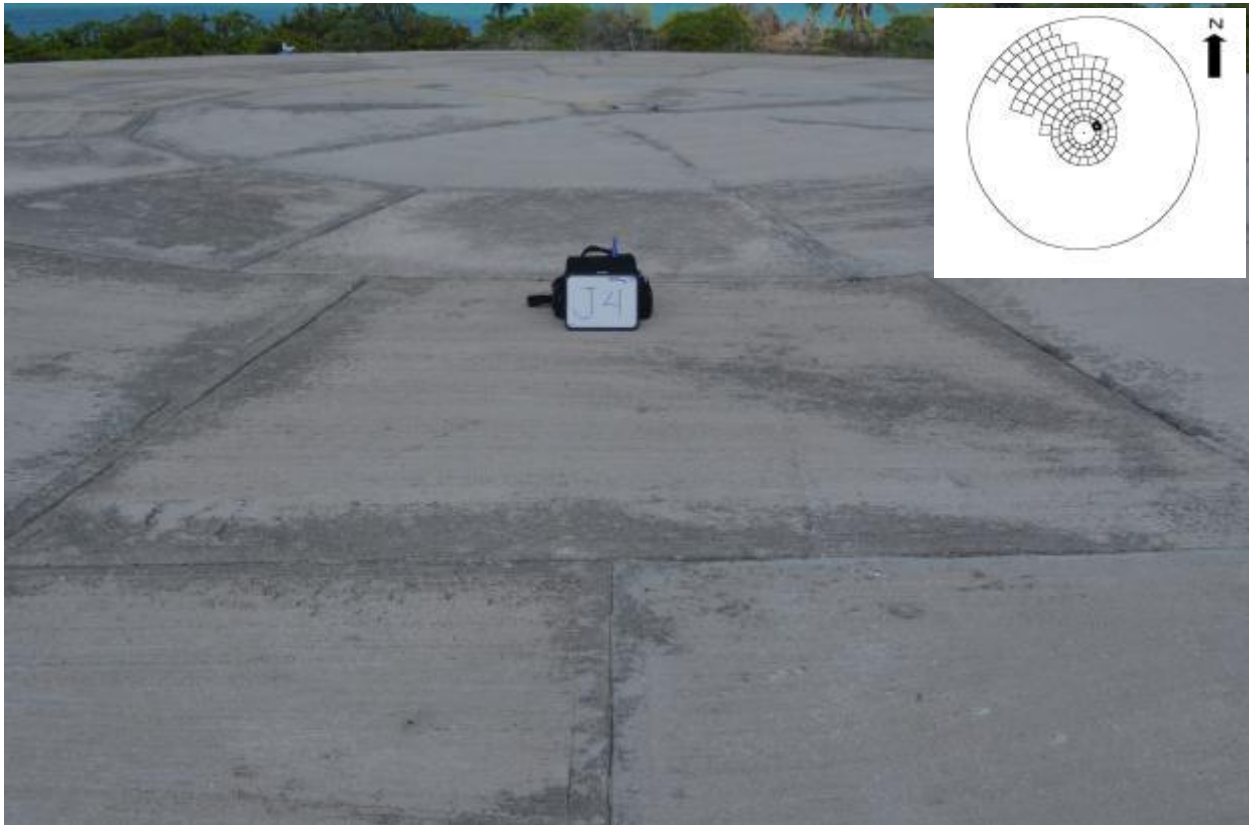
CAP SECTION LOCATION: Panel J4

No significant or obvious interior cracks or spall elements identified.

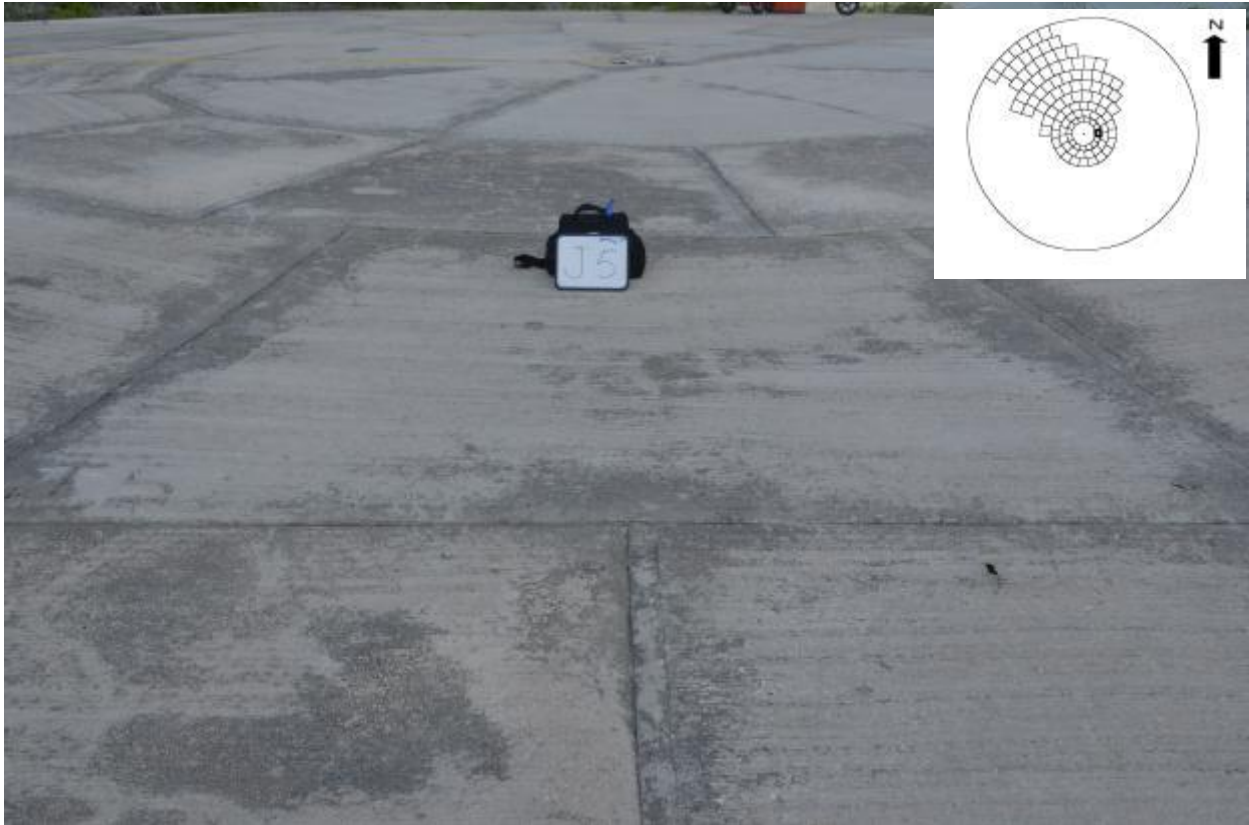
CAP SECTION LOCATION: Panel J5

No significant or obvious interior cracks or spall elements identified (no J6 panel present).

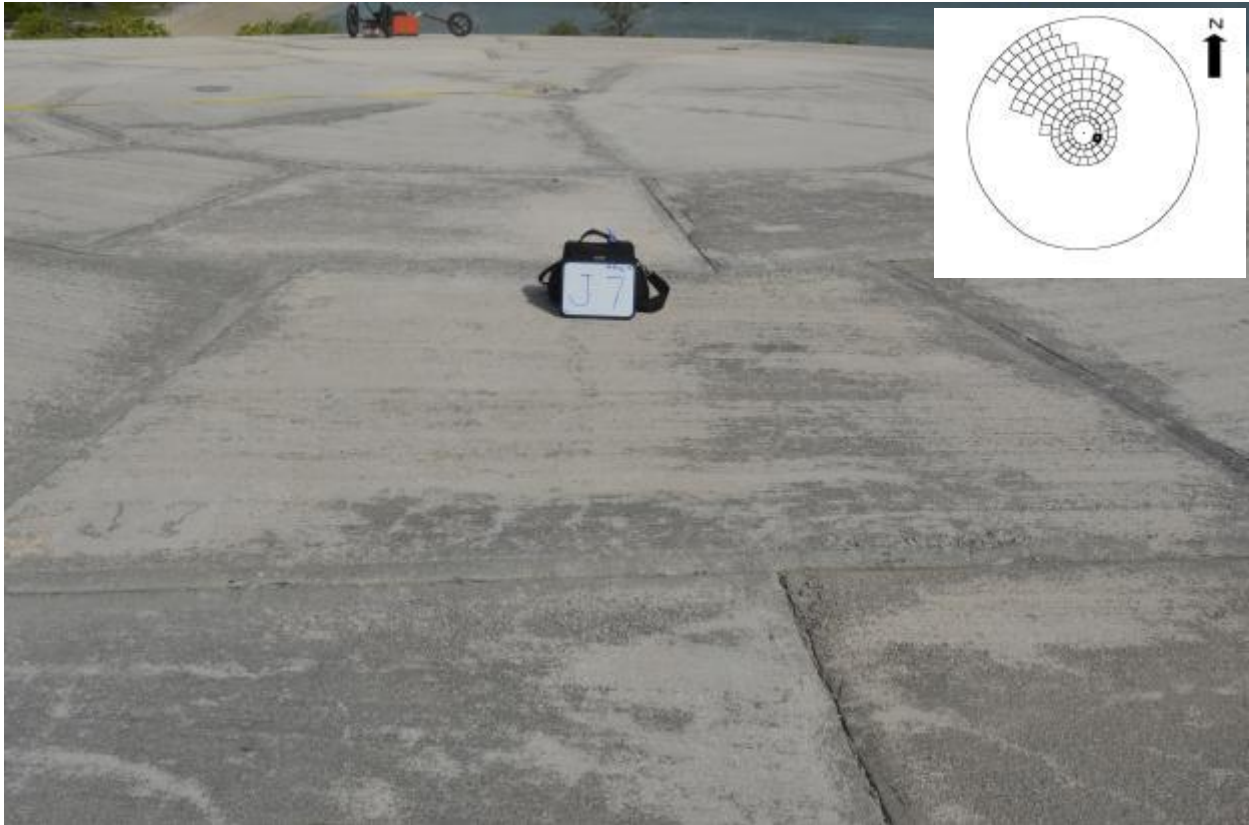
CAP SECTION LOCATION: Panel J7

No significant or obvious interior cracks or spall elements identified.

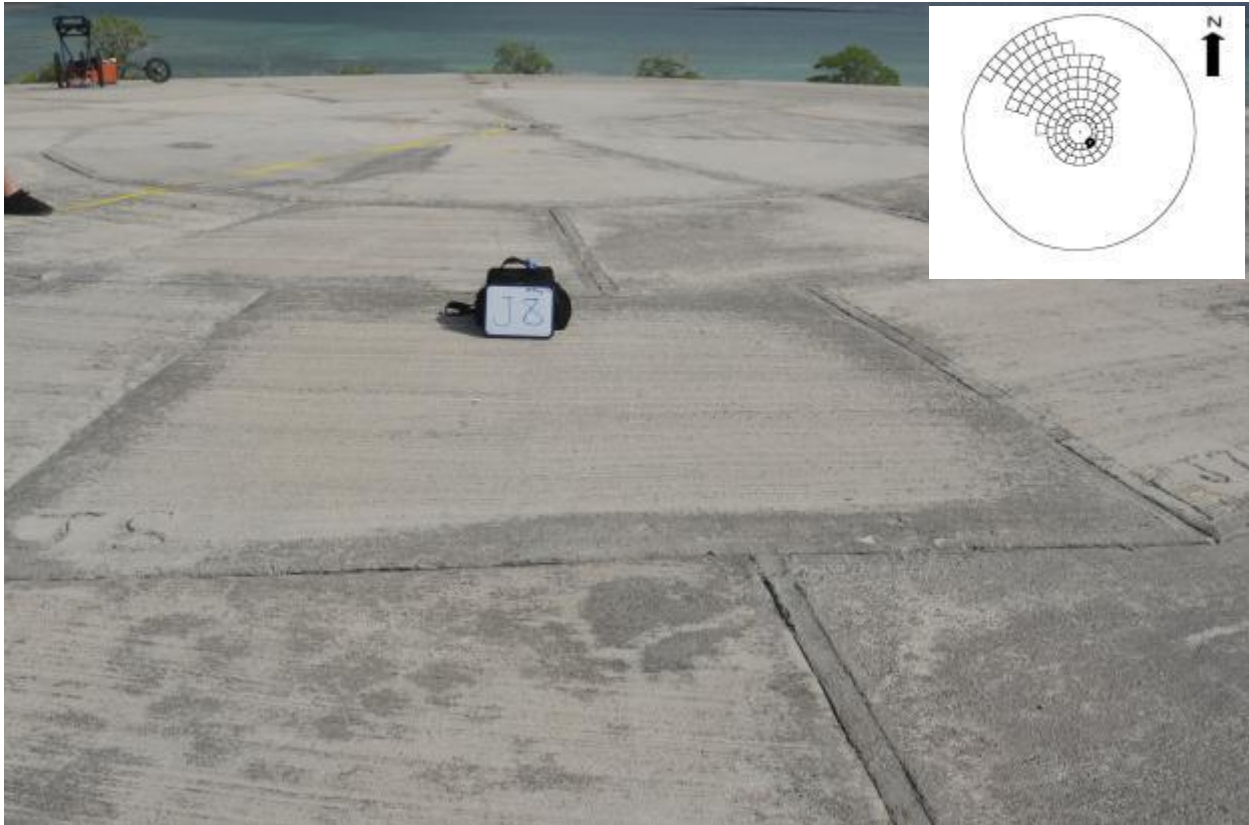
CAP SECTION LOCATION: Panel J8

No significant or obvious interior cracks or spall elements identified.

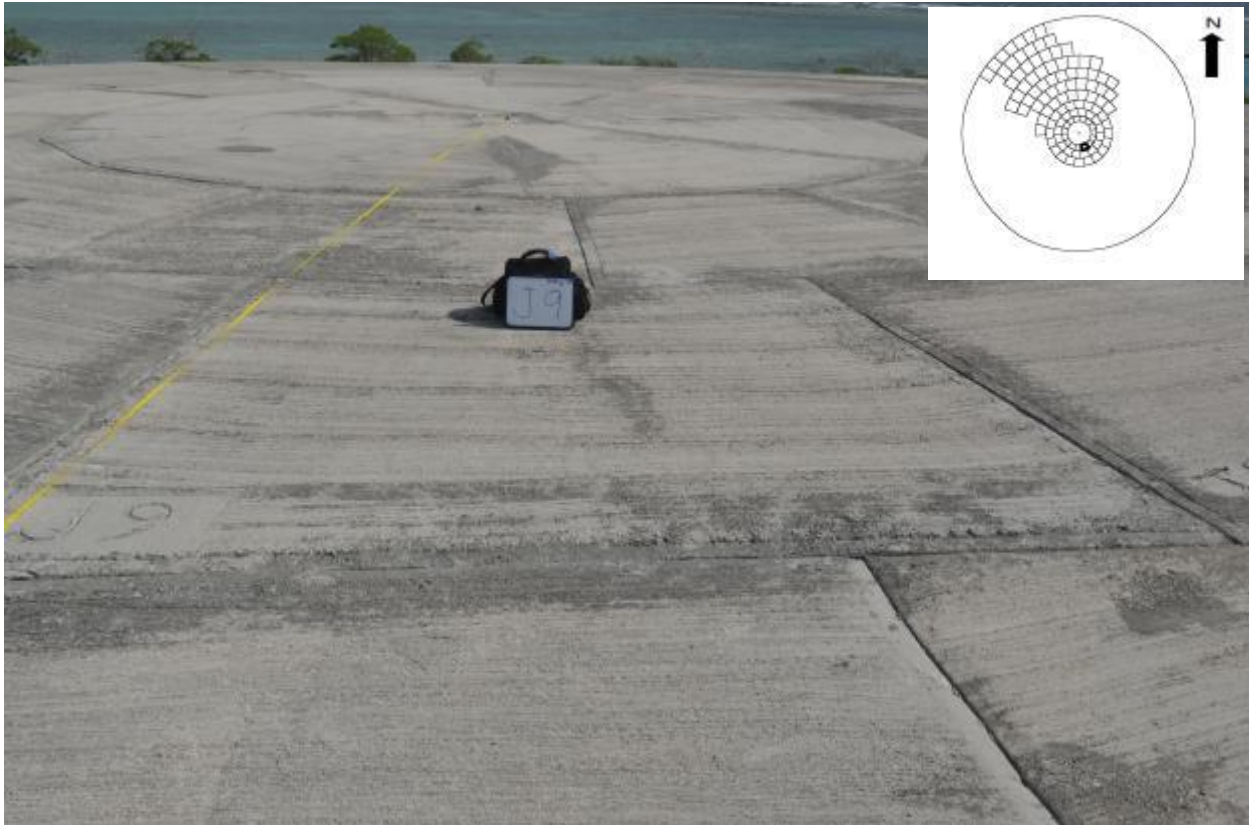
CAP SECTION LOCATION: Panel J9

No significant or obvious interior cracks or spall elements identified.

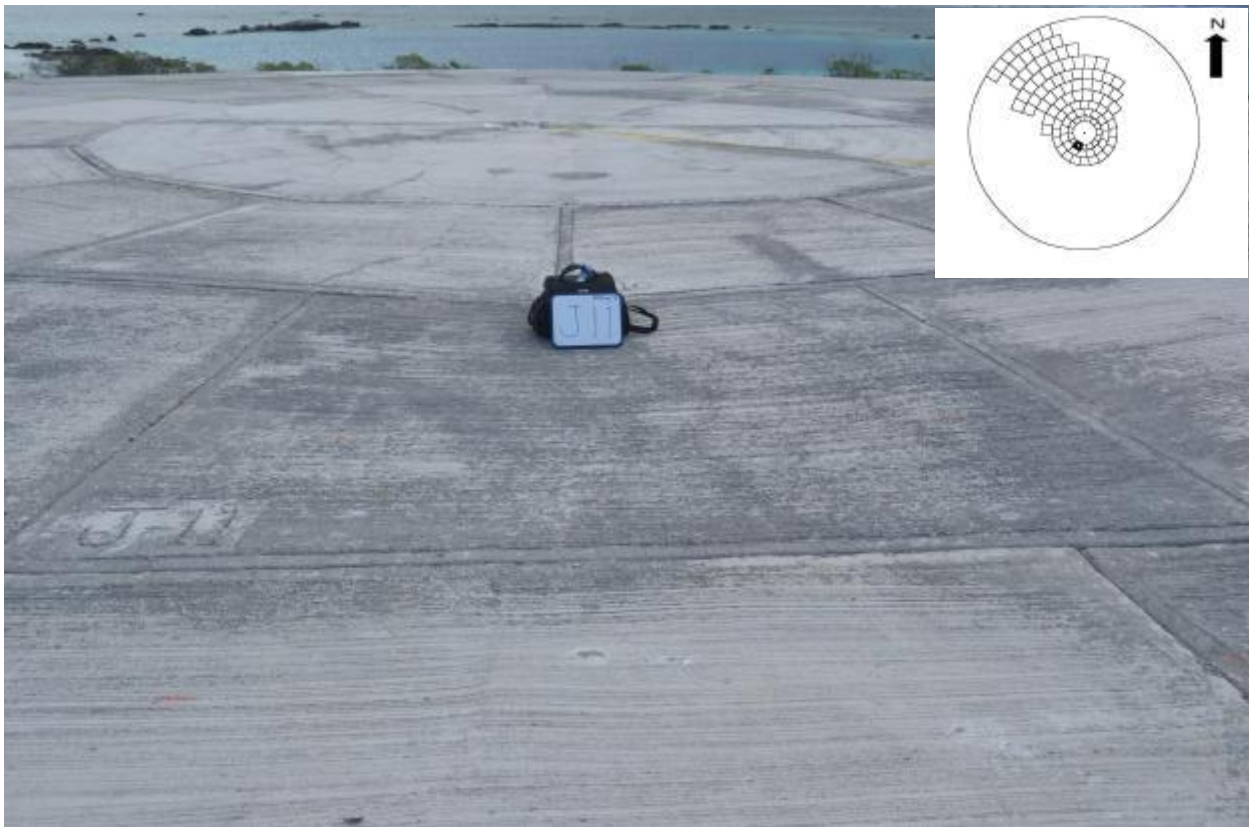
CAP SECTION LOCATION: Panel J11

No significant or obvious interior cracks or spall elements identified.

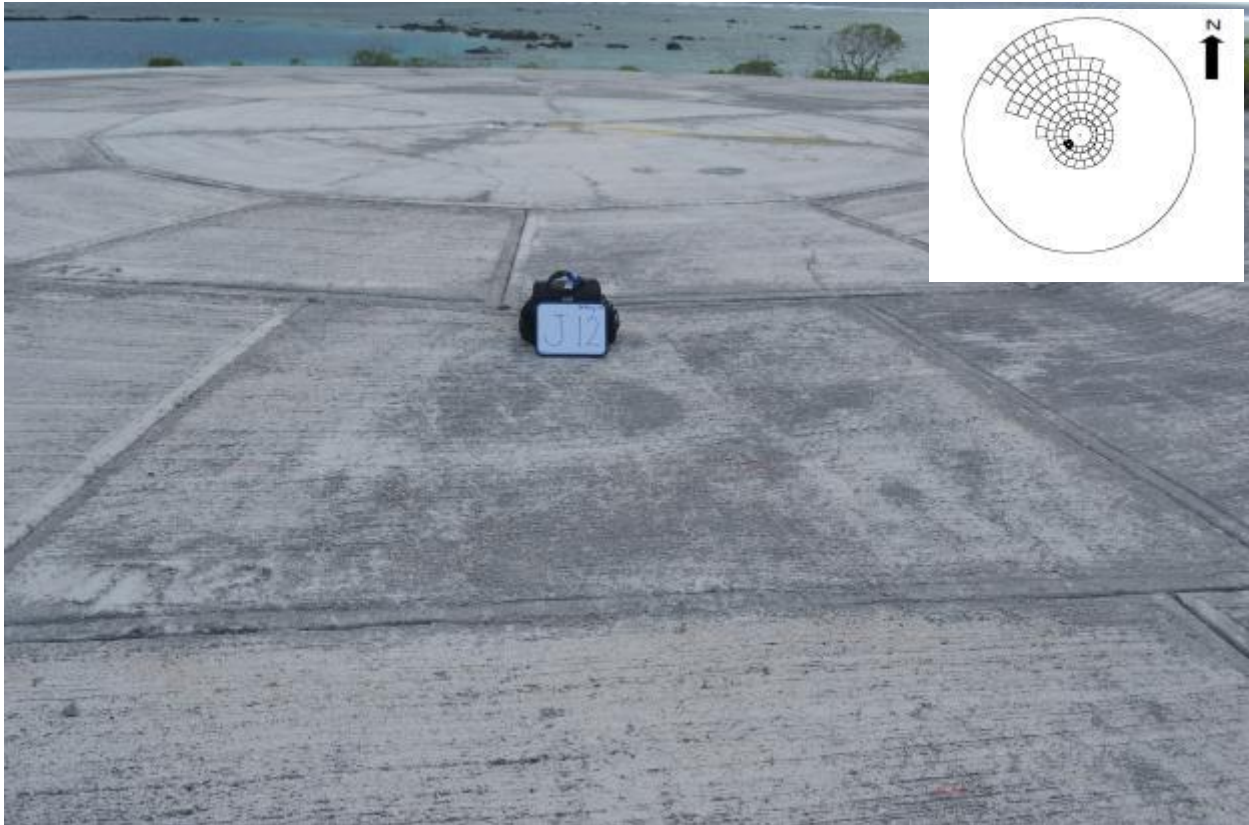
CAP SECTION LOCATION: Panel J12

No significant or obvious interior cracks or spall elements identified.

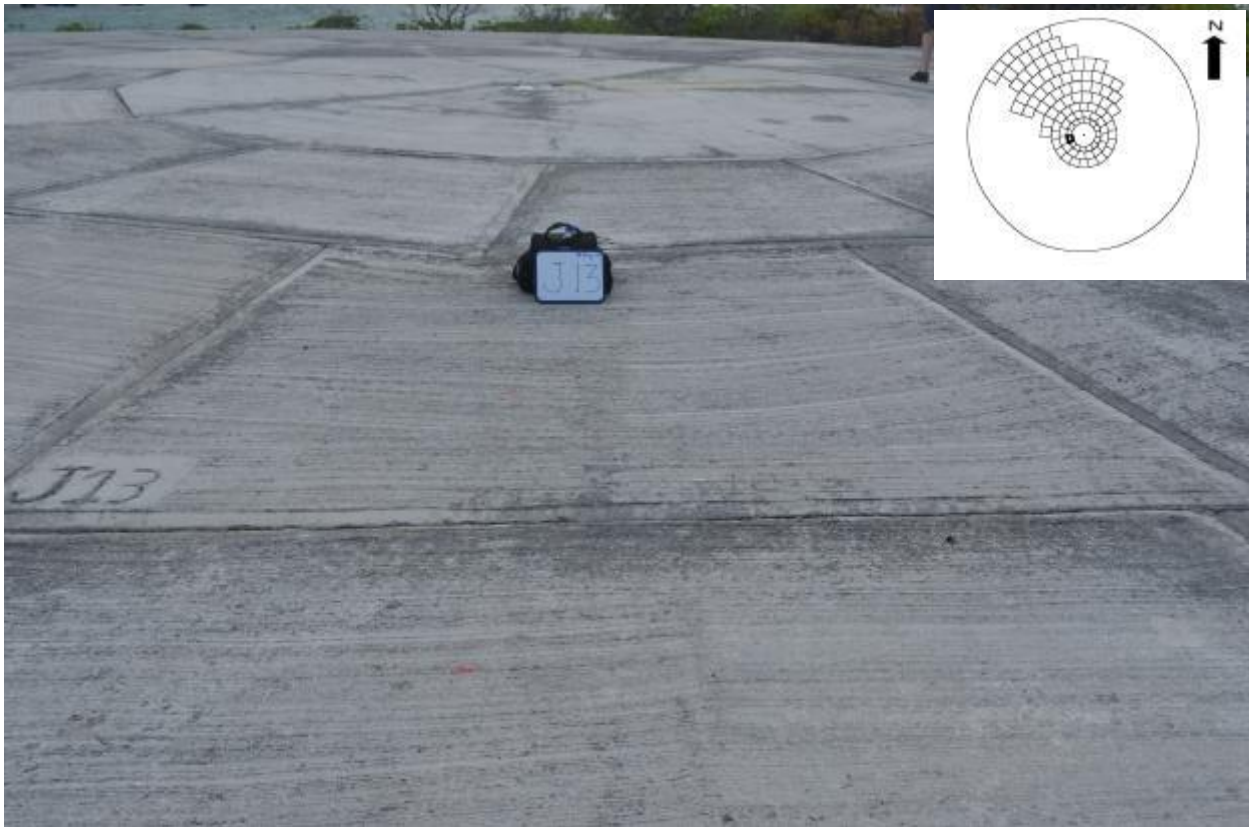
CAP SECTION LOCATION: Panel J13

No significant or obvious interior cracks or spall elements identified.
