LLNL-TR-648143

A Visual Description of the Concrete Exterior of the Cactus Crater Containment Structure

Terry Hamilton

October 2013

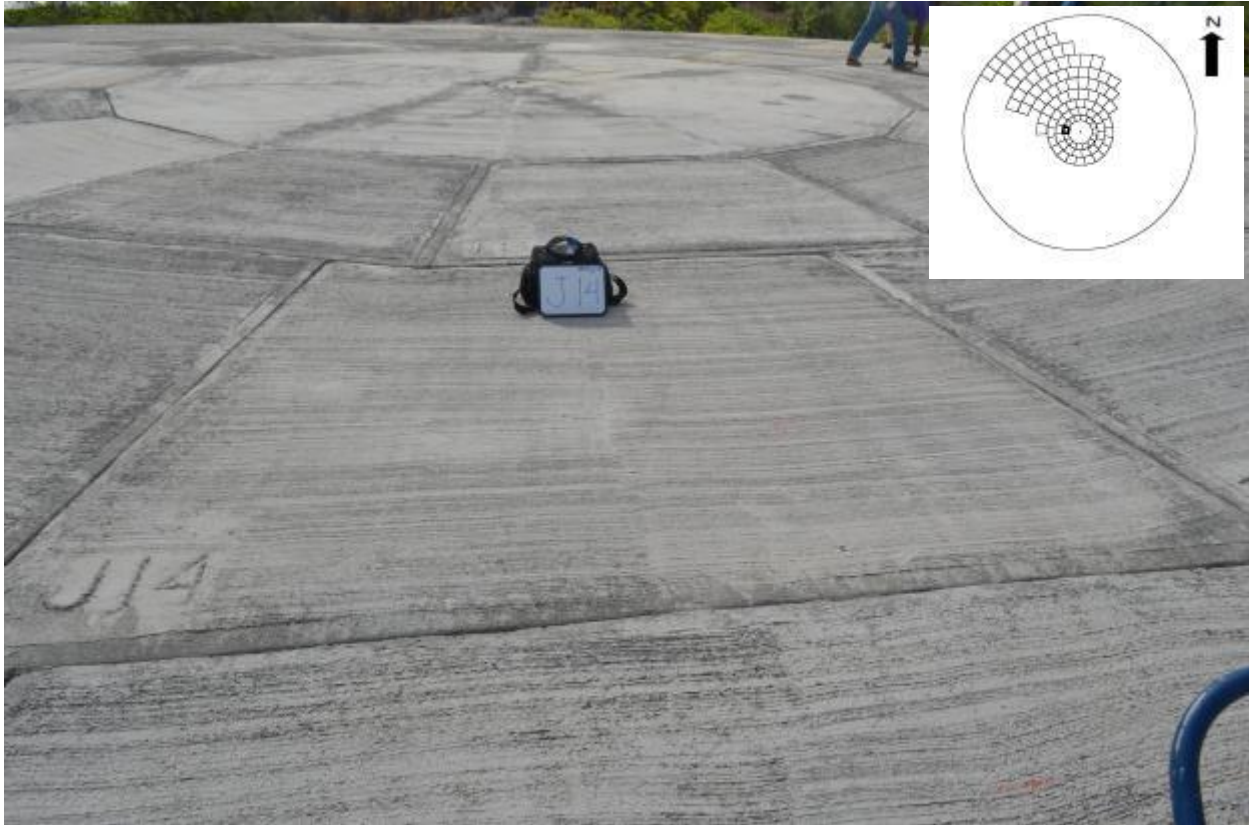
CAP SECTION LOCATION: Panel J14

No significant or obvious interior cracks or spall elements identified.

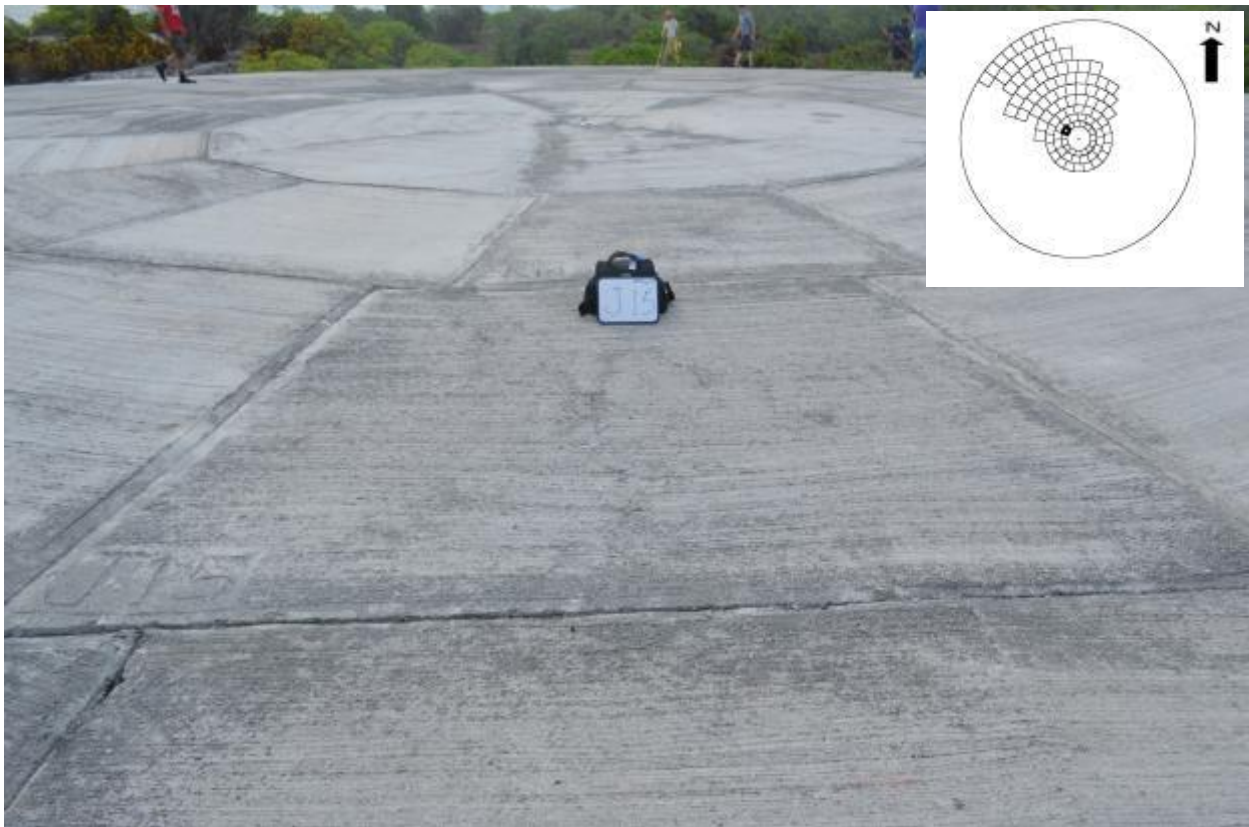
CAP SECTION LOCATION: Panel J15

No significant or obvious interior cracks or spall elements identified with exception of very minor spalling of concrete along the left side of the upper seam.

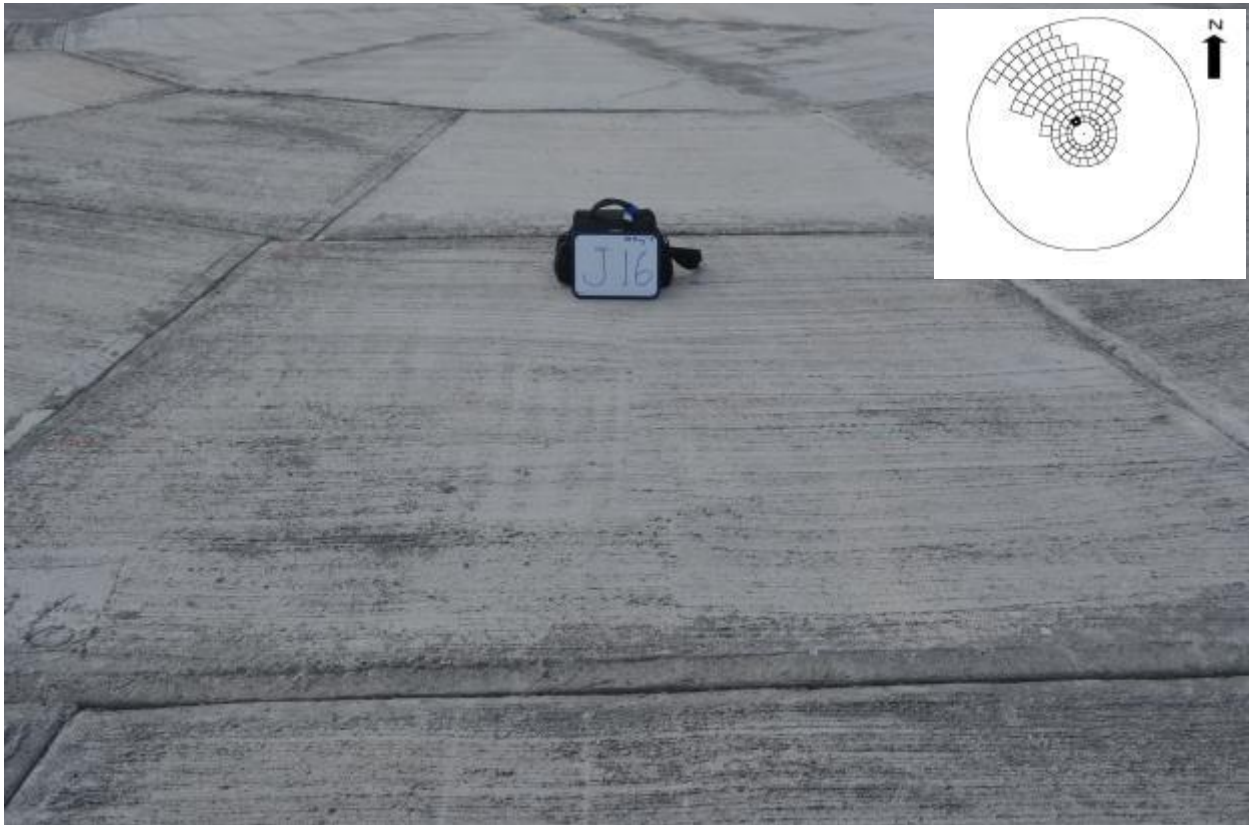
CAP SECTION LOCATION: Panel J16

No significant or obvious interior cracks or spall elements identified with exception of very minor spalling of concrete along the seams.

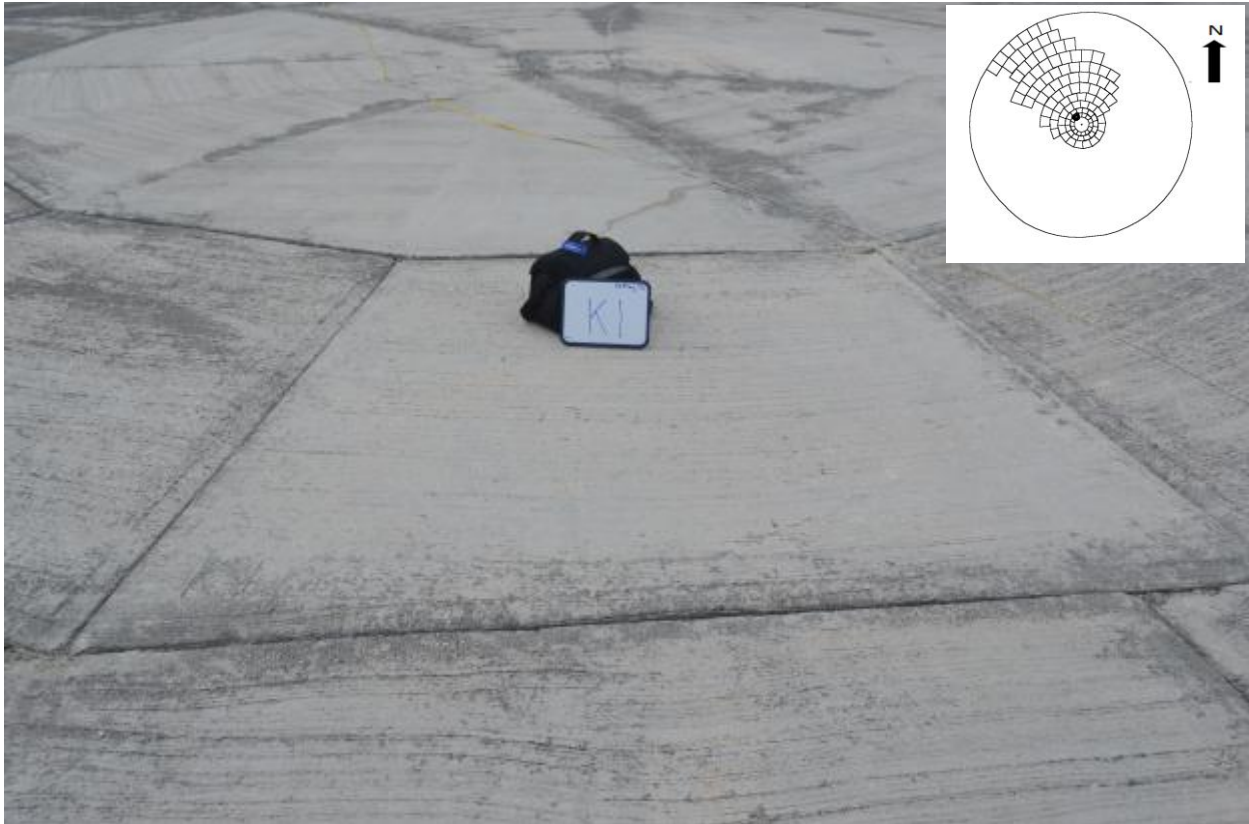
CAP SECTION LOCATION: Panel K1

No significant or obvious interior cracks or spall elements identified. Some very minor spalling/cracking observed in the upper right corner.

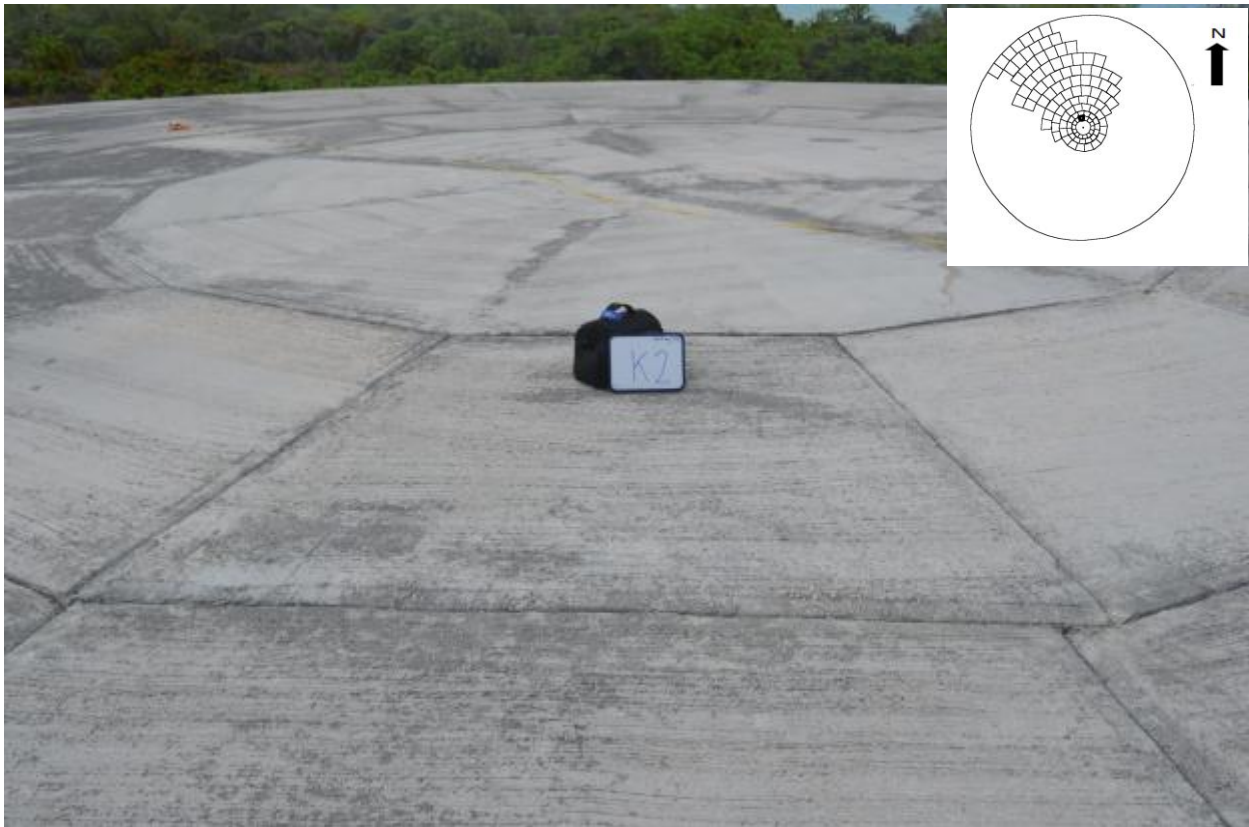
CAP SECTION LOCATION: Panel K2

No significant or obvious interior cracks or spall elements identified.

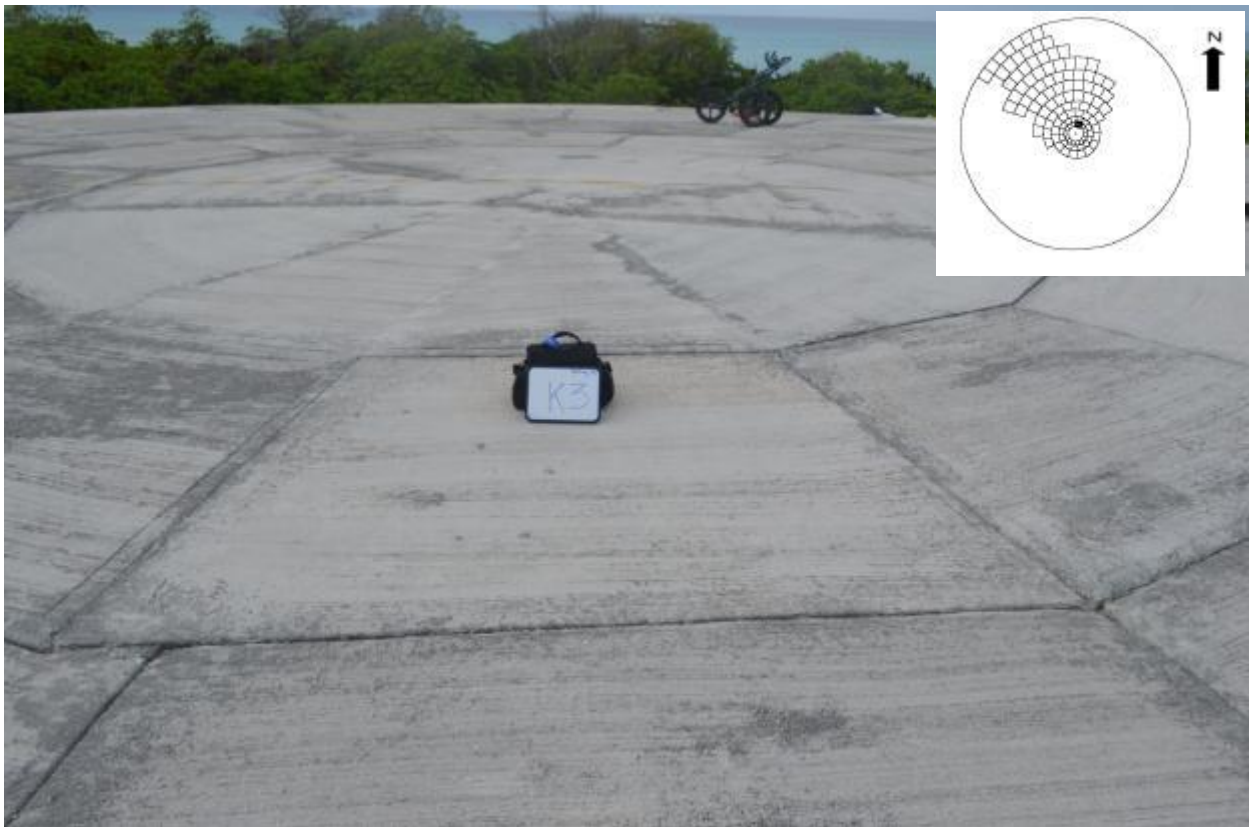
CAP SECTION LOCATION: Panel K3

No significant or obvious interior cracks or spall elements identified.

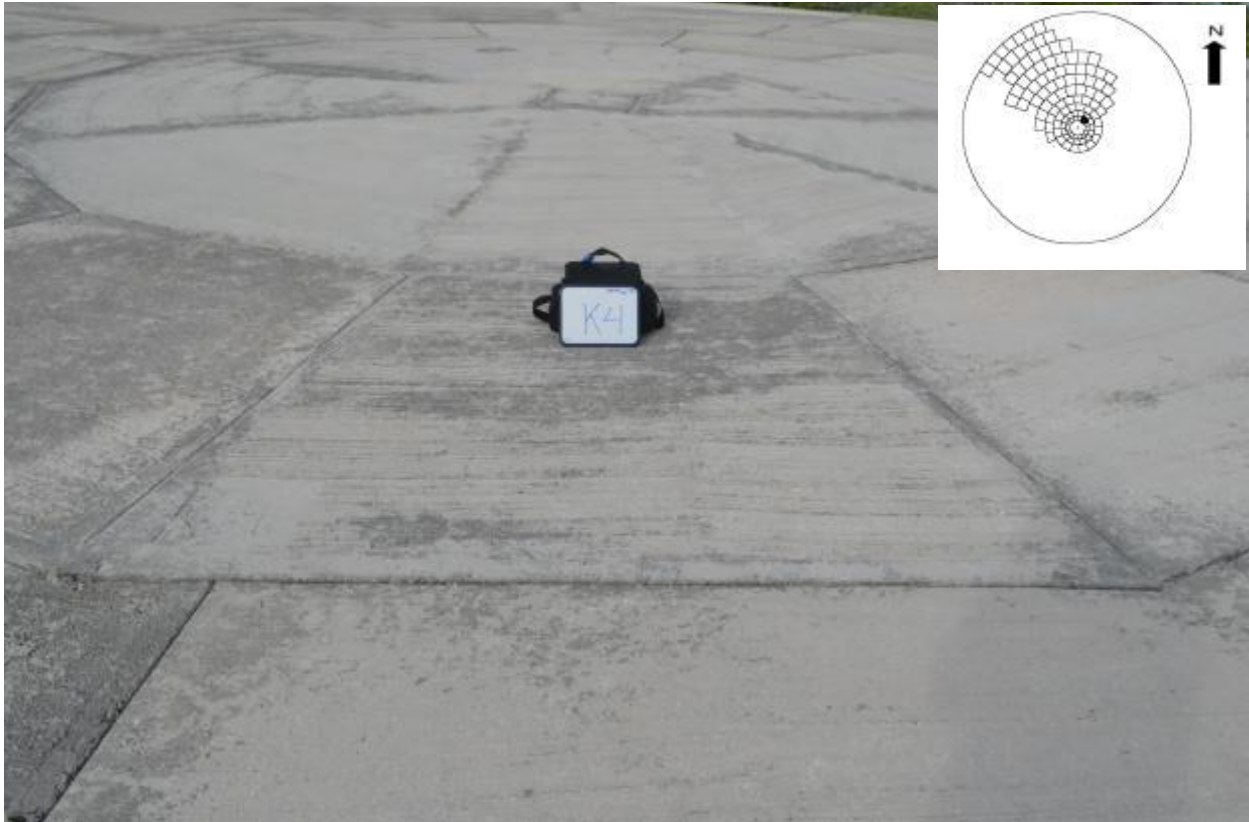
CAP SECTION LOCATION: Panel K4

No significant or obvious interior cracks or spall elements identified.

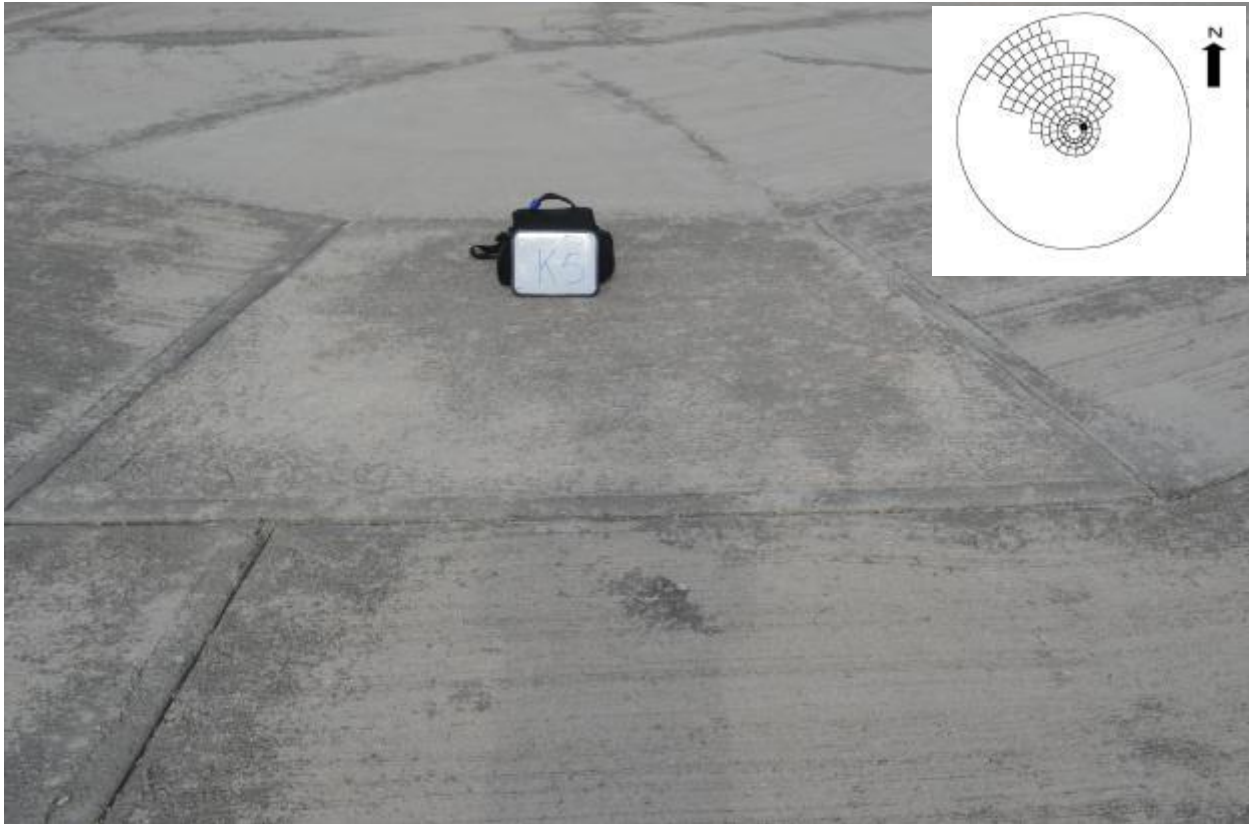
No significant or obvious interior cracks or spall elements identified.

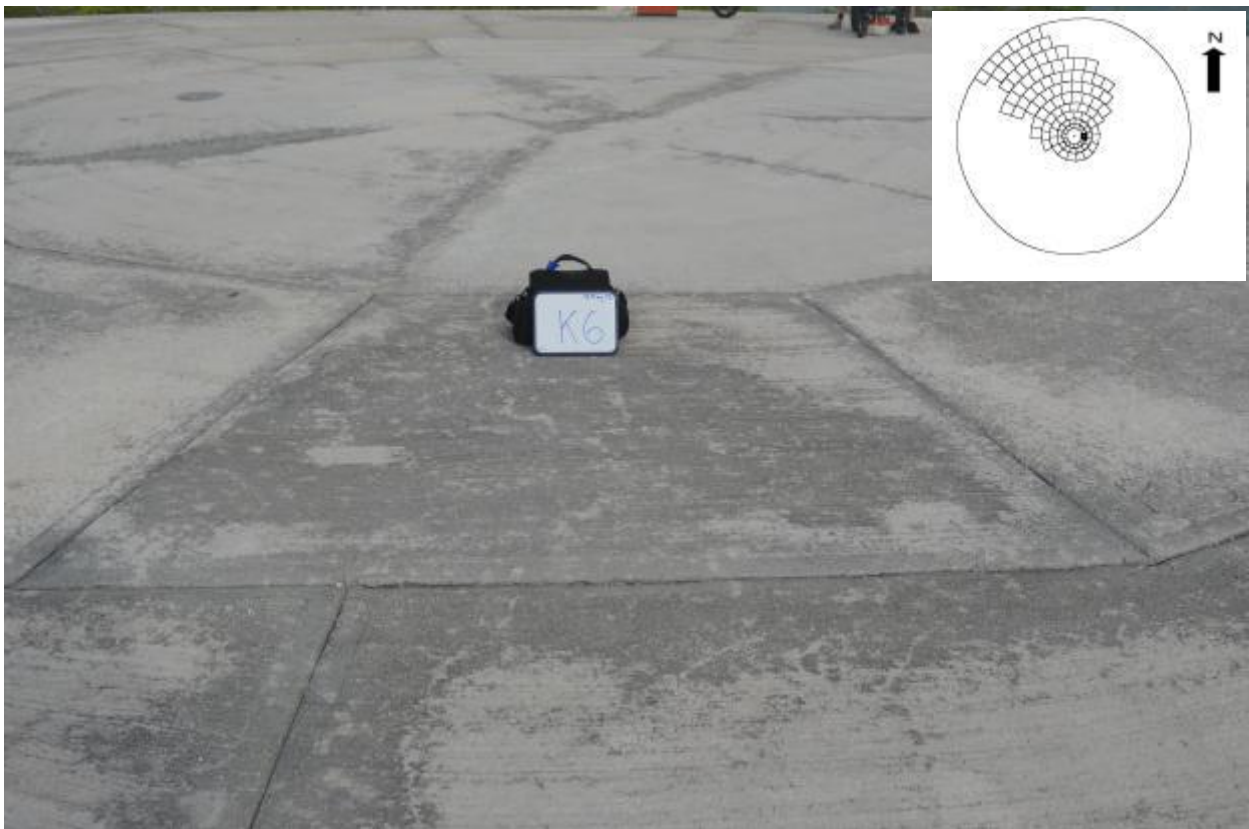
CAP SECTION LOCATION: Panel K6

No significant or obvious interior cracks or spall elements identified.

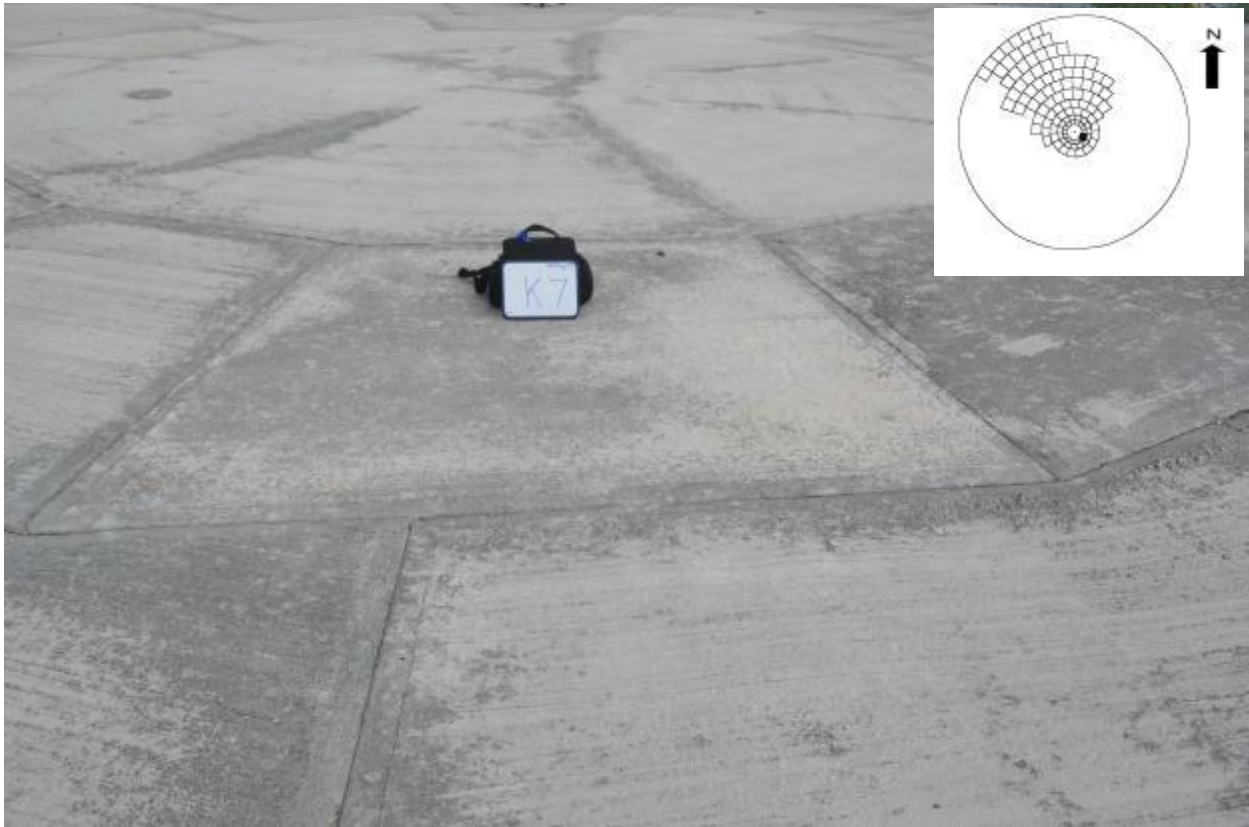
CAP SECTION LOCATION: Panel K7

No significant or obvious interior cracks or spall elements identified with exception of a small void in the concrete in the upper right corner (app. 2 centimeters deep, and 3 x 4 centimeters in area).

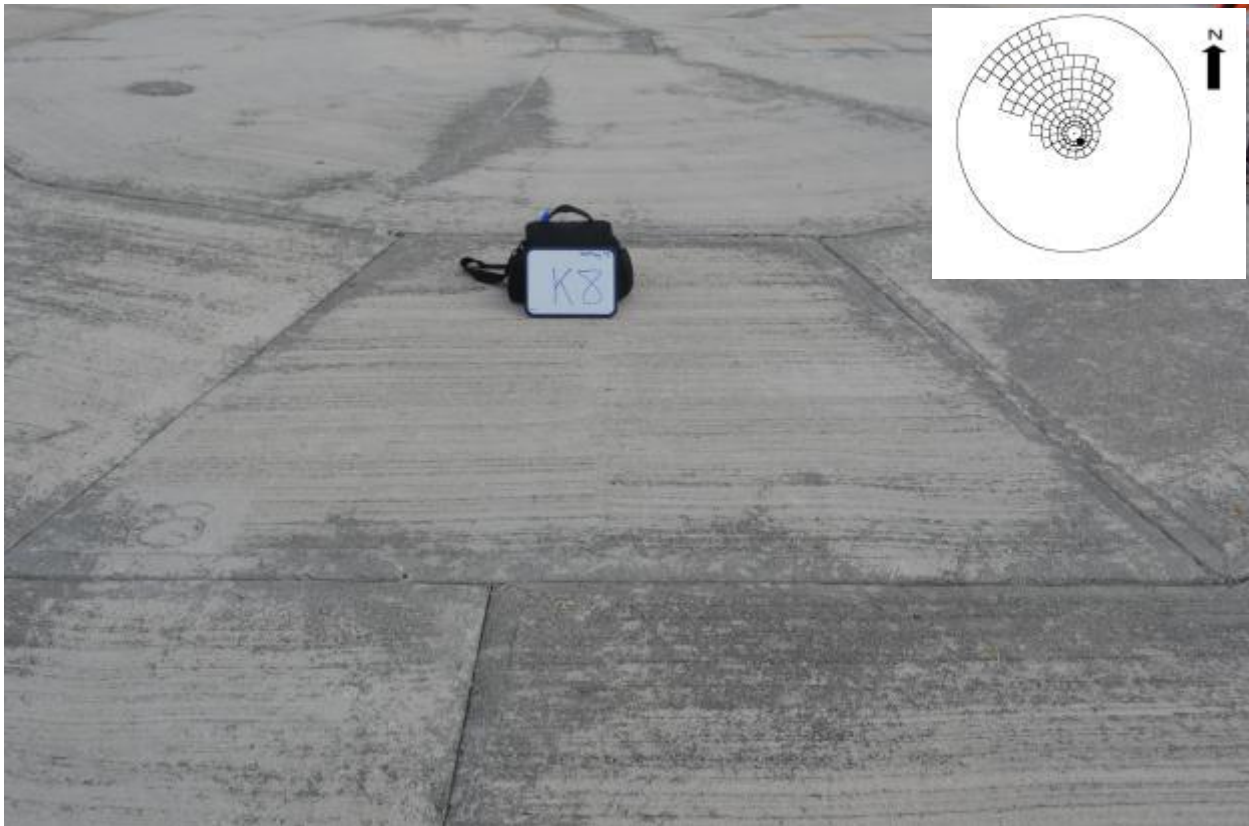
CAP SECTION LOCATION: Panel K8

No significant or obvious interior cracks or spall elements identified.

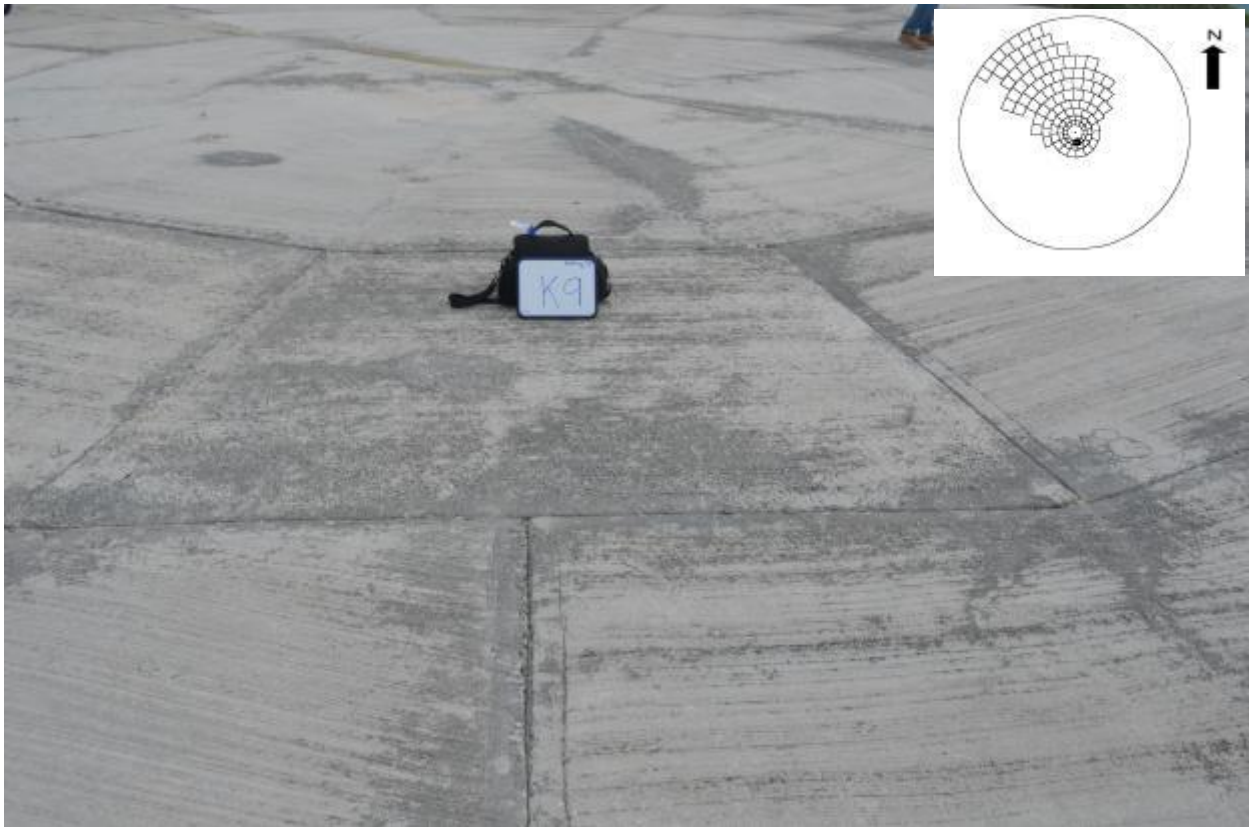
CAP SECTION LOCATION: Panel K9

No significant or obvious interior cracks or spall elements identified. Some very minor spalling/cracking observed in the upper and lower right corners.

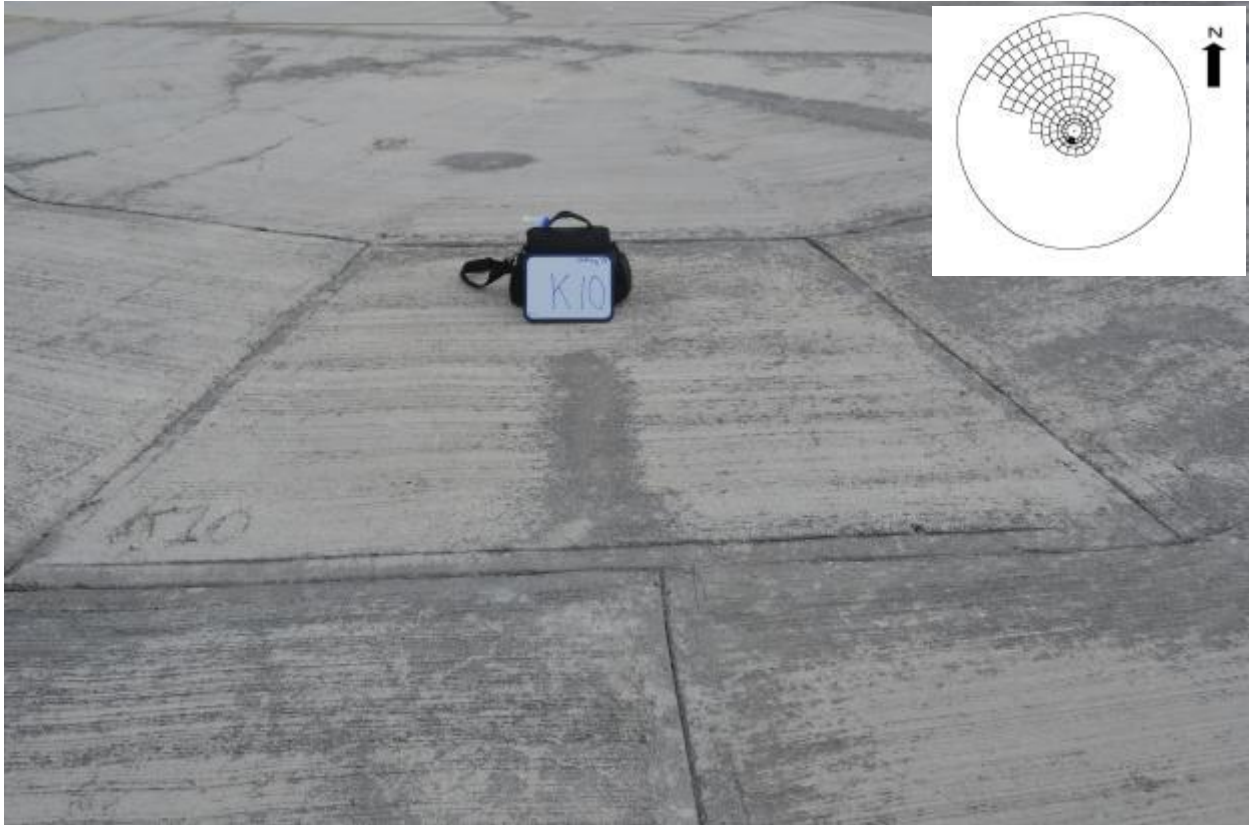
CAP SECTION LOCATION: Panel K10

No significant or obvious interior cracks or spall elements identified.

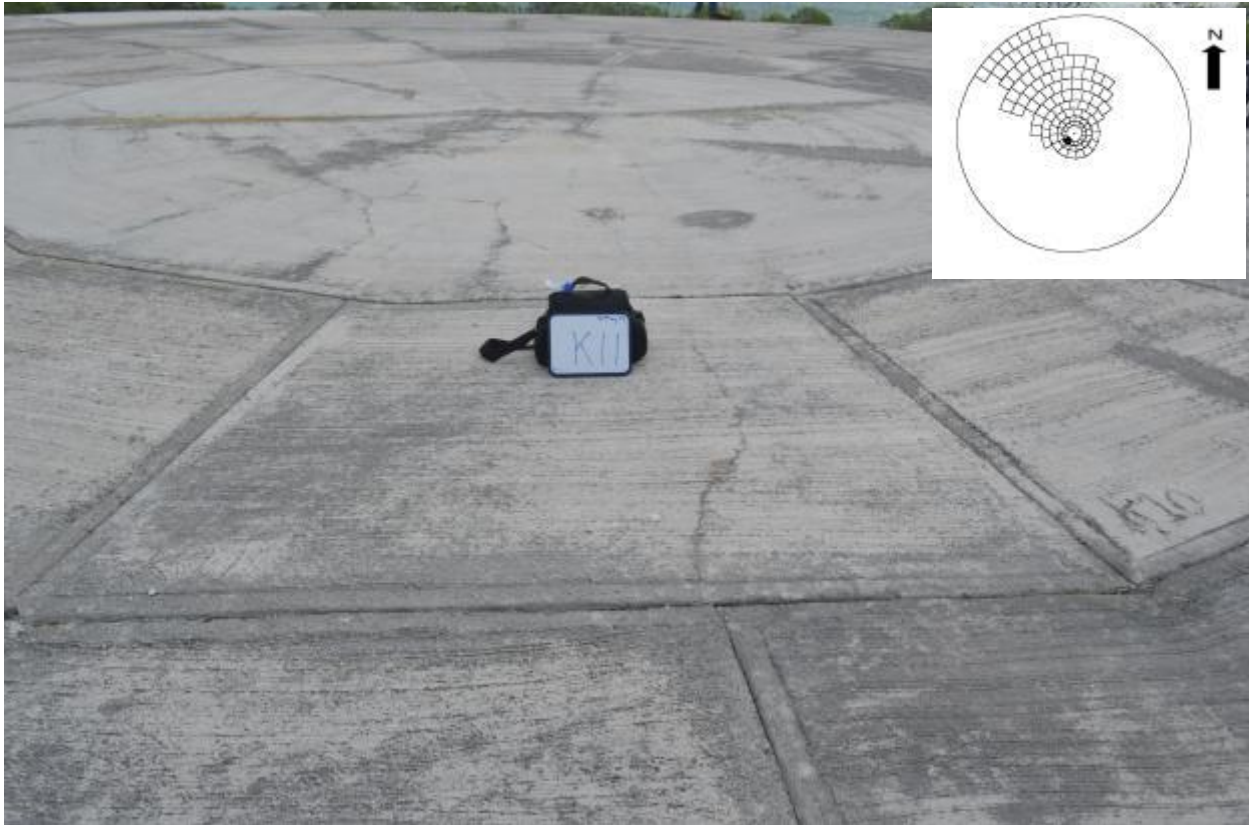
CAP SECTION LOCATION: Panel K11

Surface crack observed running up the entire length of panel and originating from near the corner intersection of the panels on the ring row below.

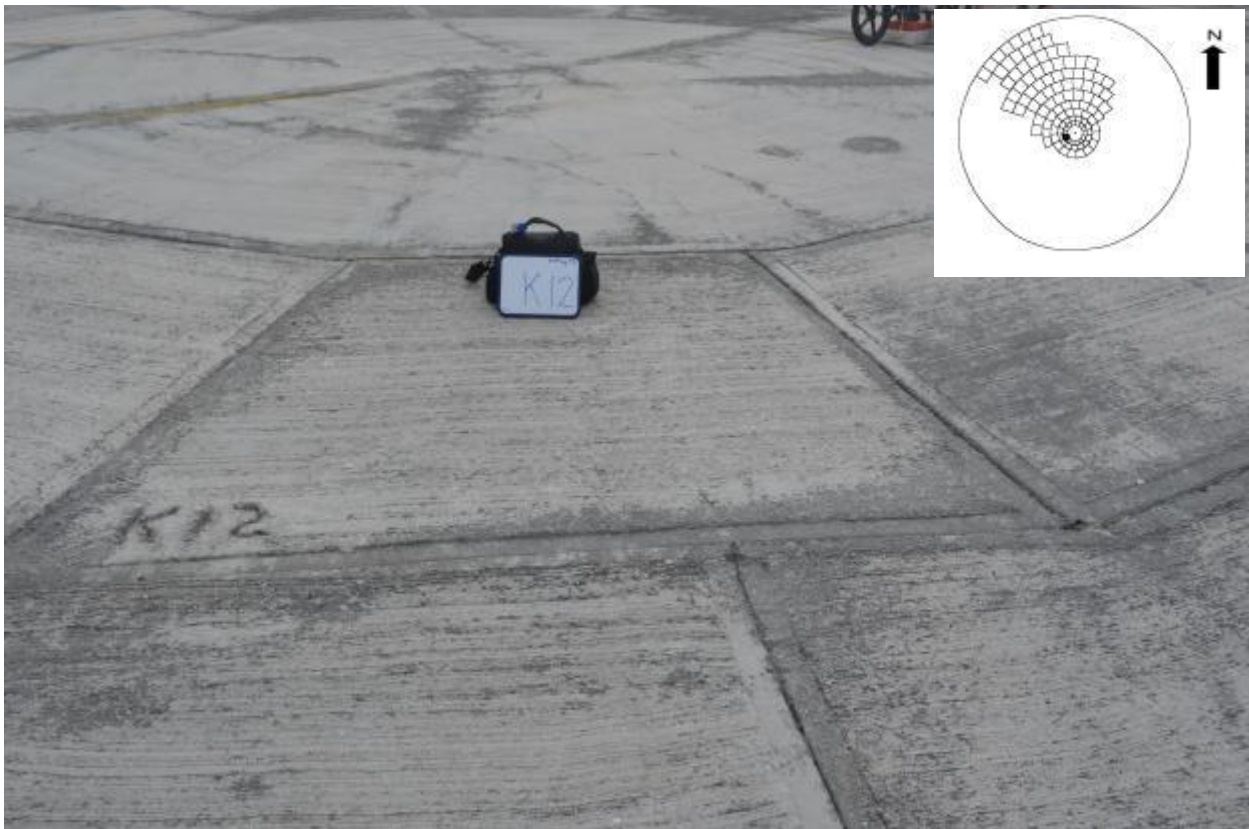
CAP SECTION LOCATION: Panel K12

No significant or obvious interior cracks or spall elements identified.

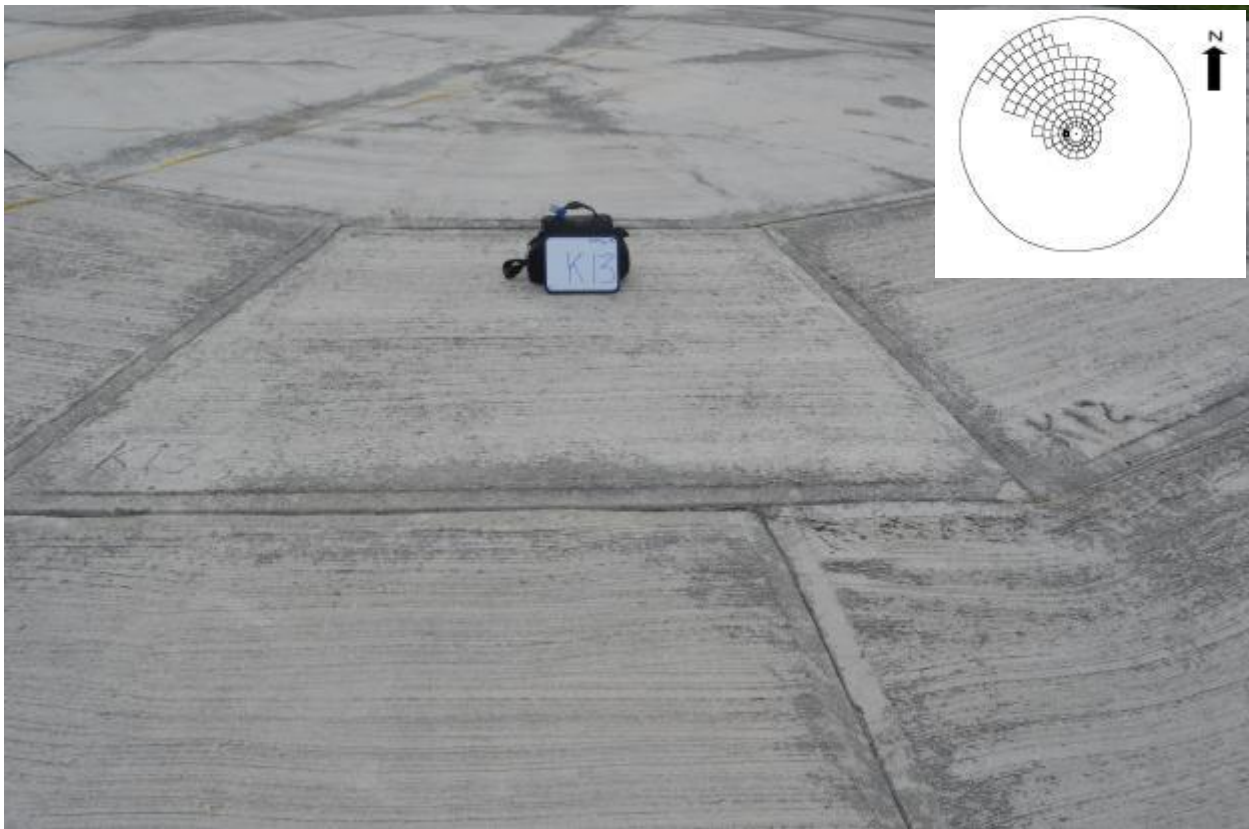
CAP SECTION LOCATION: Panel K13

No significant or obvious interior cracks or spall elements identified with exception of very minor spalling/cracking in the lower right corner of the panel.

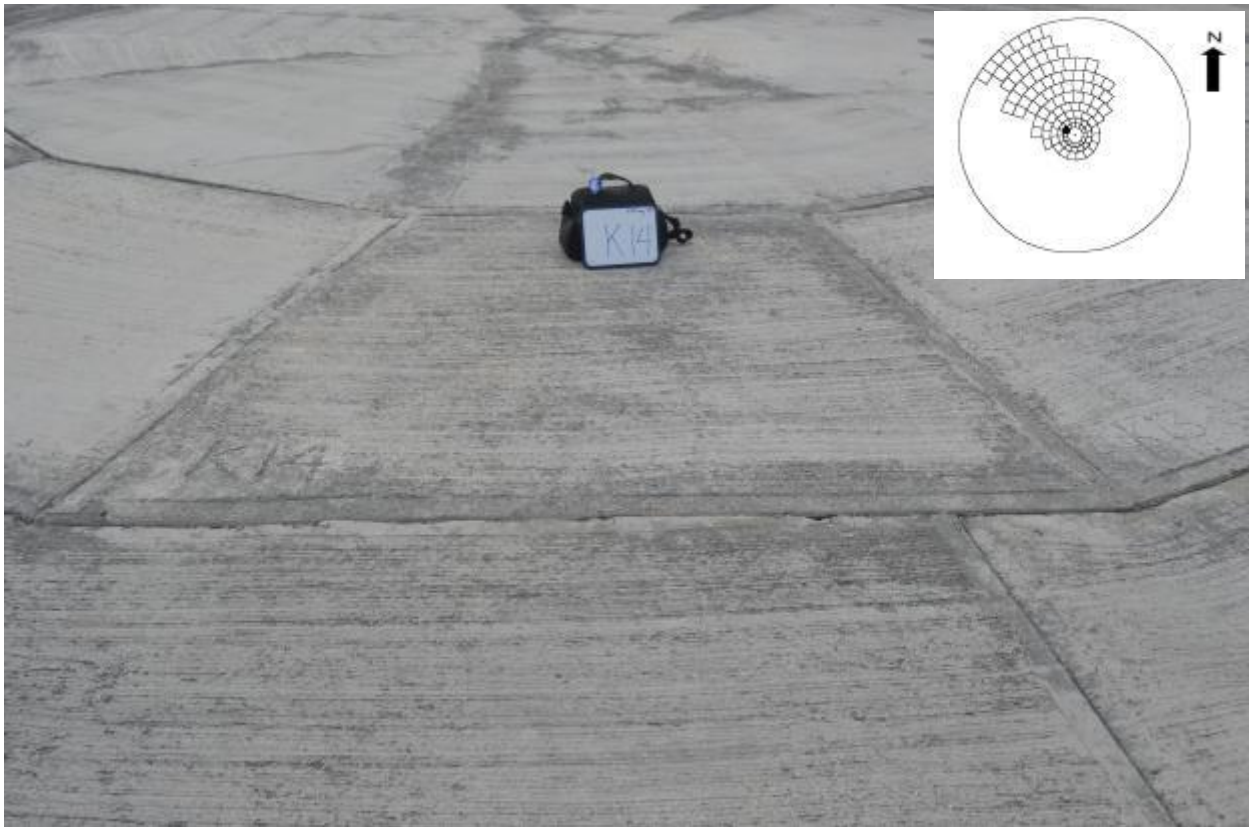
CAP SECTION LOCATION: Panel K14

No significant or obvious interior cracks or spall elements identified.
