## Downstream migration of Atlantic salmon smolt at three German hydropower stations

### **NINA Report**

Økland, F., Teichert, M.A.K., Thorstad, E.B., Havn, T.B., Heermann, L., Sæther, S.A., Diserud, O.H., Tambets, M., Hedger, R.D. & Borchering, J. 2016. Downstream migration of Atlantic salmon smolt at three German hydropower stations. NINA Report 1203: 1-47.

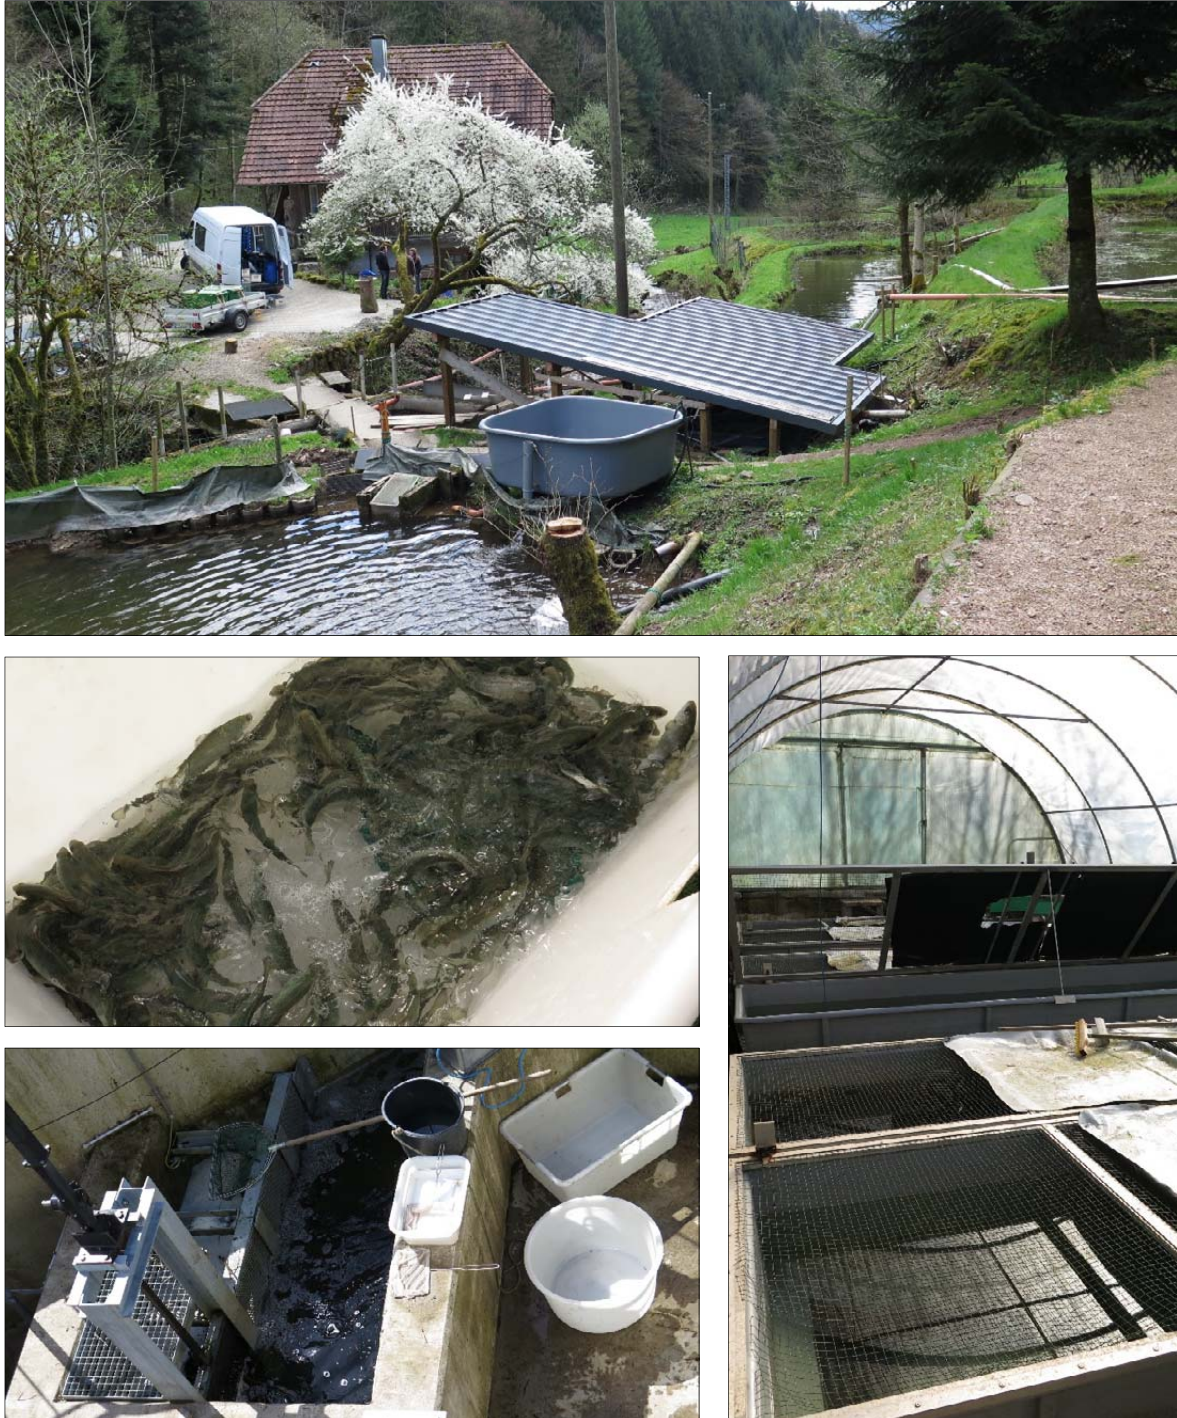
**Figure 2.1.** The fish studied were hatchery-reared Atlantic salmon smolt (Albaum hatchery or Lachs-zucht Wolfstal hatchery), or smolt captured from the Sieg at Unkelmühle (most likely originating from stocking of fry or parr by hatcheries, but could also be the result of natural spawning in the river). Photos Eva B. Thorstad and Torgeir B. Havn.

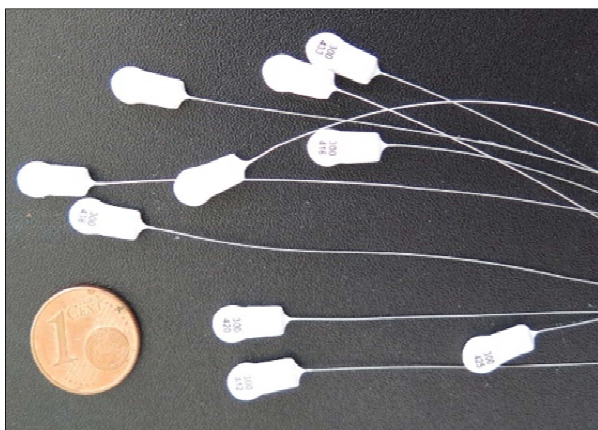
**Figure 2.2.** The Atlantic salmon smolt were tagged with small radio transmitters (shown together with a one Euro cent). Photo Eva B. Thorstad.

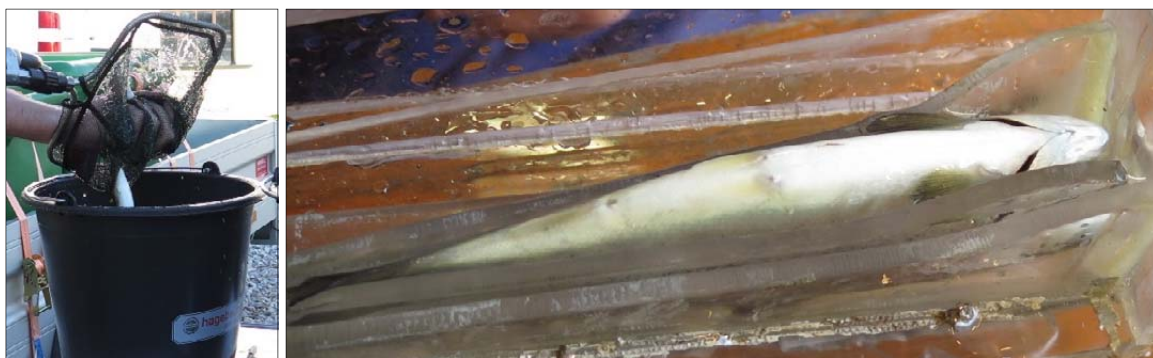
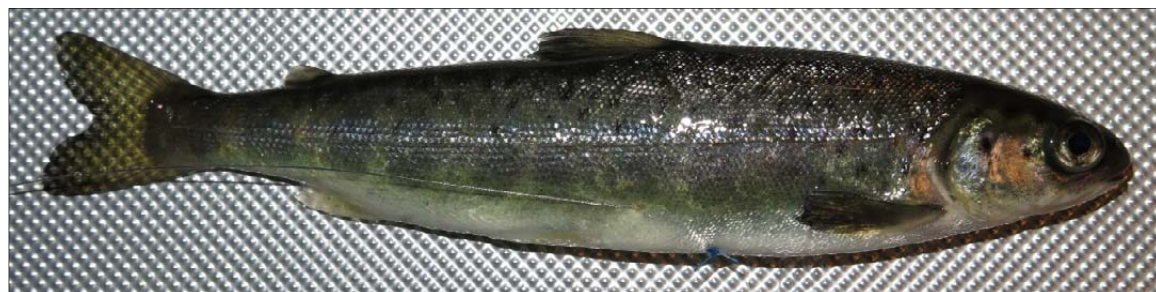
**Figure 2.3.** The fish were anaesthetised before tagging (3-5 min in a bath with benzocaine and water). The tag was inserted into the fish body cavity during a surgical procedure lasting a few minutes. The incision was closed with sutures. Photos Eva B. Thorstad and Torgeir B. Havn.

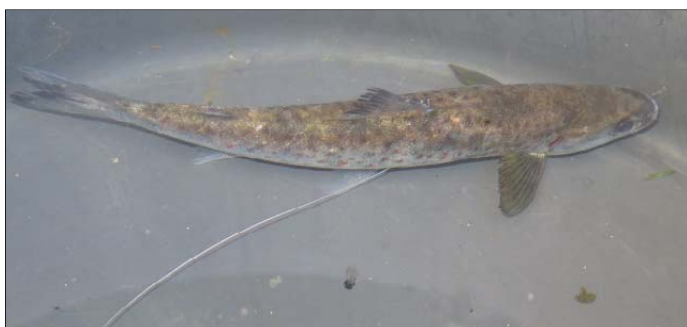
**Figure 2.4.** After tagging, the fish were kept in a bin with water, where they recovered and could swim normally after a few minutes. The radio antenna wire can be seen in the photo, exiting through the body wall of the fish. Photo Torgeir B. Havn.

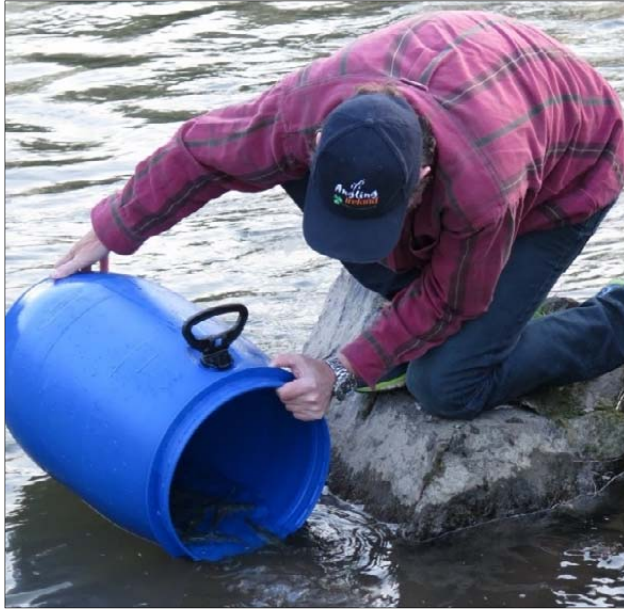
**Figure 2.5.** Radio tagged fish were released in the rivers 4.6-10.1 km upstream of the studied power stations.

In each river, downstream migration and loss of tagged fish were recorded 1) on a free-flowing reference stretch, 2) on the impounded stretch upstream of the dam, 3) past the power station, and 4) on a river stretch below the power station. Photo Torgeir B. Havn.

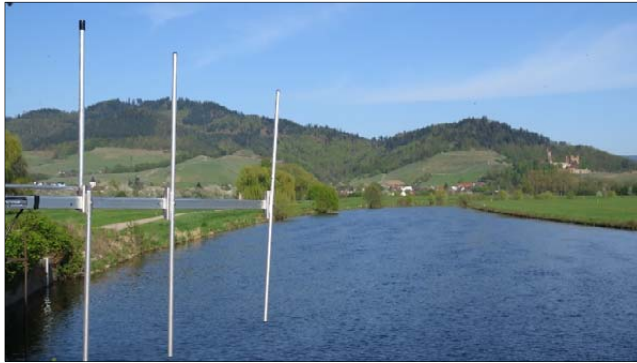
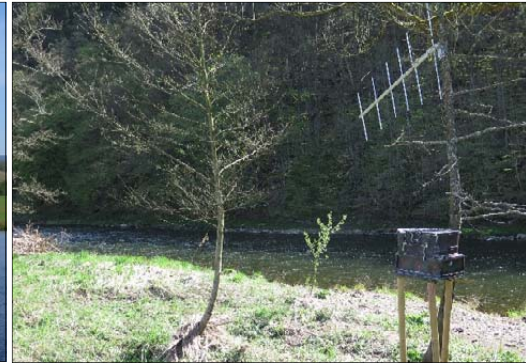
**Figure 2.6.** Downstream migration of tagged fish was studied by using stationary receivers, which automatically stored information on time and id of tagged fish when they were within the detection range of receiver antennas. Photos from the Kinzig (left) and the Sieg (right) by Eva B. Thorstad.

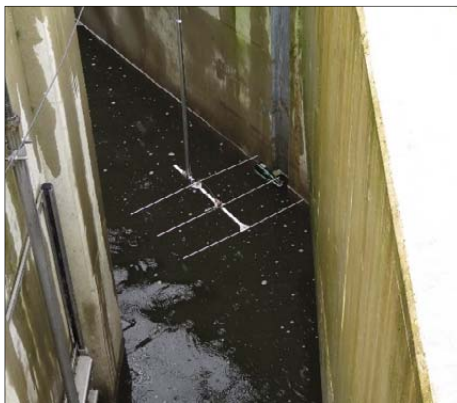
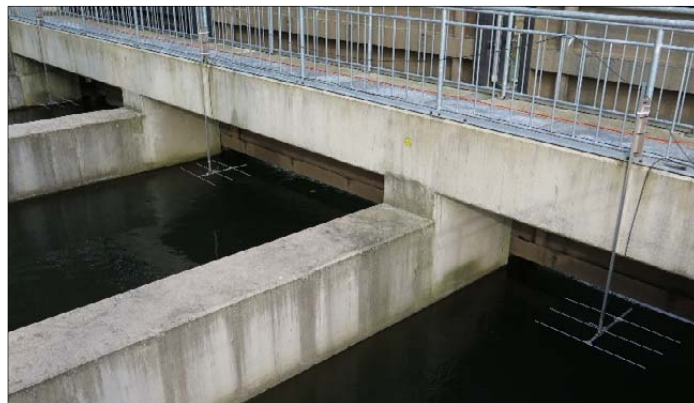
**Figure 2.7.** Detailed recording of the movements of tagged fish at the power stations was done by using a network of stationary receivers with antennas covering all possible migration routes. Lotek model SRX 600 data loggers were used with 3-, 4-, 6- and 9-element Yagi-antennas or co-axial antennas used underwater or in air. When a tagged fish was within the detection range of an antenna, date, time, individual fish code, signal strength from the transmitter and individual antenna number were automatically recorded and stored by the receiver and later downloaded to a computer. Photos from Unkelmühle, by Eva B. Thorstad and Stein Are Sæther.

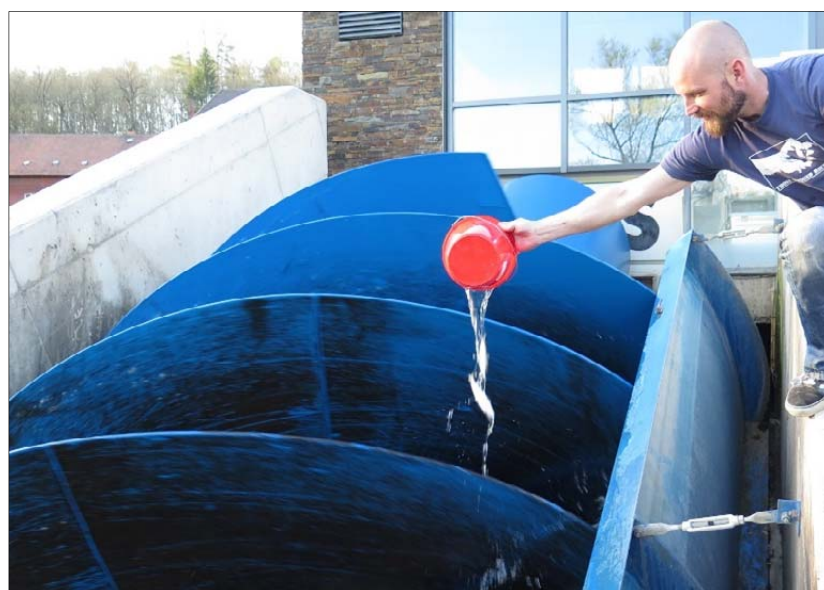
**Figure 2.10.** To help distinguishing between live downstream migrating fish and dead drifting fish, some already dead salmon smolt were released in or immediately downstream of the turbines in all study rivers. The distance dead fish drifted was up to 2.4 km downstream from the power station. Photo from Kuhlemühle, by Torgeir B. Havn.

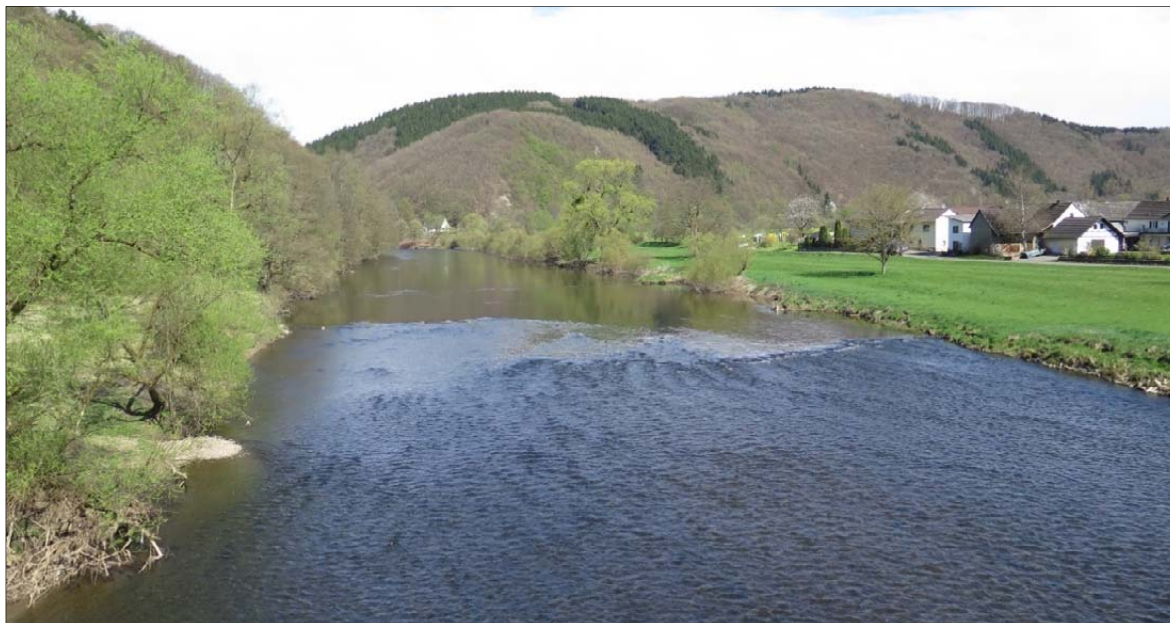
**Figure 2.11.** The loss of smolt due to hydropower development was calculated by comparing loss on free-flowing reference stretches with loss on the impounded river stretch above the dam and past the power station in each river. This is based on the assumption that the loss per km recorded on the reference stretch is representative for the developed stretch if it had been a free-flowing river instead of being impounded and having the power station. Photo from the reference stretch in the Sieg by Eva B. Thorstad.

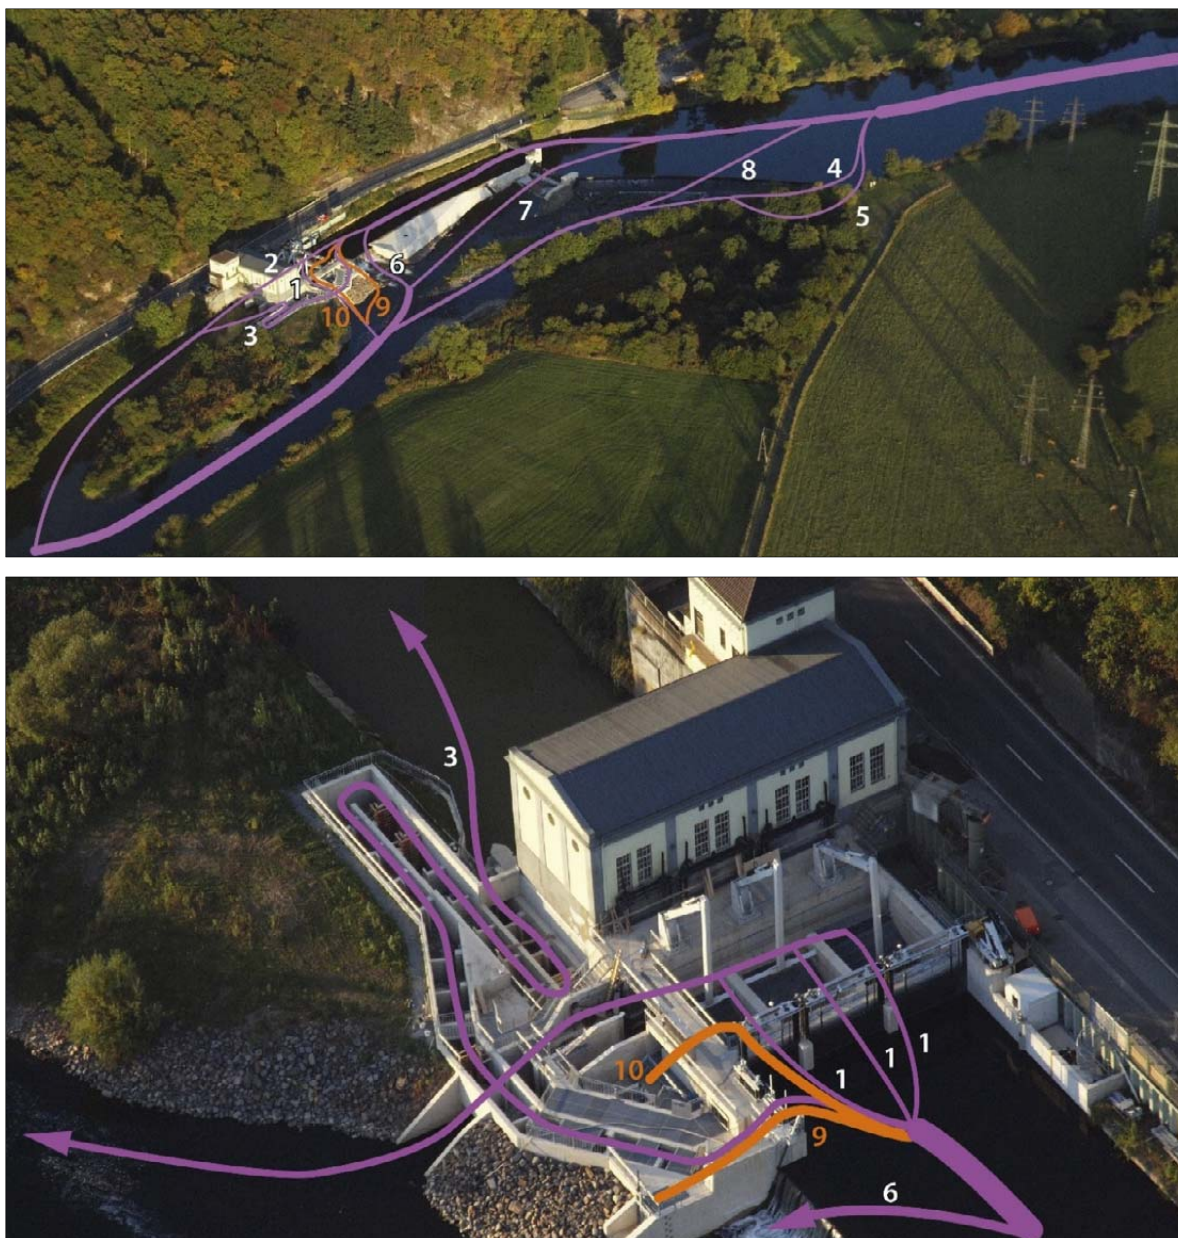
**Figure 3.3.** The different routes downstream migrating fish can use to pass the Unkelmühle power station: 1) via custom-made openings in the racks that leads fish to a route outside the turbines via the flushing channel, 2) through turbines if they slip through the bar spacing of the racks, 3) through the vertical slot fish passage constructed for upstream migrants, 4) through the nature-like fishway, 5) through the canoe pass, 6) via the ice gate, 7) over the spillway gate, 8) over the dam, 9) via the bottom bypass for eel, and 10) via side bypasses for eel (the two latter, indicated in orange, are only in operation during the eel run in the autumn). Numbers in both panels refer to the different migration routes. Photos: Wikimedia Commons.

One of the possible migration routes for downstream migrating fish is through custom-made openings in the racks in front of the turbines, which enable them to bypass the turbines via the flushing channel (**figure 3.3, 3.4**). During this study, fish could move freely from the flushing channel at all times and were either guided to holding pools where they were collected for monitoring purposes, or they were guided back to the river outside the turbines via the same channel as debris from the racks were flushed out when the rack cleaners were in operation. Which of these two routes fish are guided to is determined by the position of a movable valve. The operation of the rack cleaners depend on amount of debris. During periods of high water and increased debris transport, they are continuously operated.

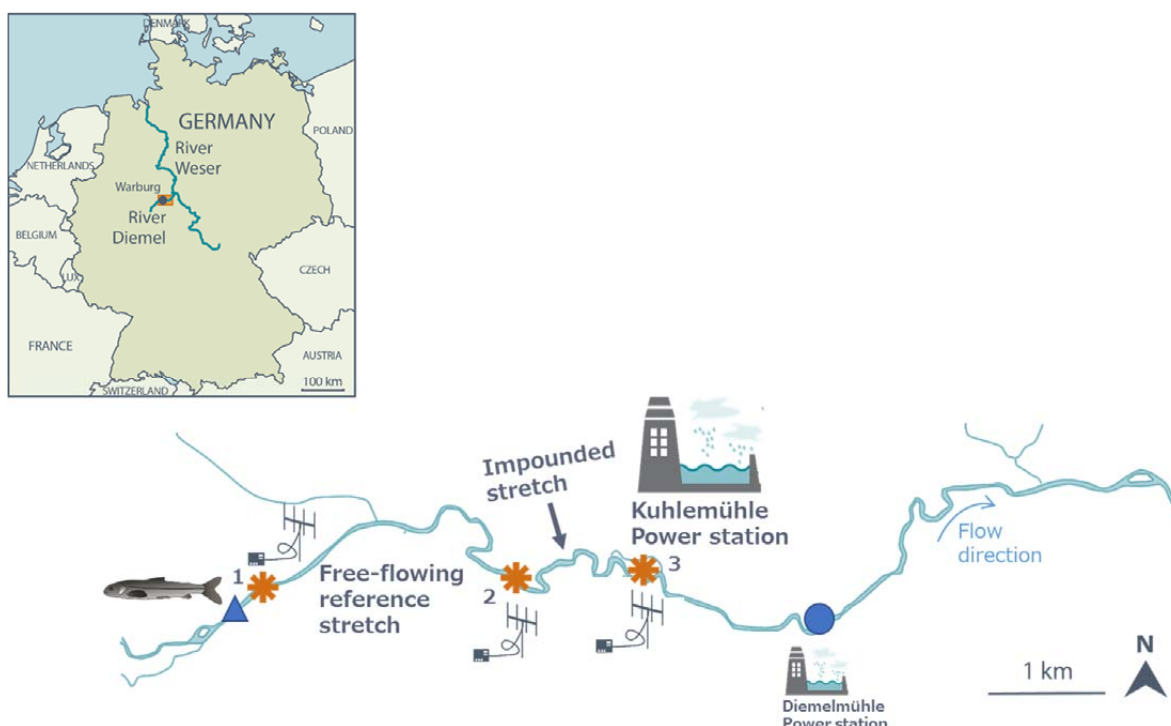
**Figure 3.10.** Study area in the Diemel showing the release site of Atlantic salmon smolt tagged with radio transmitters (blue triangle), receiver sites where they were recorded when passing (orange stars, denoted with site numbers 1-4) and the Kuhlemühle power station. Diemelmühle power station is also shown on the map, but no receivers were installed to monitor smolt at this site.

There is another power station at the Diemel, Diemelmühle, 2.1 km downstream from Kuhlemühle (**figure 3.10**). Fish can potentially be damaged or killed also at this site, but monitoring at this site was not part of the study.

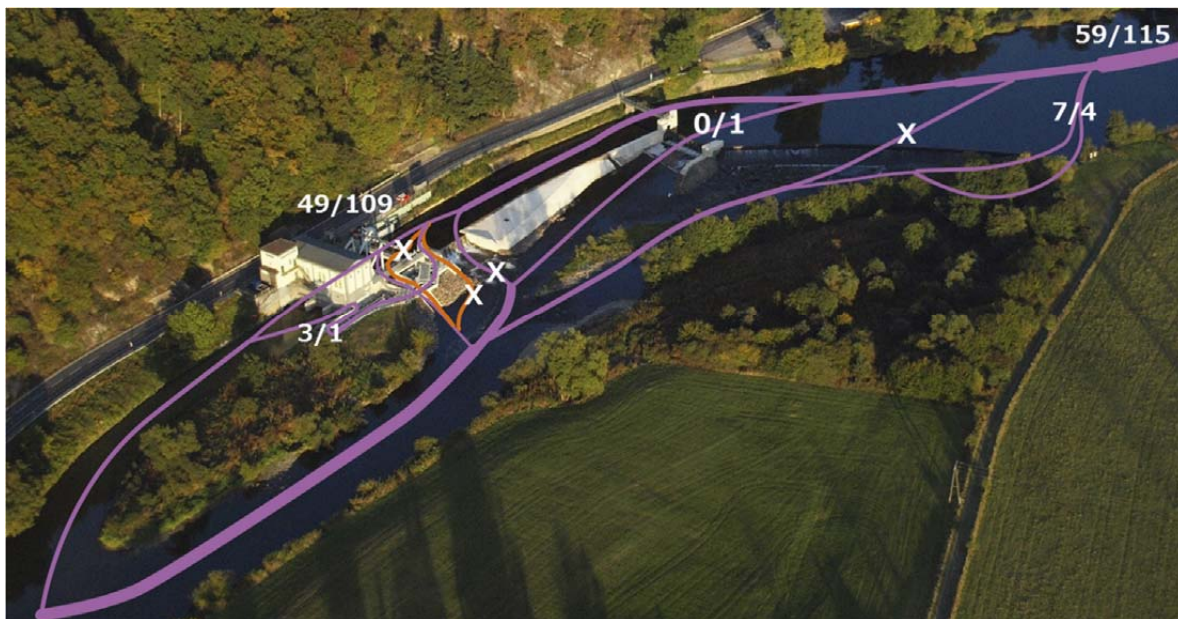
**Figure 4.2.** Numbers of smolt in 2014/2015 that used the different migration routes past the power station. Total number of smolt passing was 59 in 2014 and 115 in 2015. Water was not flowing over the dam or through the ice gate during the study, so these migration routes were not available (indicated with an X). Similarly, the bottom and side passes designed for eel were not in operation (orange lines, also indicated with an X). Water was flowing over the spillway gate only for short periods during the study in 2015, *i.e.*, 16 min - 5 hours on five occasions.

Most of the smolt that passed the power station followed the migration route towards the bar racks in front of the turbines (83% in 2014, 95% in 2015, **figure 4.2**), which leads the fish to a route outside the turbines via the flushing channel. Few smolt used the spillway gate (0% in 2014, 1% in 2015), vertical slot fish passage (5% in 2014, 1% in 2015) and nature-like fishway or canoe pass (12% in 2014, 3% in 2015). For the smolt that used the nature-like fishway or canoe pass, we cannot determine which of these two routes they used. No smolt slipped through the bar spacing of the racks and passed through the turbines, as expected due to the narrow spacing between the bars (10 mm).

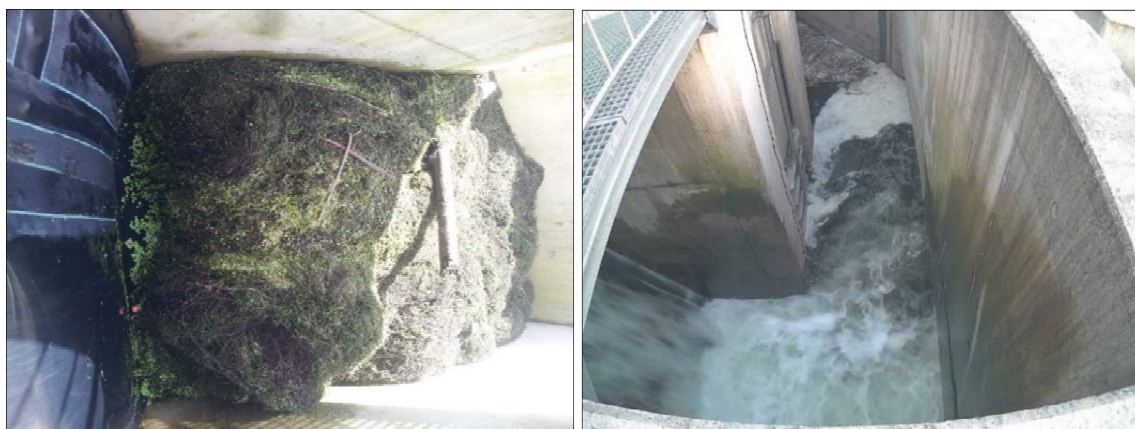
**Figure 4.3.** Area of the bypass route outside the turbines at the Unkelmühle power station where debris and branches were piling up in 2014 and likely caused mortality in Atlantic salmon smolt that were trapped (left). There was no debris piling up and no recorded mortality at this particular site during the study in 2015 (right). Photo: Finn Økland and automatic monitoring camera.

Mortality rates in power station areas may vary among years, which was demonstrated by results from Unkelmühle, where a pilot study was conducted in 2014. The mortality in the bypass route was larger in 2014 than in 2015. This bypass route leads the smolt outside the turbines via custom-made openings in the racks in front of the turbines. The higher mortality in 2014 was likely because some smolt became trapped and died in the bypass route where debris and branches were piling up in 2014, but not in 2015. It should be noted that the overall loss recorded at Unkelmühle in 2014 was lower than in 2015 (**table 6.1**), but estimates for 2014 are underestimates compared to 2015, because fish were not followed downstream of the power station in 2014 (see chapter 4.1.4).

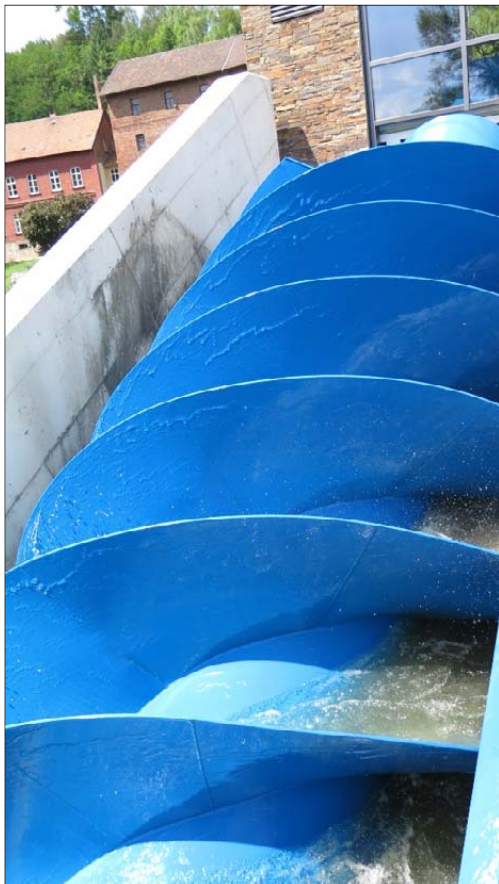
**Figure 6.1.** The Archimedes screw turbine at Kuhlemühle in the Diemel.

The Archimedes screw turbine is often regarded as less harmful to fish than other hydro-power turbines, and reported damage and loss rates are usually low (Spah 2001, VisAdvies 2007, Kibel 2007, 2008, Kibel et al. 2009a,b, Kibel & Coe 2011, Potter et al. 2012, Bracken & Lucas 2013). The reasons for being regarded as less damaging to fish are the slow rotation speed of the turbine and the absence of extreme pressures and shear forces (Potter et al. 2012). The water travels in blocks at a slow speed down the screw, with enough space to hold fish.

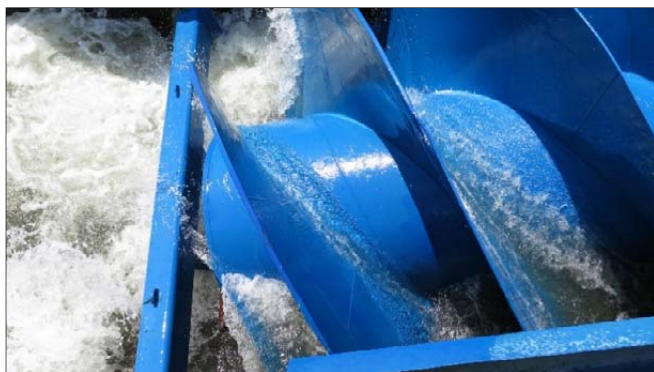
Archimedes screw turbines may differ in characteristics such as length, number of blades, speed, size of openings between different parts of the turbine and shape of the front of the blades. Such differences may affect the extent of injuries to fish. Impact of Archimedes screw turbine on fish will therefore to a certain extent be site specific.

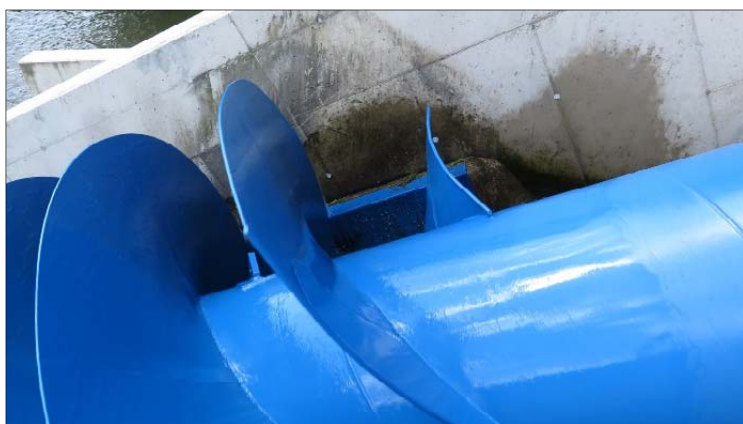
**Figure 6.2.** The upper part of the Archimedes screw turbine at Kuhlemühle in the Diemel. Photo by Eva B. Thorstad.

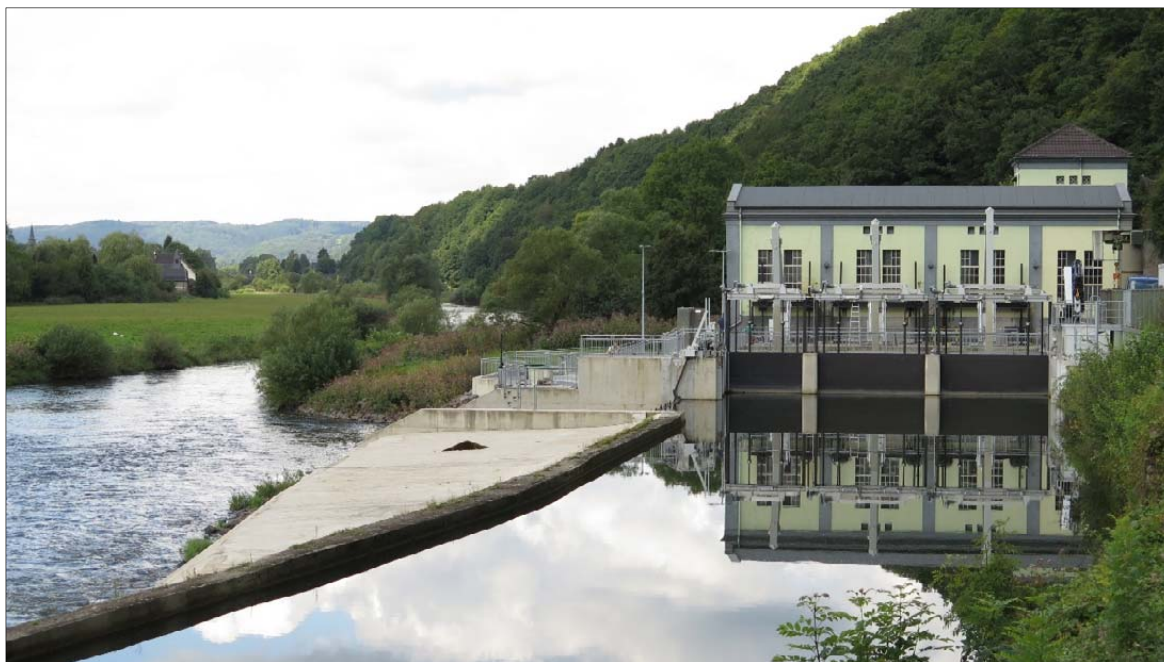
**Figure 6.1.** Unkelmühle power station in the Sieg. Photo: Eva B. Thorstad.

The loss of downstream migrating smolt due to the hydropower station was minimum 12.8% at Unkelmühle (Sieg) and 3.1-6.3% at the power station in Gengenbach (Kinzig) during our study in 2015 (**table 6.1**). For both sites (**figure 6.1, 6.2**), this represents the percentage of smolt entering the power station area that were lost due to this being a hydropower station instead of a free-flowing river. For Kuhlemühle (Diemel), a probability estimate indicated that 0-8% of the smolt that passed through the Archimedes screw suffered immediate mortality in the screw (**table 6.1**).

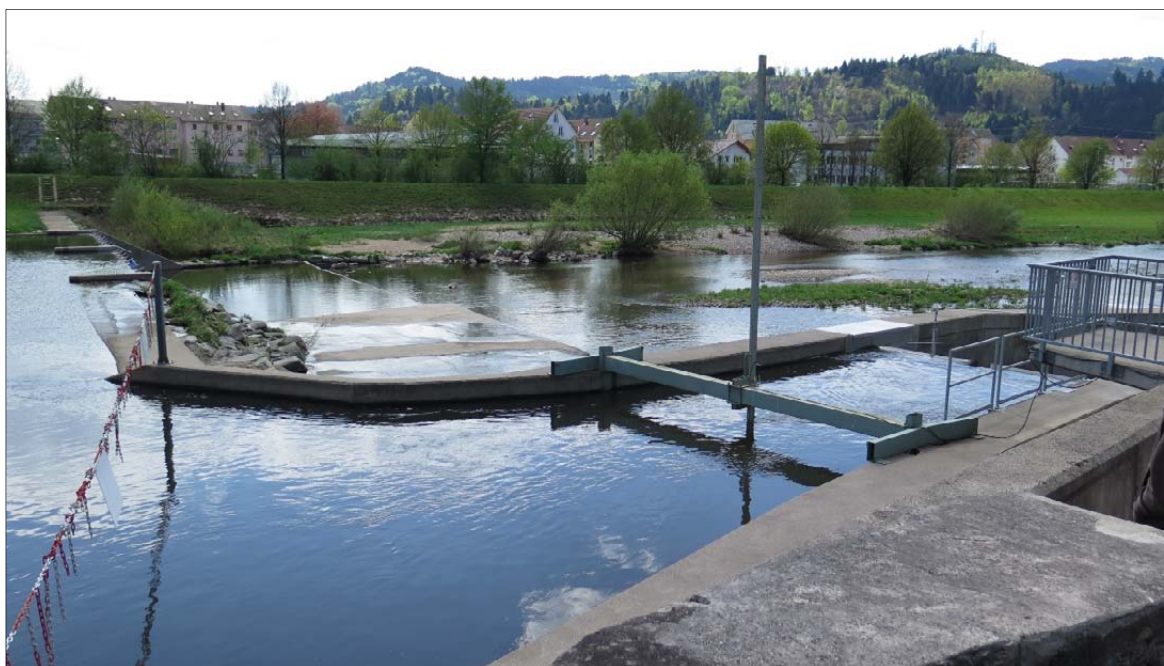
**Figure 6.2.** Dam and power station in Gengenbach, Kinzig. Photo: Eva B. Thorstad.

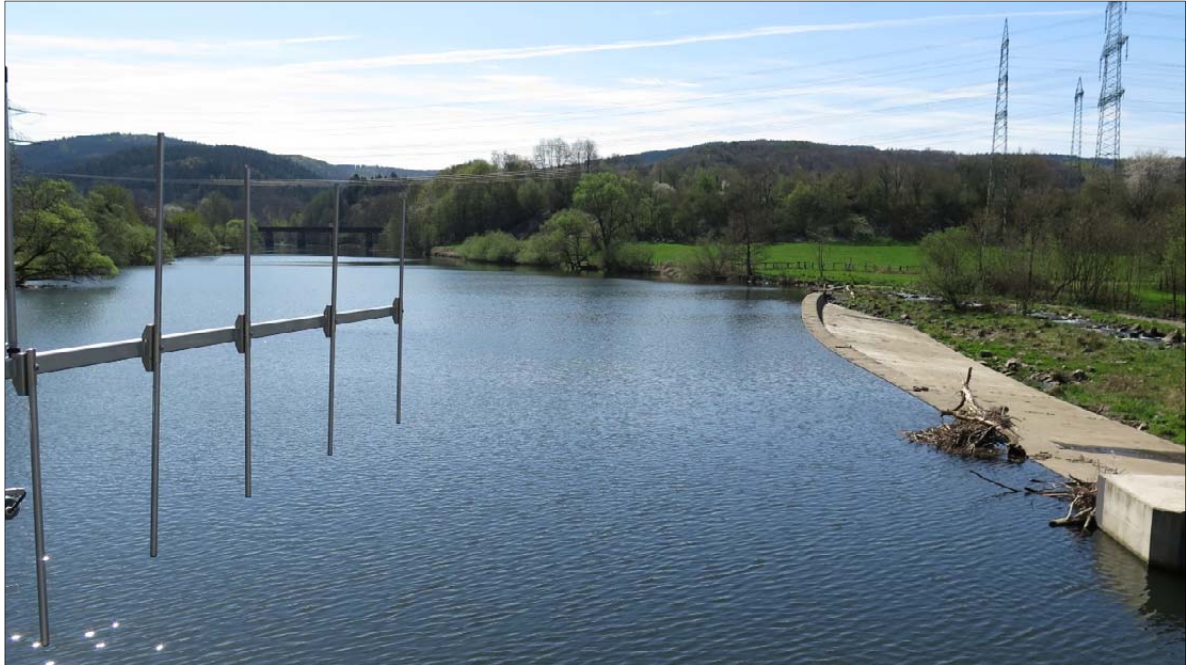
**Figure 6.3.** Lower part of reservoir upstream of Unkelmühle in the Sieg. Photo: Eva B. Thorstad.

Of smolt entering the reservoir upstream of Unkelmühle (**figure 6.3**), 7.2% (2014) and 17.1% (2015) were lost due to this being a reservoir instead of a free-flowing river. This was a much higher loss than upstream of the power station in Gengenbach (1.5% extra loss, **figure 6.4**) and Kuhlemühle (no extra loss), probably because these are not true reservoirs, but only short stretches with slightly slowed down water velocity. The reason for the larger loss in the reservoir at Unkelmühle is likely that this is the largest reservoir of the three sites, being 2.3 km long, with slow-flowing water and more resembling a lake than a river.

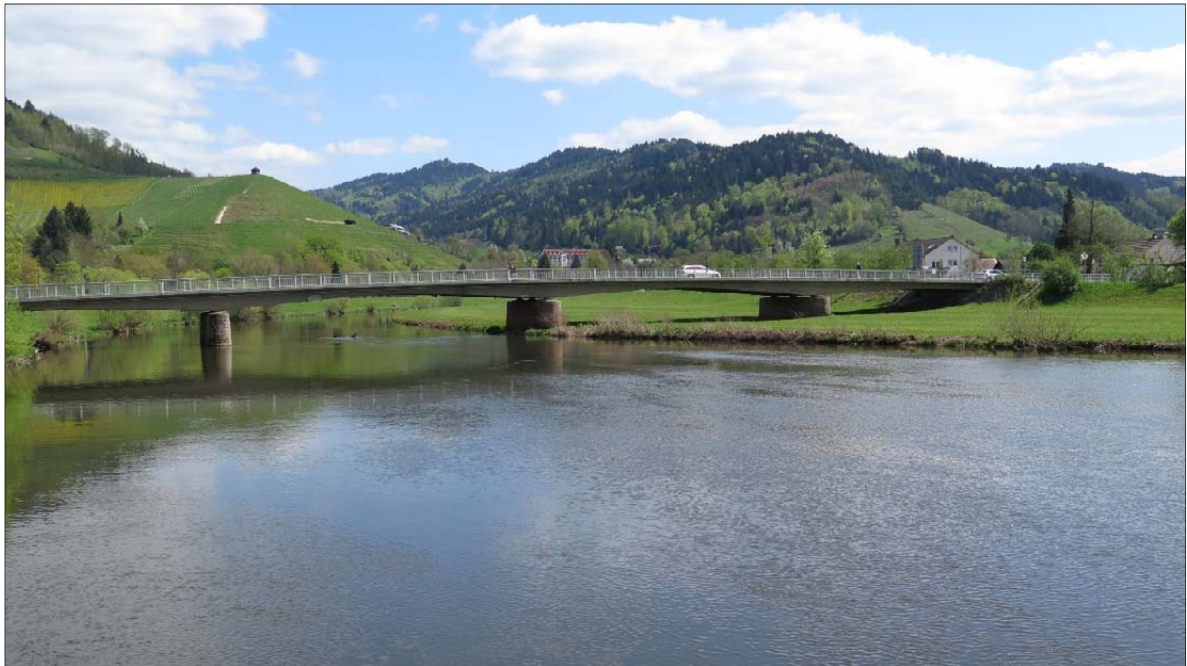
**Figure 6.4.** Lower part of the impounded river stretch above the dam at the power station in Gengenbach in the Kinzig. Photo: Eva B. Thorstad.
